PROJECT: GMAM 4079 'Lyndie Lou' - Reverser Repair: (10 - 18 Jan.)

File Name: GMAM Run - 2009-M01-24-FP1.Doc Date of Print: Wed, 04 Feb 2009

Doc. Author: Lee D. Gates Page 1 of 20

PROJECT: GMAM No.4079 'Lyndie Lou' – Drop Grate Repair:

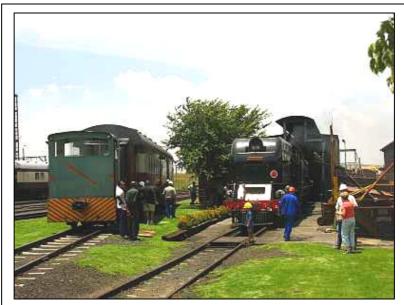
EP01 – A happy, busy scene at an old steam depot with our two green machines side-by-side and about ready to swap places. Not bad for a steam depot that should have been demolished years ago. This wasn't an 'Open Day' – just the people who happened to be on-site when this transfer run was to be made.

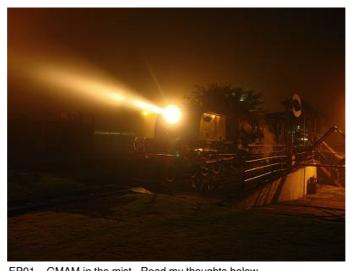
EP01 – GMAM in the mist. Read my thoughts below.
