1). INTRODUCTION :

2). PROJECT - GMAM NO.4079 – BACKHEAD WASHOUT PLUG REMOVAL :

3). PROJECT - GMAM NO.4079 – BOILER WASHOUT PLUG REMOVAL :

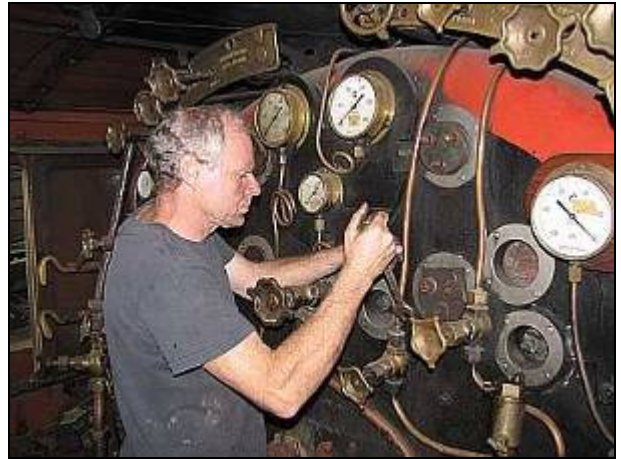
BH01 – Andrew King tackles a simple job for a change ☺, and in the comfort of the spacious cab too, while his teams are working in confined spaces underneath the locomotive or scrambling around the amply girthed boiler. Andrew is undoing the temporary blanking plates that are installed onto the four flanges of the water column glasses to eliminate possibilities of incidental external leaks for the hydraulic pressure testing.

Here's a detail ... that square headed 'bolt' in the recessed pocket, the one that has a white line on it, is the rightmost washout plug for the backhead's water space. The white chalk line is a marker that means that it leaked sometime during a preliminary boiler test and was marked to be tightened up at least once.

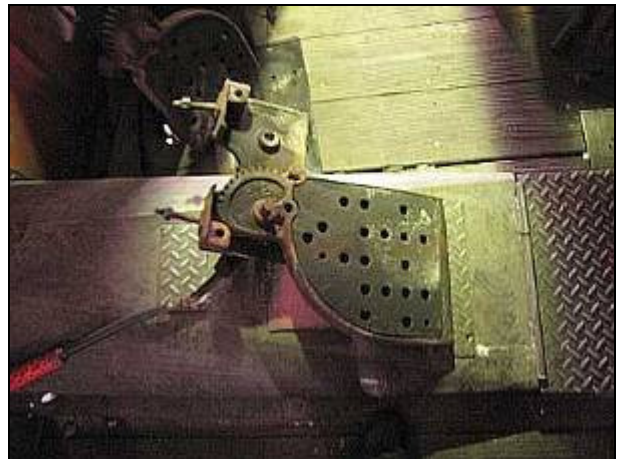
BH03 – Half a firebox 'butterfly' door that has just been removed from the firebox. The quadrant gear that usually connects the two leaves together is obvious. The doors aren't necessary to remove for inspection or testing work – but they make access for both men and tools a lot easier in the firebox. It also means those of, er, wider gauge around the middle, have a better chance of getting in.

Although the boiler has passed the Hydraulic Test – standing for 30 minutes pumped creakingly full of water at 150% operating pressure without leaks, the test will not be signed off until some cracked tube beads are repaired. So we will be seeing some repair work done in the firebox anyway, not to mention the rebuilding of the fire arch.

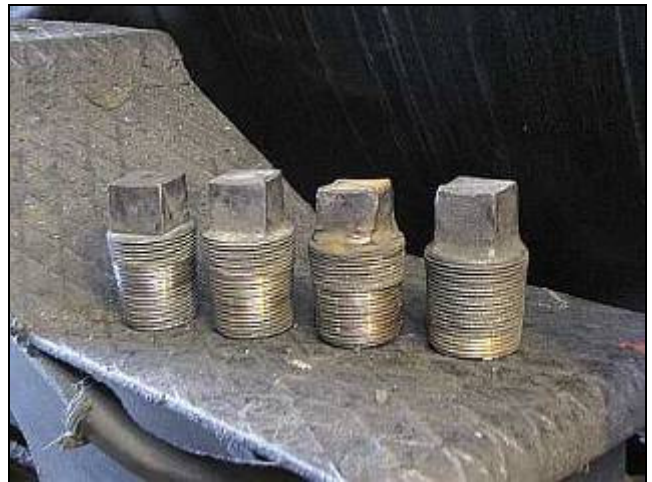
BW02 – Regular maintenance of complex machinery often brings about a paradox. While doing the original job, you observe something else that is wrong and needs to be fixed. Oh great. The snags list just gets a few more lines. But at least you fixed it under your own terms and not when handling a failure condition while in service.

A selection of four typically tapered washout plugs shows a failure condition developing on the right most plug. The shiny un-oxidised area where the threads were engaged within the boiler shell is rather thin. It is likely that this washout plug, which come in five sizes, is oversized for the hole from which it came. Regardless, it is bad fitting work.

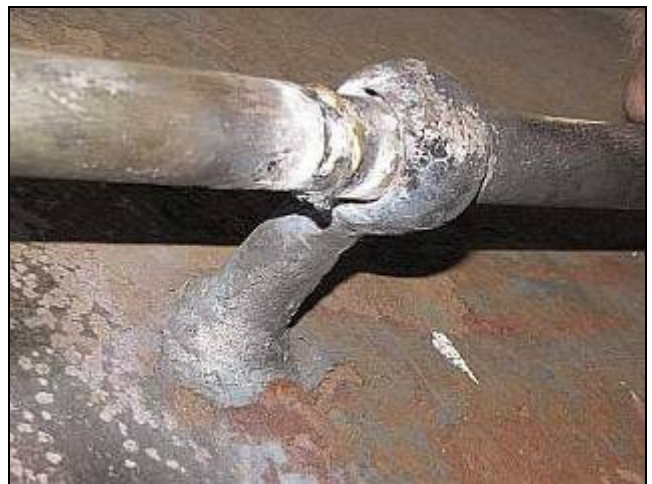
BW04 - The sobering thing about our steam locomotive hobby is that an accident can happen so quickly and without any negligence on the part of the hurt person.

It turned out to be a very poorly penetrated weld. The stanchion to the left is actually missing – so there is a long section of hand rail that is only joined by a female threaded nipple. You can, in fact, see the nipple's barrel just over the stainless steel boiler band in the left picture.

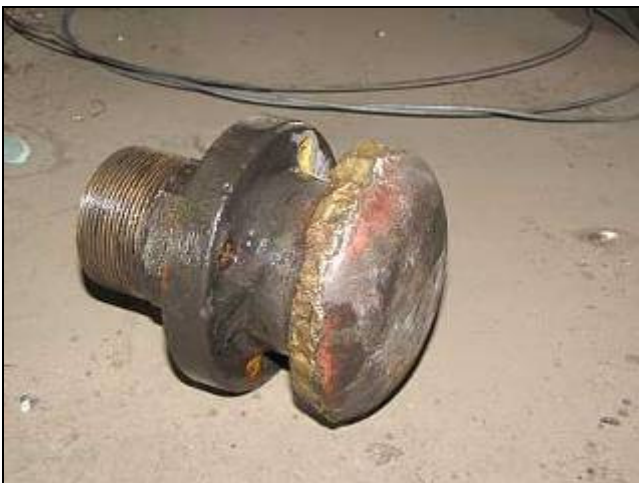
BD03 – The test plug that has just been removed. The blow down valves are potentially the leakiest boiler fittings that can cause problems during a hydraulic boiler test and they definitely have to be sealed. This test plug would fit any late era SAR locomotive once the blow-down scuttles (drums) have been removed.

The under-slung blow downs on the Garratt are harder to reach, with potentially very rusty and corroded bolts because of their location. Removal and subsequent blanking also requires making up a three-hole blanking plate as well as gaskets to suit. It is far easier just to remove the blow down drums and bung up the pipe work.

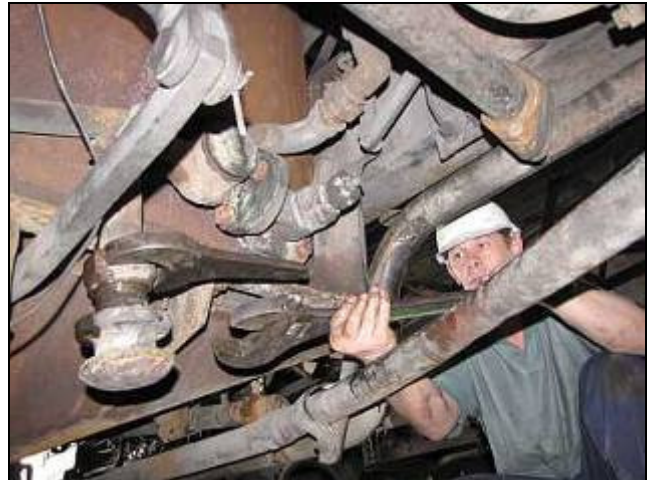
BD02 – Lucas Dreyer is using two wrenches at arms' length to get the blanking plug off. Above his head is the left side water main, and under his hand is the train brake vacuum line. The separate stop valve for the blow down is obvious here.

One of the blow down valve assemblies has been discovered to have a fractured flange.

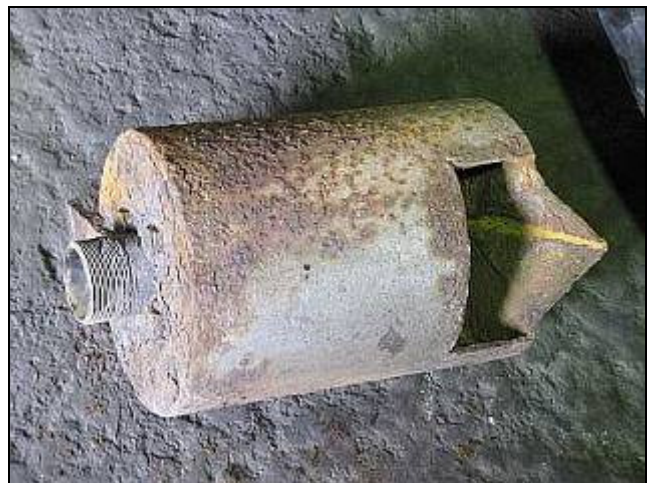
BD04 – Here is one of the two blow down drums, sometimes called 'a scuttle', with the inlet on the left. This one looks pretty scuzzy on the outside but the metal work is actually quite thick gauge and is still in good shape. Some of these drums end up paper-thin from rust at the outlet.

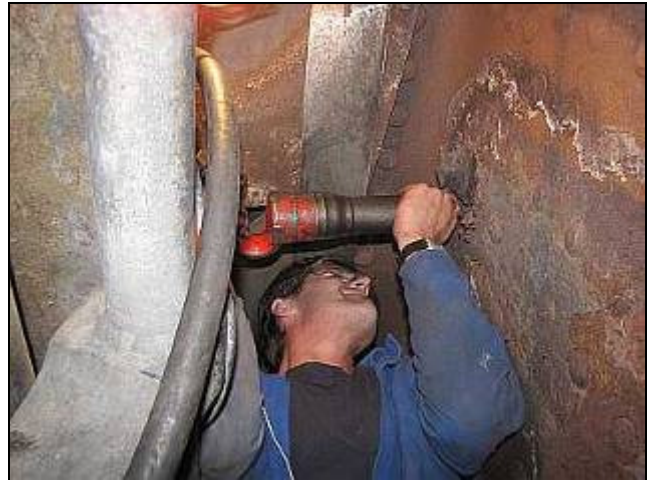
TP02 – Here's Dawie 'caulking' stay heads, working with arms over his head and in that confined space. The term 'Caulking' is a bit misleading as no caulking is actually applied – it currently refers to the process of peening the edges of the rivet-like heads of the stays back to the plate-work to establish a pressure tight seal.

You can see by the rust and lime scale marks that this wrapper plate has been seeping for a while. As awkward as this position looks on the GMAM, a conventional locomotive has frames at that point which makes access very difficult indeed.

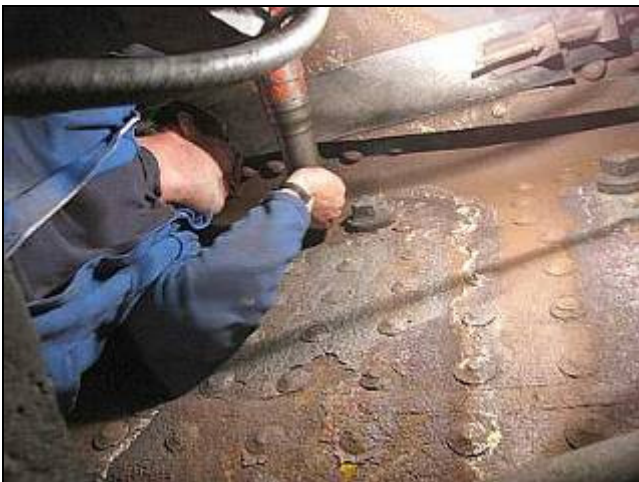
TP03 – The uppercut shot. The reason why these stays are leaking in this area is because the position of the washout plug interrupts the regular pattern of braced support. The location of the plug means that there is an unavoidable one-rivet-wide area that isn't braced – with a potential steam pressure of over 14 tons per square centimetre. The inevitable expansion and micro flexing loosens the stay heads over time.

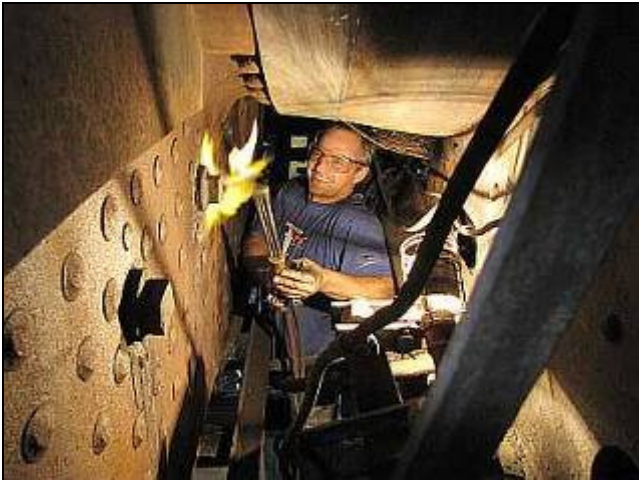
TW01 – Michael Thiel came in after lunch and he was soon sent down to tickle the GMAM's rusty belly button. The fellows had a cursory twist at those five plugs but they were as stubborn as expected. No one was surprised when the heavy artillery (aka, the acetylene trolley) had to be called into action.

A cheerful looking Michael is applying the first flambé to heat up the plug, burn off some of the oxide and force the washout plug to expand. Unfortunately, the thick steel plating, with which that tapered plug is so lovingly embraced, 'sinks' the blow torch's heat away quite effectively.

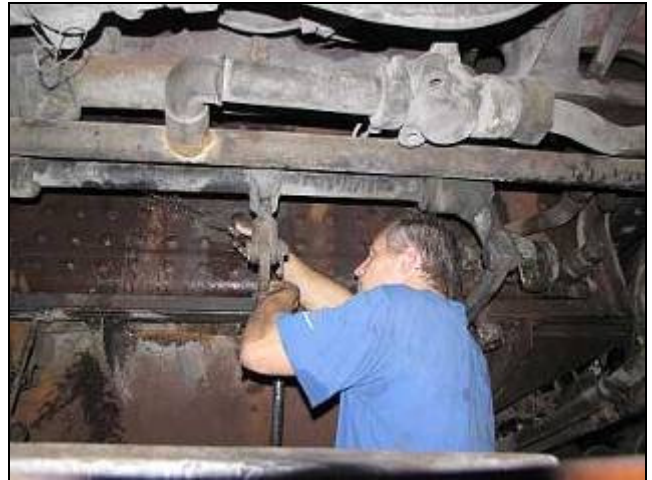
TW02 – Once the washout plug has heated up nicely – a sudden chilling with fresh cold water will hopefully cause enough contraction to break the grip of the threads and the corrosion therein.

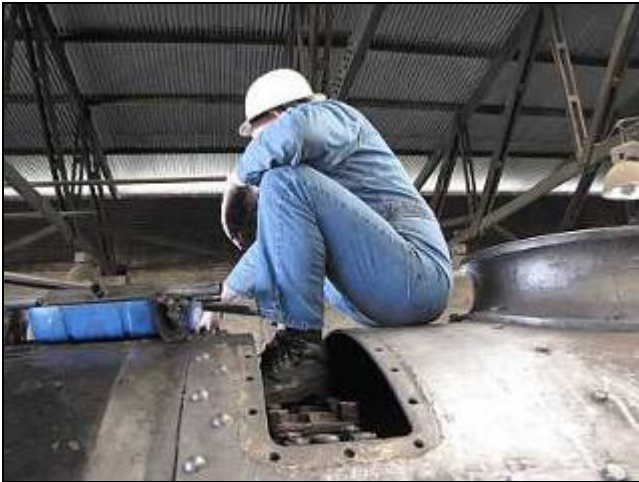
RG01 – Aidan McCarthy folds himself up comfortably into a surprisingly compact package with the aid of the deeply recessed regulator pocket on the GMAM's smokebox. The superheater header is physically located directly under Aidan's 'Big-End.'

The regulator valves always have to be opened up and specifically sealed for boiler testing – as any incidental leaks here may cause a false leak detection for the boiler. (Pressure loss.) All of these valves have been removed and re-ground. They are usually sealed with silicone for the test as well.

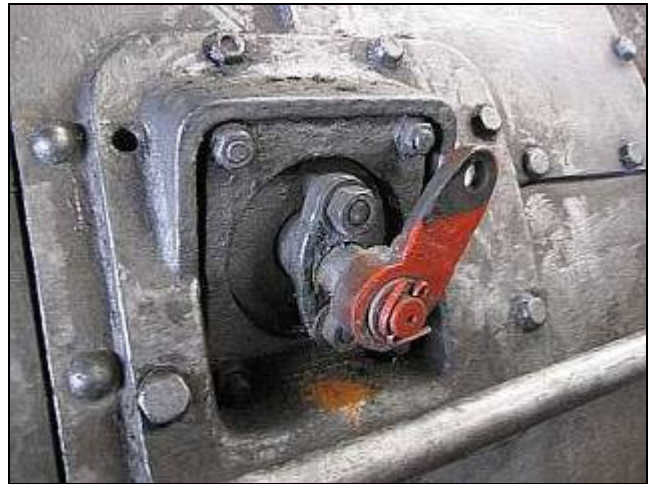
RG04 – Details of the regulator crank. Nearly all 20th century SAR locomotives have cranks that are closed when facing forward, because of the use of a relay rod halfway along the pull rodding. (You give her some 'wortels' by moving the fore-rods back.)

This crank is a frequent leak point for steam. Most glands on a steam locomotive only have to handle reciprocating motion. This gland has to handle rotating motion, which tends to open up the ends of the cut sections of graphite rope that make up the gland packing.

Notice that a bolt has gone missing - fallen out or left out by some naughty fitter along the way?

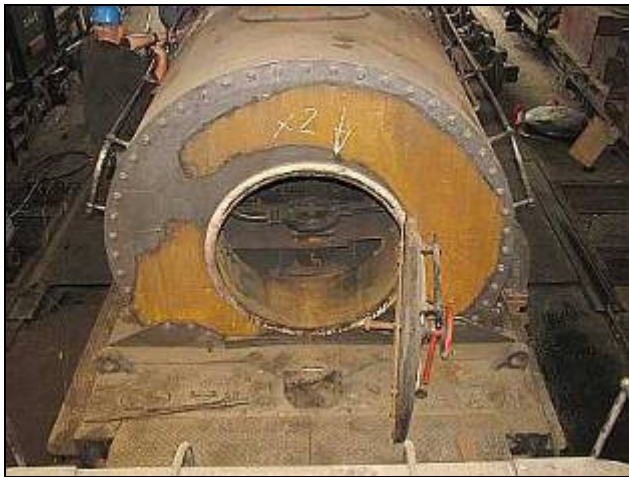
RG05 – An ominous number 'two' scrawled on the smokebox front plate in Andrew's hand writing. That 'two' could mean anything, like two leaky tubes found, or perhaps two superheater elements. In this case though, it simply refers to two front tube plate washout plugs that started weeping right at the end of the hydraulic test.

The front end does look rather rough but it is just surface rust. The paint that was previously applied was a thin mixture of graphite and silver. The paint got partially burnt off on the last run and water got underneath in storage. All the loose paint has been ground off.

The rust will be sanded off and the front end repainted before entry into service. Most locomotives with a conventional self-cleaning smokebox tend to burn their exterior finish at the lower half between 5 to 7 o'clock, especially if the smokebox char isn't removed regularly. The GMAM has centrifugal char separators arranged radially around the door opening and thus the heat is spread more evenly around the sides and later, the top of the door.

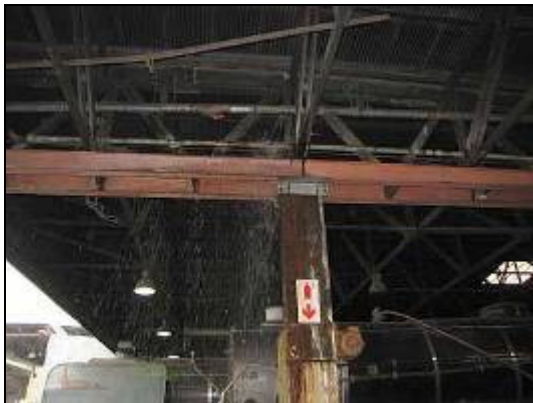
M09 – Some outstanding depot maintenance work becomes apparent during a mid afternoon rain storm. The drain pipe in the valley between the two gabled roofs of the 15M workshop has been attacked by the oxide moth. The rain water cascades incontinently next to the 15CA. It is a relatively easy repair though, requiring a wrapper patch and some hefty jubilee clips – but is a scaffold job because of the height.
