1). INTRODUCTION:

File Name: FP-3046 Steam Test 4 - 2110-M04-09.Doc Date of Print: Tue, 20 Apr 2010 Doc. Author: Lee D. Gates

REEFSTEAMERS DEPOT REPORT -STEAM TESTING OF 15F 3046 (9TH APRIL)

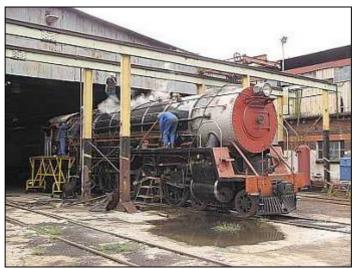
ST12 - Crew at work.

With Victor and Shorty beating some torque into their recalcitrant pipe union, Andrew King stands above the firebox and ponders the increasingly violent steam leak skirling from the manhole cover. (Dome) As the pressure was starting to rise, those two steam leaks were becoming increasingly volcanic. Andrew wasn't so much worried about the manhole cover's copper-ring gasket blowing out, but the fact that he would be working on the safety valves right next door. He's just about to remove the split pins and the bonnet nuts from the four still-quiescent Ross pop safety valves.

On a machine in service, a leak like this would be totally unacceptable as it would eventually cut through the metal work with the constant abrasion of the steam. This is how valve seats get incapacitating notches from the tiniest imperfections.

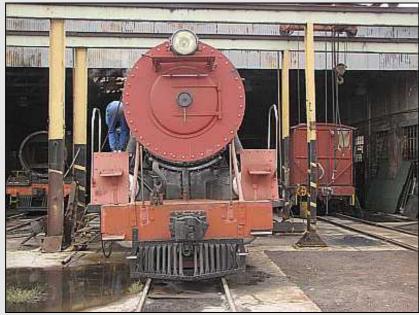
ST13 - Front view of Class 15F No 3046

Here's the front view of the iron lady in question. That smokebox front cover was an exercise in frustration as the holes were out of alignment. It appears that the front cover had been swapped out from a different locomotive in the past, one that had a slightly different bolt position on the front flange. This plate was drilled out with a set of new holes and the existing holes blanked. But the misalignment tilted the opposite way. A third set of holes had to be drilled to get the alignment that you see here. The holes left behind were firmly plugged up with custom turned 22mm plugs. When the front plate was re-primed after the plugs were inserted - you actually cannot tell where they have been put in.

This primer-tinted front view is educational as the sloped front valance plate is missing from between the two red painted riser boards with their steps. Thus, you can see clearly how the two cylinder and valve assemblies (the 'Steam Chests') bolt together. The semi-circular section is known as the 'smokebox saddle' and is actually the only area where the boiler of a conventional steam locomotive is rigidly attached to the locomotive's frame. Along the length of the boiler, support is given by transverse waist plates, which are designed to buckle slightly as the boiler and firebox expanded with the heat. The boiler assembly grows longer and the backhead actually moves back slightly on sliding mounts into the cab.

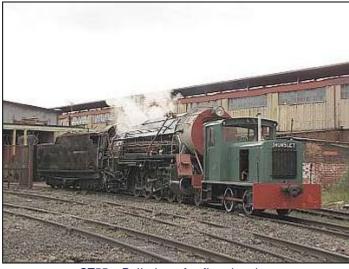
ST55 - Pulled out for fire cleaning.

Class 15F No.3046 looks a picture being carefully pulled out amongst the clinkery back-end-of-the-moon wasteland outside the 15M sheds. It would have been sweet and poignant to have been able to say that the locomotive moved under her own power but, unfortunately not. The reverser's power valve gaskets had blown and we had no heavy weight graphite Klingerite to replace it. The brakes didn't have enough suction to lip up a wine-gum. So the locomotive would have been dangerous to move although she could have easily run under her own power if the regulator was reconnected. It would have just been the stopping that would have been the problem!
