## RAISING FUNDS FOR REPAIRS

PLEASE HELP US GET OUR IRON LADY BACK ON THE RAILS

**2). PROJECT SUMMARY, CLASS 15F NO.2914 RESTORATION :**

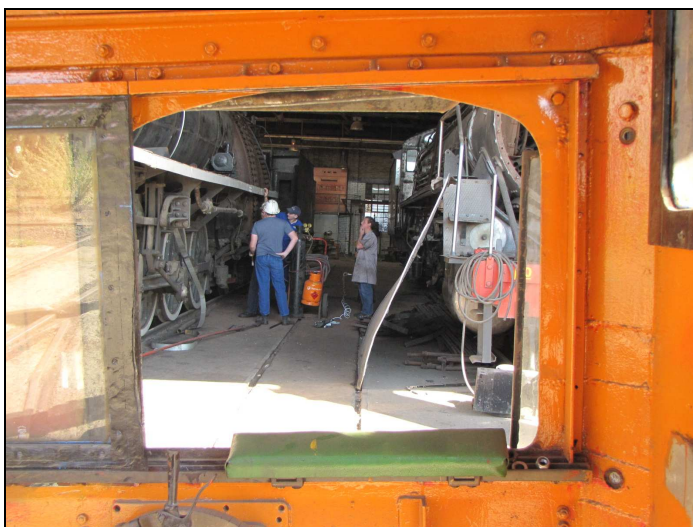
P02 - At the start of the job, after stripping the fire arch and the grates for inspection, the cab had to be removed to provide access to the firebox's corner. Here, seen through the driver's window of the disembodied cab, the strip-down gang is planning their first angle of attack. (Which would be the firebox throat plate covers – Aidan McCarthy had already exposed the firebox's tapered flanks during the previous weeks.)

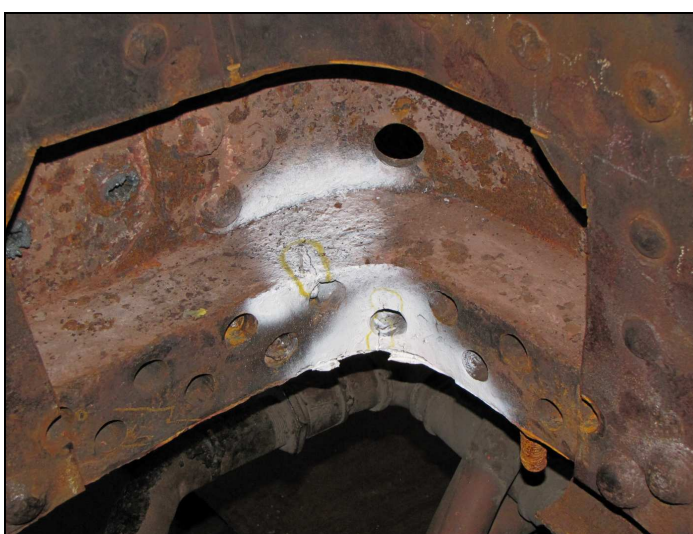
When the damaged area was cut away within the firebox, cracks were found in the foundation ring, which have slowed the project down a bit. But the rest of the boiler has been visually inspected and appears to be sound. The smokebox had some surprises for us, including a patched cover plate sealed with window putty. The various failed seals at the draft-end account for the locomotive's poor performance.

P03 - This is a view of the RHS rear firebox corner with the thinned section already cut away. Visible against the white paint are two of three revealed cracks in the foundation ring. A new plate of certified steel has been procured and has just been forged to fit the corner. It now needs to be recertified to confirm that the heating required for the forging has not degraded the metallurgical properties of the patch. Meanwhile, we are seeking quotes for certified welders to grind and weld those cracks closed and later, to install the patch for us. The staying and riveting work will be done by us.

But for now we have the funds to get the essential repairs done to the firebox's foundation ring and to patch the firebox corner, including visits from the Boiler Inspector as necessary. So far, we have managed to synchronize his visit with those required for the Class 12AR No.1535, which is undergoing replacement of eight worn boiler tubes at the moment.

Based upon the advice from the Boiler Inspector, we can start trimming and finishing the patch. Said patch has recently been forged into the corner shape required, courtesy of Andrew King's old firm, Bosworth Engineering. (Thanks, guys.) At the time of writing, a sample of the forge-bent boiler plate is being tested to ensure that the heat of the forging process did not degrade the necessary metallurgical quality of the steel plate.

The cut-away patch area still needs some cleaning up though as we still have some occupied stay holes. Luckily, we have the equipment and the expertise to make our own firebox side-stays. We also have numerous flexible stay caps and washers in the stores, although they will need cleaning up, as they are somewhat rusted from careless storage at Millsite.

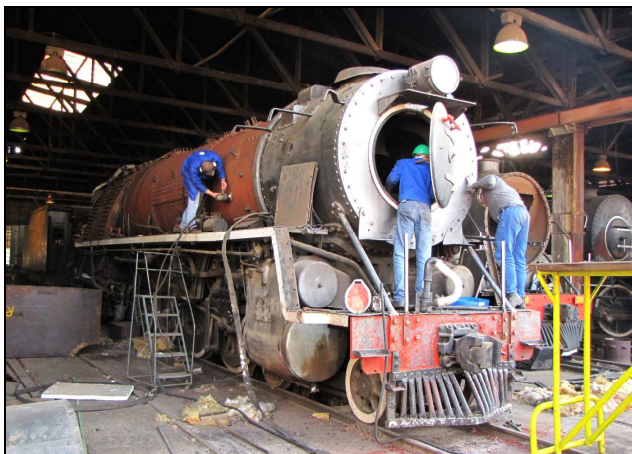
Reefsteamers last ran this locomotive in October 2007, to make use of the remaining time then available on the 3-year boiler certificate. She distinguished herself by blasting chunks of concrete from the chimney stack on the way home and the fire just would not burn thereafter. Although she made it home, she was quietly laid aside into safe storage, as there were more important projects to be done at the time. An examination by our Engineering Manager determined that the rear firebox corners had thinned, which is a known weak point on the old 15F's.

P04 - A busy 15M workshop scene – 23 June. It was the thinned firebox corner that precluded getting a new boiler inspection back in 2007. (We assumed that both corners were ‘wasted’, but only one was too worn for further service.) But on her last run, the locomotive was firing chunks of concrete out the chimney and barely drawing a draft. The saddle seal had been made with ordinary concrete instead of refractory cement, and the smokebox front plate was leaking badly. Notice that the locomotive’s cab has been removed – and a substantial part of the cab floor framing and the ash pan had to be cut away to access that firebox corner.

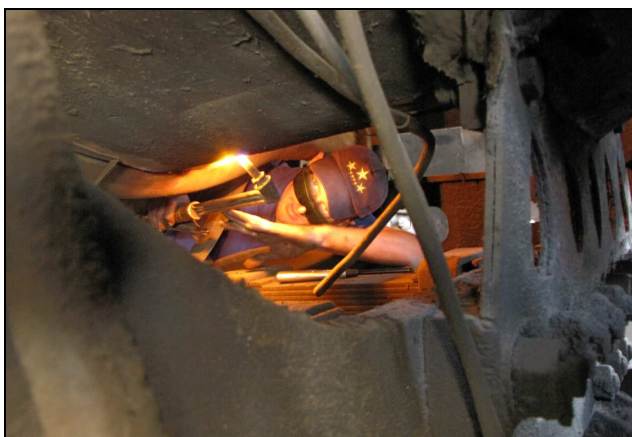
P05 - The locomotive was known to be full of half-baked repair jobs. We found that several of the boiler cladding sheets had been incorrectly tack-welded together at the bottom edges, as well as being incorrectly bolted, riveted and welded in other areas. It had all been forced together. Here, a patient ‘Hott-Nutts’ is pictured cutting extra spot welds in the confined (and gritty) space under the second course of the boiler.

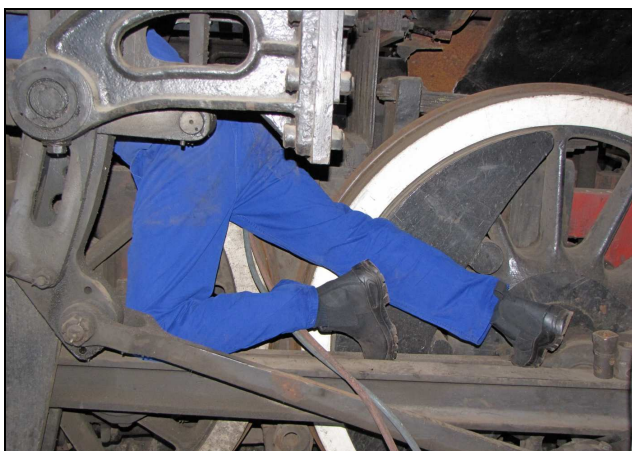
P06 - George’s other end in a MOST uncomfortable position. In theory, the cladding plates should be ‘floating’ after a few fasteners are removed from the crinoline rings and the crown brackets, and then the bands removed. In practice, on a half century-plus old locomotive, those fasteners are likely to be rusted solid, riveted, missing or welded – and we found all four issues on this rusty old grommet. What puzzled us was how awkward those welds were to get at in the first place – what a nasty job that must have been. It looks as though those plates had been removed before and were too distorted to be retained in shape with the fasteners and the boiler bands alone.

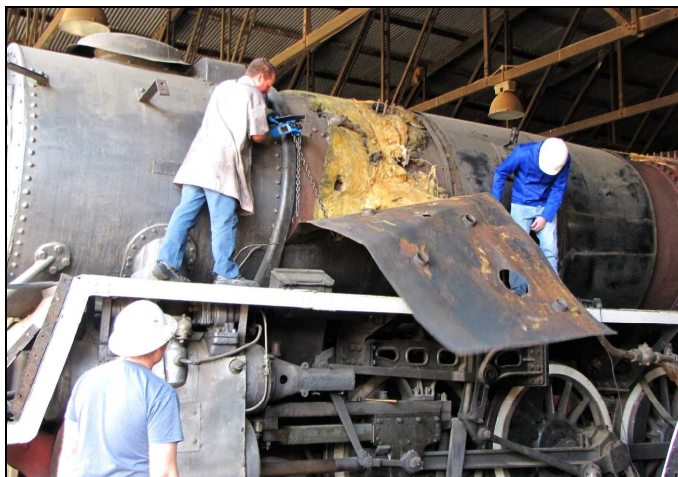
P07 - The stubborn sheet-steel boiler cladding is being winched off via one of the conveniently placed brackets of the smoke deflector. The metal work is a bit scruffy but not too rusty. But it needed to come away to reveal the boiler for a good visual inspection during the coming boiler testing phase. The boiler was known to be prone to external leaks. We suspect that we have found already some in the flank stays of the firebox, because of the previously hidden lime scale traces that were there.

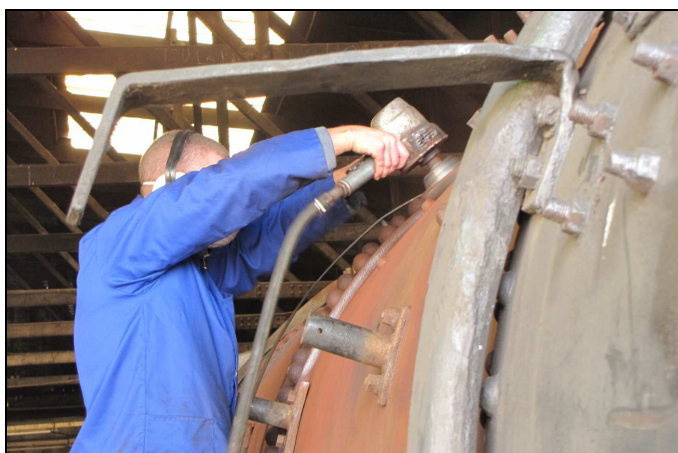
P08 - With his head 'framed' by the smoke deflector's rear hanger, Robert Cousins is doing the first pass of pneumatic-powered wire brushing of that exposed boiler shell. It is a LOT of area to cover and at all sorts of awkward angles too. The face mask is more for the remains of the fibrous thermal lagging than for the rust. When the boiler is cleaned, it is to be externally visually inspected and then coated with a good quality primer coat. The thermal lagging is to be replaced and new cladding sheets are to be made up – and sprayed with proper duco paint. We don't want to have to look at that boiler shell again for the next 20 years!

Thus, the locomotive is getting a jolly good above-walkways strip-down and the opportunity is being taken to de-rust and seal the boiler barrel, replace all the aged thermal lagging and putting on brand new cladding sheets, with top quality duco paint.

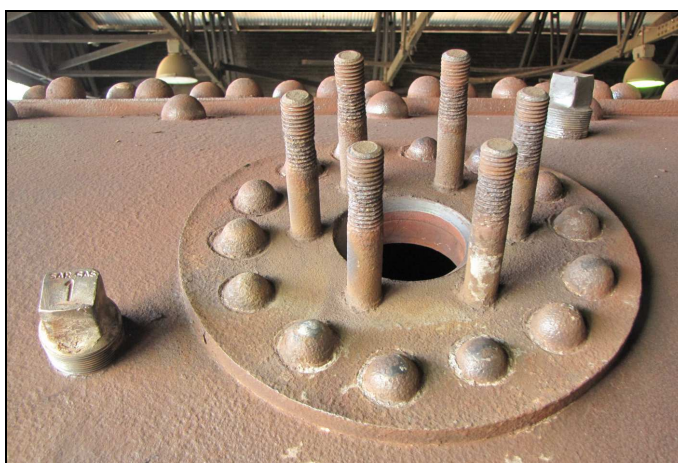
P09 - This is some of the boiler fitting detail that is revealed when the obstructive cladding and the thermal lagging is removed. This is the left side clack-valve mounting pad. Notice that the washout plugs have been cleaned, revealing their natural bronze colour. (Usually just a grubby oxidized black) These mounting pads always need checking as they can crack. The threaded studs are worn here and need to be replaced.

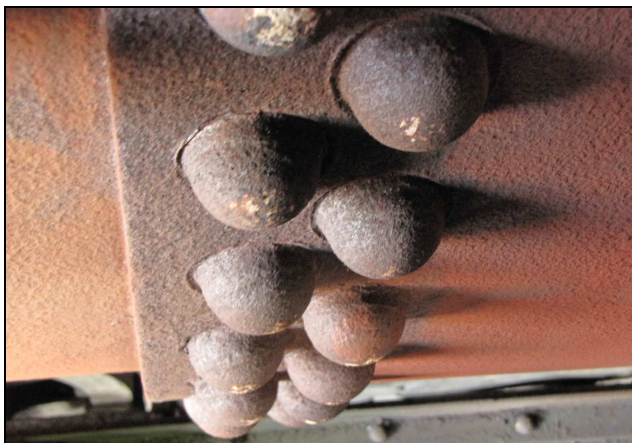
P10 - Here is a close up of some of the recently cleaned rivets at a lapped joint at a boiler course. You can still see the indented circumferential marks from the riveter guns from so long ago. It would seem that the thick platework used in a steam locomotive's boiler could never rust out – but deep localized pitting on a neglected locomotive can render a boiler unusable. That's one reason why we have to thoroughly sandblast and externally check the Class 12R No.1947's (Rosie) boiler – just for the rust that developed on an unprotected boiler shell under neglected cladding and water-absorbent thermal lagging.

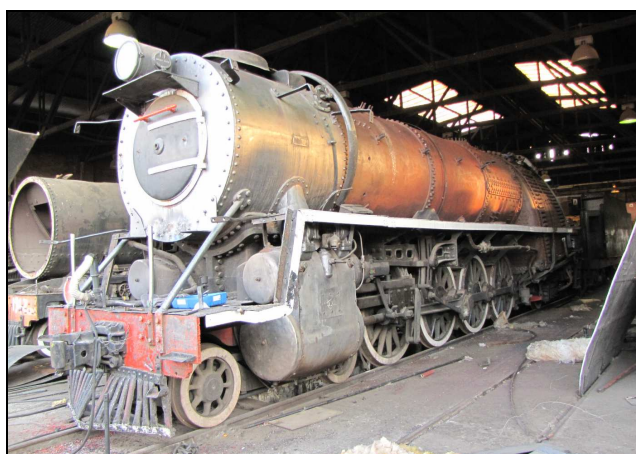
P11 - Here is the class 15F all stripped down with a 'poodle cut', with the exposed boiler shell glowing in the late afternoon sun. That smokebox front plate and door needs to come off to resolve a leak situation. But we found yet another bodge job in the reconnaissance for the process – the headlamp is WELDED into position. The final product is to be spray-painted in duco-based gloss black, with no white trimming or lining. She will run with a black etching-primer smokebox above a red buffer beam, and with bare steel wheel rims around black wheel centres. She will also permanently display a commemorative plaque to credit those who donated towards the restoration.

The front buffer beam looks oddly pale because the endless layers of red paint are being chipped off.

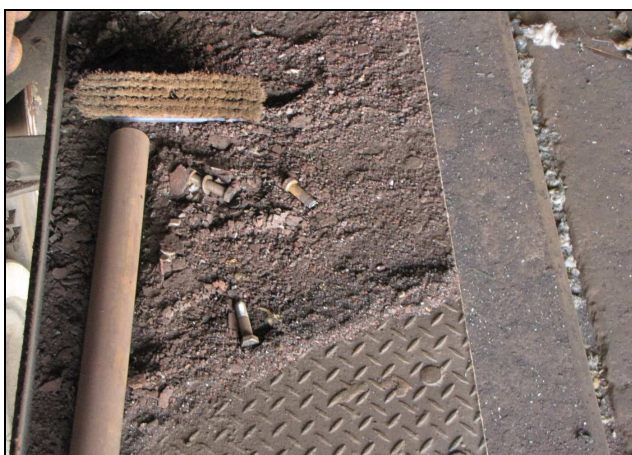
P12 - All that rust has to go somewhere and a lot of it just sifted down onto the running boards. A whole lot of rust came off that boiler and it wasn't considered to be 'all that rusty' as steam loco boilers go.

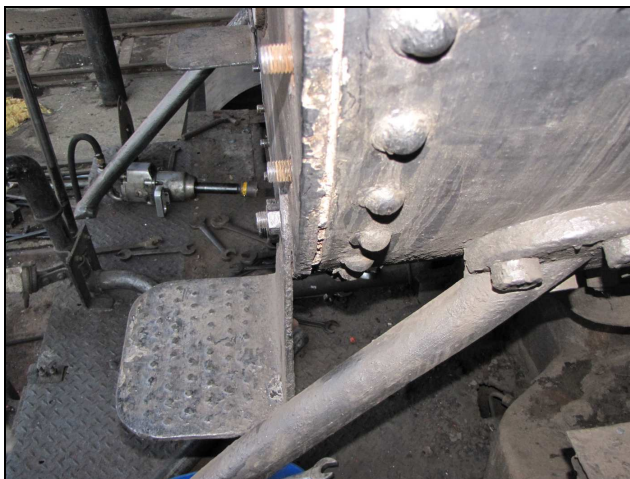
The locomotive's front end has proven to be rather leaky, with a patch on the smokebox door plate as well as a failed saddle seal. The smokebox door patch appears to have been welded skew, as well as being distorted from the heat of the process.

P13 - 15F No.2914 has a sullied reputation for being a poor steamer under load, although she usually fires up and steams up OK at standstill. During the stripping work, we found that the smokebox front plate doesn't lie flat and the gap was sealed with what looks like window putty! No conventional steam locomotive will run well with a reduced vacuum in the smokebox, irrespective of the boiler's internal condition or the skill of the coal-cat at the other end. Incidentally, this shows one reason why Reefsteamers is eliminating the traditional heat-resistant graphite paint from our fleet. When thickly applied, it can cover a multitude of sins!

It still needs to be removed and then we can discuss repairs, pressing, shimming, or perhaps borrowing a front cover plate from a scrap 15F. But the latter option isn't as easy as it sounds, as you often find detail differences in decades-old engines. We might find ourselves wrestling with a whole new set of problems with a 2<sup>nd</sup> smokebox front plate that doesn't fit for some reason! Better the plate that you know!

We could, of course, just scrape out the old putty around the front flange of the smokebox and put some fresh lashings of viscous gunk in of our own! And then apply lots of heat-resistant silver-coloured graphite paint to hide the resultant groove. But that is NOT the way Reefsteamers that does things! And that putty will always be a booby trap that is prone to sudden failure when it cracks and falls out – which could be at the far end of a long distance trip somewhere.

We don't expect the smokebox cover repair/replacement task to add to the financial cost of the project – it will just use up more of our time. It is, however, essential work as the locomotive will otherwise just knuckle-under and die on the main line if she cannot draw a draft to keep her fire hot.

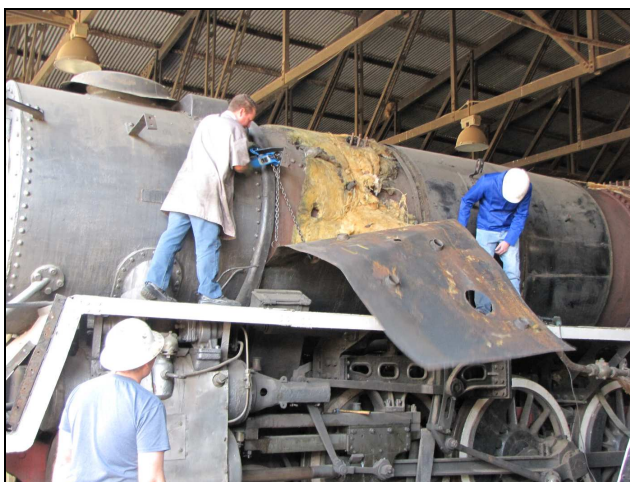
P14 - Simon Bennett is pictured using a ratchet winch to drag that piece of cladding out – even though the extra belly welds had already been cut away. Note that this sheet is properly marked 'L1' for 'First Course – Left'. You can see how the rear side of the sheeting has started to rust. The strange looking protruding cylinders are 'inside-out' sleeves for the washout plug pockets.

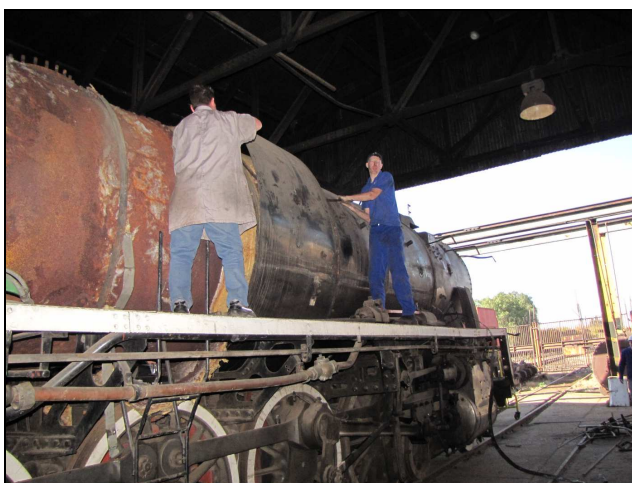
P18 - The plates on the right side of the locomotive came off a lot easier as the welds had been removed. But the front two plates still needed to be winched to get over the obstruction presented by the reverser.
