1). INTRODUCTION :

Here is the latest Reefsteamers Depot Report, issued on 24 February 2013, which covers events up to the previous weekend. This week's photographs have already been uploaded and processing has begun.

2). PROJECT – 12AR 1535 BOILER WORK:

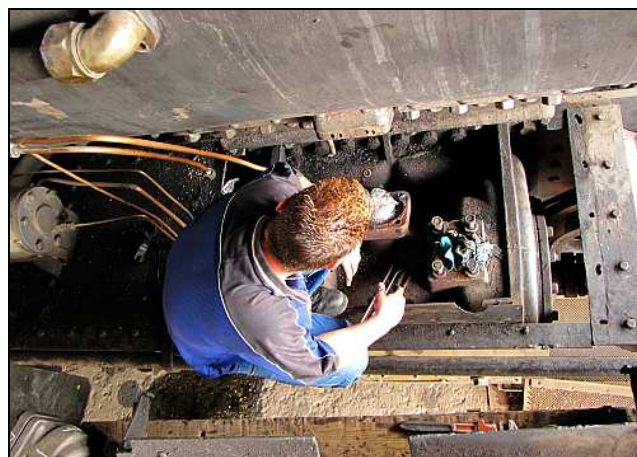
B03 – The next project would be about studs, and not the lusty male variety either. They would all need to be removed, cleaned and refitted, and replacements made for those that were cut down. Visible here through one of the steam down-pipe ports are the studs for a vacuum breaker.

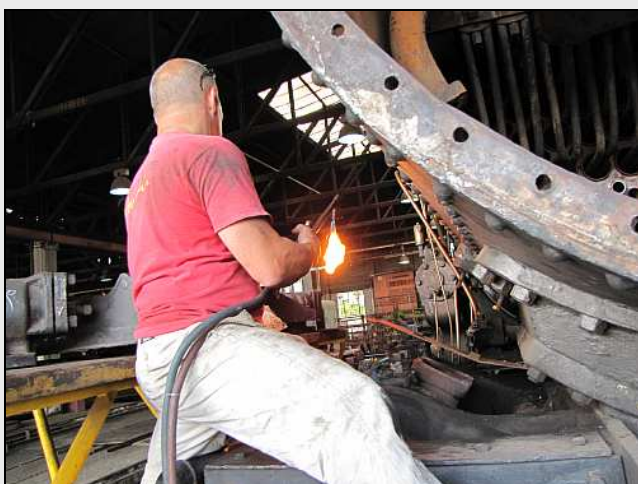
B14 – This picture shows the exacting nature of this work – Michael had to burn away the remains of the cut-down studs without damaging the flange. If you look closely, you can see some of the old threads are still intact. Naturally, the holes will be re-tapped, even drilling out, if necessary.

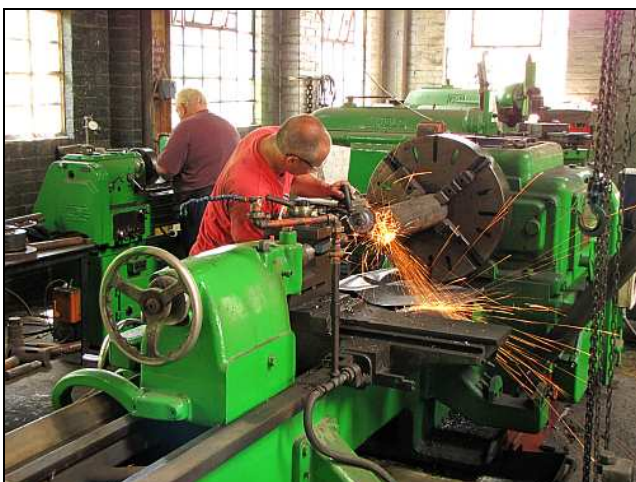
B22 – James needed to turn out the interior surfaces of the flanged collars. We are using pipes of a slightly larger external diameter. The right side collar needed more cleaning than the left, as a slightly smaller outside diameter pipe had been used on that side by railways personnel.

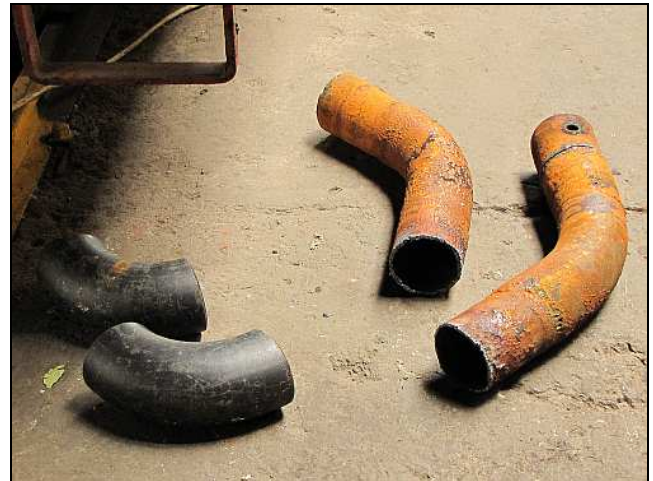
B25 – Mike exchanges Millsite Style for ESKOM Style and turns the big lathe by hand to cut the inner chamfer. This pipe has to withstand boiler pressure, so the welded edges have to be chamfered for full deep penetrative welds.

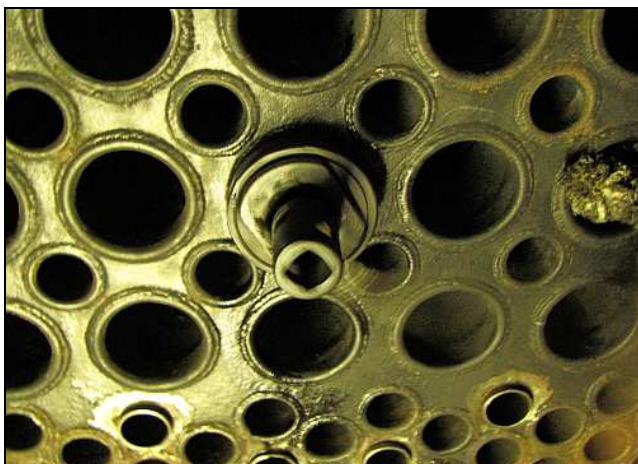
L02 – Michael has been to The Mountain, and he is the only one of the boiler boys who can stand up straight in the 12AR's firebox! We had one flue and two tubes reported with cracked beading. You can clearly see the weeping water from the flue tube currently being re-expanded.

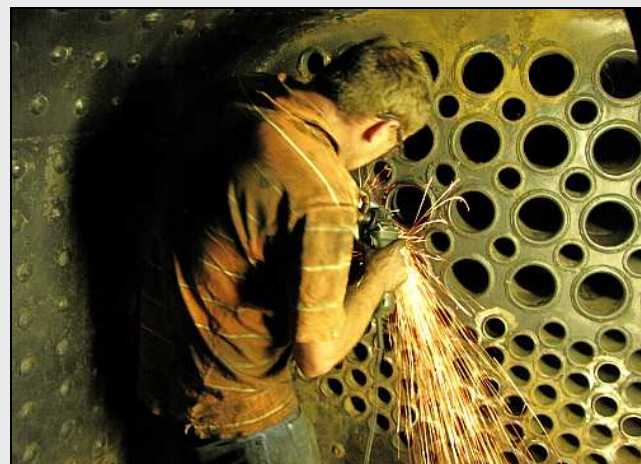
L03 – Contrary to popular belief, the rolled-over beads are not intended to seal the boiler. The copper ferrules do that job. You can, in fact, see several new 'naked' boiler tubes that had already been through a boiler hydraulic test (Up to 1650 kPa for 3 hours) withOUT being rolled and welded.

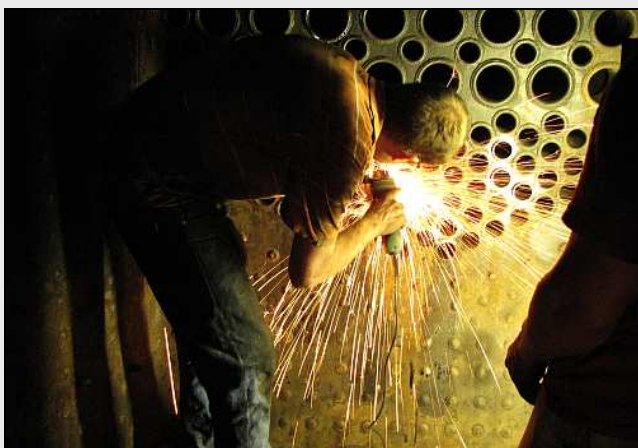
L04 – Shaun grinds down the flue's bead to try to find the crack and to dress it for welding. As it is the copper ferrule that is the actual pressure seal, it is also possible for a tube bead to crack without weeping water, if the ferrule is intact. Those ones are quite difficult to spot without weep water.

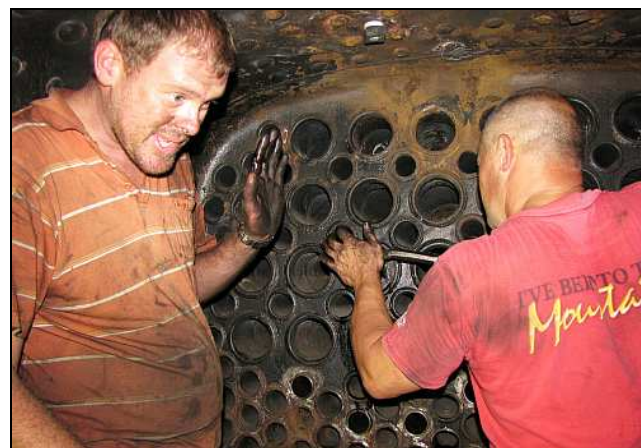
L05 – The 6ft3 Smudge-miester literally bends to his task and dresses the cracked bead of a tube, while the boiler is currently being filled by Gordon for a hydraulic pre-test.

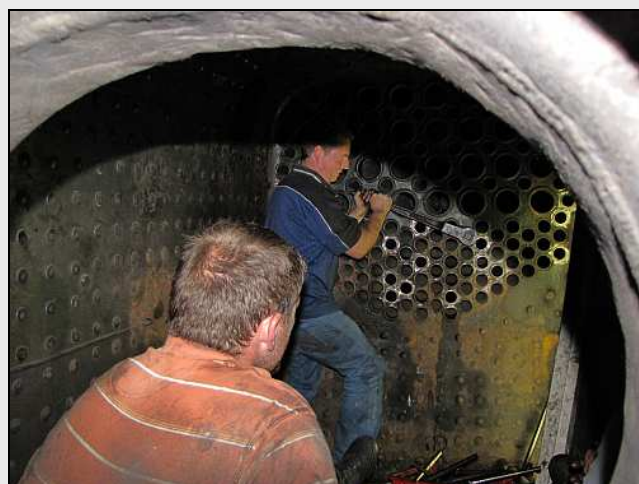
L11 – Dr. Smudge looks cheerful enough, but there was a little rat of worry scurrying within his mind. We had run out of taper on the mandrel for the flue tube's big expander, and two of the smaller tubes just would not stop weeping.

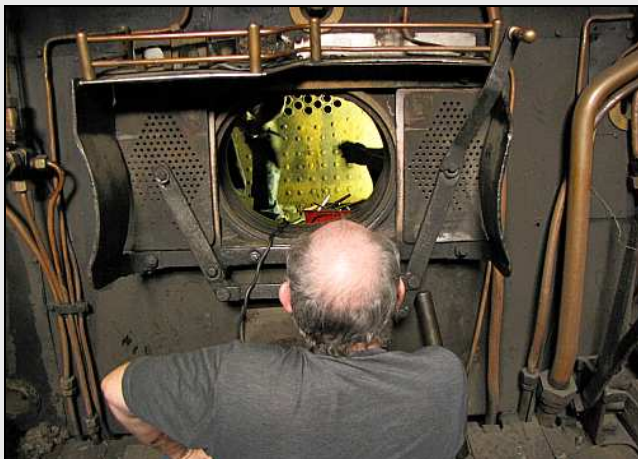
L12 – While Simon is now wrestling with another weeping tube end, Shaun has to make a call to go on or quit. Tubes cannot be just expanded indefinitely as it spreads the metal, thinning out the tube walls as well as the ferrules.

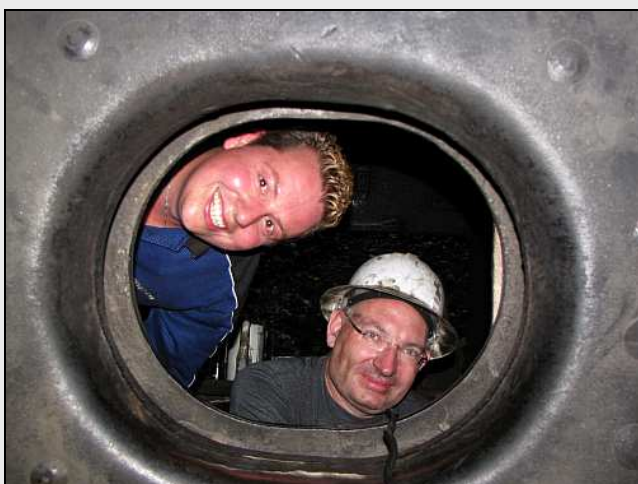
L16 – He is really putting some grunt onto this one! (Boiler is at 1600kPa.) What makes this tricky is that water gets into the doughnut-shaped cavity between the bead and the copper ferrule. When the tube is expanded, the trapped water is squeezed out under pressure. The trick is to work out if it is a squirt or a leak before over-expanding the tube.

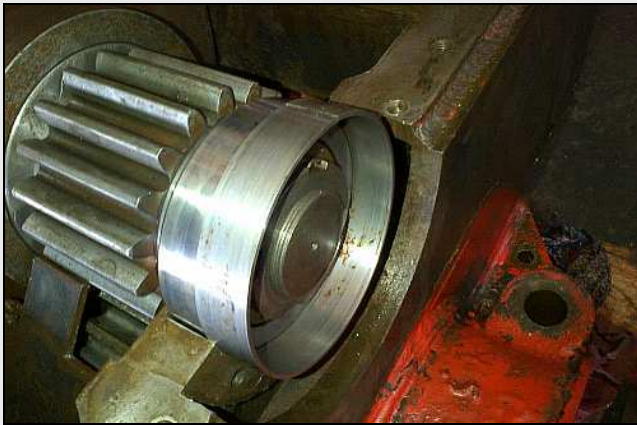
G06 – The jackshaft and counterweights went in easily, using the forklift as a hoist. And they had gotten two of the four frame sections bolted together. But the reversing shaft caused some heart palpitations as the new roller bearings were too small for the bearing seats. (Pic by VLM)

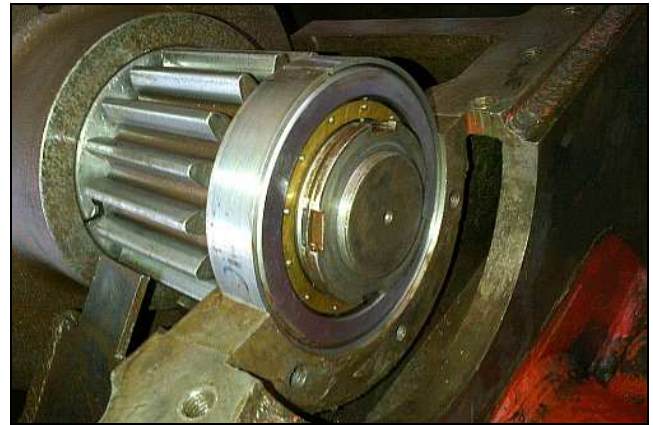
G07 – They had forgotten the seating rings, as they had been stored separate from the rest of the components. Gordon found them. These bearings and the previous set (both metricated) are slightly smaller than the originals, hence the need for spacer rings. In fact, the first set of spacer rings were made from brass strip! (Pic by VLM)

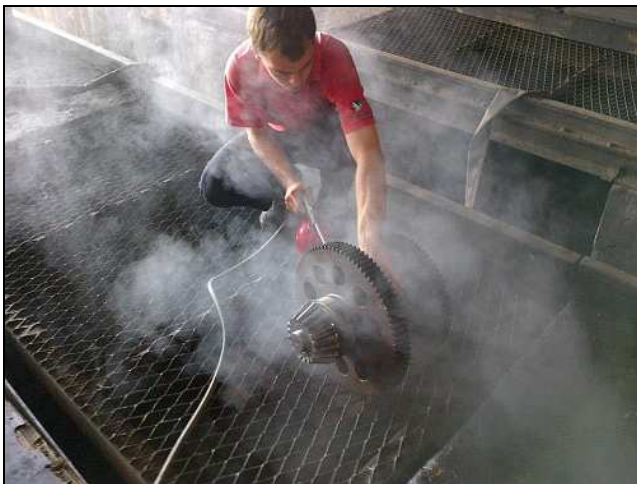
G08 – This gear is the jackshaft drive pinion. It survived the break-up of the jackshaft's old gear's teeth, but the old roller bearing got a good dose of the grindings via oil transport over the gear teeth. The canted steel ramp is one of two oil runners which fill up the 'upstairs' oil sump from this gear's drippings. (Pic by VLM)
