1). REMOVING THE RIGHT SIDE COMPENSATING BEAM – 01 MARCH 2014:

2). REBUILDING THE COMPENSATING BEAM – 15 MARCH 2014:

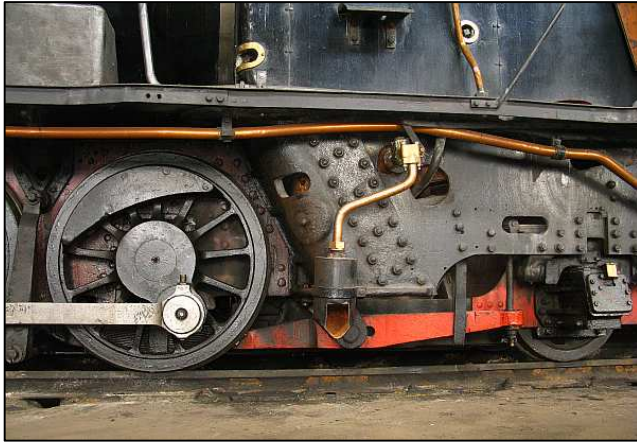
P01 - Most SAR steamers use a compensating beam in their rear suspension, like the red beam seen here. When the bissell axle (Right) is displaced upwards, the weight-bearing pivot (visible just behind the blowdown scuttle) only moves roughly 2/5 to 1/2 the distance upwards in relation to the axles at the other end. Thus, the spring-loaded vertical displacement of the bissell axle that supports the firebox end is reduced relative to the locomotive's frames.

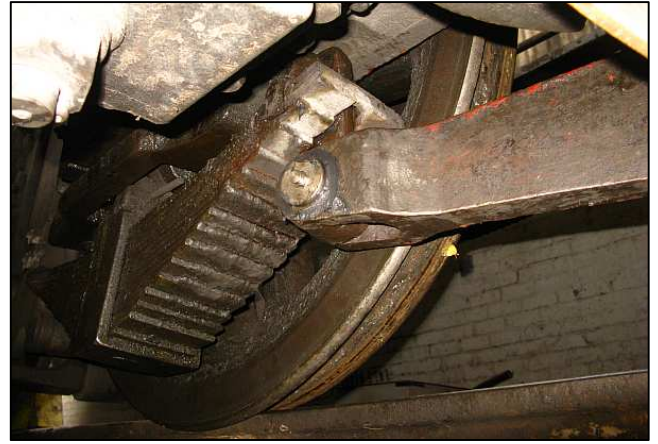
P02 - The other end of that big beam is connected to the rear driver axle suspension through a shackle. This flexes the leaf spring in the opposite way to the Bissell axle – like the opposite end of a see-saw. So, if the back end of the locomotive moves upwards over a bump, the rear driver wheel on the affected side is forced downwards. This keeps the weight evenly distributed on all of the wheels, assisting adhesion and reducing the stress on the frames.

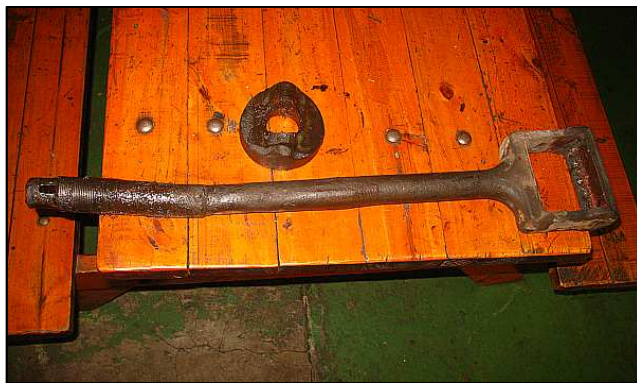
P03 - The center pivot bearing had worn, which meant the beam was standing 'knock-kneed' and leaning inwards at the top. This was bending the stirrup rod between the beam and axle spring. This rod was borrowed from 12A 'Rosie' and it was bent within two trips. (The original had been X-rayed, welded and straightened in the meantime.)

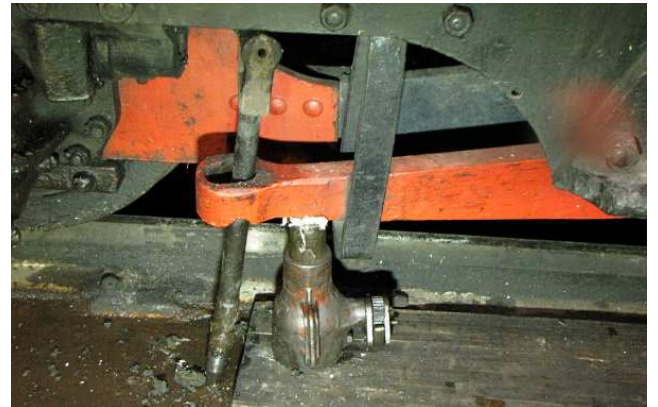
P04 - The first step in the job is to jack up the Bissell end of the beam to overcome the spring pressure on the cap to be able to uncouple the stirrup rod. The other end is then free to pivot upwards for the shackle's cotter pin to be removed from above the springs. This is the easy part of the job!

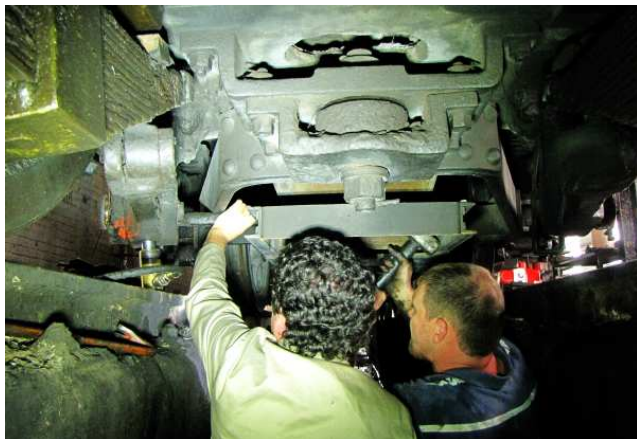
P05 - Getting the beam out was mainly a support-and-drift job. But the distorted bearing wasn't cooperating – and the hydraulic jack was leaking as well! The drift was initially fed through the ash chute door framing.

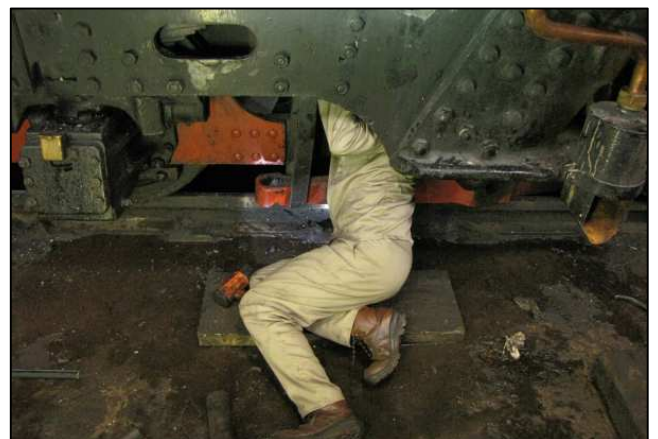
P06 - The peril of being one of the small guys - you get sent into the small spaces. Alan is fighting to remove the safety strap that is holding up the rear end of the beam.

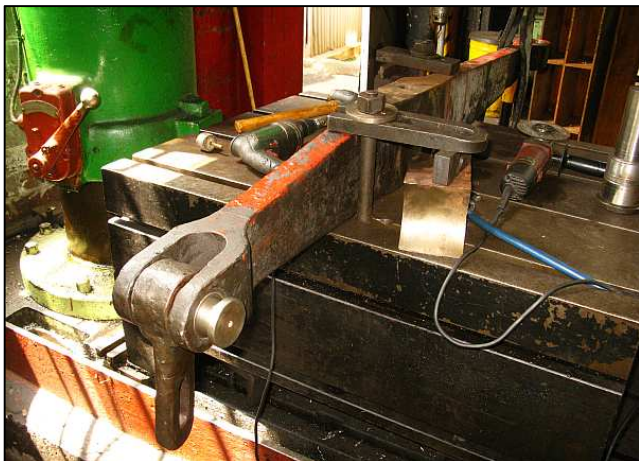
P07 - It took some ingenuity to get this awkwardly-shaped work piece clamped to the drill table! All three of the holes were cleaned out. The spring shackle end received two new bronze bearings – but with a deliberately loose fit.

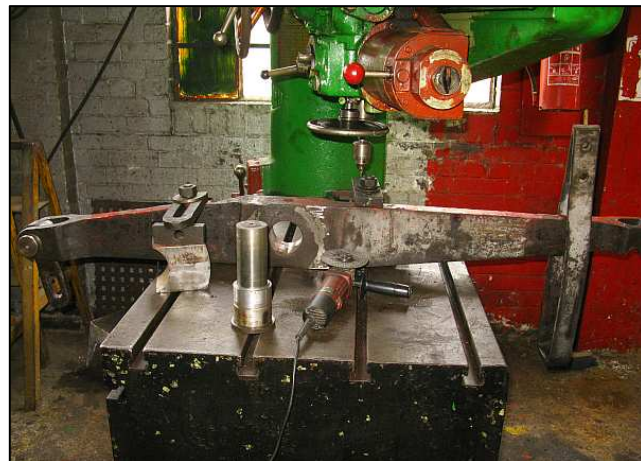
P08 - The looped safety strap (R) could not be removed without bending it or cutting it away. So it got to hang around and 'come along for the ride!' In the foreground, you can see both new and old pivot bearings on the pin.

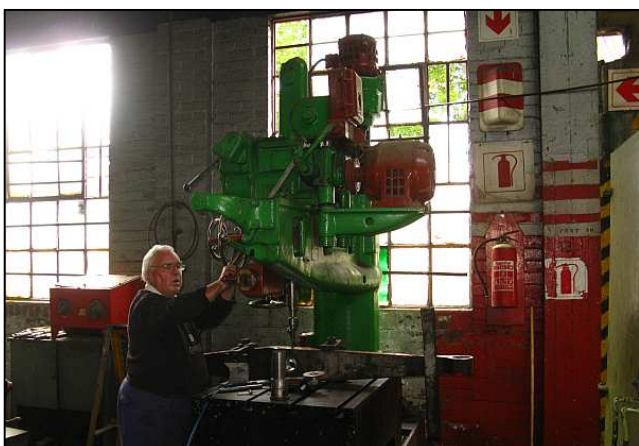
P09 - Using the big Asquith-built radial drill, James cleaned and enlarged the oiling hole, which was full of gunk. It had previously been roughly drilled out oversized, so a standard grease nipple would not fit without a lot of extra work.

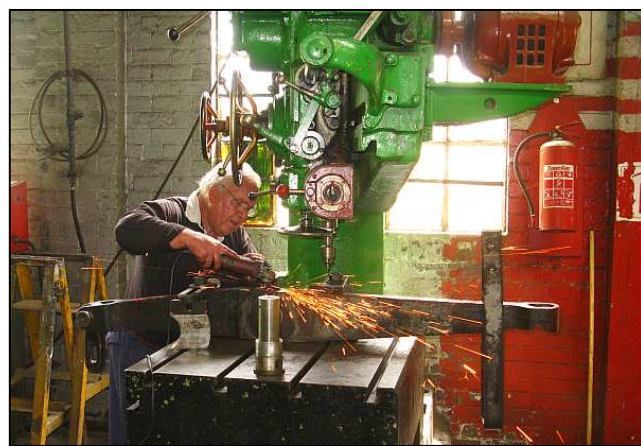
P10 - The dirty and battered surfaces were causing the drill bit to chatter and snag. James had some extra grinding and chamfering to do before the drill would run true while entering the oil passage.

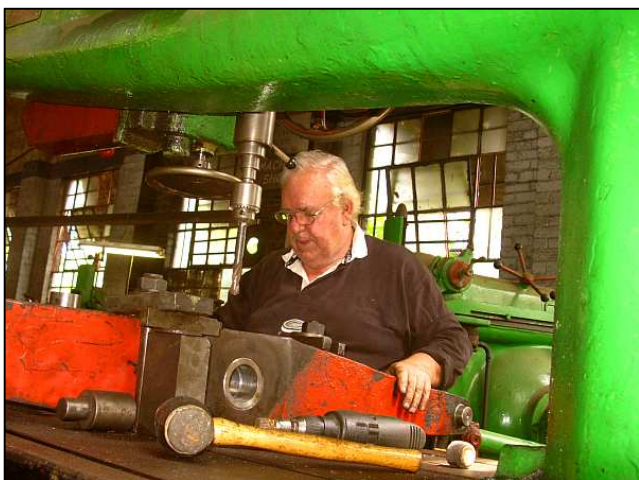
P11 - Framed by his big green rig, a happy James was starting to puff a bit from reaching over his head to operate the tall machine. He started out with an auto-feed setting but then switched to manual for fear of breaking the drills.

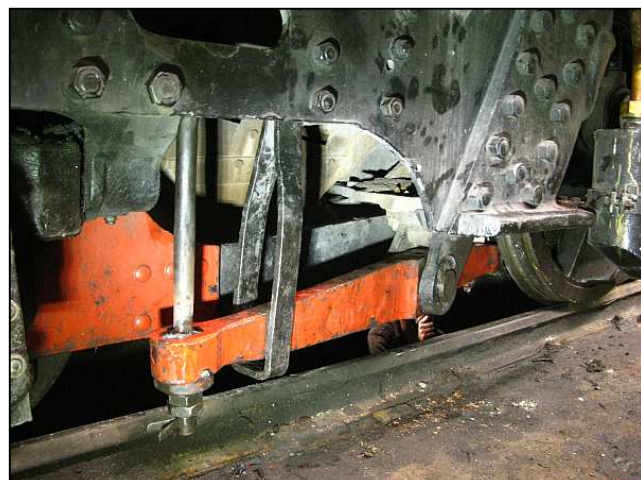
P12 - The finished beam as refitted on 21 March 2014. Although the link to the stirrup rod is actually a closed oval eye, it is still often called a 'camel's paw' by the old boys. It is filled with oil-soaked steel wool to retain oil for the indexed washer beneath. (A system we want to update!)
