2). 15F 2914 'SPIKKELS' FIREBOX REPAIR WORK :

This Depot Report was compiled by Mr. Lee D. Gates on behalf of Reefsteamers Association NPC.
For observations, corrections and suggestions – email me at documenter@reefsteamers.com

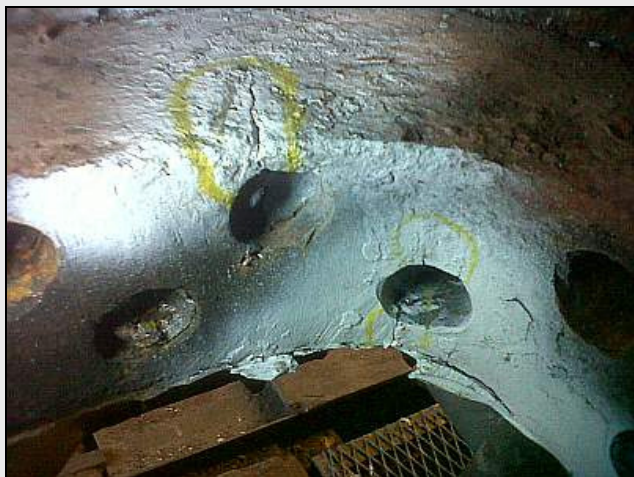
We have done very well to raise or commit to the original projected funding level of R45 000 in such a short time. However, cracks have been found within the 15F locomotive’s now-exposed foundation ring, which will necessitate further grinding and welding, as well as extra visits from the boiler inspector. We still need to get quotes from the workshop boys and the 15F 2914 Project Leader George Hoddinott, is working on getting the extra costings in.

F02 – As revealed by the MPI, here is the crack damage to the foundation ring. We were already aware of the lower crack, which goes right through the rivet hole. And there are fractures in the center of the steel mass above the hole.

After the lower corner was removed, the foundation ring was found to have cracks through rivet holes. The affected area to be wire brushed and MPI tested to determine the extent of cracking. Repair by grinding out the cracks and then re-welding. Olivier Survey Group PQR/WQR approval required prior to weld repairs commencing.

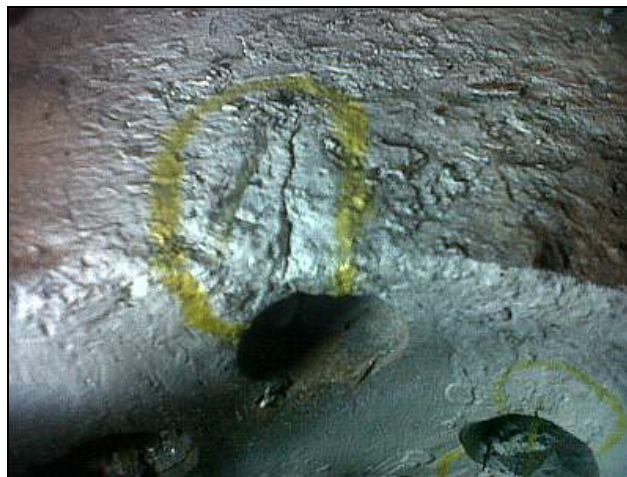
F03 – The other 50mm long crack from the top rivet hole was a surprise to us. Fortunately, it is easy to reach for welding. This crack leads directly into the water space between the inner and outer firebox plates.

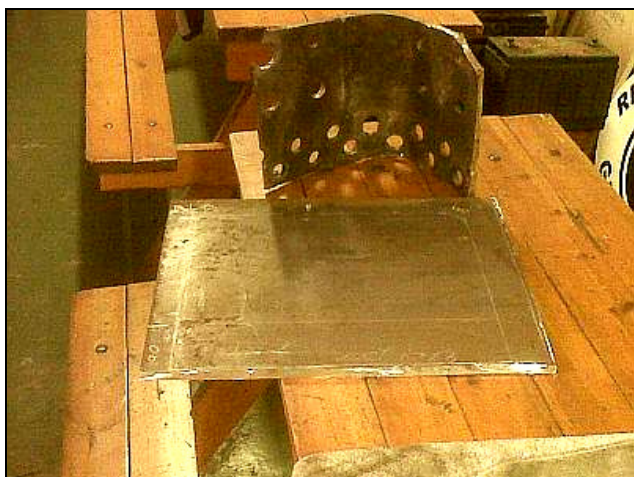
F03 – The old and new firebox inner corner plates waiting in the workshop canteen. The currently oversized patch will need to be hot-rolled to get that curvature right without cracking.

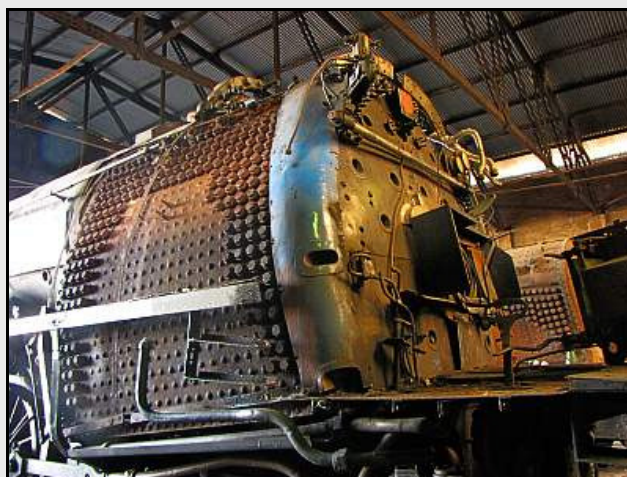
F04 – Aidan McCarthy has been keeping himself busy by removing the cladding from the left flank of the firebox. You can already see some revealed lime scale streaks from stays and stay covers that were once leaking in service.

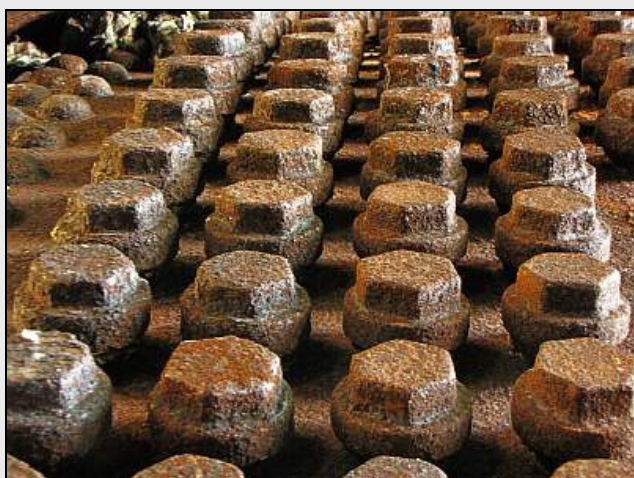
F05 – It is unpleasant work to expose the stay caps – rusty, sharp-edged cladding plates to be removed and obnoxious thermal lagging beneath. Many of the plates were welded together instead of being bolted to the crinoline bars.

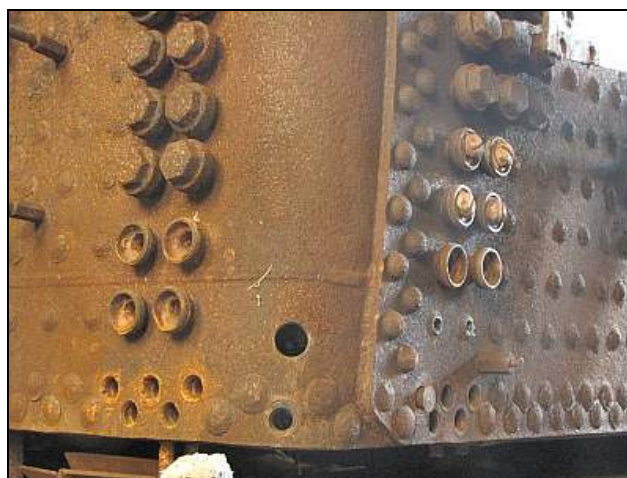
F06 – Some clean-up work still required. Some of the truncated foundation ring rivets need to have their outer ends removed. Two stay cups got bent in the process of whacking out rivets too. Note the cladding's crinoline studs.

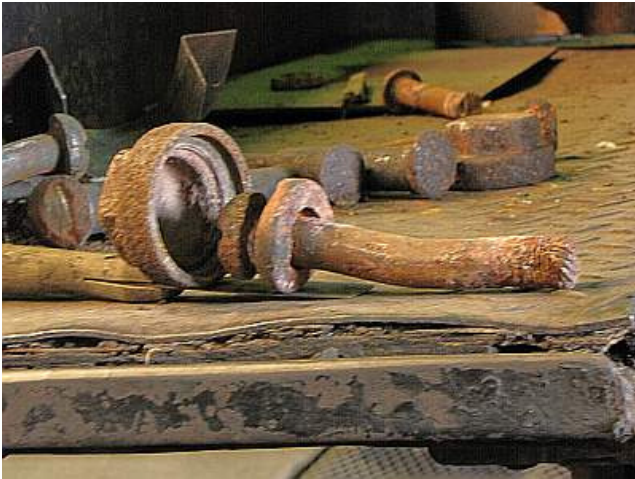
F07 – This old flexible stay put up a good fight. You can see the washer which provides the flexibility for the head, whereas the screwed-on cap provides the actual pressure seal. This stay rod got bent while being hammered out.

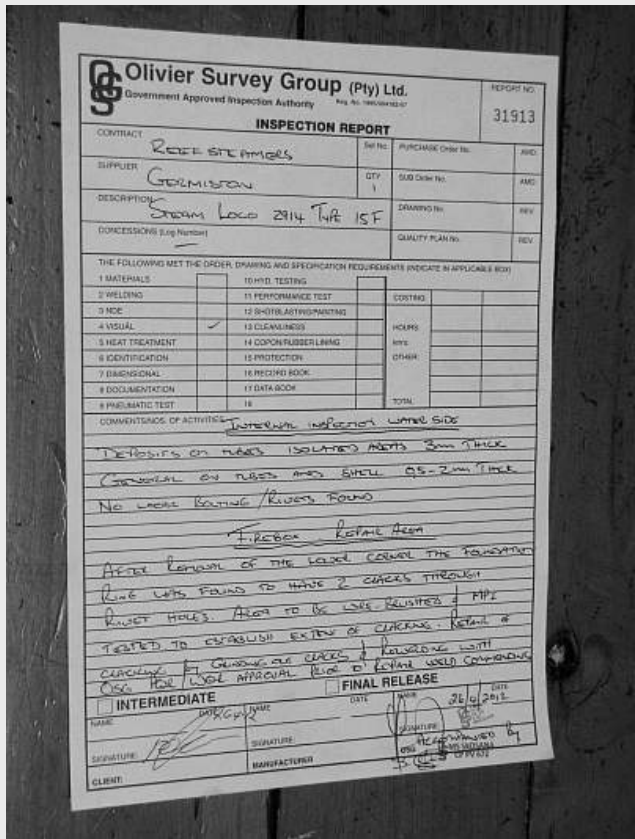
F09 – We are not 'winging' this project. Here is the boiler inspector's visual report from 26 April 2012 :

- Deposits on tubes in isolated areas = 3mm thick.
- General deposits on tube and shell = 0.5 – 2mm thick.
- No loose bolting or rivets were found.

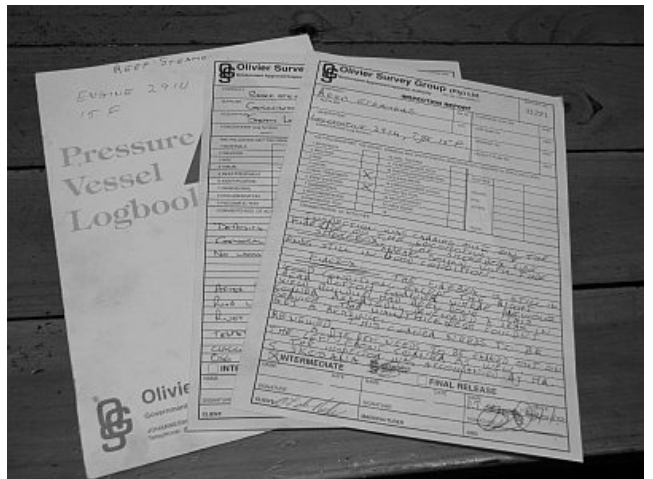
Here's the Pressure vessel log book for 15F No.2914. The report at the top of the pile is an older one from 20 Jan. 2012. The report says :

The smokebox side appears to be sound with tube ends still in good condition.

The firebox is still in good condition, except for the right rear bottom corner where previous weld build-up had been done. The corner reportedly developed a leak in service. I couldn't get a reading for the wall thickness.

This corner needs to be renewed.

A dye pen test needs to be carried out on the left front corner as well.

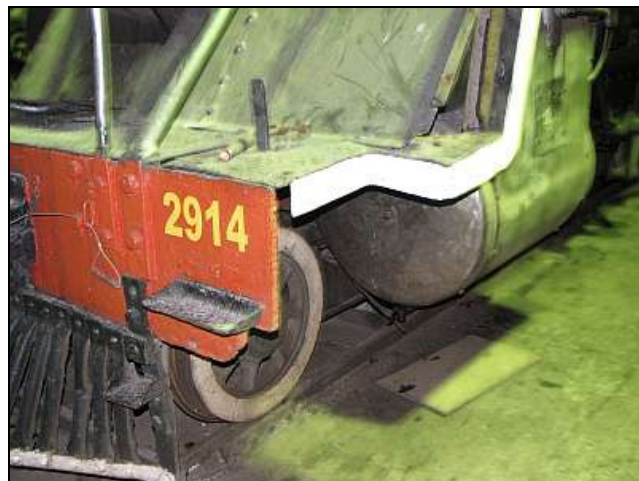
F12 – There is a story here that some ou spoorie just ain’t telling! Notice how the end of 15F 2914’s red-painted buffer beam has been torched off and then ground straight? I wonder what they clobbered with the old machine? I wonder if the repair was officially booked or some sneakily done work on a back-track in some quiet yard somewhere?

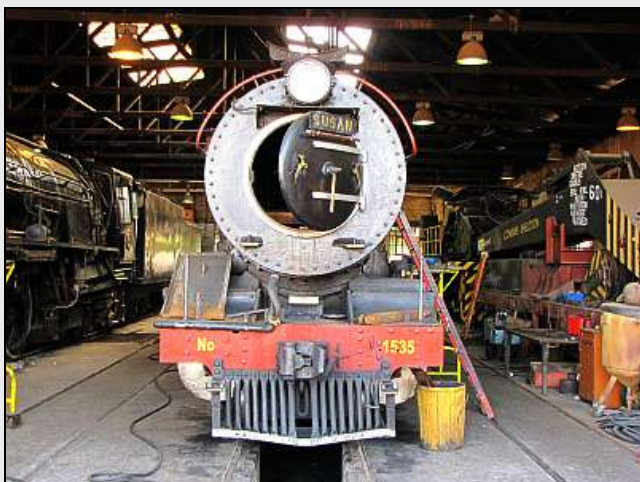
B01 – The Class 12AR No.1535 has passed her visual boiler inspection – which means that the somewhat wasted front tubeplate is good for another few years. Discipline in the after-run cleaning has arrested further corrosion.

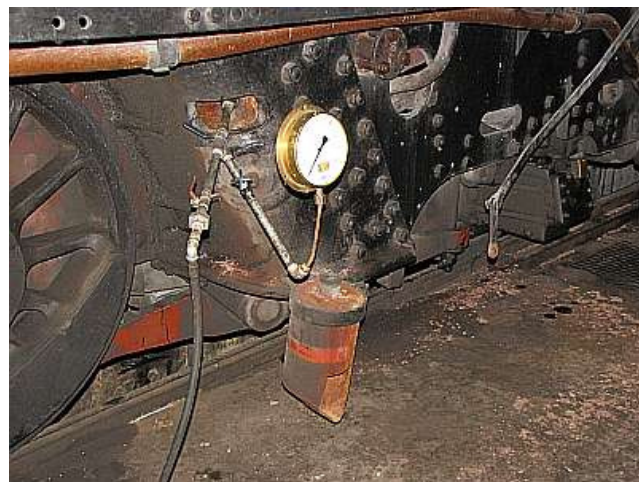
At the time of writing, (09 May 2012), the 12AR’s boiler has been hydraulically pre-tested and a few problems have been revealed. Five tubes and a flue are leaking. However, this is not an unexpected issue as the tubes in that boiler ARE elderly, and the week-day workshop gang will start the repair project as soon as practical.

B02 – Pre-hydraulic test leak-busting. This set up is a bit unusual for us as we usually blank off the blow down valves at their outlet under the valve body. But we have blanking plates for 1535’s blow downs – you see them at top center.

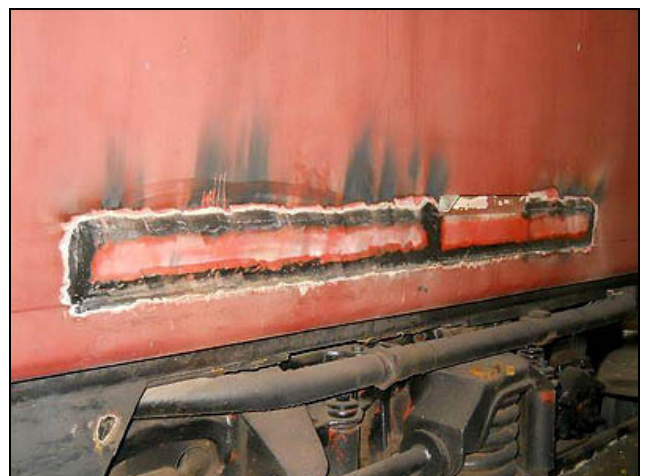
C06 – A newly ground-down MIG-welded patch on the Sandstone Sleeper No 28332. As the base metal is more sound on this coach, it is being used to fine-tune the tricky combination of welding techniques that are required.

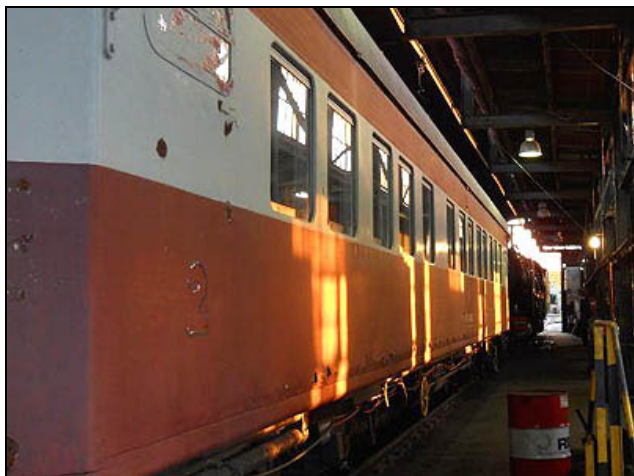
C07 – Now for the worse side! We are learning how to weld in patches on the rusted Sandstone Sleeper, using a combination of MIG, TIG and stick-welding for the job. So, the patchwork will not be so simple and straight forward.

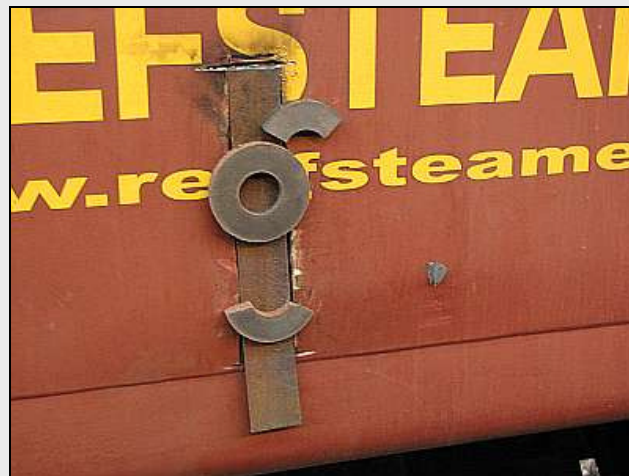
C08 – A assortment of magnets hold this patch in place, so the measured steel doesn't go astray. This scary looking hole started as a fine vertical crack over the frame – and ever-more rusted metal was revealed when it was cut back.

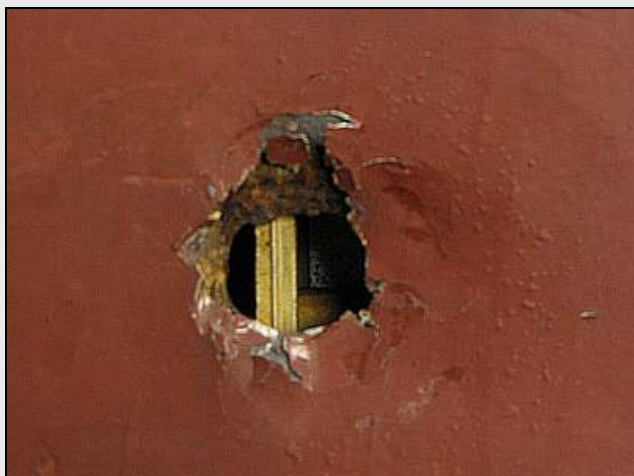
C09 – Tin-worms usually pupate after monsoon season and then fly away, leaving characteristic chewed holes. A common starting point for the rust are the drainage paths from the inset and unsealed window apertures. Seen here through the hole is a window glass runner.

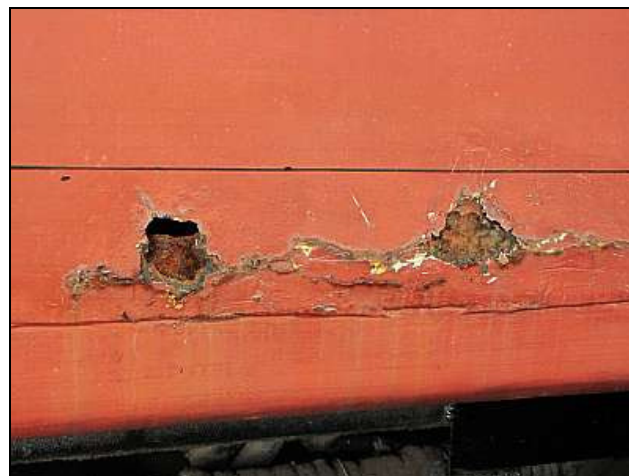
C10 - A lot of our coaches have this sort of damage above their footing rails. It is caused by leaks and condensation from the steam-heat lines within the coach. The bitumen sealing also tends to fail here, providing close, laminated layers that wick up the condensate and rain water.

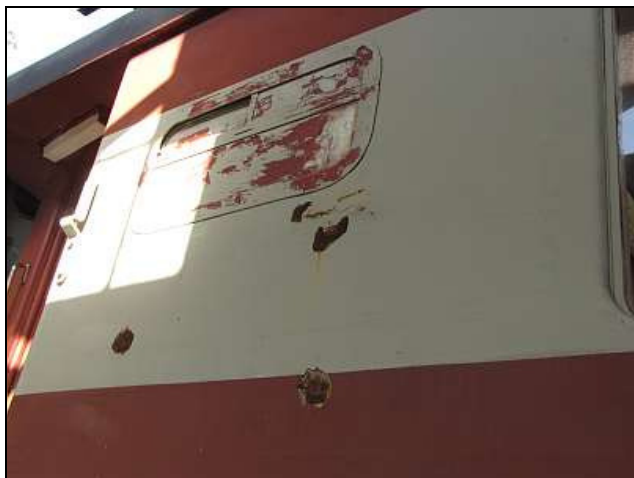
C11 – This rust pattern is unusual. We believe it to be from chemical fumes rising from the toilet (Bleach or Ammonia) from when the coach was standing plinthed and coupled to the Locomotion Restaurant in Weenen. The majority of the rust on our coaches had started from the inner panel sides.

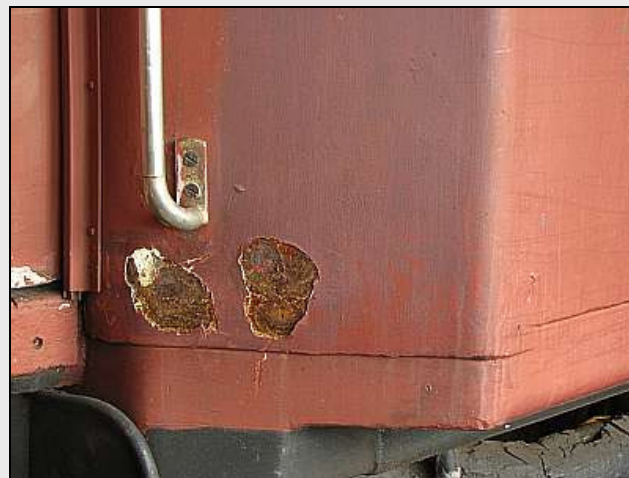
C12 – One of the few examples of external rust on sound plate work. It takes a good workman to resist the temptation to just patch and paint over a rust hole instead of bravely cutting back. But a bodge job just won't last on a steel railway coach, especially when parked in sun light.

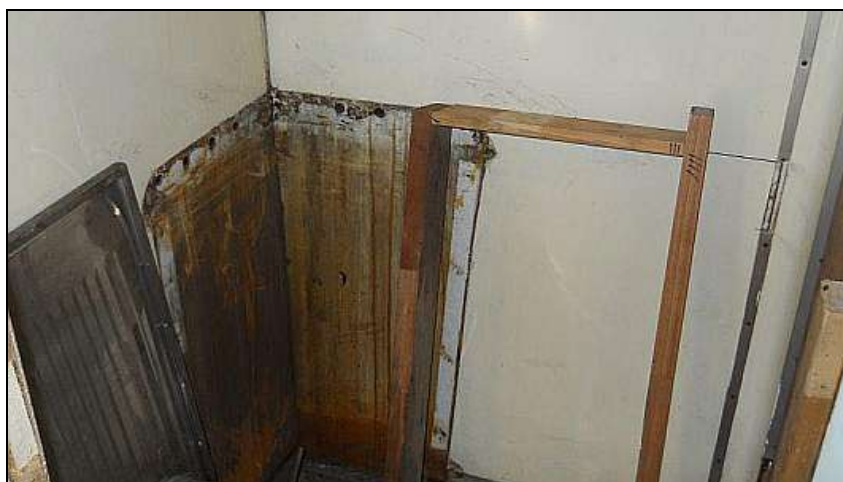
C16 – Here is the still rather raw scullery area being made up for the 'Locomotion' coach. The stained area on the wall is where the corner basin used to be. The coach boys are planning to do some much-needed surface preparation and then to apply white enamel paint to the whole compartment ... before installing the new sink. They might even rip out the old toilet floor pan and put in something more robust and waterproof.

As is usual with this sort of project, complications occur. Here, it was the realization that the door into the new scullery (ex-toilet compartment) is too narrow to carry a standard tray through. Answer : Remove the door and the widen gap. Result : We had to remove most of the compartment's rear wall! Oh well.

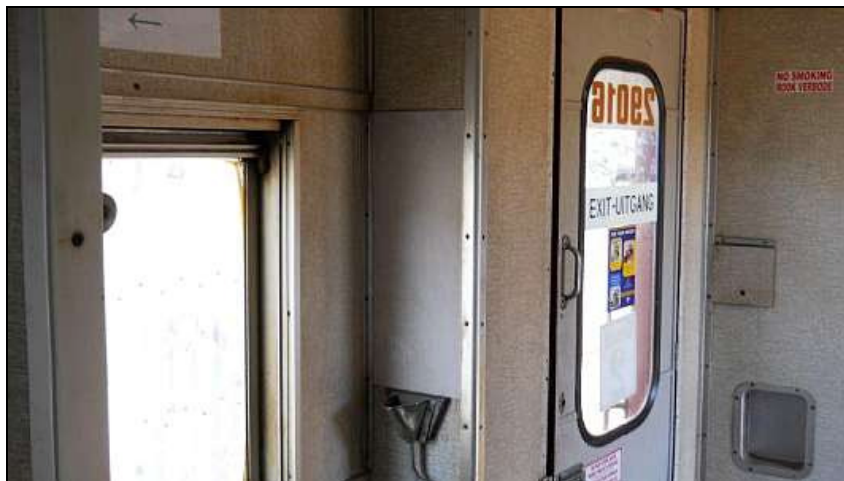
C17 – Reefsteamers is in the awkward situation of having about 8 regulars who are trying to look after all the locomotive repairs as well as the coaching stock. We desperately need people who are willing to consistently take on the numerous small improvement and repair projects required in the coaches. Here, you can see a patch neatly installed on a vestibule inset wall where a damaged drinking-water container enclosure was removed. (The drip tray still remains.)

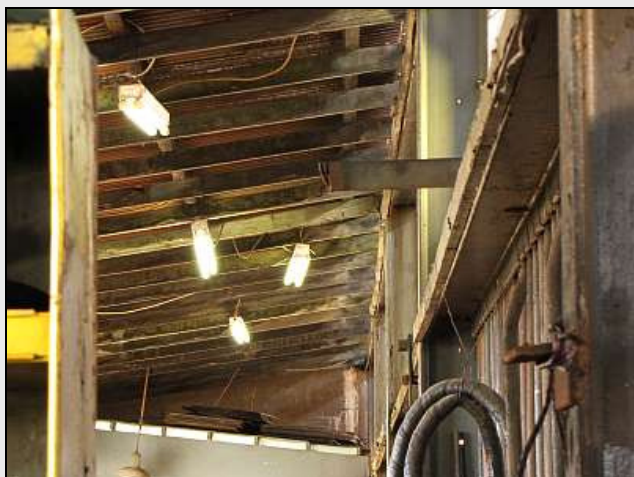
M03 – The 'interesting' wiring at the depot is gradually getting sussed out! These old lights have been restored to action by tapping power from the ex-upper-machine shop DB, and the other (corroded) end safely terminated. How nice it is to have ample lighting in the oil store and not to have to TASTE the difference between Steam Oil and MH!

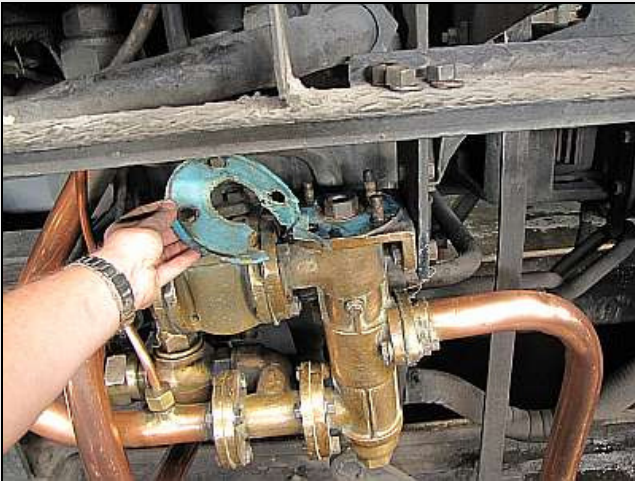
M07 – A blown gasket on the top cover of 15F 3046's left injector. Cause – incorrectly rated gasket material.
