1). INTRODUCTION :

Our featured Class 12AR No.1535 'Susie' is running great and she is currently the only bread winner for the depot fleet, which are hungry for new boiler tubes and firebox repairs and what not. Quite a voracious, heavy weight family for 'Gran'ma Suzie' to support. She's developed a few minor steam leaks in the auxiliaries, as can be expected for any elderly locomotive, and it is suspected that there is a restriction in the steam feed for the fireman's injector as it isn't picking up properly with the turret-based steam valve at part throttle. You have to move quickly to wind the turret valve out – no convenient quick-opening Seller's valve here! But ever since being returned to steam after her dry crown sheet incident, she is confirming her reputation as a tough, sure-footed and reliable old girl. The Vesconite™ bearing conversion to the valve motion is working a treat.

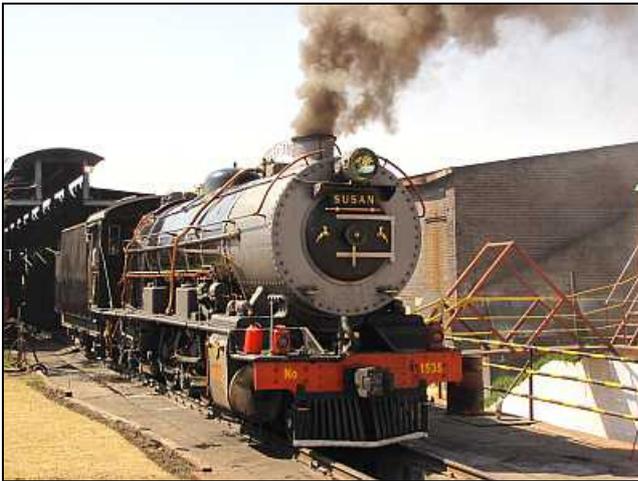
FA01 – A few flicks of coal are casually going into the 41 sq. foot grate during a relatively rare open-air Reefsteamers Fire-Lighting session. We normally do fire lighting work under cover in the old boiler house (visible in the background) Our Class 12AR No.1535 ‘Susan’ was rostered to take a 17 vehicle train to Boksburg East on behalf of our tenants, the Shongololo Express. The red lamps on the buffer beam are not SAR standard. (Neither is the ‘Oom’ Attie trademark – an oil can left on the buffer beam.)

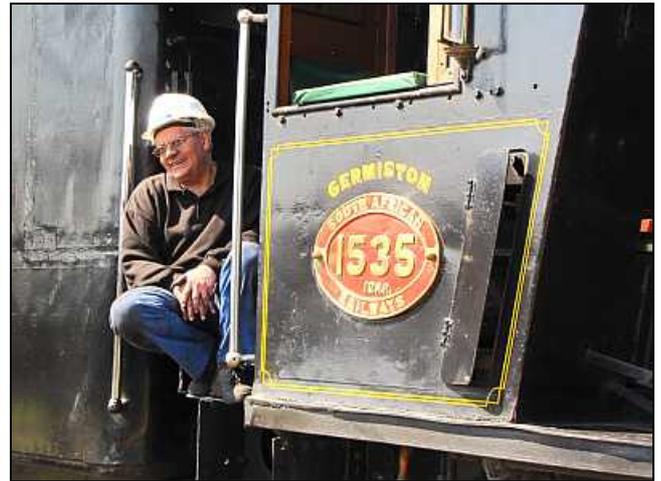
FA02 – Senior fireman Johann Breydenbach relaxes and chats to Attie and Sakkie out of frame. The locomotive was raising steam at 500kPA, but with the firebox doors open and the fire hardly blown, to slow the pressure increase down ; as the staff of the Shongololo Express were still busy preparing their coaches.

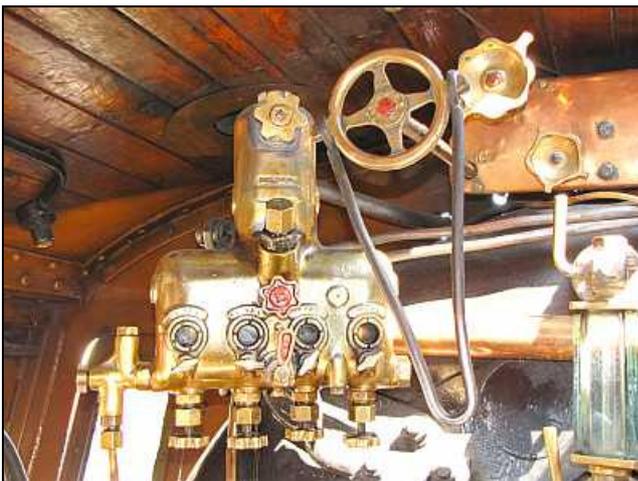
FA03 - The Hydrostatic Lubricator is charged and ready to go – but is bubbling and hissing from the filler plug. The valve with the extension handle is the steam valve for the fireman's injector – this elderly locomotive does not have a Seller's valve set-up, so the steam supply for the injectors is operated directly from the outermost valves on the turrets and not from pull levers from halfway up the left side of the boiler backhead, as with our 15F's, the 25NC and Sandstone's GMAM.

The medium size valve wheel is the blower and the small valve wheel is for the steam turbine driven dynamo. The square copper cover from which the valves protrude is not a standard item – but was custom made and fitted for the locomotive. (Our Class 15CA No.2056 'Dorothy' has a similar turret arch cover fitted by the Boosens duo (Timothy and Chris) – but in stainless steel.)

The spindles on which the valve wheels are mounted fit loosely in a cast iron plate – to allow for relative movement between the boiler backhead and the locomotive's cab. This plate has an added luxury – the valve functions are actually stamped in.

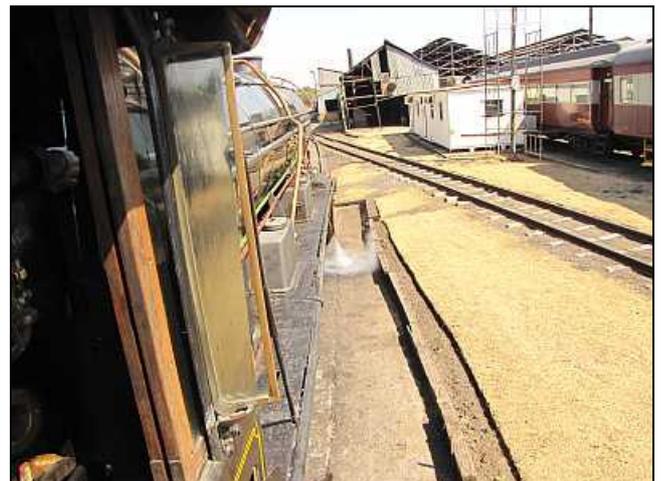
FA04 – A driver's eye view of power reverser testing. Fireman Johann Breydenbach is operating the reverser lever while Driver Attie de Necker has already checked the right side and is now out of sight on the left side of the engine.

The power reverser should be checked before every run, for full extent of operation, leaks and for the operation of the locking cylinder. The displacement lubricator must be confirmed to have been drained of condensate and refilled with oil. The Class 12AR is a bit unusual in that the reverser's exhausted steam discharges to ground level via a vertical pipe mounted behind the RHS cylinder chest (center of picture), instead of between the frames or the ash pan like the reverser discharge pipes of most more modern SAR locomotives do.

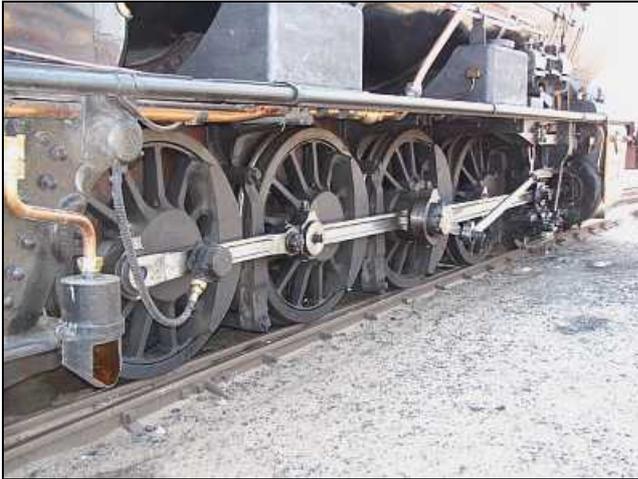
SP01 – Some extra preparation work went into this locomotive! Against the unadorned, solidly black painted goods-train sized wheels (4 feet 3 inches), the newly polished coupling rods and valve gear really stand out. These rods were done with a pneumatic powered flapper wheel but the job is still a long and tedious one with the crannies, recessed webs and gaps needing hand work where the bulky flapper wheel can't go.

It's a thankless job too, as those rods get dirty again quite quickly, especially up front at the valve gear end. However, if they are rubbed down with paraffin before a trip, the dropped grease and oil doesn't stick. It's easier to put a little extra effort into keep the rods clean than letting them get crusty.

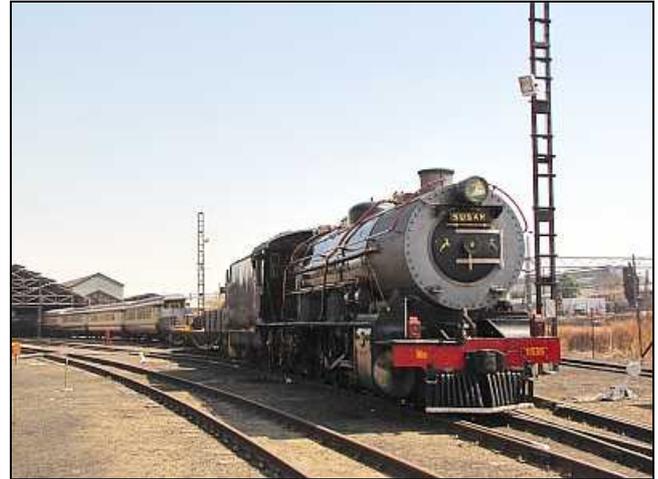
SP02 – Class 12AR No.1535 'Susan' is standing hot, but silent and dignified at the head of her train. She is facing east, as she will be hauling the train eastbound to Boksburg East station. So she will be PUSHING the classically profiled clearstory train out of our west-facing yard-lead today. The two flat vehicles behind the tender are special roll-on road vehicle transporters used by Shongololo Express for their mini and midi busses.

It would require extra care on the shunt as you're pushing a set of heavy coaches on a curve with two light vehicles in between the locomotive and the coaches. When a train is made up, ideally the light vehicles should go towards the back.

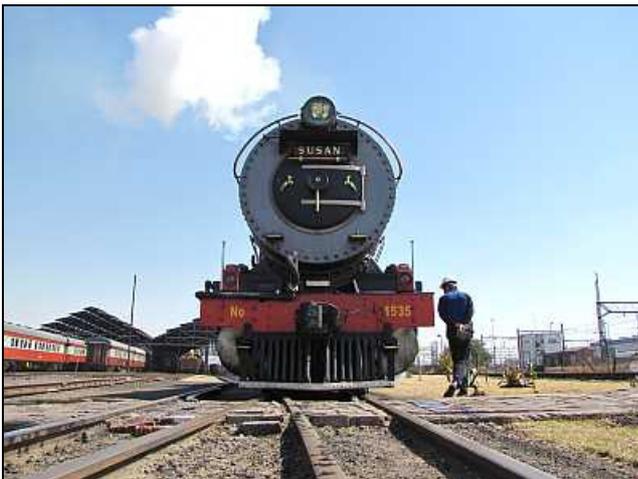
S03 – Like a fly to a honey pot (A really BIG honey pot!), Ackerman Slightly Junior (aka 'Patrick') is irresistibly called from his graphite painted perch from astride the 25NC smokebox to come and watch the live steam action. He is just about to walk a-pace with the engine right through the carriage shed with eyes for nothing other than the mesmerizing movements of those coupling rods and valve gear, courtesy of Uncle Walschaert.

This 'small-ish' locomotive weighs just over 99 tons, and is coupled to a 66 ton tender. It is always remarkable and a little uncanny how smoothly and delicately a heavy steel-wheeled machine like this can actually move.

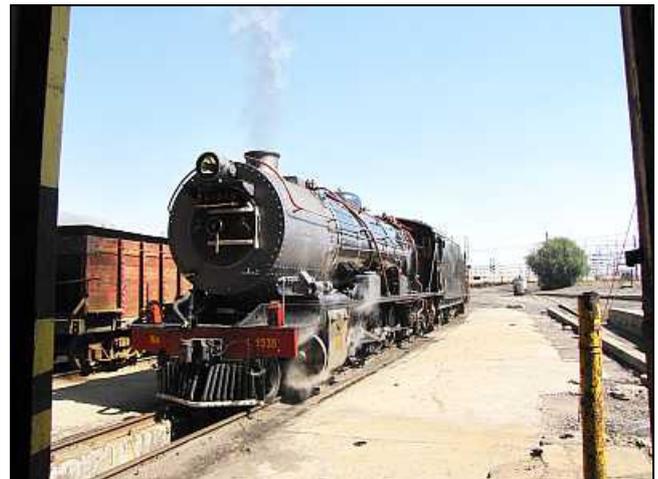
SP04 – Spot the running repairs required to this loco?

By the time 'Susie' has chuffed in a stately manner right though the Carriage Shed, the cylinders and the pistons are warm enough to close the cylinder cocks. But the left hand piston gland is blowing a bit and the backward slipstream forms a steamy wreath around the cylinder chest.

LD02 – The leaking gland pointed out in photo SP04 has since been serviced and we now have a clear view of the rear cylinder head end of the steam chest, helpfully spot-lighted by the early morning sun. The rods still look clean from their polish of two weeks previously.

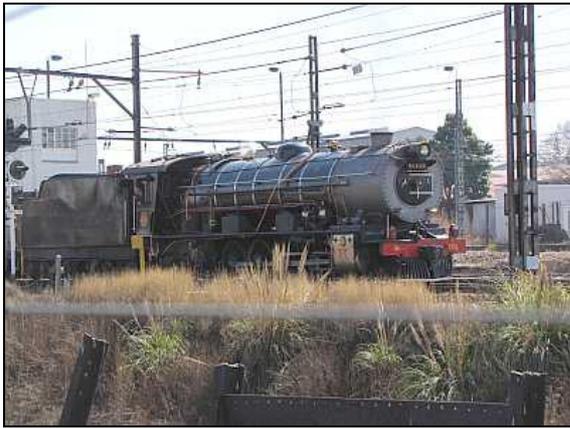
MV01 – One of the reasons why we no longer use the Boksburg East station for our own trips is the extra shunting required to cross the goods lines and line up for the eastbound junctions.

Class 12AR No.1535 Susan has backed out of our west-facing yard lead, and has run forward onto the Reefsteamers siding and joined the mains. Now she's backing up again with driver Attie looking backwards next to the control cabin before finally running forward on the selected set of irons towards Boksburg.

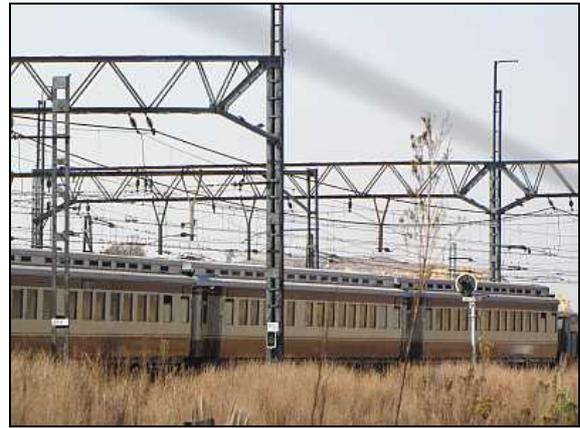
MV02 – 1950's vintage Metro-Cammel built clearstory coaches out promenading on the main line and finally on their way. This is the Shongololo Express 'Southern Cross' train set on the way to Boksburg East. This is one of the last wooden-panelled interior sleeper coach sets still running in the country.

The boiler, which is oversized for the 24in diameter cylinders, blew off twice during the tedious shunting movements with this long train.

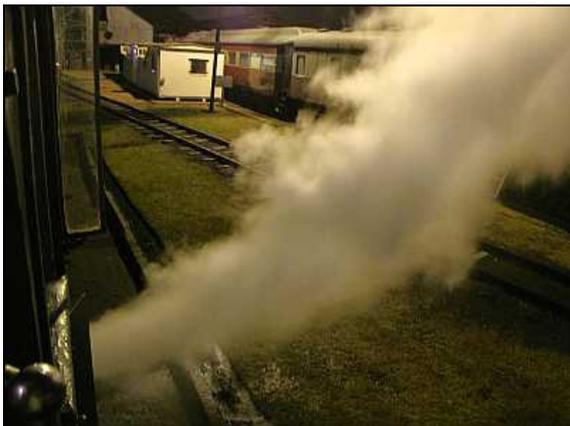
LM01 – A driver's view of a throttled blow-down. The blow down deflector has long since been removed in our recent yard neatening exercises. One needs a bit of restraint if blowing down to manually to reduce the steam pressure from the right hand blow downs when on the reception track. Even so, the adjoining coaches and the water tankers got drenched in condensation.

When one blows down to clear the foundation ring, being one of the 'official use' of the blow downs - let her rip! Just be careful of doggies, Reefsteamers, open windows and loose panes of glass. Out on the rails, the blow downs are used to reduce the concentration of suspended impurities in the boiler water to reduce foaming and the resulting priming.

When blowing a stationary loco down to relieve boiler pressure – the boiler pressure initially barely drops but the water level falls dramatically – because you are releasing surface pressure in the boiler and the water boils off rapidly, increasing the rate of evaporation. When the resulting lower water level is topped up via the injectors, the boiler pressure then drops as desired. One can run the injector(s) at the same time the blow down is open and achieve both effects at the same time.

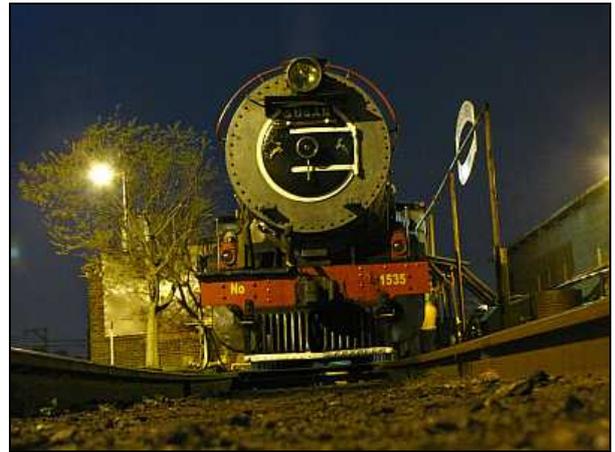
LM04 – Not many leaks on this baby – at least, not on the outside or through the regulator. Actually, the dynamo piping needs work but it is switched off and steam-free in this picture. Fred Sewell’s new yard lights work a treat and light up the front area of the locomotive well.

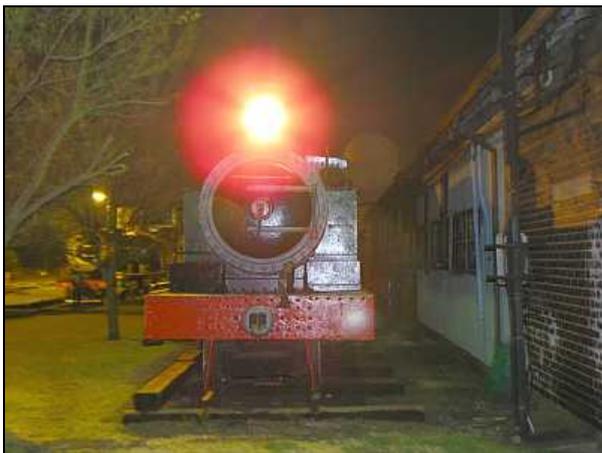
LM05 – Patrys, the plinthed Class A tank engine, now has a working headlight which was wired in to mains power during Fred Sewell’s yard lighting project. (The original Pyle Industries turbine-dynamo is still present above the LHS water tank though.)

This little engine is on our wish list for restoration – being a good little steamer with a responsive, densely packed boiler and would be ideal for shunting and crew training. Of course, the supply of the wildlife marked paper is a perennial problem. Apart from the cab fittings and the injectors + pipe work, this cool little engine is quite intact.

Although the engine is stored outdoors, it is still in good shape as it has been repainted with a deliberately thick coat of paint for water proofing purposes. Note that the engine still has link and pin couplers.

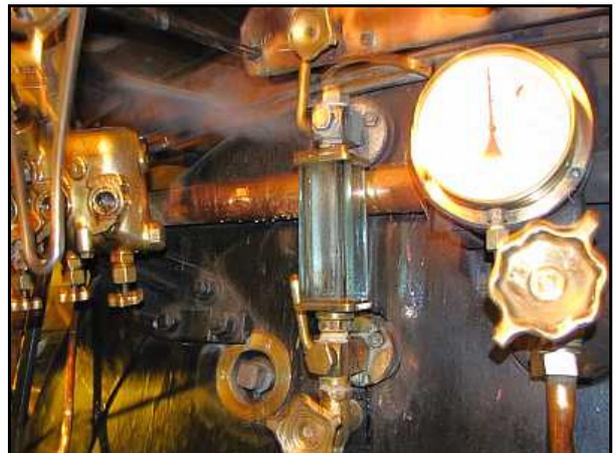
LM06 – The steam test cock on the LHS water column needs repacking. Shutting the test cock off only made the leak worse. The funny thing was that it only showed the ‘steam’ and dribbling water when the water level was higher than the glass – which is what we often do when loco minding. When the water level dropped, the leak was still there – but the escaping steam was invisible and didn’t fog up the inside of the glass. Rather dangerously, it was still capable of scalding the unwary fireman.

It illustrates a danger of steam - it is a colourless invisible gas. What we think of as being ‘steam’ is actually condensation.

The water level is visible at just under 1/3 height and the steam pressure on the over exposed pressure gauge is just under 1000kPA. I had let the water level drop with steam pressure rising when preparing a tall center fire to cook supper – it ignited quickly burning on three sides. After supper, I’m about to drop the pressure down to about 800kPA by filling the boiler up but not over the glasses as we usually do. The water level will need some watching tonight....

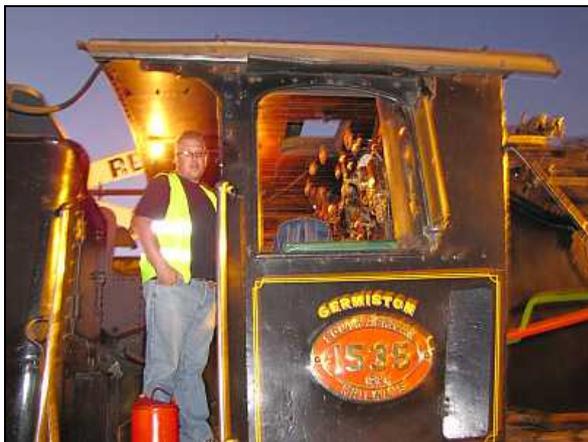
MP02 – Trainee fireman Riaan Coetzee takes a breather as the fire is still too hot to shake out. (There is a risk of buckling the ash pan if too many hot coals are dropped at once and they aren't raked or rinsed out fast enough.)

I had to shake the fire out myself at 3:15am as the dense ash had just gotten too thick. My midnight coal bank laid under the firing hole after the late supper fire hadn't even started burning in the middle as evidenced by an early morning test-raking. Using the blower (which is quite fierce on the 12AR) was just cooling the boiler down without achieving much with the fire. The shake-up worked and I had a decent fire going by 4am.

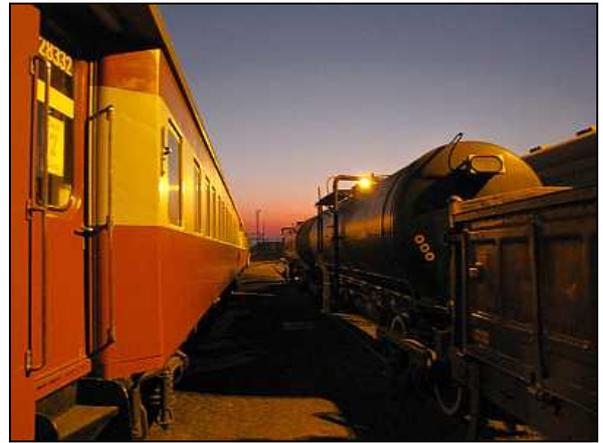
MP01 – A freight train and a passenger train sit side by side just as the sparrows are finishing up their birdie REM sleep cycles. We have three tank cars on the premises, one painted in dark brunswick green to match Lyndie Lou the Sandstone GMAM Garratt, but the water pump equipped tanker gets to do most of the runs as it is required to provide fire protection.

There is a thin skin of rust forming on the naked steel wheels – but we'll polish that off on the Cherry Festival 2009 run when we'll be taking two water tankers of 33 000 liters each with the 12AR and our 25NC No.3472.

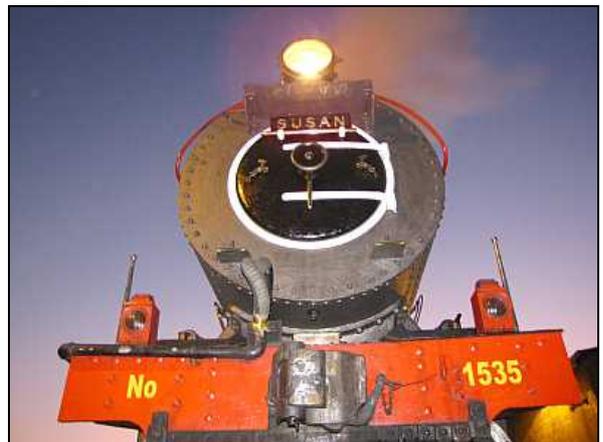
MP02B – Looking good, babe! A low angle shot taken from the steel plate walkway that bridges the west end of the ash pit. I could have gotten right into the service pit to get the cow-puncher in the picture as well, but declined for safety reasons, as I would have been invisible to both driver and fireman.

There are many rail enthusiasts and photographers who do not like smoke deflectors and hence they appreciate the clean, classic profile of a locomotive so unadorned. Our Class 15CA No.2056 is a popular photographic choice for the same reason. Our 'Royal Locomotive', the Class 15F No.3046, which has just begin a final restoration, will probably also have the smoke deflectors left off to provide a photographic contrast with the normally so equipped 15F's such as Dave Shepherd's 3052 'Avril' and our Class 15F No.3016 'Gerda' as well as the hand-bomber Class 15F No.2914 'Spikkels.'

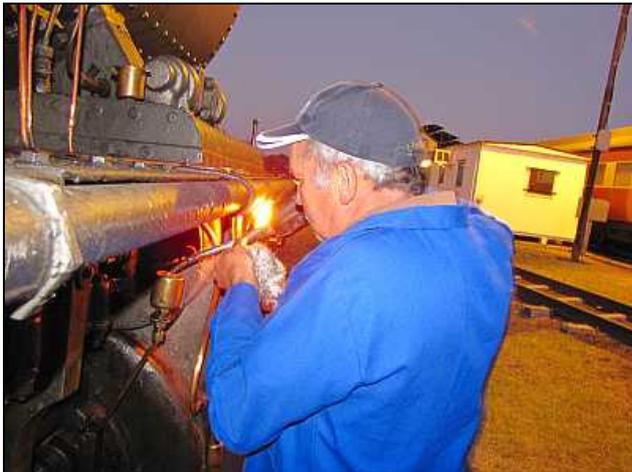
MP03 – Oiling around the engine is usually done after the fire cleaning is done but here it is being done before. Here, in the light of his flare lamp, driver Piet Molentz is topping up the oil cup that lubricates the right-hand-side piston rod. The brass oil cup that feeds oil to the corresponding valve rod can be in line with and to the left of Piet's cap.

Including the cross head slide bars, there are five oil cups per cylinder chest on this locomotive. The other oil cups or oil boxes, such as for the bogie pivots, need to be topped up and the grate shaker and the power reverser displacement lubricators need to be done. Ideally, the dynamo is checked as well but this is usually a workshop item as that runs with a captive oil type system.

These oil pots are a 'total loss' lubrication system as all the oil used is eventually lost – but the thinner MH oil used also flushes grit and dirt from the exposed working surfaces.

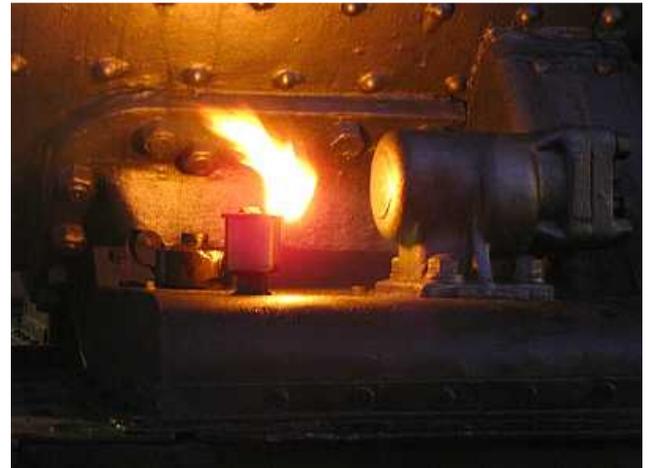
MP03B – The pre-sunrise breeze has picked up and Piet has tucked his guttering flare pot right under the smoke box as a wind shield. The oil pot in the foreground is for the front LHS valve spindle. Luckily the grey graphite paint is heat resistant!

The aerial-bomb shaped contraption to the right is a bypass valve of which one is fitted to either end of the valve chest. When the locomotive is drifting at speed with the regulator shut, the still-moving pistons and valves act like an air pump. A vacuum forms in the cylinders because of the moving pistons. The vacuum acts as a brake on the free running train, tending to hold the pistons back. But it also tends to suck in abrasive grit and ash from the smokebox back through the exhaust ports when the valve gear opens – scratching the cylinder bores and damaging the piston rings.

These valves automatically open to admit air to break the vacuum. A competent driver would also open the drifter valve to admit a small, measured quantity of steam to the cylinders – not enough to propel the train, but enough to occupy the spaces behind the moving pistons and to prevent a vacuum from being formed in the first place.

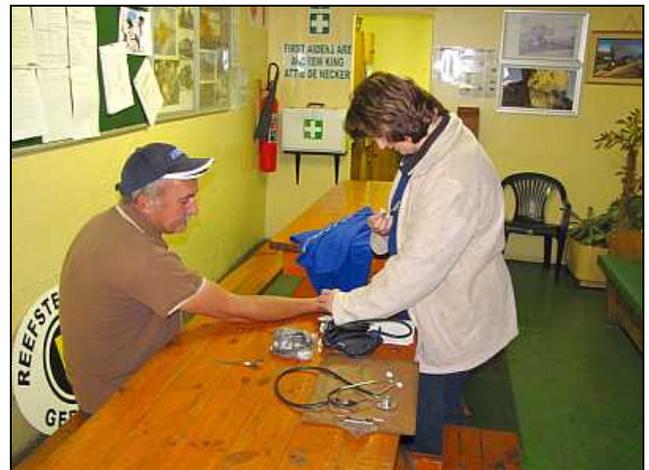
MP05 – It isn't just the locomotive that gets a roadworthy check before a run – the footplate crew are given a basic medical check-up. Sonnette Britz is a qualified nurse and reports early to the depot to check the crews and staffs the train as a first aider. Driver Piet Molentz, along with driver Chris Saayman, are both still active drivers on the railways and Piet, ironically enough, had just undergone an official railways medical the day before. Maybe that's why he doesn't look too impressed?

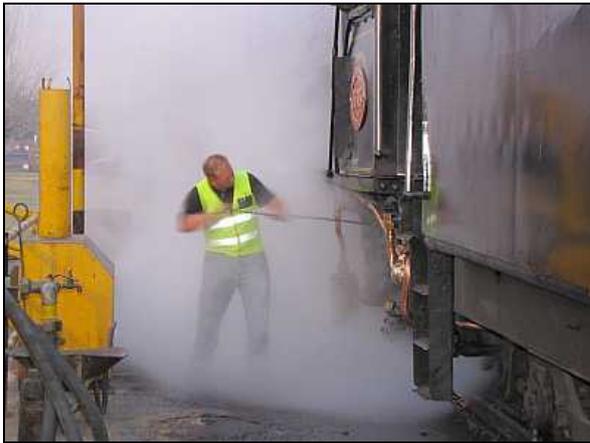
MP06 – Finally it is fire cleaning time and a gently steamed Riaan Coetzee comes to grips with the two pathetically small oval shaped holes which are all that is provided on either side to rake down the ash pan on the Class 12AR. The steam exhaust is from the grate shaker cylinders and the copious discharge has encouraged Riaan to take off his glasses. The fierce, staccato grate shaker exhaust noise is quite hard on the ears too.

As evidenced by the lack of tail drips from the injector overflow pipe (peeking out from just behind the steps) the fireman's injector is running to feed water to the ash pan coolers but often the ash needs a helping nudge to fall down the ash chute, past the open trap door and into the pit between the tracks.

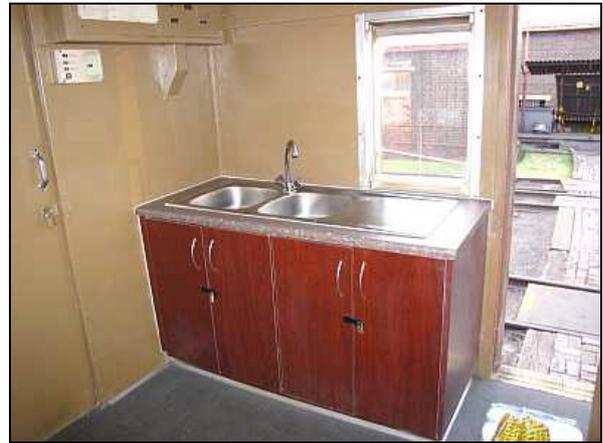
MS01 – Here is a view of the new sink cabinet that has been installed into the old guard's area of the Power Van (ex Staff and Baggage Van) – a matching storage cabinet is out of frame to the left. The Power Van originally had a coupe compartment converted into a kitchen. The old kitchen had been removed and converted into a full shower and washroom facility for the crew. The guard's handbrake still functions – just out of frame to the right.

This revamp not only included cabinets and the res-pray, as well as window and door repairs, but also complete re-laying of the floor substrate and new vinyl sheet floor. The new crew kitchen has hot and cold running water, and is equipped with a gas geyser.

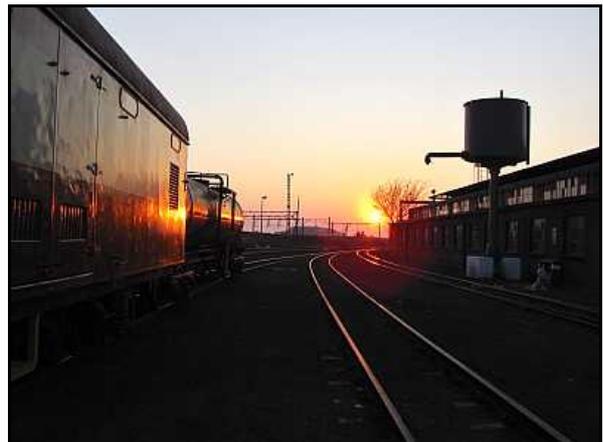
MS03 – The two service vehicles at the end of the train reflect the morning sun. It is strangely quiet at the moment as the fire cleaning is done and Piet Molentz is in the oil store topping up his grease gun to do the coupling rods. The coach controllers are still thin on the ground and the generator set within the power van hasn't yet been started.

That tanker car is our home-bound water canteen. It really is a nuisance having to haul 33 tons of water around in a big tin can tied to your tail but there are no watering facilities at the destination, although an intact, but disconnected water tower does still exist at Magaliesburg Station.

The sun is shining against a custom air vent that was fitted to the power car by Patrick Ackerman, to help reduce overheating of the diesel engine within. With the large generator set now installed in addition to the existing Perkin's-powered generator – even the improved air flow will be insufficient and we'll be fitting grids behind a set of the closed doors that you see (on the opposite side of the coach though), and running the train with the doors open for ventilation.

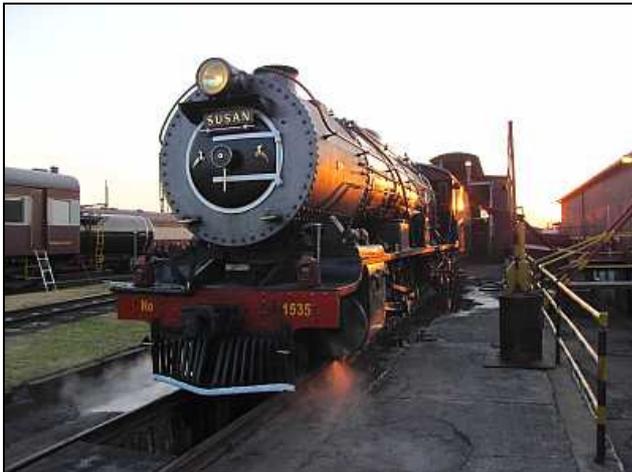
MS04 – A sun-bronzed Susan is just about to be nudged forward to align one of the four holes in the bogie wheels to the 12 o'clock position. This needs to be done to allow access for lubrication of the bogie bearings and the axle horns behind those wheels.

The cylinder cocks are open to expel the incompressible water from the cylinders, which would otherwise hydro-lock the engine if the space between the piston and the cylinder head at top-dead-center (TDC) is completely full of water.

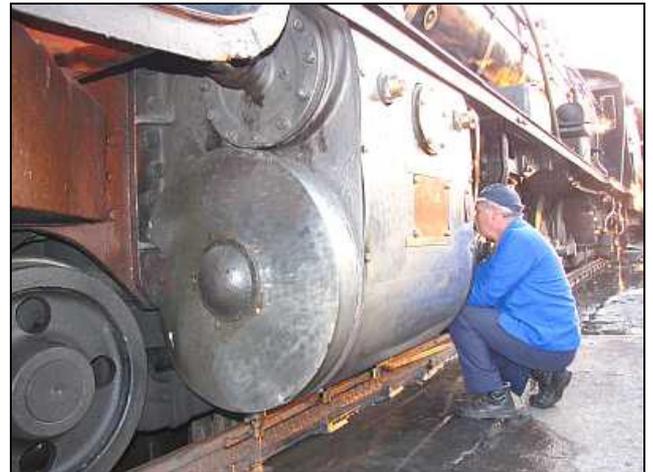
MS05 – How's that for driving? The clock quartered positioning of the holes in the front bogie wheel are accurately placed. Remember that the driver cannot see the position of his bogie wheels from within the cab. Furthermore, in this case, Piet did not use a shunter or an assistant to tell him how far to move.

While Piet tends to the bogie's trailing axle bearing, the front cylinder cock can still be seen to be freely discharging a dribble of condensate water. It takes a while to warm up the massive steel cylinders and steam chests of these locomotives to a point where steam is no longer condensed back into water.

In the meantime, the hydrostatic lubricator is still working and a dripping cylinder cock like this soon provides a nice greasy green-onion-soup-coloured oil slick around the front end of the locomotive – one of those hazards one has to watch out for.

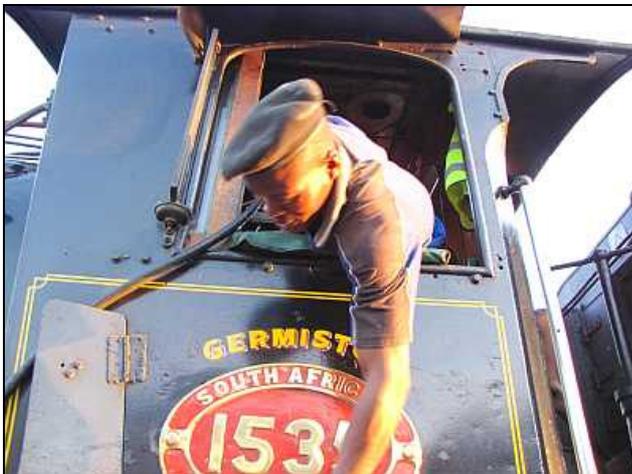
LD01 – As No.1535 'Susan' first moves off to pick up her train, fireman Sakkie 'Sakana' Kekana takes the opportunity to quickly wipe down the cab sides as the engine moves off.

A conscientious loco minder would normally give the steam locomotive a quick wipe down during the night, but she normally gets splattered and dusty again in the morning if the safety valves pop off and there's fly ash from the fire cleaning. Luckily, Susie was still looking clean in the morning with Luca's fresh paintwork on the front fixtures n' details and 'Oom' Attie's polishing on the black paintwork. But it took Sakkie some time to wipe the engine down with the slightly late fire cleaning.

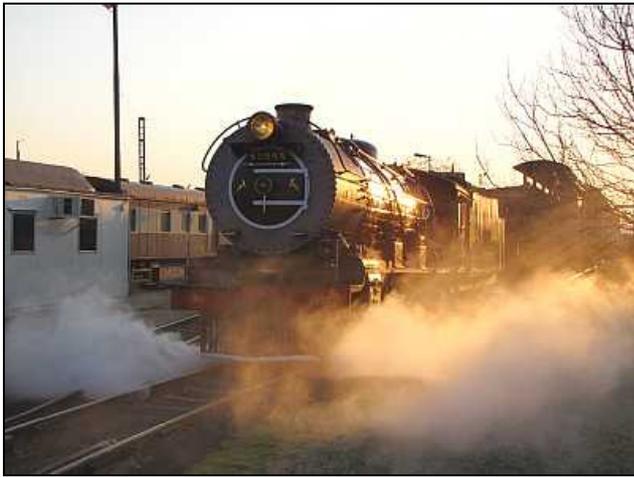
LD03 – After the previous photo I sprinted through the steam with one hand cupped protectively over the camera lens to avoid condensation fog and oil droplets. The reception track is actually on a downgrade from the cross-over, (The points to the left) so locomotives under repair or servicing can never roll out onto the track work even if they do accidentally roll free for some reason.

It takes a patient hand to get an engine out with the drifter open, cocks open and resisting the temptation to open the regulator. Slowwwl-l-l-y does it! You can get an idea of the uphill slope by comparing the sun-lit running board line with that of the roof of the converted container next door.

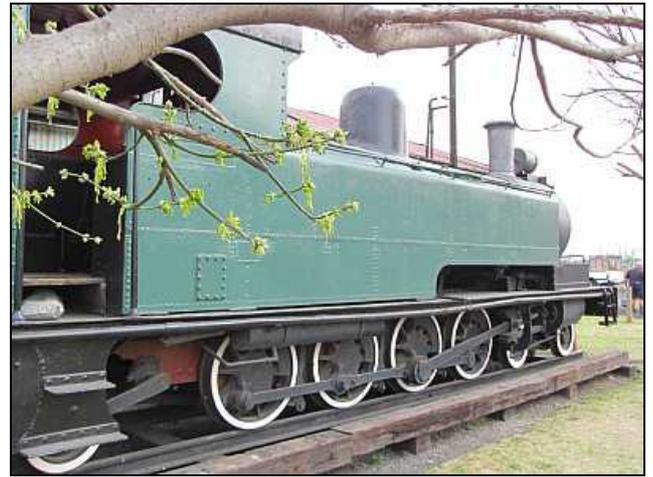
LD04 – Green buds against a green loco. Spring is definitely here, but will there ever be a new season of work for this neat vintage engine? Notice one of the oddities here – this ‘little’ tank locomotive has the same wheel arrangement as most of our big locomotives, the 4-8-2 arrangement, commonly known as ‘Mountain.’

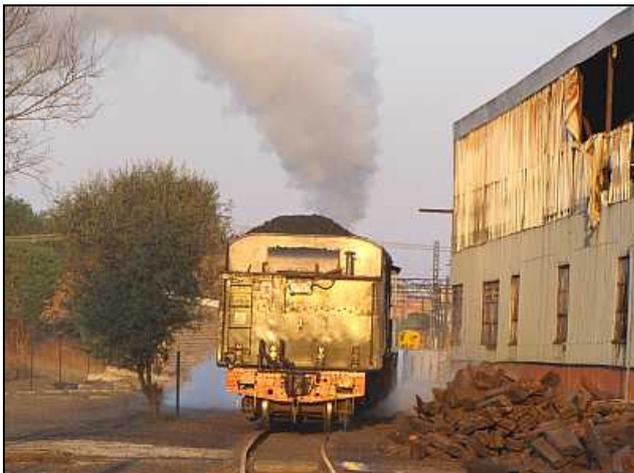
LD05 – Can a steam locomotive snigger? I’m sure our little Suzie sniggered while starting to run on the regulator, trundling around to the eastern yard on the forge house track.

She cheekily surprised me with a short shower of sh ... water from the chimney as she passed me. It’s almost like a prime. What happens when a locomotive has been running on the drifter and the regulator is finally opened for the first time – the condensate that collected within the regulator casting and within the super heater header is suddenly ejected.

The tender still needs to be fitted with an external filler pipe with an agricultural bell coupling for fast filling via pump or hydrant – the standard adopted by all our other locomotives.

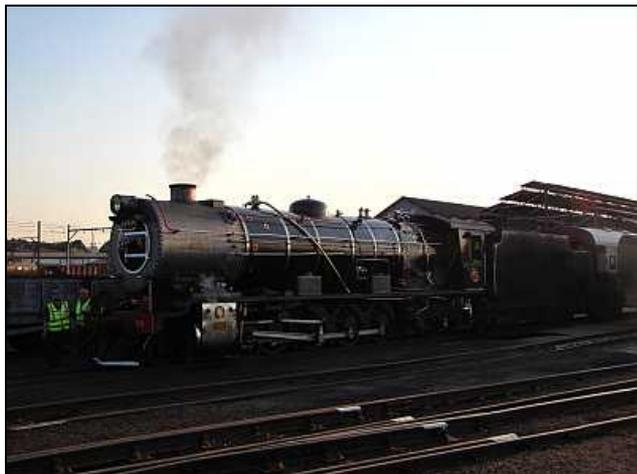
LD07 – She's been coupled onto her train and is waiting with the rods down. Walking around the front are Train Manager Attie de Necker and Safety Officer Clifford Matthee. They've done the brake test and checked the inter-coach connections and couplings. Now we're waiting for the departure time.

We always try to do the standard vacuum brake test a little earlier than we really need to so that we have time to trace and rectify any faults before the trip starts. It is standard procedure to test the train's brakes with the locomotive(s) that will haul the train, regardless of how recently they were checked and operated with another locomotive or perhaps a stationary vacuum pump.

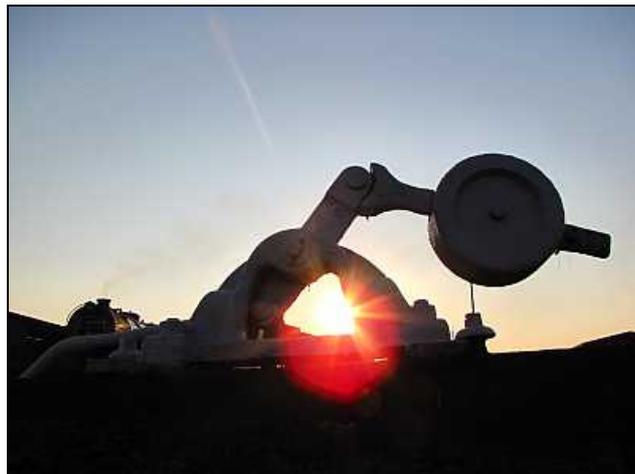
LD08 – The last picture I took before shuffling off to bed in a sleeper coach. It's been a long day at the office with the yuppies followed by a long night with the loco – but worth it to have been a part of the hidden process of getting a heritage locomotive out on the tracks.

This is a classic points tumbler – so called because the idea is to lift the weighted rod and let it fall the other way by gravity. The knuckled joint seen in the middle of the lever then closes and the inertia from the weight's arrested fall acts as a good firm donkey-kick to get the point blades switched over.
