1). THURSDAY - LOCOMOTIVE PREPARATION :

Conventionally it takes several days to do the final work to load and prepare a train for a long distance trip although many of the arrangements have to be made several weeks before. Traditionally, many of us take a work day off before the train departs to do the final preparation work. This section of the report covers that period of time.

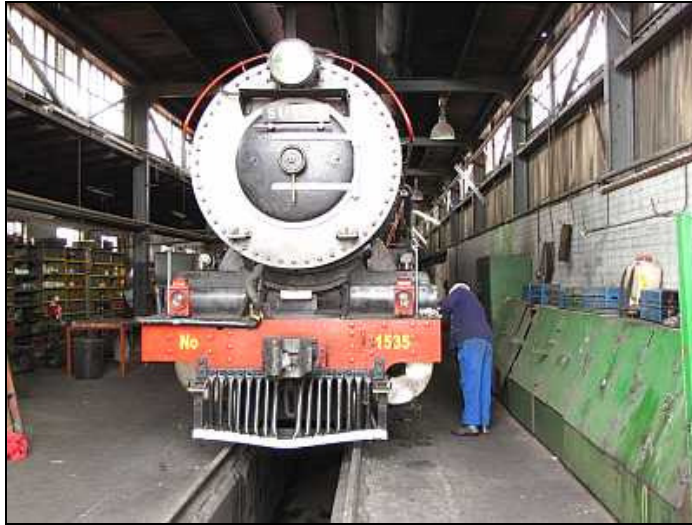
FP01 – The Class 12AR No.1535 'Susan' is still cold as she faces out of the old boiler house into an opalescent and colourless mid-morning. Senior Driver Attie de Necker is already doing the humble job of brass work and paint cleaning – which he regularly does as a matter of pride.

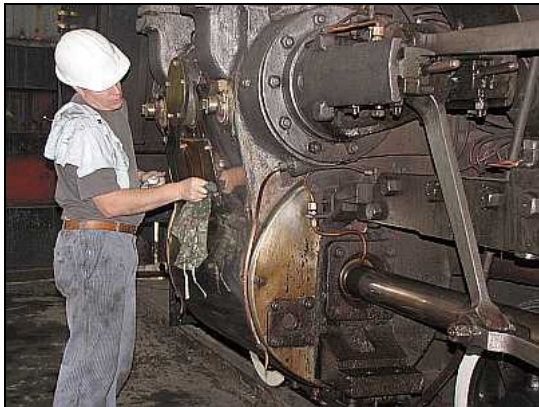
PR01 – A journey of nearly a thousand kilometres starts with a little polishing. Guest driver Philip Maurer, fresh from battling 5 foot high snow drifts on the mountainous railways of Switzerland, enjoys a little shirt-sleeve work without the assistance of erratic Swiss OBB cab heaters.

He's polishing the steam chest cover inspection plate on the Class 25NC – with a rather effective brand of polish that he brings over from Switzerland. The polish works chemically, rather than with abrasives. He now owes me a genuine Swiss Loco oil can for the free publicity.

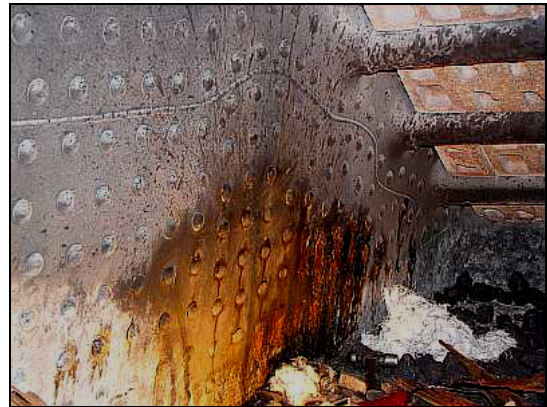
PR02 – One of the firelighters had been a bit too quick with the 25NC's boiler on a previous hippo-soup session and these firebox side-stays got stretched with the expansion. Each one of these weeping rivet-like stay heads had to have their outer edges tapped back to form a tight seal against the side plate.

The firebox stays separate the inner and outer walls of the firebox, the space between being full of water. Those flat flank plates have to withstand a bursting pressure of up to 14 tons per square centimetre at operating pressure on this locomotive.

This tedious and rather noisy process is misleadingly known as 'caulking' – but there isn't a silicone or caulking gun in sight. Our normal fire lighting schedules allow for 6 hours to light up an engine. Sometimes, the engine is accidentally over-fired in a hurry, especially after a delay such as fusible plug repairs.

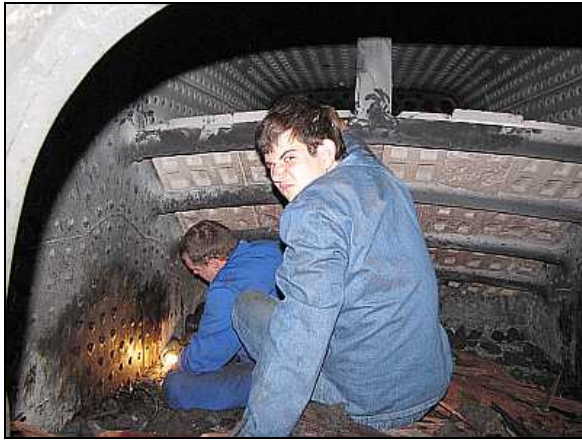
PR03 – As Shaun Ackerman inspects his 'caulking' work with his ears ringing, Luca Lategan gives me a playfully disgusted nose wrinkle from with the firebox.

Notice the unique T-shaped siphonic arch tubes of the Class 25NC firebox, as well as the modular nature of the fire arch itself. The fire arch deflects the hot combustion gasses backwards towards the firing hole, before they move up and then forward again through the boiler tubes, thus giving a longer dwell time and a greater chance to transfer heat energy into the water.

When the arch is incandescent, like the fire clay panels behind a domestic gas heater's elements, it assists in instigating and maintaining secondary combustion above the fire bed.

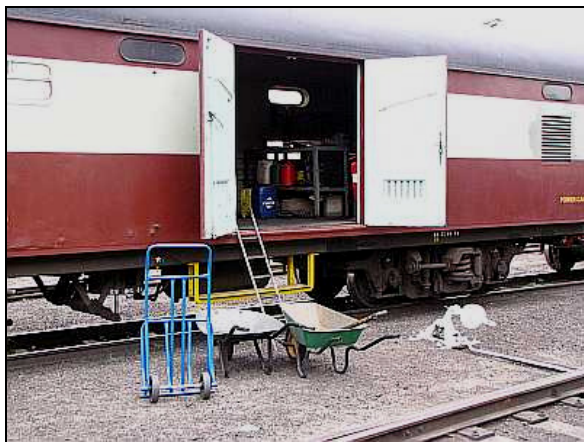
PR05 – A quiet moment in amongst loading the power van's generator room, which also acts as a workshop and store. We have to pack everything we might need, from 20 ton jacks and the acetylene trolley, to spare brake pipes and re-railing frogs.

The Power van is actually a converted Staff and Baggage van. Those steps under the doors are useless because there are no hand rails – this opening is designed to be used from station platform height. We have to use ladders to get up from the ground.

Visible just inside the door is the work bench that was relocated to be able to fit the larger generator required to run the heavier electrical load of electric powered geysers.

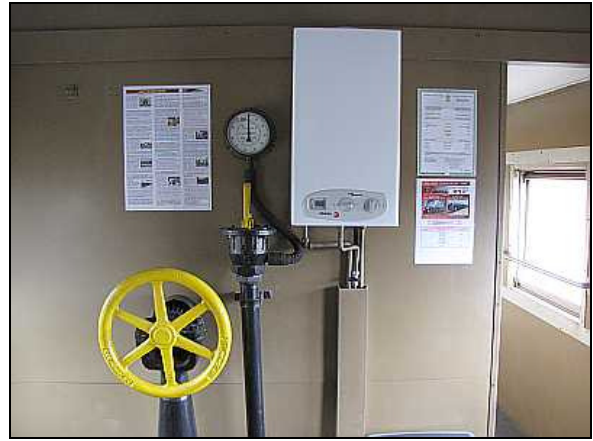
PR04 – The best shower in the house – and we crew members deserve it! Unlike the showers in the sleeper coaches, this one is a gas powered semi-flash heater and it works really well with a minimal dead leg of cold water in the piping. The shower itself is roomy with a fully enclosed domestic shower stall, a porcelain pedestal sink and all the fittings. I

The incidentally pictured hand brake, release valve and the vacuum gauge are fully functional.

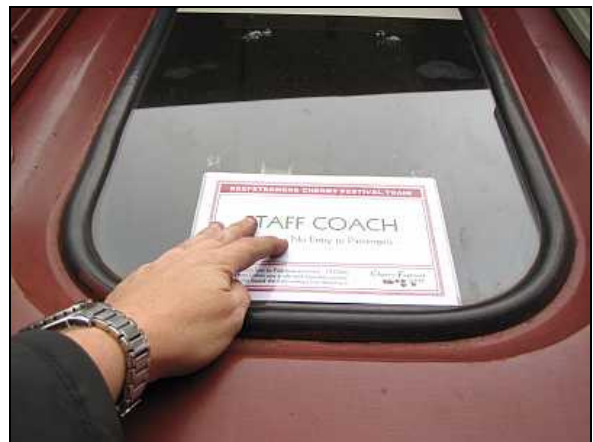
PR06 – Passengers seem to find the yellow five-digit SAR numbers on the coaches confusing. I made up a full set of laminated labels for the coach door windows and mounted them on the outside with Shaun Ackerman's trick of using silicone sealer as an adhesive. It doesn't deteriorate and doesn't lift the paint when removed from a wall. He knows his stuff, does young 'Smudge', and we didn't lose a single one of the more than 48 signs that were mounted in spite of the windy, rainy weather.

I later discovered that although the silicone blobs peel off easily from the paint and laminates inside the coaches, it REALLY sticks to the glass. I spent almost two days scraping the glass clean to prepare the train for the New Year's trip and I wished 'Smudge' Ackerman the joy of half a dozen spiky kidney stones while I hung on those steps in the sun, scraping and scrubbing.

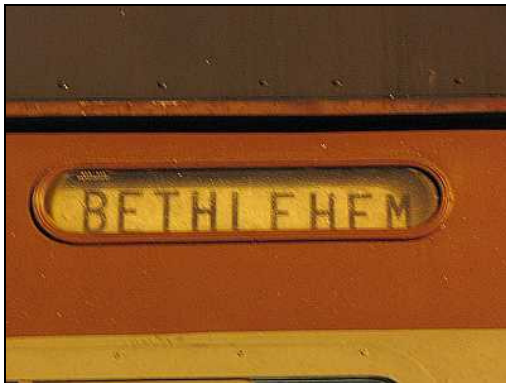
PR09 – A subtle Luca detail. Most (but not all) of our coaches still have functioning destination markers. Luca got hold of a coach key and reset them all to 'Bethlehem' – which would be our changeover point from electrical haulage to living steam.

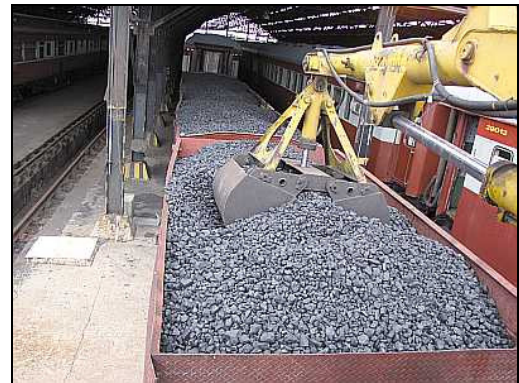
PR10 – We took along 60 tons of kibble, 50 tons of which are visible in one grab wagon bunker and within a 40 ton DZ gondola. There is another 10 tons in an identical grab-wagon bunker behind me.

To our surprise, we came back without even a kibble-nibble of the 40 tons in the DZ – this year's coal was of very good quality! In fact, at no point did we even have to hand-shovel scrape the bottom of those two bunkers in the grab wagon ... just taking easy loads with the clam-shell grab.

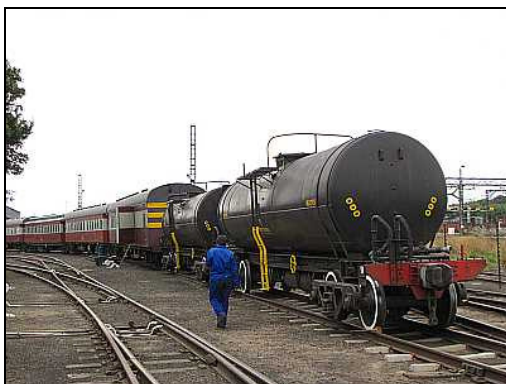
PR11 – The waiting train stands in the drizzly late afternoon – with two auxiliary water tankers of 31 000 liters each at the ready. Notice that the wheel rims have been freshly painted in white enamel. The tanker further in the background is the fire pump tanker and would always run with our leading locomotive, which would be the Class 12AR No.1535 'Susan.'

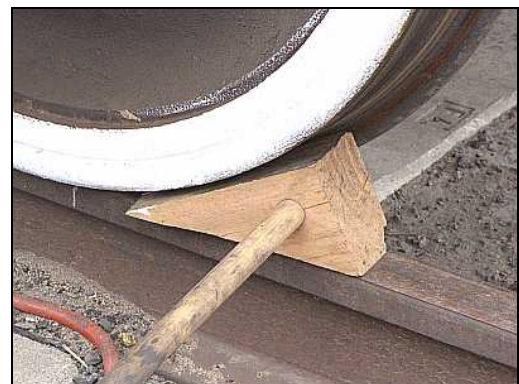
PR12 – Our shunting yard isn't as flat as it seems and a 'scotch block' like this one pictured under a tanker wheel is a necessary safety device. The use of a wooden block seems anachronistic in the modern railway context, but steel blocks and ramps don't grip the rail – they just tend to slide along uselessly along the rail head should the train begin to roll.

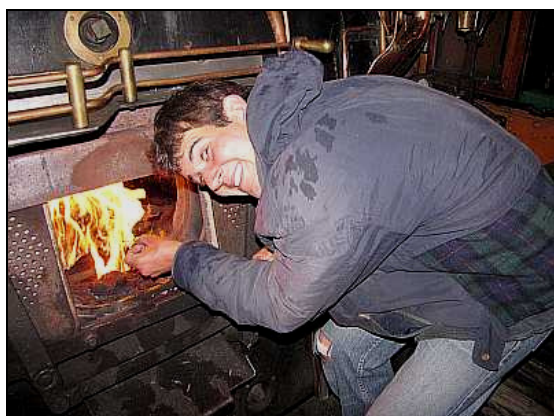
PR17 – A Luk-ey Strike. Luca got the privilege of lighting the first fire of the trip. Conventionally, the fire is actually pre-lit in a coal shovel full of paraffin-soaked cotton waste, which is then tipped in through the firing hole. Still, this pose looks impressive and you can just see the match and the fact that Luca still has both of his eyebrows!
(As they say in steam locomotive circles, blow-back's a bitch!)

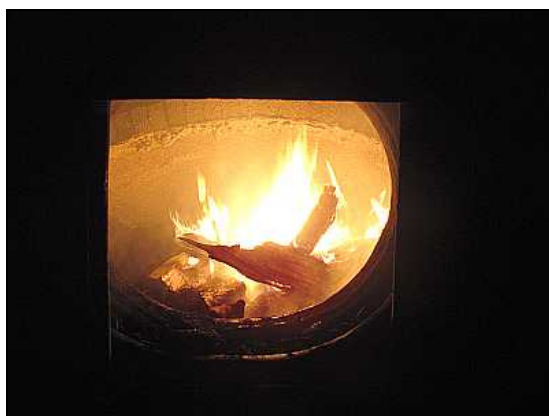
PR18 – The 12AR's fire arch, carefully built from individual refractory bricks on a wooden semi-circular former, has fused together beautifully although you can still see the colouration of the brick joints on the end face. The stalactites of molten refractory liner are starting to form at the end. I went to bed after this shot, leaving Shaun and Philipp to potter around the locomotive all night, while she raised steam at a leisurely pace.

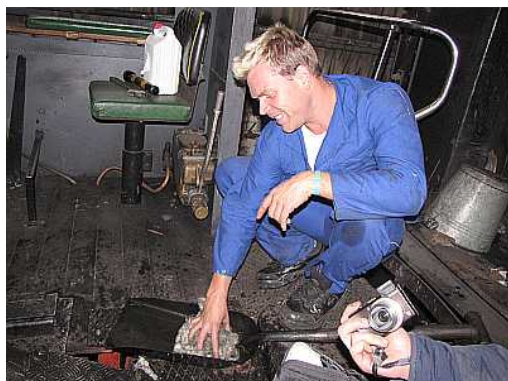
FR01 – It is 5:40am Friday morning and my fire lighter trainee, Ryan Fincham, is happily stuffing paraffin-soaked waste into the intercostals of kindling wood on his favourite loco, the 25NC. The kindling wood was sparsely laid all over the grate and I first had him rake it all together into a pile with the pricker iron. That's Luca sneaking a pic of me in the lower right. The can on the driver's seat is paraffin, which is always in short supply at the depot. I brought 10 litres of the stuff and hid the leftovers.

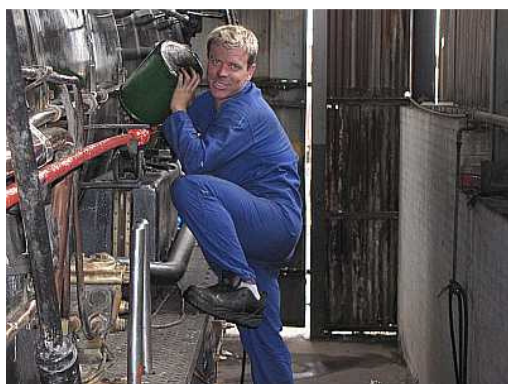
FR03 – Filling up the lubricator's oil tank, Ryan is still smiling as he is dispensing the first of four green cans of delicious valve oil and is only just beginning to realise what horror lies ahead. This viscous green tallow-enhanced lubricant literally flows like chilled treacle when the ambient temperature is flirting in the lower teens. Blop Blop Blop Blop....stre-e-e-e-a-m.

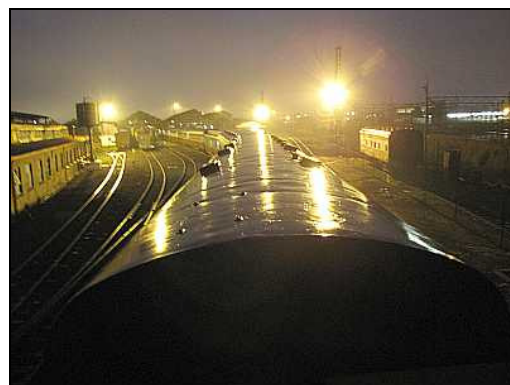
PR20 – Did I say I was going to bed? Then what was I doing standing on the top of a 50 ton water tanker, in the rain, taking pictures of a standing train at nearly 2 o'clock in the morning? You don't have to be crazy to like steam trains ... but it sure helps! And I'm one of the saner of the Reefsteamers...

The two water tankers were coupled at the rear of the train as they would be taken out first, as a pair, by the tender-first Class 25NC and only then would the remaining 15 vehicles be moved out by the tender-first Class 12AR, currently being fired up. Our head shunt on the west end of the yard isn't long enough to take 17 vehicles and two locomotives.

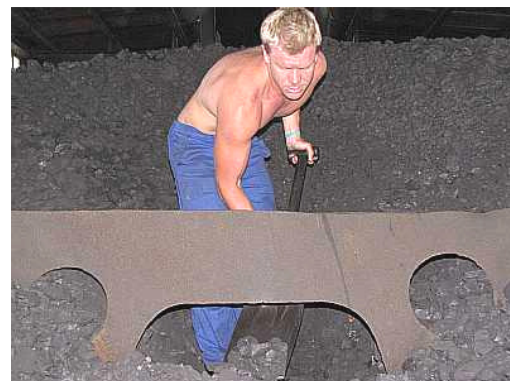
FR02 – Tri-athlete Ryan discovers the joy of having to uncover the sliding covers of the mechanical stoker's trough, to reset them. 'Reset' means to push them towards the back so the stoker's Archimedean screw feeds coal from the half-slide wide hole left at the front of the receding slide. The kibble pile kept collapsing – we would have to wait to scoop some out with the grab. As you can see – it's warm work even though it was a cold, drizzly dawn!

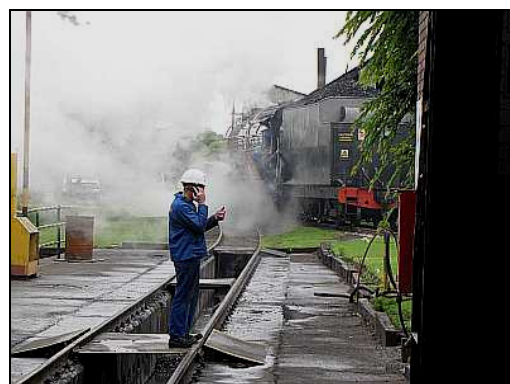
FR04 – I was busy with the 25NC and didn't get out much. Here, the Class 12AR is just ambling back over the cross over to couple up to the train to do a brake vacuum test about 5 hours in advance to allow time for rectification of any faults. Andrew King stays 'put' in the foreground as he uses his cell phone and dates the photo to the 20th century. (It's an old cell !)

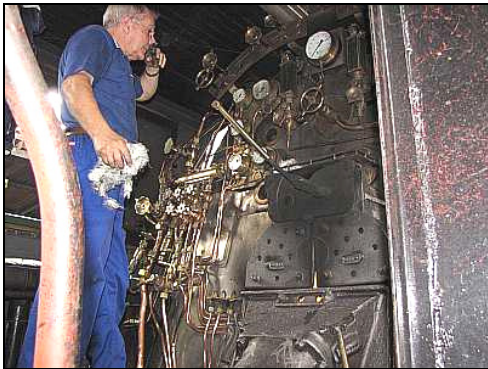
FR07 – Here's the other loose nut. Johann Breydenbach got kicked out of home. Excited about the trip, he had packed early and was restless - pacing like a caged tiger when his wife told him to just get lost, get on with it and have some fun.

We didn't have much draft on the plant blower and a very stiff valve. We changed it over to another and the second option didn't work too well either. You can see the fresh, soft soot on the firebox doors and the butterfly gearing caused by the tendency for the fire to blow back. Johann deliberately opened the fire early to improve the drafting. (Thinner fire.)

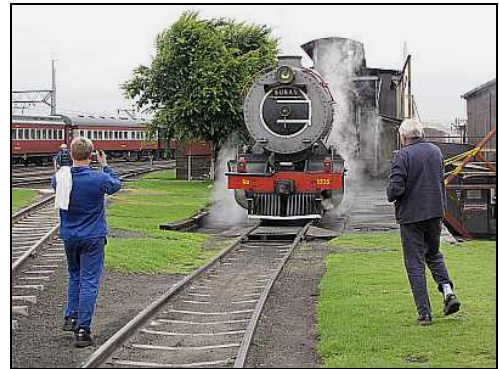
FR08 – After a successful brake test, and shunting the two water tankers out to the west end of the yard, the 12AR 'Susan' backs in for a comprehensive greasing and some gland packing adjustments on the turret manifold.

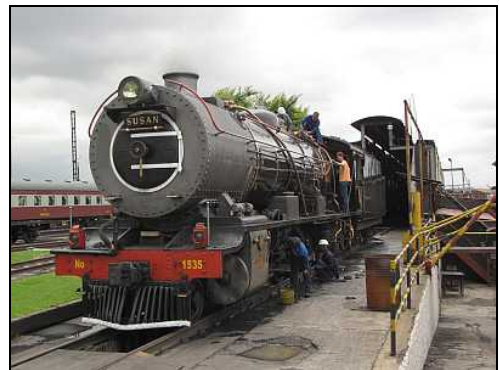
FR10 – A steam-powered termite queen is faithfully attended by her blindly loyal workers. Andries and Shorty are on their haunches, cleaning the motion, while Luca, in the orange shirt, is polishing the boiler cladding. Shaun, on the cab roof, is inspecting the packing for the blower valve and Philipp (white hard hat) has just climbed up on the right side to pass on some tools and unsolicited advice.

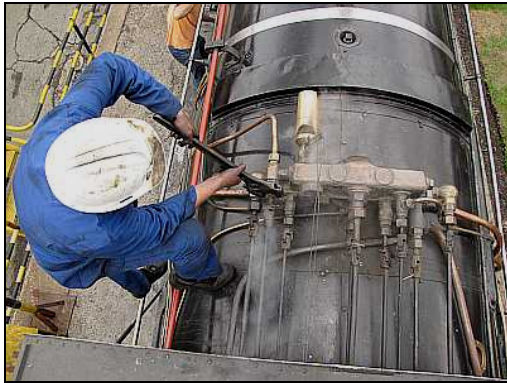
FR11 – Classic running repairs. Dr 'Smudge' Ackerman is struggling with a hot, blowing packing nut on the blower valve. The blower is the second most frequently used valve when on the road – the most frequent valve being the steam valve for the fireman's injector.

Notice the whistle – SAR whistles are mounted horizontally to clear the loading gauge.

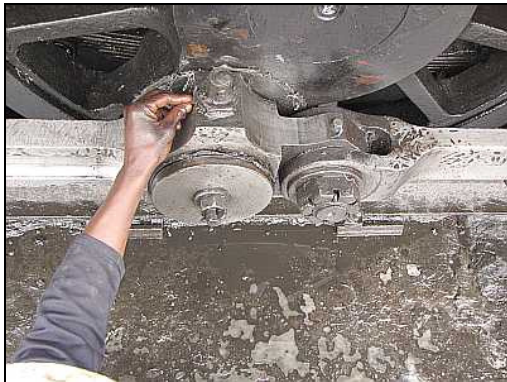
FR13 – Cotton pickin'. Andries discovers how sticky freshly applied hard-grease can be and the amazing affinity it has for loose strands of cotton waste. Cotton strands on the motion joints, such as this knuckle joint on the left intermediate driver, don't do any harm apart from looking untidy.

However, they are a constant risk around hydrostatic lubricators as loose cotton strands can get into the works via the filler port and cause blockages.

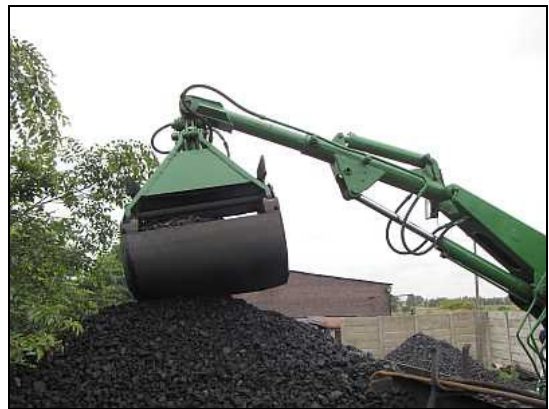
TU04 – Steady as she goes – aiming for the center and the front face of the coal pile.

You also see the locomotive minder's curse here ... see the iron rod protruding into the picture on the RHS? That is the handle of the slice iron. This and the other irons often get buried under the edges of the coal pile. After coaling, the first person to have to use the fire irons faces a challenge to get them out the pile, without tangling them up with each other or the hooks. Usually a fair amount of coal falls over the side as well and also needs to be cleaned up.
