ZZ01 – That does it for the first half of the Cheery Festival Trip report.

This Trip Report was compiled by Lee D. Gates on behalf of Reefsteamers
For observations, corrections and suggestions – email me at leeg@leaf.co.za

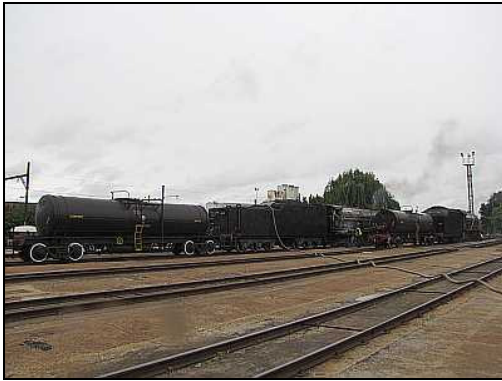
BS19 – Here's a more distant view of the locomotive servicing scene. That neat white fire hose was in three sections and you are seeing less than a third of it in the picture. Guess what the extra length did to the water pressure?

The sealing washer had gone missing for the bell coupling for the additional tender filler lines, so the hose had to be routed through the water chute. The sharp angles and the kink as it goes into the chute slows the water flow down even further.

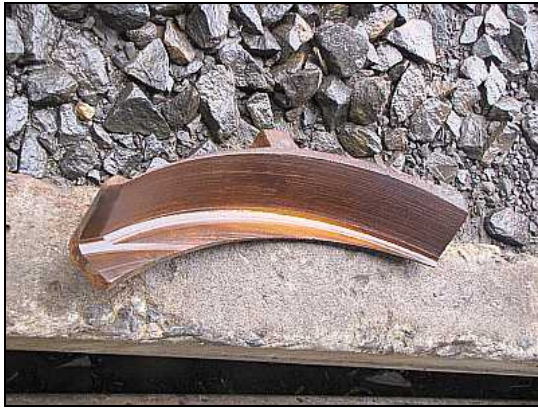
BS25 – Not one of ours! Here's a badly worn cast iron brake shoe that I found on top of a dead brake shoe pile. Whatever equipment this came from obviously doesn't get many regular inspections! The top of the brake shoe is the end facing the right. The double wear pattern looks as if this particular shoe got partially kicked out its bracket.

Other worn brake shoes were found that had actually broken into pieces at the narrow end.

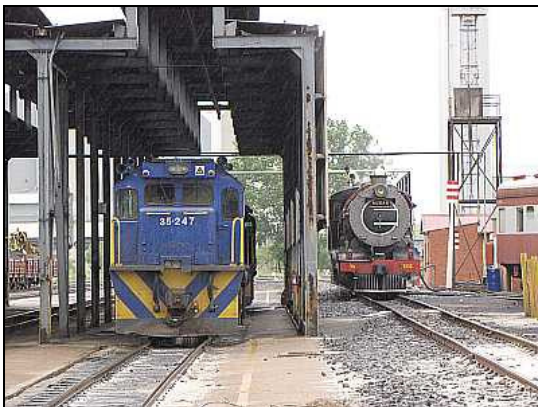
BS27 – An EMD type Class 35-200 dozes while the 12AR takes on water. Just after this photo was taken a call had come in that one of the two locomotives on a goods train had broken down on the Ficksburg line and the other unit wasn't running well. This diesel locomotive was rudely awoken, started up and taken out as an emergency relief engine.

This General Motors EMD locomotive was built in South Africa in early 1974. The USA classification of the locomotive is GT18MC. This is the diesel equivalent of a class 19D – being specifically designed as a branch line engine, which make's the rescue duty even more impressive.

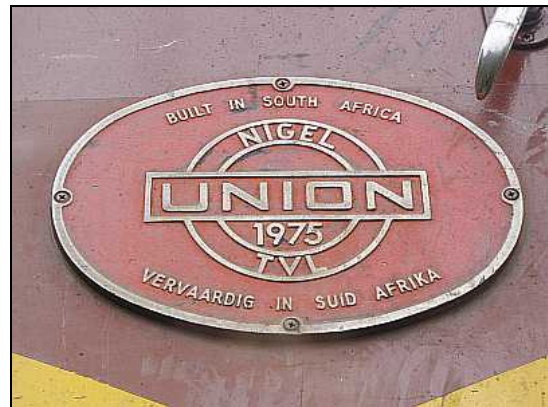
BS28 – Toaster heritage – Our leading electric unit in late SAR+H livery (short stripes on the sides) still has the builder's plate on the nose door. This locomotive is the most numerous type of any type locomotive ever built for the SAR. (The 15F holds the record for steam and the 34 class for the diesels.)

Both the 6E and the 6E1 have electronic traction control. However they have very different designs for transferring their torque. The original class 6E have air bellows between the bogies and the frames while the Class 6E1 has the distinctive external traction links. The simpler mechanical design won out.

The previous generation of 5E's and 5E1's had a rating of 351kW for each of the four traction motors while the 6E's and 6E1's have a rating of 550kW per motor. Both models use slip ring motors.

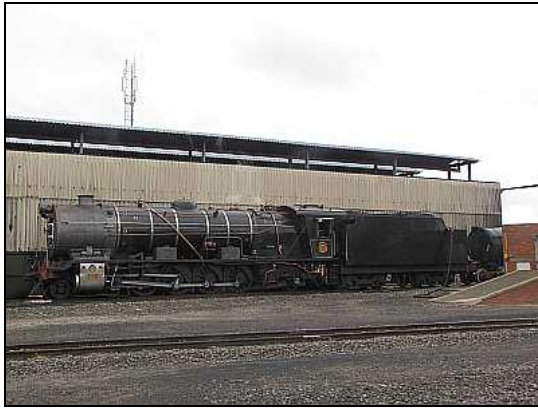
BS29 – A fairly rare shot in a real life situation, an unobstructed side view of a working locomotive.

Because of the missing washer, the bell coupler could not be used to fill the water tank – and this locomotive doesn't have an extra filler pipe as all our others do – so both the tank and the loco tender have to be filled from the top. If the valves are open between the tender and the tank car, the water can actually flow backwards to the tank car as well.

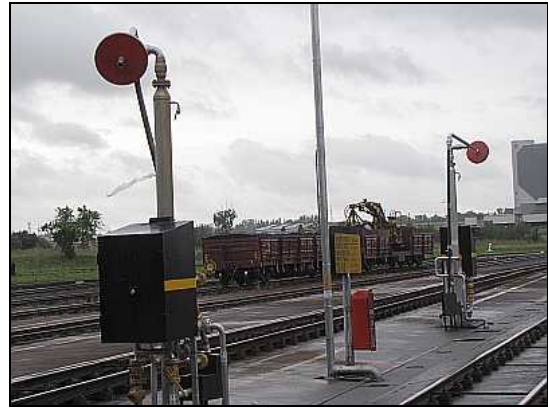
BS30 – In the foreground is a diesel refuelling station, with red disk targets showing the swivelling heads and the black enclosures protecting the flow meters. In the background is our mobile 'fuel depot', the DZ wagon full of coal and the hydraulic coal grab wagon.

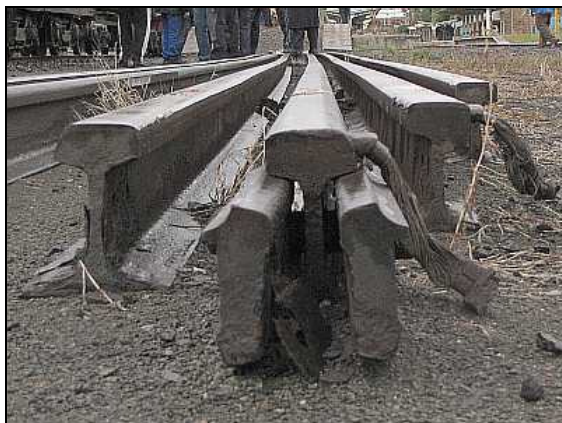
CB03 – The rationalization continues at Bethlehem Station and many of the North East Sidings have been removed, leaving a lumpy wasteland of grease spotted ballast.

Notice the very bad corner wear on the left–most rail. The tattered pieces hanging off the right are the braided-cable bonding straps used to ensure electrical continuity across the joints. These are not only used for signalling as is commonly supposed, but also as earth returns for the traction current on electrified lines..

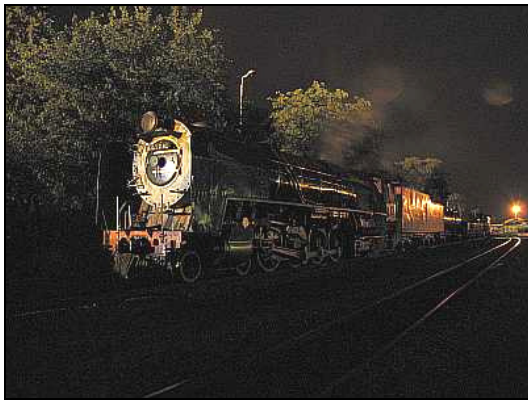
NT05 – Seen through a rain tipped lens, resting quietly after her 460 km long journey, Class 25NC No.3472 'Elize' is being kept warm by yours truly. I'd seen that the coal was good, so was only 'feeding the goldfish' on this massive loco. I had laid a fairly small bank of coal and was then topping it off with occasional rounds of up to five loosely spread shovel-loads each.

The 'rusty streaks' on the smokebox's front plate is actually a double shadow caused by the yard lighting. The 12AR is just out of frame to the left. This dormant, but beautiful machine was officially my charge for the night.

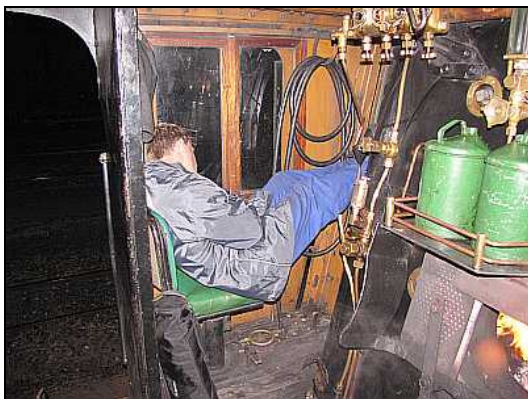
While Ryan is drooling down the cab window, you'll notice the firebox door is open. It breaks the draft through the grate and allows cooler air to mingle with the hot air and slows the rate of pressure increase. You can see the steam being pulled into the cab just below the wing plate. That long cylindrical object the foreground is my tripod bag.

Notice the two green cans of valve oil heating up for ease of flow during the morning lube-up session.

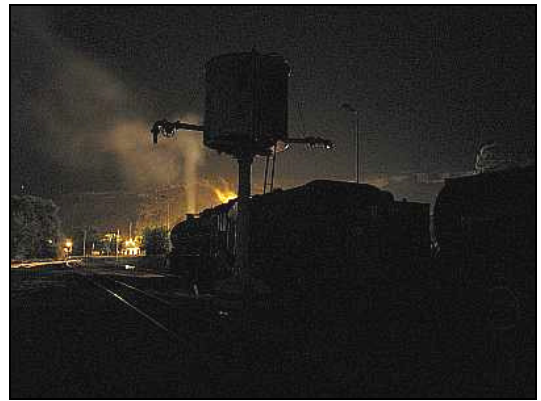
NT06 – The black back-lit hulk of the 12AR No.1535 looks a bit more wide awake under the water tower. Actually she was drowsing at the 1000kPa mark (12 o'clock on the gauge dial) and very gradually gaining pressure. The blower is not on during this picture – just the air was very still, hence the vertical smoke column.

She isn't feathering at the safeties either, they are a bit further forward. That backlit steam visible in front of the cab is from the inevitable small leaks at the turret valves.

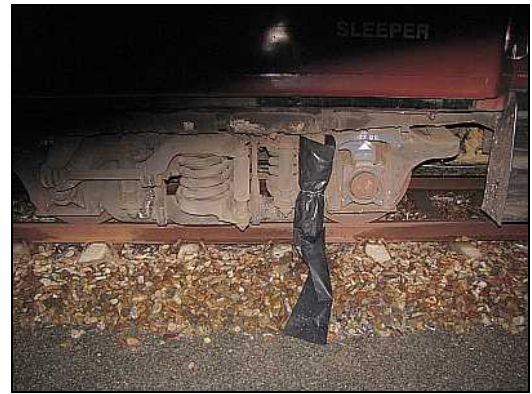
NT10 – A fitted bag lying alongside a commonwealth bogie. You can see by the deflated appearance of the bag that this crew made a mistake – they should have 'primed' the bags with liquid lime as a deodorizer and disinfectant. But that makes an unpleasant job even worse. The horizontal pipe above the bogie is the insulated steam heating pipe – now disused.
