1). INTRODUCTION :

Two of the steam locomotives are waiting for funds to repair them – and they look sad sitting around with open front ends. But they'd look even sadder sitting outside, forlorn, amongst the weeds. The two cranes, particularly the 60t Crowans Sheldon unit recently rescued from scrapping by Sandstone Estates, are simply waiting for manpower to complete them. No.3016 has been moved to storage in the carriage sheds.

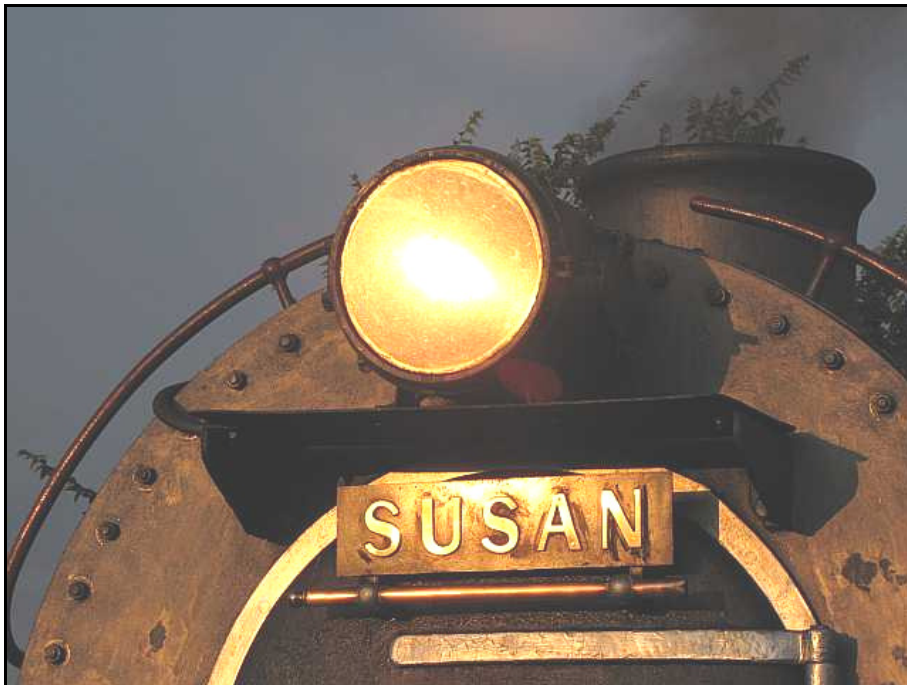
- 02). A solar powered headlamp? The headlamp's simple parabolic reflector catches the low-angled sunlight at just the right angle. The finish on Michael Thiel's silver painted hinge fixtures and the smokebox ring is holding up very well in operation, much better than the usual traditional white enamel paint. However, it is quite hard to catch a picture of an unblemished graphite finish as the front end of that smokebox gets quite hot in operation.

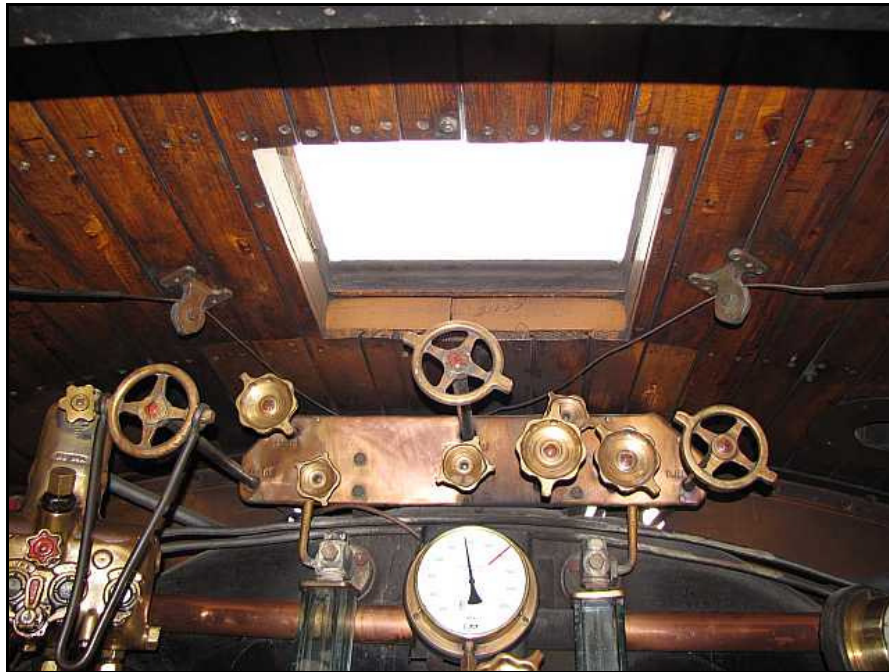
- 03). Here is a quick snap of the turret valves before I quite literally whistle up 'Oom' Attie out of where he's hiding and use the locomotive's whistle to tell him that I am now on duty. Our guest stars on the copper valve plate, from left to right, are Left Injector Steam, Blower, Dynamo, Turret Main (spoked wheel - top center), Grate Shaker main, Lubricator, Power Reverser, Brake Vacuum Ejector and the RHS Injector Steam. The climbing boiler pressure on the over-exposed pressure gauge is about 950kPa. Glasses are over full.

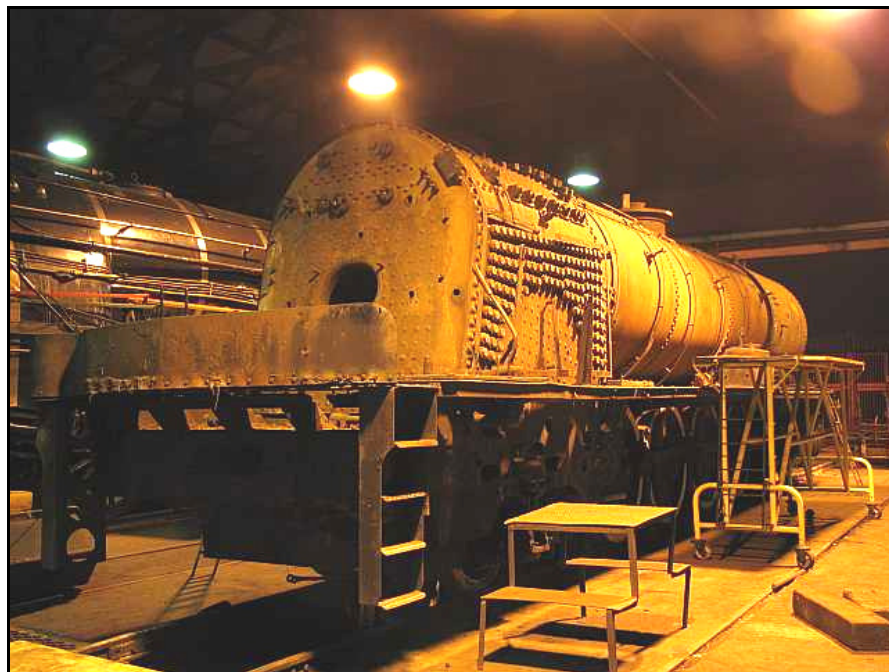
- 04). The gaunt, rudely cab-less firebox end of the shorn and naked Class 12R No.1947 – aptly nick-named 'Rusty Rosie' these days. She was the Germiston station pilot from about 1974 until displaced from her duties by our own Class 12AR 'Susan' in about 1982. This locomotive has been systematically stripped down for a visual boiler inspection to assess whether she is worthwhile restoring to operation, given our current funding. She is to the topic of the next formal Reefsteamers Depot Report.

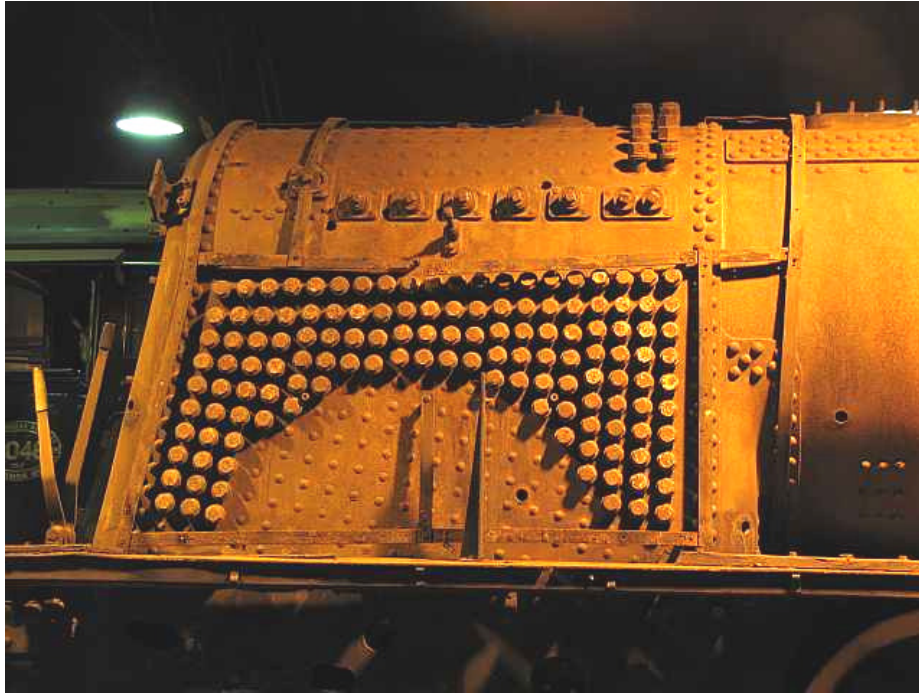
- 05). Under the amber tinted light of the workshop aisle lamps, the rusty steel looks almost like dull brass. This is a detail shot of the right side of the firebox. The heavy duty 'nuts' that you see are the flexible stay caps and they are arranged radially from away from the center of heat and also to hold the top side and front corners of the very simple square firebox within. They tie the inner and outer firebox walls together but allow some flexibility for the different rates of thermal expansion. The corroded crinoline bars that hold the sheet metal cladding are still in place. They are going to be completely re-fabricated.

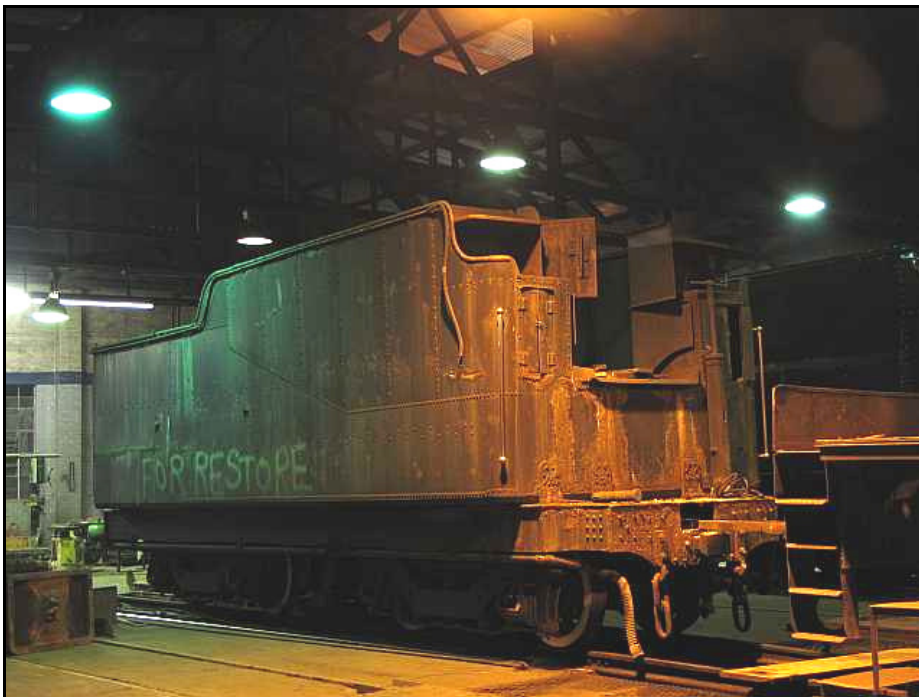
- 06). Here's the 12R's tender – Albeit weathered, it looks pretty OK from this angle but the steel plate work is shot and it has more holes than Joost v d Westhuizen's underpants.

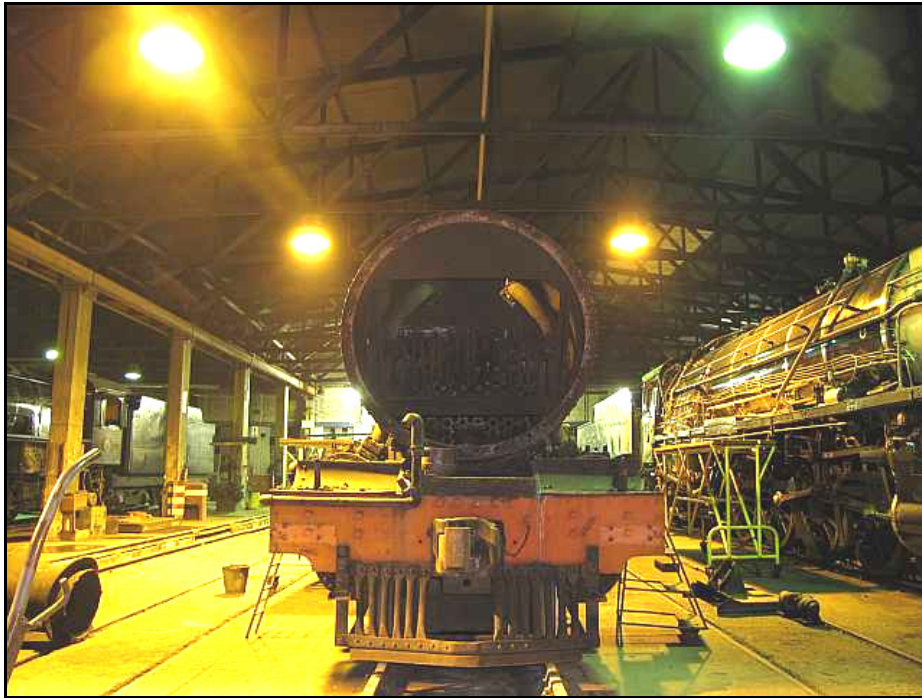
- 07). The stripped down front end of the 12R No.1947 'Rosie'. This locomotive has been subjected to two weeks' worth of stripping to get her ready for a visual boiler inspection. Much of the hardware in the smoke box is rusted out and the blast pipe is missing.

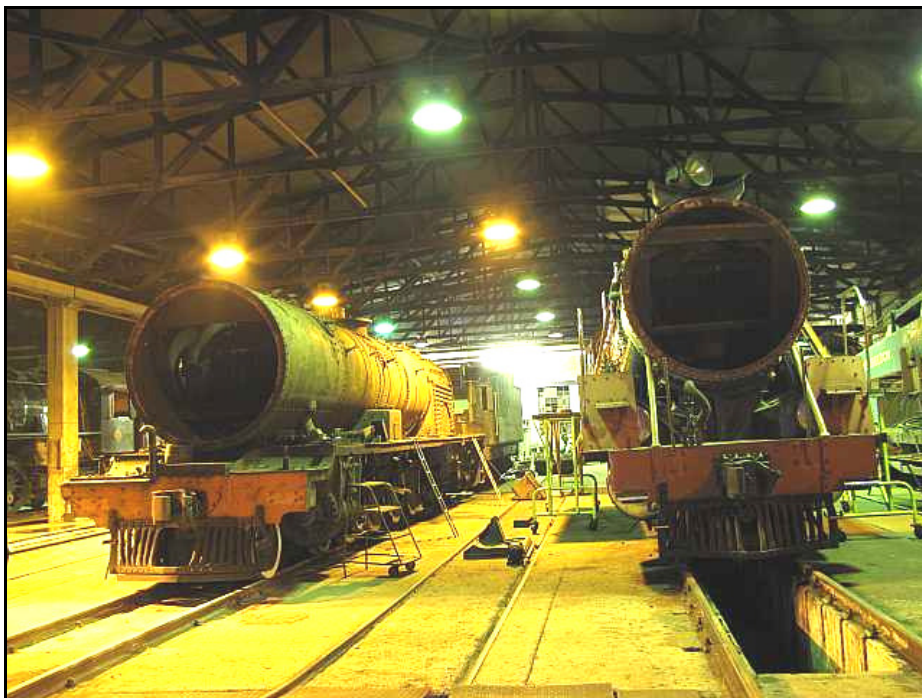
- 08). A study in different boiler pitches with the 12R No.1947 'Rosie' on the left and the much more modern 15F No.3046 on the right. Number 3046 has just been completed but waits patiently with the smoke box front cover and the underlying spark arrestors missing to facilitate access for boiler inspection and certification before she can run for the first time in nearly 20 years. That odd looking assembly on the chimney is the upside down regulator valve box upon which is nestled the old fashioned barrel headlight.

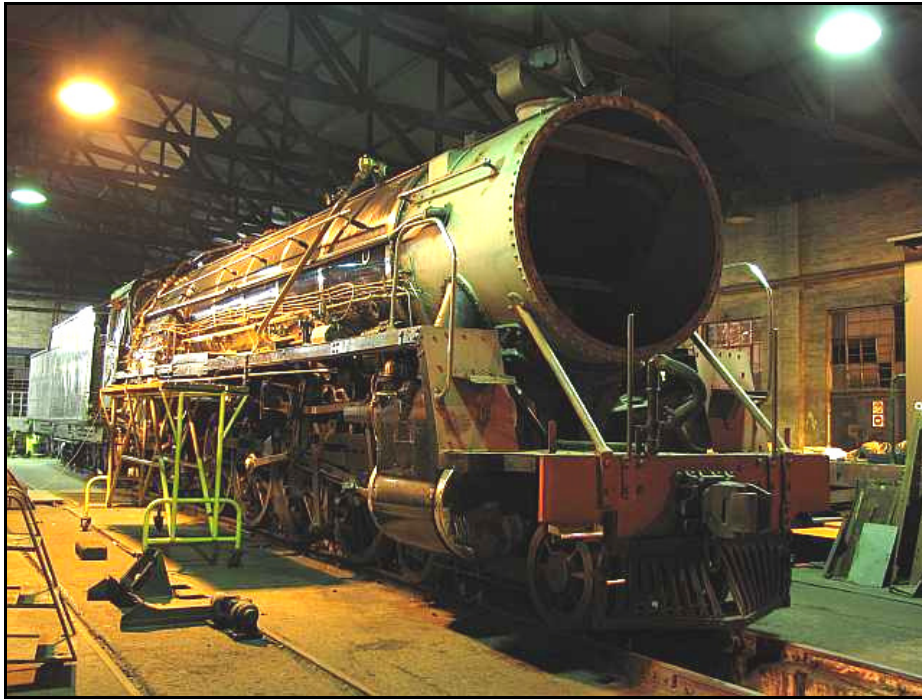
- 09). Here's another view of the Class 15F No.3046. That isn't steam in the rafters – I had oil on the top rim of my camera lens – always an optical hazard around a real steam depot. Note that this 15F is going to run like the very first batch did – without smoke deflectors. Those are modified Class 19D hand rails on the footboard risers. This loco is going to be a bugger to climb up to put the blower in the chimney stack when lighting up!

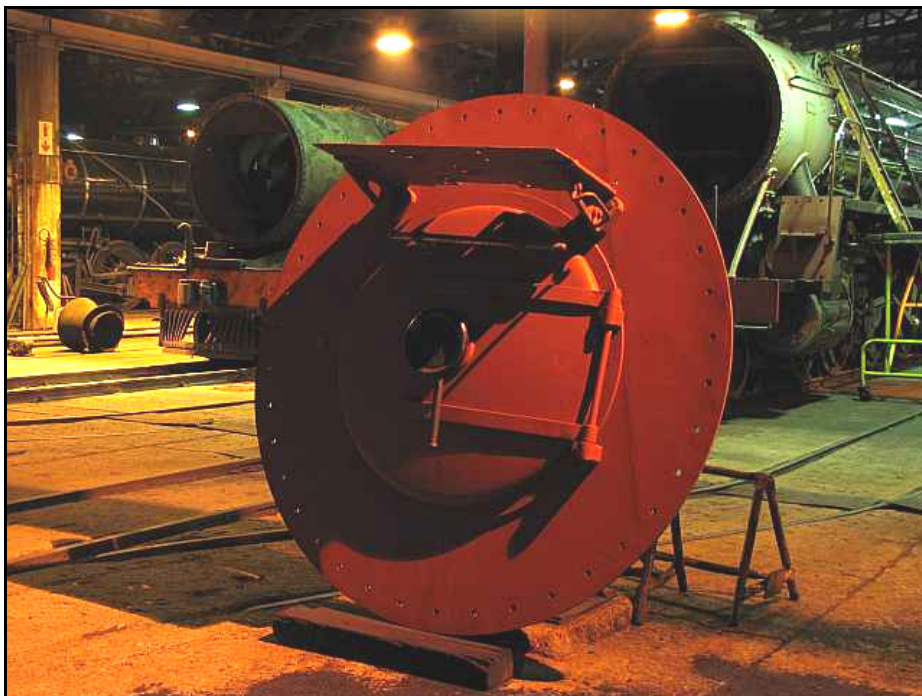
- 10). This thoroughly red-oxide primed smoke box front plate, complete with door, the nose wheel latch and the headlight bracket, looks as if it belongs to the Red Devil! It is the front end for Class 15F No.3046. The locomotive is likely to be called 'Elizabeth' after the then young Princess Elizabeth, now HRH Queen Elizabeth of England, whom she hauled within the Royal Train back in 1947.

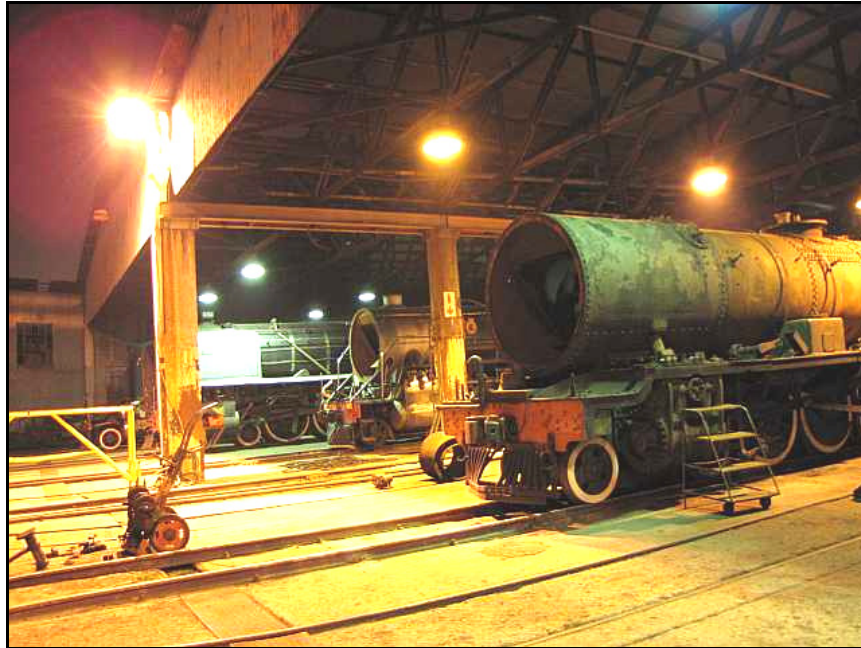
- 11). The Germiston 15M shop is still full 18 years after it was officially closed. In the far background, David Shepherd's Class 15F No.3052 'Avril' awaits new boiler tubes and is the current subject of a sponsorship drive. The locomotive with the 'silvery' cylinders is the Class 15CA which needs new flues. Sandstone Estates' GMAM No.4079 shyly shows a wheel, visible within the angle brace of the yellow painted platform.

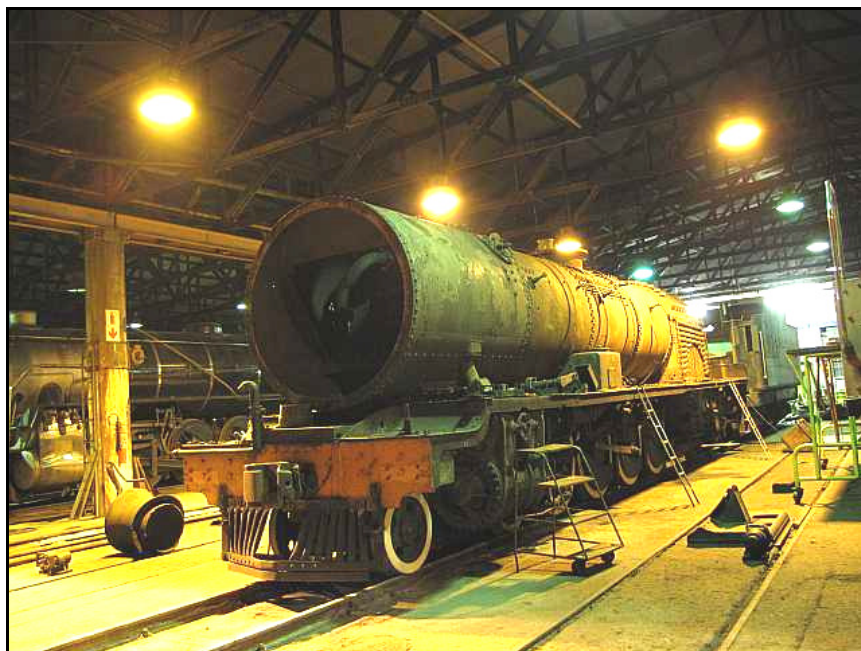
- 12). Another view of the stripped down 12R Class. Reefsteamers have recently been posted on a preservation website within the Hall of Shame pages, although the caption for the photo gives mild credit to Reefsteamers for moving the locomotive to a place of safety. This locomotive was actually stripped down by railway personnel as she was plinched on the depot property when the depot was still open. Some parts probably went for souvenirs but many of the parts probably ended up on other 12R's and particularly the 12AR's which were working at the time. I'm going to ask the webmaster to update his site.

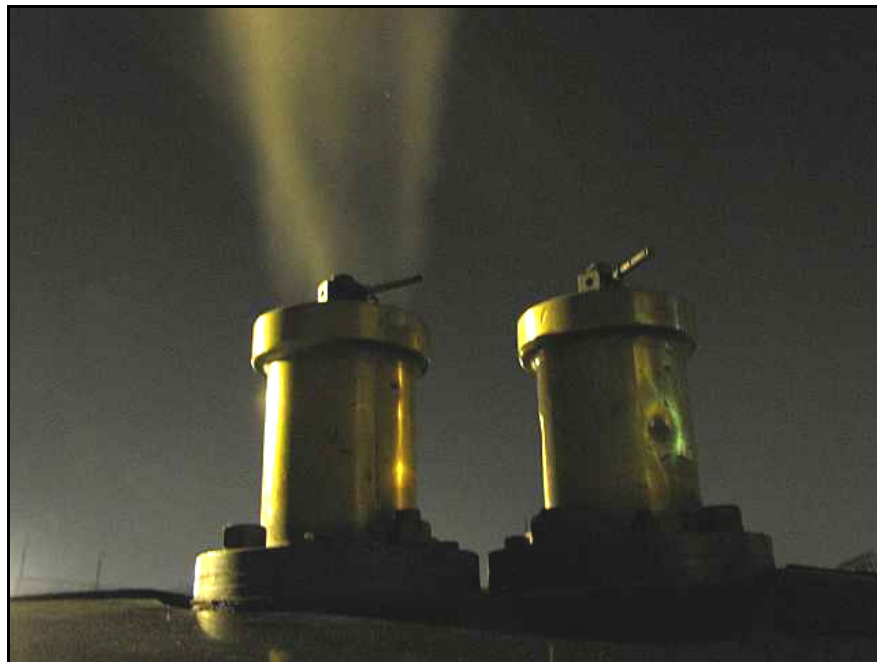
- 14). She's a-gonna blow ! Actually, even with a minimum of coal, the boiler pressure never fell below 1300kPA the whole night and the front, lower rated safety valve was 'feathering' all through the night. The locomotive didn't blow off once. I lost some skin with this shot – accidentally letting the underside of my right arm rest on the blistering hot dynamo feed pipe. I had both my hearing aids on but switched off for this pic – they then act as form-fitted ear plugs. Having safety valves let go at this range can cause permanent hearing damage – ask Les Smith and if he hears your question, he will tell you it's true.

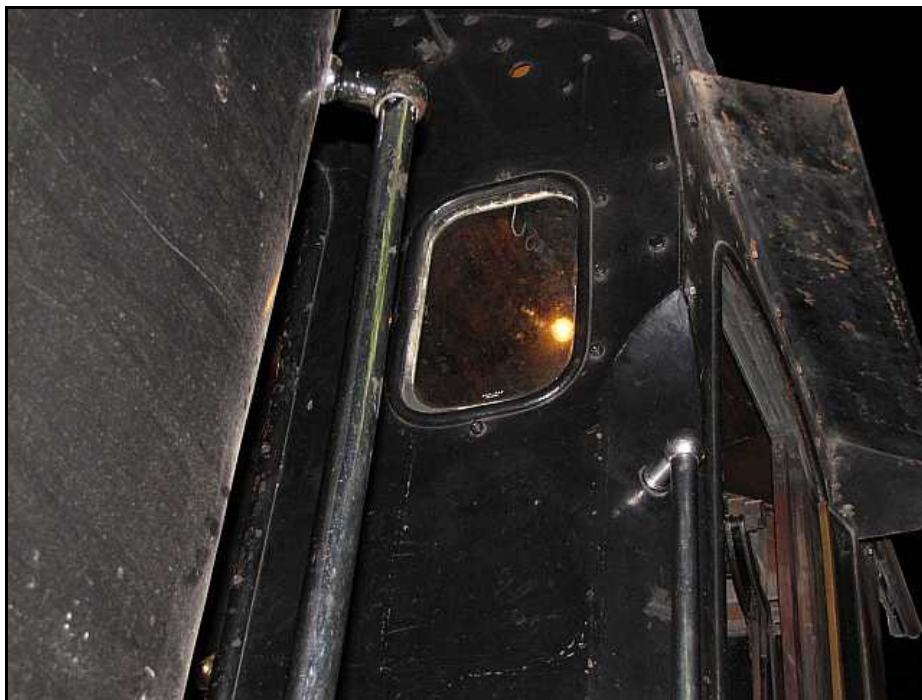
16). Now this is a rare sight! The driver's cab light is in working order. Usually, it is switched off as not to spoil the driver's night vision, and being the most unpopular bulb, it is often the first candidate to be used as a spare should one of the other 32V light bulbs blow. Some of the more experienced crews create uni-directional bulbs by wetting wads of tissue paper, or sometimes cotton waste, and sticking them to the globe glasses to block undesired light from the driver's side. In fact, when the locomotive is running, the only bulb really needed is the one right behind the lubricator – the bulb so placed to back-light the oil feed sight glasses. The open firing hole lights the way for the shoveling fireman.

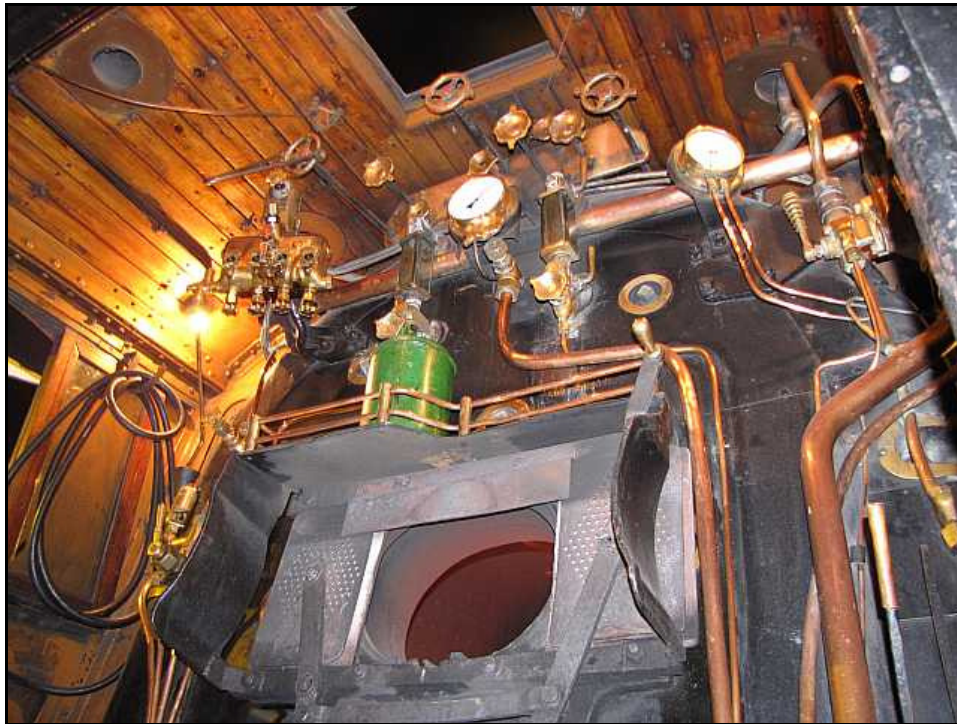
- 17). A view of the relatively simple boiler back head from just above the toe board. The firebox door isn't posed. It is open to reduce the draft through the glowing fire bed and to help hold the boiler pressure in equilibrium – notice the pressure gauge straining at the red line. The curved wing plates help deflect heat but also help to deflect steam downwards should a tube end fail within the firebox.

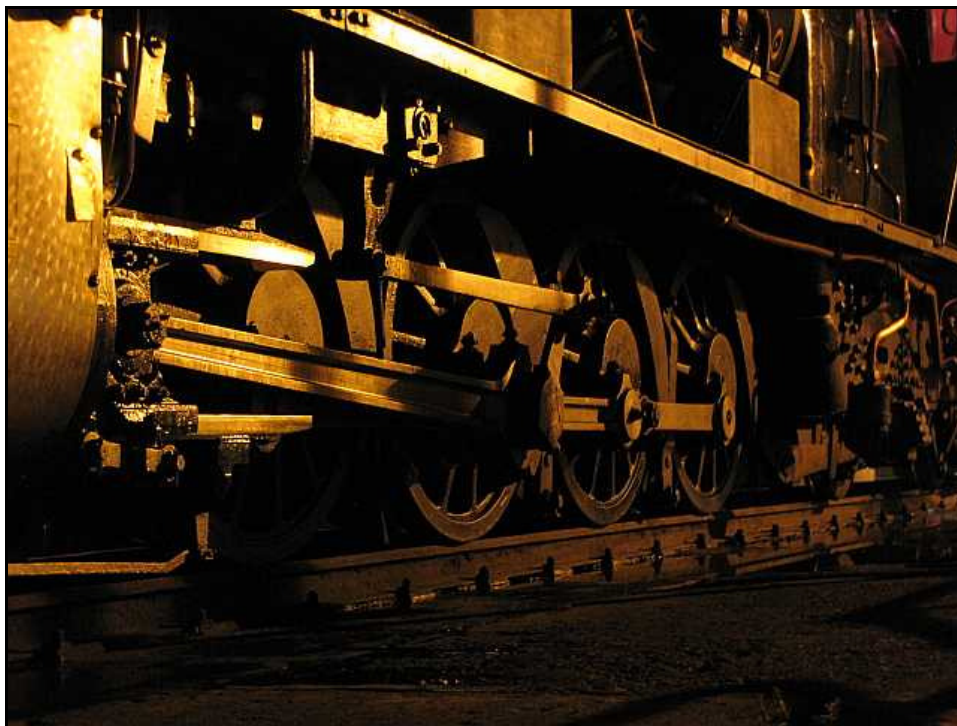
- 18). Wheels of steel - 12AR Motion at rest. They would do just under 200km the following day.

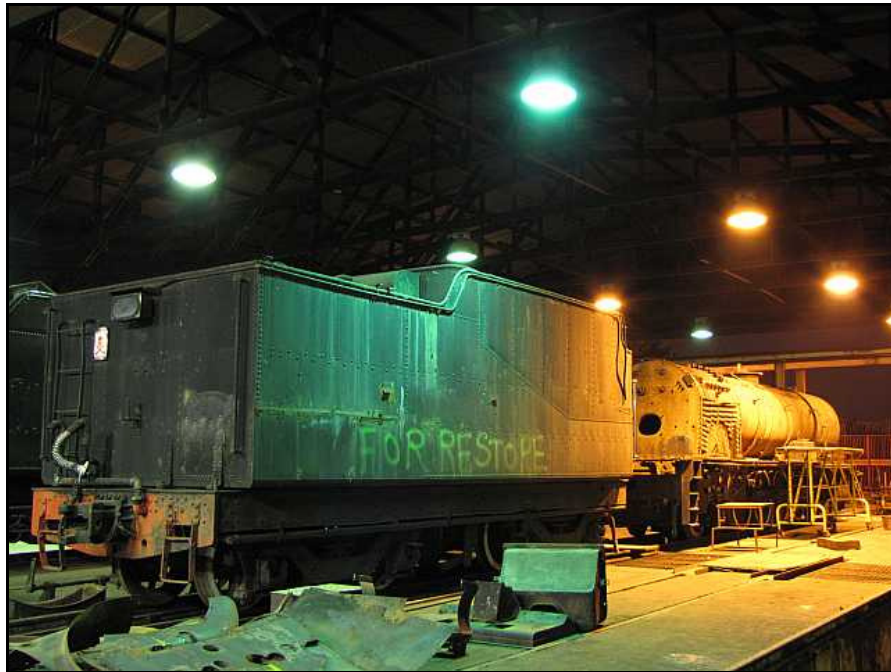
- 19). A rear view of the stripped down 12R 'Rosie' and her disconnected tender. In the foreground is a huge pile of loose boiler and back head cladding, beneath which lie the fire box doors. Beyond the pile of plates lies the RHS steam chest cover and then one of the old fashioned rectangular footboard-mounted sand boxes.

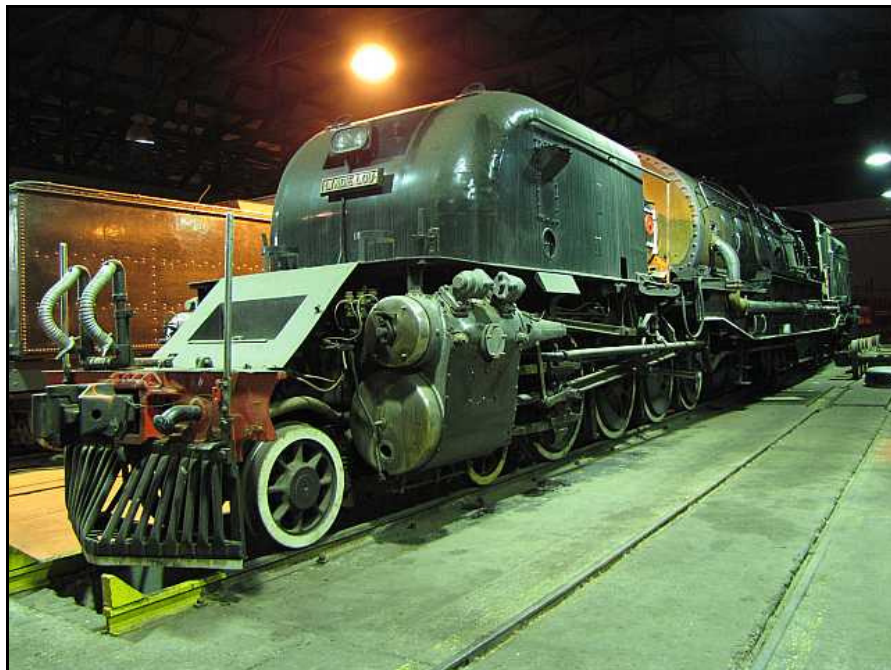
- 20). Uncle Wilfred's GMAM Garratt No.4079 'Lyndie Lou' looks impressive even when cold and standing. After a resolution of the problem of a stubbornly leaking clack valve on the previous day, she is now ready for an official hydraulic boiler test and to be steamed up for a steam test and then to be put back into service with a 3-year boiler certificate. The boiler and the sealed off fittings holds the required test pressure under hydraulic testing. The fault on the clack valve was a tiny blemish on a seat – not enough to be noticeable really, but enough to cause a leak at the hydraulic test pressures. This cute little locomotive has been placed into our care by the Sandstone Heritage Trust.

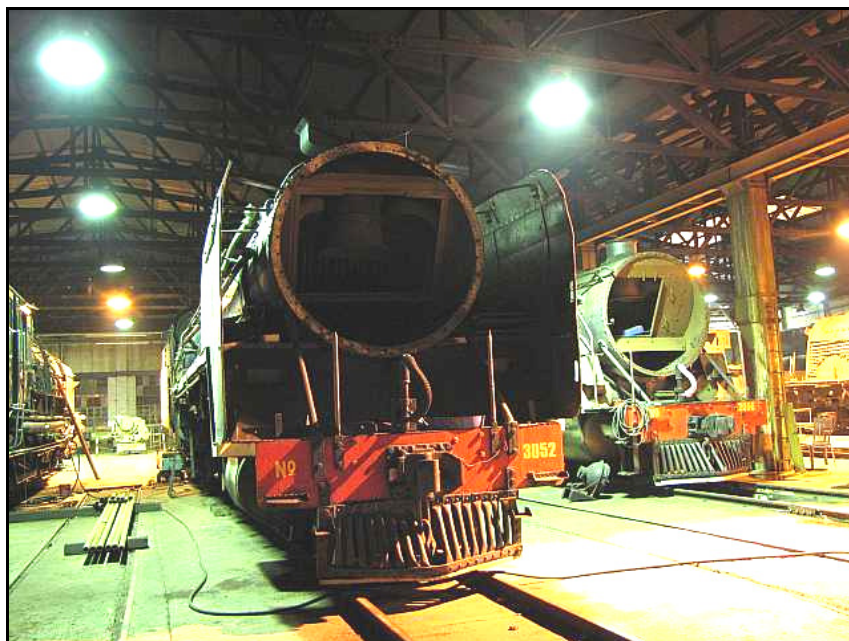
- 24). David Shepherd's Class 15F No.3052 'Avril' (left) and Reefsteamers' Class 15CA No.2056 'Dorothy' both look forlorn without their smokebox front plates. Both locomotives are in excellent shape mechanically, particularly the 15CA which was treated to a full motion rebuild to Reefsteamers' Vesconite™-based standard in 2007. But both locomotives are down because of waiting for funds for boiler repairs. It illustrates a problem that all steam, preservations groups eventually face – when the boiler flues and tubes reach the end of their lifespan at the same time on several locomotives. But if the affected club can get those boilers sorted out, those steam locomotives will last just about forever under the usually light loading of preservation operations. Where is Daddy Money Bags when you need him?

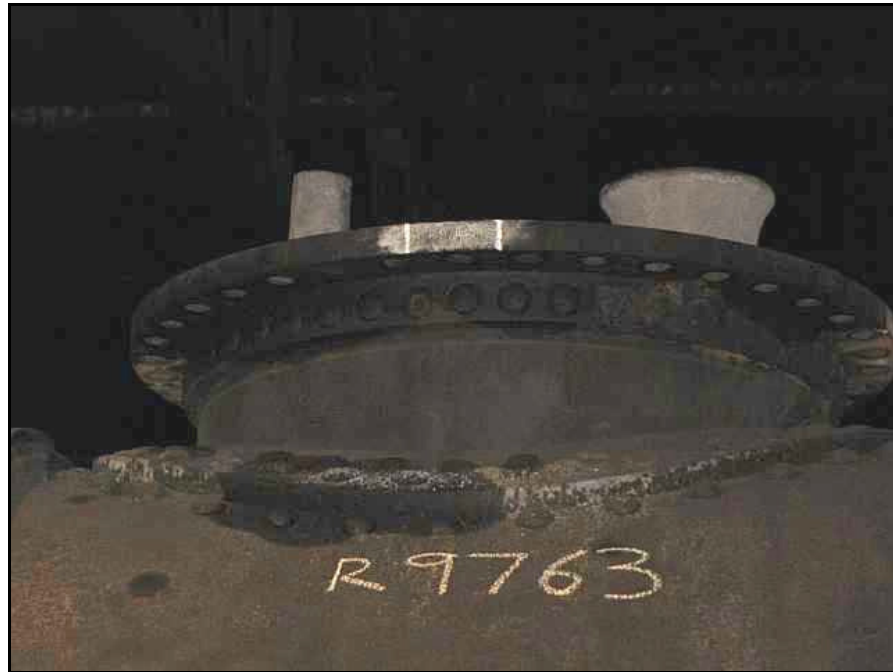
- 25). A new safety requirement is to prove that each boiler was originally built to certified standards. Unfortunately, the paper certificates were lost long ago and the manufacturers no longer exist. But every boiler operated by the old SAR+H should have the certificate number stamped on or beneath the flange for the steam dome or the manhole cover. Here, the numbers are clearly marked on the 12R. We are going to remove the dome covers on each one of our locomotives and photograph those numbers, and then highlight them with a card – and then step back to photograph the entire locomotive with the cab plate (number) and the highlight card in view. There's going to be a lot of shunting!

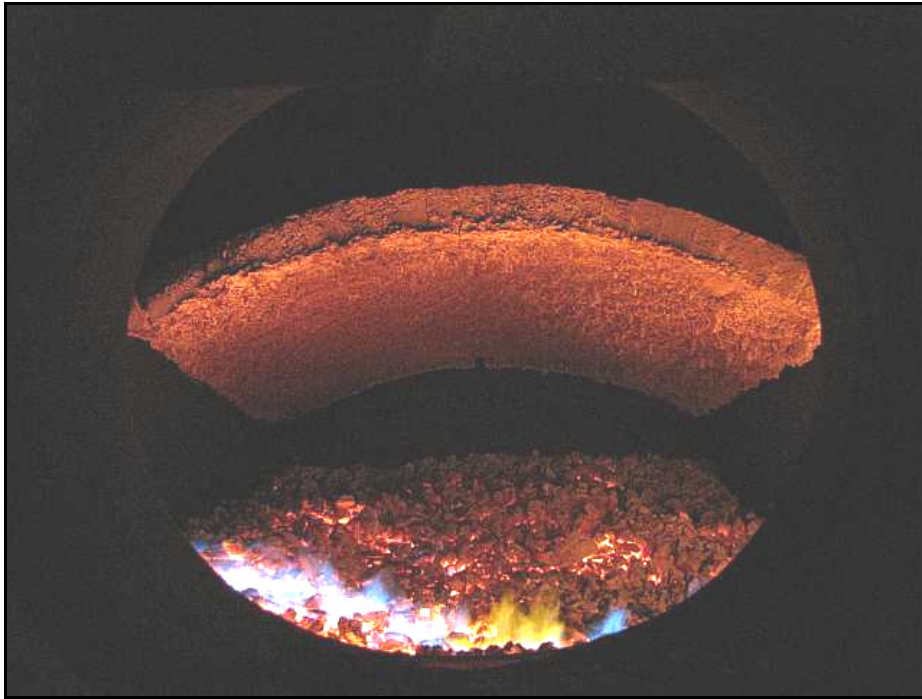
- 27). A distinctive shot of the brick fire arch within the firebox of the Class 12AR No.1535 'Susan.' The coal bank is glowing nicely with just few clinkery, burnt-out deposits beginning to form on the top layer, hence the blue flames. The relatively new fire arch, constructed from separate fireclay bricks mortared together, has fused together nicely in service. Only the rear coal bank is burning – the glowing flat front end of the fire is an optical illusion caused by the rough 'horizon' of the bank and the ruddy red reflection.

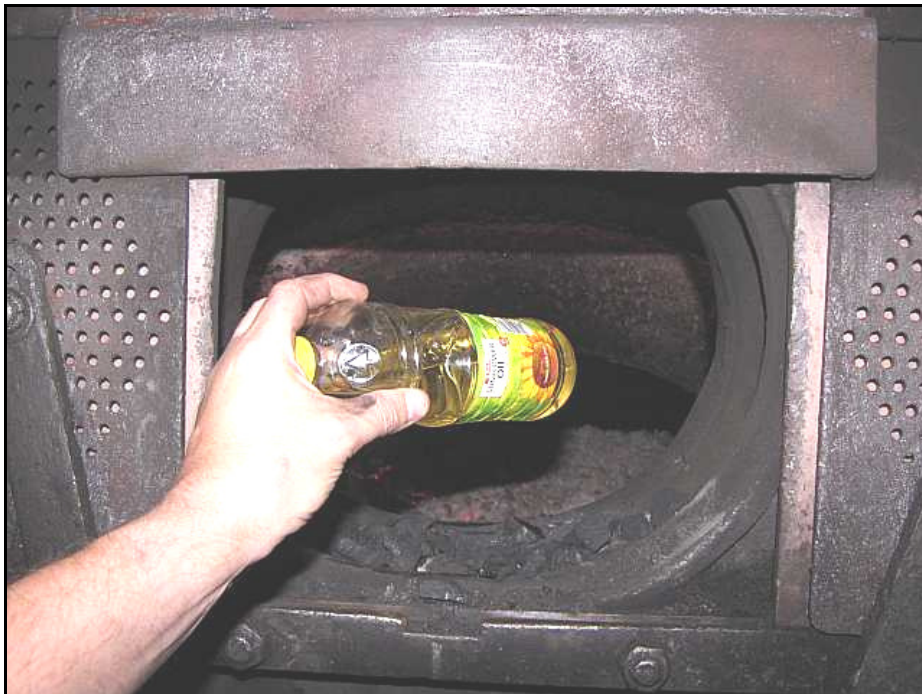
- 28). Experiments in making the 12AR into an oil burning locomotive. I'm just about to chuck in a 4-month old bottle of presumably oxidized sunflower-based cooking oil. You'd be surprised what gets thrown into locomotive fireboxes! It isn't every mode of transport that comes with a built in incinerator.

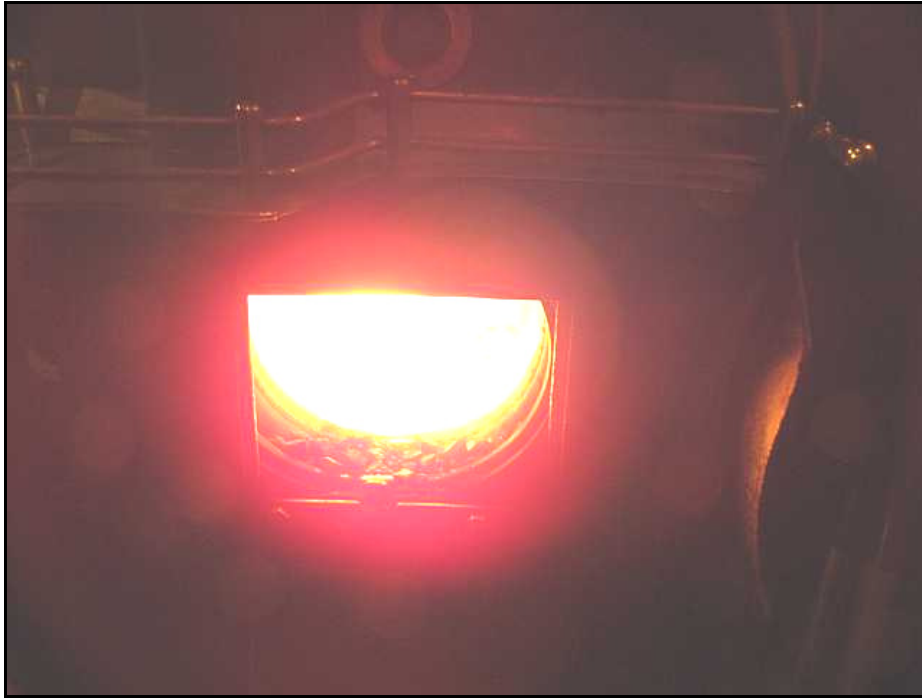
- 29). Whoomph! Actually the crusty top layer insulated the plastic bottle and it took about 15 seconds to melt through. The oil initially spurted out the melting bottle and was then wicked up by the porous deposits. There was no change in the scent of the coal smoke from the front end.

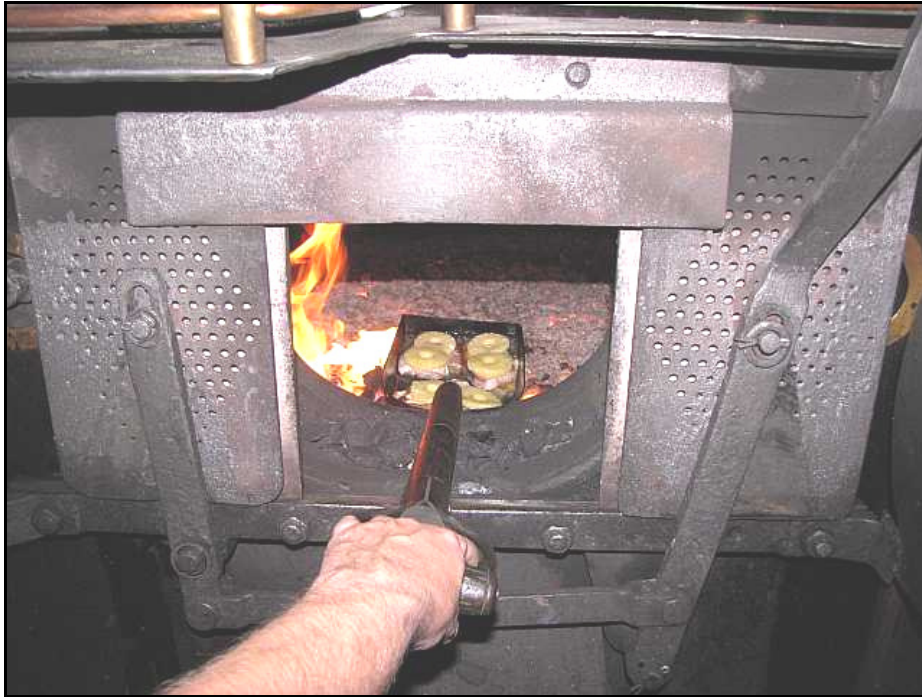
- 31). Cooking up some marinated pork and peppered pineapple rings in a dedicated cooking shovel. The all round heat coos the food remarkably quickly and one has to be aware that it continues cooking even when the shovel is removed. It's very easy to overcook 'fireboxed' meat and you need to withdraw the shovel in literally a minute or two. Pork is a little tricky as if you want crispy, crunchy crackling, you need to cook it separately from the meat – otherwise the meat dries out before the cracking is done. I ate lean tonight and tossed the fat. I didn't bother warming up the fresh bread rolls tonight either.

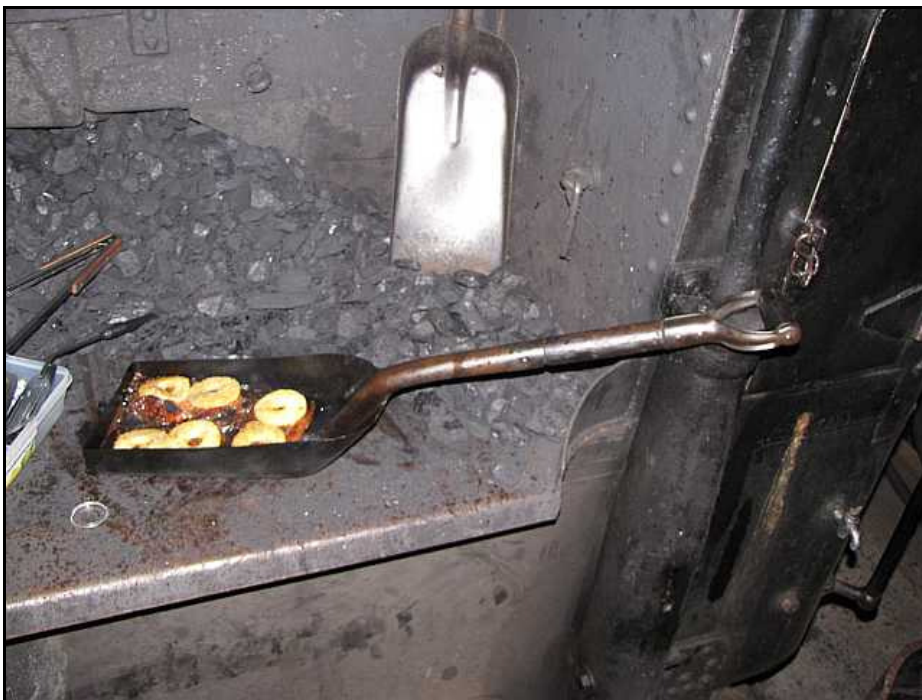
- 32). Here's the very useful 12AR handbrake stand in action. As this was about 1am in the morning, there were no scrounging, pathetic hungry Reefsteamers to fend off. Not even the dogs were sniffing around, so I ate in peace within the clubhouse.

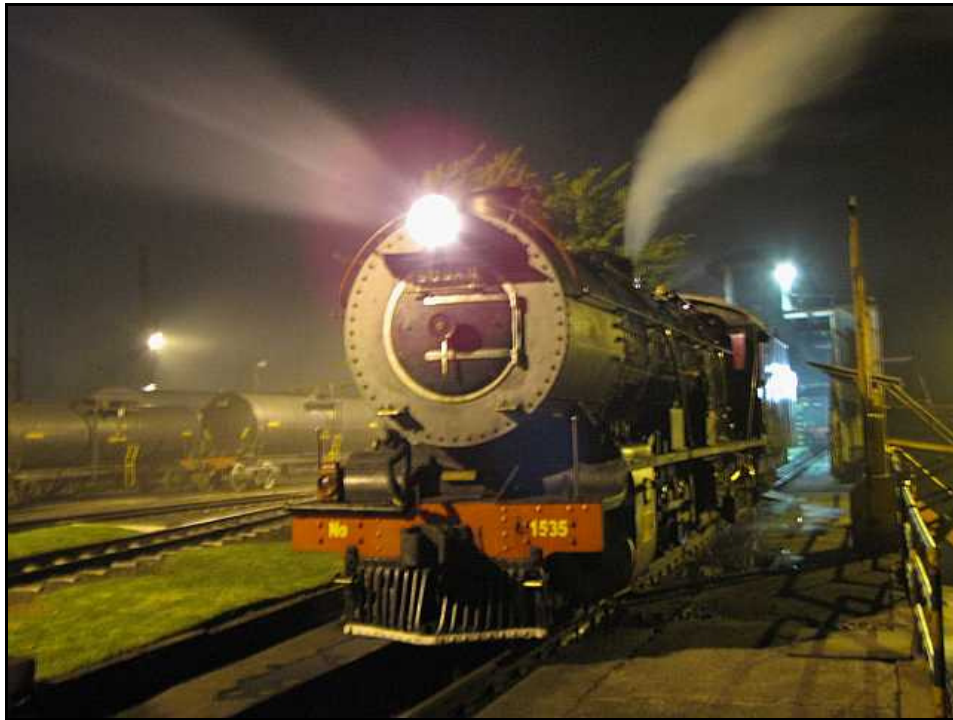
- 33). At about 3am, a light mist stealthily came down, gently shrouding the depot and here is the result, a beautifully defined headlight beam. The mist was thin and the stars were still visible in the clear sky above it. Yeah, the locomotive is STILL feathering at the safties.
