1). INTRODUCTION :

2). PROJECT : CLASS 15F NO.3046 – SAFETY VALVE SERVICE :

3). PROJECT : PRESSURE GAUGE SERVICE :

4). PROJECT – CLASS 12R NO.1947 - POWER REVERSER DISMANTLING :

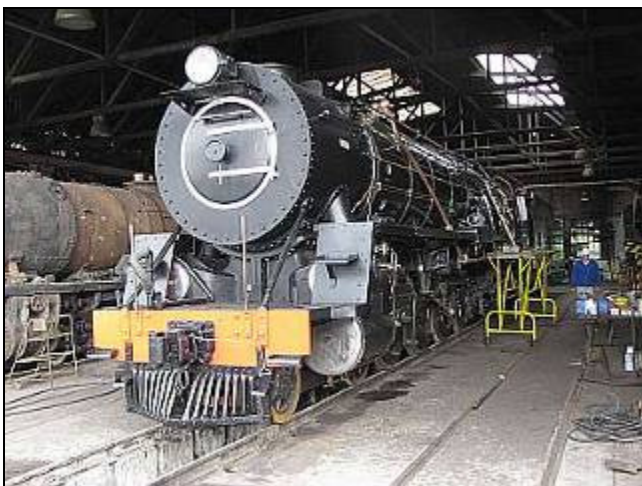
BP01 – Business-like in Black.

This delicate, little 108 ton lady, Class 15F No.3046 is about to blush pink instead of black as Colin Hall prepares to work on the underpinnings. The front end now is painted completely black with etch-type primer. The smokebox and the attachments still need to receive several more coats. However, no gloss paint will be applied over the primer coats – so the front end will always have a matte finish.

Note that the exposed smokebox saddle and valve chest castings have also received the black-brush treatment.

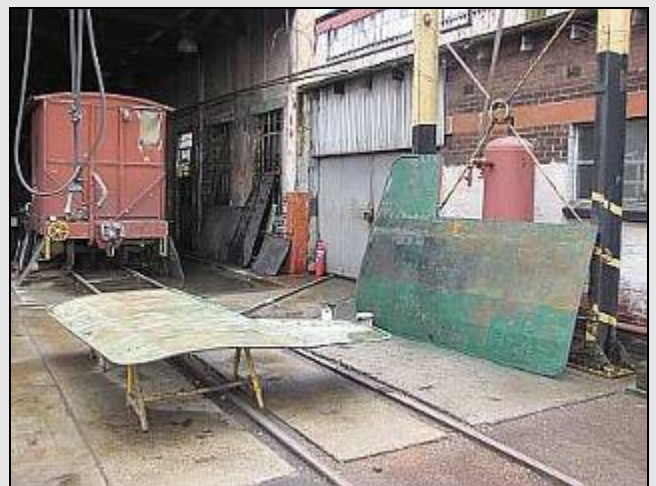
BP02 – Smoke Deflectors.

These are the original smoke deflectors that came with the 15F locomotive attached – and the locomotive was removed from the deflectors so they could be easily stored. They are having years of paint and painted rust (in equal quantities) ground off and will also be getting a bit of 'panel beating' to knock out the dents. (Or try to, anyway...)

15F No.3046 was once resplendent in green. However, the bright Taiwanese Christmas Tree green seen here is the primer that was sprayed on to protect those deflectors in long-term storage. You can see the locomotive's original colour (albeit a bit faded.) in the vertical center panel on the deflector to the right. (Next to the black I-beam column.)

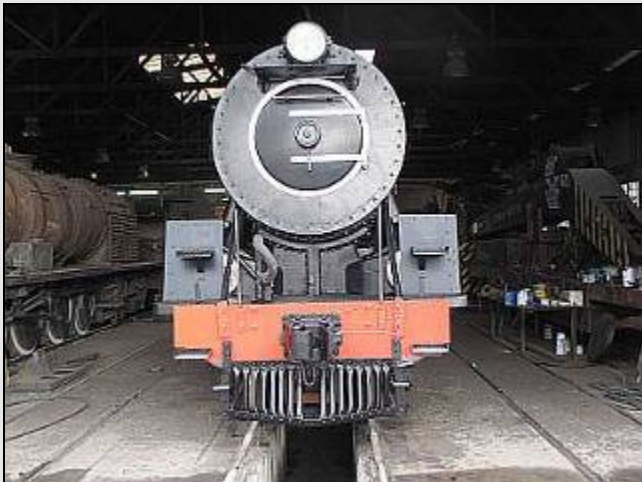
BP03 – Front view in black.

The painted front end is really 'looking the business' now and it is remarkable, how the midnight-in-a-Persian-coal-mine black actually looks slate grey in the angled light.

The smokebox door ring and the hinges have been painted in silver enamel. These are traditionally done in white gloss paint. However, we have found that the silver paint lasts longer, is more heat resistant and looks cleaner for longer. (Bonus!) It has been used with great success on our Class 12AR – until somebody wiped it down with valve oil in an attempt to gloss it up a bit. (And the steam soluble oil has since gone brown with the dry, baking heat.)

The toe iron still needs to be fitted to the beef scraper.

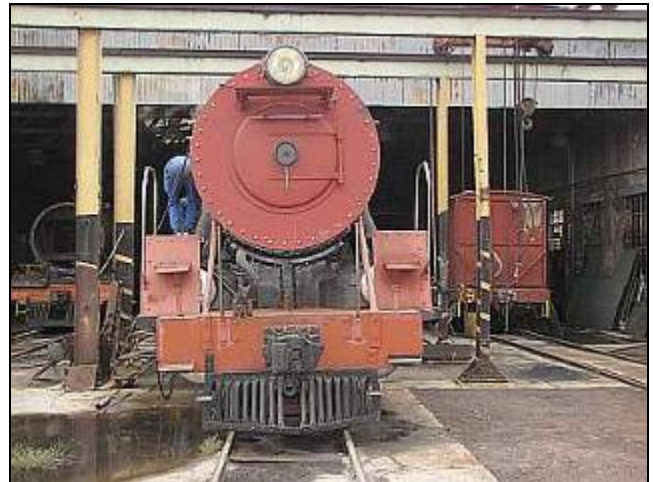
BP04 – Front view in red.

The exposed smokebox saddle will soon be hidden behind the angled wind deflector plate. This is not an optional feature, for the plate is what channels the slip-stream air up and behind the smoke deflectors. The smoke deflectors direct the pressure wave rearwards and upwards and it is the upwards 'spillover' that lifts the smoke clear of the laminar slipstream around the boiler. At very slow speeds, the smoke deflectors are sometimes more obstructive of vision than the smoke itself.

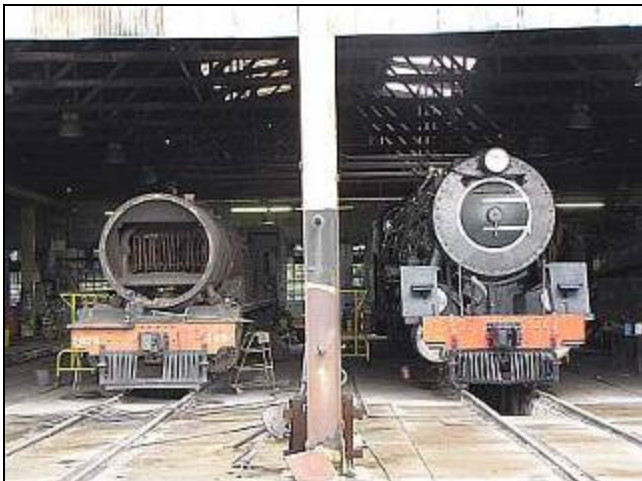
BP05 – Two ends of restoration.

On the right, Class 15F No.3046, undergoing final assembly and rectification work before striding proudly out on the high irons once more. On the left, the Class 12R No.1947 'Rosie' has been stripped down and is undergoing assessment for feasibility for a rebuild – the thinness of some of the firebox plate work being the major worry.

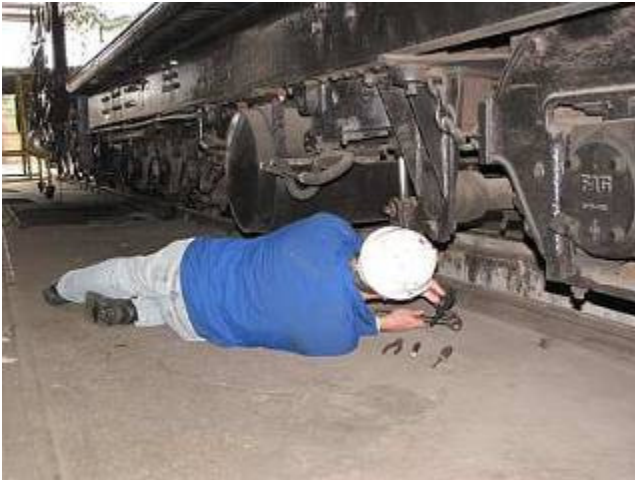
BP07 – Split pin checks.

As he methodologically works his way around the machine, checking the dozens of split pins for security of fitting, Colin Hall gets to lie down a bit on the job. And he's lying down in absolute luxury too! No water puddles, no steam, no hot water or oil dripping down from above and no coal or gritty cinders lying on the ground ... just clean, cool, fairly smooth concrete.

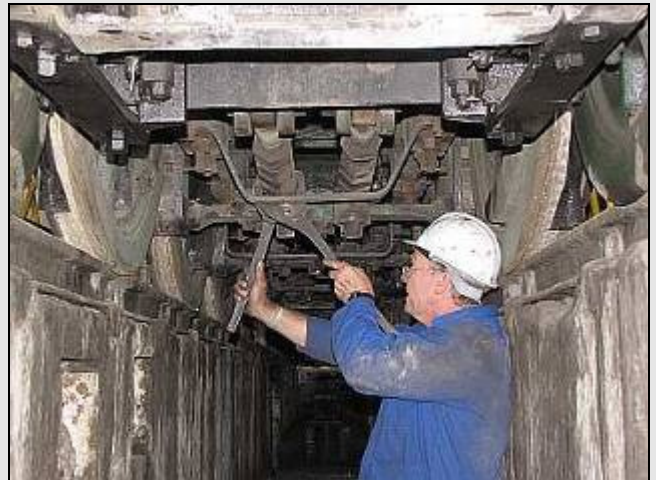
BP08 – Brake Adjustment.

In the gritty darkness beneath the beast, an increasingly dirtier Colin gets to grips with the paired brake adjusters of a 15F. Although they both pull on the same spar rod, they can be adjusted to apply a slight tilt to the rod should the brake shoes wear at different rates. This works but to a limit. The shoe that is displaced outward ends up with an unworn outer edge that cups and overlaps the wheel rim.

The 'U'-shaped struts are safety bars that are designed to catch a rod should the end pin fall out and the rod falls towards the track. The current job of tapping, adjusting and fitting split pins is, of course, designed to prevent just that.

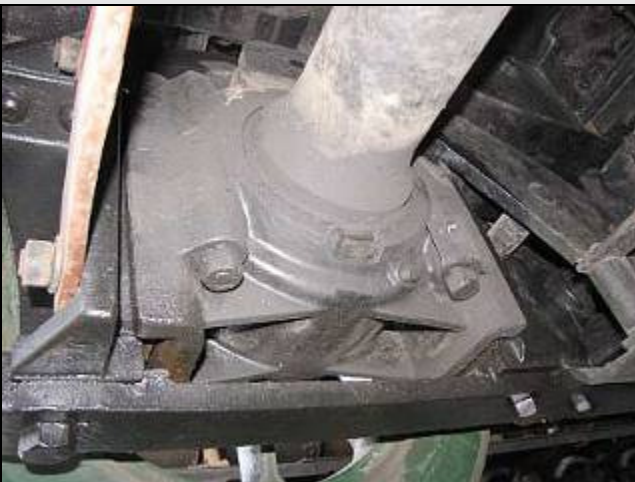
BP09 – Bogie bearing.

Over the years, the 15F's and other locomotives often ended up with a mixture of SKF and Timken bearings, depending what spares were used from available stocks when they were repaired. The roller bearings themselves are not necessarily specific locomotive components.

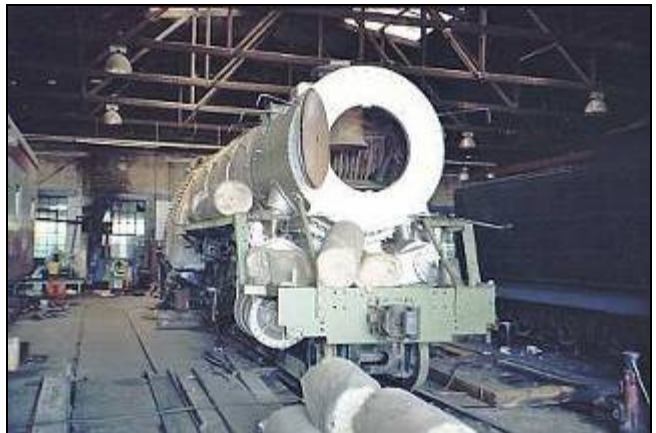
BP10 – Rolls of boiler lagging.

Back then, 15F No.3046 was treated to some new rock-wool type boiler lagging as about 10% of the material had rotted under storage. The boiler lagging is perhaps one of the most vulnerable parts of a stored steam locomotive as rain water gets in through the banding and especially through the washout plug pockets. This is why stored locomotives quickly look like total rust buckets even though they may still be mechanically sound – and this has sometimes lead to premature scrapping.

In the United States, where they have an established tradition of plinthed display of locomotives, the rusting boiler jacket problem, coupled with the risk of rust exposed asbestosis from old style insulation has led to many a formally safe display locomotive being scrapped. A few lucky survivors have their boiler lagging and the plate work stripped and end up standing on display like shorn sheep.

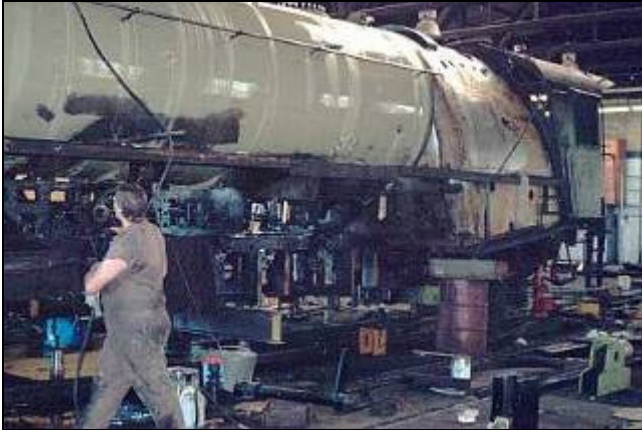
BP11 – Down to the bones.

15F No.3046 had the motion rebuilt before we fully adopted the policy of using Vesconite™ bearings. She will thus be the odd one out in our operating locomotive fleet and in spite of being a bigger locomotive, will be less tolerant of bearing problems. However, some of the smaller bushes were replaced with Vesconite™ during the restoration work.

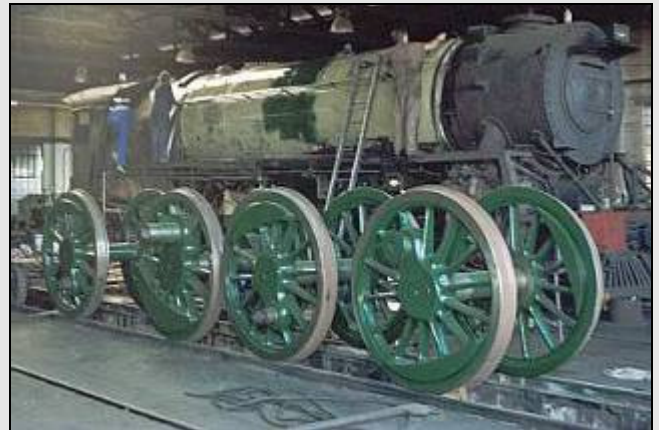
BP12 – Mechanno-green wheel set.

Here are the removed driving wheels, looking quite attractive in the green primer that was applied when their old paint was stripped. The paint was stripped not just for an aesthetically smooth paint job, but also to check for incipient cracks forming in the wheel spokes.

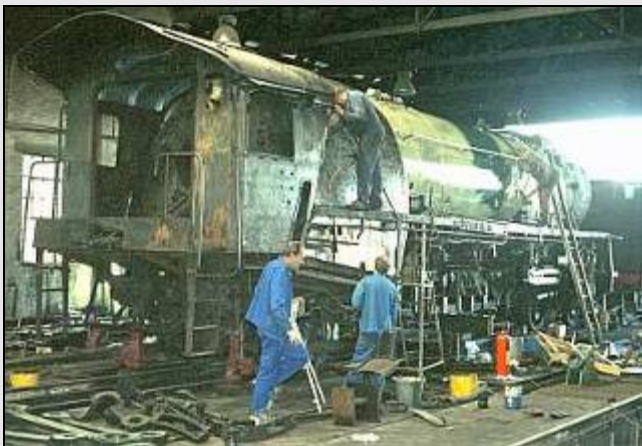
BP13 – Work Crews.

Although most of the boiler lagging was still in serviceable condition, the entire boiler shell was exposed by removing the sheet steel cladding. The boiler was then de-scaled, and then primed. It is invisible work and is unlikely to be appreciated – but there won't be boiler shell corrosion on this locomotive for a long time yet!

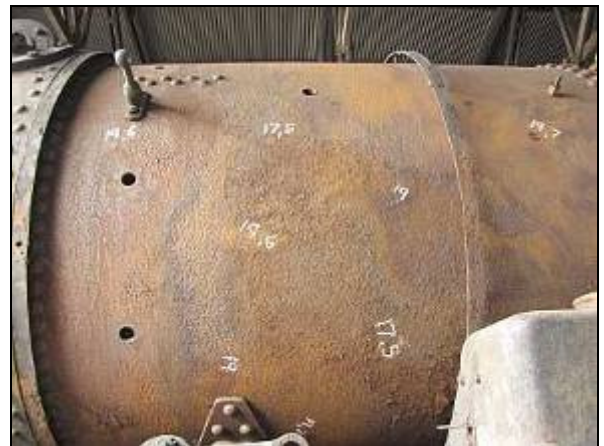
BP14 – Boiler Corrosion.

Here is what they were trying to prevent. This is the first course (or ring) of the boiler of the Class 12R No.1947 'Rosie.' The chalk marks represent the detected thickness of the externally corroded boiler shell and the readings vary from 19.8mm to 17.5mm. So, at the worst points, over 2mm thickness of the rolled steel plate has been lost.

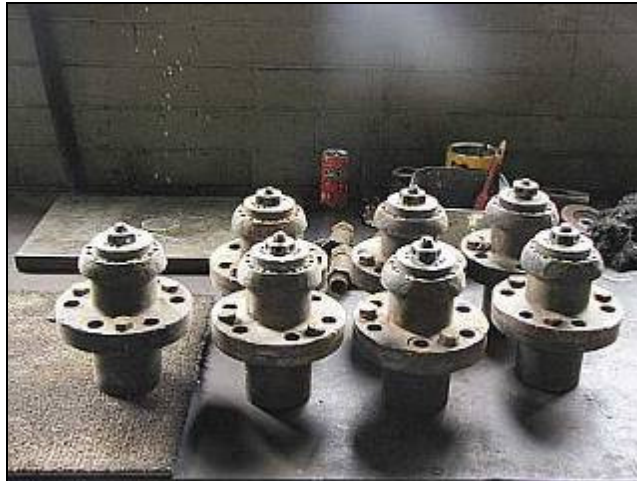
SV01 – Seven Safety valves.

The low profile design can be easily seen. The section below the bolt flanges is actually 'submerged' within the boiler, which makes for a lower profile appliance within the loading gauge. The original Ross Pop valves were surface mounted. If tall old fashioned valves were bolted to a high pitch SAR engine they would stand the risk of being knocked off (now wouldn't that be fun?) or causing flashovers from a low lying span of the overhead traction wires. (Not too improbable – our 12AR once caused a flashover from the traction wire to an ornamental brass finial bolted on top of the steam dome.),

All four safety valves were removed from the recently steam-tested Class 15F No.3046 'No name yet' the previous week and they were dismantled and carefully serviced. They were opening properly during the steam test, and with the correct 'popping' action. But they weren't closing properly afterwards. It turns out to be an assembly problem. A shim was missing between the body and the seat spacers, so they were blowing past their seats and not the actual valve elements. All four gaskets had to be remade. Three safety valves were re-installed with a fourth one fitted from stocks. In a final gesture of spite, one of the rusty mounting studs broke off from the mounting pad – so that valve needs to be removed for the second time and the stud drilled out. Aidan McCarthy wasn't TOO annoyed and attributes his muscular strength to the arduous palming and pushing of a rodent in his day-to-day job. Actually, the 'stuffed stud' was rusty n' a bit corroded to begin with.

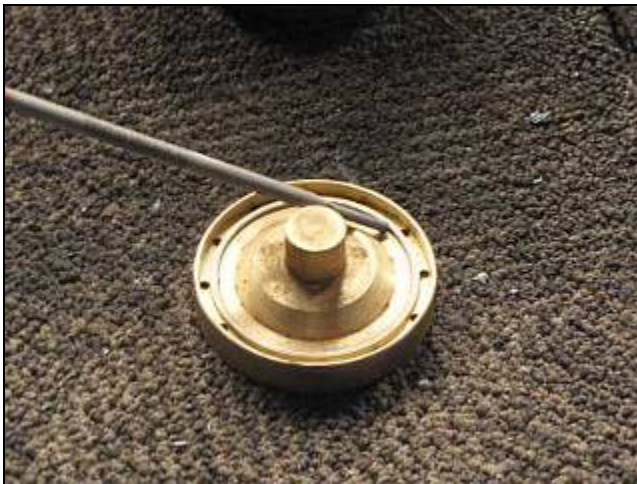
SV02 – The sealing lip.

That ring of holes are bleed holes to the atmosphere. If there is a slight leak at the valve ring or its seat, the leaking steam would eventually pressurize the outer ring of the valve element and cause a premature 'pop off', wasting steam and the energy used to create it. Via those holes, steam from a slight leak can escape through those holes without causing a false premature 'tripping' of the safety valve's pop mechanism. This is the source of the gentle 'steam feather' of a leaky safety valve. This is also the source of the 'steam feather' when a properly functioning safety valve is just, just about ready to lift.

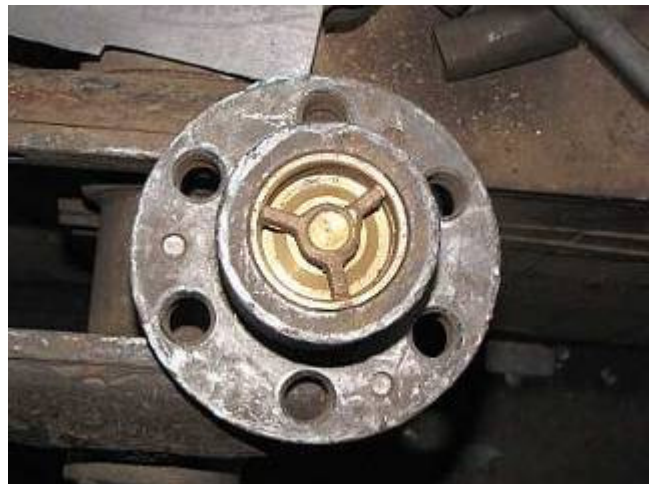
SV03– Boiler's eye view.

This valve has a two inch nominal working diameter.

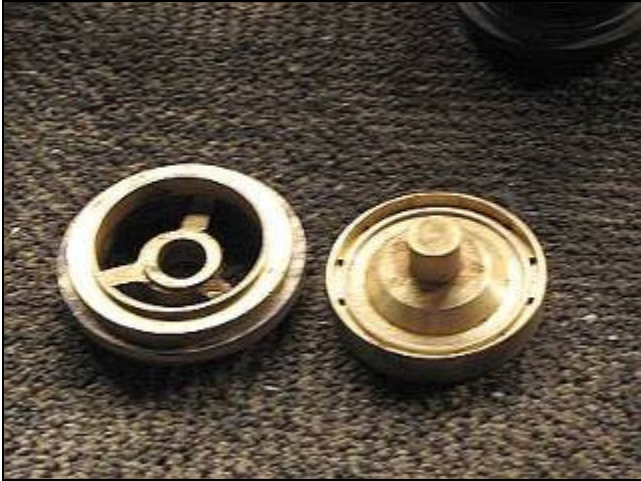
SV04 - Valve seat and element.

We Reefsteamers sometimes stand back with a sense of wonder that these monstrous machines can actually move at all. This is one of the reasons why we wonder – the myriad brass-to-brass seals. There are no rubber washers to take up imperfections in the valve seats. These valves need careful grinding, not only between the element and the seat, but the lower faces of the seat need to be 'lapped' to the body. Thus, valve parts from different, supposedly identical valves aren't really interchangeable as they are lapped to and match each other.

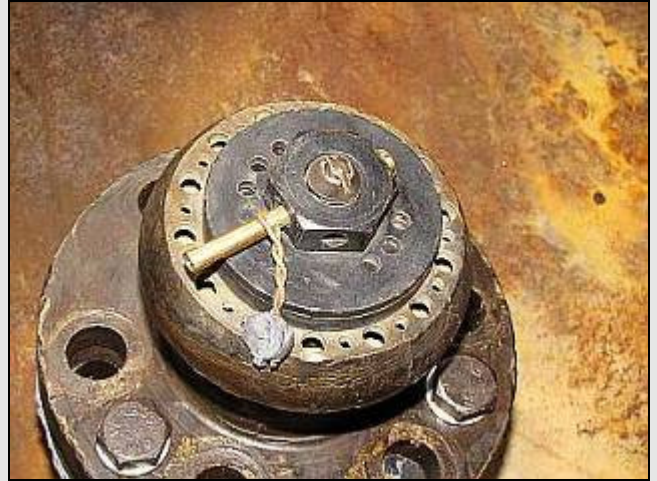
SV05 - Sealed valve.

Long disused valves, even with a boiler inspector's seal, may no longer function properly due to corrosion in storage, or perhaps even from being dropped or roughly handled in storage.

We are going to re-use the one of the spare sealed valves that we have – but they will be reopened and re-calibrated when 15F No.3046's safety valves are re-tested.

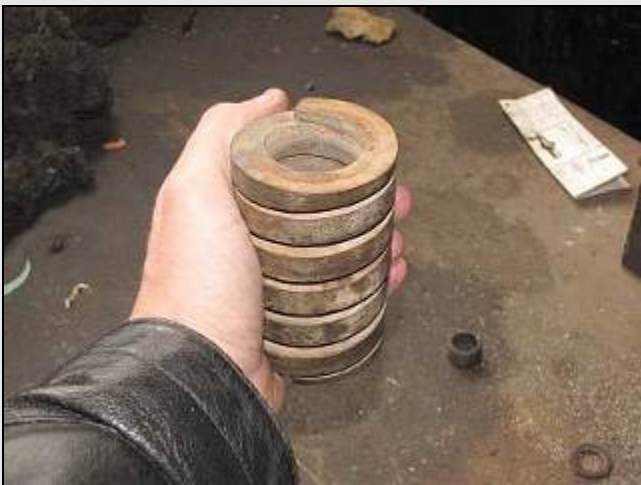
SV06 - Safety Valve Spring.

If the spring was a more conventional round coil spring of the same grade steel, it would need to be of larger diameter, which makes for a more bulky valve.

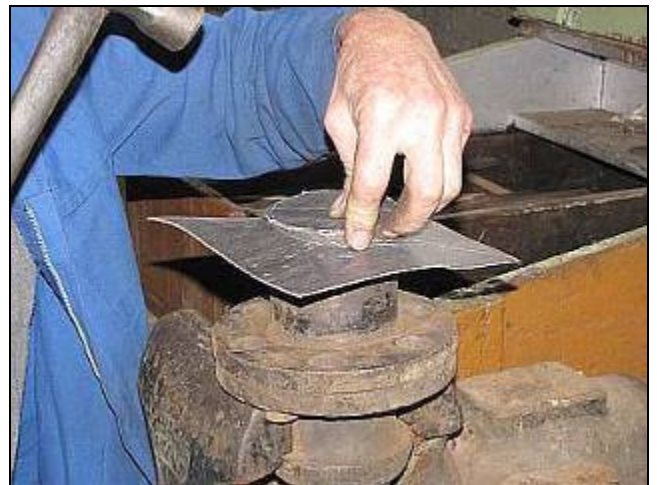
SV07 - Rapping out a gasket.

You might get away with it – but even a small leak would eventually notch the brass or the edge of the mounting pad on the boiler and necessitate even more repairs over time.

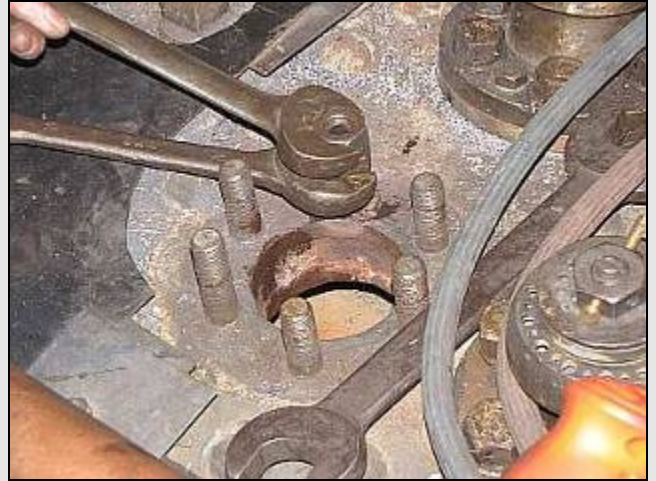
SV09 – Stud power!

Picture taken the following week - Dr. Smudge (S.T.A.) is busy replacing the one stud that broke off on the right rear safety valve. Actually, out of 24 studs (6 x 4), to only have broken one stud is pretty good going on these old clankers.

The manhole cover ('dome') was another story – the boiler inspector condemned all of the rusty studs and all 24 of them had to be drilled out and replaced. But that's a story for the next report.

The double spanners are being used to turn two hex nuts up against each other so the top nut of the locked-together pair can be used to turn the stud in. Luckily the original stud itself was weak and not so much the threads. So the threads got away with cleaning and cutting – and thus the same sized stud could be used for replacement.

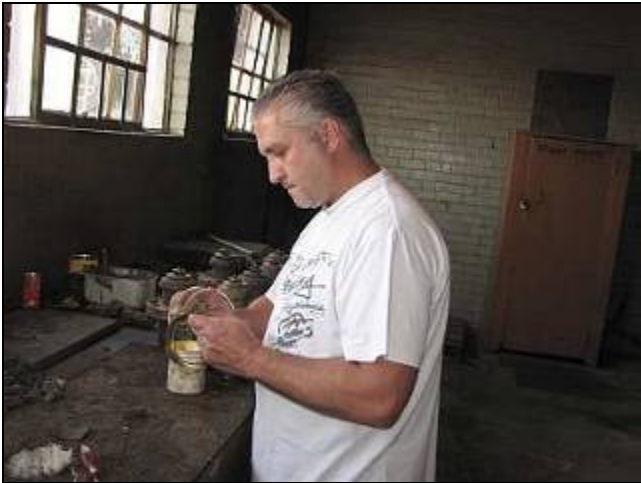
PG01 – The Brasso treatment.

It isn't always about bashing things with 16 pound hammers and levering with crow bars ('gwalas') and cut-off lengths of boiler tube. There is sometimes delicate work to be done on our heavy duty coffee pots. Andrew Kruger works on perhaps the most delicate mechanical components that exist on our pachydermous beasts. (2nd most delicate being the dynamo governor.) He is stripping and cleaning a backhead pressure gauge. These are spare gauges being commissioned to replace a faulty stoker engine steam pressure gauge, as well as one of the two stoker jet pressure gauges on the Class 15F No.3046.

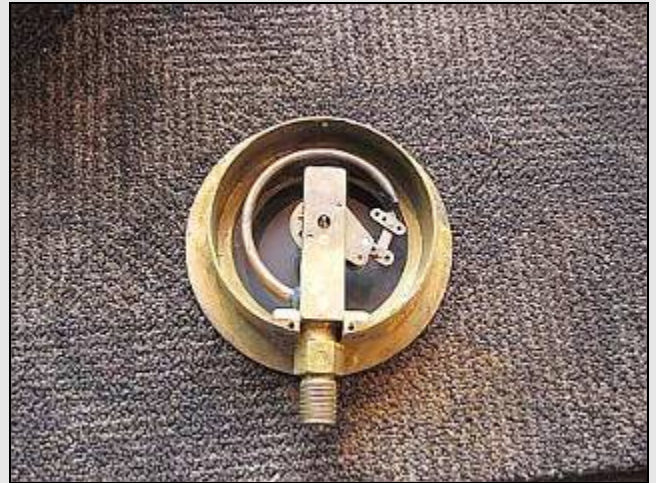
PG02 – Behind the dial.

Andrew Kruger was tasked with cleaning the gauges and ensuring that they're dry and free from corrosion. Luckily they are fairly water resistant when assembled and the glass seals are intact, especially as all the openings (except one bezel screw) point downwards. The biggest risk is when the pressure gauges are sprayed by a careless fireman with the cab's spray pipe.

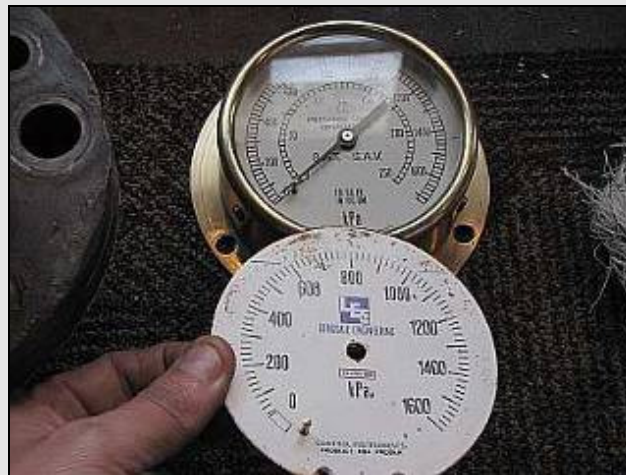
PG03 – Bi-Dials.

The upper gauge is marked 'SAT – SAV', standing for 'South African Transport – Suid Afrikaanse Voertuie'. The lower modern dial face was made by Longdale Engineering and cheaply stamped from mild steel, hence the rust starting up.

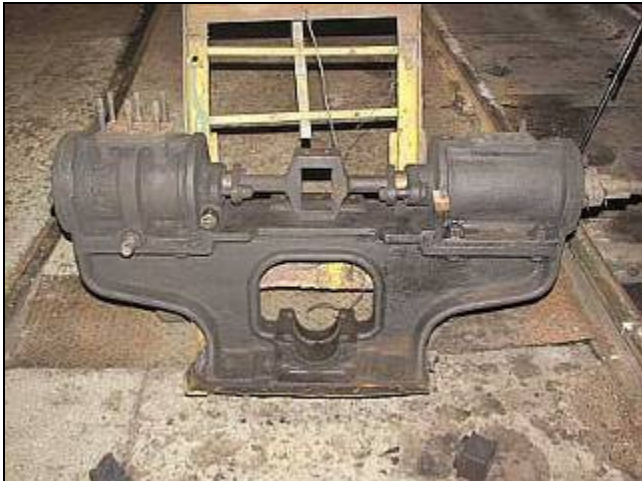
RV01 – Reverser Assembly

A picture taken while I was loco-minding the 12AR No.1535 'Susan' back on 22 March 2010 and the stripping of 'Rusty Rosie' had just commenced. Here is the reverser assembly as removed from the Class 12R locomotive.

Notice that all three of the stuffing box covers are still present and with their original bolts too.

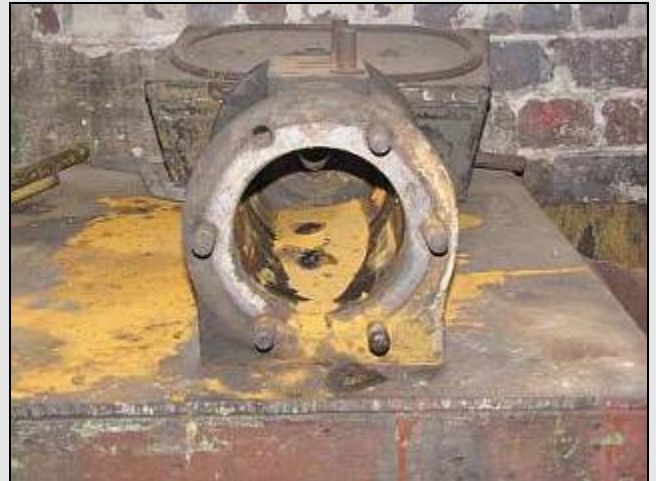
RV02 – Rusty Lock Cylinder

Here's what the dismantled hydraulic locking cylinder looked like with a generous helping of dried rust deposits inside. It is actually a ferro-fossilized rain water puddle. Unfortunately the two oil transfer holes are on top and without the cataract valve in place, they are very open to the ingress of rain water. Our Mr. Murphy scored five out of six with those rusty studs but they actually aren't in as bad a condition as we expected.

Mike Murphy carried on with a project upon which he had worked the previous week – stripping the Class 12R's Hadfield Type Power Reverser (What's left of it anyway) into its separate components for clean up and possible rebuild. He had already managed to strip and remove the hydraulic locking cylinder. However, the actuating piston within the power cylinder just wouldn't budge – which meant we also now had an awkward-to-handle cylinder casting with a long shaft sticking out defiantly from one end. Mike, and a later arrival, James Thomson, rigged up a simple bar puller and managed to get the piston out. In the end, it literally just 'porped orf' and turned out to be a taper fit on the shaft. In fact, the piston and its rings are barely rusted and it was the rust deposits within the cylinder bore that were causing the seizure.

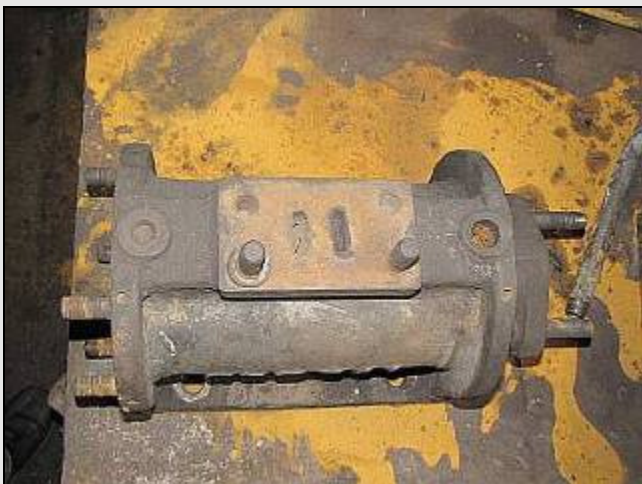
RV03 – Dual porting

Here's the mounting pad for the cataract valve. Somebody had broken off a stud in the past – top right. (Wasn't us ... promise!)

As this is for the cataract valve, there are only two ports to allow oil to flow from one end to the other when the valve gear is adjusted. When those ports are closed off from each other, the trapped oil within either side hydraulically prevents the piston from being able to move. As it's on a shaft common with the power cylinder's piston, the reverser is held locked into whatever position the driver has set it in.

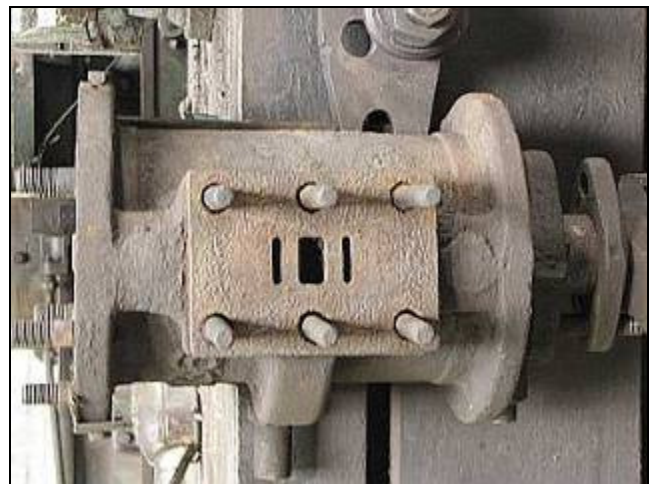
RV04 – Triple porting

This is the machined plate on which the D-valve slides but it is too corroded for easy recovery. Luckily, the SAR&H used the same valve gear on their reversers, even though the cylinders were often of different lengths. We have matching valve plates in the stores and this one will be kept as a pattern.

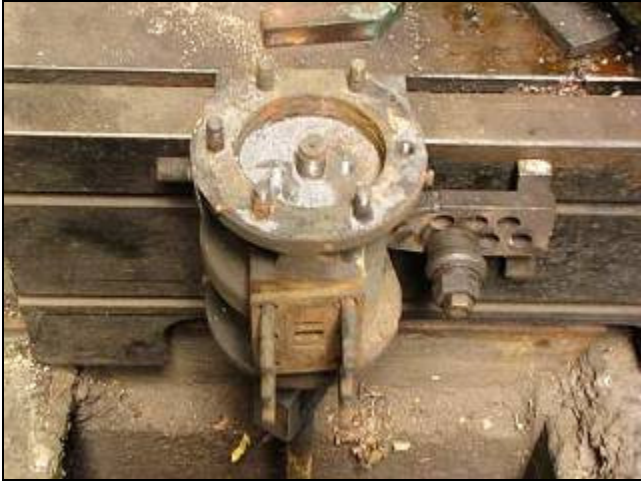
RV05 - Drilled Piston.

Here is the actuator piston with two freshly drilled and tapped holes ready for the puller bar that was currently under fabrication. The unit was partially seized in the center position but Mr. Murphy got it loose – but was unable to get the piston out and couldn't get the shaft to disengage.

These are blind holes, not going all the way through the piston. If the grooves can be re-machined – the piston will be returned to service, threaded holes and all, and they won't affect the operation of the finished assembly.

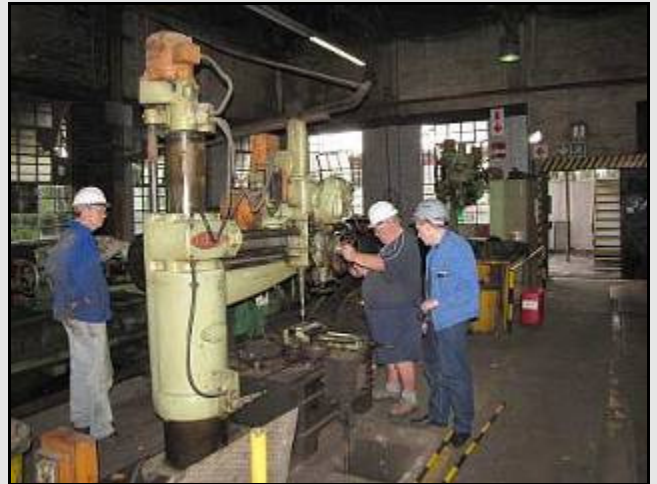
RV06 - Setting up the drill.

Although Mike Murphy (Right) has machinist skills, James Thomson (Center) is more familiar with our machines at Reefsteamers as well as where the tool stashes are. He is setting up the Asquith-manufactured radial drill to drill the pilot holes in the puller's bridge bar.

Notice that the work piece power cylinder is clamped to the SIDE of the drill's table. The seized shaft protrudes into the recess cast within the floor especially made for such protruding parts. Not so daft were those old civil engineers!

James has been measuring up the puller's bridge bar and is now drilling the first of two pilot holes for the clamp bolts that will screw into those threaded holes within the piston.

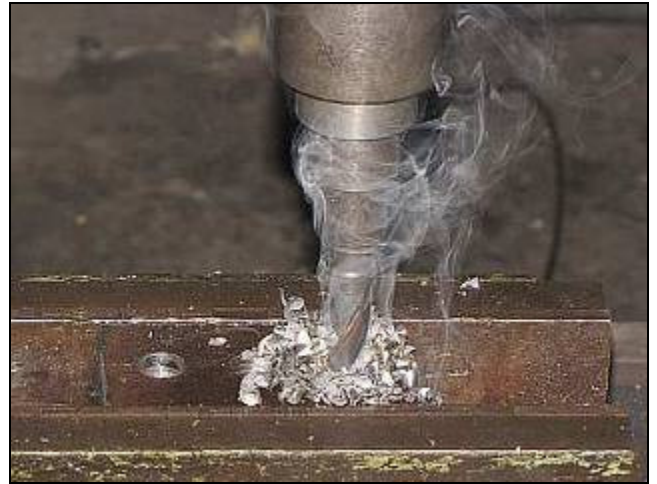
RV08 - Smokin'!

The puller's bridge bar is under fabrication. It's not too unusual to have to make up jigs and tools to assist in loco work. This would be a simple center-shaft puller.

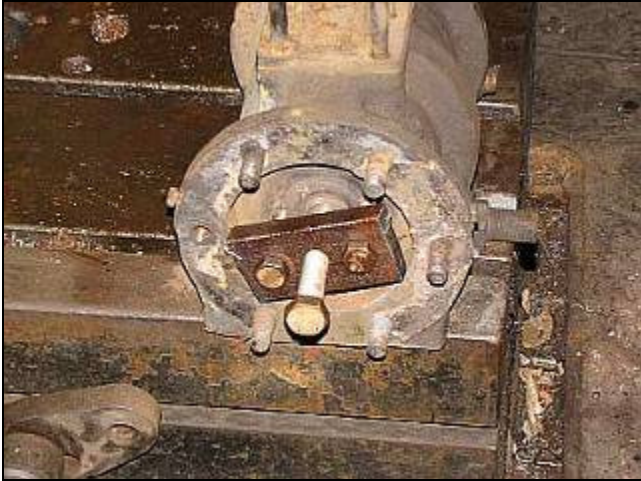
RV09 – Ready to be yanked.

The puller is in place. Notice that although the bridge bar was cut so that its corners would fit inside the cylinder bore; it wasn't screwed down flush to the face of the piston.

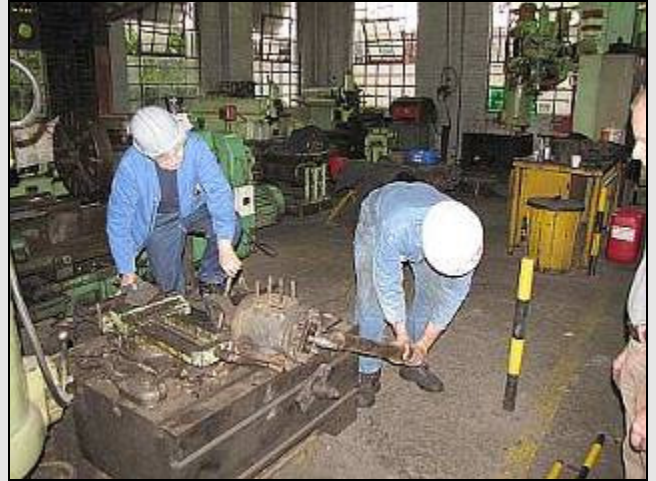
RV10 – Getting the twist on.

It was actually an anticlimax after all the preparation – the piston literally just popped off the common shaft with a muted crack. I had visions of two or more fellows hanging on a long bar with an equal quantity of lever-fodder trying to apply torque on the shaft – through the scotch yoke.

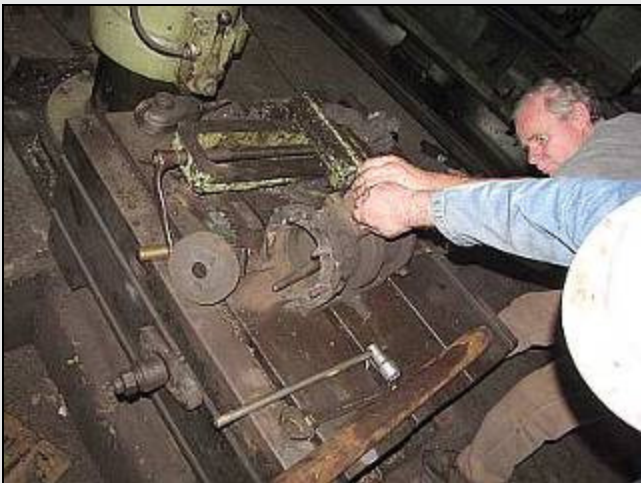
RV11 – Out she comes.

With the piston driven loose from the shaft's taper, it could be tapped out from behind to drive it through the slightly corroded cylinder bore. It didn't take too much knocking to get it out in the end and the piston itself isn't particularly corroded. The rings would be replaced as a matter of course.

We could have tried to lever the piston out using the shaft to scuff and force it through the rust – but that would have entailed a high risk in terms of bending that shaft. Because of the scotch yoke forging in the center, such a shaft would not at all be easy to re-fabricate.

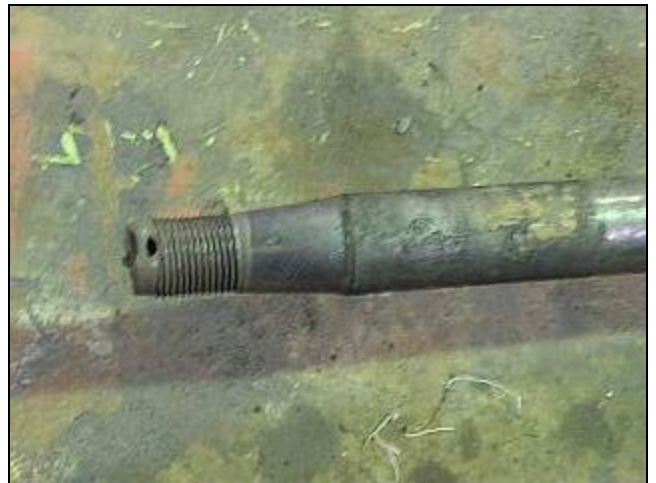
RV12 – Shafted.

The common shaft doesn't look too bad although the section that runs through the glanding needs a skim and polish. The threads are in good shape but a little worn (You can see how they taper inwards at the bottom edge.)

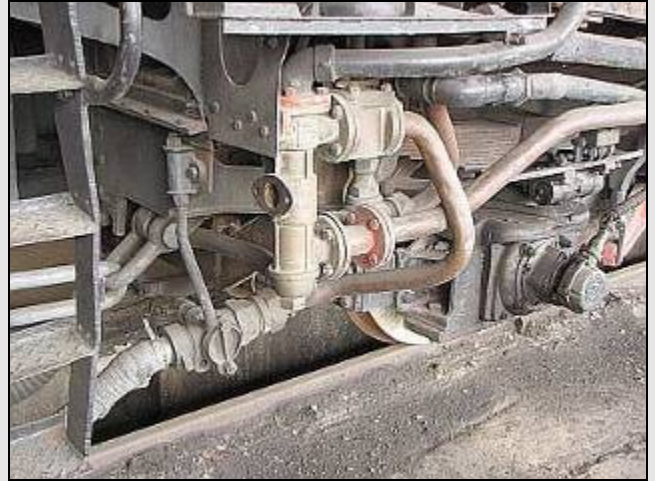
X06 - Spot the missing piece.

One of the first parts to go on any locomotive when light fingered people are around are the overflow pipes for the injectors. Here's the long-ago pilfered right hand injector on the hand-bomber Class 15F No.2914 'Spikkels'.

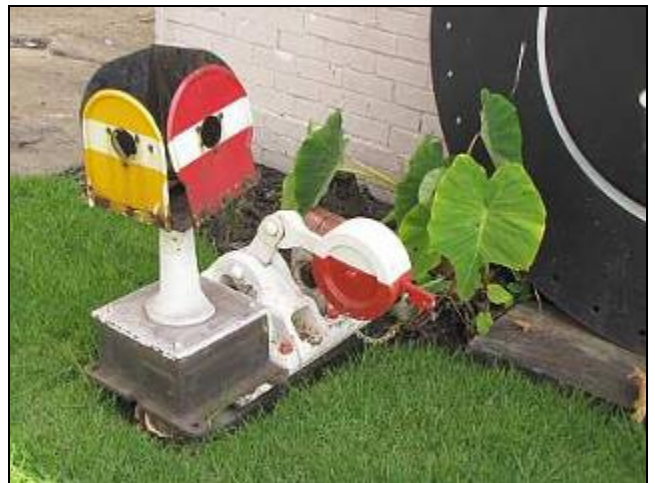
X08 - Lawn Ornaments.

The contraption on the left is a mechanical illuminated points signal for shunting. It was rescued from Ficksburg, Station from where had been dumped in a grassy verge.

Just behind the points tumbler is a quad-red lensed work lamp. It isn't, technically speaking, a railway tail lamp but was primarily used by road works and occasionally, the railways right of way crews.

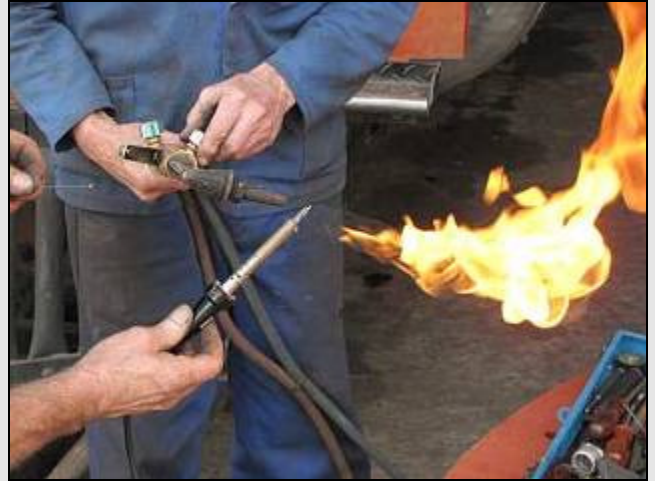
X10 – How to use a soldering iron.

Andrew King and Peter Labuscagne demonstrate how NOT to use an ELECTRIC soldering iron! The electric soldering iron had actually failed, so they fired up the acetylene set – which turned out to be low on oxygen.

The soldering iron was required to repair a number of PCB relay terminals of the portable drill press, which was found to have failed after being set up to re-drill the misaligned holes within the smokebox front plate for Class 15F No.3046.

The failed portable drill press can be seen in the foreground. The gents were successful in re-soldering the pulled switch relay contacts and managed to get the drill running once more.

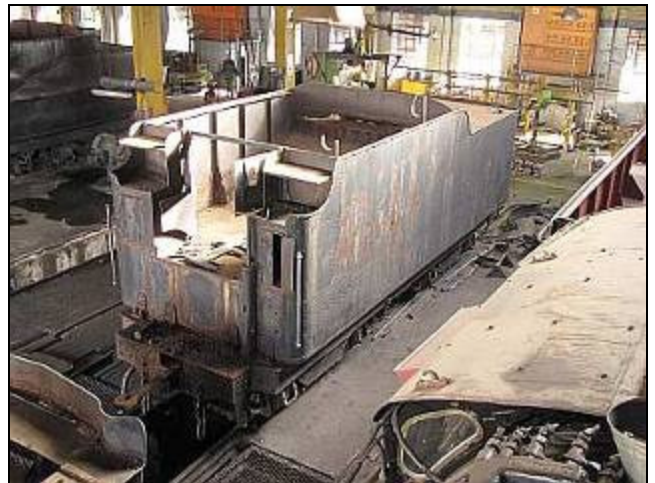
X12 – Rosie's Handbag.

Even at this distance, you can see the damage and corrosion to the coal bunker's gussets. The rust holes through the rear scuttle plate can also be seen. But so long as there is still more steel than rust, this tender can be restored!

This tender takes 12 tons of coal and 6000 gallons of water.

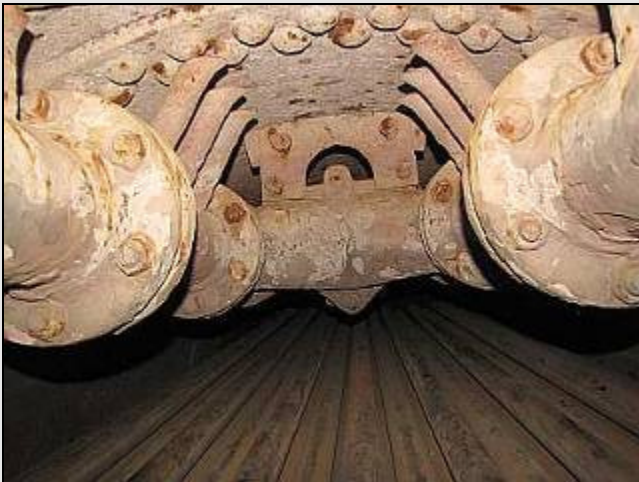
X15 – Hidden Engineering.

Here is the dry pipe arrangement of an SAR Class 15F locomotive – considerably more complicated than that of most steam locomotives. The pipes are laid out in an H type arrangement with a tap-off from the center bar of the 'H' forward towards the regulator. (You can just see the bottom point of the flange in the center.) The steam actually enters through the slightly flared tops of the angled pipes.

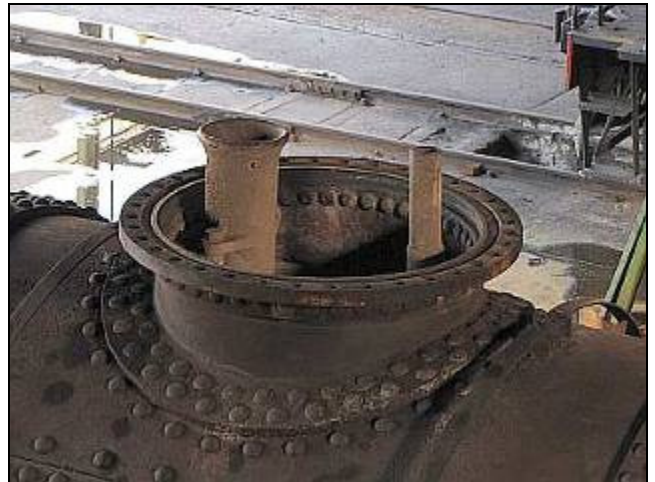
X16 – Schorkelsh.

You can clearly see the old fashioned arrangement for picking up steam from a classic, tall dome. The traction steam for the front end is picked up via the large pipe and the steam that is supplied to all the accessories via the turret manifold, is picked up via the small pipe.

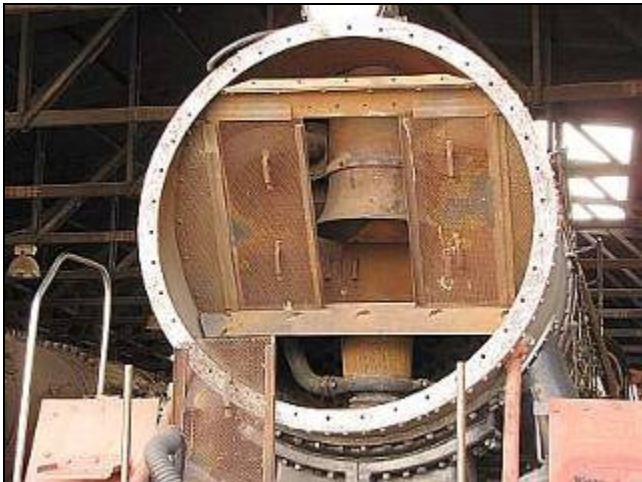
X17 - Cheese Grater Smokebox.

The self cleaning mechanism works via centrifugal force. The combustion gasses, after passing heat to the water, exit the boiler tubes under the table plate. Because the area is baffled with removable plates (Visible behind the petticoat) the gas flow speeds up. When the gasses come forward in the restricted space under the table they do a 180 degree turn at a high speed before slowing down and passing backwards through the spark arrestor grids. That high speed turn throws out the char and coal particles and dumps them in a pile into the front corner.

This is why a poorly serviced SAR locomotive burns the paint off the smokebox in the lower quadrant.

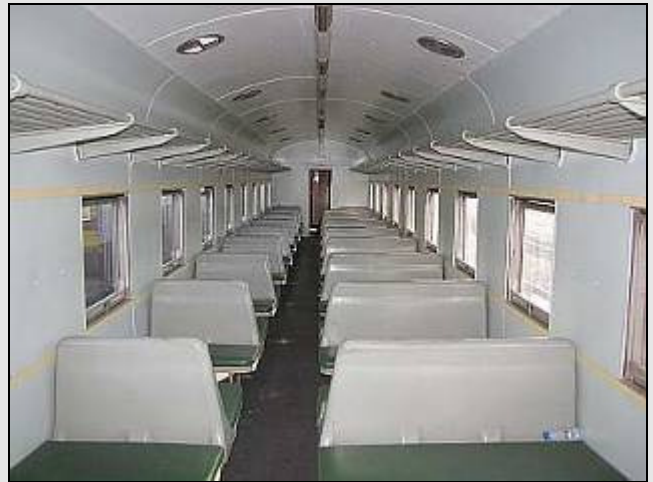
X18 - Clean in green.

Here is the refurbished interior of the Sandstone Estate's day-sitter coach No.25206. The coach has been treated to a new vinyl floor and a full interior strip down and paint job, as well as repairs of sundry fittings. The paintwork, with the unusual lemon yellow stripes, matches the new colour scheme of our dining car.

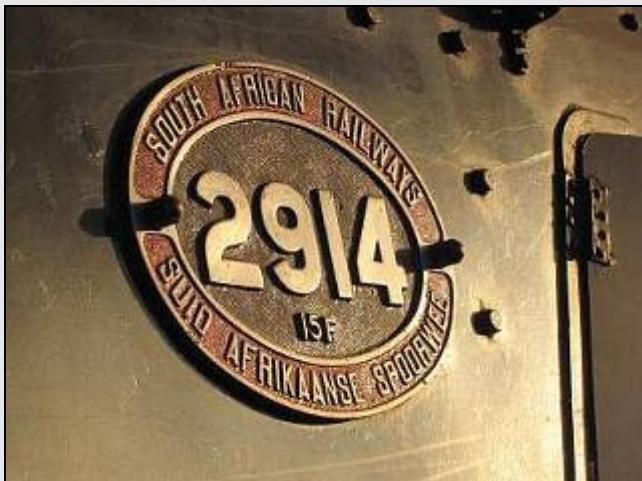
X19 - Defeated Oval.

Class 15F No.2914 'Spikkels' is one of several of our basically intact locomotives that are waiting for repair - and is the only intact 'hand bomber' Class 15F locomotive remaining in South Africa.

If the boiler was filled up and a fire put in, Spikkels would actually be able to move under her own power. She has very poor drafting under load though, because of a failed blast pipe collar. (It was poured with builder's cement instead of fire clay.) However, with an expired boiler certificate and known thin points in the firebox plate-work, she isn't safe to use until repaired.

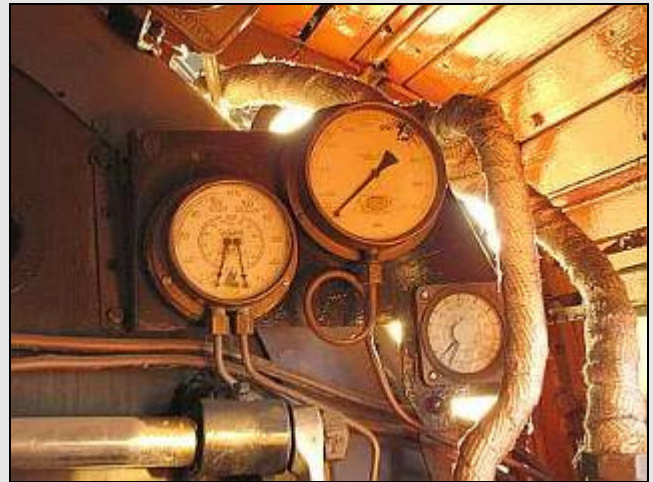
X22 - Backlit Gauges.

Here are the driver's side gauges of 'Spikkels', backlit by the westering sun shining through the right hand spectacle glass. From left to right we have a duplex vacuum gauge (Train Pipe \ Vacuum Chamber) then the steam chest pressure gauge and then the speedometer.
