1). INTRODUCTION :

**- REEFSTEAMERS PHOTO PACK -
A FIRST NIGHT'S DATE WITH THE 3046.**

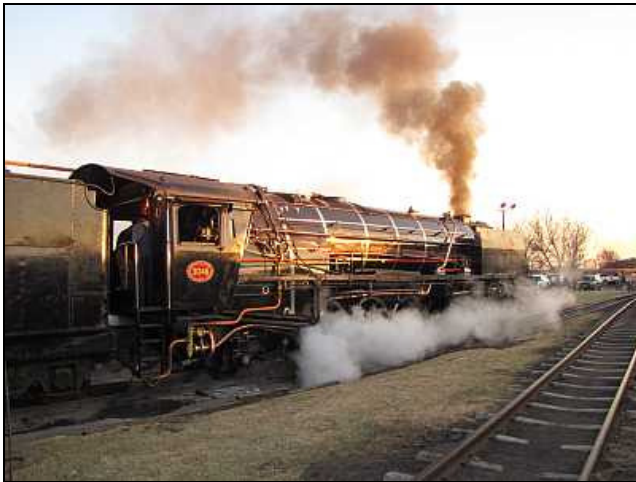
01 – Puff. Puff. Pass.

The wheels are barely covered by the discharge of a rather tame blow down.

Because of the tripping hazard, the steel blow down deflector plate that used to be here has long since been removed – so the grass gets burnt off in strips from exuberant blow downs.

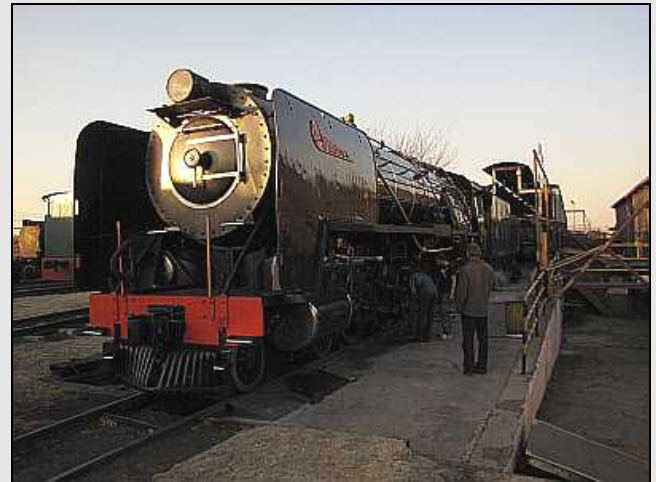
02 – Facing the sunset.

Class 15F No.3046 looks a picture facing the westering sun. She is just starting to enjoy a bit of hard greasing while the tender's brake cylinder valve is being inspected.

The front end of the loco still needs a bit of work as the center wind deflector plate is missing – you don't normally see the valve chest covers and castings from between the walkway risers. That shiny black paint on the smokebox door would be starting to peel off already after the first long run home from Magaliesburg the following evening.

The copper stanchions in front are to either be painted in black or covered in loose stainless steel sheathing. Reefsteamers is 'dressing their engines down' partially for authenticity, partially for ease of cleaning and partially to make them less attractive to scrap metal bandits.

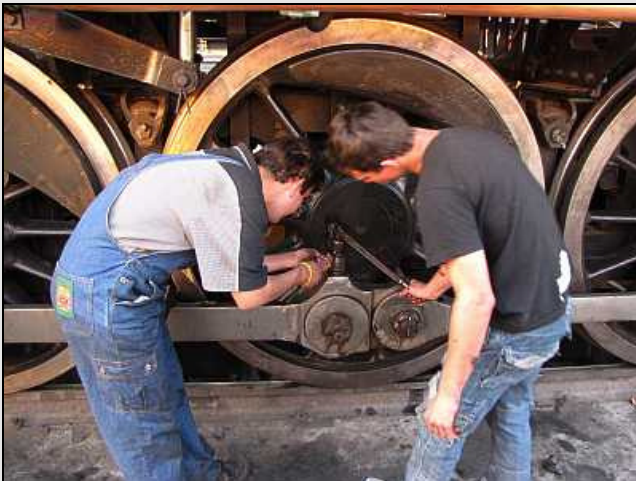
03 – Greasing up.

Two youngsters at the grease gun. Luca (Left) shows a potential new member how to use a 'chopper' grease pump. They were battling somewhat as the bearings were already cooling down as the locomotive had stood in the coaling dock for extra yummys before being spotted here.

The double-man operation of an old 'chopper' pump isn't a recommended practice as one false enthusiastic stroke on that lever could cost you the first knuckle of a finger. Luckily, because the weather is chilly, the grease sticks are fairly hard and Luca wasn't having to have his fingers flirt within chopping range of the tapered grease aperture.

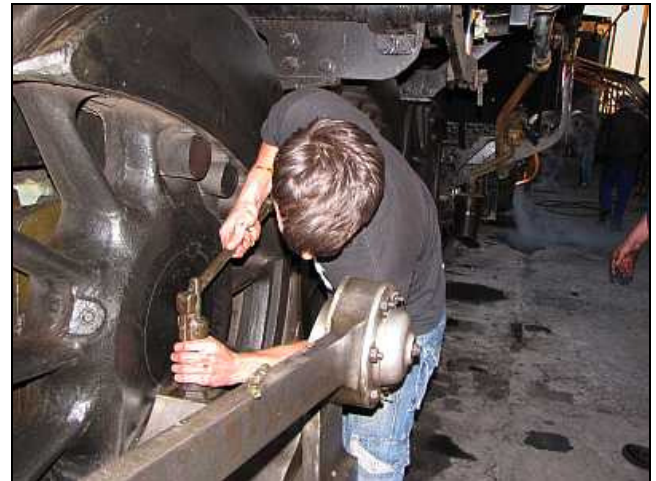
04 – Question of scale.

The appy's appy is left to finish the job and he's working on the main driver axle. Actually, this lean but muscular fellow did well although you can see he isn't using the full mechanical advantage of that lever.

The grease droppings are building up and he is leaving them on the eccentric rod.

You really get a sense of scale here, when you work right up against those wheels and the running boards are comfortably above your head.

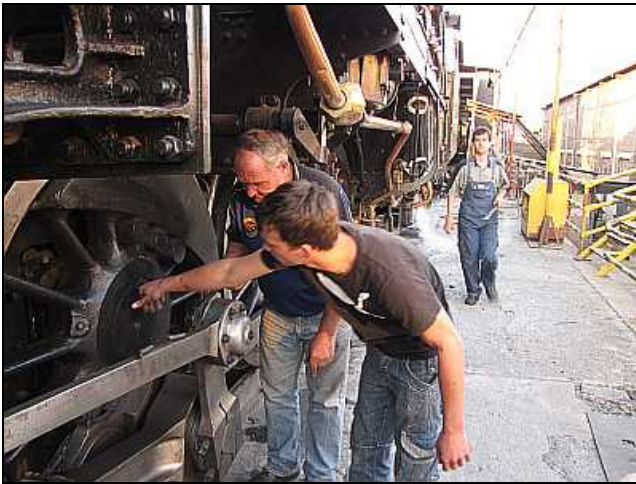
05 – It's here, feel it.

A common quick check is to feel the hubs of the wheels and the joints in the rods for unusual localized heat. However, if the locomotive has been standing for a while, like this big beastie has, the heat dissipates throughout the large mass of metal and the results can be misleading.

One uses the knuckles as a) It's easier to pull the hand back if the axle end or joint is too hot to touch and b) If the knuckles get burnt after all, they aren't in active use like the finger tips or the palm of the hand. The knuckles are often more sensitive to heat too as they aren't prone to calluses.

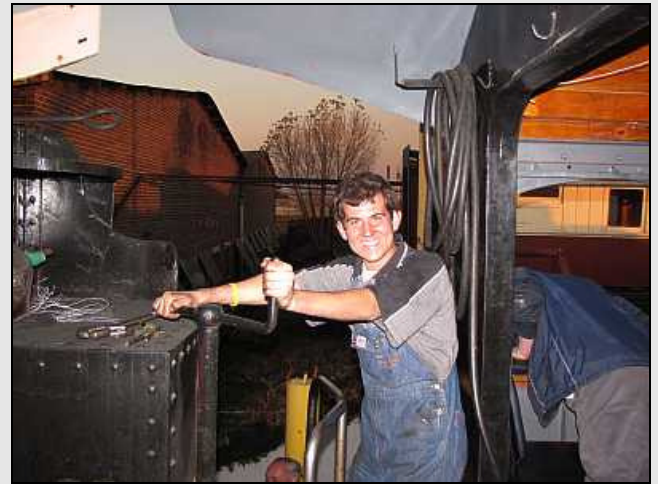
06 – Torsion.

Luca Lategan discovers Gate's Law of steam locomotive handbrakes – the thickness of the brake shoes and the length of the adjustable rodding is always as such that the brake handle winds up (pun intended) protruding awkwardly from the tender's tool bunker area.

I've asked Luca to put some grunt on the handbrake stand and he is cheerfully doing his best to twist it off.

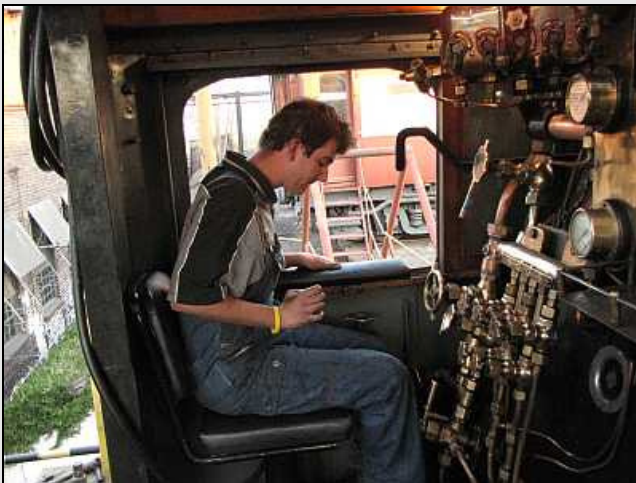
07 – Kicking the cocks.

The injector and ash pan cooler cocks are badly placed on this locomotive and their handles interfere with each other. Normally one kicks the injector water cock forward and taps it back after opening the injector's steam supply – but on this set up, the ash pan cooler cock gets in the way. Luca didn't realize that the handles and their shafts can be freely withdrawn from their valves and the handles freely rotated through angles of 90 degrees.

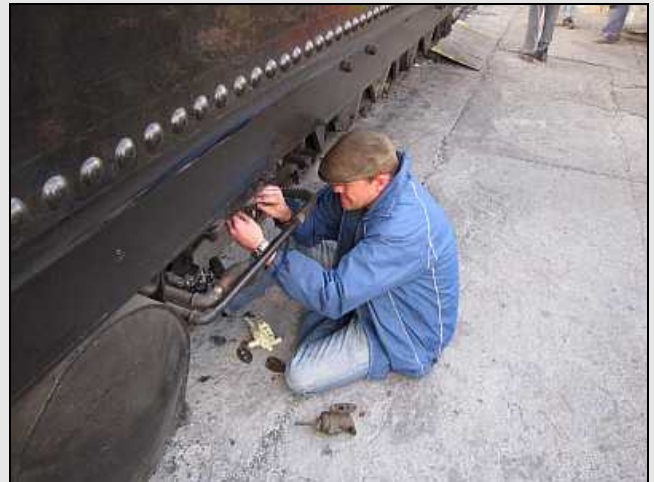
10 – Dr. Smudge attends.

Dr. Smudge T. Ackerman attends to replacing the control valve on the tender's brake vacuum cylinder. Unfortunately, corrosion on the oval flange and on the bolts made this simple two bolt, two pipe and one cable job a bit more complicated than it should be.

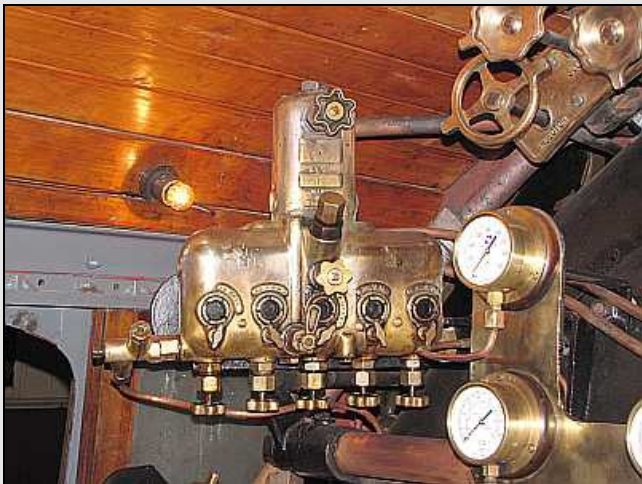
11 – Five pots.

It's been quite a while since I last worked on a mechanically stoked 15F, so the sight of a five-pot Detroit lubricator looks a bit strange to me at present. The center port is for the mechanical stoker's donkey-engine.

Class 15F No.3046 is experiencing lubrication troubles. The turret valve leaks and the restrictors aren't functioning properly, so the system is always pressurized and is very prone to blow back.

Not being very experienced (yet) with hydrostatic lubricators I chickened out of trying to drain and service this one when I saw the steam and hot water spray from the top port of the drain valve. It turned out to be a wise decision because this Big Brass Bugger (BBB) tried to blow back over Fireman Dawie Viljoen in the morning. He was alert enough to see this coming and the engine stood for a while with the lubricator lines blowing freely from the front end.

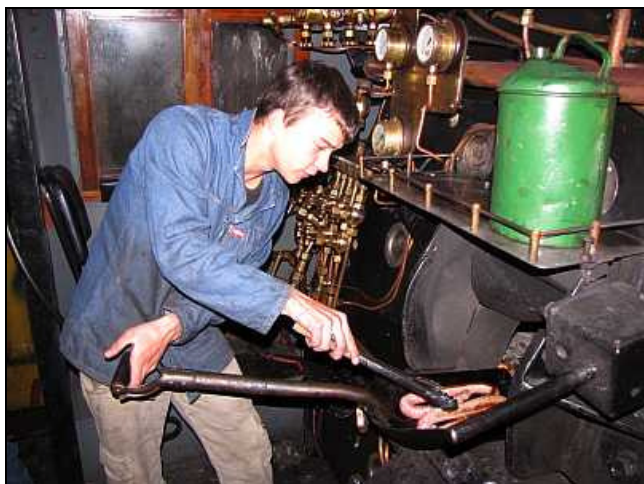
13 – Chez de loco.

The spreader table of the mechanical stoker forms a convenient resting place for the heel of the shovel. It also means the shovel gets a lot hotter at the front end so if that is anticipated, you have can use the gradiented heating surface to your advantage.

This fellow has just realized that and has withdrawn the elegant cooking appliance and is flipping his wors around front to back.

Because there is a negative air pressure in the firebox, you actually don't get to smell your food too much (while in situ) with the air flow moving into the firebox door. With the dim yellow-tinted cab light, a thin, easily overheated shovel and a reduced sense of smell, it's easy to overdo your food.

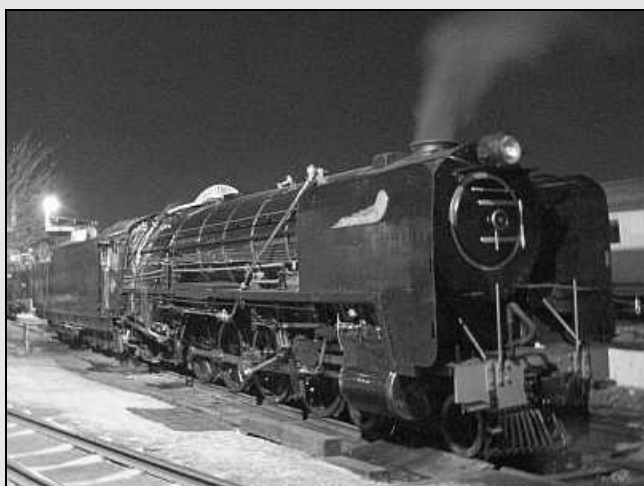
15 – Standing proud.

Notice that there are no standing leaks on this recently totally re-fitted loco and the chipped, scarred concrete is dry under the cylinders. Not very lively, action packed or photogenic perhaps, but quite desirable from an engineering point of view!

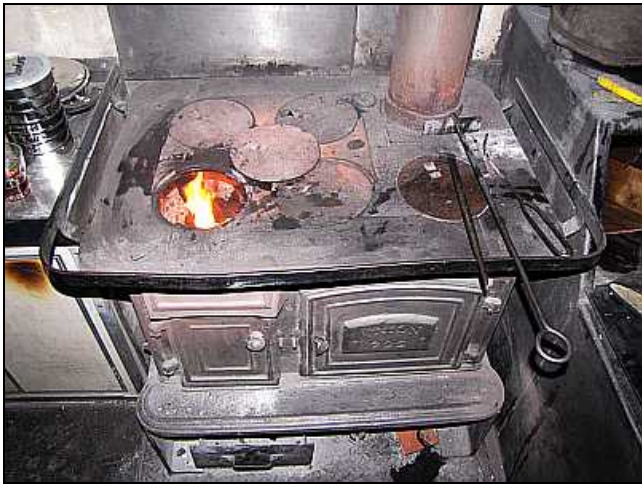
17 – Hot Spot.

Having been just lit up here, the Union No.725 coal burning stove did some brisk business and kept the three enthusiastic youngsters warm in the K-boose. Luca kind of has the hang of this geriatrically ferrous contraption but with the 'assistance' of the other guys, the fire went out two or three times during the night.

Seeing that the whole stove is 100% radiating surface, full black-body radiation none the less, it is a surprisingly effective space heater. It continues to keep the place warm even after the fire has gone out.

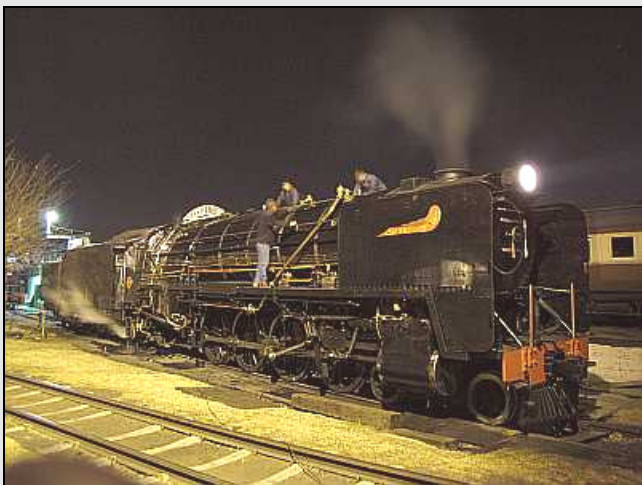
19 – Spyt n' Porlish. (sic)

The young apples are up and enthusiastically wiping down that great porker of a boiler. I was wondering how many burns each one would pick up from the myriad copper pipes and sizzling hot bronze fittings. Didn't hear any complaints anyway.

Even though the engine was doing well banked up on somewhat ashy coal, and the boiler was stable, I was still keeping a very careful eye on the pressure gauge to forestall the safety valves going off and blowing someone's ears in. But she was quite content to drowse a few ticks above 1000kPA.

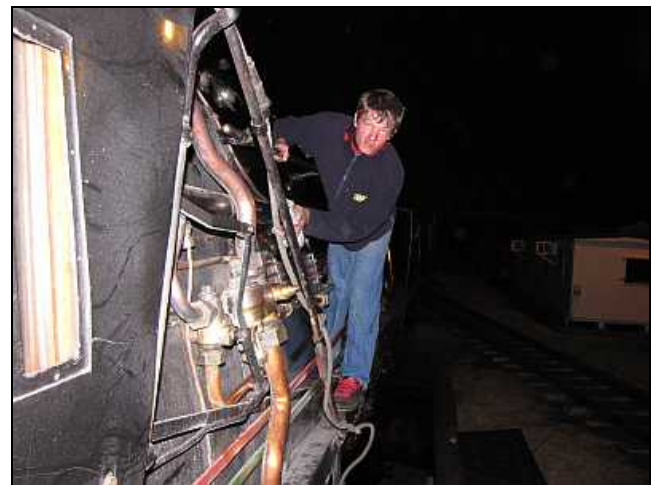
20 – The narrow road.

There isn't much walkway left on either side of the characteristically wide Wootten type firebox of the 15F. The diagonal front cab stays are a nuisance and the area is festooned with piping-hot (pun intended) non-ferrous hand traps such as the seller's valve (with the conical ferrule) and the drifter. (Nearside.)

The trickiest pipe is, of course, the exhaust for the brake ejector as it is painted black and is the right height to be used as a hand rail. Luckily, being pinned down with the handbrake, we didn't need to be drawing off vacuum and that pipe would be relatively cool. Leastways, I didn't hear any four or five letter Afrikaans swear words.

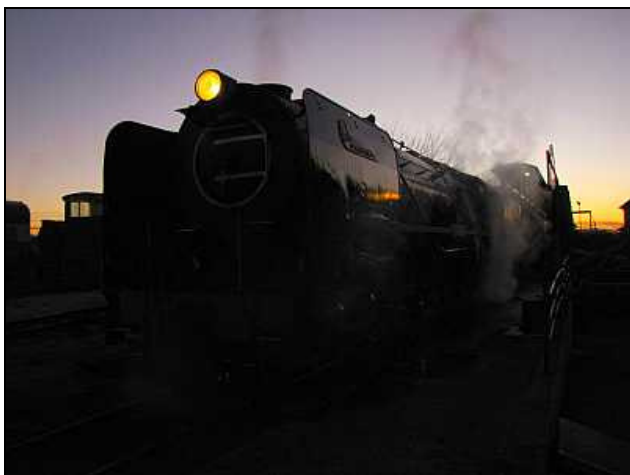
21 – Dawn Scene.

The great black bulk of the machine looks even blacker being backlit by the morning light. It is about 6:30 and the grate shaker is already running. My fast-set camera shutter makes it seem darker than it is.

I spread the fire out at 4:30am, expecting a 5am arrival for the crew. To my disgust, they only arrived at 6:10am. So I had to baby-sit a thin, sluggish fire on top of a thick-ish bed of ash. I struggled to hand fire to the front with the narrow, winged door of the 15F firebox so I fired to the center n' back, and then pushed extra fire forward with the irons – a hack way to fire but it did the job. I did use the mechanical stoker twice, being very careful not to over-do it, being worried about reduced air draw with the stoker-ground coal.

Fire cleaning was quite easy for although we had copious amounts of ash (especially as the shunters never cleaned fire the day before) it was nuggetless, soft n' fluffy stuff.

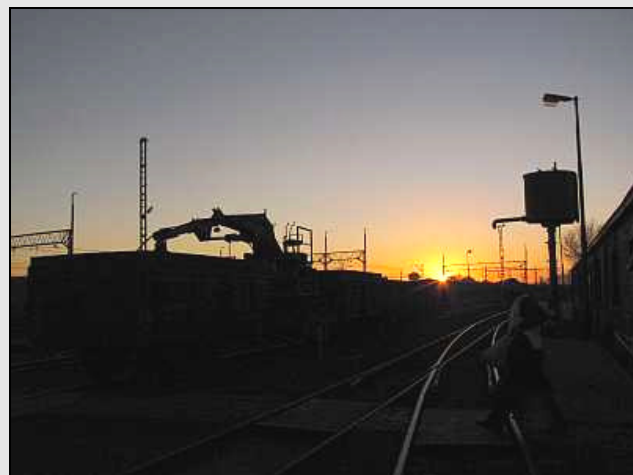
22 – Hello-o-o-o, Mr. Sunshine!

The coal handling wagon, with the secondary arm and the hydraulic ram so prominently silhouetted, is normally stored under cover - usually in the old boiler washout area. However, we've been doing a lot of unusual shunting for the Shongololo Express boys lately as they've been doing coach maintenance and so the coal handling wagon has been temporarily turfed out of bed.

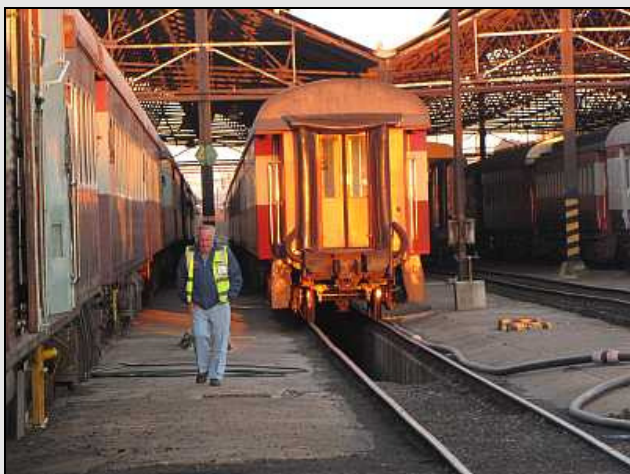
23 – Train Check.

De Necker does the 'Attie-Amble' as he toddles along back to where all the steamy action is. He has just walked the length of the train, eyeing the couplers, brake lines, electrical connections and the under-slung water tanks. It isn't unheard of for a coach's tank to be accidentally left empty or the filler cap to be left hanging on its chain.

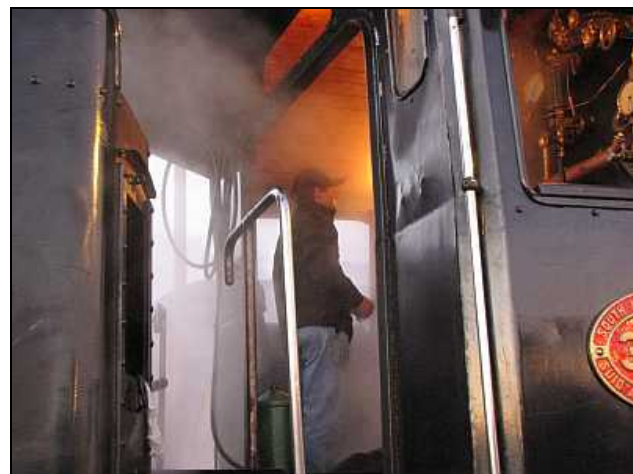
24 – Steam facial.

Dawie's smooth, confident morning and easy session of fire cleaning hits a speed bump when he tackles that bloated lubricator. It is under pressure even with the lubricator's turret valve switched off. An attempt to drain the beast released an arc of blindingly hot water and steam into the cab. Casually removing the filler plug (which I almost did) would result in hot oil being blown into the cab.

A hydrostatic lubricator will continue to operate (somewhat) even with some back-pressure in the oil lines. But it makes the oil-feed rate weak and erratic, requiring constant fiddling during the changing conditions of the train journey.

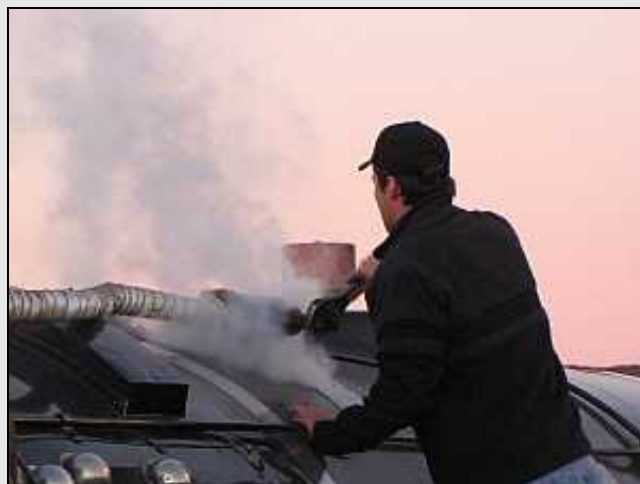
26 – Main switch.

Because the Class 15F locomotive has twin turret manifolds, there isn't a single, large centrally-mounted turret valve in the cab to switch off the steam to all the auxiliaries. The actual turret pick-ups are remotely located from the manifolds and forward of the firebox, and each of them has a square shanked valve stem to shut off steam to that particular turret manifold. (With a spanner or wrench.)

Dawie is shutting the fog down from the right side turret so that Andrew King can work on replacing a sheared split pin in the universal joint of the brake ejector's spindle. It sheared off overnight and needed to be chiseled flush before being punched out – said tools not available to the overnight shift. That particular valve's gland packing was blowing – which made jiggling the crude universal joint a rather warm job!

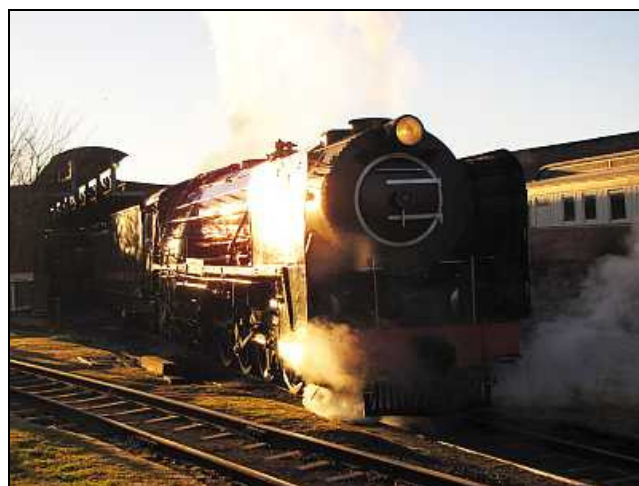
32 – False Start.

The oil line restrictor for the right cylinder still wasn't operating properly and the hydrostatic lubricator was still blowing back with the steam pressure from the cylinders.

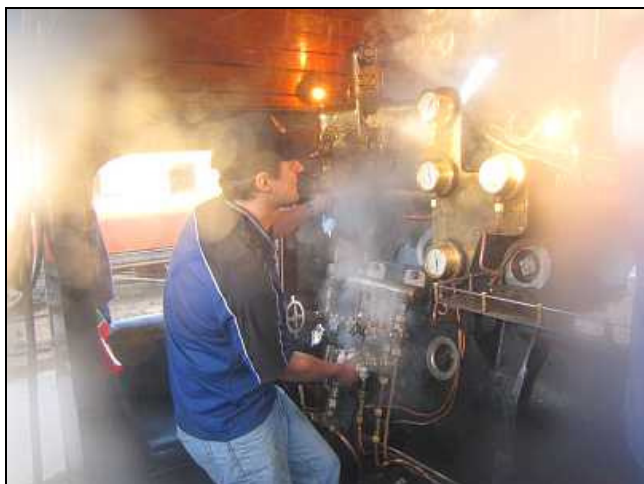
33 – Framed!

Fireman Dawie is beautifully framed by a mixture of steam and the fogging on my camera lens. He's blowing down the lubricator again to get the oil out of the sight glasses. Normally this job is done slowly and carefully with a shovel to catch the spray – but the train is now nearly an hour late to couple to the coaches, although we aren't late just yet for the main line.

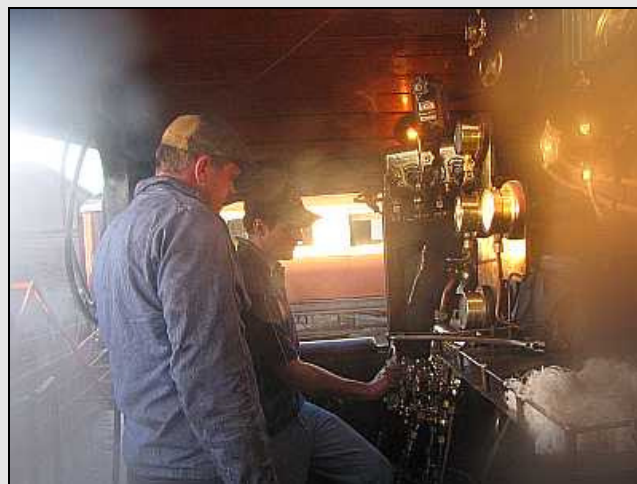
34 – Just a tweak.

Dawie tweaks the left-most stoker blower jet as they run some more coal in during the delay. Even supposedly identical engines sometimes require different adjustments, which is a part of their life-like character.

The fog to the right is condensate on the camera lens – the left side is steam drifting up from the stoker.

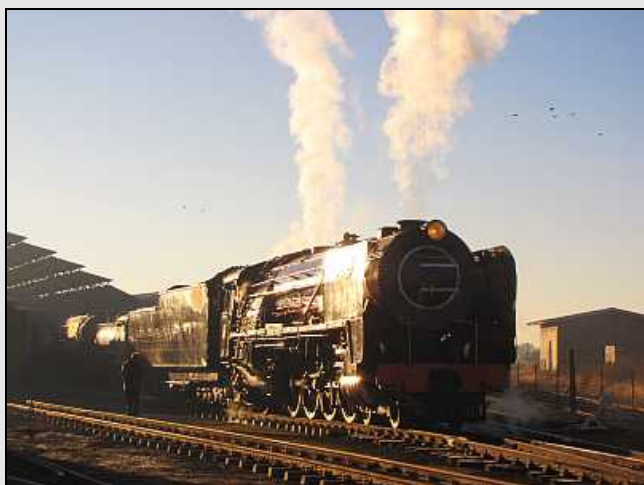
35 – Backing up.

In the western yard now, Class 15F No.3046 backs into the siding where the waiting coaches stand. The Class 15F's weren't designed for shunting in particular, but proved to be quite effective as heavy shunters in their own right – if rather too large to be truly economical. They just aren't tolerant of rough track with their high pitched boilers and of tight curvatures with their long wheel bases. 15F's were also known for rough riding when running in reverse at speed and this is a situation that we try to avoid.

Their 18.5 ton axle load provides sufficient adhesion for tough starts. Of course, in the old days, you wouldn't have seen locomotives backing up to coaches in the running shed, but it was entirely probable that a loco would be backed up by a shed man onto several 'dead' locos to haul them into the workshops or for boiler washouts and such.

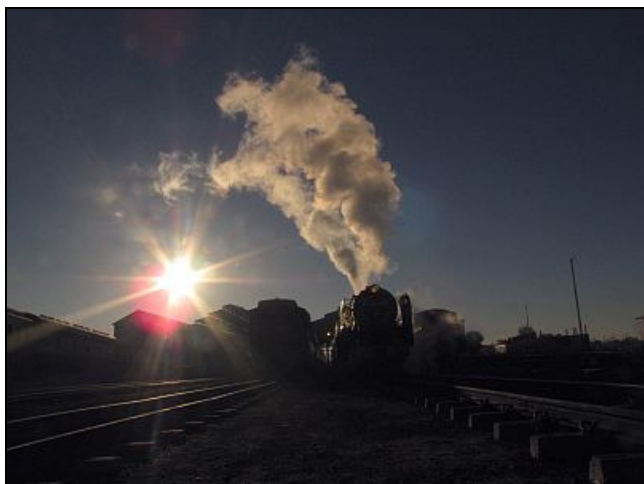
37 – Hookai.

The characteristic shunter's 'hookai' has been called and there is a muffled, dull clank as the buck-eye couplers close. Now is the wait while the vacuum brakes are tested.

No matter how late we are, as in today's situation, the brake test is always done. Fortunately for us today, there were no nasty surprises lurking amongst the vacuum system.

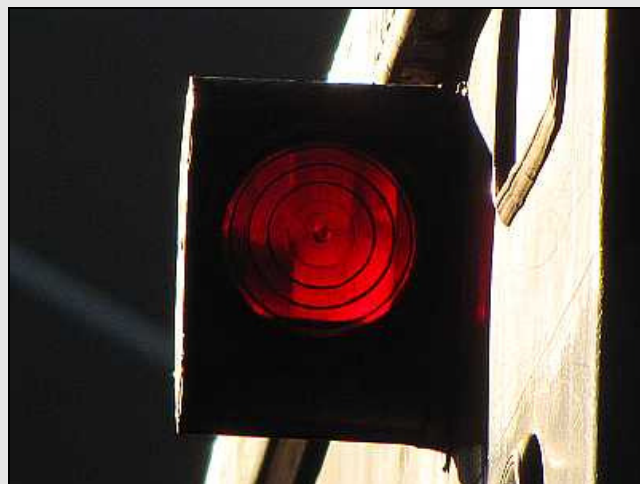
38 – Backlit jewel.

The wing light on the leading coach is perfectly backlit by the nearly horizontal rays of the morning sun. This is one of a pair of functioning lamps that show red towards the rear and white towards the front – the white light being a spotting guide seen looking back from the loco cab, to ensure the last coach is still attached to the train. (!)

Because this is the lead coach on the outbound journey and will be the tail coach on the way back, this wing light is currently back-to-front.

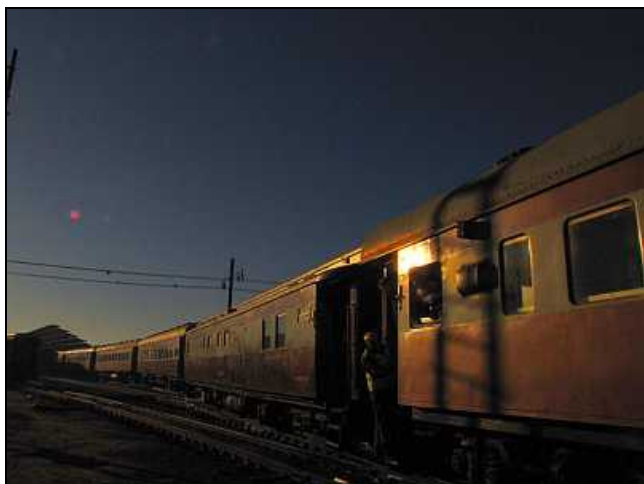
41 – The load.

This is the last full set of operatable steel main line coaches in the country still painted in traditional SAR colours. Today's load is 485 tons on 44 axles (11 vehicles) and the train would be taking families to Magaliesburg for a Father's Day run.

That overhead line is a 3000V DC traction feed to the main tracks – hence the unusual thickness of the dipole wiring.
