1). INTRODUCTION :

2). MOVING THE WICKSTEED MECHANICAL SAW

3). CLASS 15F NO.3046 - CATARACT VALVE INSPECTION AND REPLACEMENT :

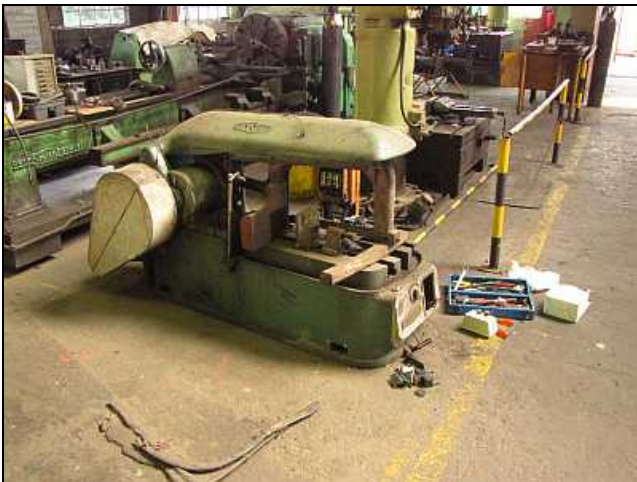
WSR-01 – Original position.

Here's the start of today's electrical project, the Wicksteed mechanical saw as off-loaded on 4th April 2009. It was donated as a surplus machine from Andrew King's firm, Bosworth Engineering, and no, it didn't just 'walk away' from the factory floor. It was properly handed over otherwise it would have probably have been scrapped or dumped by now.

There are two problems with the current position. A). There is no electrical power although the juice-jacks are available and B), The work piece, which will typically be boiler tubes and flues, would protrude into the work space of other machines, as well as inter-machine walkways. This end of the workshop is getting crowded anyway and there is barely enough space to swing a DZ wagon.

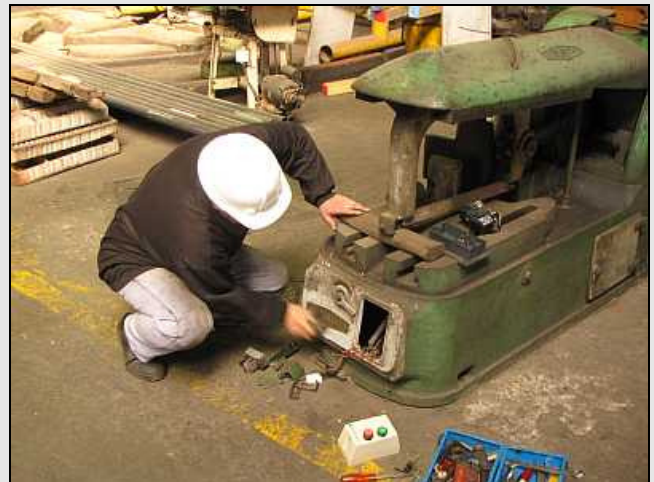
WSR-02 – Rubba-dub-dub.

Ex-South African Railways Fireman Johann Breydenbach shows that he still has luke-warm steam oil circulating in his blood stream. (The body temperature thins it out.) The percentage is probably less after years of selling properties instead of hurling chunks of carbon, but this old boomer has got steam in the blood until the day they finally call in his boiler ticket.

You can tell he is the genuine article because no true steam man can tolerate a corroded or a dusty name plate or badge without at least one wipe.

After spotting me taking a high resolution picture of that machine manufacturer's badge for prosperity (because they do, ahem, 'disappear' sometimes) Johann just could not take it any more and gave the dulled name plate a brisk rub down with a piece of oily waste.

The shardic debris scattered there are the remains of the old starter and its enclosure.

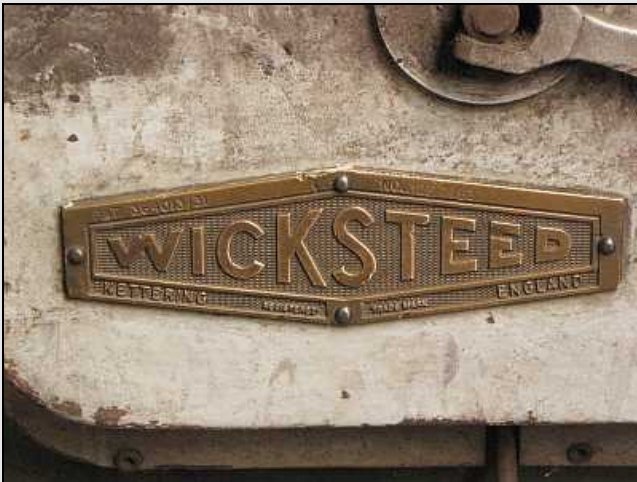
WSR-03 – Trying hard to be brass.

It is always charming to see the ornate name plates and badges that were placed with pride onto older machinery and they often become collectables in their own right.

This one says 'Wicksteed, Kettering – England.' Patent 364013/31 No. 1257763. The last number, being the machine's serial number, is hand stamped while the other numbers are cast.

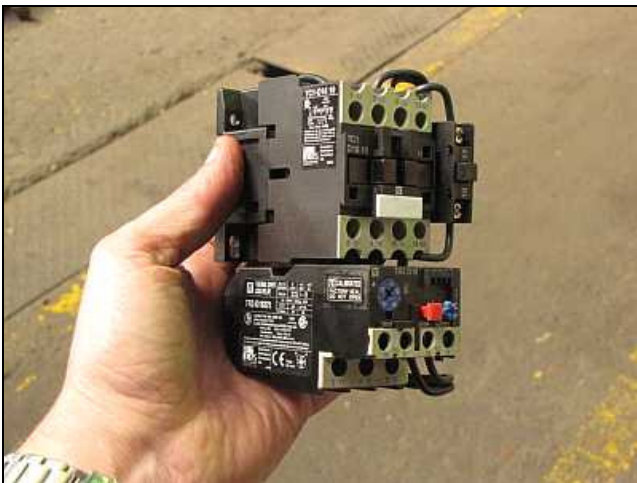
WSR-05 – Snazzy!

Here is the replacement, being a much more modern and compact thermal overload replay combined with a contactor, pre-wired with a latch switch as well. The latch switch functions as the start. The red button on the thermal relay would be the stop and the blue button, the reset.

Heavy machinery often requires load relays to cater for the 'inrush' current that occurs when the machine is started. A standard circuit breaker rated to try and protect the motor under running conditions would tend to trip out if the machine is started under load. A fuse would generally be too slow if the motor overloads or goes partial short circuit.

The use of a thermal overload relay allows for tighter, more intelligent protection downstream of the cable – and lets the over current-protection in the distribution board be rated to protect the cable without worrying about the transient characteristics of the electrical load.

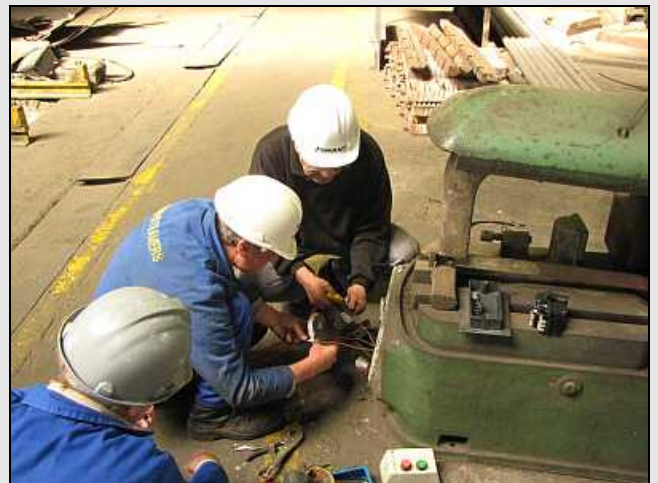
WSR-06 – Snip n' Strip.

Those mangy wires were re-crimped and then taped up by Andrew 'Noddy' King. (Center) Being used on a reciprocating machine, a twisted wire or a screw connection probably wouldn't last long. I wasn't so sure about that tape though but it is fairly cool and dry under there. I now have photographic proof of who did the wire taping should the ol' Wicksteed go FIZZ...BANG one day. (Probably when trimming donated 15CA boiler flues – hint ... hint.)

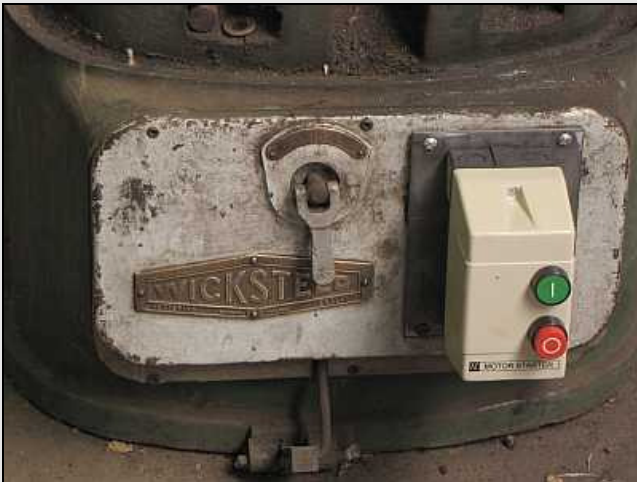
WSR07 – Much too clean.

Not even a single greasy thumb print to give it some genuine steam workshop ambiviance. Uncanny. Unnatural. Here's the finished installation of the starter box which definitely needs a bit of 'weathering' to blend into the surroundings.

It is, unfortunately, in a very vulnerable location and is liable to get kicked or knocked. The external buttons operate the overload relay's actually controls remotely via little stamped Tetris-like push-plates. Thus, there are two layers of mechanical protection for the electrical components.

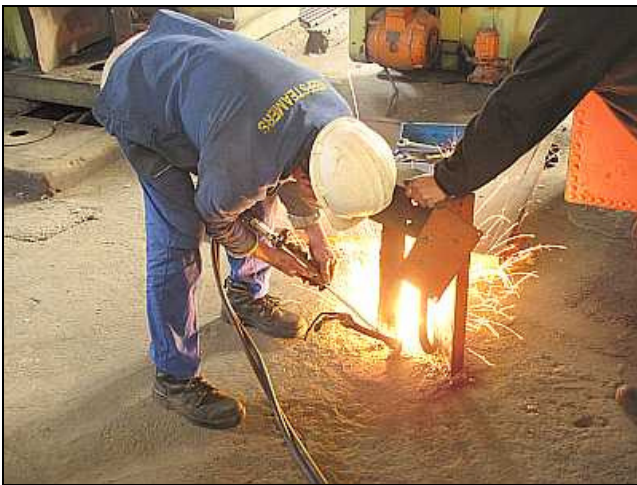
WSP01 – Sparkin'

Andrew King's second-most favourite depot tool is the acetylene torch. (The all-star swingin' favourite being the 16 pound mallet.) After Mike Murphy removed one of the old cable glands which was good enough for salvage, the derelict isolation box could be cut down.

The plan is to mount a junction box directly to the machine once the final connection is made. The cable that is hotly haloed by the fire is actually a piece of scrappy flexible conduit with no conductors within.

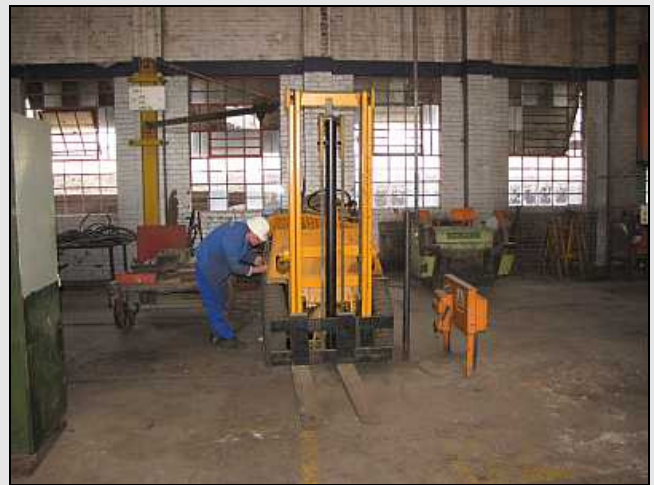
WSP02 – Hyster-resis.

A bit of hysteresis enters the job flow as time out is taken to check the vitals of the Depot's gas powered Hyster forklift before firing up. This machine is a bit battered and scruffy, even with a relatively fresh safety-orange paint job, but it is 100% functional.

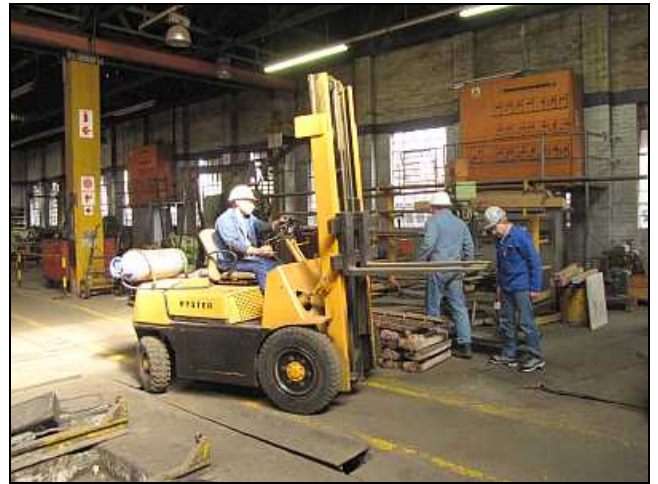
WSM-01 – Rat Run.

You can see the treaded trench cover flipping up from under the forklift's rear wheel. This is one of the covers of 'The Rat Run', a traverse drain trench that runs the full width of the 15M workshop and separates the machine shop from the eight locomotive repair bays.

All the trench covers are slightly bent from years of use, so there is a particular metallic grating, slapping sound that ensues when one even walks on a grate, much less wheeling a trolley or a barrow.

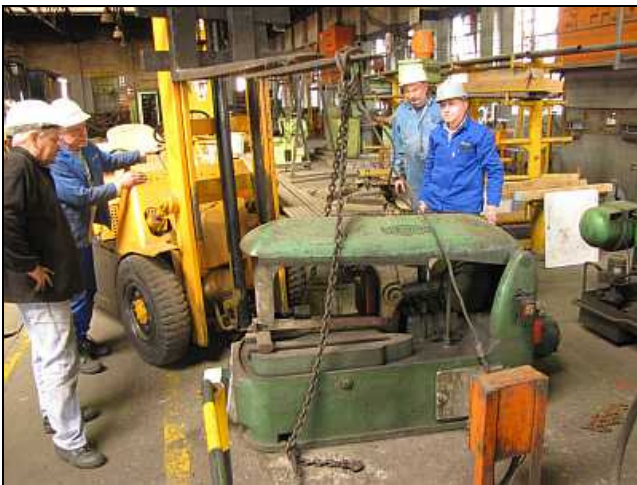
WSM-02 – Chain + Cable = Cradle.

Here's the lifting arrangement.

The front sling is a two-part chain with link-hooks and a central eye, while the rear sling is a cable. They are both attached to 'gwala bars' passed through lifting holes in the machine's hollow base. The alignment worked out almost perfectly - although it wouldn't have been a problem if it didn't, because the forklift's tines can be moved laterally.

The slings are retained on the tines by a long bolt that was pinched from around the Dean Smith lathe and passed through a hole cast into the forklift's tines. It looked like a specialized bolt and I wondered if it would find its way back home. I'll sic James onto Johann if he wants that bolt back.

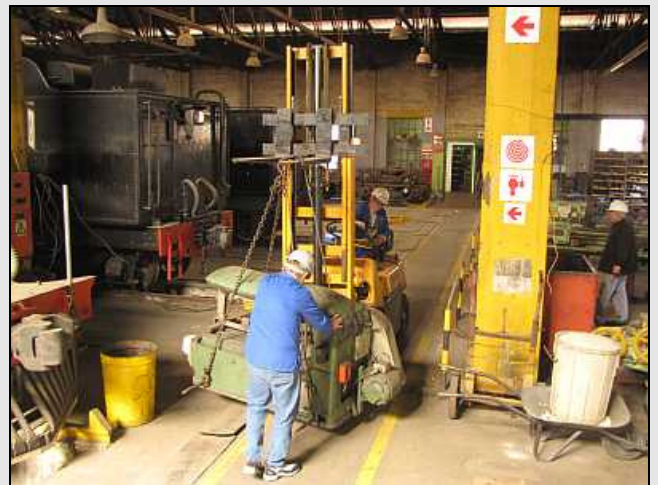
WSM-03 – Murphy Motion.

Mike Murphy guides the suspended mechanical saw as the forklift is carefully backed up. Andrew gets to breathe his own exhaust fumes. Guiding a load like this can be a tricky when lifting locomotive-sized parts or machines like this one - for although the weight is taken up by the sling or the tackle, the suspended object still has inertia and momentum, and can be damaged or can hurt someone.

You can see the vulnerable new box protruding out from the left and having just survived a close encounter of the dustbin kind. The machine's design doesn't look good with all the electrics on the right end, where the starter could have gone. But the starter was located to be within easy arms reach of someone closely examining the work piece.

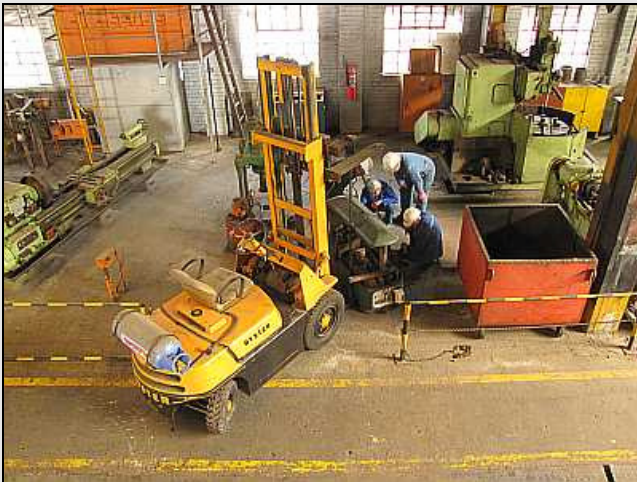
WSM-04 – The Wicksteed has landed.

Here is a tender-deck (15CA No.2056 'Dorothy') eye-view of the approximate new location for the saw. The protective block of wood under the saw blade shows the alignment of the future work piece, which will sometimes be about 6 meters long. There is ample clear space to the left for a work piece to protrude alongside the drive-end of the lathe without protruding into the demarcated walkway area.

The oxide red container is our scrap metal bin and it is castor-mounted. It can be easily moved out the way when needed.

The yellow and black handrail sections for our workshop area are removable. Their bent-over ends slot into the tops of the hollow round posts. I can thus certify that no heritage handrails were harmed during this operation.

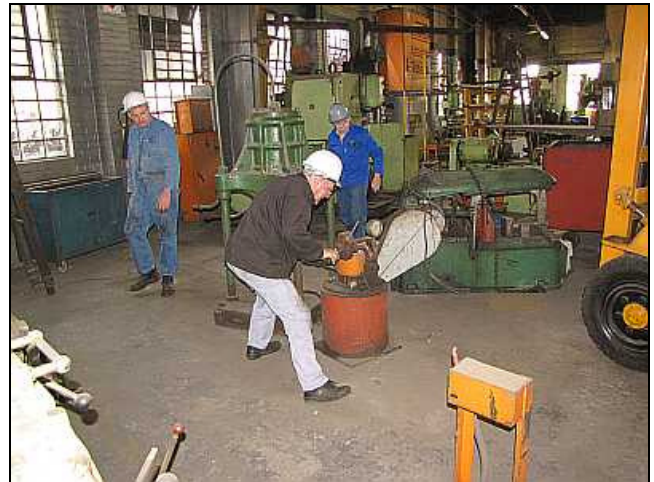
WSM-05 – Power Pack.

Grey-headed Johann Breydenbach, of course, still thinks he's 21 and instinctively hurls himself into the spine-wrenching, cumbersome task of shifting a heavy hydraulic power pack. While he's grunting and scraping it away, the other chaps are just about to turn around and rotate that blue work cupboard in the background.

The next project is to move that green hydraulic press out of the center-ground. It is out of service and is just sitting there, rather than being bolted down onto the floor.

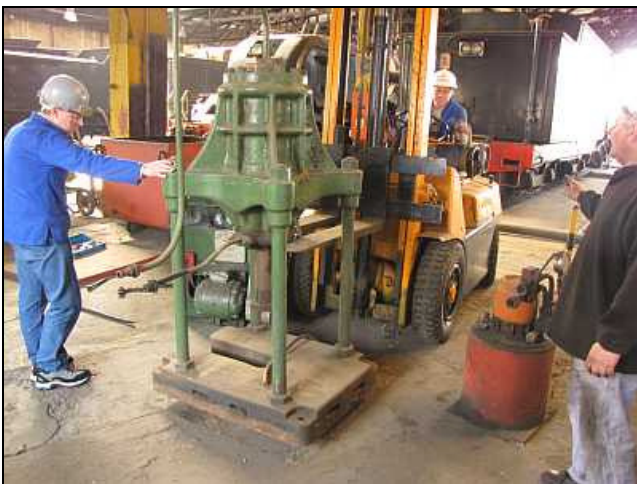
WSM-06 – Hup!

The hydraulic press is lifted a cautious centimeter or two off the floor and is just about to be rolled back into a pickle. The rear-most corner 'connected' with the mechanical saw's belt drive cover. (Visible just behind the press's ram.) Luckily nothing got bent and no damage was done.

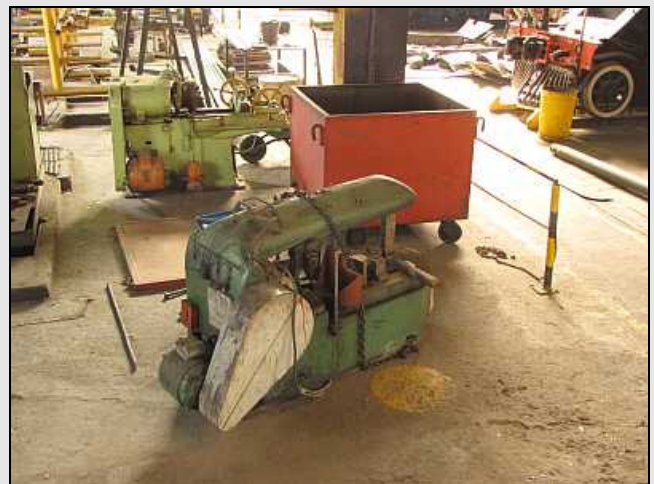
WSM-07 – Final pozzie.

Here is the Wicksteed mechanical saw as seen from the drive end, with the slings still attached. This angled arrangement works out well. The machine just visible to the left is the vertical boring mill but it is primarily operated from the far side. No one needs to stand where the scrap metal bin's lid is seen lying on the ground.

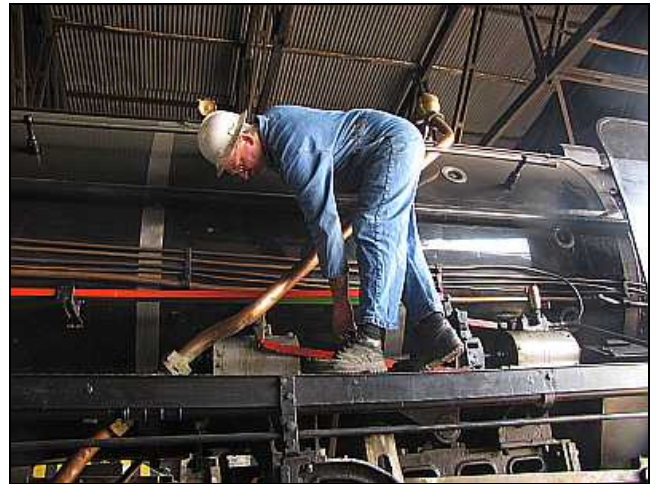
CV02 – Aidan checks.

The green rods are the indicator links which drive the pointer on the quadrant back in the cab, so the driver can see to what percentage the steam cutoff has been set at. They are driven from a crank plate directly from the way shaft and provide actual feedback of the cut-off settings.

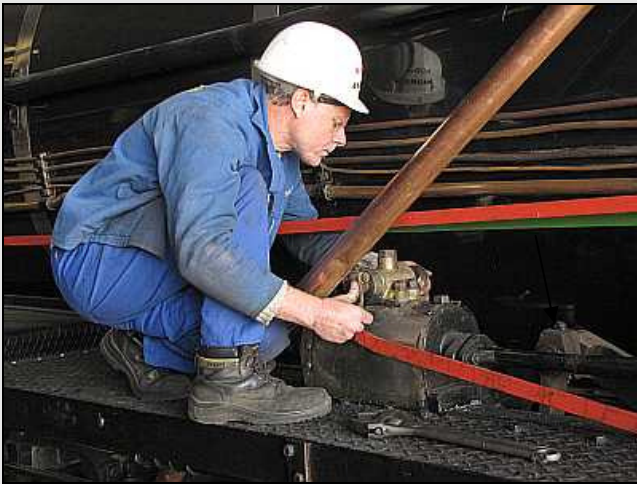
CV05 – Inspecting the gadget.

Andrew King was called to consult and he wasn't happy with the loose movement either. He has started his inspection by removing the rear cover, which also in cooperates the loading spring that presses all the tapered parts together. It isn't usually a suspect though.

The spring and its cap seemed to be OK and Andrew was sure the problem would be at the other end, where the counter taper washer is. We did incidentally find that the gland packing was done with a spiral piece of graphite rope and that is a classic example of bad fitting practice.

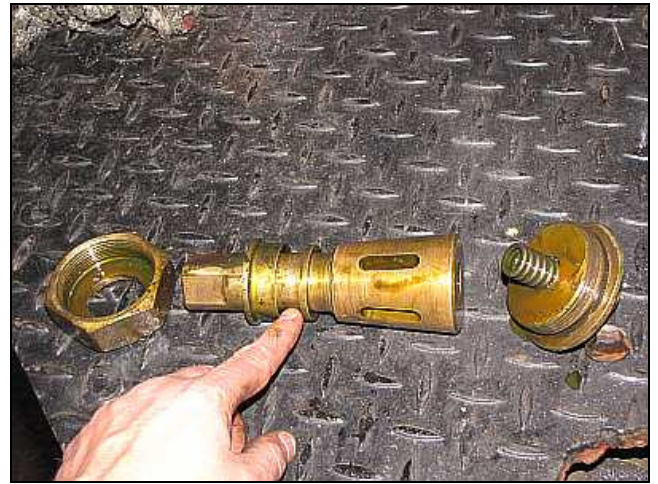
CV06 – Haynes Spread.

The top-hat profile jumper washer that fits on the end of the spring and engages with the spring's bore within the valve spindle is missing. It all looks a bit primitive, but this valve has to maintain a metal-to-metal seal.

The long slot passages in the spindle (See Pic. CV06) through which the oil flows from one end of the cylinder to the other. are joined in a tee-shape into an internal circular bore, into which this circular hole also communicates.

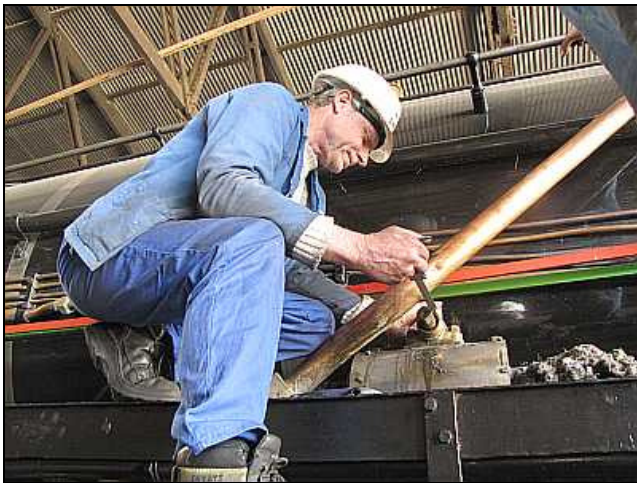
CV07 – Depths ... of despair.

But due to wear or bad fitting, there is too much longitudinal clearance and it seems as if the oil is sneaking around the ends of the valve. This valve was probably assembled with mismatched parts from totally different units.

King Kondemned the existing valve and went a-hunting for a replacement – convinced that a cataract valve was rebuilt and safely stored when No.3046 was originally worked on years ago. He wasn't able to find it, but this scabrous, black-painted example looked like it might be useful.

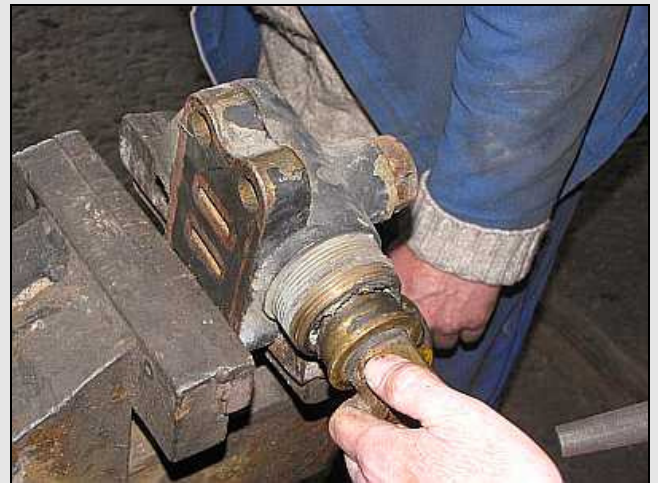
CV08 - A cautious pull.

Here, the packing spacer wouldn't come off over the square shank for the crank. Some desperate(ly) incompetent fitter had beaten the spindle roughly in the past and the chamfered corners had raised burrs on then.

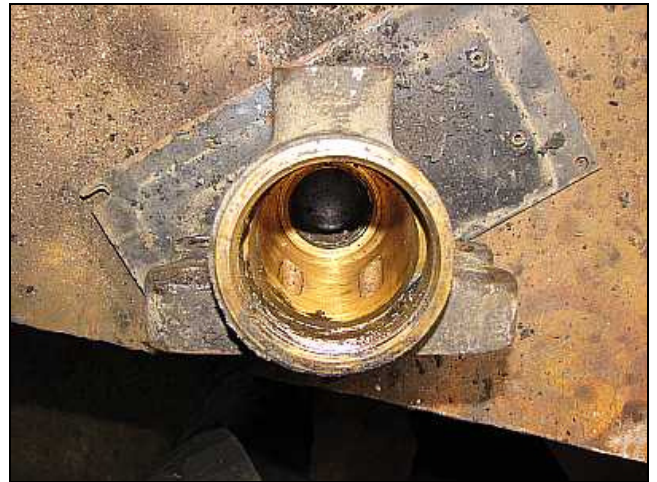
CV10 – Down the bore.

When the driver operates the reverser lever in the cab, the tee-connecting passages rotate 45 degrees (Either way) and oil flows via the base of the tee and one of the arms. This allows the piston to move within the locking cylinder beneath, pushing the oil ahead of it through the valve and back behind it. Not only does the cataract valve and its locking cylinder act as a hydraulic latch, but the restricted flow of the viscous steam-oil also acts as a damper, rather like those hydraulic door closers one sees. When low on oil, a Hadfield Reverser gets twitchy and shoots towards full-forward or full-reverse before the driver can react.

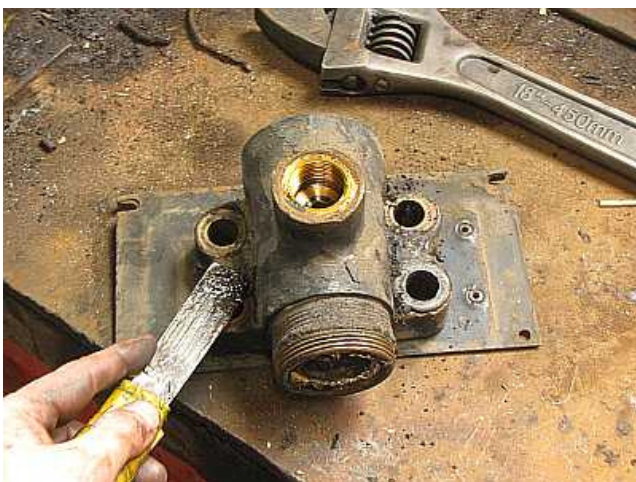
CV11 – Scraping up some work.

You can clearly see the filler hole in this picture. This hole is used to fill up the cavities and ports of the cataract valve with oil. The hydraulic locking cylinder itself is filled with steam oil via hex-ended plugs at either end.

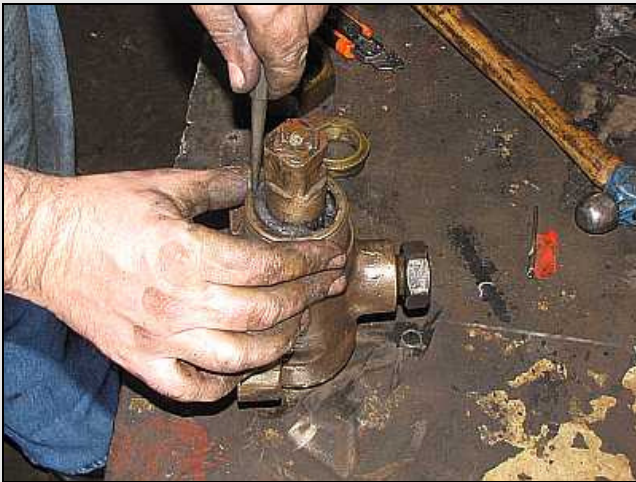
CV13 – Get Stuffed!

Muttering dire imprecations against those who still do spiral-wound gland packing, Aidan has been cutting little rings from the graphite-impregnated packing rope and is patiently inserting them one by one. The idea is to stagger the split ends of the rings 180 degrees apart so the packing rings form a serpentine seal. A spiral-wound packing rope, when it settles in, quickly forms a continuous path for leaks.

This is one of the most unusual packing joints on a steam locomotive as the packing has to seal oil, not steam. Oil leaks here though, are relatively rare because of the tapered washer on the out-board end of the valve spindle.

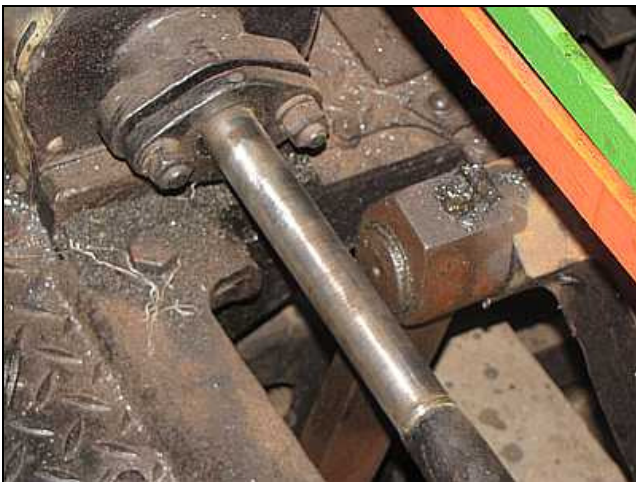
CV15 – Gland Eater.

Here is the locking cylinder's end of the common spindle. As you can see on close inspection it has become a bit pitted with rust. In operation, this shaft is naturally wiped with oil from within the cylinder but it had been standing dry for over a decade. The rough surface abrades the packing.

In the background is the bridle rod that couples onto the rear end of the radius rod. There is a matching one on the other side and it is rotated by a crank from the way shaft that passes right across under the boiler. The crank shown here is a bell crank (bottom right) and the opposite end is moved by the scotch yoke which is moved by the reverser.

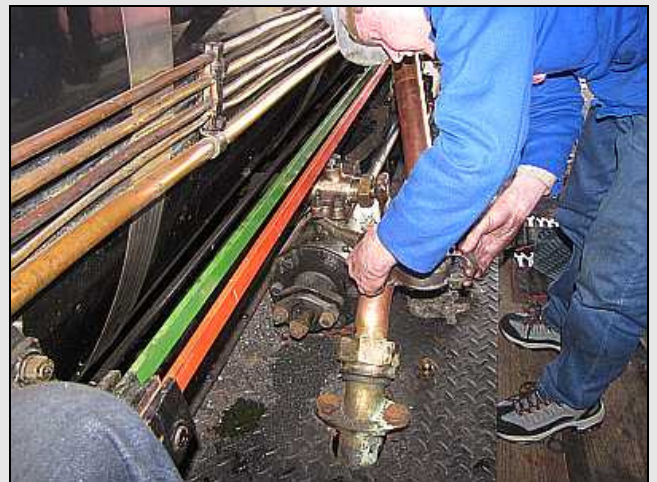
CV16 – Fill 'er up.

Thinner oil would pour and settle easier. But depending on the volume used, it would reduce the damping qualities and speed up the operation of the reverser. However one can use heated compounded steam (valve) oil for easy pouring.

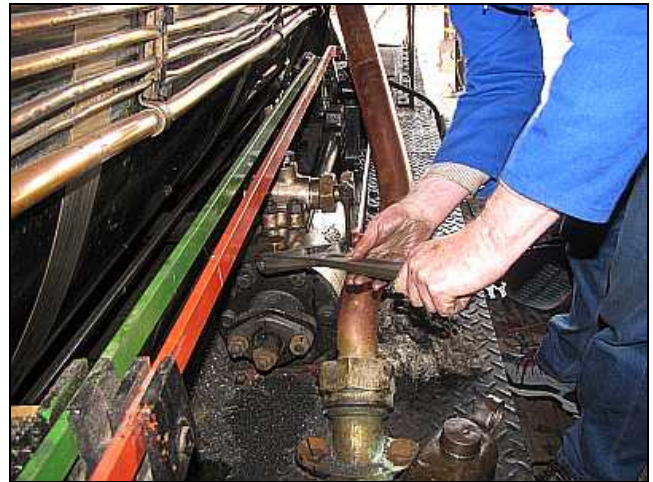
CV18 – Finishing up.

Poor Mr. Murphy had to patiently undo those end plugs a third time to check the oil level after a few air compressor-powered forward and reverse cycles. The oil level seemed fine this time around and this job could be wrapped up.

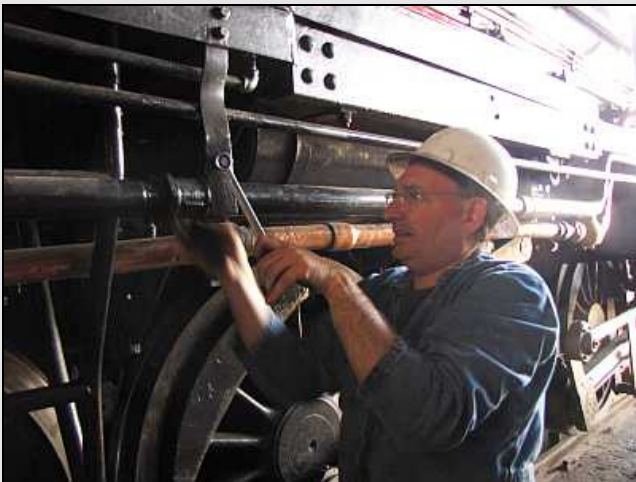
JB03 – Concentration.

Aidi-Mac also had to wrestle with the bracket’s hangar-strap as it was twisted and distorted in two planes.

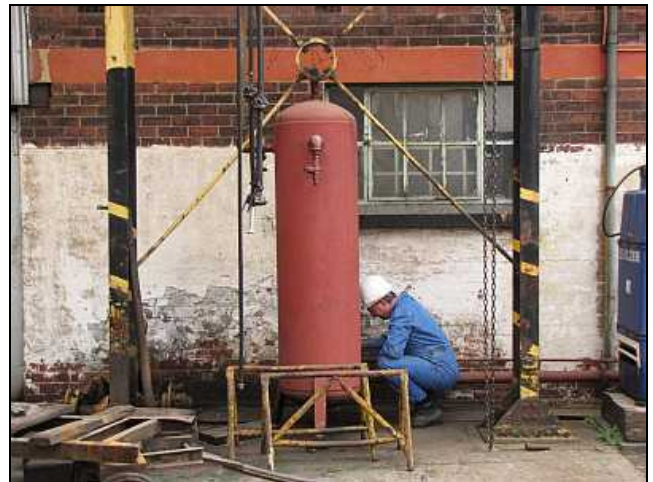
JB04 – Milking Time.

One of the first jobs in starting up the air compressor plant is draining the condensate from the air receiver and from the intercooler. Aidan knuckles down to the plug valve, which drains directly into a trench. The discharge is a sick milky-caramel colour, so the photo header isn’t too inapt.

Try as we might, there is always moisture in the air lines and we always blow them out for a minute or two before hooking up a pneumatic appliance or even a draft blower.

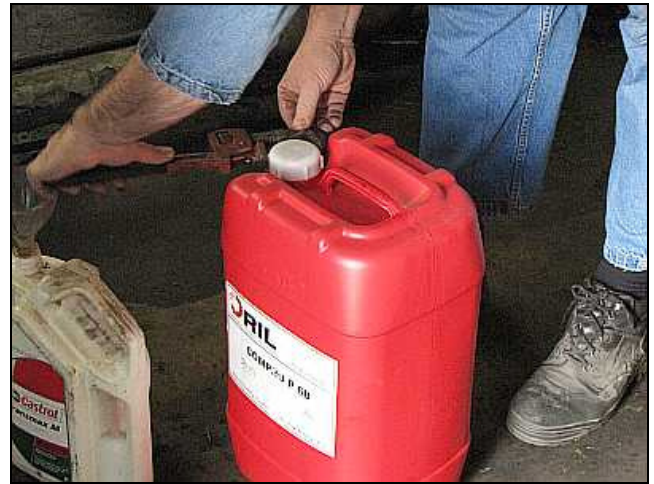
JB06 – Strong arm approach.

The general rule when working with steam locomotives and their supporting equipment is that if the job can be awkward, it will be. Aidan had to resort to the use of a stilson wrench to get the bulk oil can open.

The oil is Compro P68 and is the second thinnest oil in the typical range of viscosities for this application.

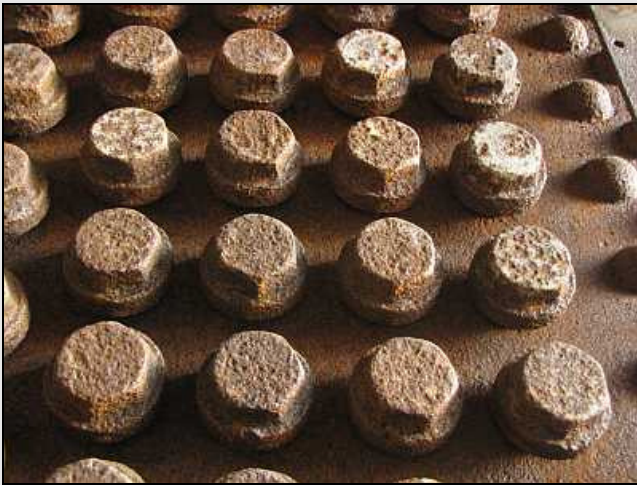
MX01 – Stay Array.

A close up of an arrangement of somewhat corroded flexible stay caps on the right flank of the Class 12R 1947 'Rosie's' firebox. All 20th century SAR steamers have flexible stays.

The commonly understood name 'flexible stay' is somewhat incorrect. The stay 'bolt' that extends between the firebox's inner plate work and the outer shell is as rigid as ever. But the outer end is allowed to be able to pivot very slightly as the firebox's inner plates thermally expand and move in relation to the outer plates.

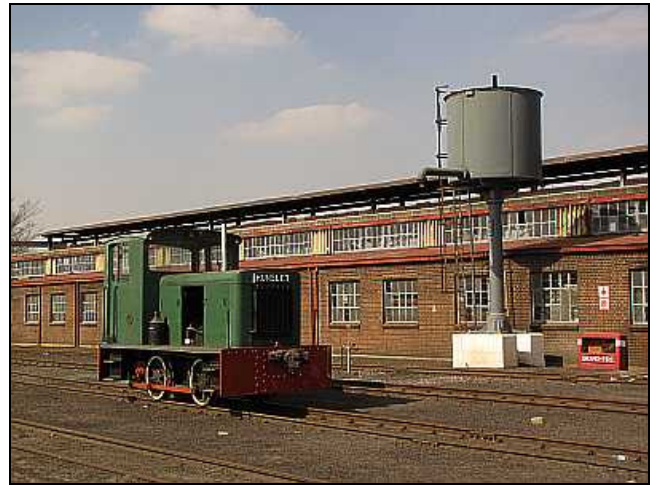
MX02 – Not a customer.

Here's one little locomotive that doesn't drink from that giant hamster bottle.

The 1951 vintage Hunslet Taylor is now running with a traditional steam loco 'milk churn.' That churn is actually a sand bottle to assist with the shunting on the winter mornings, when we tend to get frost on the rails.

Mr. Hunslet does actually have a sanding system – which is basically gravity discharged from hoppers. But it is defunct and we have found that manually sprinkling sand on the rails ahead of the lil' loco is sufficient for our shunting.

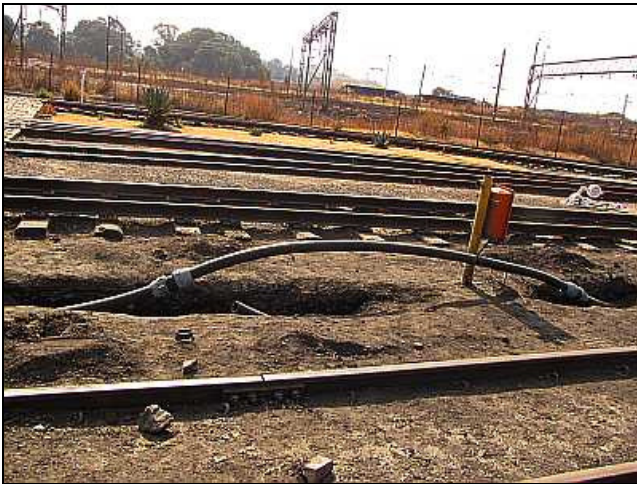
MX03 – Pressure gradient.

The depot water mains continue to be a problem. It was originally too narrow to supply more than one hydrant and was replaced with a wider bore pipe.

The wider pipe increased the pressure available at the end point, but the pipe material is not SABS rated and is definitely not UV resistant. Since then, the surface mounted sections of the pipe work have been splitting in response to the UV from the sun and in the harsh sunshine of summer we literally get a leak every week or so.

This splice looks ridiculous but it looks as if they were trying to avoid the electric cable going to that service box.

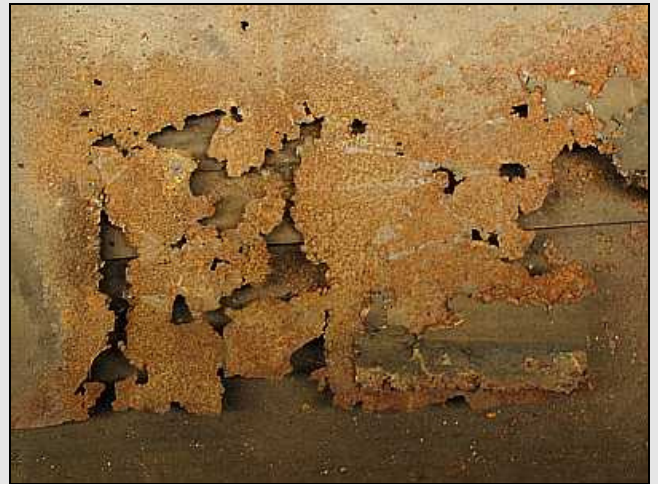
MX04 – Lacework.

The saying goes that 'Rust never sleeps.' This is the tin-worm-chewed boiler cladding of the 12R No.1947 'Rosie.'

The boiler cladding is the outer sheet that covers the gaunt, riveted boiler and protects the sheets of thermal lagging. It is the most vulnerable part of a steam loco in terms of rust as the thermal lagging gets damp if a locomotive is stored in the open and not used regularly.

The effect is rather like damp carpets under a piece of furniture – it takes forever to dry out. The thermal lagging, be it sheet insulation or rock wool, holds the unwanted moisture lovingly against the unpolished interior of the sheet metal, and the eggs of the tin-worms start to hatch.

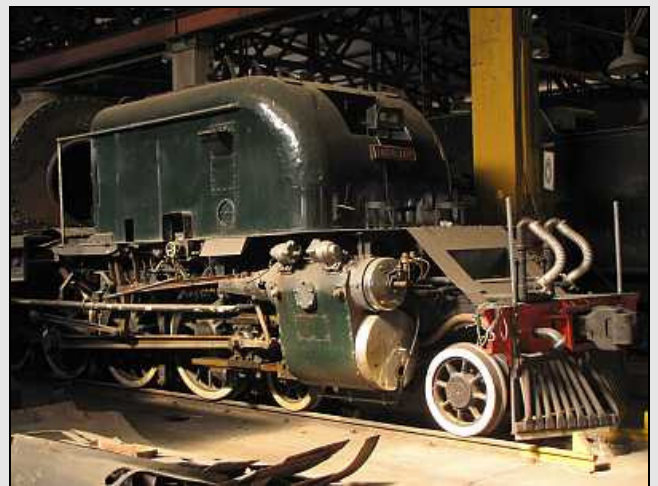
MX08 – Highlighted.

The recently tested boiler is OK from a pressure testing point of view. No leaks or containment problems found.

But a failed girdle bracket on the dry pipe within the boiler needs to be repaired. The dry pipe is the large diameter pipe that gathers the steam, usually from the dome, and leads it forward to the regulator. It is usually supported by flat-section traverse hangers inside the boiler.

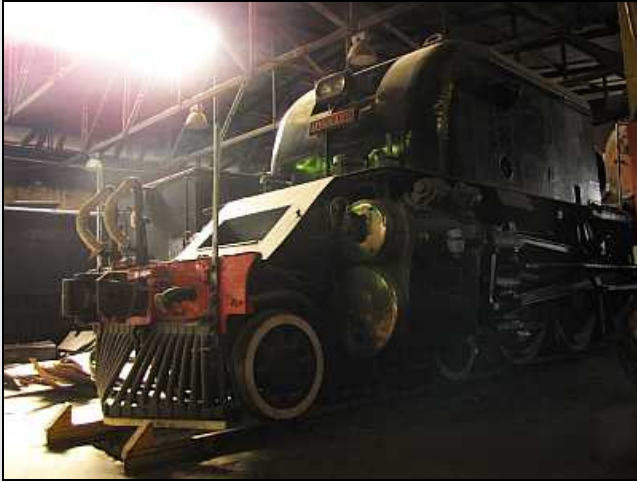
MX09 – Sunlit Saturday afternoon snooze :

Yeah, another pic of the same end of the same GMAM at the same time but I couldn't resist the backlighting effect. The strange green highlights on the rounded front nose of the water tank are reflections from several sun-lit green-painted machines.
