THROUGH THE SMOKE WE CAN SEE CLEARLY NOW!

Another perfect hectic week has passed in the Eastern Free State and even through a smoke screen of work we could see clearly our goal: Steam!

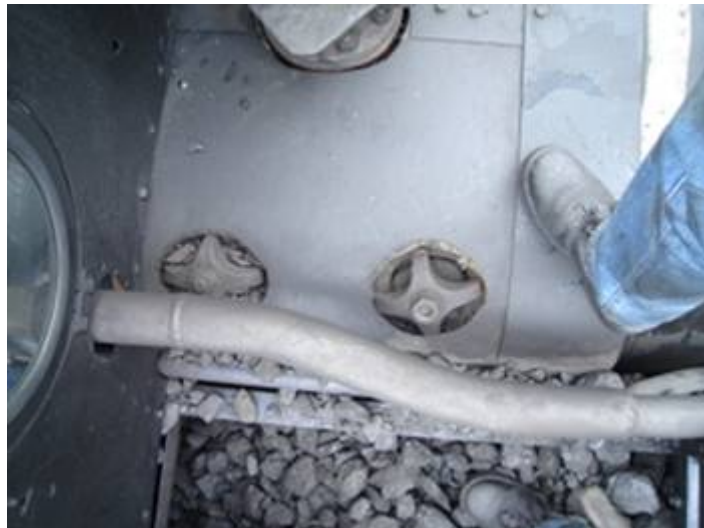
The mud hole covers on the boiler of the NG 4

The NG 4 Boiler mud hole covers were fitted back after it were removed for drying purposes and we then steamed to test her and discovered quite a lot of repair work to leaks on various parts on the locomotive. Luckily she was in steam and we could fix the leaks in steam and test it the same time. Both injectors failed but we discovered and repair the problems, she will be steamed again to test the injectors after the repair was done.

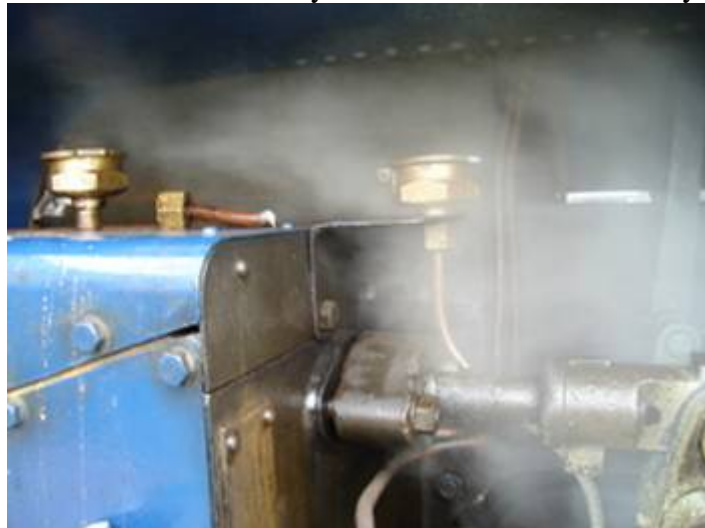
While the NG 4 was in steam we performed a list of tests to insure that she is okay, in the photo below we cleaned the lubricator by removing the valves and open the steam. All the blockages are blown out this way and it also cleans the bull eye glasses.

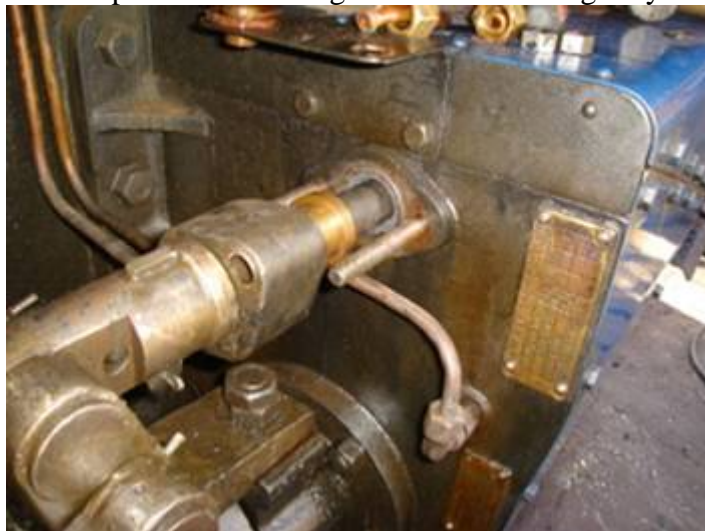
Both the piston and valve glands were blowing very bad.

While she was in steam we packed the valve and piston glands with graphite asbestos rope. We then tested the repairs done and all were 100% better.

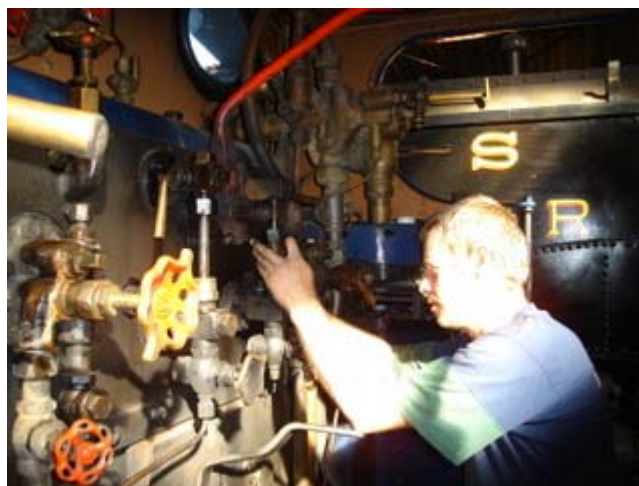
At last she suffered from a non return valve problem on the right side injector. Derrick opened the valve and removed the hard little pieces of scale that prevented the clack to seat properly.

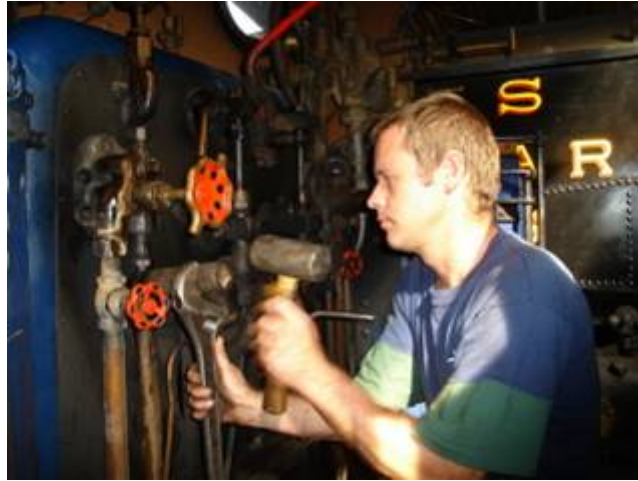
Derrick fitted a new gauge glass rubbers to the gauge columns that were leaking.

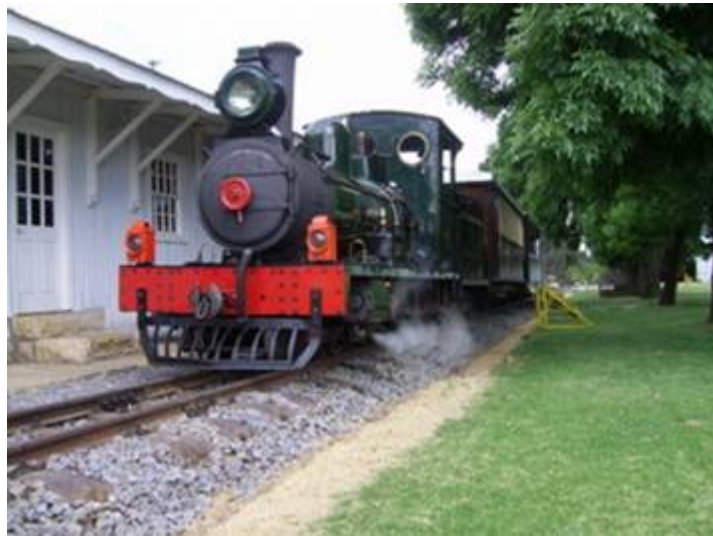
The only locomotive that is not a free steamer is our NG 6 number 106. The problem is the flow of air through the firebars. Derrick removed the fire bars and made the space between the

fire bars bigger to allow that more oxygen can access the fire box from below. This also will ease the cleaning of the fire that usually was a big problem if the gap between the fire bars were too narrow.

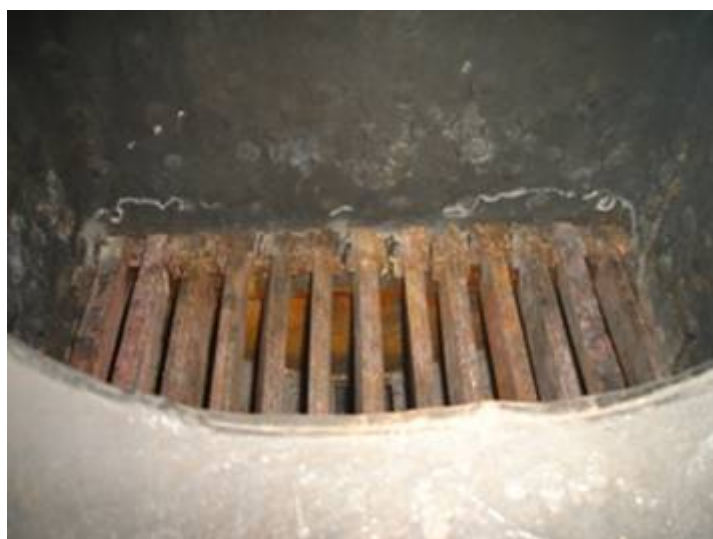
Derrick busy to remove all the NG 6 fire bars.

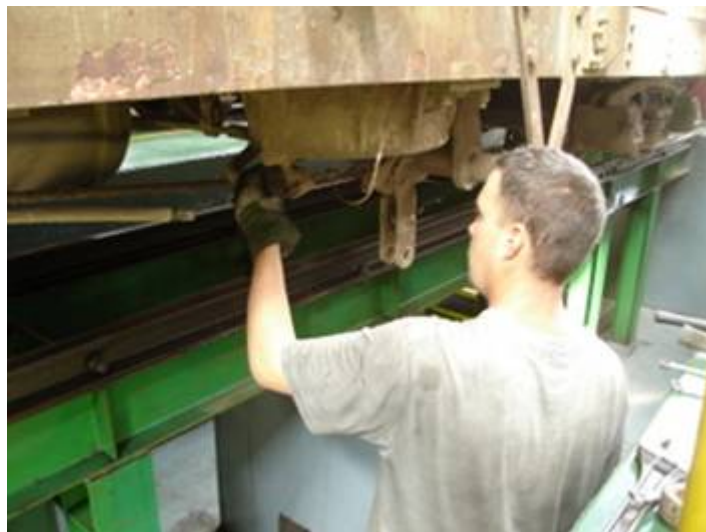
Number 3911 on the Inspection pit for mechanical restoration that was needed to get her roadworthy.

- Vacuum overhaul
- New vacuum release valves
- New chamber and vacuum rubber hoses were fit.
- Brake blocks were fitted
- Brakes adjusted.
- Vacuum brake tested.
- Boxes packed with new soaked wool.

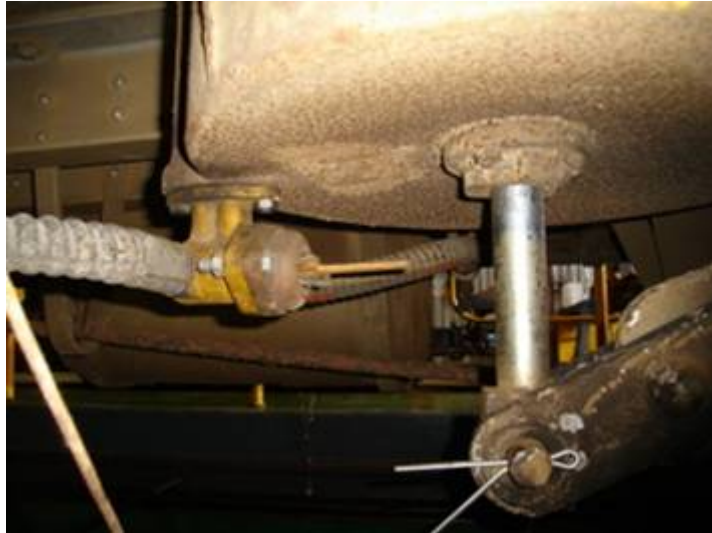
Wouter stripping the vacuum cylinder release valve to fit a new one.

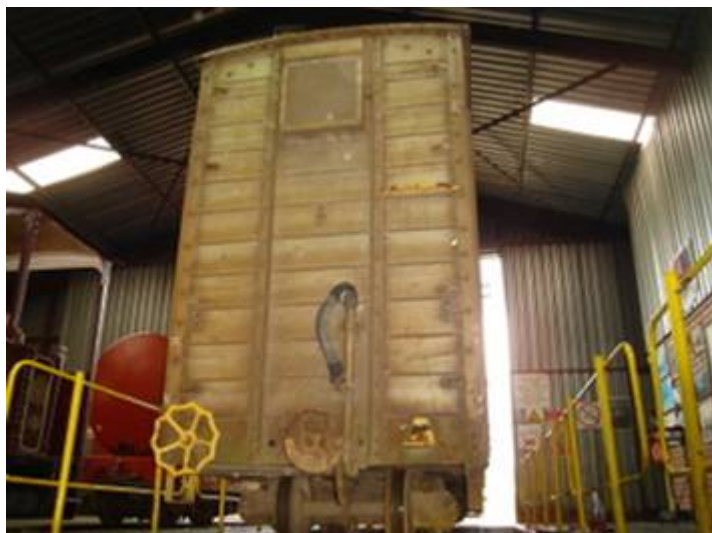
The brake efficiency test was performed.

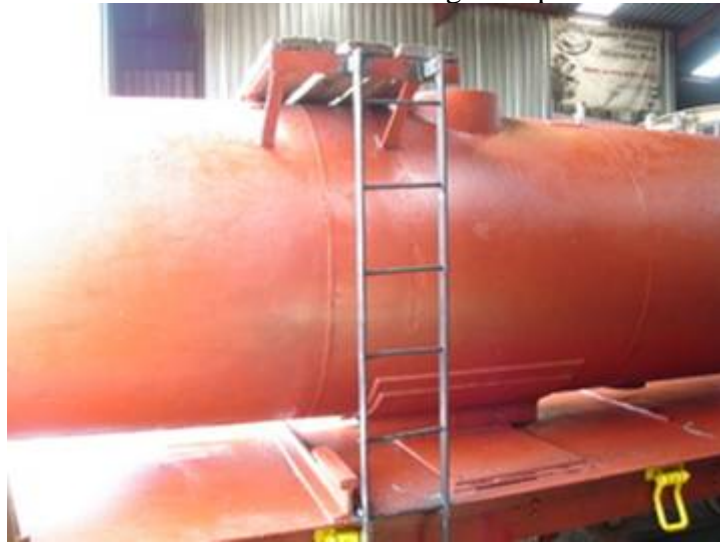
The new made XC wagon steps.

The second XC wagon side steps were welded onto the second Xc this week and now only needs to be painted yellow.

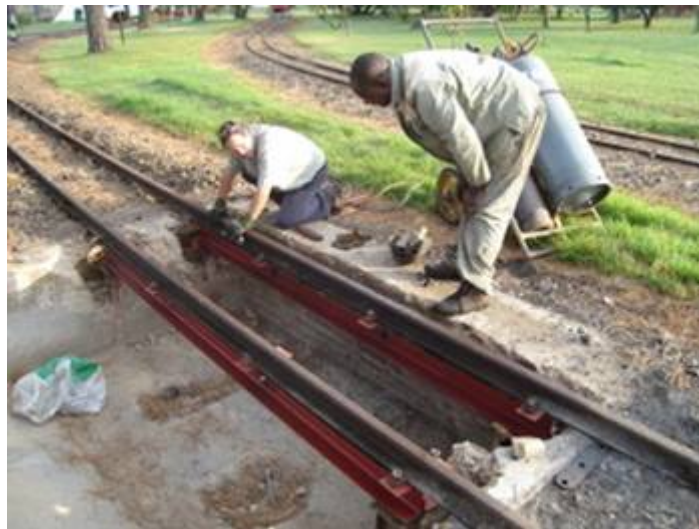
The rails being fitted back with the new beams in place.

The ash pit beams in Hoekfontein were removed and the new beams were fitted. The rails were fitted back and the supports were welded. Len Hudson will now throw the new concrete blocks around the supports.

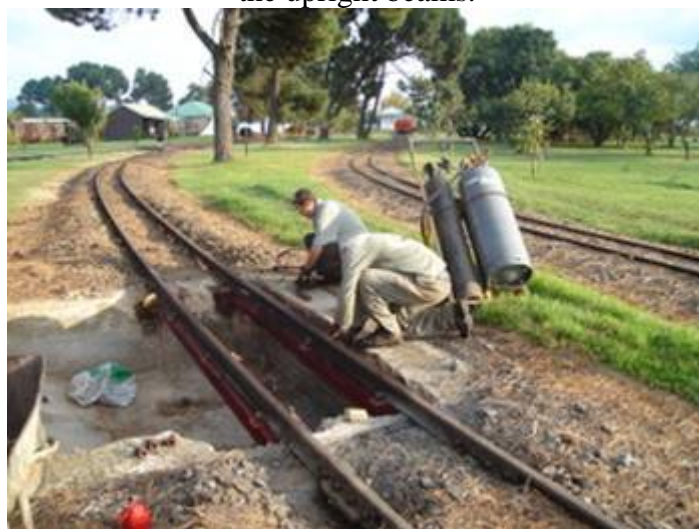
Henk and Petrus securing the rails on the beams, now only needs the concrete blocks around the upright beams.
