1). THE LOCOMOTION COACH NO.25282: (AND SOME HISTORY!)

The 'Locomotion Coach', along with her long time friend and partner, the 'Sandstone Sleeper', have quite an interesting history. They were once coupled together on a plinthed set of rails and formed a railway-themed restaurant, bar and a hotel complex at Weenen. Ahead of the two coaches on their Cape Gauge rails, was the 2ft narrow gauge NGG11 Garratt that once worked the Weenen-Escourt line. The locomotive was driven by a fellow called Billy Bester (Deceased) who, with other local people, had a passion for the railway scene that was passing away. The hotel was Porky Cunha's dream but other people were quite enthusiastic and poured much of themselves into the project. In return, they were remembered in the décor and with the menu – back in the days when R25 could buy you a full steak dinner! (I have the menus to prove it!)

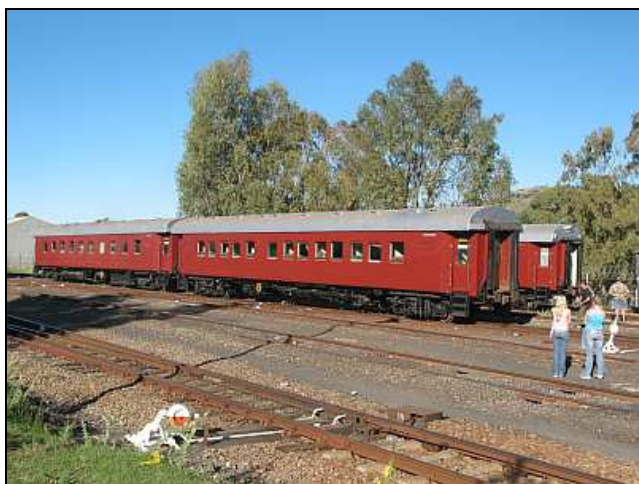
L01 – C.O.D. (Coach on Delivery.)

The 1972-built UCW 2nd class sleeper coach No.28332 (Foreground) and the 'Locomotion' coach, are being shunted on the tracks in front of Sandstone Heritage Trust's storage shed at Ficksburg. (Since dismantled and moved.)

This picture was taken 7th October 2007. The coaches had been repainted and the roofs 'silvered' as the paint work had degraded before coming into Sandstone's possession.

The Sleeper has since been repainted to match the old SAR scheme but the 'Locomotion' has not. Since the old restaurant coach will likely as NOT be used on photographic tours and trips, we are not in a hurry to repaint the coach to match the rest of the rolling stock.

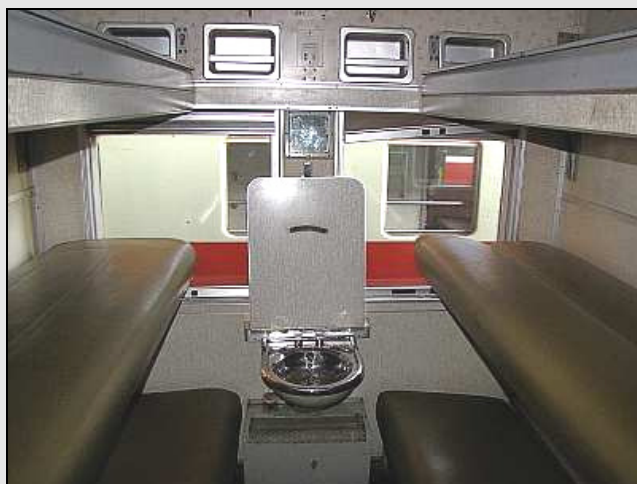
L02 – Bunking History.

This is a typical interior shot of No.28332, the coach we now call 'The Sandstone Sleeper.' The interiors of the coach compartments are in very good condition with the SAR-era fittings intact – including the mirror, the shaving plugs, the night-light circuits in the cabin lamps, the coat hooks, ashtrays and the sliding hooks in the luggage racks.

Like most of our coaches, the center bunks usually run reclined flat against the wall. Seeing a six-bunk set up like this is rare, even at Reefsteamers.

One thing railway writers don't note is that the window seat in an SAR coach is somewhat uncomfortable because of the location of the steam-powered heater under the sink!

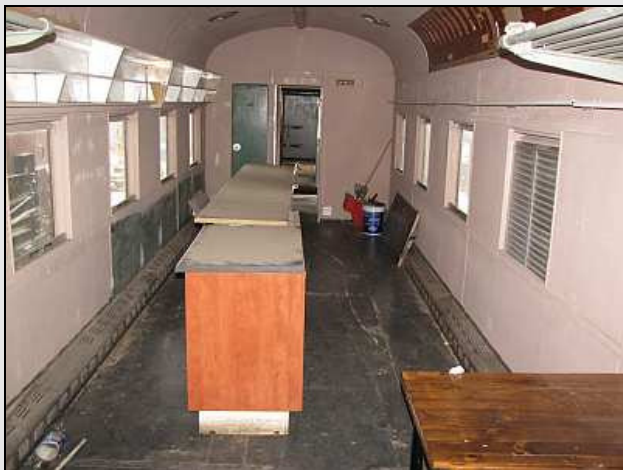
**L03 – Bar in Bits.**

The Ekurhuleni Council made a half-sewn pig's ear out of this coach when they removed the bar's partition wall and half the bar. This bar was called 'The Puffing Billy Saloon.' They gave up when trying to move the massive insulated shell of the under-counter fridge. Ex-bar man Sid Cunha recalls that the custom-built fridge (for the narrow doors) was installed first and then the bar was built around it!

They aren't coming through with the rest of their deal – so we're taking over. The shell of the old bar has been removed and has been replaced with the full set of laundry cabinets from the ex-Setimela Tours Generator Van. They still need to be fastened down. These units come with a full set of fitted doors, which saves valuable time which would have been wasted trying to recommission the old bar.

This coach end is to run as a combination tuck shop / kitchenette unit, as well as a primitive bar when necessary. It will eliminate the inconvenient and potentially dangerous queuing that occurs in the narrow side-corridor of No.127 'Kango' the Kitchen coach – which was designed as a catering coach and not a tuck-dispensing chuck wagon.

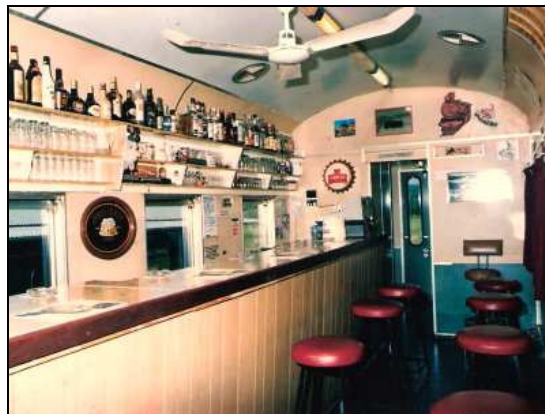
**L04 – (Above) The Puffing Billy Saloon.**

Here's the 'Puffing Billy' in it working days. The bar end was connected to the coach that we nowadays call 'The Sandstone Sleeper'. It was a great idea as people could drink themselves silly at the bar, weave drunkenly through the gangway and flop straight into bed to snooze the booze away! The Puffing Billy Saloon was actually marketed as a Ladies Bar – but the males frequented the stools too. ☺

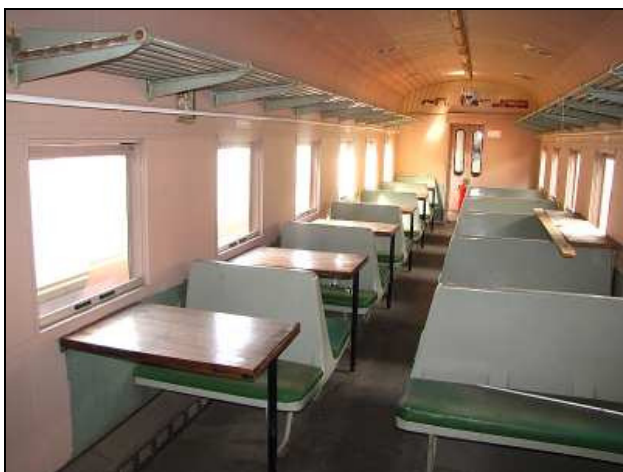
**L06 – Tables.**

This section of the coach had tables fitted on both sides for meals, but those on the long seats had been removed. We will probably be refitting them, or converting this area to sofa-style seats. The extra curtain rails have survived.

Historical Fact : The original tables and the old bar were made in a COFFIN factory owned by a fellow called Taffy!

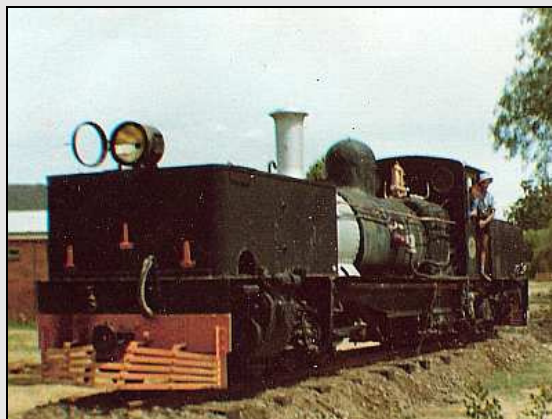
**L12 – The actual Lilliputian.**

Here is the titular NGG11 Garratt having just been replinthed at the new site before the two coaches arrived. There were 5 of these locos built, but this is one of only two built (April 1925) with piston valves and a superheated boiler. No.55 was retired in 1973. The coaches came by rail from Pretoria (Sleeper) and Welwerdiend (Restaurant) to Escourt and were then flat-trucked to the hotel's site.

NGG11 No.55 'Lilliputian' was restored by Lucas Nel at Bloemfontein (Sandstone) and now works on the Paton's County line although she no longer bears the name.

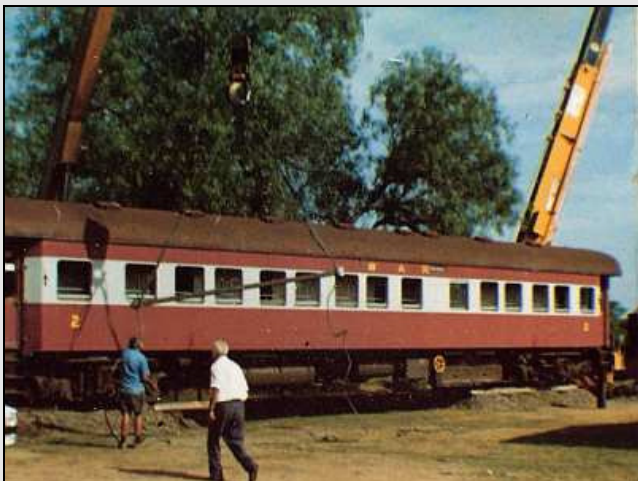
**L13 – Clumsy!**

This particular lift was properly done with spreader bars and two 30 ton cranes. But at some time, probably when the complex closed, the coaches had been clumsily lifted.

The parts on the frame to which the chains were attached are actually jacking pads and were not designed to bear the weight of a suspended coach! One has turned away from the frame like a torn toenail and bent outwards through 90 degrees. It needs to be cut off and a new jacking pad fabricated.

Notice the strange angle of that bogie on the far end? Check out the following picture to the right.

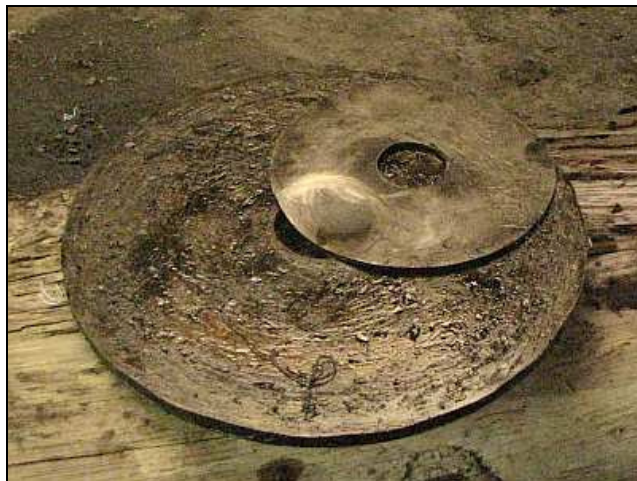
**L14 – Shift.**

We have been working on the suspension and the brakes of the 'Locomotion' coach – to get it to main line standards

Here's one of the reasons 'the 'Locomotion' listed badly to starboard. During one of the lifting operations, the spacer washer had slipped off from the bolster pin, and got caught against the bearing pad by the descending coach. The spacer then popped out to the side instead of tearing or punching through.

This was found at the bar end. The restaurant end was worse because it had TWO such spacers, and both of them had popped out!

The shorter triple coil springs that were fitted to the Caboose on Saturday and then removed, were fitted to the bogie at the restaurant end of the 'Locomotion' coach to bring the excessive ride height down. The short-spring exercise worked and both the coach and caboose are now in spec and able to couple in safety. The shorter but triple coil spring sets have the resilience to support a 40 ton coach.

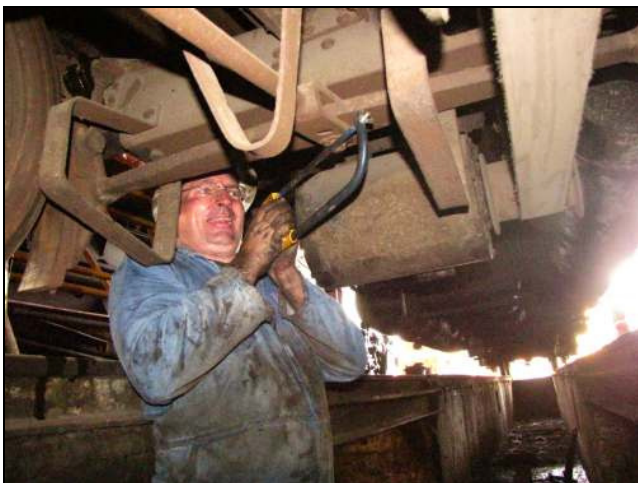
**L15 – Splitting stuff.**

The 'Locomotion' coach had to be lifted off its bogies for inspection because of the starboard list. And although not a problem on the coach itself, the bogies were fitted with 'outboard' brakes rather than 'inboard' brakes as our current coaching stock does. Outboard brakes are sharper but harder to modulate, so this coach would have tended to brake early in a Reefsteamer consist, or possibly even skidding its wheels, before the train manages to stop.

Aidan is pictured stripping the entire bogie brake system.

Aidan wasn't up to wrestling with a chewed-up split-pin and decided to just cut the head off instead, and improvising half-baked inverted hacksaw strokes. The brake rigging on a typical rail vehicle is literally held together with loose-fitted pins, which are retained by split pins a-plenty!

The 'Locomotion' coach now needs to have the brake rigging replaced and the vacuum cylinders need to be stripped, inspected and serviced if necessary. As per the rest of our stock, the coach will then need to be put on the books, and the frames + cylinders marked with the inspection dates. Mechanically then, the Locomotion coach should be complete.

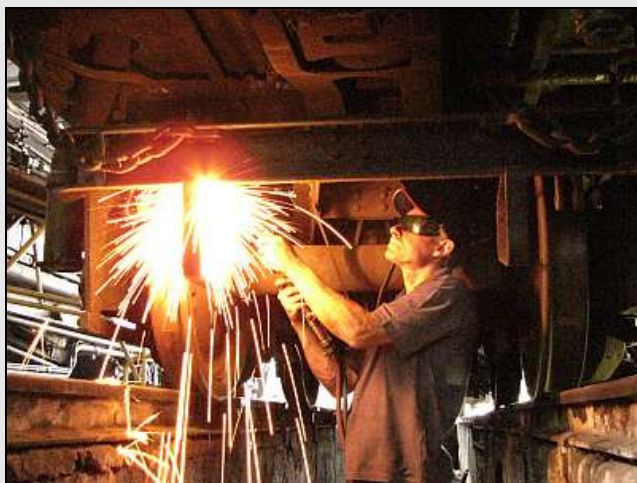
**L16 – Cut-Down.**

This bogie had been fitted with both inboard and outboard pivot eyes on the frames, so refitting the modified brake system wasn't such a big deal. However, the safety straps that are positioned to catch the rods and beams should their connections fail, all needed to be removed.

Andrew King is pictured removing one of the safety straps that originally protected a brake beam hanging outside the wheel.

The freshly cut-down material was reheated and re-bent to make new brackets for the new configuration, using the pit rails as an anvil and the blow torch as a forge. This particular strap ended up on the outboard pull rod.

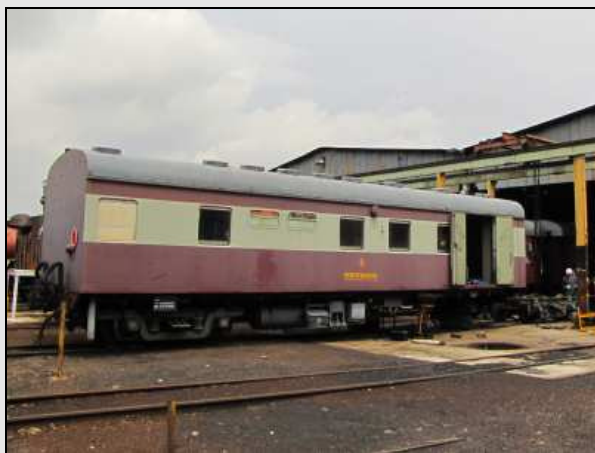
**C01 – Hup!**

After several years of standing idle, the last major trip being the Dave Rogers tour of 2007, the old Works Caboose is being refitted and tuned-up for regular service once more.

It will serve as the generator van and crew quarters for the day-trip train, and the existing Staff and Baggage (S&B) van, with generators, will then be allocated to the sleeper train. This will allow us to run day-trips and longer distance sleeper-train pics at the same time, or to hire out our sleeper train coaches.

Furthermore, the caboose is a bit lighter than the full lengthed S&B van, which saves a few scoops of coal. Crew quarters are for bunks for footplate crews and there is a full size table ideal for the Train Safety Officer and all his papers. There isn't much room for other staff and visitors but they shouldn't be in the Caboose anyway.

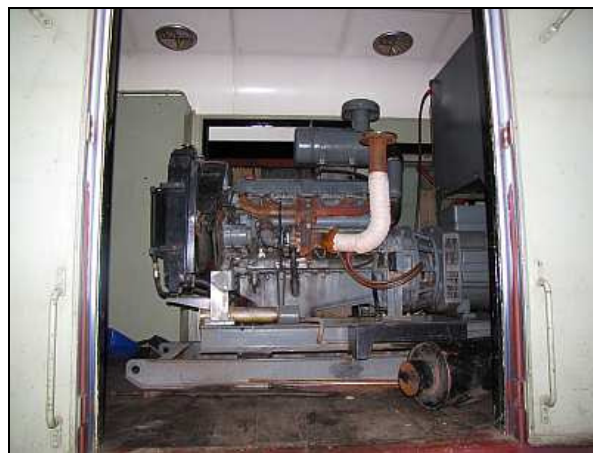
**C02 – Genny-rous.**

Here's the recently donated generator resting on its skids in the store room at the corridor end of the caboose. This machine was very kindly donated by Diesel and Electric and the arrangements were made by John Dunne.

The alternator, fuel tank and control panels have been installed. The wiring remains to be done, and the engine's exhaust system remains to be connected. (You can see the waiting silencer on the floor in the foreground. (The exhaust was connected 26 March)

The alternator is a 63kVA unit and will be more than ample for the day-train's pumps and lights, as well as the electrics of the bar/snack coach. The engine is a six cylinder turbo diesel with 1 litre displacement per pot. Governed speed will be a conventional 1500rpm for 50 Hertz output.

The new exhaust system has since been fitted to the caboose's engine room and the generator set has been started up. The engine appears to be slightly worn as there is some blue smoke being emitted – but it's not at all serious and the engine runs well. We are not yet certain whether the oil burn-off is from the rings n' bores, or from the seals within the turbo charger. The speed governor works and the generator is electrically functional – it was generating electricity on float and the output was around 52Hz. Not bad for an unloaded generator.

The engine was claimed to have been recently serviced before being retired by a more modern unit. The claim appears to be true as the oil was clean, as well as the various filters. The engine will run on a light load as the estimated power consumption on the day trip train is only about a 1/3 of what the generator can supply when 'maxed out.'. When the generator runs unloaded, the engine actually runs too cool. This engine and generator combo should have long, trouble-free service.

The fan caught us by surprise as it pushes air through the radiator instead of pulling, as we were told. No ducting is to be fitted initially. For ventilation, the double side-doors will be fitted with tie-back hooks, and the open doorways will be gated with expanded mesh, just as was done in the existing Staff and Baggage van.

This generator set was built a stand-by generator rather than being intended to provide plant power. Thus, the control box has quite a complicated mains-to-backup change over and monitoring system, none of which is needed. Most of it will be bypassed and removed. We're going to ask John Dunn to help us connect up the wiring.

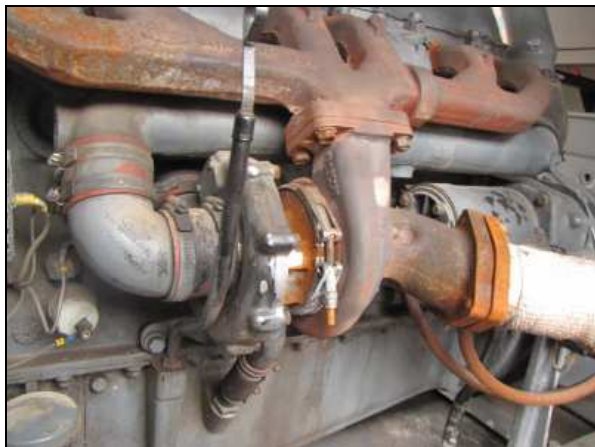
**C03 – Cool? Not.**

C03 – The 'new' genny is a Ford Ind. Turbo Diesel. I rather like Ford Turbo Diesels for some reason. This one is a bit primitive with an ambient cooled turbine housing, although the engine does have a separate oil cooler. The turbo spindle's bearings are pressure lubricated. That chunky exhaust manifold is gonna be great for trying out engine-cooking ideas from the 'Manifold Destiny' recipe book!

All that bare-baked metal is going to give off a lot of heat, which, as well as the radiator, oil cooler and silencer, will make this room rather warm.

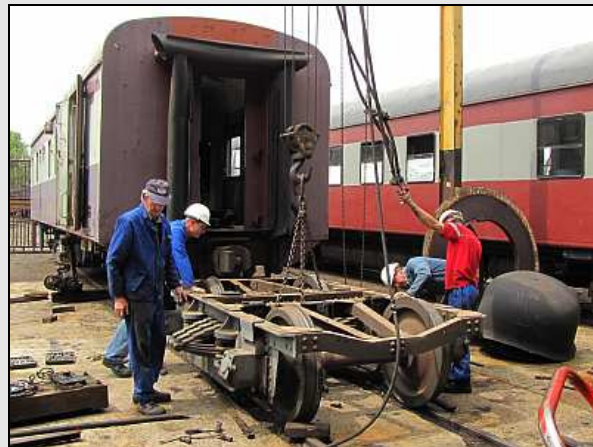
**C04 – Springing the bogie.**

The work caboose had always been riding a bit low at this end, but the sagging problem was exaggerated by the weight of the newly installed generator set.

These fellows had just boosted the suspension by installing an inner springs into the double coil springs of the primary suspension. The caboose will now run with triple concentric coil springs on this end, as do full sized coaches with this bogie design. However, where the coaches have four sets of leaf springs, the caboose only has three.

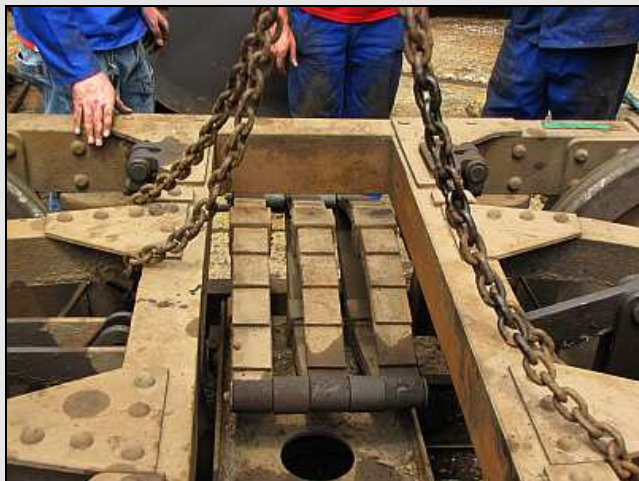
**C05 – Bolsterless.**

Front the point of view of jacking the bogie frame up and away from the equalizer beams to swap out the coil springs, the steel-clad wooden bolster beam did not really need to be removed.

However, with the nasty surprises that we found lurking under the Sandstone Ex-Locomotion Restaurant coach, the entire suspension was checked here anyway. It was also rather dry and the springs appear to have gone a bit soft – but nothing untoward was found.

We took the opportunity to grease up everything anyway. I went through two oil cans of MH on the links, pivots and the axle horns

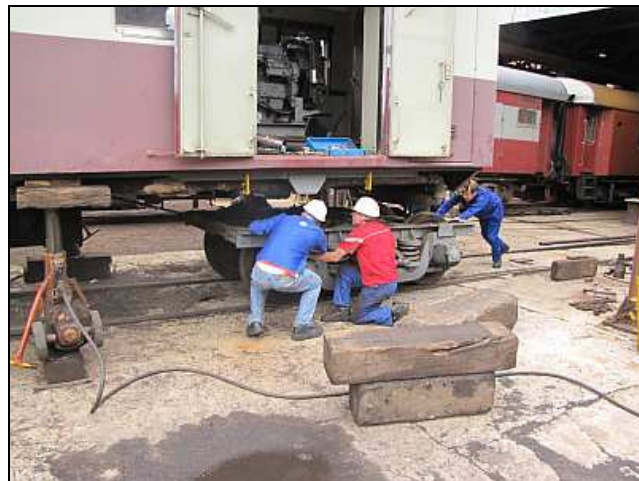
**C06 – Roll Back Plan.**

We couldn't get the leaf springs to engage the bolster spring-pads without weight on the pivot, as the bolster beam just kept moving sideways with the displaced springs.

So we rolled the bogie back, settled the caboose and then realigned the elliptic springs with an angled hydraulic jack. The job was done in less than 15 minutes, excluding reconnecting the brake linkages.

The ride height was much improved although still about 1.5cm low. Longer springs were found from stock and so the caboose's bogie tediously rolled out to be 're-sprung' all over again. The longer springs worked to bring the ride height to specs and only two concentric coils were needed per set.

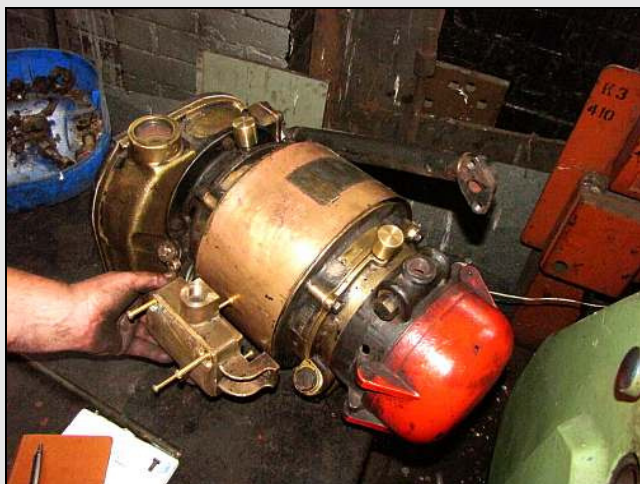
**T01 – Brass**

James Thomson is the Stokmo specialist, now primarily working on Dynamos and Stokers these days, as we try to keep one of each ready as a spare. He's been having some extra some fun with this S Stone-built machine though, as he has gone to some effort to polish back to the naked brass.

James is wrestling with getting those old studs out of the drive pulley ... with vice grips. New studs will thus definitely feature on the parts list.

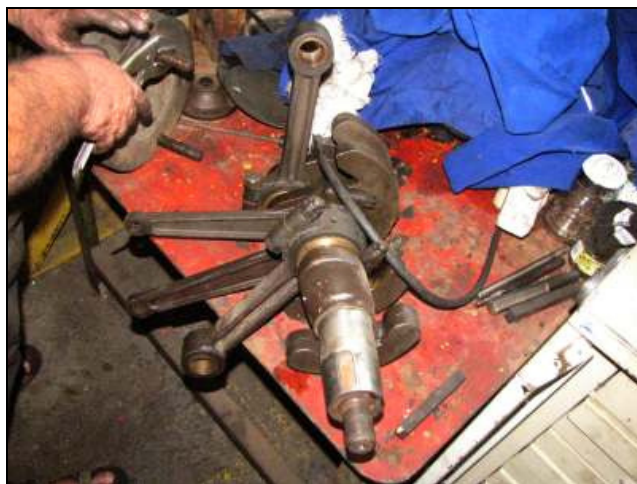
**T02 – A new start.**

James starts a new game, stripping down a spare coal mincer for a rebuild. This is according to our established spares components policy.

What looks like a set of Cylon bagpipes is the crankshaft, complete with the two connecting rods and the two eccentric-driven valve rods.

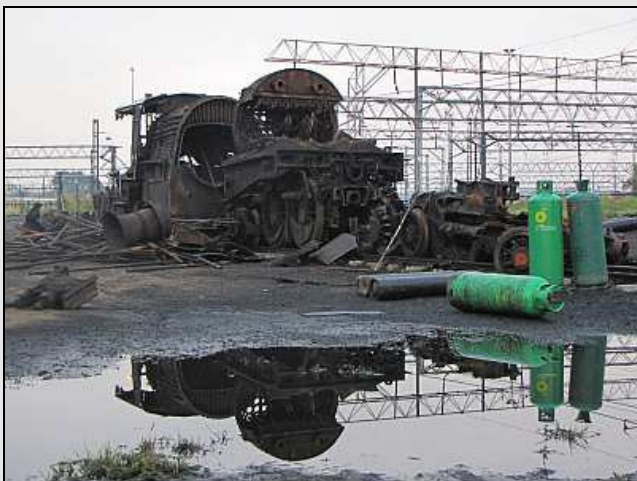
**G05 – Indecent Burial.**

A late picture – the torched-and-quartered remains of the privately owned GMAM 4148 (Tweefontien Colliery No.6) in the corner of the western coach yard on Saturday morning, 26 March 2011. There is actually still a thin strip of the boiler barrel holding the two halves together.

Although this stripped locomotive was uneconomic to store and repair, it is still sad to see even a bombed-out wreck finally go down to the torch. But if you catch a scrapping operation in time with the camera, you can catch some educational real-life cross-sectional views.

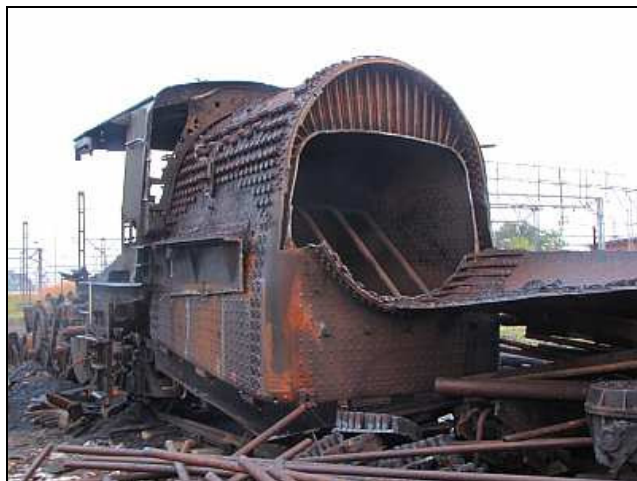
**G06 – Educational.**

Here's one of those educational views of the sectioned firebox and its hundreds of stays. Closer examination shows the special riveting and the foot-braces for the boiler shell where it joined the firebox. Unusually by this stage in scrapping, the fire arch tubes are still intact.

I hadn't realized that the GMAM has sharper corners at the crown sheet rather than the taped 'eaves' of the 15F. Just look at that commodious steam space! And the narrow water spaces at the sides – compressed in width due to the characteristically wide boiler barrel.

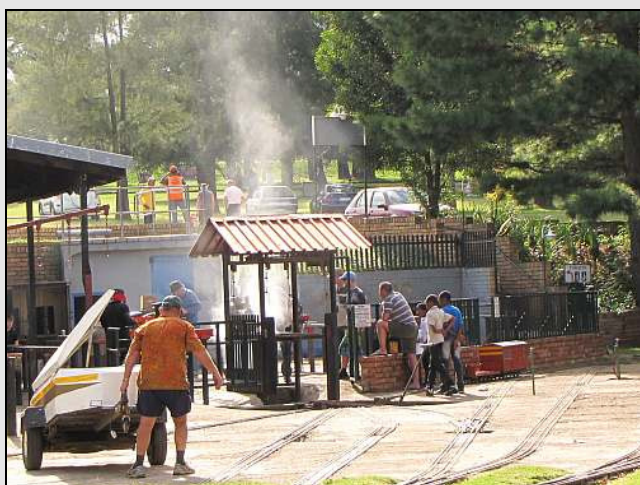
**F03 – Blow Down.**

Even the little engines are capable of making quite a steamy fuss when being decommissioned. This one is being blown down in dramatic fashion on the clinker, er, ash track.

Other fellows, including myself, fill the boiler as much as we can (or until the injector fades out into prostate-strangled dribbles.) and let it cool down naturally over the dropped fire. It is more gentle in terms of de-stressing the boiler, albeit, not so visually interesting. But if that practice is adapted, you need to remember to do a blow-down on steam-up.

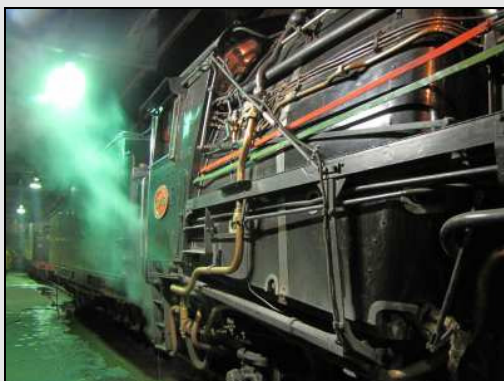
**M01 – A bit too much atmosphere.**

It looks as if the Sellar's valves need lapping as both injectors exhaled steadily through the night. Coupled with the steam leak on the left side, it didn't do the water level much good. But it did add much to the atmosphere – especially as 'The Fitter' didn't pay me a visit this night.

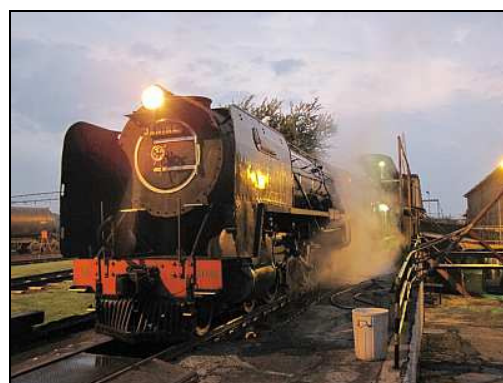
**M06 – The Wake-Up Shake-Up.**

The great grate shake-up is almost done. The thick fire had burned down to a soft ash, but Andre was making a combination training and economy exercise of salvaging the unburnt coal at the front end – with trainee Hott-Nutts Hoddinott on the cooler end of the pricker. The cab was getting a bit crowded with that pricker swinging around, and I was tired and bit discouraged, so I just walked off to photograph the post-mortis remains of GMAM 4148.

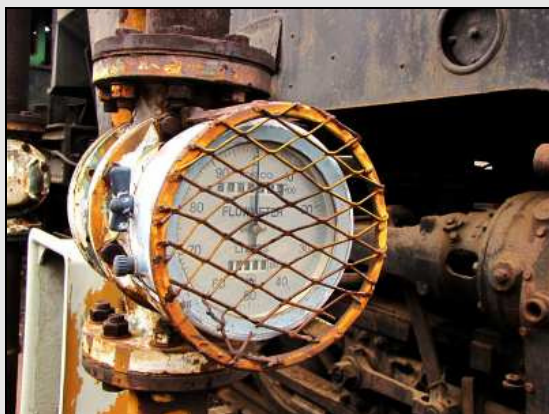
**K03 – Meter.**

One of the few surviving facilities in the yard where so much was cut down, the diesel fuel dispensing meters still stand. That's the GMAM 4148 in the background, and behind the doomed machine is the plinth where the local diesel tank once stood – which is now the site of our library.

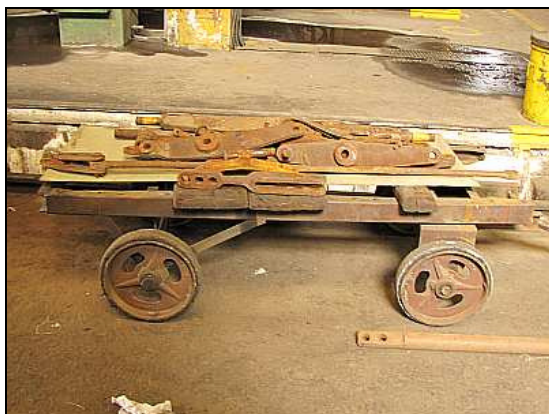
**K05 – Brake Wagon.**

This is one brake wagon that has no braking power whatsoever! It carries a choice assortment of 'precision engineered' coach brake rods, adjustable links and relay rods, gradually building up from the recent bogie mods and swap-outs. These will go safely into the parts store.

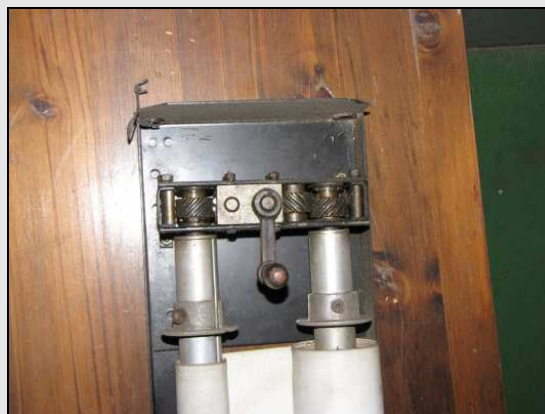
**K06 – Geared up for 'Bloemfontein.'**

Something not often seen; the gear drive of a roller destination board. That 45 degree helical drive pattern is normally engineered to reduce gear tooth contact pressure and for a quieter drive. Here, it is cleverly and compactly used to rotate the drive axis from the crank handle.

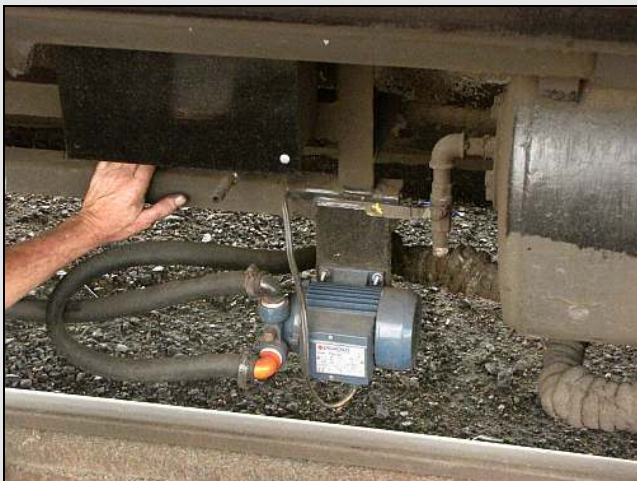
**F07 – A bad pump job.**

Here's a bad piping job discovered on the sleeper train while it is under assessment and tuning for service during the year. Those flexible pipes are not rated for the pressure of the receiver tank, and would almost certainly rupture if the pressure switch stays on.

It would make the trip fun for the passengers as the pump would then just continue to run and helpfully pump the coach's entire water supply out into the ballast, while their taps and showers remain dry and the toilets become rather fragrant.

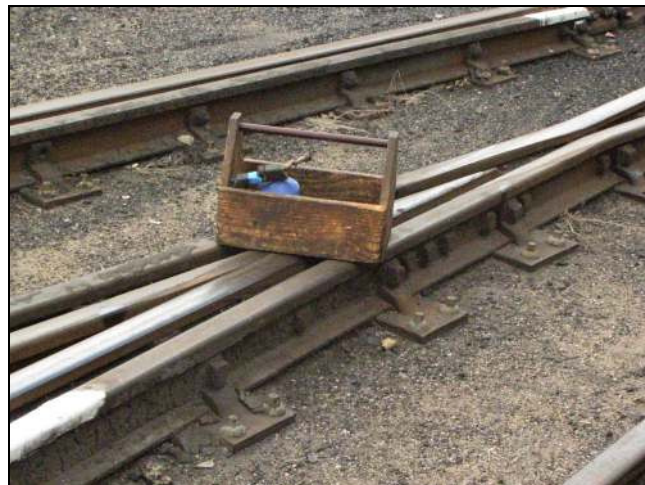
**F08 – Flat Frog.**

Peter Labuscagne's old fashioned tool box tells a story as it sits innocently on a point-frog out in the yard. That's a blow torch in there – which means he has been working on copper piping with brazed joints. (e.g. Coach plumbing.)

On long distance trips, the most unreliable vehicles are not the 14-wheel clankers but rather the coaches. And on the coaches, it is the plumbing systems that give us the most issues. A part of the problem is that they only run a few times a year so the weak links, or perhaps areas of poor workmanship, are not put to the test.

We are hoping that with the sleepers running a bit more often, the weak points are gradually repaired and the plumbing system, apart from freeze damage or theft, don't keep 'tuning us grief' as the Afrikaans people say.
