1). INTRODUCTION :

With the 12AR chugging around out on a Magaliesburg day trip, the depot was fairly quiet with 5 people at work. All of the action was centered on Sandstone Heritage Trust's 'Locomotion' coach with continuing work on modifying and servicing the brake system. The one exception was Robbie Davies-Hannibal, who was in orbit and patrolling the electric fence for niggles, before his orbit decayed and he came in to land by the coach team.

3). 'THE LOCOMOTION COACH' – CARRIAGE AND WAGON WORK :

4). 'THE LOCOMOTION COACH' – BRAKE WORK :

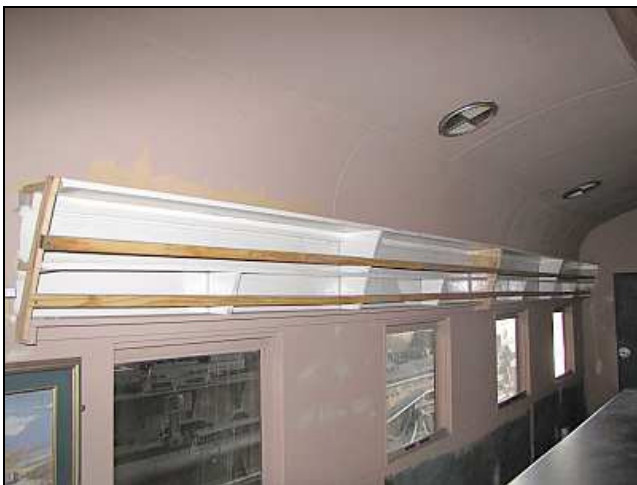
**B01 – Barred.**

The shelves that saw such good service in this coach end's 'Puffing Billy Salon' days are to be retained. Shelf runners have been fitted to protect the contents from falling, as this coach will be in motion rather than standing static as it did for so many years. An end-panel needs to be cut out and fitted to the nearside end, as this is where the partition wall used to be between the bar and the 'Lilliputian' restaurant.

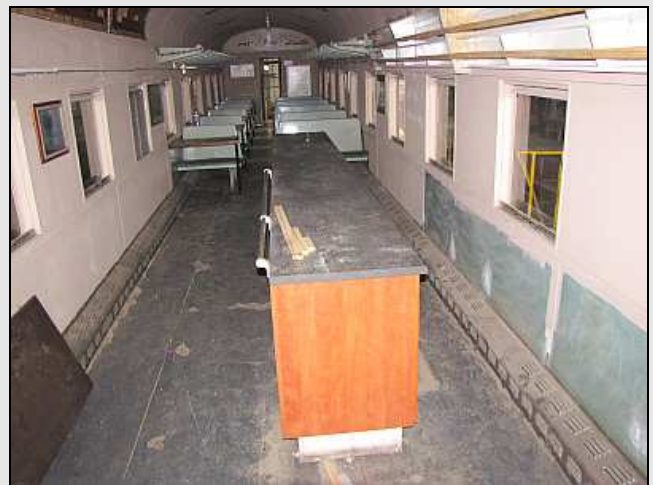
**B02 – The bar has landed.**

The cabinets have now been aligned and bolted down. The various doors have been refitted. These once served as an on-board laundry's counter in the service coach of the defunct Setimela Tours company.

The paintwork in this coach is now dreadful, a pale pink paint that we suspect is exterior grade Crown Microtec™ or something similar. Apart from the roughly brush-painted finish, the paint itself has dried to the rough texture of a lion's tongue. It's a good built-in self-defense mechanism to keep the walls clean as if you are unfortunate enough to rub up against the walls, you lose some skin n' surface hair.

The whole coach interior now needs to be sanded down smooth and repainted to our standard two-tone brown.

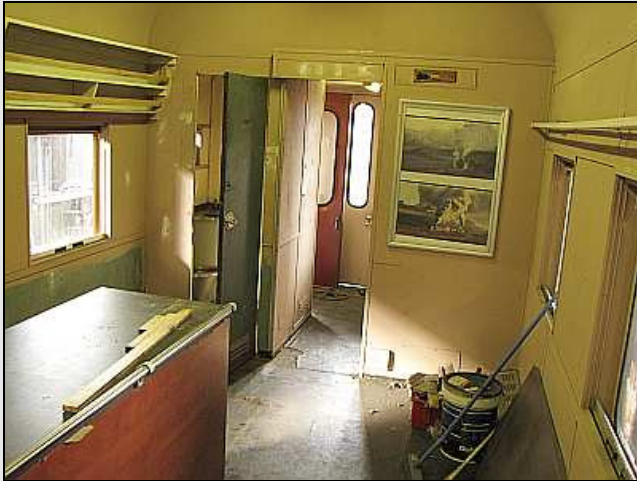
**B03 – Service End.**

The extra gap at this end of the bar is to be occupied by a free-range chest freezer ; said well-travelled freezer originating from Management Coach No.42 and presently serving in the S&B van. The freezer, with the thermostat dialed down, will be for the drinks and have the advantage of giving us a flat top to work with when it is not being used.

Both of the toilet compartments are to have their intact fittings removed and stored. The left compartment is to be converted into a little kitchenette, while the right side toilet will be converted into a store room.

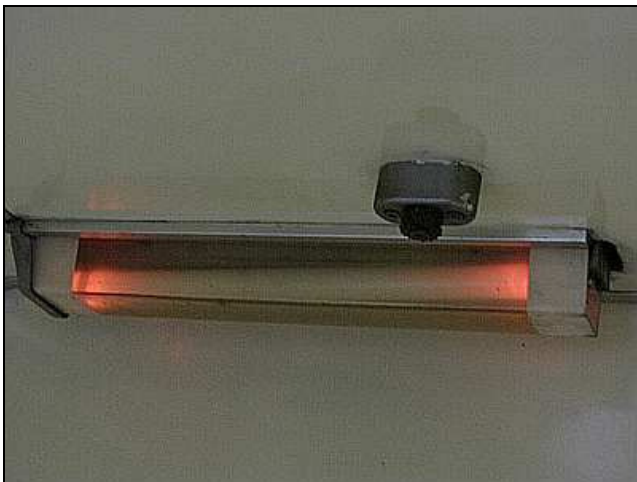
**B05 – Dark Light.**

They missed this one out though. This dud hot-cathode fluorescent lamp in the future kitchenette didn't have a trace of a flash in its tubular self. Looks like starter failure.

I hadn't seen a light fitting quite like this in an SAR coach's toilet before though. Normally the diffuser is a quadrant cross section and the entire lamp is mounted at the juncture of the ceiling and the wall.

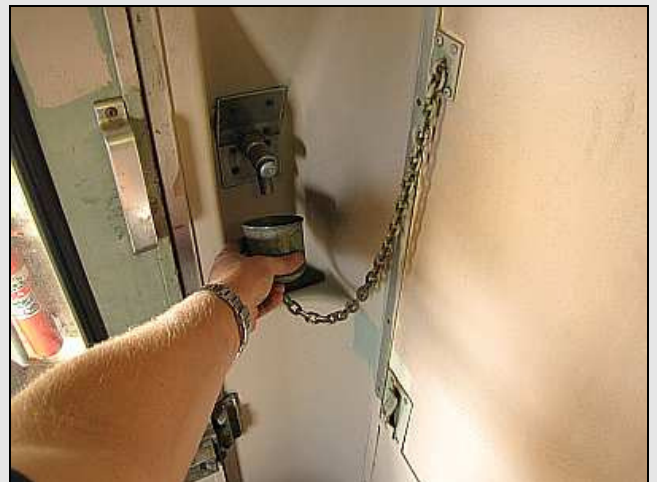
**B06 – Trust Me.**

Here is a bit of the coach's history that will probably need to be removed. This coach came from Sandstone still fitted with original pressed-steel communal drinking cups still intact within both vestibules. In these days of bodacious bacteria and vivacious viruses, I don't think they are going to be a popular and trusted feature!

Notice the matching cup clip on the end wall.

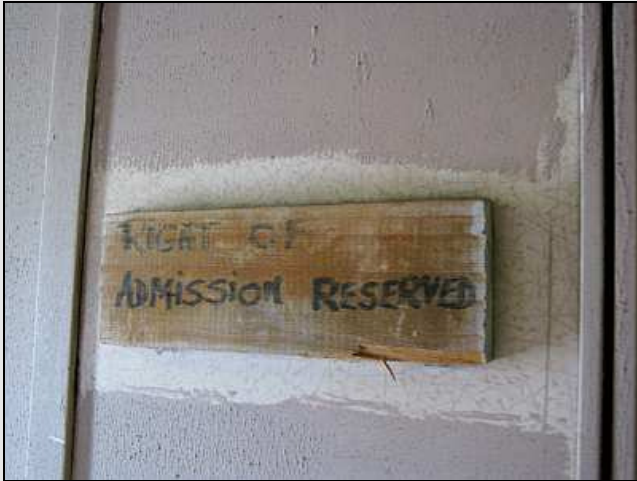
**B07 – Cunha Humour ***

In keeping with the wood plaque scheme, here is an unusual and roughly-made home-made sign on the toilet door. This, er, 'heritage item' definitely has to go. However, you can see the already-mentioned rough texture of the paint work. We are gonna have to get the coach team re-convened and enthusiastically oscillating sand paper!

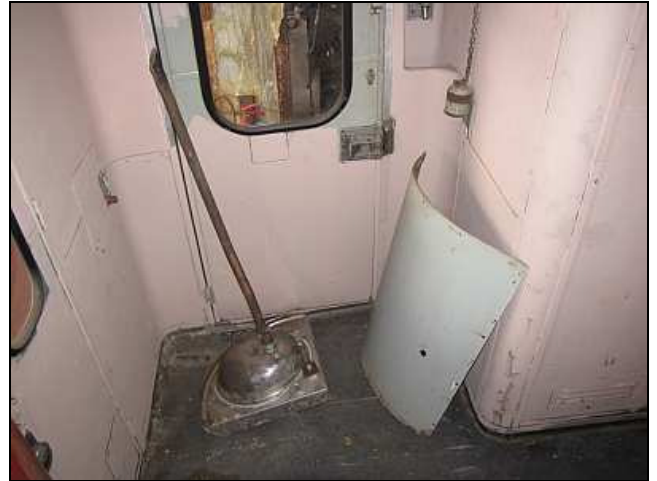
**B08 – Strip-Out.**

After a long morning chasing out short circuits and other gremlins from the wires of the electric fence, Robbie got going on removing this corner-mounted basin and the classic SAR-style quadrant panel. Except for the pipes, the whole thing is held in with wood screws. Notice that there is no water trap on the sink's drain – not necessary on a drain that discharges onto the ballast instead of a sewer.

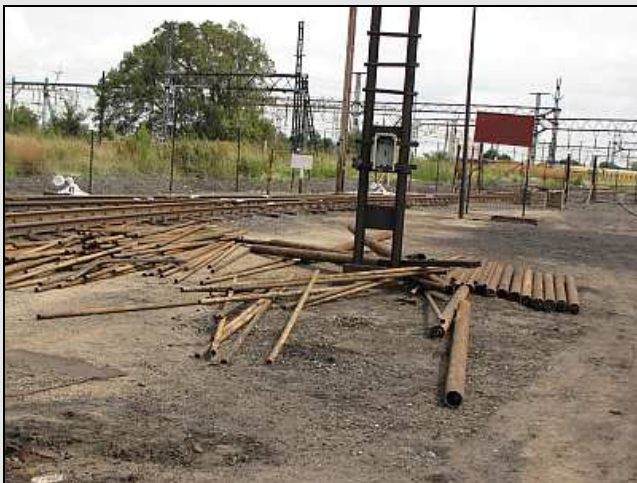
**G01 – Pickup Sticks.**

A few piles of mixed boiler tubes and flues are all that remain of Ian Welsch's GMAM No.4148. (Ex-Tweefontien United Collieries No.6) The locomotive was too clapped-out for economic restoration in South Africa – where there is very little financial support external to what the various clubs can raise themselves. It wouldn't have even been roadworthy to be railed out and anyone who wants to move a stripped 200 ton articulated locomotive by road (whether in one piece or in three) is welcome to contribute the funds!

These tubes have been set aside by the scrapping team upon request to be used as heavy duty tubular fence poles by one of Mr. Welsch's associates.

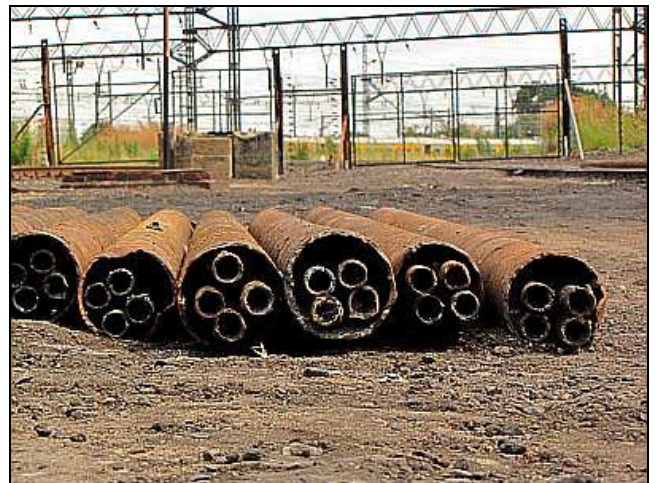
**G02 – Flue Sections.**

Here are sectioned views of the so-called boiler FLUES, as opposed to the smaller tubes. The four truncated tubes within are the tubes for the super heater elements. The bundle of four tubes is not actually physically attached to the flue in any way.

In practice, the super heater elements slide in a single 'bundle' out of the flues once they are disconnected from the headers up front.

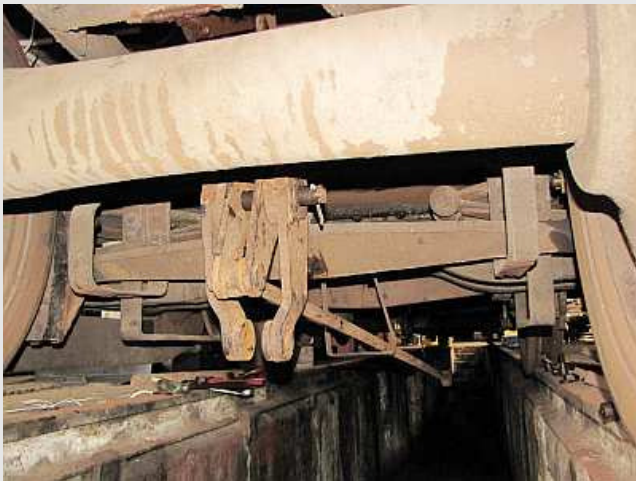
**C01 – Rigged.**

As per the other end, the brake rigging has been stripped and rebuilt to operate brake shoes on the inboard edges of the wheels, to match the rest of our fleet of cans. The job this end was a scalp-scratcher as several joints had holes that were too big for the original pivots. Larger spare pins were found but as they were hardened, they could not be turned down to fit. Sleeves had to be fitted to the pins to get them to snuggle home.

The brakes would have worked, but would have required excessive travel of the piston rod before applying – and the brakes at the other end would have applied first. Notice the new split pin. It is only on temporarily as we may have needed to strip the rigging again if clearances were wrong.

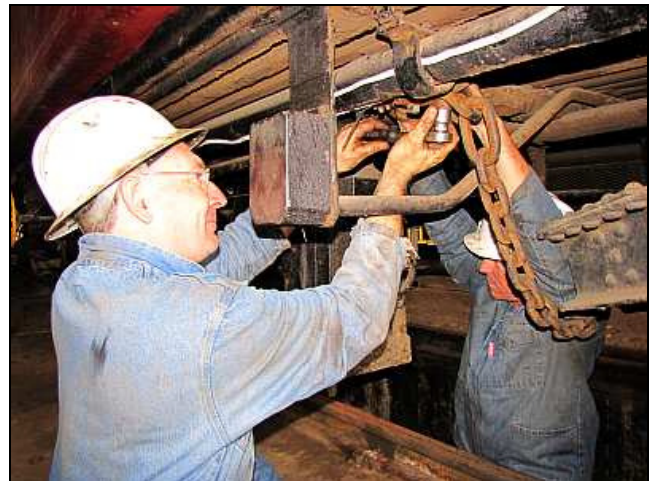
**C02 – Chains for Trains.**

The orig. safety chains were attached and tightly torqued. Aidan McCarthy is sitting comfortably cross-legged on the floor slab while Alan Lawton is holding the spanner on the nut while standing at almost full stretch in the loco pit.

These chains play no role when the train is calmly steel-wheeling along. But should the train derail, they help to keep the bogie attached to the chassis. A wildly twisting bogie may flip the coach or even punch through the floor.

The box in front of Aidan's dial is a hinged cover for a land-line link with screwed in terminals. This link is intended for DC power upon which the original wiring ran – the heavy gauge wires tell of the higher amperages used.

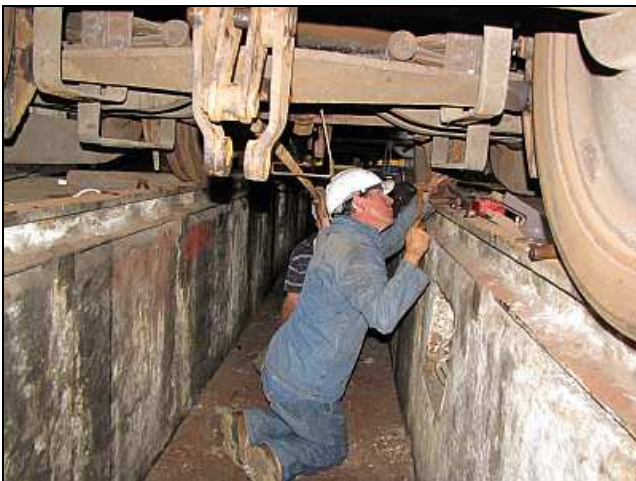
**C03 – Shoeing Up.**

Alan and Andrew, both being tough but short of stature, are the prime candidates for under-coach work. Alan is seen tapping a retaining spring out before changing out a shoe. The other end of the coach was fitted with new shoes while this end got good thick used shoes. The two systems for the bogie brakes are independent from each other.

Notice the many safety straps hanging underneath. The small ones in the foreground were cut off and re-fabricated to suit the relocated brake beams. This coach also has wide safety straps for the traverse leaf springs – something that is absent on a coil-sprung bogie.

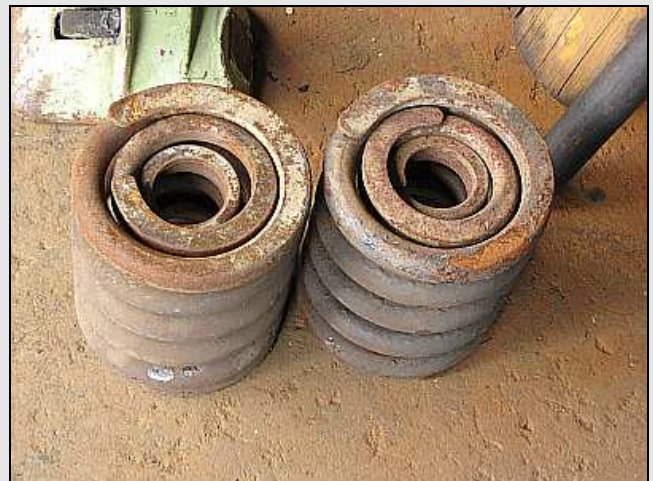
**C04 – Triple Springs.**

Here is a pair of triple concentric coil springs that had been swapped out from the primary suspension (Equalizer Beam) at the restaurant end of the 'Locomotion' coach. The springs that we fitted to the caboose to raise the caboose's height were insufficient to do the job. However, they later worked to bring the height of the restaurant end down to specifications. The twin washers removed from the bolster pivot helped matters muchly as well !

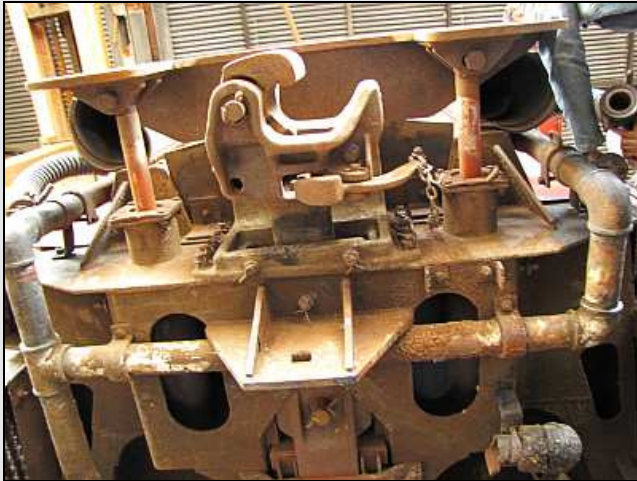
C05 – Up yer kilt.

Here's an underside view of the draft gear and buffer plate of this elderly coach. The actual buffering forces are taken up by the centrally mounted draft gear, while the spring loaded rods at the sides, that look like traditional buffers, keep the gang-way scuff plates together.

This bone-dry draft gear really needs some TLC, and some sanding mixed in with a few generous handfuls of graphite grease. The coupler itself will probably need shiming. But the greasing will likely be left for the C&W boys when the coach is no longer being worked on in the 15M shed.

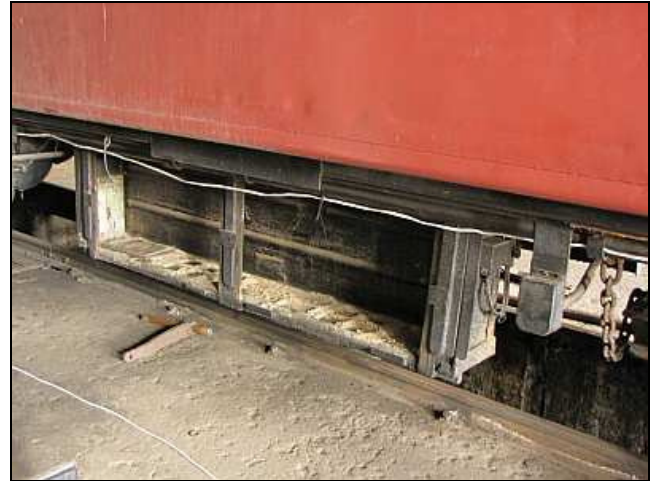
C06 – Crusty.

The fossilized external-bridge lead-acid batteries have been removed and will be going for scrap. That's almost a ton of weight removed from the coach.

The bent jacking pad at this end has also been removed. While it didn't affect the operation of the coach, it might have hurt somebody walking along in the narrow confines between the vehicles and not noticing a lump of metal stuck out sideways. It was also at risk of fouling a station platform.

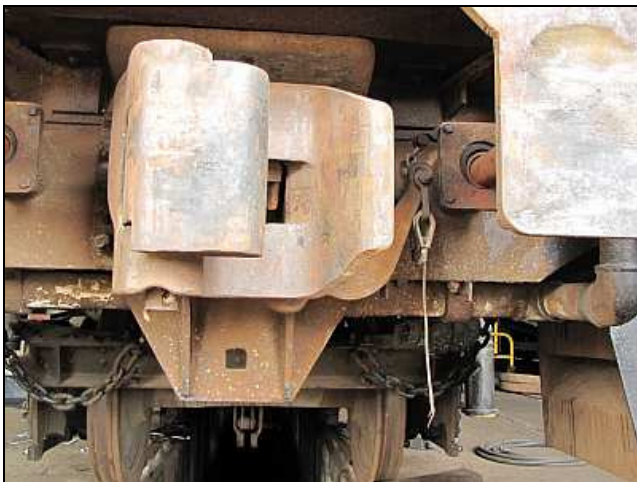
C07 – Cut cable.

Here's something that can hurt a shunter in their duties. The cut cable to the right of the coupler has frayed, rusted and eventually snapped. That means you'd have to get between the vehicles to set the coupler to uncouple by lifting the locking pin – or somehow cross the vehicles to get to the cut cable on the adjoining vehicle. (Said cable will automatically be on the other side.)

Passenger coaches are nasty for access to the lifting-lever as the buffers and the scuff plates cover the lever, whereas it is conveniently in the open on most goods vehicles.

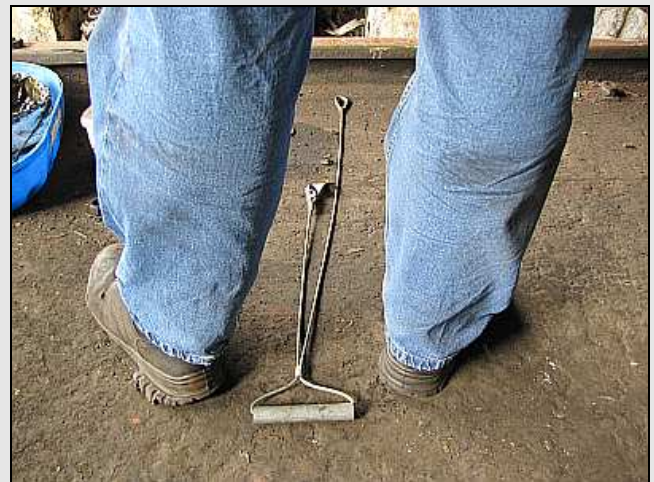
C08 – Cable Span.

Here's a new cut cable ready for installation while the brackets are being removed. We still have a good stock of ready-made cables. The tubular handle will need to be painted 'sunshine' yellow to satisfy safety requirements before 'Locomotion' returns to full service.

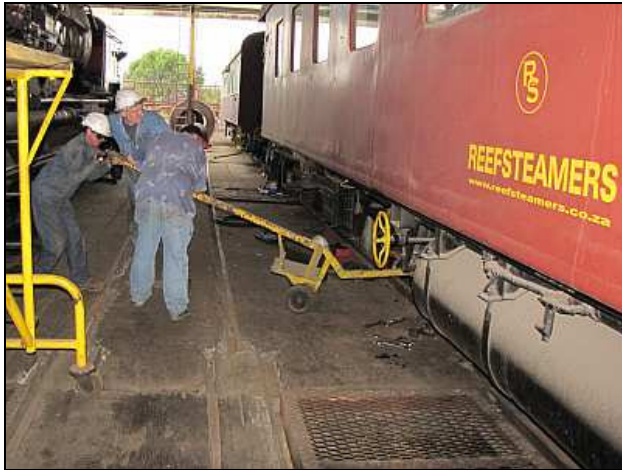
**V01 – Leverage.**

Getting the vacuum cylinders off is always 'fun.' (Putting them back is even worse.) The coach label shows who is nutty enough to do this on a pleasant Saturday afternoon. They should have put the big fellow, Robbie, on the end of the lever as the backstop instead as they did a little later. But even Robbie eventually ended up hanging futilely on the lever with his feet suspended in the air.

That wheeled lever cart had been modified in SAR days and the effort end had been lengthened for extra vertical reach – losing a lot of the vital leverage in the process.

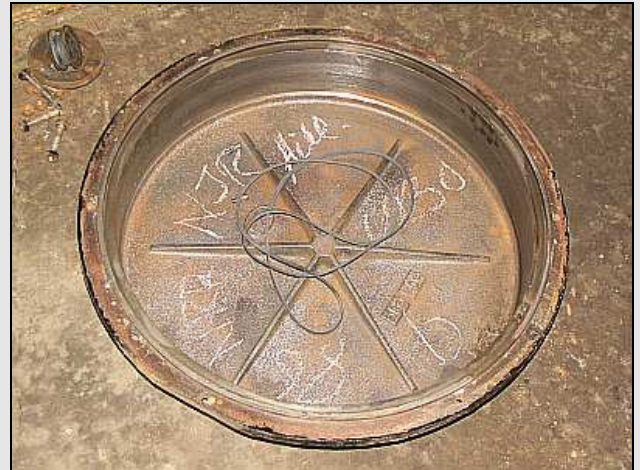
**V02 – Pan Lid.**

It looks as if this inverted cover was sourced from stores in September, 1986, but the other marks are cryptic. It's a bit odd to think of those engineering chalk scrawlings remaining intact inside the cylinder and hidden from view for 25 years. There is a very slight patina of rust on the unmachined surfaces on the cover – but as the cylinder and piston are 100% rust free, this must have been the preexisting condition. This is a 21 inch cylinder.

The o-ring type gasket in view needed to be replaced as this one was squished and had taken on an oval shape.

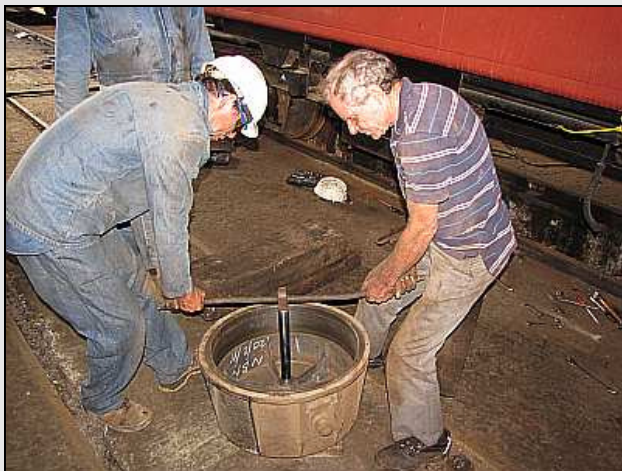
**V03 – Heave!**

The deeply-dished piston kept tilting and jamming upon attempts of withdrawal, so the piston rod was screwed back in and used as a tee-handle in combo with a short 'gwala'. I'm just about to stow my camera and apply my foot to the nearside pivot boss to hold the cylinder down against the stubborn tractive effort of the Lawking combination.

The roller ring turned out to be in good condition and the chalk markings on the piston indicate it was last inspected in 1991. As the roller rings are not natural rubber they don't crack with surface oxidation in stasis – as car tyres, for instance, do. The neck seal was in good shape (as the rod isn't pitted with rust, as often happens in disuse.) and the cylinder is rust free, so it just needed a new cover gasket and some grease on the bosses before being reinstalled.

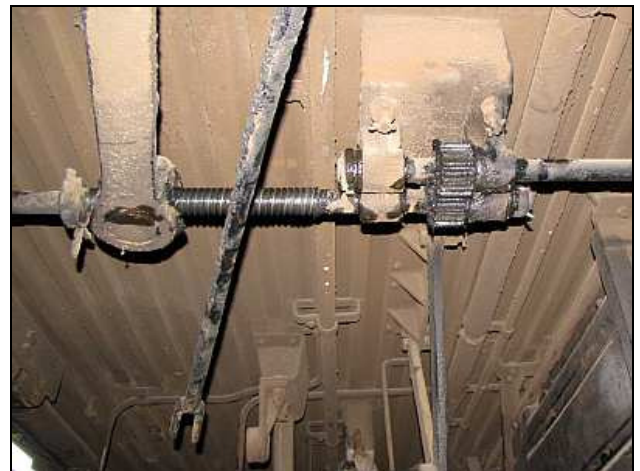
**V04 – Grease Job.**

The handbrake gearing and follower nut were clogged with fossilized grease and dirt, although not nearly as rusty as initially thought. I got the job of freeing it all up with a wire brush and then 'rinsing' it down with MH oil lovingly trickled into those myriad crusty crevices. Then the actual grease was applied – and the handbrake freed up handsomely. The loose clevis-ended rod is the handbrake's pull rod from the bell crank behind my head.

The inner trunnion for the brake cylinder is lower center.

Aidan was asked to cut down the bracket on the lever cart to allow the cylinder to tilt back. Once that was done, the cylinder was in and hand-bolted within 5 minutes. No photos though, as I stayed at basement level to help guide the heavy cylinder back into the trunnions.

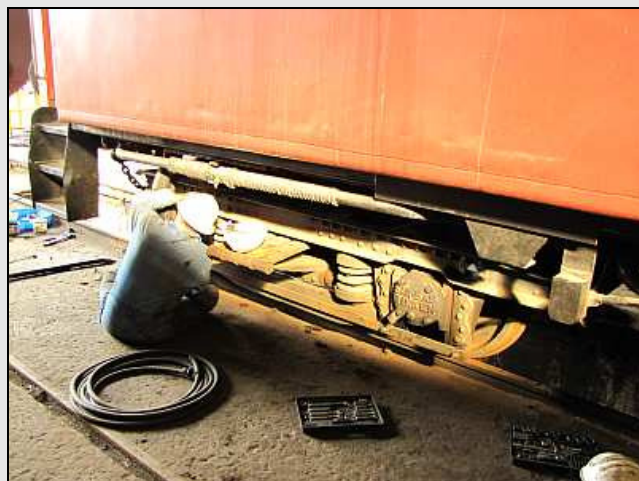
**L02 – Spot-Lit Aidan.**

Aidan McCarthy gets to work on a toilet's scat pipe (thankfully dry) next to a 'Locomotion' coach bogie beautifully spot-lit by the sun.

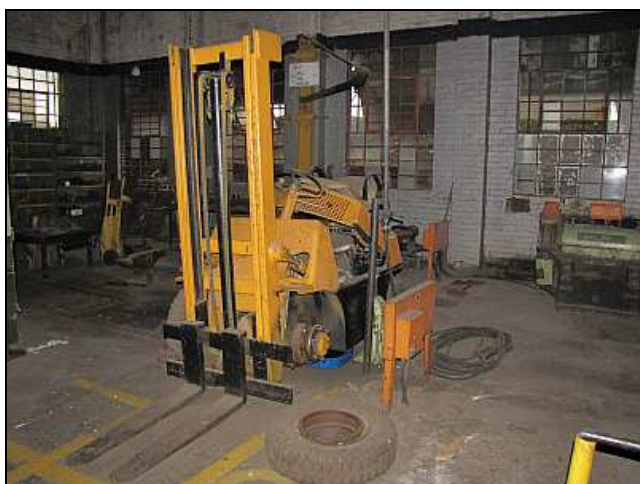
**M01 – Brake-en Forklift.**

The useful LPG gas-powered Hyster forklift sadly hasn't run for a while. It has had the starter motor rebuilt and now the bendix shaft seals leak. The Hyster uses an oil-filled wet clutch, so the starter's pinion runs immersed in oil, rather than in air as opposed to a conventional arrangement.

Unfortunately, somebody 'helpfully' topped up the hydraulic brake system with mineral based hydraulic oil. The fresh oil reacted with the natural rubber seals and made them go all gooey and kablooey. The entire brake system now needs to be stripped, flushed and rebuilt with new seals.

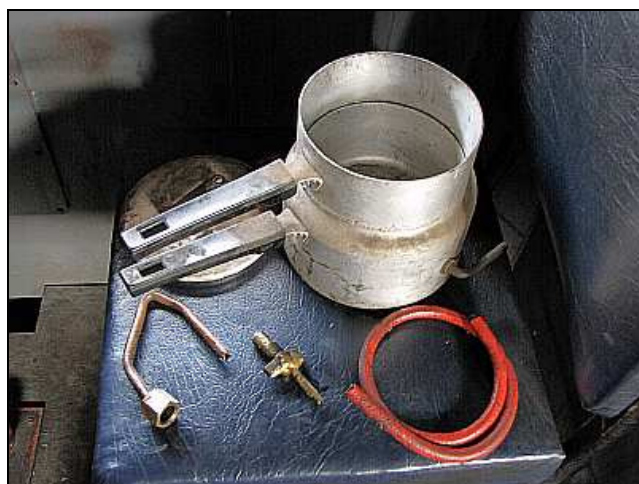
**M02 – Gone to Pot.**

Here's something I found while rooting around the oil store ; pair of saucepans welded together to make a steam-jacketed cooking pot. Notice the steam nozzle to the right.

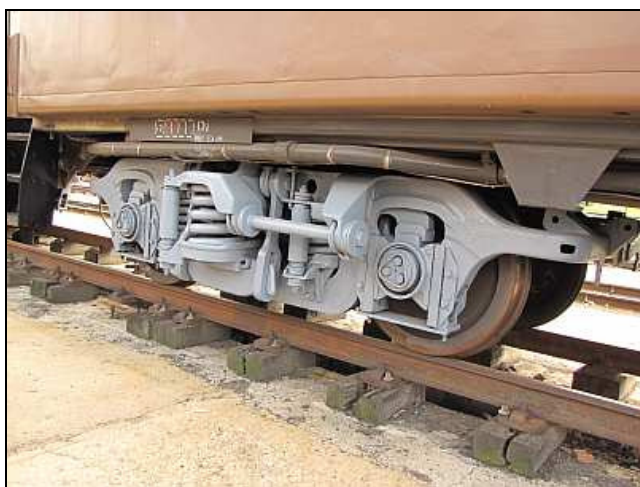
**M03 – Grey Bogie.**

This bogie design is interesting. The swing links (Vertical rods) are externally mounted and readily accessible – using the flexibility of the spring to substitute for the bottom hinge. (Thus, the swing link lower ends are slotted instead of pivoted.) The secondary suspension (big coil spring) incorporates a drag strut to control longitudinal motion of the sprung bogie frame. (As the big coil spring can otherwise deflect longitudinally along the bogie's axis) The primary suspension (small coil springs and the compensating beams) has a damper on both ends.

The so called 'Commonwealth Bogie' was designed and first manufactured in 1935 by the 'General Steel Casting Cooperation' in Granite City – Illinois, USA. The actual factory they used to cast and assemble the early bogies was previously owned by the 'Commonwealth Steel Company.' The purchased factory was then colloquially known as 'The Commonwealth Plant.' This type of bogie inherited the name ever since.

These are also called 'Equalizer Bar Bogies.' They are classified as high speed bogies (for their time) with some designs capable of 160kph. These SAR Commonwealths are rated at 120kph. They are a popular, smooth riding and easily serviced bogie.

They have the disadvantage of being costly to make and being fairly heavy because of the complicated casting of the frame. Standard gauge examples can weight 6 ½ tons. These ones weigh nearly 5 tons a piece.

They also restrict access to inboard brake shoes.

Leaf springs on ye olde bogie designs provide their own damping to a small degree (via inter-leaf friction) but coil springs do not. Hence the need for separate dampers. But the different pitches, lengths and tensions of the concentric coil springs allow for tuning of the ride height of a bogie under differently weighted coaches. (As we've been doing) The coil springs can also be selected to eliminate or shift the nodes for resonant frequency – eliminating coach-bounce on known undulatory track.

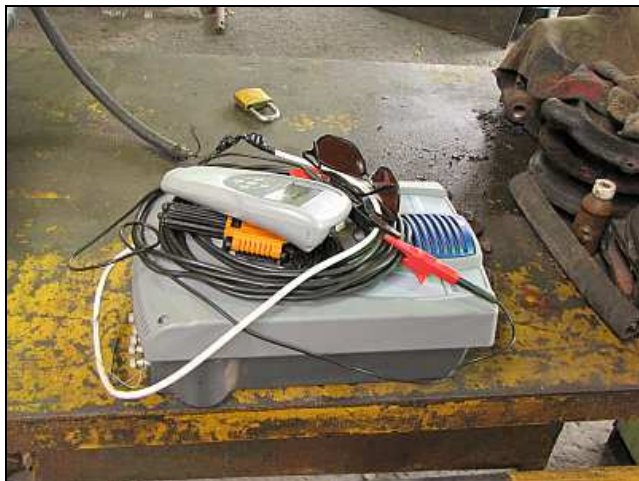
**M05 – Zap Gear.**

A sure mark that 'Honeyball' has been 'walking the long mile.' Strand after strand of electric fence to be checked.

Remember what I said about stupid contractors? The team which cut up Ian Welch's GMAM 4148 deliberately shorted out the live electric fence by twisting two conductors together next to the site of the old turntable. The sustained short circuit eventually damaged the energizer. A spare energizer has been fitted and this one is going in for repairs.

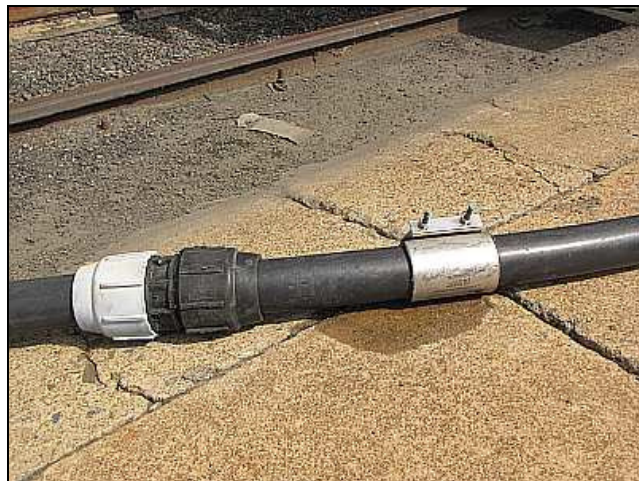
**M06 – Water Mains**

Our delightfully quaint water mains failed THREE times during the previous week. The patch density is ever increasing and we'll soon have more patches than piping. The three failures had our resident 'Yorkie' muttering vile imprecations and getting his car beautifully muddled on the approach road. (The old railway underpass comprising our final entrance road is still under the summer water table.)

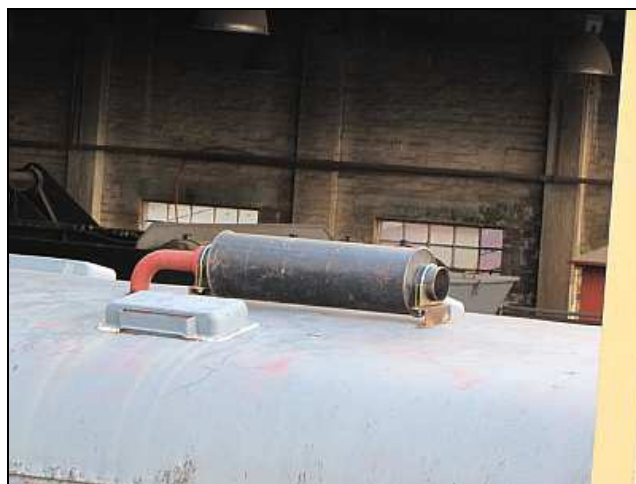
**M09 – Exhausted.**

The newly installed Ford Industries Turbo-Diesel generator is ready to rock with its new exhaust system. Unlike the installation on S&B van, the silencer have been mounted outside. It'll make the train nosier at this end but hopefully a bit quieter in the kitchenette \ tuck-shop end of 'Locomotion' which will adjoin the caboose
