**1). INTRODUCTION :**

2). PROJECT - CLASS 12AR SUPERHEATERS AND FLUE :

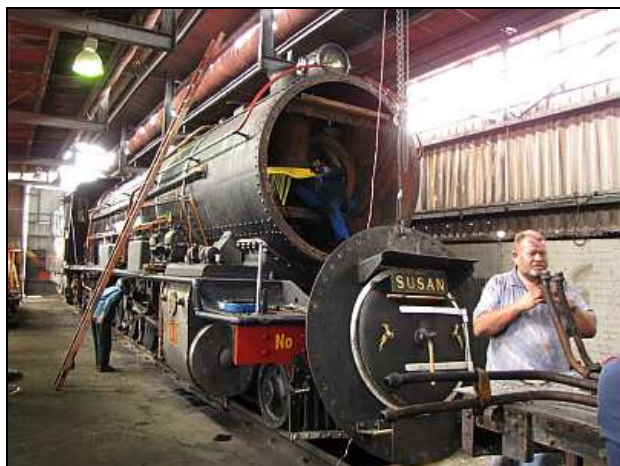
**BF01 – The patient.**

This plucky little shredder managed to get her train home with a flue that was blowing in up to three places and a super heater that was leaking as well. She had been noted to not be drafting too well and the driver (Shaun Ackerman) had reported an unnatural 'blowing noise' at the front end.

They suspected superheater trouble, especially as the noise picked up on an open regulator. (The superheaters are downstream from the regulator valves) It turns out that he was right. The super heater WAS making the noise. But the steam leaks from the failed flue were cancelling out the vacuum at the front end and thus reducing the fire draft.

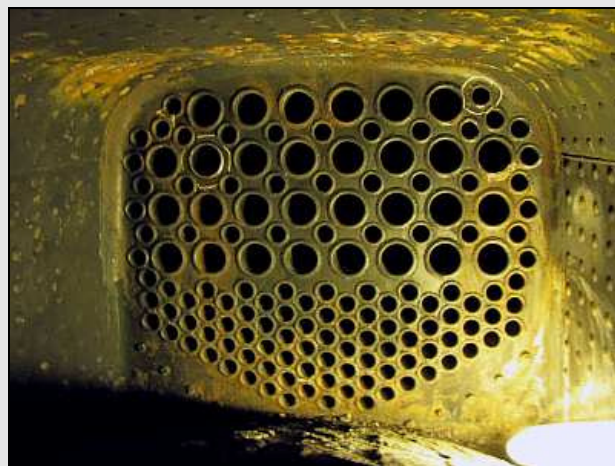
**B02 – Backstop.**

A full view of the vintage-looking rear tube plate with the replaced flue outlined in chalk in the top left corner. (This was designed in 1943 so it's not that old in loco terms.) Two tubes and another flue have been marked for beading. The old-fashioned narrow proportions of this firebox, especially when compared with the wider Wootten boxes of the F and 25, are obvious. Although our Class 12AR goes like the clappers, the old railway crews who drove the 12A's with their combustion chambers, considered the 12AR to be inferior after they were re-boilered.

Our Little Susie, as old fashioned as she is, has a fairly tolerant boiler. The 15F's and the 25, if they are lit-up too quickly, or hammered after going cold over night with a loco minder letting the fire die out too much - have a tendency to develop hot-toes on their fires and stretch their stays in the wide front corners – with subsequent leaks.

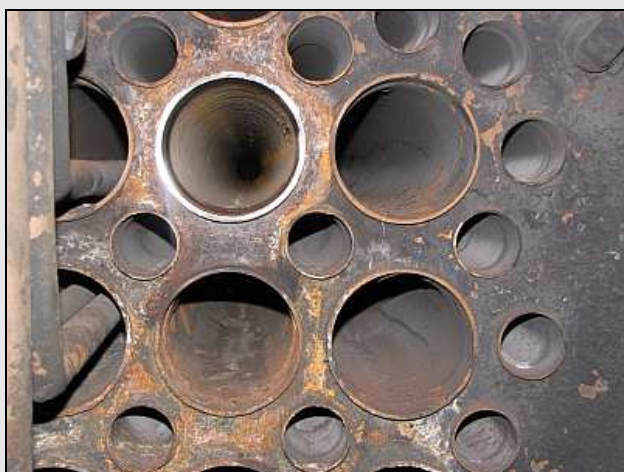
**BF03 – Front End.**

A remarkable shot considering I was reaching in past the petticoat and cramped on top of the table plate brace – the camera lens ended up going straight down the bore of the new flue. The apparent thickness of the flue's walls is not an optical illusion caused by the shiny edges. The new flue walls really are thicker than the originals and caused Peter Labuscagne to lose some sweat when he expanded the rear end during the week.

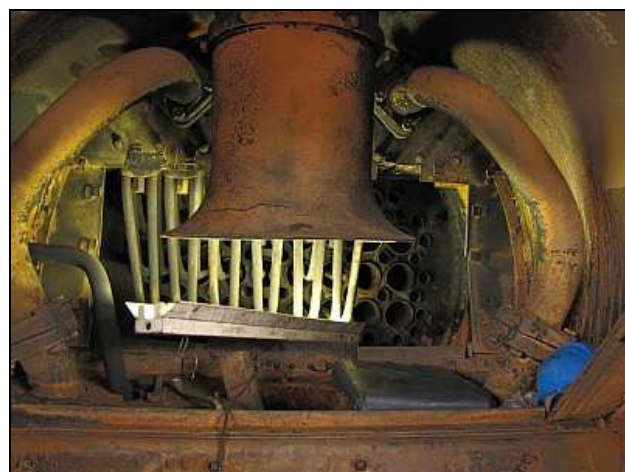
**BF04 – Loco Sinuses.**

Not much room in the smokebox! What is good news is that with the regular smokebox cleaning after every run, the wasting on the tube plate has been arrested. Originally it was thought this plate wouldn't be fit for another boiler cycle, but now it should last for another 3 year ticket, and with luck, possibly a subsequent one.

Yes - the petticoat is developing a nasty crack and will be welded before the front end is closed up.

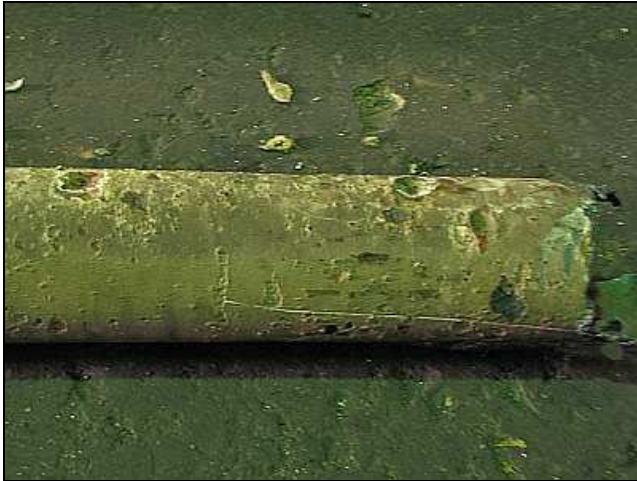
**BF05 – Cavities.**

With cavities like these, you could be forgiven for thinking that we are running our boilers on sugar water! There were three of these corrosion pits, all of which had pin-holed through to the inner surface.

A problem with boiler flues is that the impinging jets of steam cut into the superheater elements. And leaking superheater elements within the flues can cut into the flues.

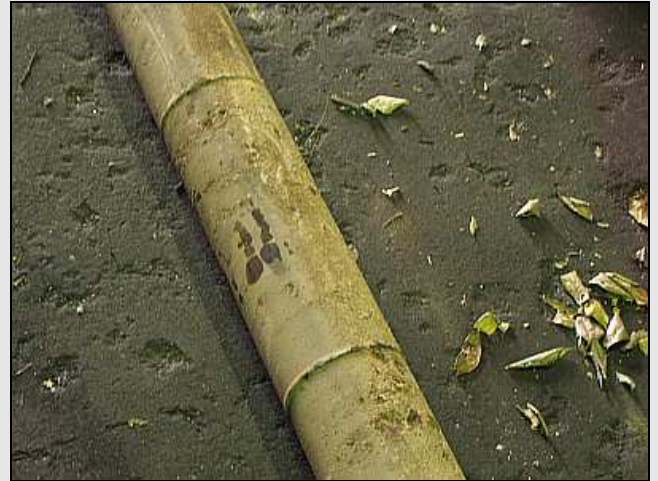
**BF06 – Boiler surprise!**

Here's another surprise. This flue had been double-safe ended. As they normally corrode towards the ends, and the ends are exposed to char cutting, a worn flue (or tube) can be salvaged by welding on a new section. It is unusual to see it done twice. But if the welds are done properly (Certified welder) and are close to the tube plate, although not ideal, this isn't really a problem.

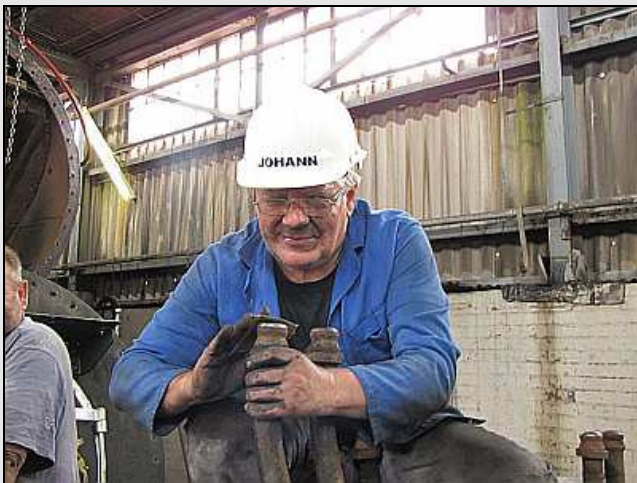
**BF07 – Polishing Up.**

The superheater elements have all just been tested and Johann Breydenbach, one of a crew of three, is happily polishing off the surface rust from the bell ends. Johann had made arrangements to get a lift and come and fire the train today – but as the train was cancelled, he was quite content to get busy in the workshop instead.

It is remarkable that a superheater can be coupled to the header with a rounded bell coupling and remain leak-free without gaskets, olives, crush rings or such like. The elements themselves are also loosely braced and those two end pipes can be lifted semi-independently and can even rotate slightly given the length of the pipe work.

The loose fitting methodology seems flimsy but is actually clever design in its simplicity– the boiler can expand and contract slightly with the flues expanding around the relative position of the super heaters. A locomotive boiler expands back into the cab when it is hot, so the superheaters actually move away from the boiler backhead, relatively speaking.

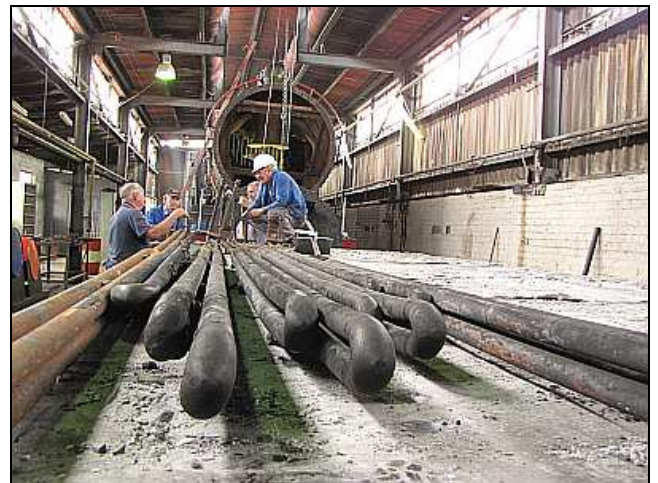
**BF08 - Elemental.**

Seven superheater elements were removed in all – being one column of four and one column of three – from the two right-most sections of the superheater header. In a perfect world and with compact tooling, only two would need to be removed as the long necks of the lower rows block removal of those above them.

But while we were at it, the seven elements that could be removed without messing with the petticoat were taken out for ease of access and inspection. One of them was found to be leaking. Each element was visually inspected and also subjected to a portable hydraulic pressure test.

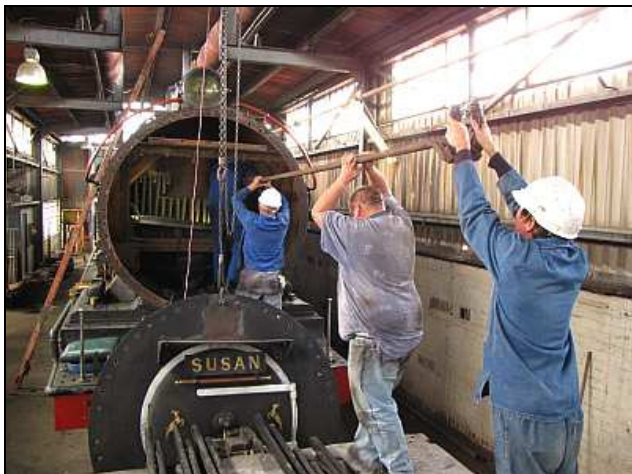
**BF09 – The overhead grip.**

With Peter Labuscagne putting the screw onto the headers, the element gang lift the first of their loads. The short necks in Alan's hands (rear) indicating that these go in the top row. This one seemed heavier than it should and then the fellows realized that it was still full of rust tainted water from the hydraulic test! Alan got the slops!

Notice that whoever painted the black etching primer on the smokebox cover plate wasn't able (or willing) to get behind the headlamp – which normally resides on that bracket. Incidentally, the etching primer is working brilliantly on pre-prepared surfaces (15F) and is to be our new standard – down with the labour-intensive and slippery graphite paint!

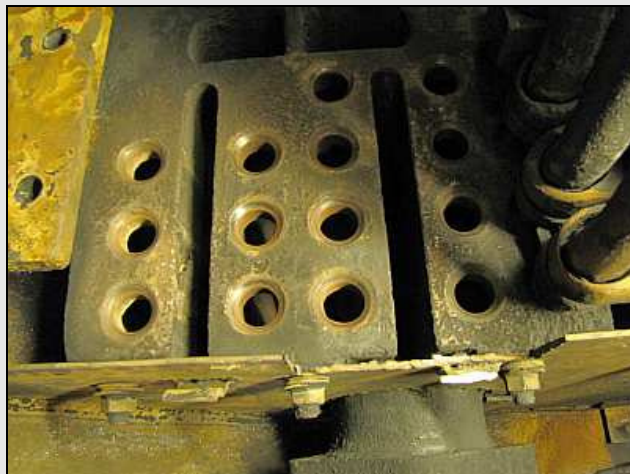
**BF10 – The header box.**

Here is an unusual picture, looking up vertically into the header into which the superheater elements are fitted. The outer column (left) has 3 sets of 2 paired holes while the inner set has four. (Front of loco is bottom of pic.)

The strange square-lobed shape of the header serves two purposes. Firstly the cast-in slots and walls help to strengthen the casting. But the primary purpose of the slots is to accept the t-heads of the super heater clamping bolts (shown in the next photo.) The protruding threads of which protrude downwards through the slots for tightening. It is a simple but ingenious system which allows for wide tolerance and flexibility. The downside that a failure in an element in a top row of flues, requires that all the elements in the flues below need to be removed.

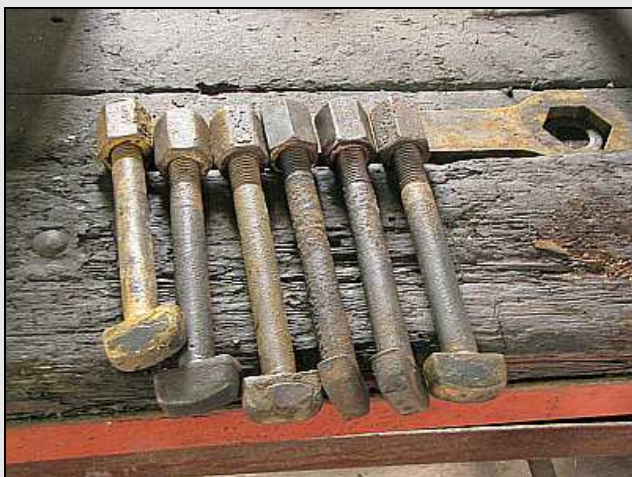
**BF11 – Header Bolts.**

These are the clamp bolts for the super heaters, with their distinctive club-hammer shaped heads. They are inserted into the lobe slots and then rotated 90 degrees, almost like a bayonet bulb. I know where number seven went... ☺ but I'll keep the blackmail on the driver concerned for when it can be of useful profit for me. ☺

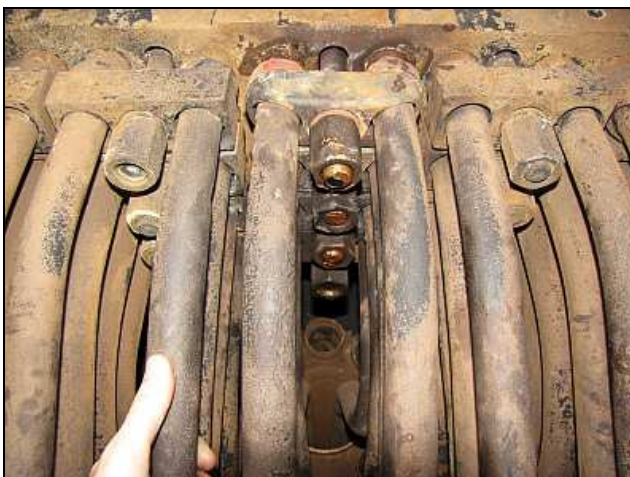
**BF12 – Elemental.**

Here you can see the tee-headed bolts having just been fitted on the Class 15F No.3052 'Avril' in October 2010. While the pipe clamps are plain rectangles here, the principle is exactly the same. Notice that the threads have been properly 'copper-slipped.'

Here too, the awkward stacked nature of a typical locomotive superheater array is easily seen. A failure in an upper flue required removal of all the elements in the column below. You can actually see the short necks of the top-most element just entering their flue.

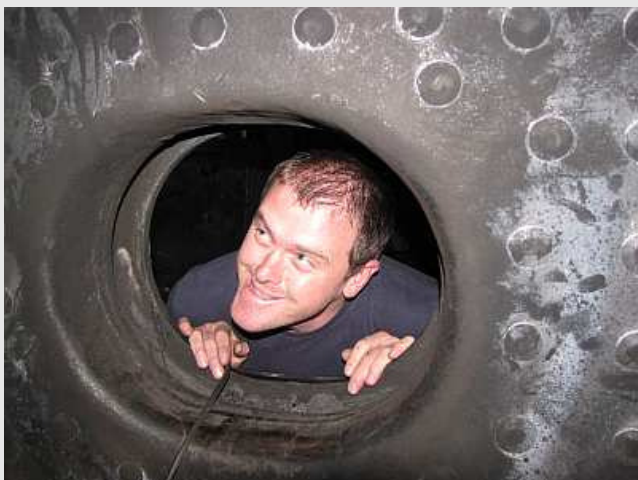
**GB01 – Looking in.**

Thus, here is a very clean and cheerful looking 'Smudge' checking out the rear tube plate and the new flue, illuminated by a big fluorescent lamp lying on the upper face of the fire arch.

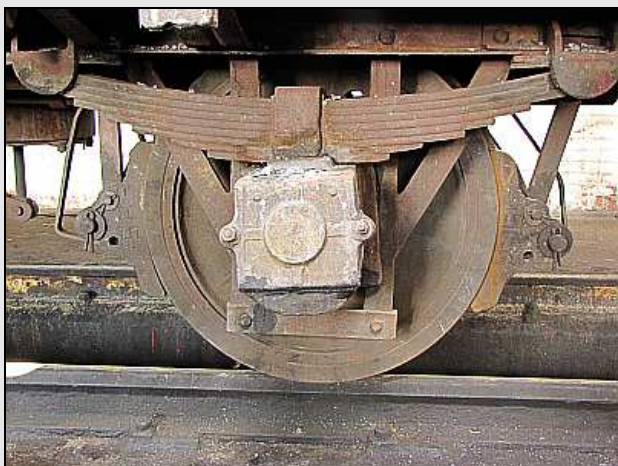
**M01 – Bogie Detail :**

Some bogie detail on the 'Tea Trolley' currently carrying 12AR boiler bits in the top shed. Fit for high speed service on the Orange Express ... not. This is a sprung railway axle at its very simplest. Our humble tea trolley wagon is probably one of the few full sized 4-wheel wagons still in service and it has hand-operated pin-down type brakes.

Interestingly enough, it is still fitted with a matching pair of 'Alliance Couplers' – and can this be used with normal SAR knuckle couplers as well as link and pin, even with home-made variety of link bars, chains and slings.

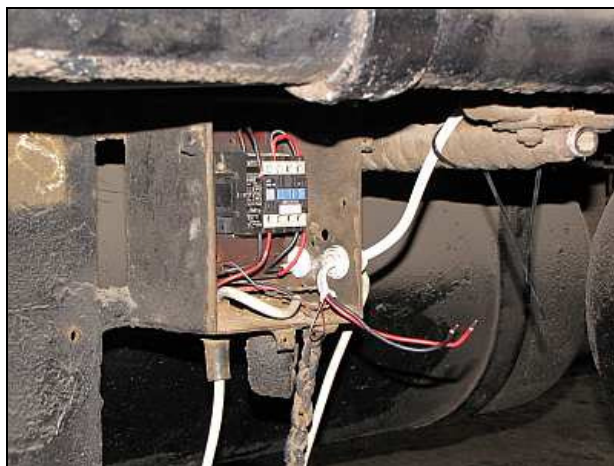
**M02 – Winging the Wiring.**

It's always a bit strange to see fresh, clean wiring with stripped copper-bright ends on the typically crusty undercarriage of a coach. This is the contactor for 'Locomotion's' new water delivery pump – since wired up and tested.

Our coach water pumps are operated by pressure switches. The initial pressure is provided by that of the pressure tank itself, provided of course, that the non-return valve doesn't leak.

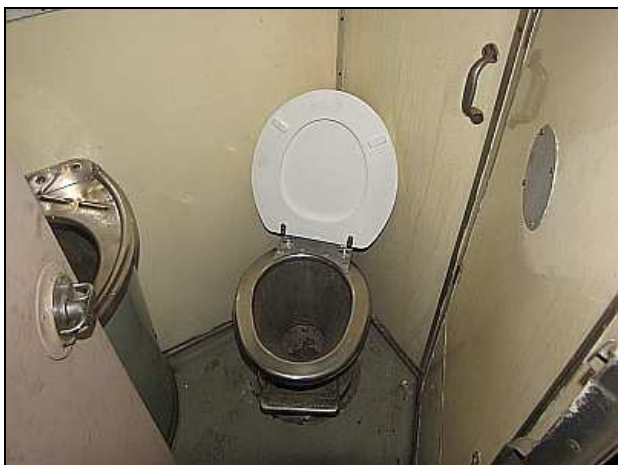
**M03 – Bowl Bowl.**

The restaurant coach, 'Locomotion's' two toilet compartments are completely plumbed in and functional. Some cleaning and painting is still required.

Unfortunately, when the pressure tank reached full pressure while the plumbing test was underway, the rust and layers of paint holding the water in blew out and the previously-patched tank end leaked like a shower rose.

Since this picture was taken, Locomotion's pressure tank has been dropped and a spare tank salvaged from the derelict restaurant coach 'Kariega.' The pipes don't quite match but that ain't nuthin' to steam train mechanics.

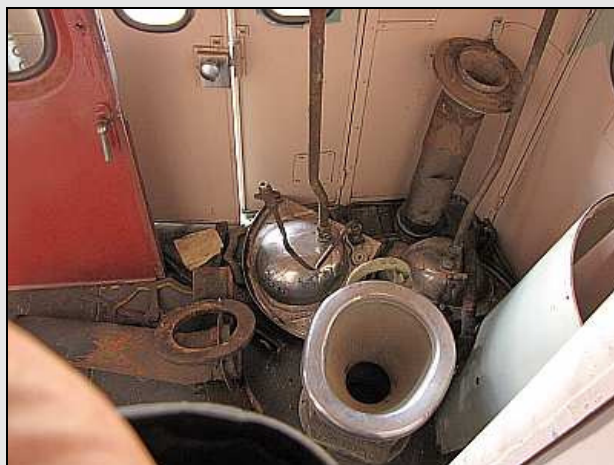
**M04 – Spares.**

We have enough plumbing spares for two complete toilet compartments – as the two toilets at the other (bar) end are to be converted into a store and a kitchenette.

The quadrant panels that enclose the corner sinks, in particular, are rare items.

The scat pipe standing vertically in the corner has an extra luxury feature. It has an extra collar at the discharge end from when the Locomotion Coach was plinched and the drain pipes connected to a water-bourne sewerage system.

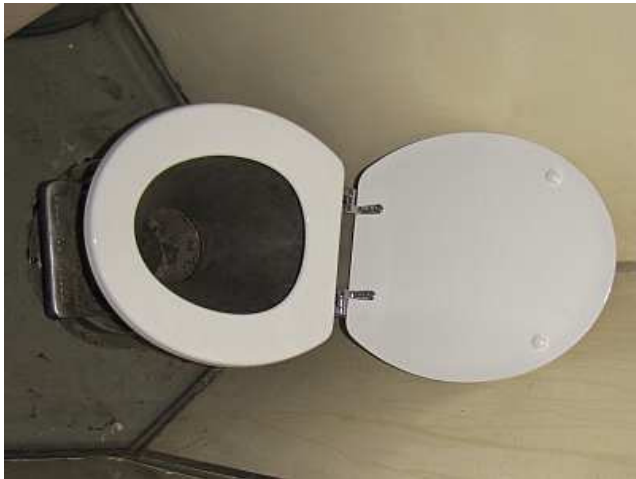
**M05 – Not a spotty-potty.**

Reefsteamers is in the gradual process of converting the coach toilets to domestic plastic type toilet seats. We did try wooden seats for a while. They definitely looked more homely on a clinical stainless-steel pan and were warmer to plant tushees on. But they proved fragile with the joints in the laminated wood fracturing under lipodexrous passengers, as the SAR toilet bowls are narrower than the domestic type. The fat would literally hit the pan with the extra stress at the seat overhangs.

Many of the day sitters still have the spring-loaded oval seats in speckled grey. These are comfy for the 'pax' – but as they gradually fail, we'll be going for domestics.

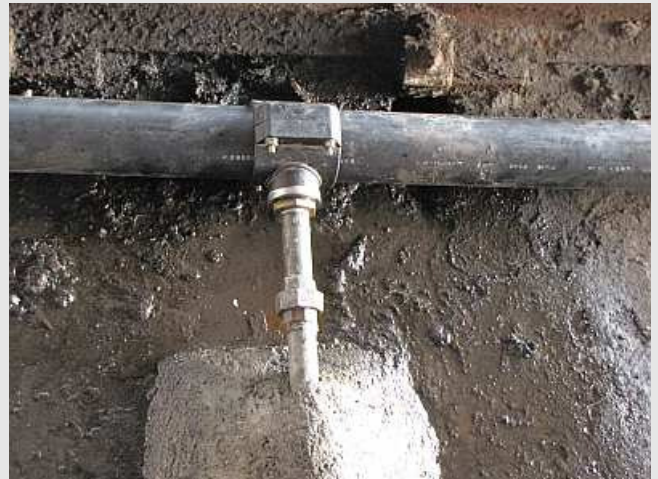
**M06 –Plumb Leaky.**

Actually, the water was spilt during pipe work. The west end of the UV-embrittled water main has been replaced and the various tee-offs were fitted with new clamp-on tees, like the one seen here.

As we receive more donations for the water mains, the rest of the pipe-work will gradually be replaced.

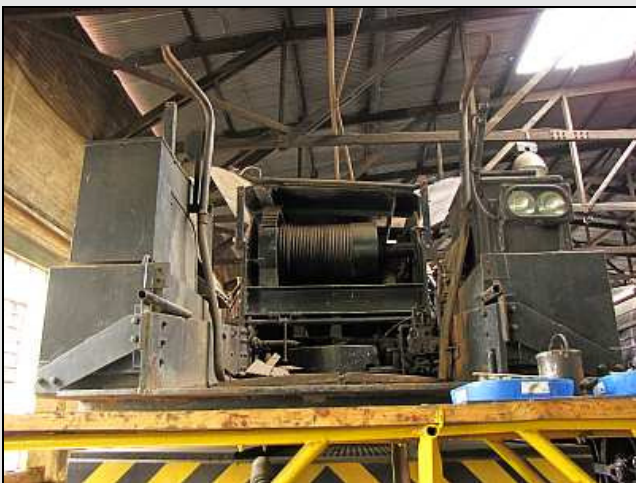
**M07 – This space to let.**

The gaunt looking boiler platform of Sandstone's steam crane. The future boiler of course, is the red article in the following pic. Unlike our 35 ton Booth Rodley steam crane, this one's operator cab is along the flanks on the side. Like the American camel-back locomotives of old, the fireman worked on his own at the rear platform. Or the operator would take a short scramble to his boiler.

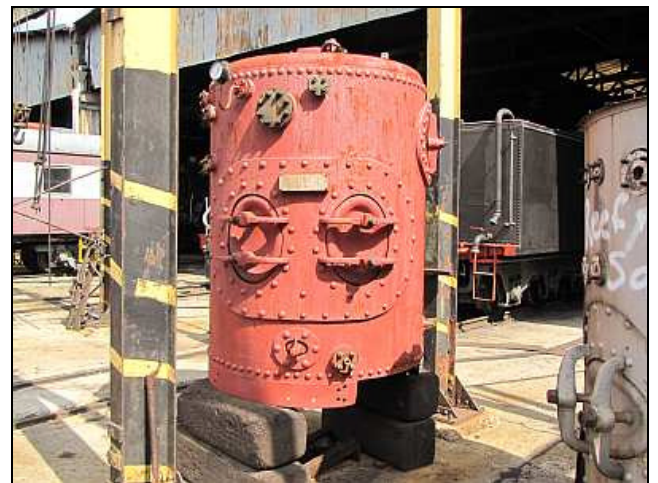
**M08 – Red Hot Pepper Pot.**

Here's a replacement boiler for Uncle Wilfred's Crane. It has been filled with water for testing and leaks copiously at the foundation ring just from gravity – not because of rust, but because of poor riveting. Before pressure testing can take place, all the foundation ring rivets need to be replaced. Many of the heads actually stand a bit proud.

It doesn't look like much progress has been made- but a lot has been happening. We've been getting stock to make the unusually long rivets which pass right through the water spaces. A die block has been machined and a tup has been fitted to our 50 ton press. We'll make our own rivets. The rivet holes all need to be reamed out and a suitable reamer had to be procured to replace one that 'took a walk' earlier, and the worn reamer itself had to be sharpened up.
