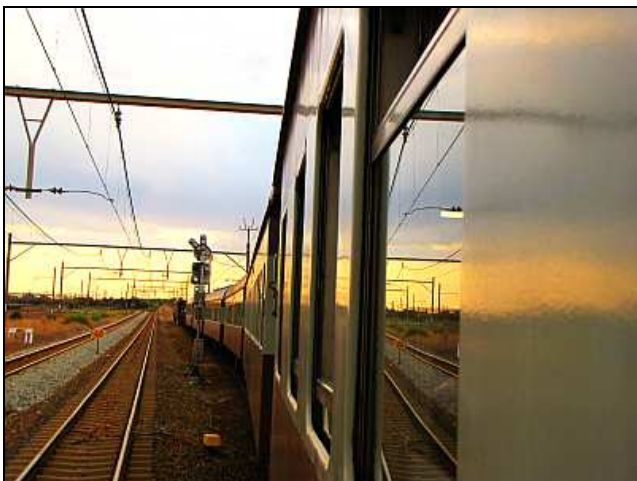
P01 – We weren't at Kroonstad much longer than required for loco service and crew change; and it wasn't long before we were moving again. Here, the sadly-smokeless train is switching over to the irons that will take us to Bethlehem.

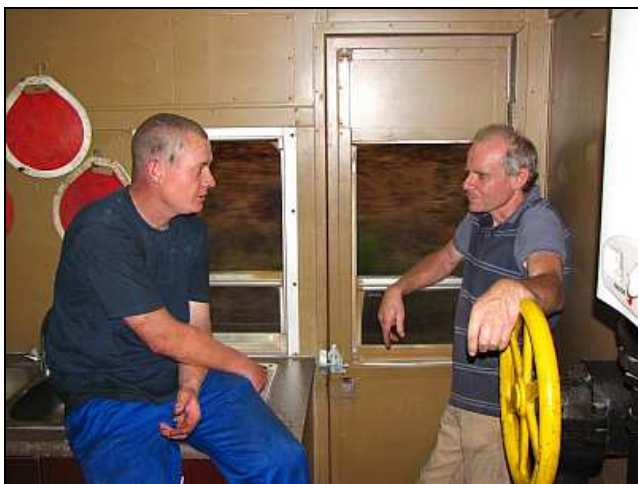
P05 – The 'King' (R) and the 'Kousin' (L) enjoy a chat in the S&B Van. With 2 years' worth of repairs and improvements to the coach electrics and plumbing, little had gone wrong and the still-clean King was at a bit of a loss by now.

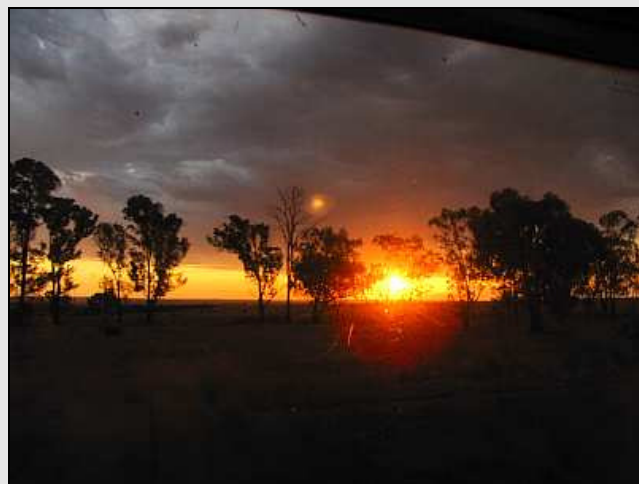
P06 – Edge of the storm...edge of the night. The setting sun finally clears the edge of the cloud bank – the last clouds we'd see until Saturday evening. Note the cinders stuck to the window glass, even from a towed steam loco.

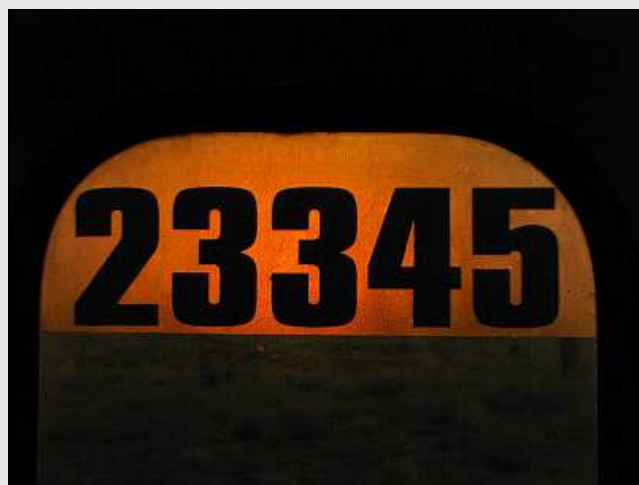
P10 – Some of the coaches have a 'frosted glass' effect on their aging door-glass stickers, while others have independent yellow numerals. Can anyone tell me what is fundamentally wrong with this picture?

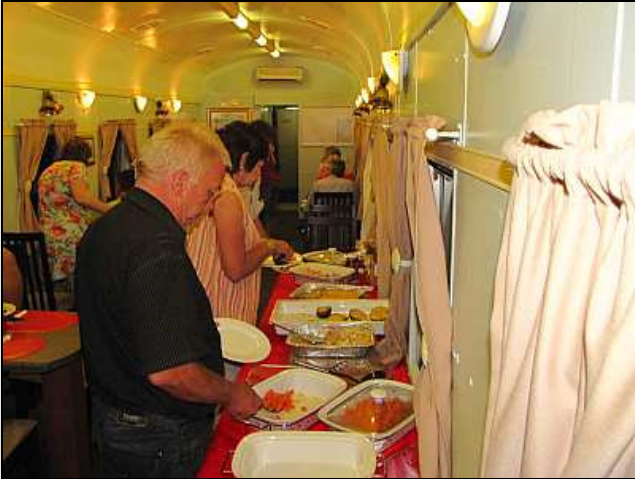
P11 – First seating is almost done. Our first train-board dinner was home-made chips (not the yucky oven-baked kind), gem squash, traditional Afrikaans ‘soet wortels’ (Sweet carrots) and an amazing home-made chicken pie.

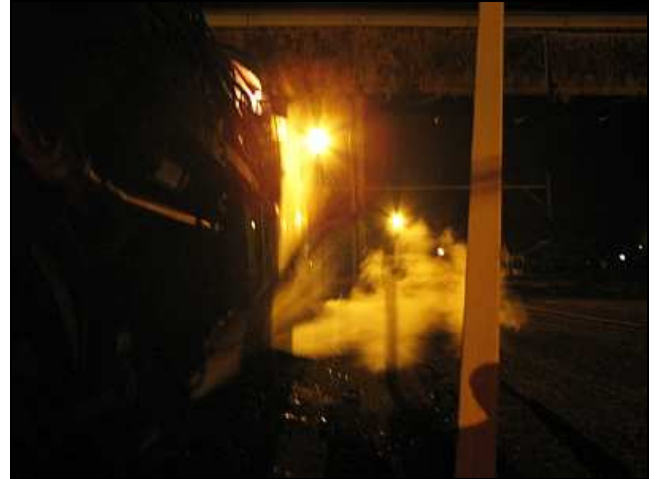
P24 – Not a pretty photo, but I found it interesting to see how the pole in the foreground was able to cast a distinct shadow on the copious injector overflow steam leakage. An attempt was made to solve those leaks on Saturday.

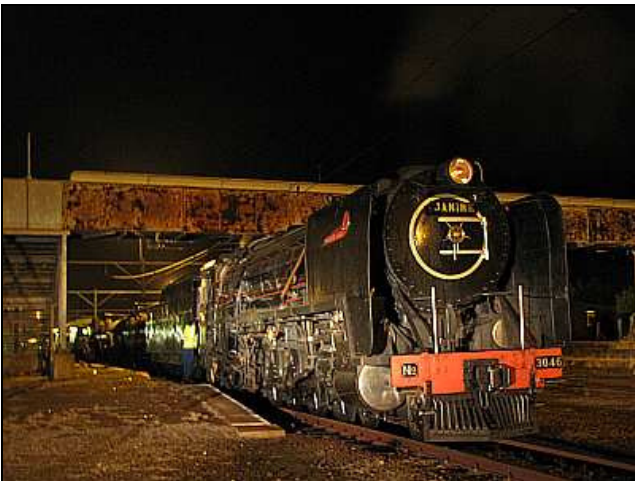
P25 – Settling down for the night and snuggling up to a pedestrian footbridge, our 15F No.3046 ‘Janine’ has some weird lighting up her skirts. An enterprising line-sider had parked his bakkie and spot-lit the scene with headlamps.

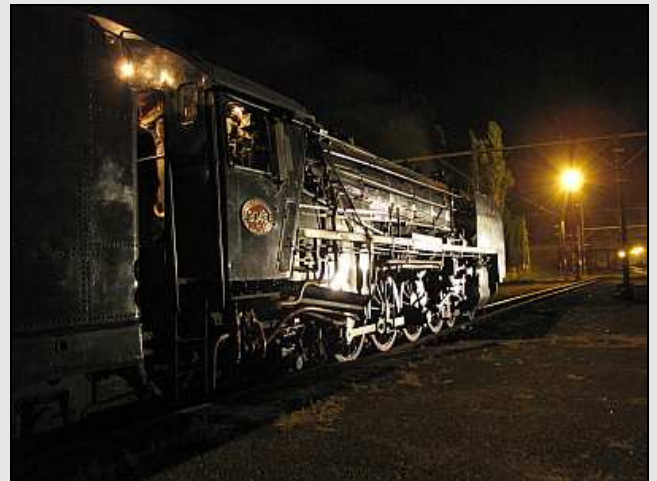
P26 – The previous scene from another angle. Notice that there are no steam leaks on this side. The rarely driver’s injector and Sellars valve set functions perfectly. (I used it through the night.)

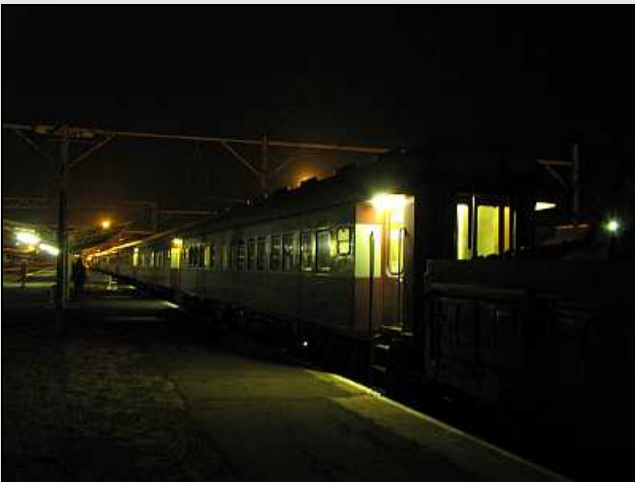
P27 – There are still a few passengers mooching about as the train stands at the platform. Even though the yard is lifted, the platforms and roof are still intact and the lights work. Even the fire hydrants gave us good water pressure.

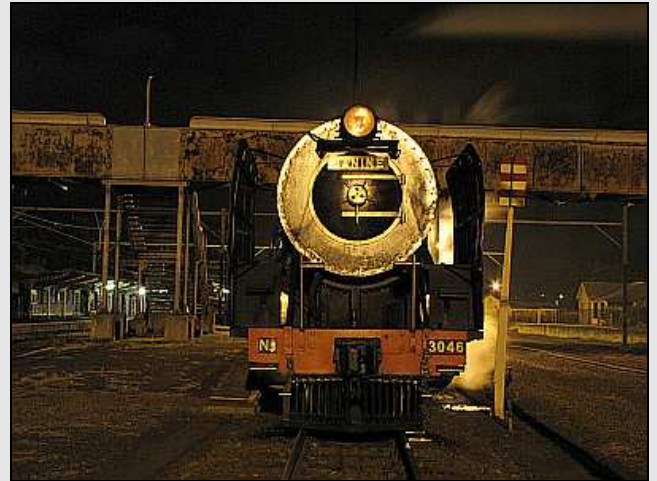
P30 – A front view of our not-so-little princess. I found it interesting that it was difficult in the reflected light to distinguish between a graphite finish and the semi-gloss black etching primer that we had used on the smokebox.

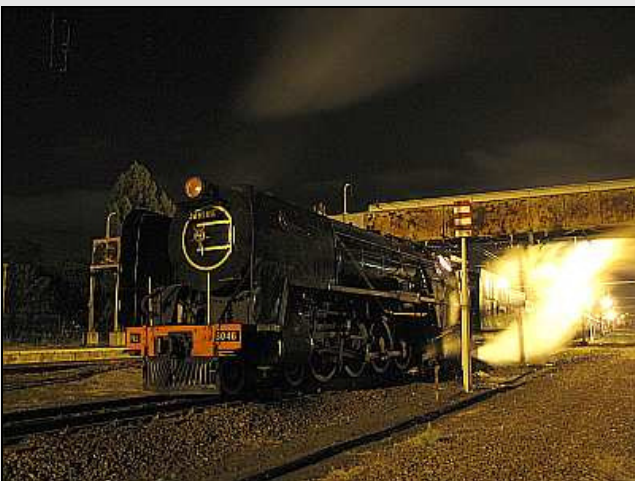
P31 – These quad-bladed fire markers are usually right above a hydrant or hose but can be placed in-line instead. The hydrant in question is way off to the left and we had to pass the water hose under the rails of the adjoining tracks.

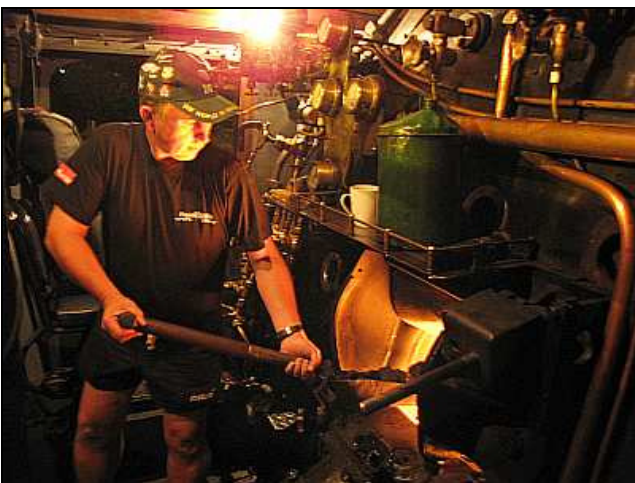
P33 – Rhyndard has fun trying to fire into the corners (to make my faster-burning 3-sided fire into a proper back-bank) and ended up making a mine-dump in the center. ☺ No harm done – I just tidied the fire up with the pricker.

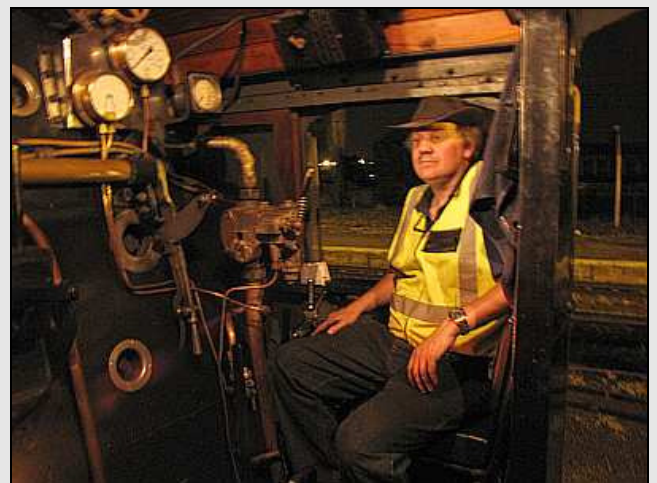
P34 – A rare photo of yours truly in the 15F's hot seat. Notice the duplex vacuum gauge is at zero. We pin hand brakes and scotch the wheels; and do not rely on either live vacuum or residual vacuum (coaches) to hold the train.
