This Photo Pack was compiled by Mr. Lee D. Gates on behalf of Reefsteamers Association NPC.  
For observations, corrections and suggestions – email me at [documentor@reefsteamers.com](mailto:documentor@reefsteamers.com)

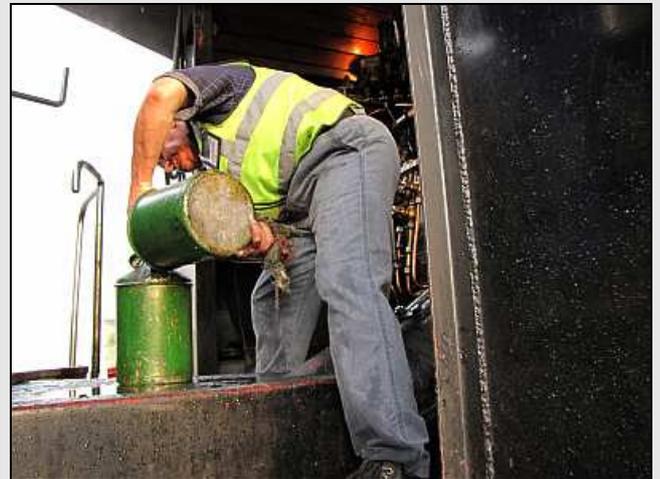
P02 – Normally I at least drain and fill the lubricator, even if I don't have time to blow down the sight glasses and fill the metering chambers with water. But I chickened out this morning, as I didn't know then if it was a fault on the loco or procedural error, which caused the trainee burns yesterday.

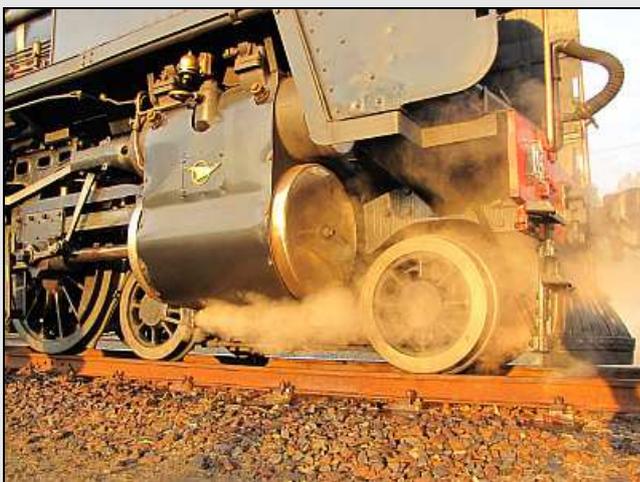
P03 – The warming-up steam chests add atmosphere to a mellow morning as the valves have been set to forward gear to shift the linkages to allow access for lubrication. Nothing like the smell of tallow-n'-steel-scented steam! ☺

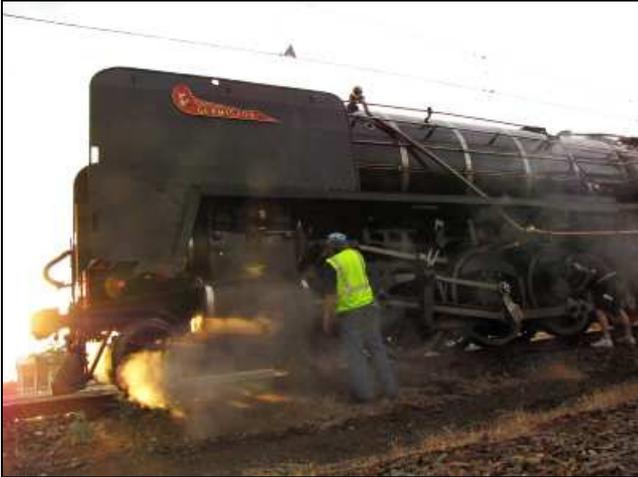
P05 – The rising sun is at coupler height. It is always astonishing to see how much fresh air and ‘through-gaps’ there actually are in a locomotive’s frames and motion. Louis is adding MH oil to the two crosshead slide oil pots.

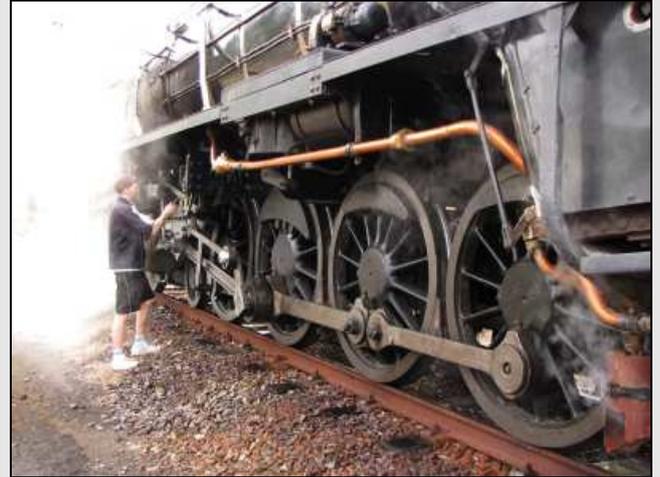
P06 – With steam shrouding the locomotive’s front end, ‘Hott-Nutts’ George is in a world of his own, applying ‘soft grease’ to the expansion link trunnion bearing.

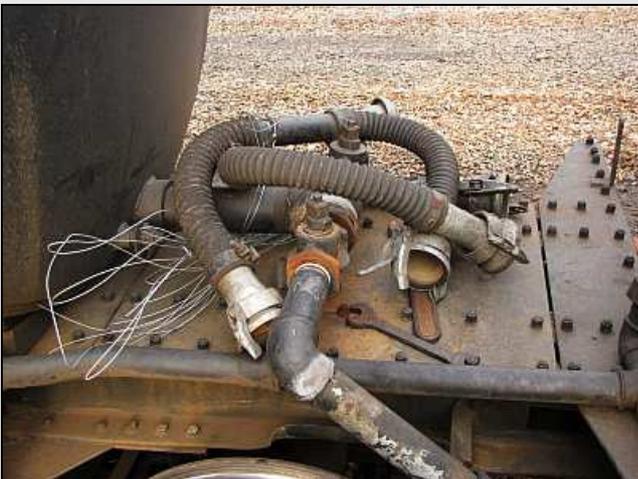
P07 – Just some of the paraphernalia required to keep a long distance bean-boiler going. These are spare water transfer hoses with bell couplings, baling wire to tie down the clamps and spanners to operate the transfer valves...

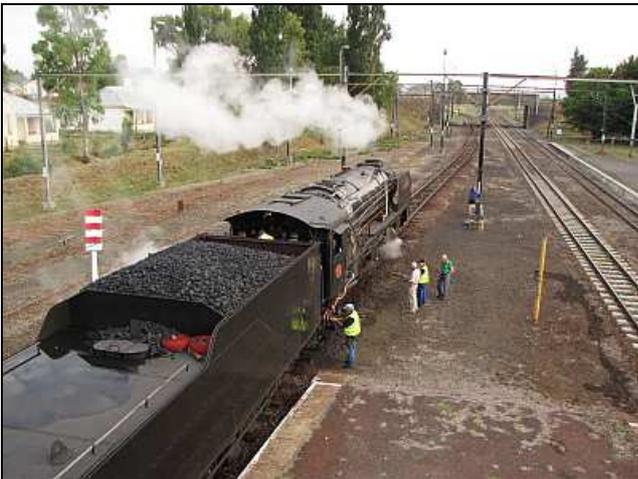
P09 – Johann Beret-bach has re-laid his fire and she’s on the blower, as evidenced by the lifted plume on the stack. Louis is wisely wiping his hands clean at the ‘waste cubby’ before trying to use those handrails with greasy hands.

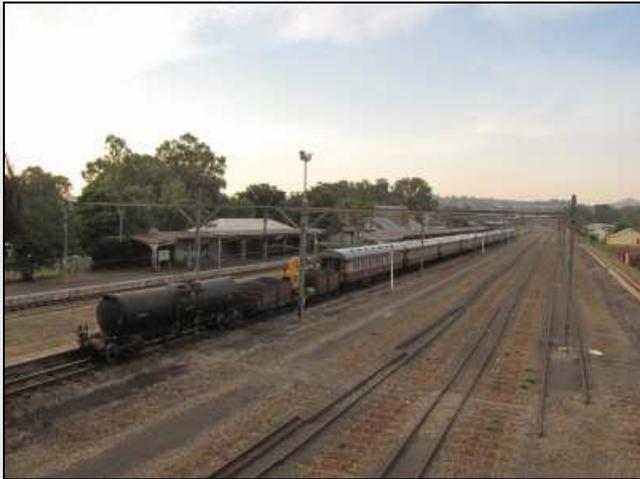
P11 – We left a tanker on the train. We did have to top the tender up. The water coupler blew apart at about 3am and we only got to repair the coupler at day-break. (You can't run a hose through the hatch under the traction wires.)

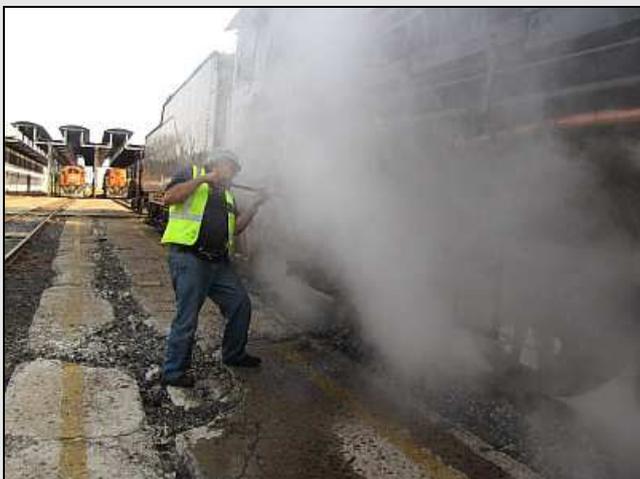
P19 – Driver Louis cleans fire simultaneously with George on the other side. But Louis is stuck with the fire pricker, which tends to snag in the rocker grates’ linkages. Johann is doing the raking and Cousin Rob operates the shaker.

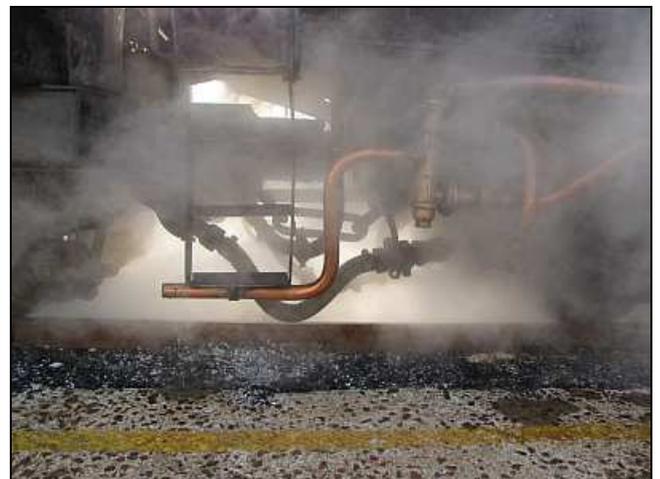
P20 – The loco interlinks. From front to rear, RHS Injector Water Feed, Vacuum Brake Pipe, Safety Chain, Stoker Steam (McCaughlin Coupling) and far back, the LHS injector feed. The draw bar is visible above the pipe work.

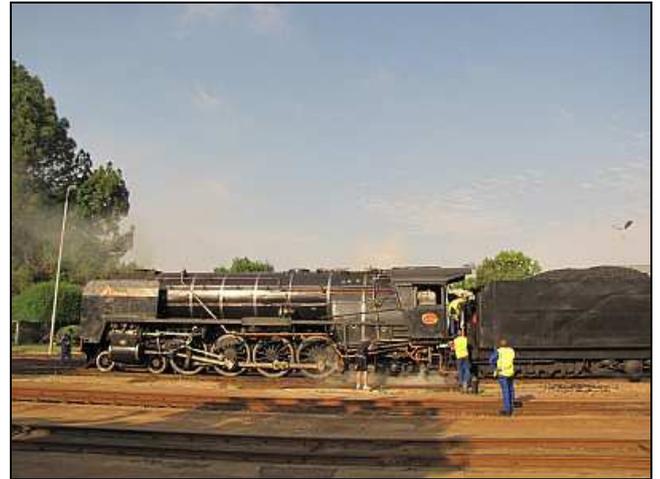
P24 – They are just passing up the water bottles just as Johann starts the second round of fire cleaning to do the rear half of the grate. The 15F's drop grates are in the centerline of the fire and Johan does the front half first.

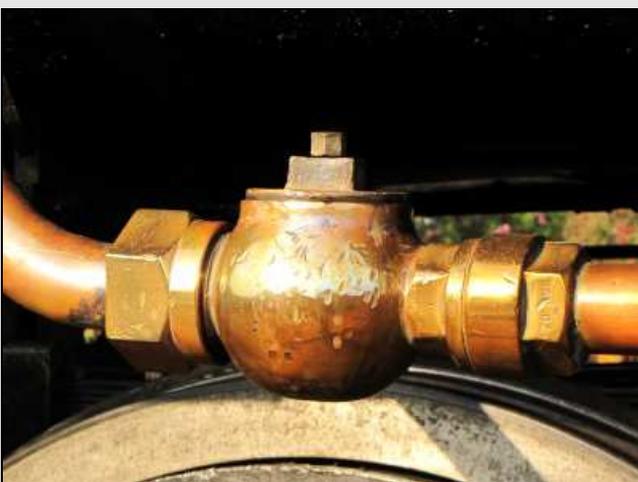
P27 – The non-return valve in the left side boiler delivery pipe. These had been brightly polished by Oom Attie, but were already starting to oxidize with the heat and humidity. Note the decades of hammer n' spanner-blow marks.

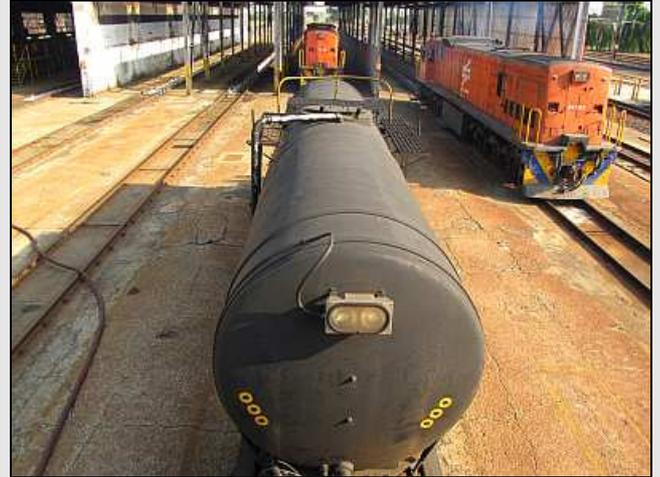
P30 – We do it Garratt-style these days, hauling 1 or 2 31,000 litre water tankers to extend our range. This WAS a Garratt’s tank once, hence the fitted lamps. We would use the extra water for the coaches as well as for the loco.

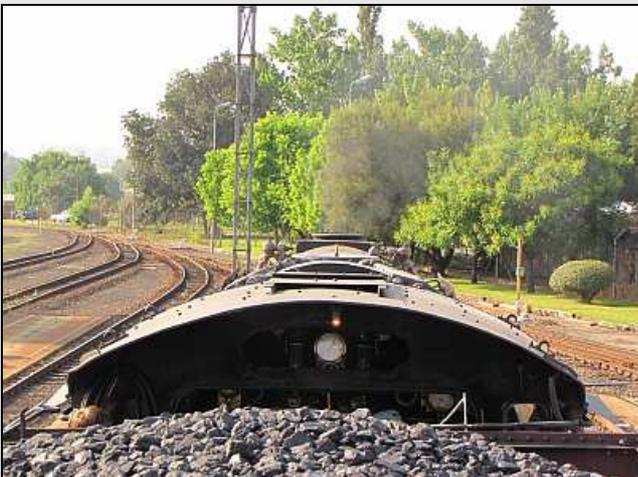
P31 – Servicing is done, the tender tank is almost full and she’s about ready to pop with boiler pressure at 1300kPa and climbing. Notice the canopy lamp is still burning and has survived a session of reciprocating fire irons and slices.

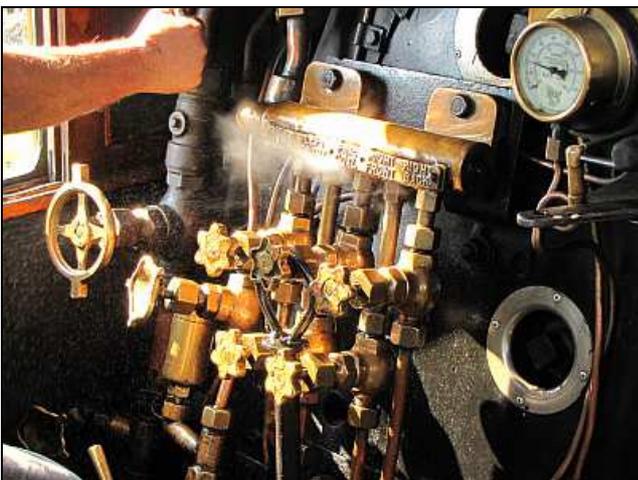
P33 – She’s getting a leaky at this side of the cab – Johann Breydenbach rolls in the coal towards the front quarter of the firebox, with 400kPa showing on the stoker jet gauge. Note the fine-coal jet valve (center of 5) is disconnected.

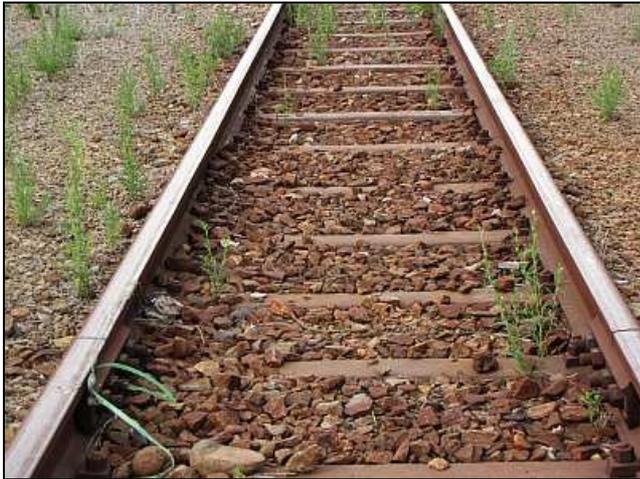
P41 – The outer loops and sidings at Ficksburg are still iron-pan sleepers and 4-bolt fishplate joints, except for the newly laid bypass track in the grain yard. Noteworthy here is that the fishplates have all eight bolts intact and tight.

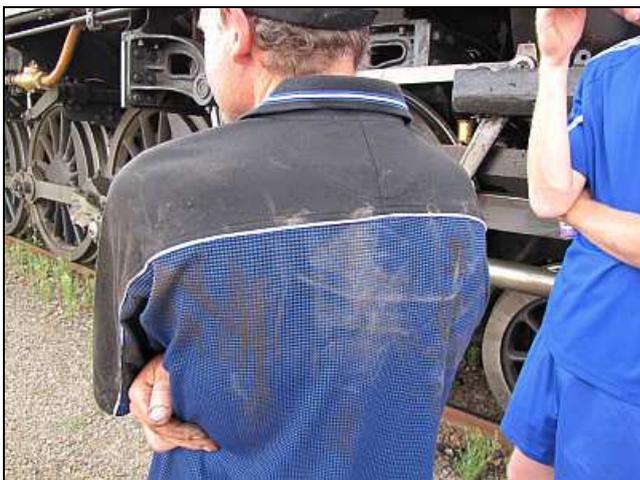
P45 – At last Andrew King is dirty, as he should be, and my fragile world is restored to order! An axle grease pad was out of line and was charring at the edges with unloaded-dry friction, although the axle journal itself was not at risk.
