1). INTRODUCTION :

This Depot Report was compiled by Lee D. Gates on behalf of Reefsteamers
For observations, corrections and suggestions – email me at documentor@reefsteamers.com

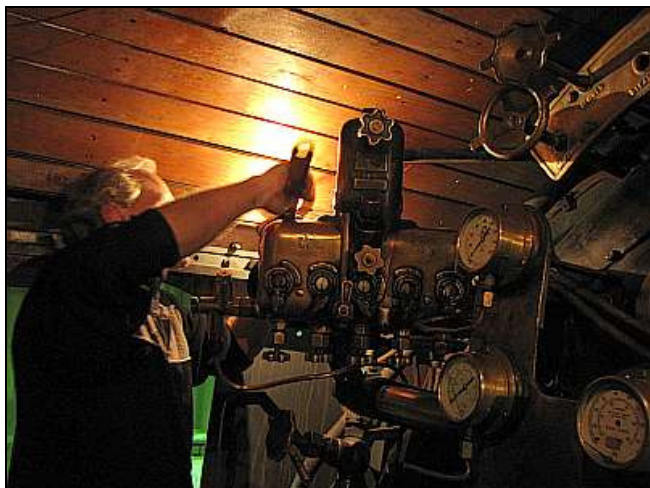
P01 – Temporarily swapping a pair of oil lines to assign a working port (center) to the left cylinder, and an erratic port to the less critical application of the mechanical stoker. A longer small-bore copper oil feed pipe had to be fitted to reach the crossed-over stoker port's outlet.

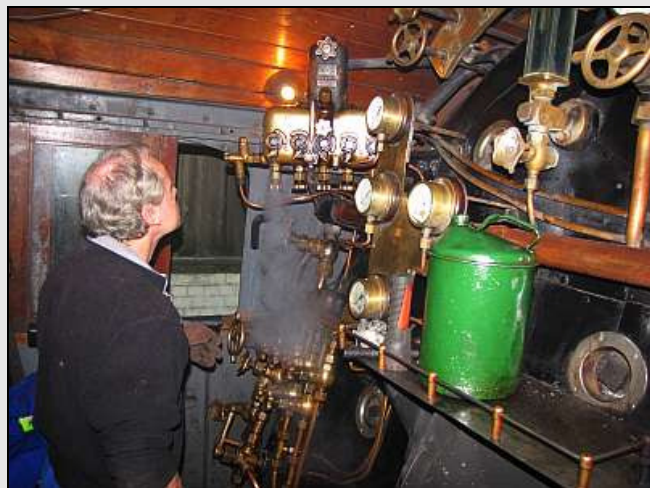
P02 – Andrew does a test blow-down of the now-stoker sight glass. There is a blockage somewhere, which cannot be repaired in time on a live loco. As the pipe work no longer had a non-return valve, Andreas needed to switch the stoker steam off before safely working on the lubricator.

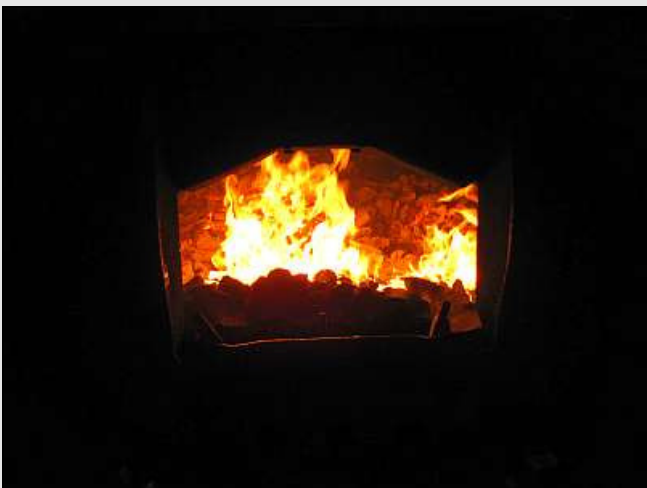
P07 – A sharp truncated, full-width coal bank burns on the leading edge. The central and front firebed stayed aglow untouched for more than 5 hours with the hard high-carbon coal. This class 15F rail-grinder actually LIKES this stuff!

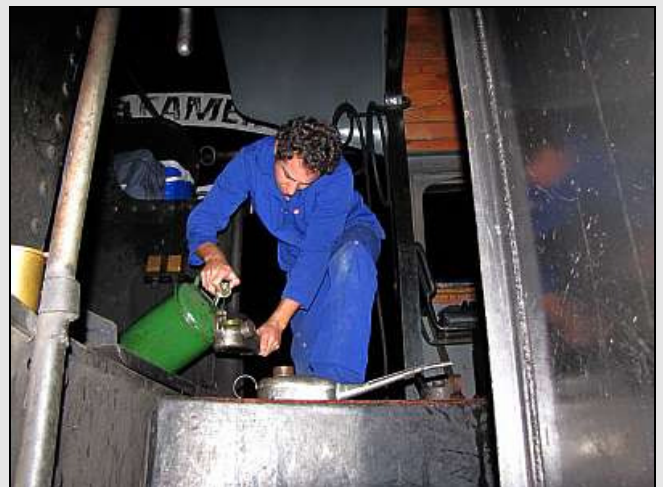
P10 – Recently qualified fireman Andreas Matthee fills up the short-spouted oil feeder to start topping up the Detroit-type lubricator for the day's work. His face is still intact and burn-free, so he listened to the updated stoker instructions.

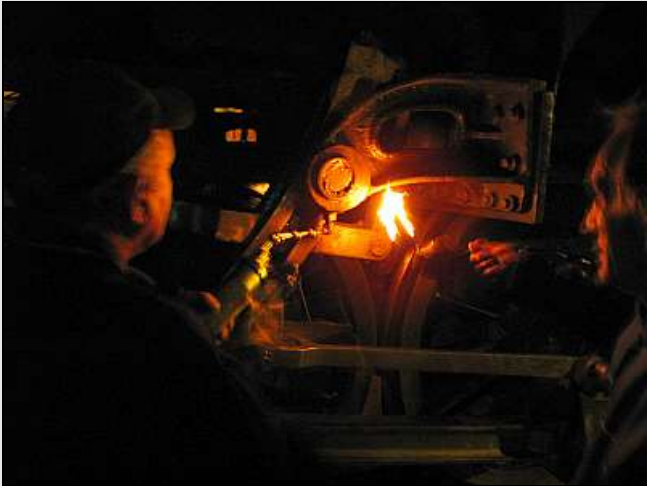
P11 – Piet Molentze greases up the LHS trunnion bearing by the light of a flare lamp. (Held by his friend William.) Note to Reefsteamers : The next driver who asks me for paraffin will get his arse kicked.

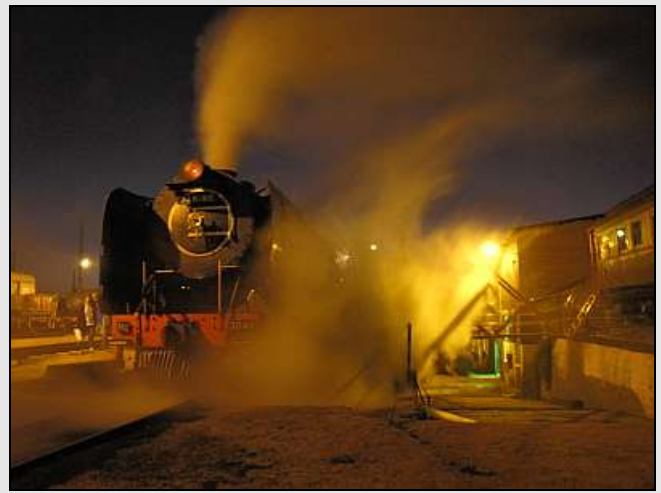
P13 – The flare lamp has either gone out or is missing and Piet is now topping up the bogie axle boxes by feel and instinct in semi-darkness. Luckily, the 15F's bogie wheels are spoked and allow for easy access to their axle boxes.

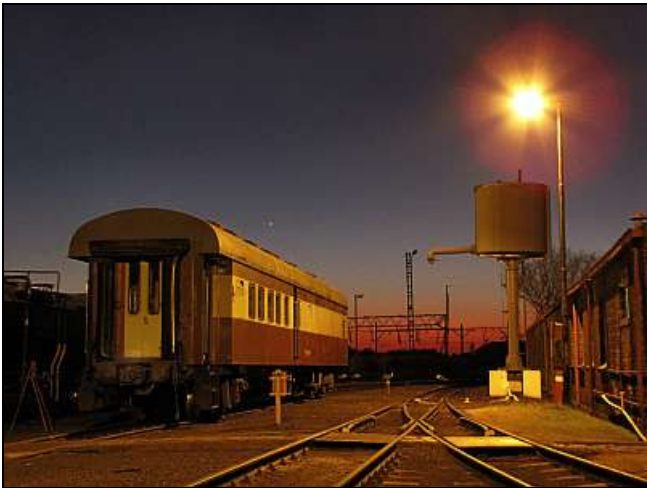
P17 – The Venus-topped Staff and Baggage Van is now booked off for improvements. The relative positions of the two gen-sets are to be swapped over to maximize space usage and to improve the cooling for the larger generator.

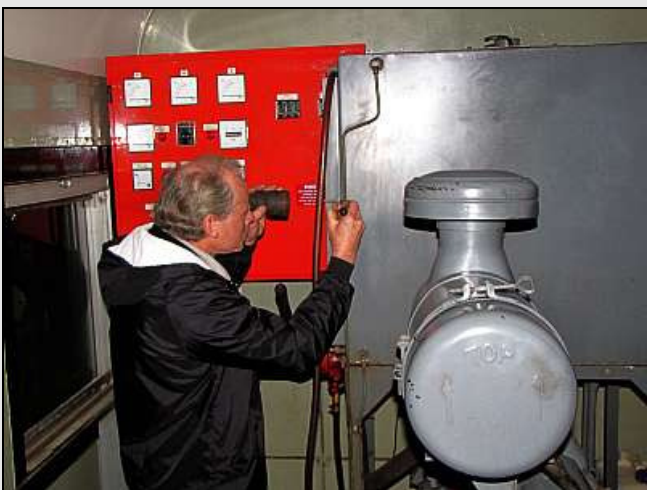
P19 – Engineering Mngr. Andrew King went along for the gen-set's first ride although it had already run for 9 hours while powering the coaches. Here, Andrew is marking the fuel level in the gauge glass to check fuel consumption.

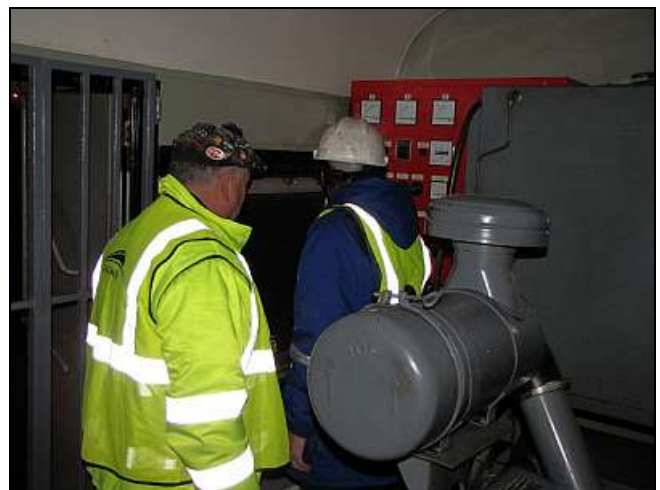
P20 – Training the Train Manager. Dennis Edgar gets a run-down and (simple) start-up procedures presented by Alan Lawton. The gen-set has a strange, almost-spooling startup from cold, but fires up within less than 2 seconds.

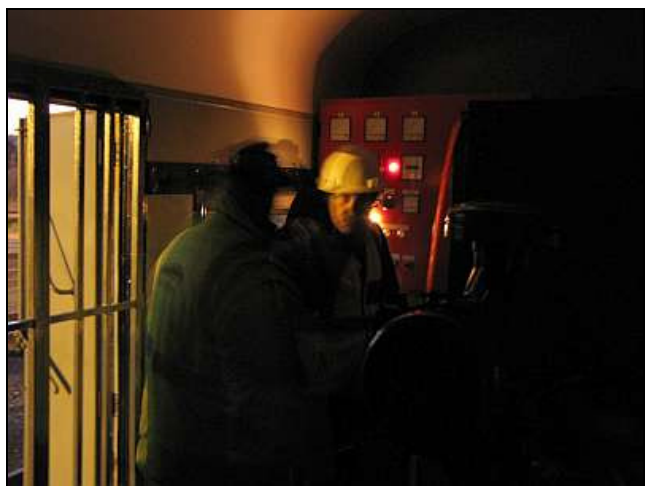
P21 – The white lamp sez that the 12V starting battery is under charge. The red light indicates that the generator's stator is live. The load hasn't been switched in yet, so the lights are still dark and the 3 ammeters all read 'zero.'

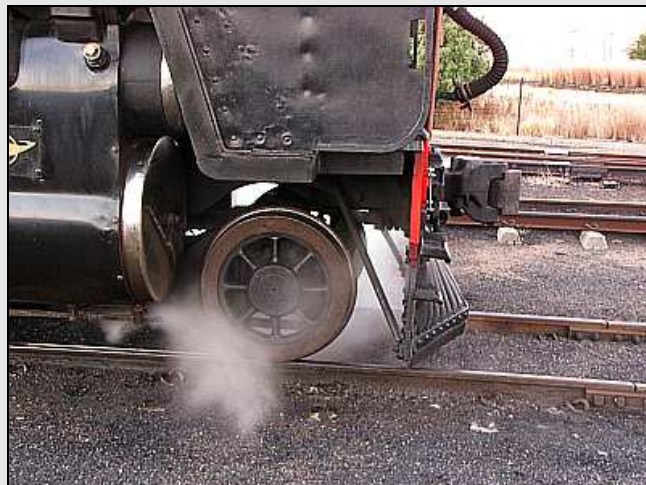
P30 – Being Cape Gaugers, there naturally isn't much space between the frames. But it is always startling to see the open gaps and 'see-throughs' around the wheels and under the boilers. Here the bogie axle looks a bit exposed.

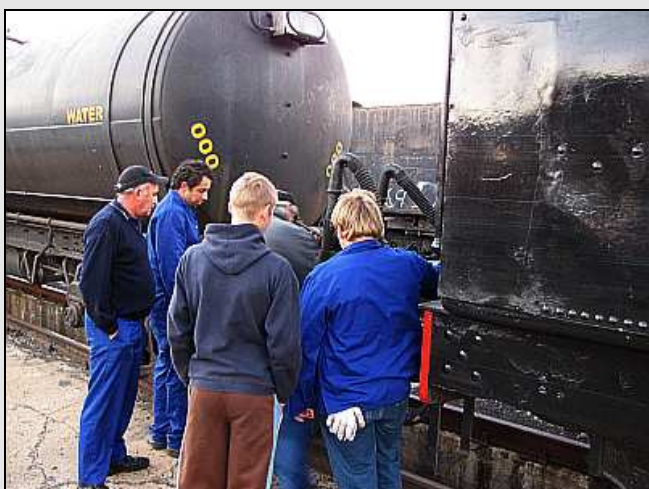
P31 – If it doesn't leak, it's not a steam engine : whether it's oil, hot or cold water, steam, vacuum, sand, amps or air. The fellows are wrestling with the tanker's water coupling. The rubber sealing rings are less resilient in the winter chill.

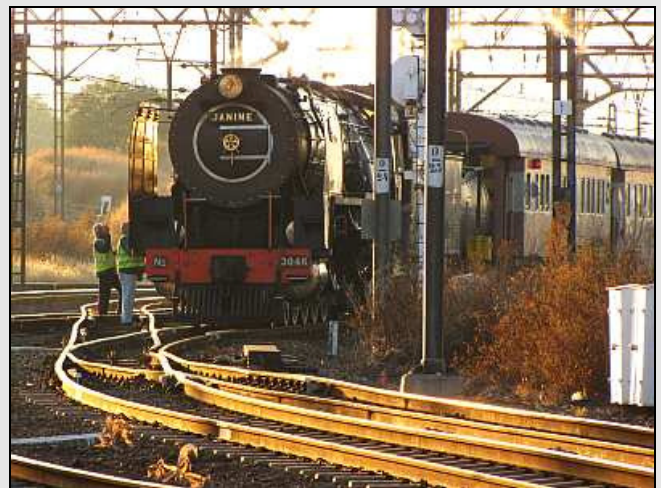
P37 – Not seeing us behind the bend, Andreas is already starting the injector as he approaches us – you don't often see this angle! The overflow isn't blowing as bad as it looks – that steam is condensing heavily in the cool air.

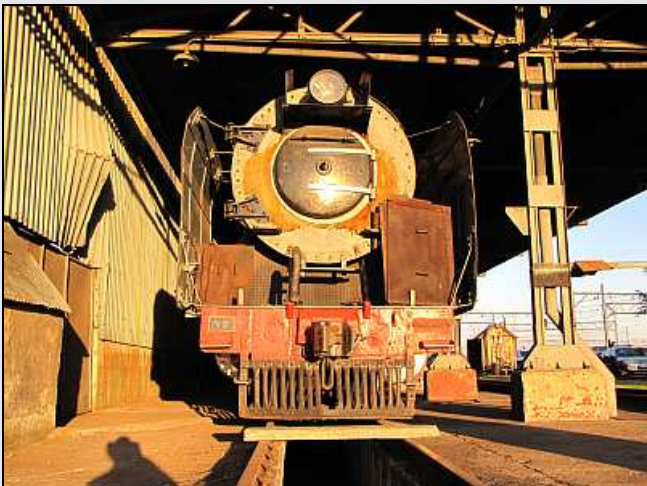
P43 – Recently shunted to the old boiler-washout area for security, Friend of the Rail's 25NC No.3404 'Elsabe' lifts her rusty face to the sun. On the buffer beam are stacked the spark arrestors (right) and the baffle plates (left).

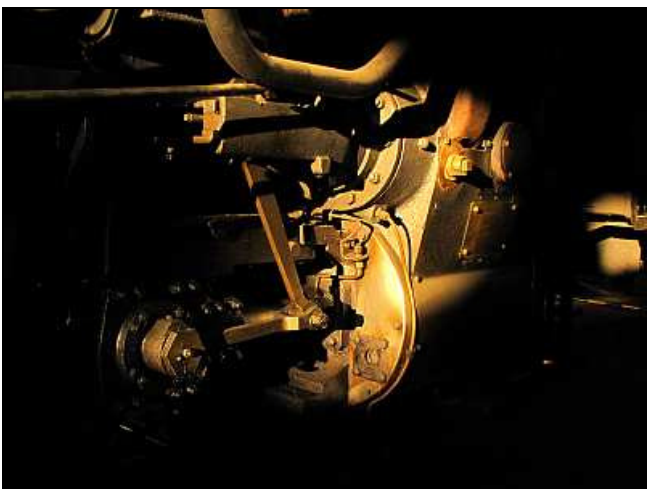
P45 – Where the steam meets the steel ... No.3472 'Elize's' massive rear cylinder cover, combination lever and union link are nicely highlighted.

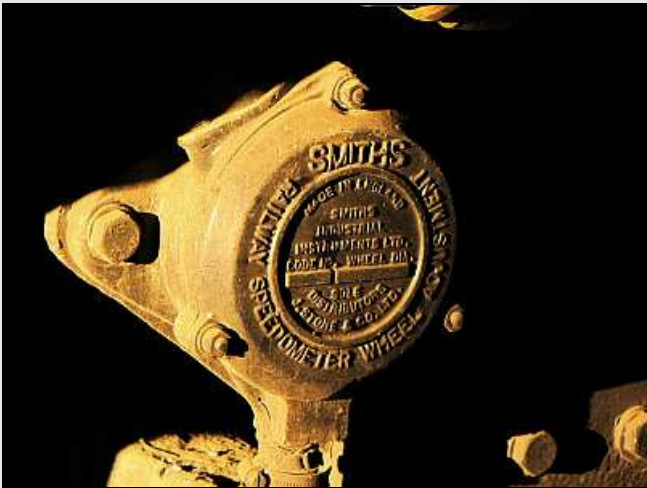
P47 – The terminal head for the pulsed speedometer. These are universal across the later SAR locomotives with the speedo sets being calibrated for the wheel diameters.

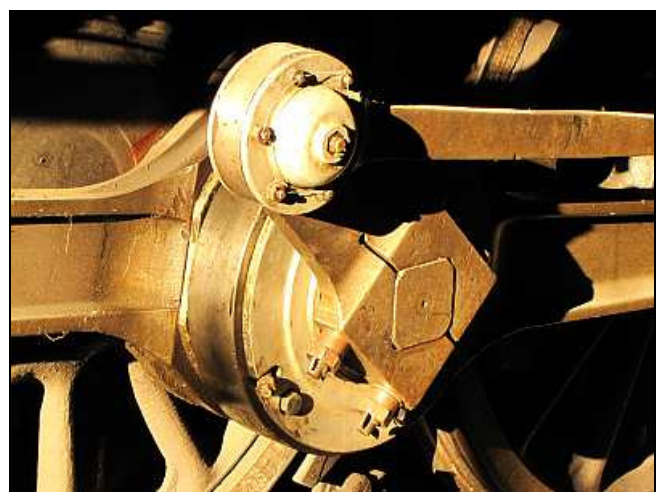
P52 – Details of the roller bearinged return crank – including the usually-unnoticed thrust plate between the two housings. Contrary to popular belief, these bearings DO need greasing on occasion – but not for every run. We top up this housing with pumped white grease once a year.

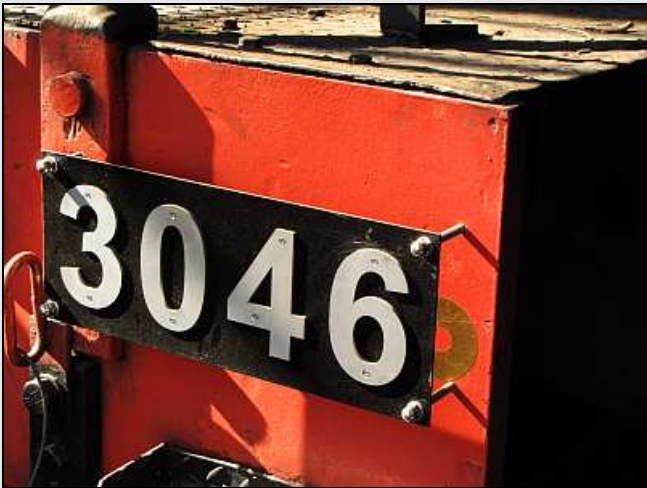
P53 – Photoed the previous week – No.3046 ‘Janine’ now has stand-off number plates. The numbers were custom made and will not require polishing. The existing stickers were left intact. They are still firmly stuck but their slightly gold colour makes them harder to read at a distance.
