1). INTRODUCTION :

Class 15F No.3046 'Janine' behaved well overnight. I was a bit overconfident with the hard-coaled fire bed staying aglow for me as it did the previous week and I ended up over-shooting a bit with the bank, as you see in the second pic. (I had over-estimated the thickness.) But the grandly porky old iron sow soaked up all that errant heat energy in her capacious bellyful of hot water and hovered at about 1200kPa for most of the night. ☺

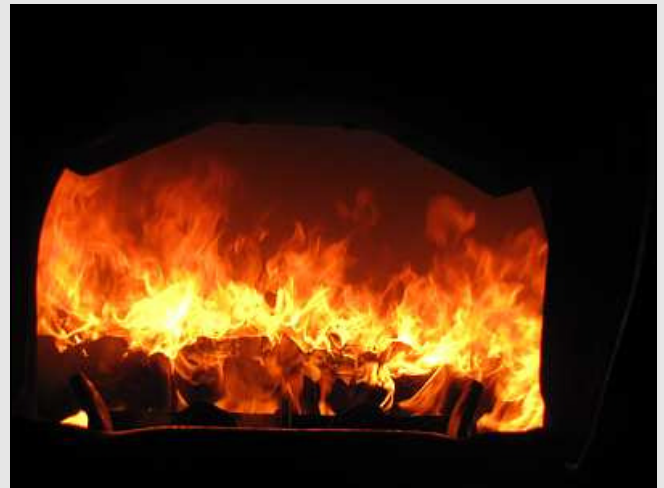
P02 – Deep Heat. Oom Louis left me with an incandescent firebed and bubbles at the whistle. No extra raking or blow up required. I had to ladle out careful portions of coal to get the bank up without the boiler running too far away with me.

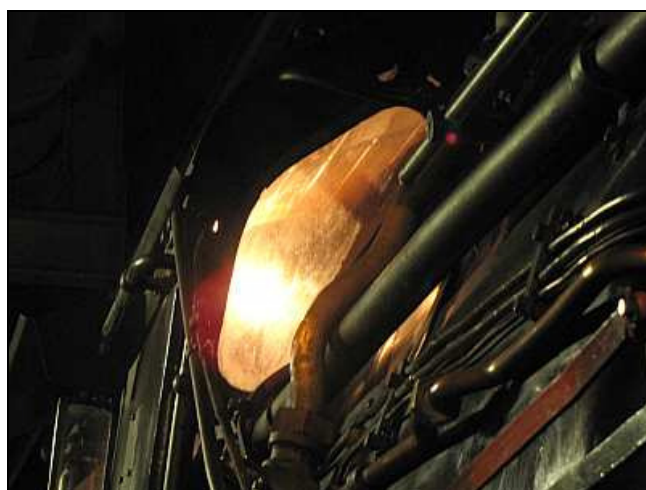
P08 – The 32V Romanian-made incandescents of a loco cab always add an attractive warm glow to the proceedings. No.3046 'Janine' has done well with three out of four cab light globes intact and functioning for two runs in a row.

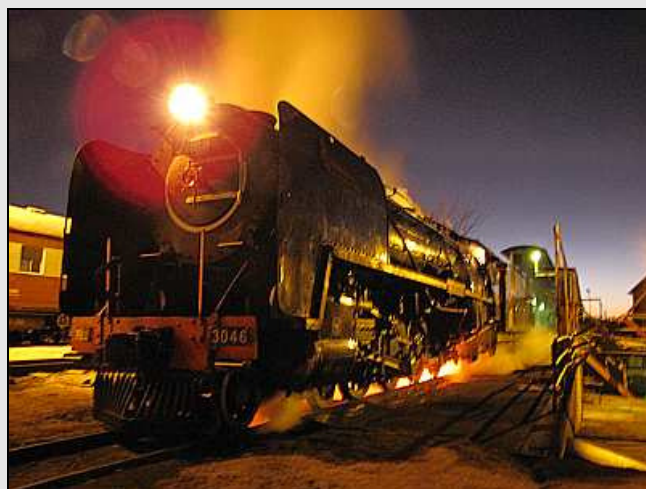
P10 – Fireman Breydenbach had rolled in a bit more coal than usual for a thick firebed with plenty thermal reserve for fire cleaning on a freezing morning. A 15F's fire is cleaned in 'quarters' as the grates, unusually, are in the middle.

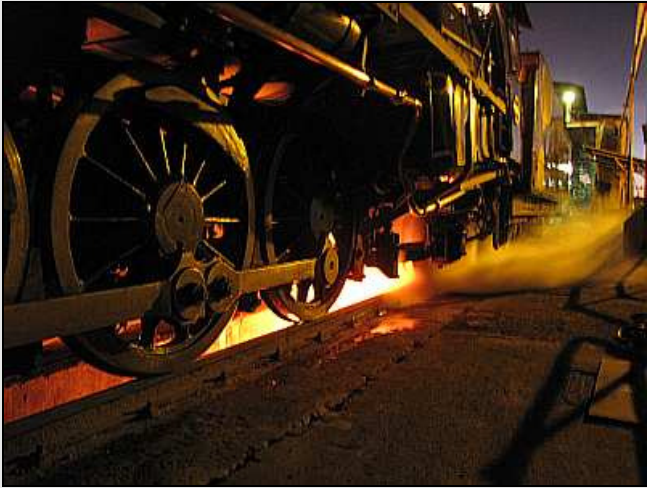
P11 – This looks photogenic, but the glowing yellow trench indicate that partially burnt coal is going through the chute. Johann B. had miscalculated slightly, as he wasn't aware that we leave ½ hour earlier these days on our new YQ.

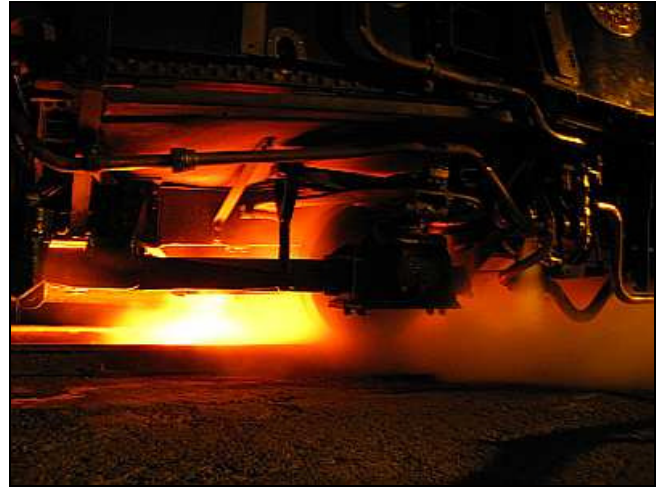
P12 – The bissell truck's yoke and the leading spring link are backlit by the tumbling inferno from the chute. Notice how the aerodynamics in the morning breeze cause the wheel to be shrouded in steam but the axle box stands free.

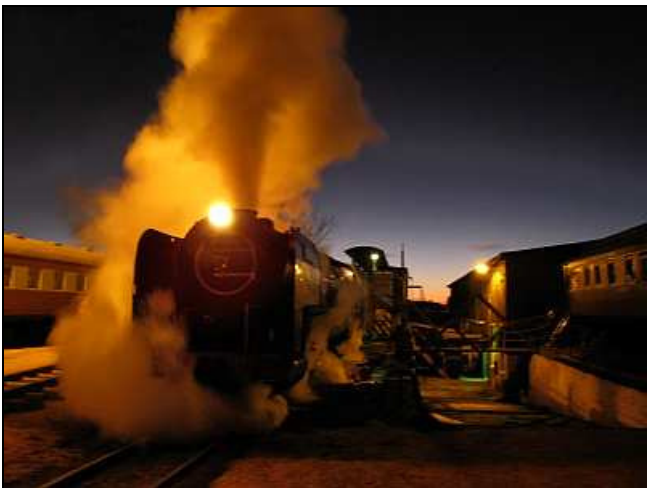
P13 – Smoke stack! As often happens, the copious ash pile blocked the ash chute. Louis had to creep back over the pits to clear the discharge. The sky is still clear but the vanguard of the morning cloud bank are already visible.

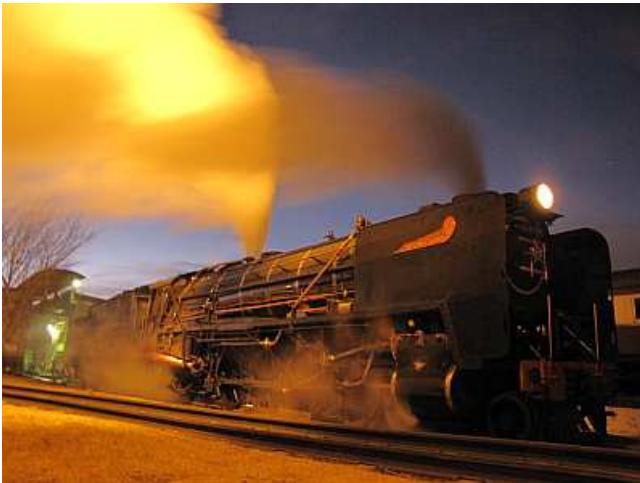
P17 – Now Breydenbach cleans the second half of the firebox, note that the ash pan is aglow and the safeties are still lustily blowing! And this is after sitting with the ash pan coolers running and thus putting in fresh water in the boiler.

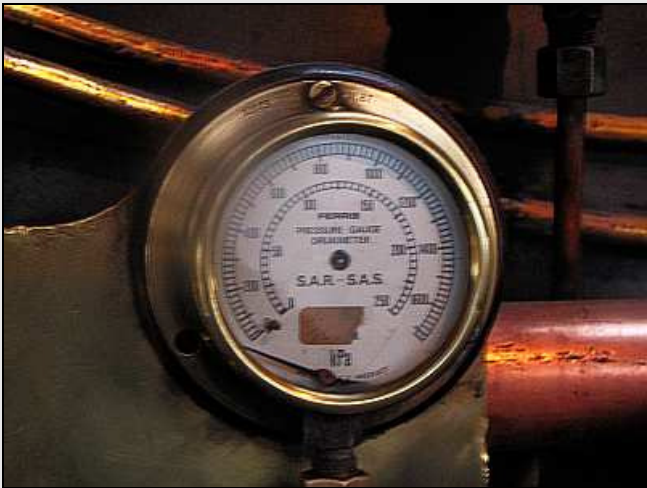
P23 – Is preserving these rusty old sleds a pointless exercise? This pressure gauge has dropped its pointer. It is the old passenger steam heat pressure gauge and isn't actually connected any more anyway – so ... no problem...

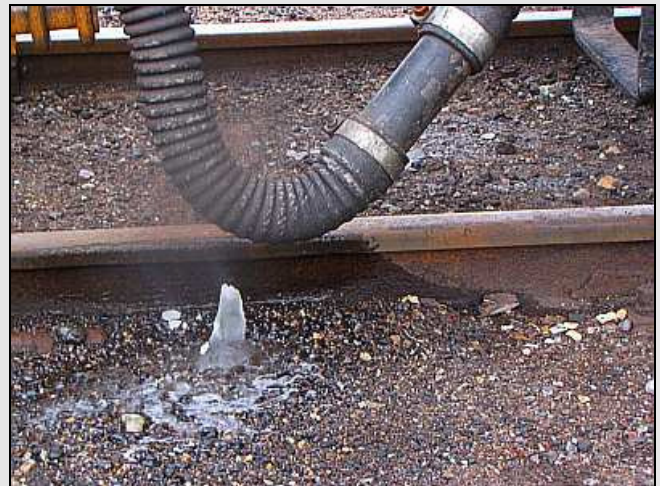
P26 – The rubber rings in the hose couplings had hardened with the cold and were making an even worse seal than usual. The inevitable water drips formed this impressive stalagmite in less than 10 minutes! (Temp was -1 deg.)

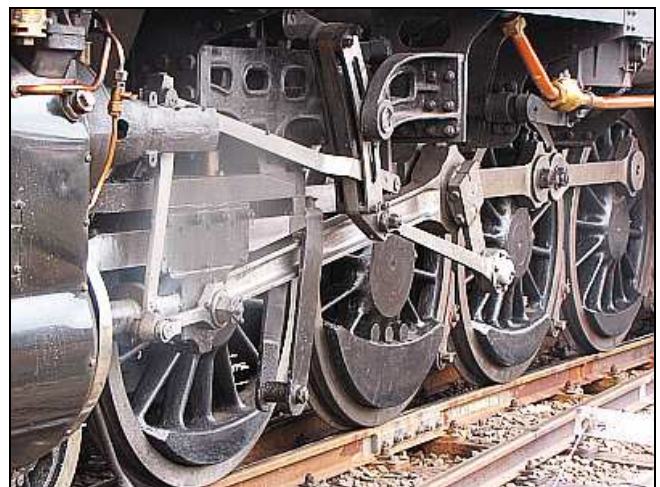
P28 – No matter how many times you look, there's always something new. See how the counterweight on the intermediate driver is differently sized from front and rear drivers? And the main's counterweight 'trails' the others.

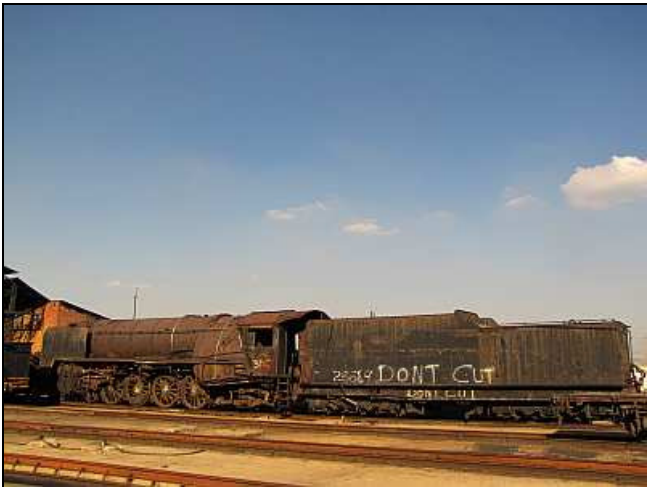
P29 – Derelict 15F No.3042 has a good boiler and reasonable axles. The EW type tender optional extra! She was assigned to us in an exchange deal for previously assigned Class 15F's that were mistakenly cut up in 2006.

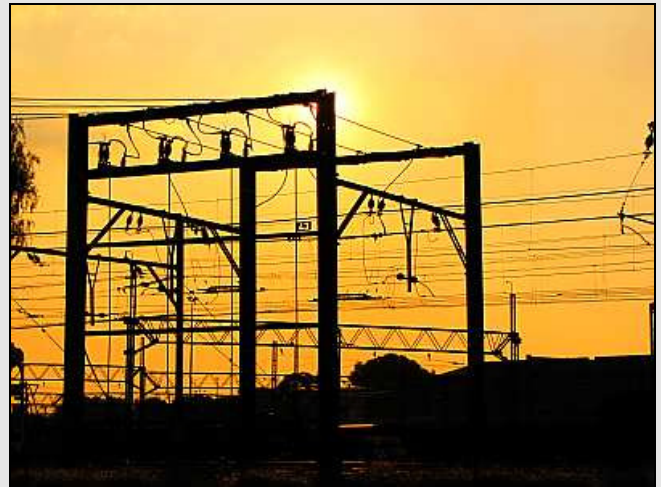
P30 – These are the 4-line isolator frames that supply the 3000V DC traction current to the adjacent section of the main line. In the cantenary in the background, you can see two mid-span section breaks in the traction wire.

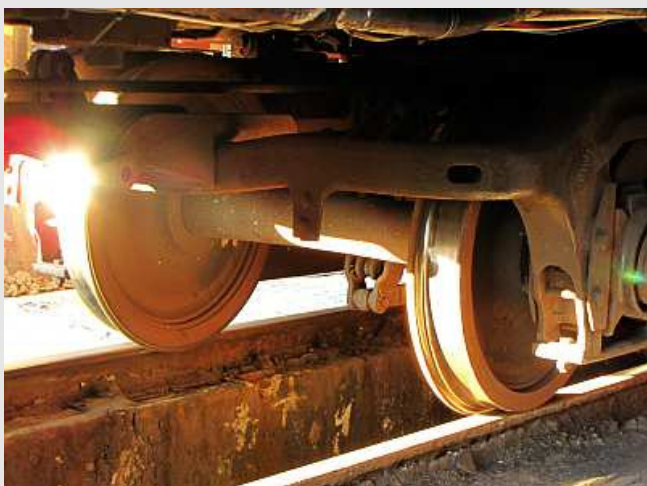
P31 – A sunlit axle on a commonwealth bogie. Note the one piece cast perimeter frame as compared with the old-fashioned multi-piece frame as shown on the right.

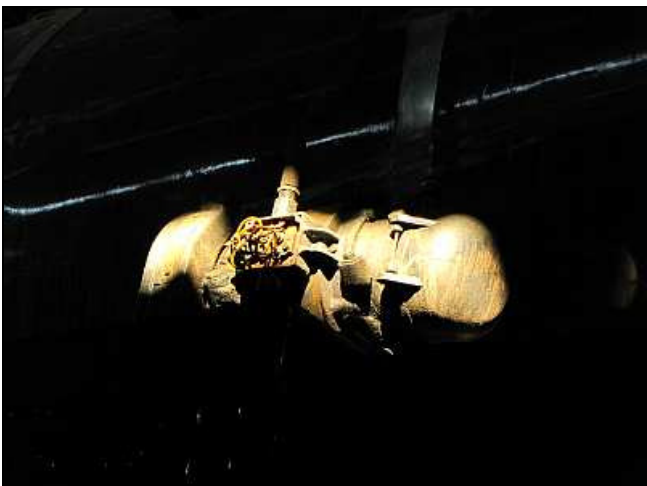
P33 – A spot-lit 'turbo-mo' on Class 15F No.3016 'Gerda.'

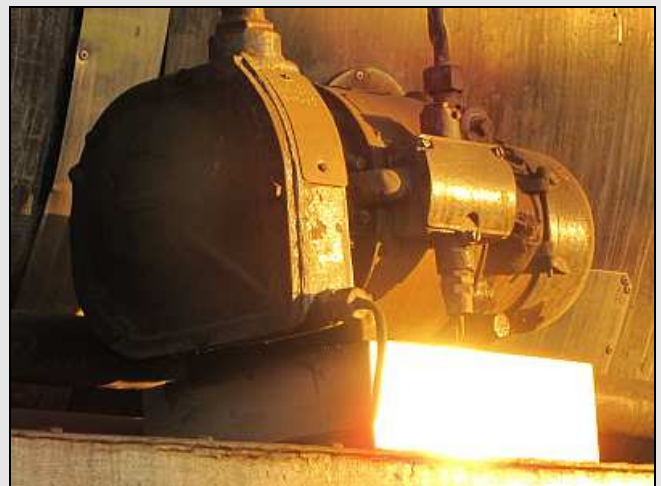
P34 – The sun-lit dynamo on the stored 25NC No.3404.

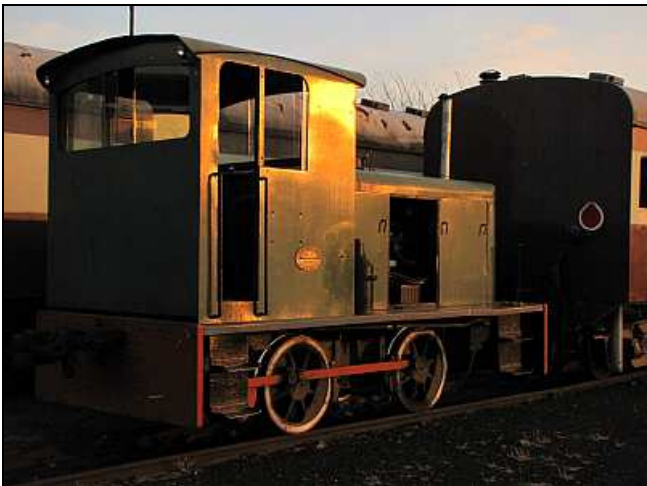
P37 – The Hunslet Taylor at rest. Apart from occasionally running out of diesel (no fuel gauge) he's been doing well post-overhaul. Two bay doors are open to assist in cooling and to provide quick access to the battery and fuel valves.
