## Progress Report – Bloemfontein – 14 June 2011

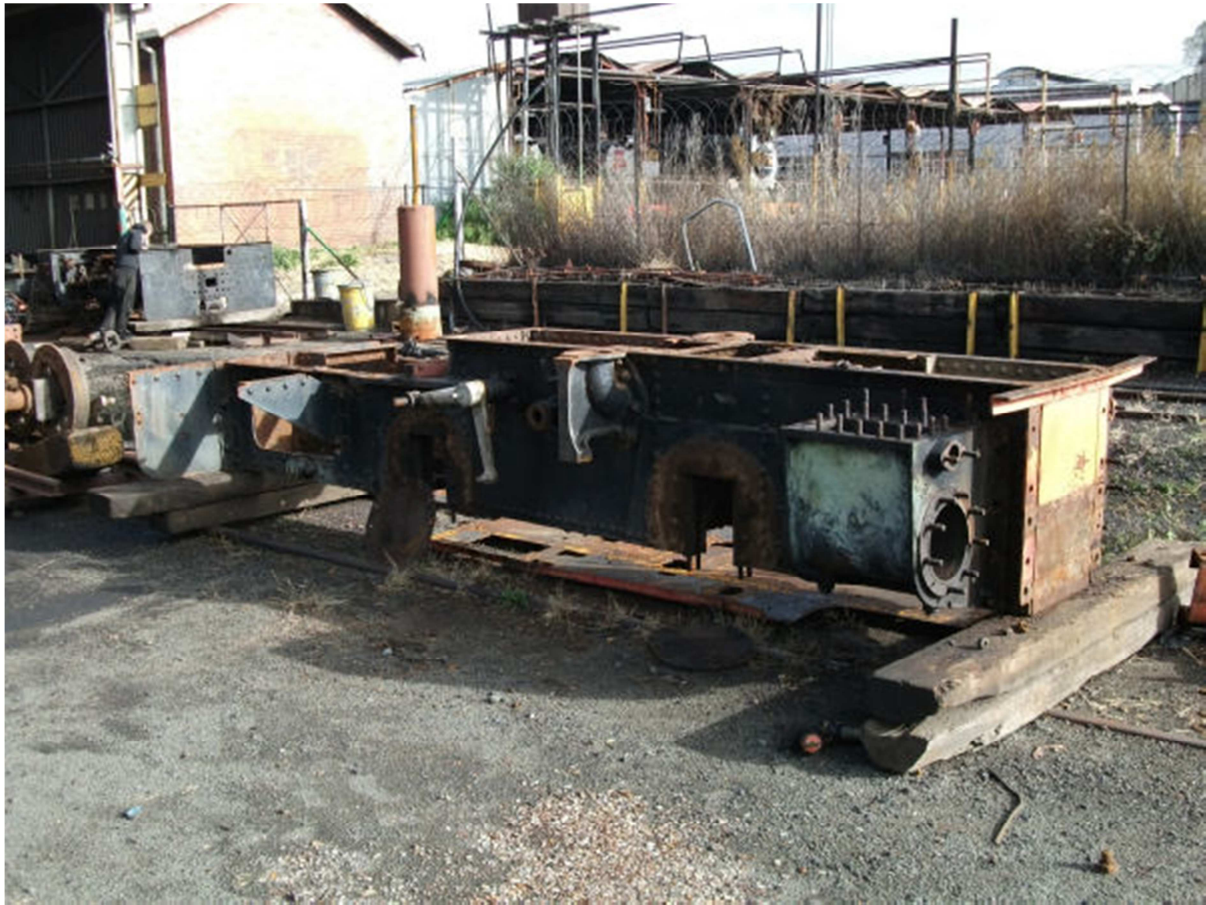
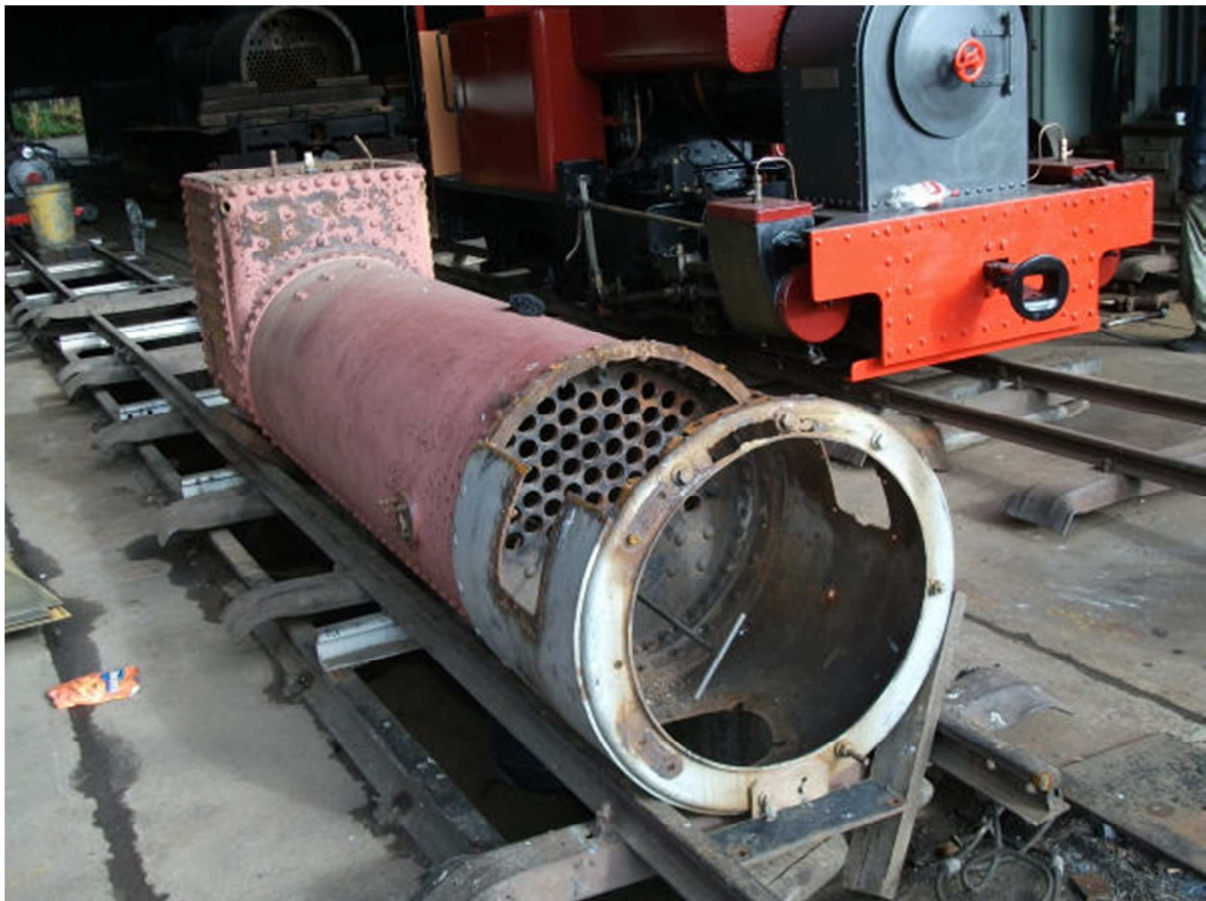
1) Ex SANRASM O&K locomotive, No. 12691.

The photographs show the locomotive in its fully disassembled state. Indications are that the boiler is repairable. We do not have any technical information on this locomotive and would appreciate photographs of these locomotives in use, drawings etc.

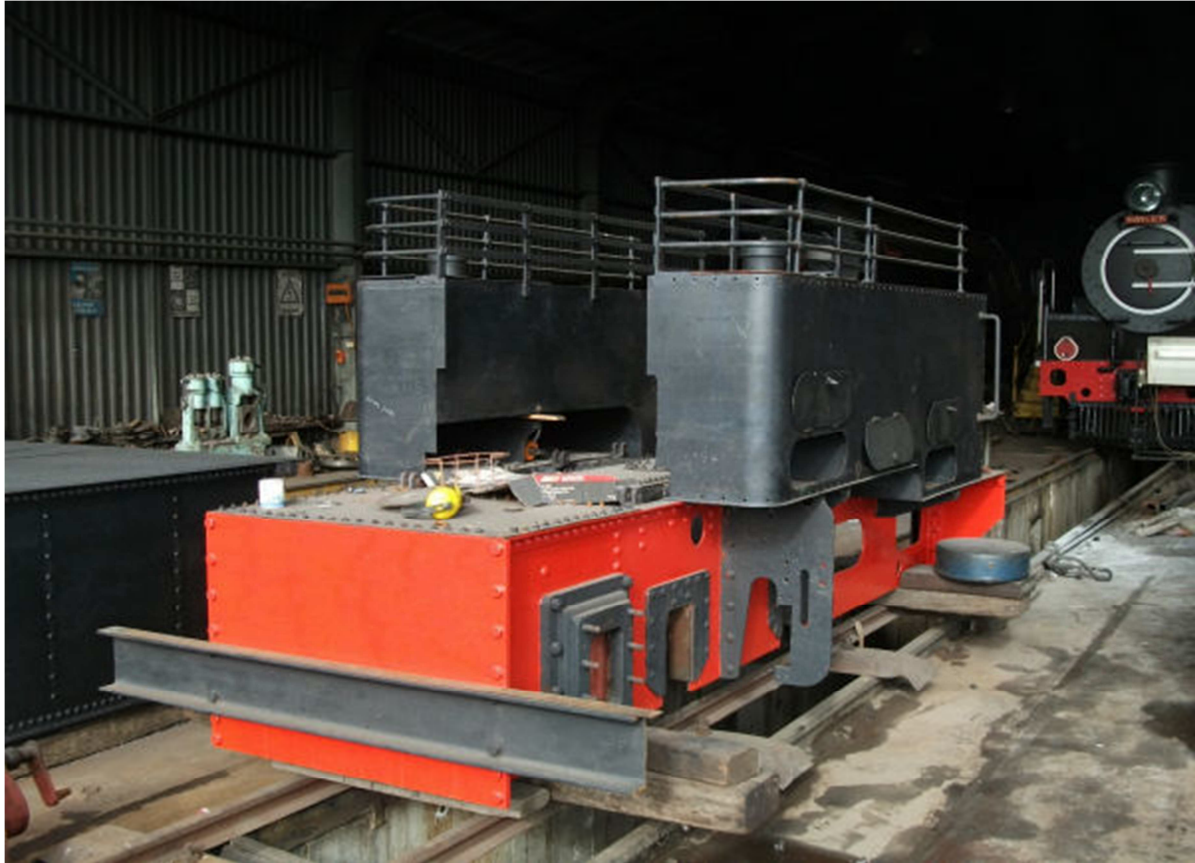
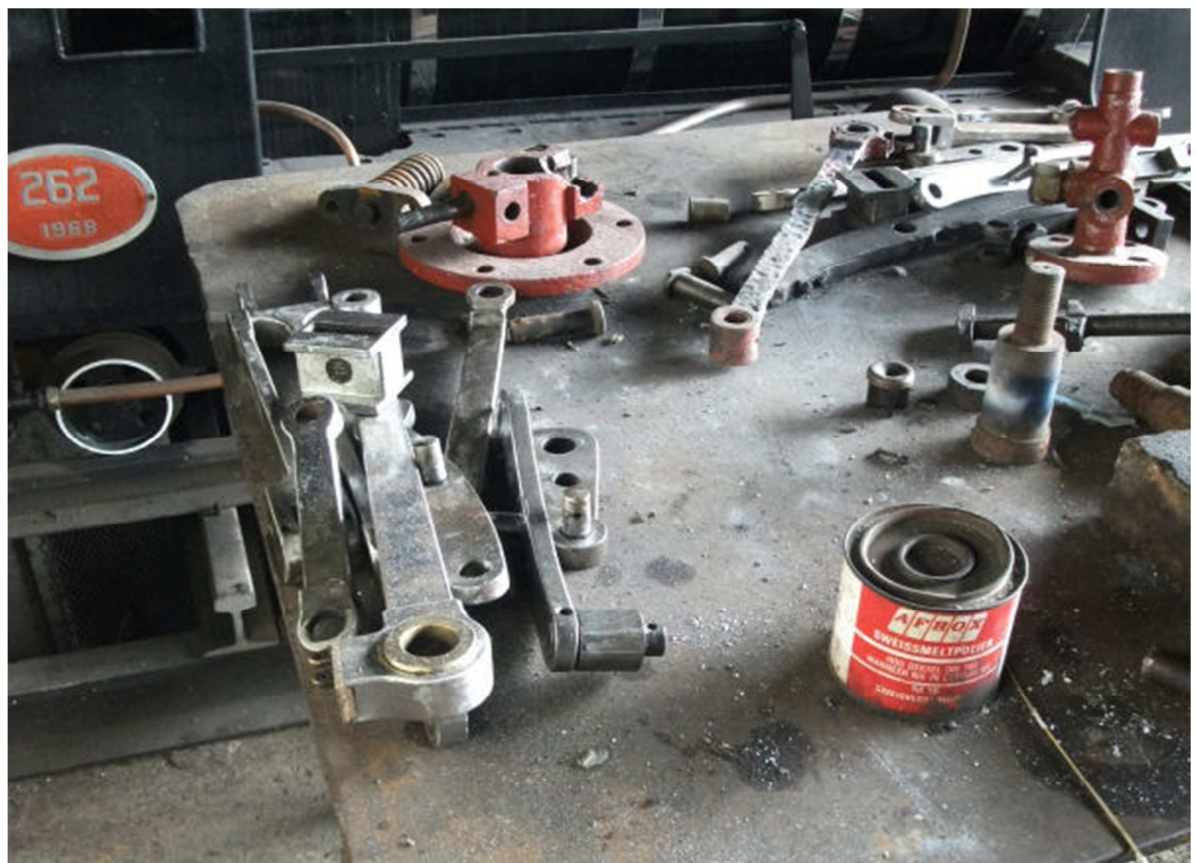
## 2) Arn Jung 847 locomotive.

We hope to replace the cylinder next week when they return from the engineering works. They had to machine both the cylinder and valve faces.

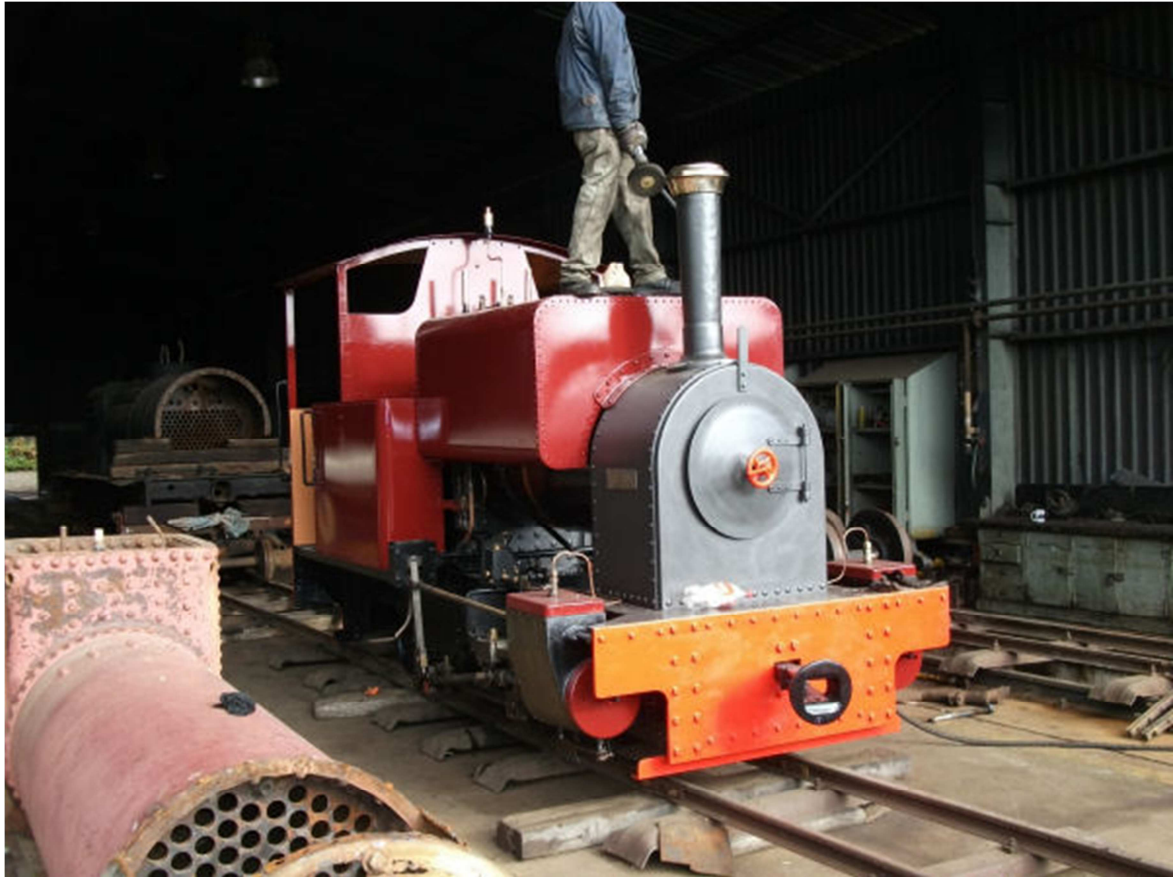
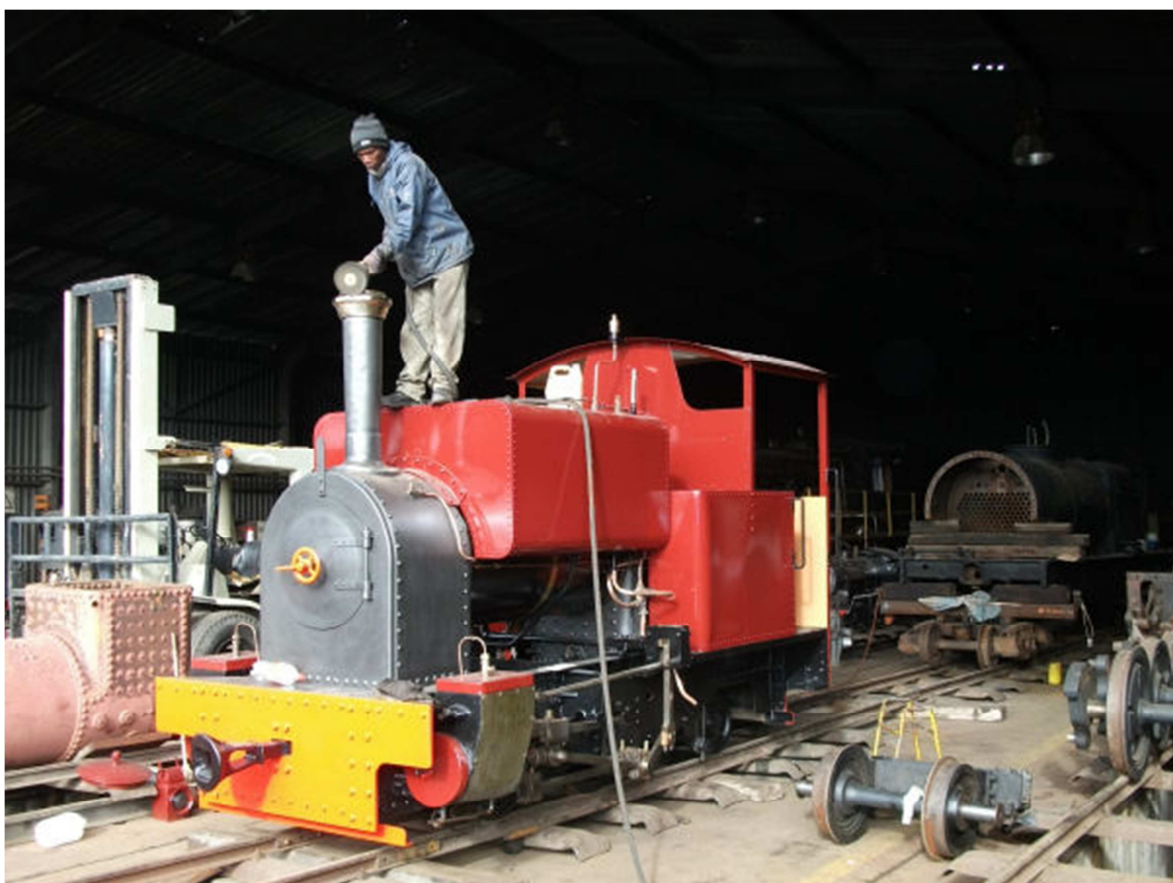
### 3) Kerr Stuart locomotive, No. 4063.

Kerr Stuart, No. 4063, had been restored by Lukas some time back. However due to a steaming problem the boiler was damaged and the restoration had to be redone.

The job is nearly complete.

We completed the repairs to the boiler and assembled the locomotive. We did start the paint job last week but bad weather forced us to move on to more suitable work..

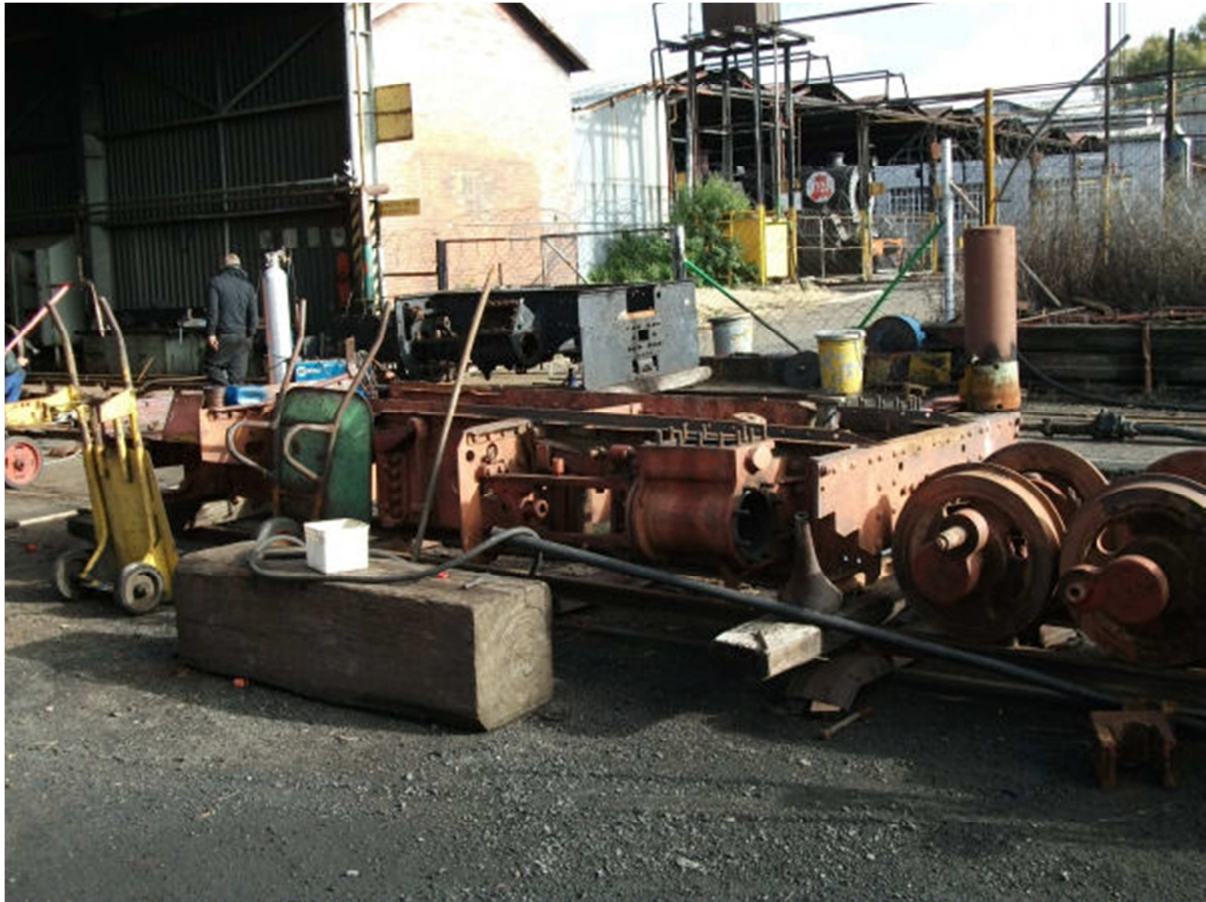
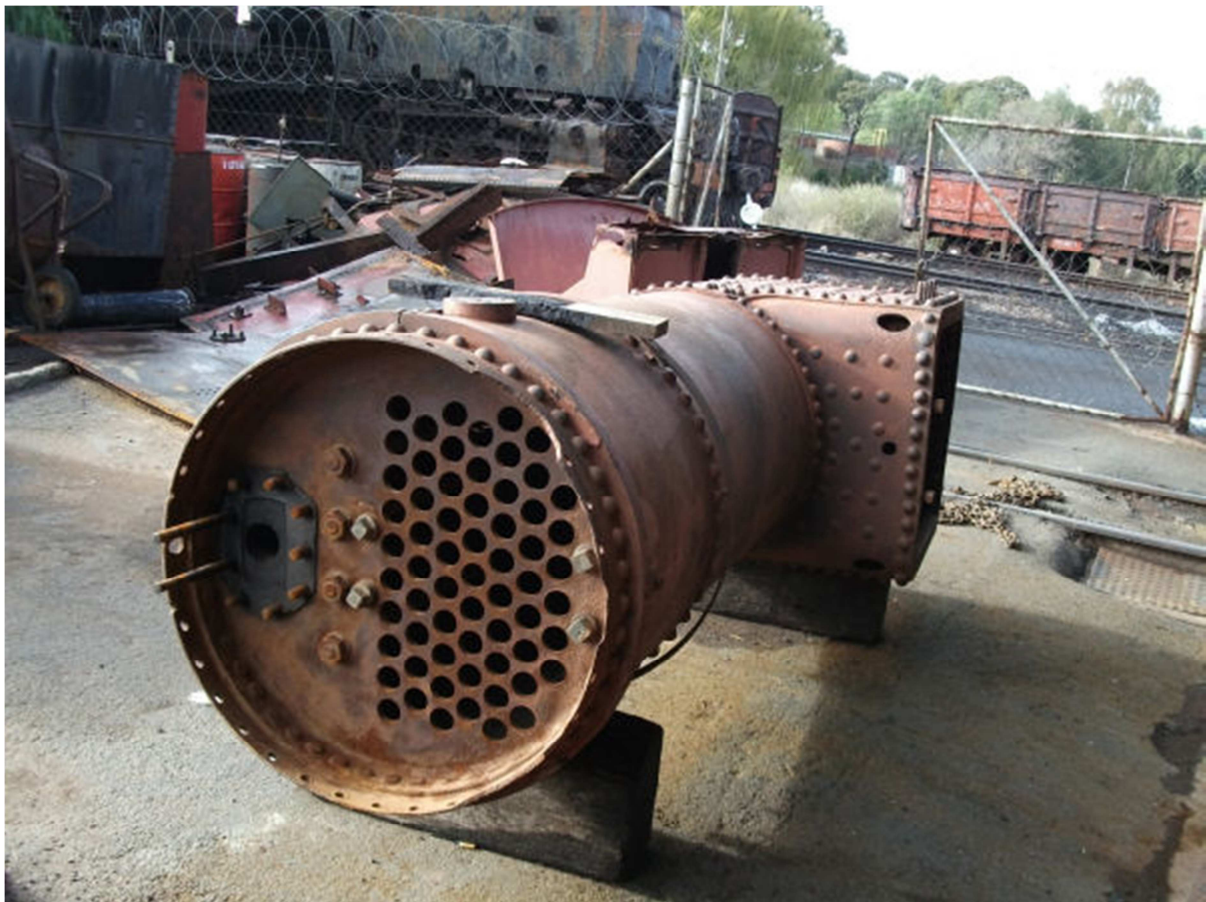
#### 4) Ex SANRASM Avonside, No. 1624.

The locomotive is now stripped in the Bloemfontein Works.
