1). HUNSLET TAYLOR SHUNTER – GEARBOX REMOVAL AND DISMANTLING:

2). PROJECT : CLASS 15F NO.2914 RESTORATION :

This Depot Report was compiled by Mr. Lee D. Gates on behalf of Reefsteamers Association NPC.
For observations, corrections and suggestions – email me at documenter@reefsteamers.com

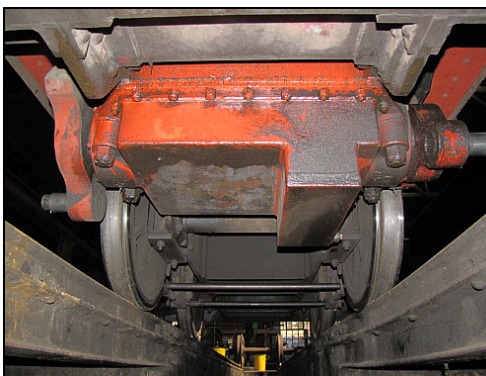
Here's the under-slung beast still in position.

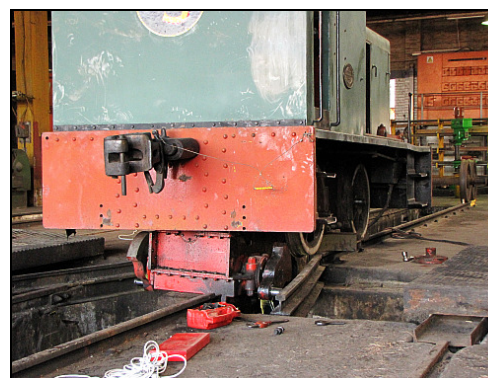
A very difficult birth in progress. We were a bunch of tjops though, as we could have removed the steps – but getting the gearbox past the rear wheels was still a challenge.

The faulty gearbox was both removed and dismantled in a single marathon Saturday session lasting until 0:15am on Sunday morning the 12th. Because of the patient's short wheelbase, and the close proximity of the gearbox to the rear wheel, it took quite some juggling to get it out. It was removed by a team of 7 people, one traversing trolley, a forklift, several slings, a chain hoist, lots of timber, one pile of boerie rolls and endless trays of tea!

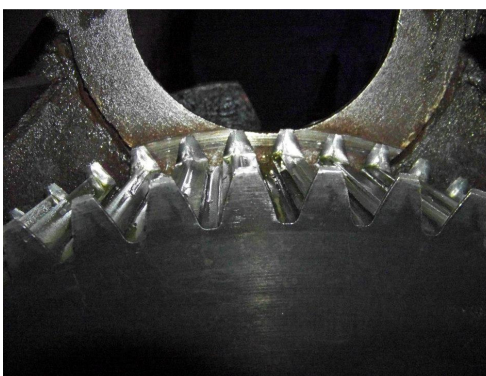
The worn and broken jackshaft gear teeth as photographed by the Mini-Mienie. You can compare their worn state with their original profiles derived from the unworn edges.

The gearbox fault appears to be a metallurgical related fault on the jackshaft drive gear. The teeth are worn down to sharp triangular points of half their original height and completely broken off at some points. We already knew that the case hardening wasn't quite right, but it appears that the gear was of inferior material as well.

The gear will need to be refabricated. The double taper-barrel bearings will need to be cleaned and carefully inspected – but it is very likely that they will need to be replaced due to oil contamination. The remains of the broken gear teeth have literally been ground up into a firm silvery-coloured paste, which has settled out into the corners of the oil pan. The bearings are lubricated on a primitive semi-loss system, regulated by labyrinth seals. It is thus almost certain that the bearing rollers have been damaged from abrasive metal particles floating in the oil.

As we don't have the facilities or manpower to rebuild that jack shaft, it is to be taken to Surtees Engineering for quotations for repairs. The gear needs to be re-made, and the beaten shaft ends skimmed and re-sleeved for a tight fit.

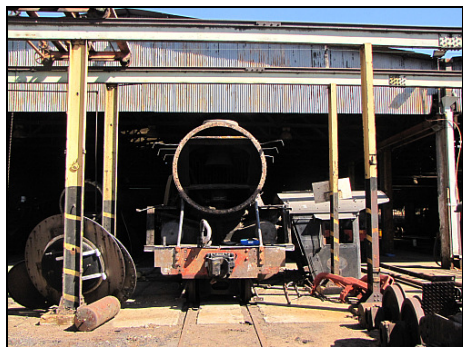
Class 15F 2914 joins the 'faceless brigade!
You can see the uneven putty (light brown) from this distance away! No wonder she had no induced draft from the front end!

Class 15F No.2914 has kinda been shunted into the background recently, what with the Open Day n' all. But she will soon be in the limelight again! The smoke box's front cover has since been removed for access to the smokebox's interior as well for as inspection of the mounting flange. Even though the crudely applied sealing putty is still in place, you can clearly see where the flange was roughly ground down after an accident. Apparently No.2914 once sideswiped another 15F loco.

The smokebox front flange will need to be cleaned and shimmed and/or welded and then reground to obtain a flat surface. We might use the cover plate from one of the rust bucket F's stored in the carriage sheds, if we can find one that is flat. That would be a quicker fix – if the bolt holes line up!

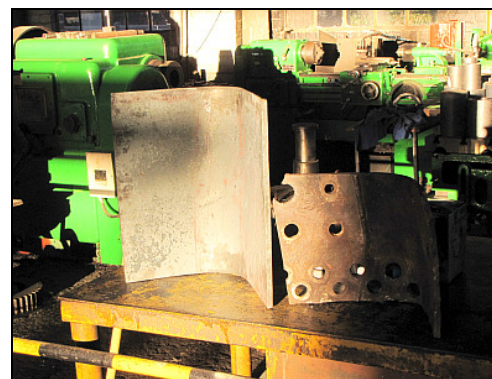
15F No.2914's new firebox corner patch as set up for display on our Open Day.

The patch plate (for the firebox's right hand rear corner), which has been forged into a matching radiused corner, has been certified as still-compliant even after being heated. It is now waiting to be cut to shape and drilled. The next work team project on the No.2914 locomotive itself is to finish de-rusting the boiler barrel and to start applying the primer coat.

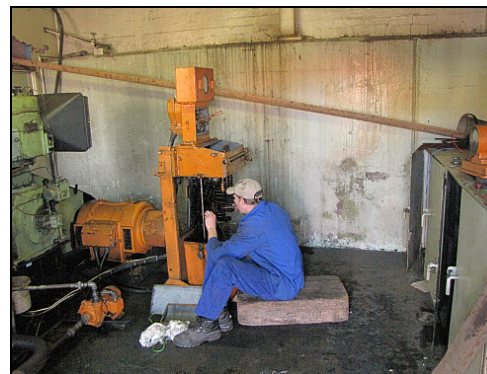
George tackles the lonely job of diagnosing the faulty starter, with neither wiring diagram or colour codes available.

George previously managed to get the compressor limping along. He spent Saturday afternoon poking around the exposed resistance gear and contacts, all of which are normally oil immersed. It took quite a few hours of tracing wires – all of the same colour, and with no accompanying no wiring diagram, to find the fault. A section of wire had burnt off from one of the phases of the pilot relay. The semi-vapourized remains of the copper were found in the acid sludge at the bottom of the tank.

It appears that the recent air compressor fault had been caused by incorrect shut-down procedures. People have been shutting the compressor plant off via the main switch and straight away switching it to 'start' mode via a small rotary switch. The heavy motor, instead of spooling down naturally, is then actually connected to the starting resistances.

The 6 pole motor, still rotating under its own inertia, generates its own electricity in a form of regenerative braking. The unwanted electric current is sent straight into the starting circuits, which are not designed for the load.

Originally, it is an example of poor design, as an interlock coil should have been wired-in to automatically disable the starter circuits once the compressor is de-energized at The Main.

It is a matter of training now, really. Instructions get passed on verbally with a little bit getting corrupted each time, instead of being derived from a fixed and referable set of documents. (The 'broken telephone' game effect) The air compressor room is to be locked and a start-up procedure to be drawn-up.

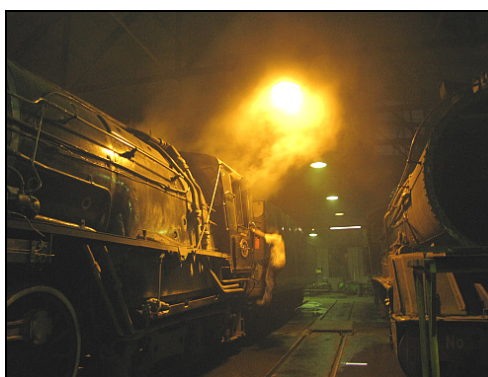
A smoked-out Mini-Mienie hitting the deck for some sulphur-free oxygen shows what happens when you try to light up a 25NC with hardly any draft. That cab REEKED.

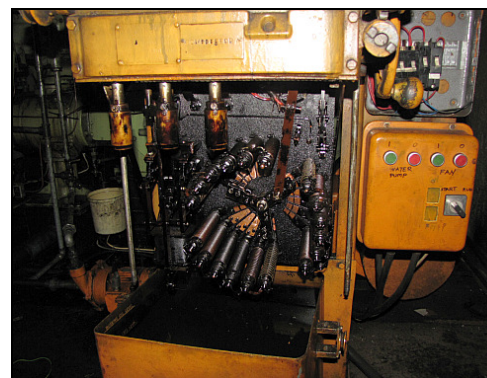
The somewhat scary looking interior workings of the de-tanker starter.

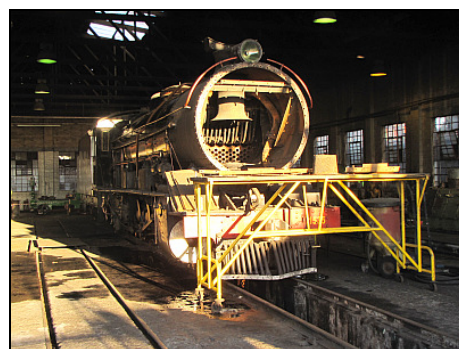
Unfortunately, one of the holes shows signs of having been built up with welding, and the welds are showing cracks. It needs to be carefully inspected and the Boiler Inspector called out to check. It is likely that we will need to do a penetrative die test. If the hole fails – then we will have to cut out a section of the tube plate and make a patch – which means 12AR 'Susie' will be out of action for a while. But we Reefsteamers don't mess around with these old boilers!

Class 12AR No.1535 'Susan' – patiently awaiting retubing and another visit from the boiler inspector.

The Class 12AR No.1535 'Susie' is patiently waiting for her 8 new tubes to be fitted. Both of the tube plates have been treated, and the copper ferrules are already in place at the firebox end. Some of the tubes are to be fitted over the next two weeks and we have a certified welder booked for the final job.

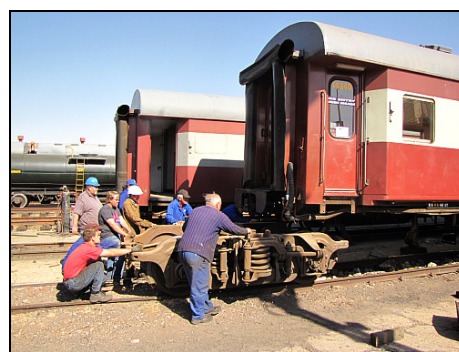
The job went with little trouble, in spite of the jacks being a tad too short for easy working. The obsolete steam heating line had to be cut off the donor coach, as it was obstructing the bogie's removal.

The donor bogie rolls in a bit too fast – notice the two human brake shoes doing their best to dissipate momentum!

The Bar Coach's faulty bogie was swapped out with a spare on Saturday 11th. We had a good sized team thanks to the good response that we got to our somewhat last minute appeal. Thanks guys, for turning up and pitching in.

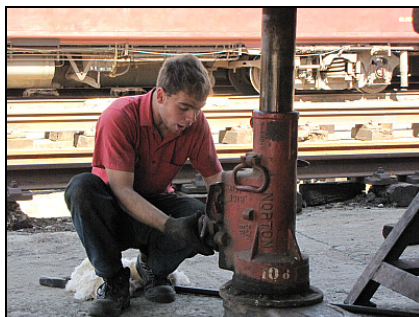
Jacked up, ek se! Jeandre looks a bit startled, but he is actually confirming instructions in terms of coordinating the heights of the jacks on either side.
