1). SHUNTING OUT THE NO.1 ROAD:

2). 15F CAB SCENES:

3). LIGHTS FOR COACH NO.25073: ('DUSTY' THE SEMUMA COACH.)

4). AROUND THE DEPOT:

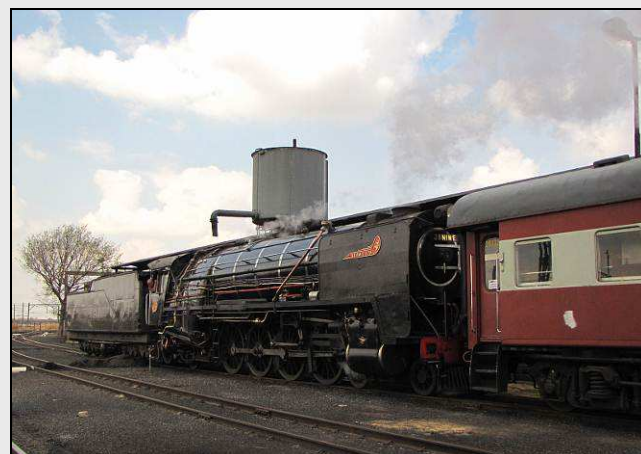
S04 – 15F No.3046 pulls out a rake of coaches. Although most of the load is moving upgrade, the loco is actually starting a mild downer. Note that she isn't in full reverse gear, according to the position of the canted radius rod.

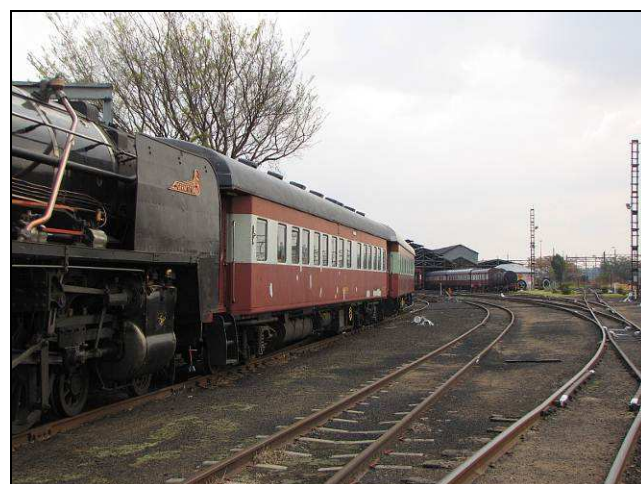
S06 – The coach with acne is the 'Sandstone Sleeper', and the white-heads are paint applied over the recently welded patches. Once the No.1 road is cleared out and its tracks serviced, the body work will recommence on this coach.

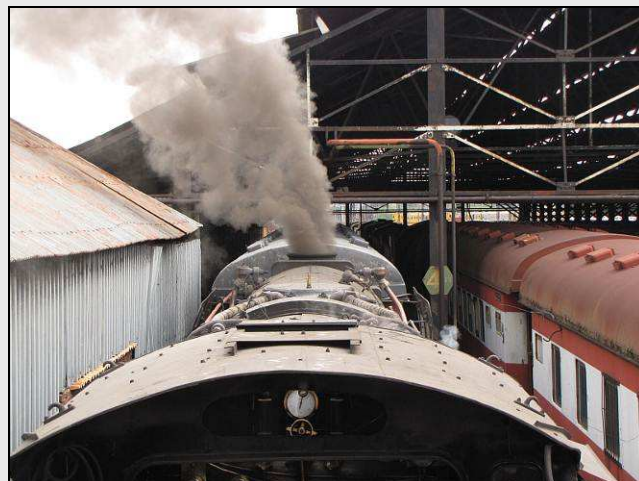
S08 – Nothing quite like a ride in the tender during a shunt! Fireman Victor is doing OK with 1100kPa on the dial and glasses at $\frac{3}{4}$. Note the surviving diesel supply pipes on the columns, as well as the hexagonal 4kph speed limit sign.

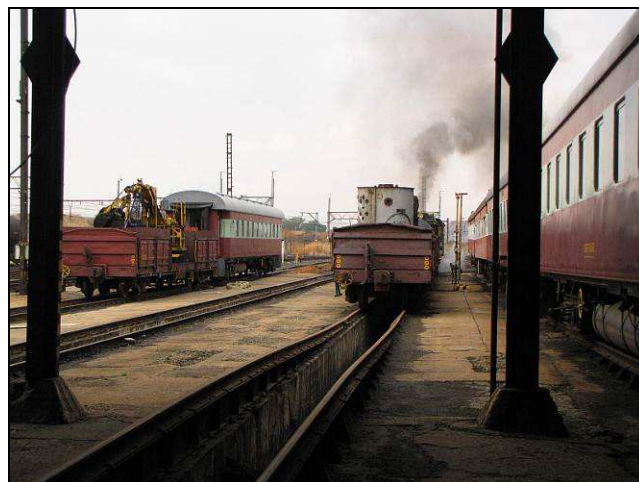
S10 – Salt n' Pepper commin' right at ya! Two vertical boilers for the steam cranes head in for some welcome cover. This is Rnng. Shed Road No.2, one of the 2 tracks assigned to diesels, and you can clearly see how the rails were raised to provide clearance under traction motors.

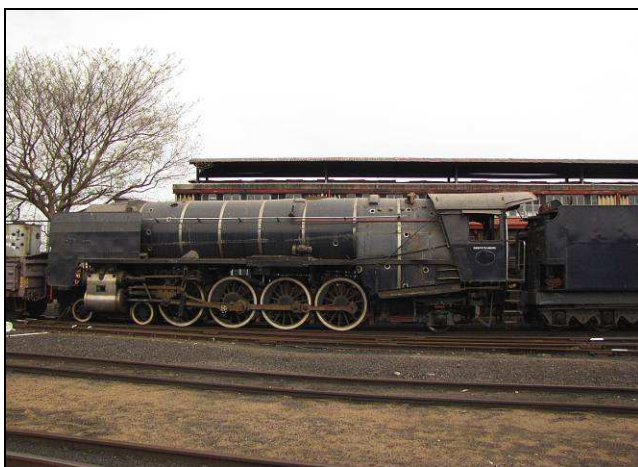
S11 – Poor old 15F No.3016 'Gerda' is pulled out. She has No.2914's firebox problem twice over. She is unlikely to run again until we get Hott-Nutt's 15F 2914 and Dave Shepherd's 15F 3052 'Avril' running again. Then we'd rather get the 12AR, then 15CA, then 12R back in steam.

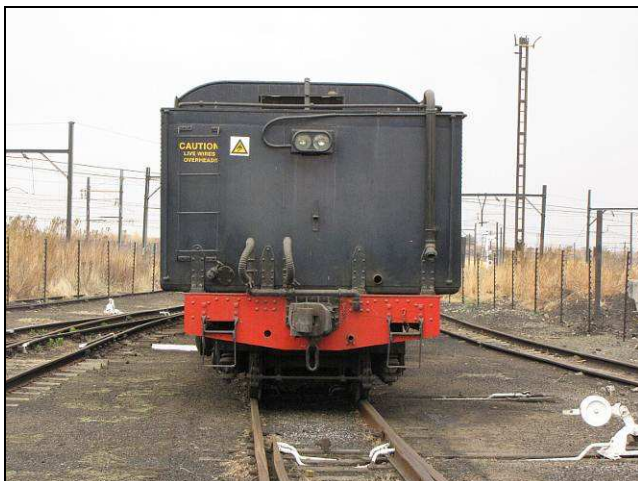
S13 – Just to freak out our overseas friends with their boring 4ft 8½ inch gauge sledge-irons, how's this for a classic Cape Gauge overhang shot? Notice the point blade stretchers are painted white. The theory is that it makes it easy to see if they have broken or have been removed.

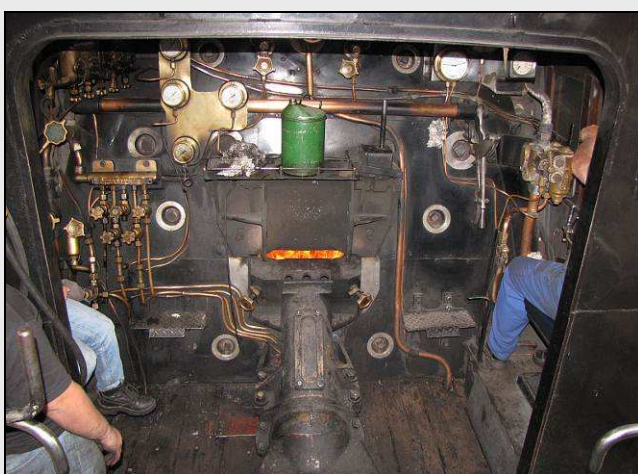
C05 – A more general view of a rather sooty 15F cab. You can see the effects of a blower-less ‘opsteek’ in two sooty updraft streaks on the regulator cross-shaft, the blackened stoker jet gauge and a nicely blackened lubricator.

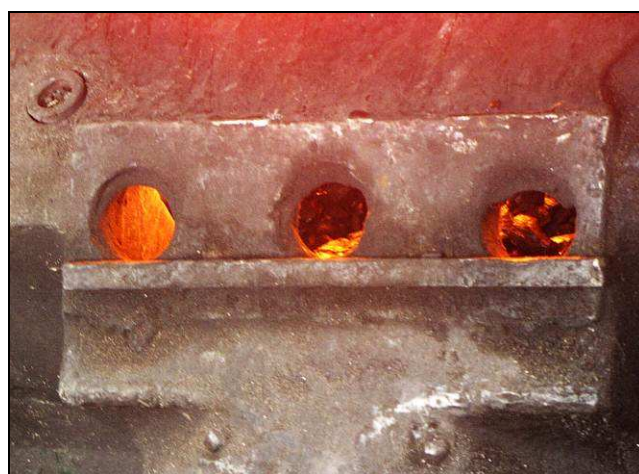
C06 – A new charge of coal has taken up nicely, visible through the inspection ports on the spreader table’s atrium. There is often a bolt placed in one of these to temporarily change the spread without having to adjust the steam jets.

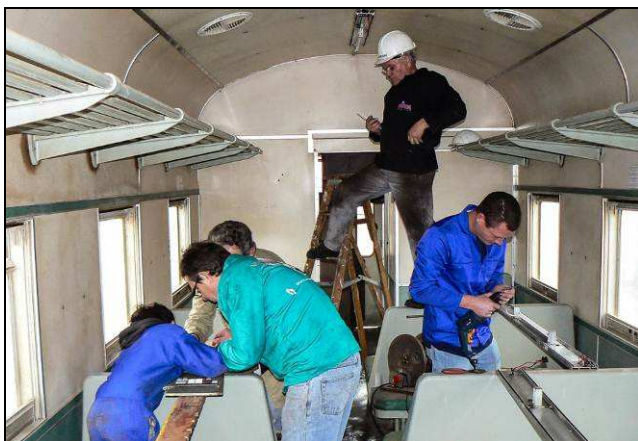
L03 – This project involved a removal and total strip-down of all the old luminary bases and mounting of entirely new fittings, connectors and hardware. Alan and Gordon had to electrically trace the original wires and in classic Union Carriage and Wagon fashion, the wires were all the same colour! (Yellow)

Some of those base plates have rusted and need to either be buffed up or painted to provide decent reflectors.

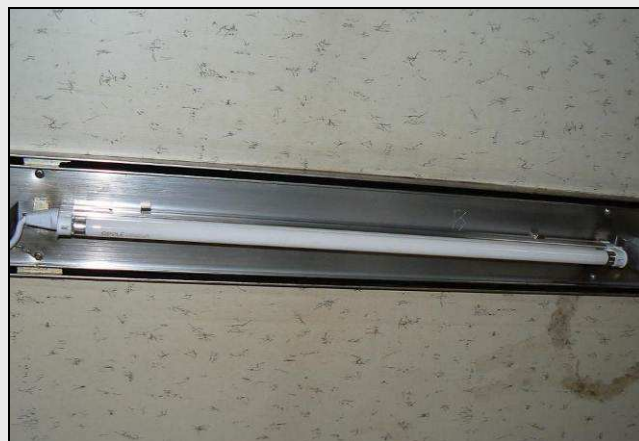
L04 – A close up of one of the fittings. The 14W flourescents run with integrated inverters and thus do not require external starters and ballasts. We have found that even the inherently more rugged 220V ballasts and starting gear fitted to the other coaches tend to be a bit unreliable in the rigours of railway service. The original 110V gear running from DC-AC inverter sets, is even worse after several decades of use. (We don't use them anymore.)

These tubes are fitted on an experimental basis and were organized by Cousin Rob. If they prove reliable, or easy to swap out, when 'Dusty' is in revenue-earning work, we will gradually start converting the other coach light fittings to this technology when they come in for their service.

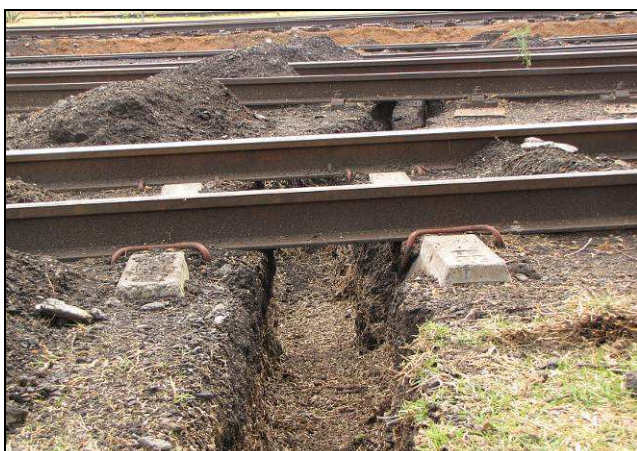
M05 – Some of the money collected from the recent Open Day is being put to good work. This is just a part of the extensive trench work that has just been dug to insert a new, underground and properly specified water main! By the time you read this, pipework will have been installed.

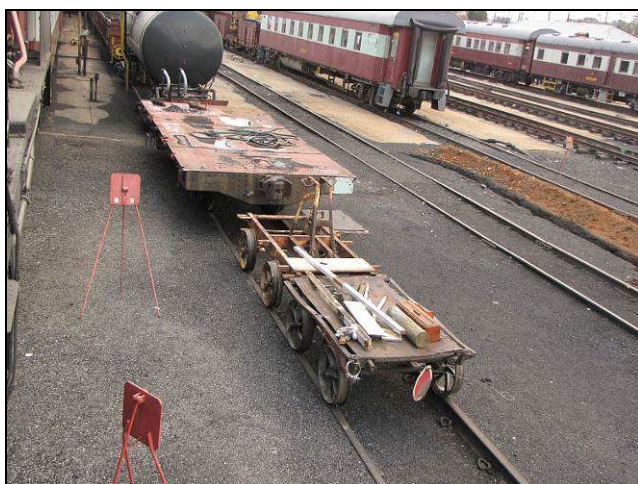
T09 – The tea trolley and a pair of coasters. These are surprisingly useful around the yard. The middle coaster is actually a man-powered pump wagon sans the lever and ratchet. However, it still has the reduction and axle gears.

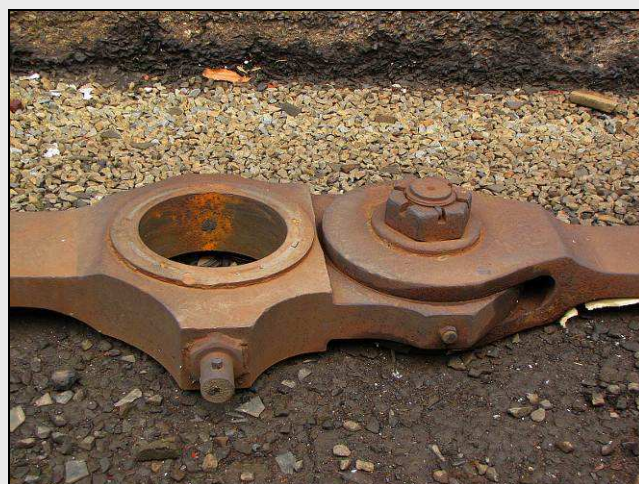
T10 – A pair of newly-revealed coupling rod knuckles – dumped aside and long-hidden on the normally occupied siding. Note the sharp profile between the pin boss and the tongue – not great engineering but seems to have worked!

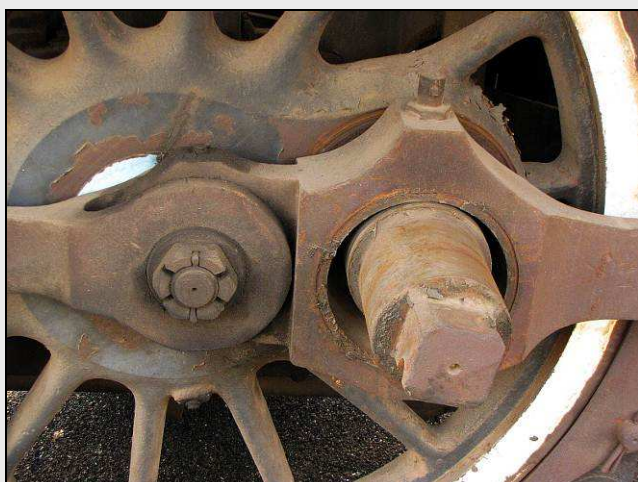
T11 – The same components on 15F No.3135 – hangin' a bit loose without the bronze bushings. A loco being shunted like this makes a metallic gritty hissing sound. This coupling rod was still attached to the other wheels though, so no danger of it dropping off from the shunt!

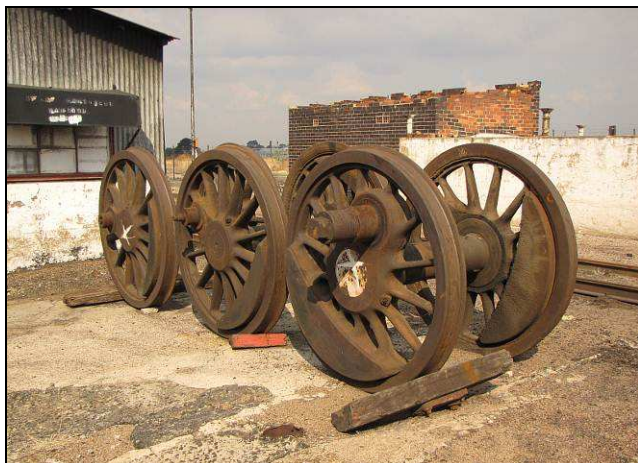
T13 – The axle packing project of a few weeks ago, now seen in daylight. There is still a fourth axle (and two front bogie axles) on a service track within the Running Shed. The area behind is the old sand bunker, although we draw our traction sand from a pile of white builder's sand stored and kept dry within the covered Forge House.

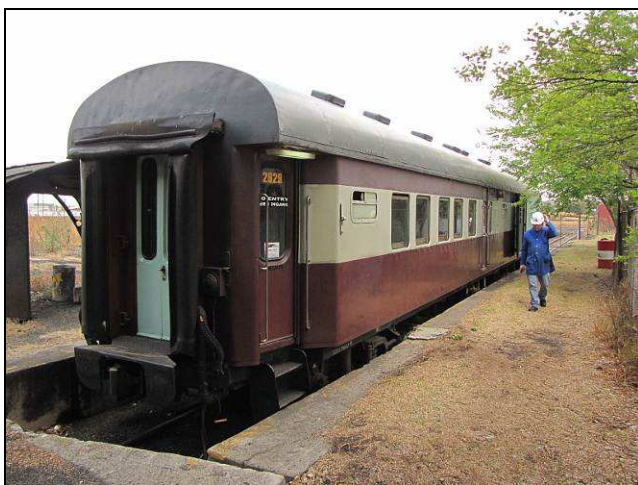
T17 – The Staff and Baggage van, type GD-1 and one of only 20 made and the only one currently serving in preservation, stands duty in the coal dock as a stand-by generator for the 15M shops.
