This Reefsteamers Waybill Newsletter was compiled by Mr. Lee D. Gates on behalf of Reefsteamers Association NPC. For observations, corrections and suggestions – email me at documenter@reefsteamers.com

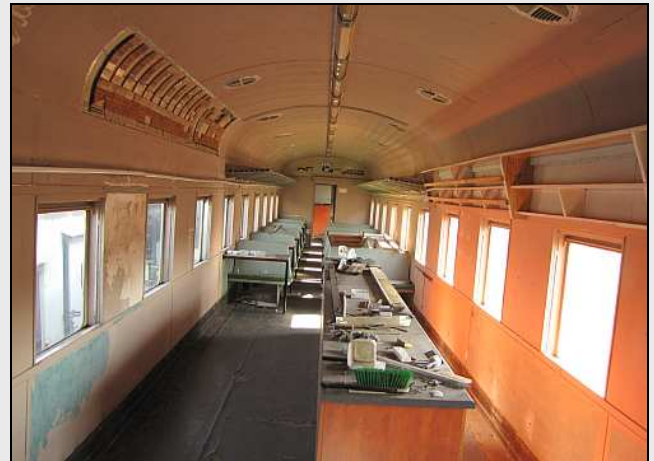
W02 – The new Bar Coach kitchenette project and the Sleeper Coach upgrade projects are higher priority now, but we would still like people to commit to helping us with stripping and repainting the 'Locomotion' coach's interior. Unfortunately, the current pink paint job is so bad and roughly textured that it actually has to be removed before repainting.

It is not a cosmetic issue – the rough paint actually grazes your skin and it will be nigh on impossible to keep clean.

This coach needs a team of people to strip out the dining furniture and then to carefully remove the aluminium strips after recording their locations. The entire coach interior needs to be stripped, which will require a mixture of machinery and hand sanding.

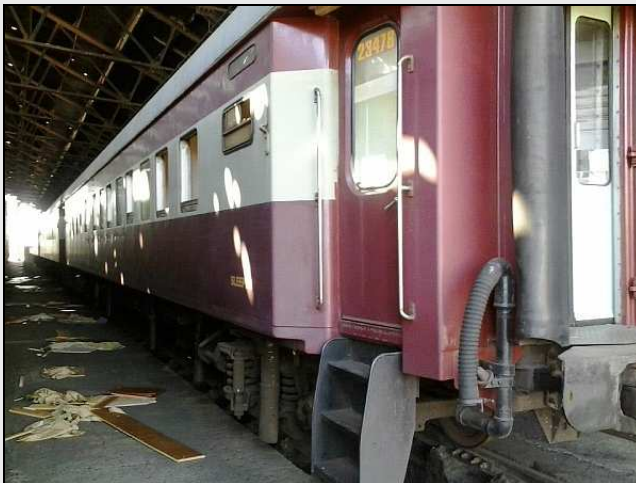
W03 – Most of the conversion work done on the Sleeper Coaches by Setimela was shoddy and much of it is being corrected. Philipp Maurer took a few weeks off work and flew over from Switzerland to get this project started. (He is also heavily involved in marketing the November Tour.)

Current work involves stripping out the poorly done, open sided showers in the Silver Class and also the garish vinyl flooring from the Gold Class coach. The Silver Class Coach bunks are also being worked on to revert them to the original one-sided double-decker SAR arrangement. People in the lower beds could not turn over and the bunks were obstructing the sliding doors into the ensuite bathrooms. There is lots more to do – a whole FILE full of jobs. **We are calling for sustained assistance to continue this project, as Philipp will be leaving for home soon.**

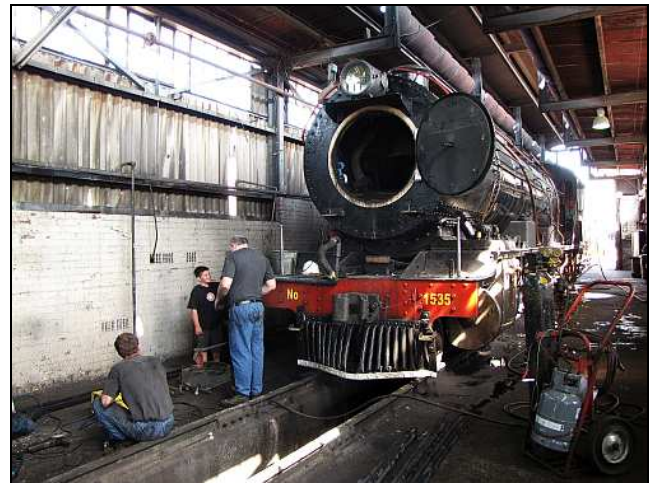
W04 – 12AR No.1535 'Susan' was reported to be blowing within the smoke box with the regulator open. The problem turned out to be a perforated superheater element. Unfortunately, it was in the top row so the three elements below had to be taken out as well. Conveniently, the smokebox front plate did not have to be removed.

While the 12AR 'Susie-heaters' are well aged in general, this one had been hammered into place, with the indents impinging into the hot gas flow and encouraging further erosion. It was ground-back and welded with relative ease.

Some of the superheater header T-bolts were found to be loose and were tightened, but we have missed a few. Luckily, she still ran OK on her last trip but another session in the smokebox is called for before Susie runs again.

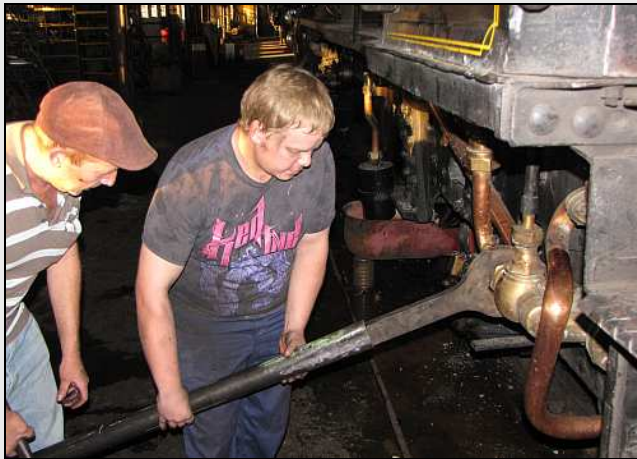
W05 – The 12AR's left injector was running poorly, picking up hesitantly and only in the rear quadrant. The crew were struggling to keep the water level up in the hardest parts of the route. The injector was partially dismantled on 29 April and we found that the steam cones hadn't been replaced as they should have been in 2012. Luckily, the new cones were found stashed away in the brass store and refitted.

It didn't solve the problem though, and more investigation was called for a week later. A clue was that the injector would only work OK with the ash pan coolers running. The problem turned out to be that this water valve had been rotated 180 degrees within its body. It wasn't sealing and was lifting away its seat in operation. All is well now!

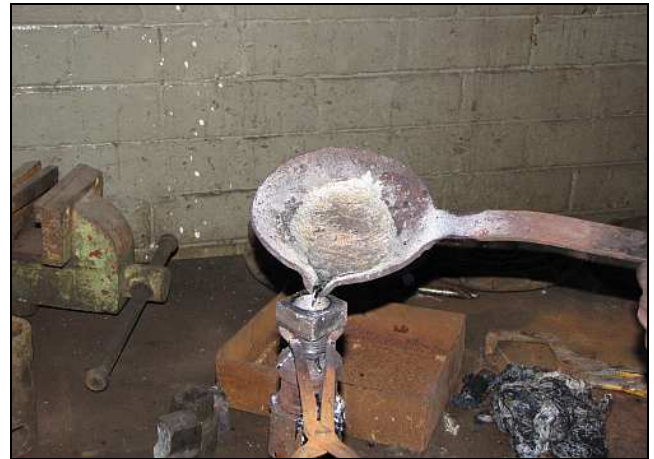
W06 – The 12AR was also treated to a freshly-cast set of fusible plugs as the fitted ones weren't standing up too well. The photo shows the hot, melted lead being poured into the core cavity, while the plug is being held into a mandrel with a semi-hemispherical cavity to mould out the domed head.

Susie's back plug still leaks from the threads and needs attention. It's a pain, as it drips into your cooking shovel!

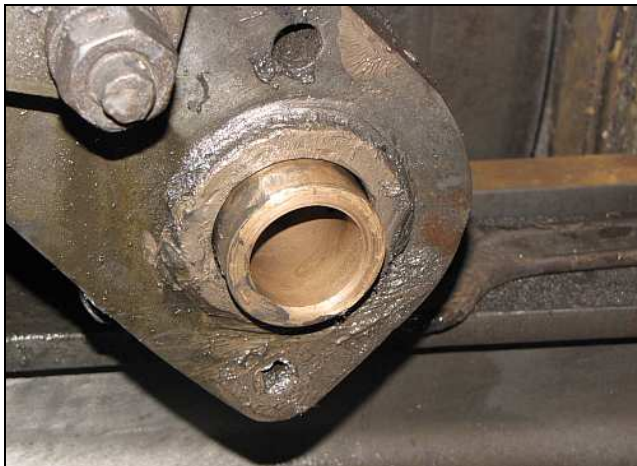
W07 – Class 15F No.3046 has had the front end of her left valve motion stripped due to excessive wear. Pictured is the eccentric bush that forms the bearing between the eccentric rod and the expansion link. When the locomotive was recommissioned 3 years ago, these bearings were incorrectly made from plain old brass instead of the proper phosphor bronze and they have worn badly in service. You can see the outer wear gap even in the reduced photo.

James Thomson has been tasked to machine new bushes from Vesconite™. We have been using this synthetic material for over 6 years in some of our engines, with no discernible wear in main line service.

To not delay things after boiler testing, only the worn bearings will be replaced, so 15F No.3046 will run with Vesconite bushes on the left and ol' 'brassies' on the right.

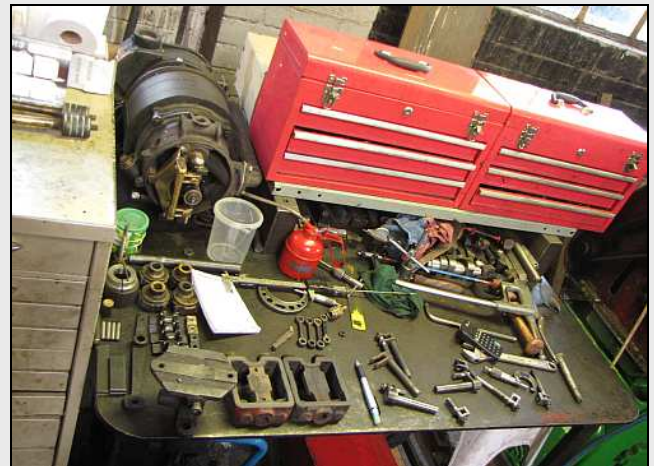
W08 – The Sandstone Crowan Sheldon Steam Crane No.578 project is continuing with further stripping and analysis of the two dismantled feedwater pumps, many components of which are seen on the work bench.

The red-painted casting is a valve chest chamber that has been borrowed from the identical feedwater pump on the Booth Rodley Steam Crane No.96. You will recall that the original casting had burst, probably due to a crack.

The steam-driven duplex pumps, by the way, are made by Worthington Simpson Co.

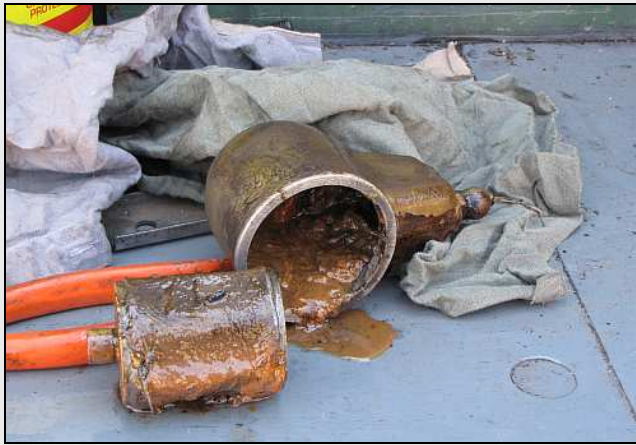
The picture is of the primary fuel filter showing some bad sludging due to water contamination of the diesel fuel. The condensate cock was also disabled and was found to be bunged up with hessian threads. It was probably leaking fuel at one time and somebody ‘fixed’ it.

Unfortunately, the diesel injector pump is already a bit worn and it leaks diesel fuel into the crankcase. (Via the gear drive chamber.) So, we have to keep a careful eye on the constantly rising engine oil levels, and also the resulting lower viscosity of the diluted lubricant.

The finely sieved copper filter element was taken home for brazing as it was coming loose from its end caps, and Dennis has medium-sized brazing equipment available from his model railway activities.

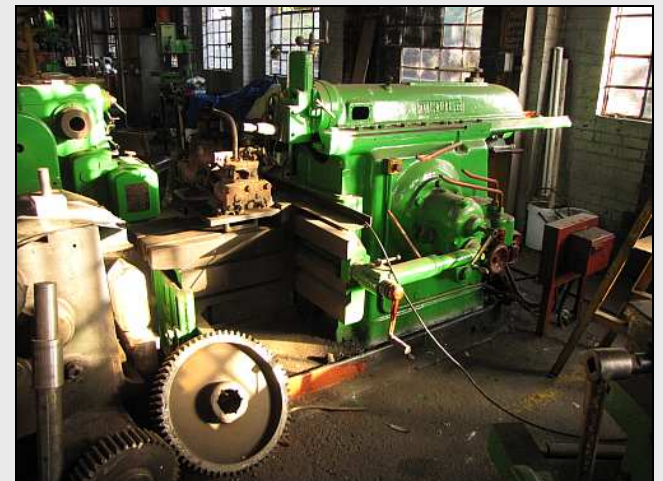
W12 – One of the old Wheel Lathe gears leans terdly against one of the Thule shapers in the late afternoon. We are still very keen to get the Wheel Lathe project going but for now, the workshops focus is on getting the 15F 3046 back into steam, getting the sleeper coaches upgraded and getting some semblance of catering facilities back onto the day trip train.

The wheel lathe gearboxes need to be reassembled and tested (human-powered) before being dismantled again and the gears sent away for hardening. As we need them for patterns, we will not scrap the worn, old gears until the rebuilt lathe gearbox is proofed and reassembled.
