1). PROJECT : 12AR STEAM DOWN PIPE REMOVAL:

2). PROJECT : CUTTING TUBES FOR 12AR BOILER:

3). PROJECT – ANNEALING 12AR BOILER TUBES:

4). PROJECT - WHEEL LATHE ROOF:

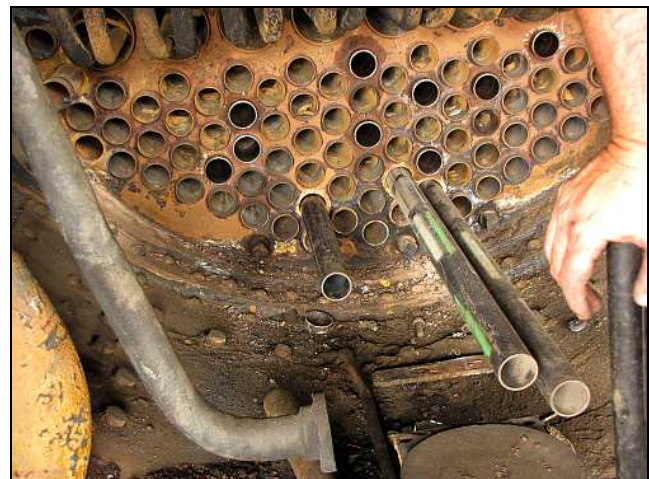
B02 – The boiler inspector missed a few eroded tube ends the first time round, so we have to replace a few more to get her 100% dunbopped. The recently installed tubes are obvious by their black interiors. The protruding tube at the top left was blocked by the RHS down pipe. The lonely pipe hanging in the foreground is the brake vacuum ejector exhaust and it is normally connected to the blower ring.

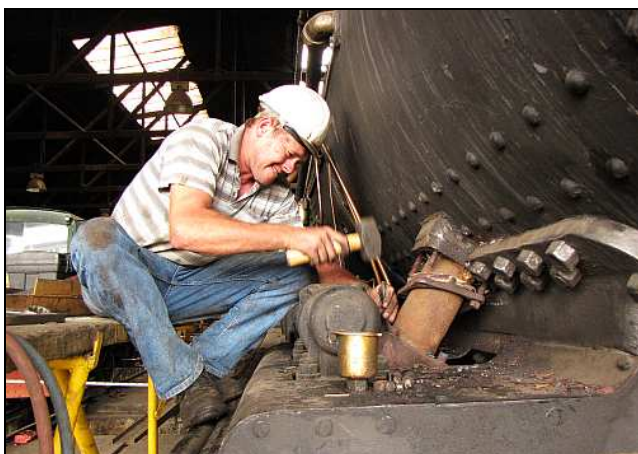
B03 – The incomparable Dr. Smudge gets to work to remove that downpipe. But naturally, the steel studs were seized and wouldn't loosen even under the 5-pounder drift.

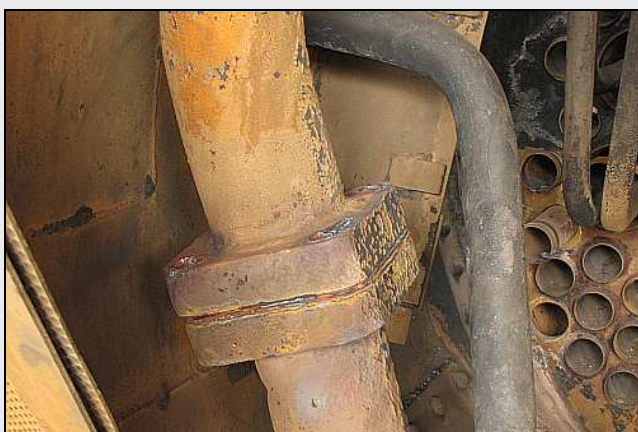
B05 – A part of the problem was the loose waist flange between the wing pipe and the down pipe – the movement reducing the effect of the hammer blows. You can clearly see the protruding boiler tube whose removal is blocked.

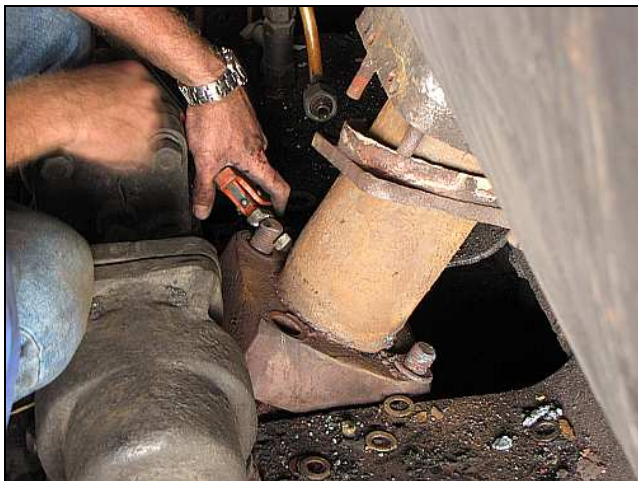
B07 – A hopeful tweak with the Bobbejaan (Baboon) Spanner actually got the front stud out, but there was no room to swing for the rears. And we weren't then up to taking the vacuum breakers off from the valve chests.

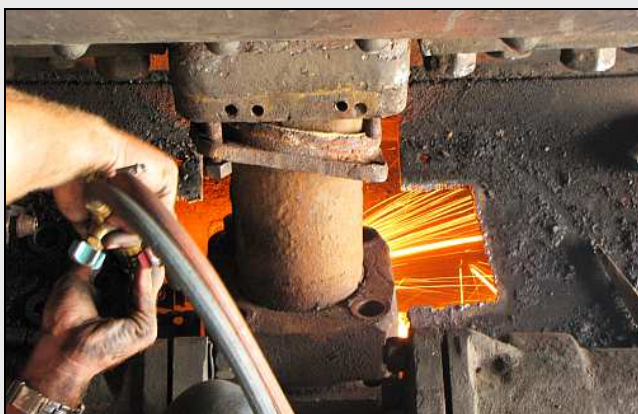
B09 – The last of the seized studs is getting some serious heat treatment to cut right through, before drifting the upper shank out. You can see by the extra access holes (for the collar ring) drilled into the smokebox's protruding boss that this pipe has been removed before, since the original boiler was replaced and this loco became a 12AR class. (The pipe is noticeably thinner than the opposite counterpart.)

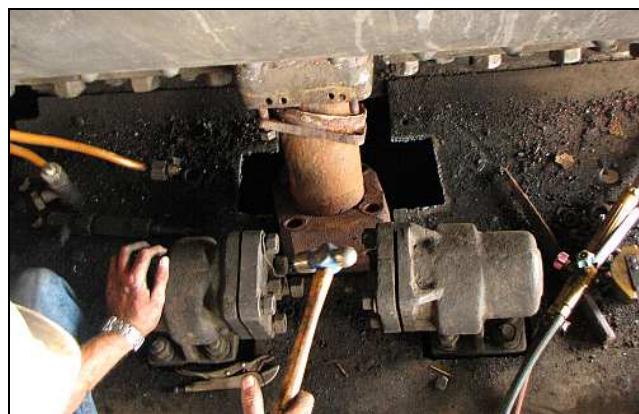
B10 – With all the rotating, a hole was found in the down pipe. The steam leak under the now cut-away pipe fairing had earlier been misdiagnosed as leaking vacuum breakers. (The down pipe fairing is in one piece with the steam chest cowlings on the old Hendrie-type engines.) Instead of repair, the valves pictured had been naughtily borrowed from the similar 12R 1947 'Rosie', but to no avail.

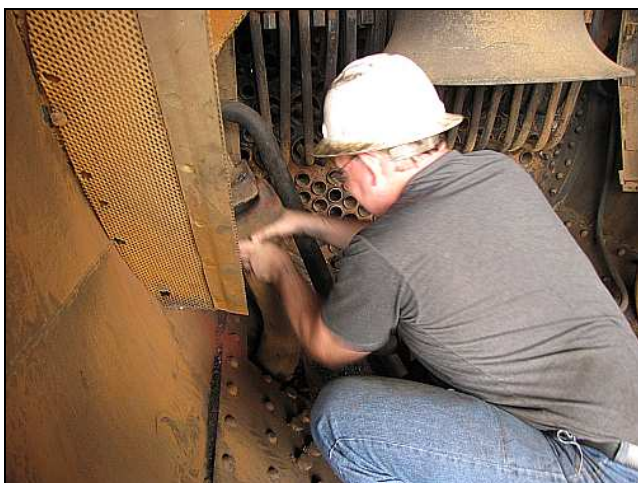
B11 – Aidan gets his 'grunt on' and wrestles with that now-warm pipe. For full access, the wing pipe from the dry side of the superheater header should have been undone first. This way was harder, but avoided breaking open an extra joint.

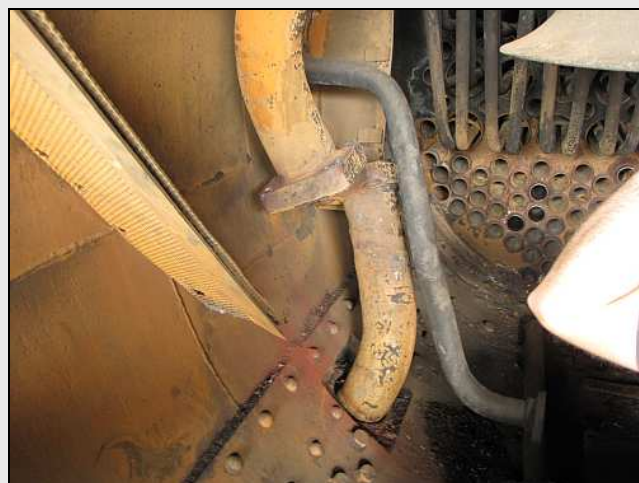
B12 – Success! Aidan managed to get the pipe down far enough to clear the flanges for radial displacement. With subsequent removal of the spark arrestor's chord panel, the down pipe could be rotated forward and flat to clear the way for the withdrawal of that protruding boiler tube.

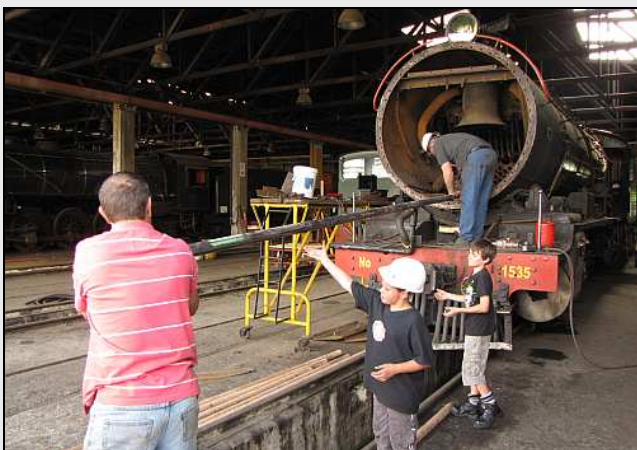
C03 – Jeremy Wood withdraws another tube while the little coalers get ready for the other tube end to drop. The tubes were first slipped in to get the length correct, including the important standard 8mm overhang at the firebox end.

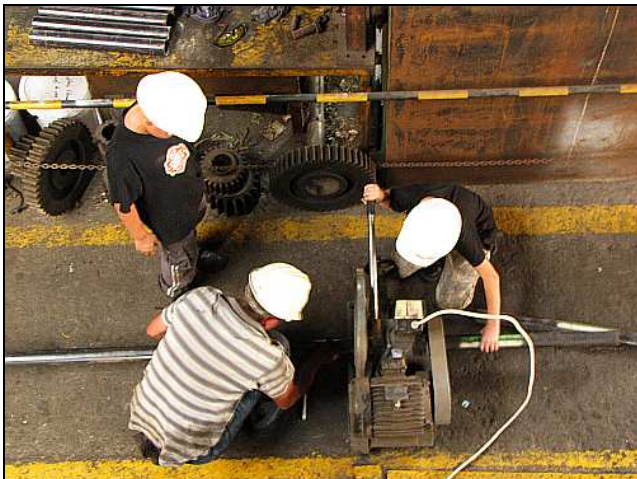
C09 – While setting up the boiler tube firmly in the clamp, Shaun teaches the youngsters the principle of cutting shy of the marked line to allow for a margin of error. Tubes protruding a bit too much at the front tubeplate can be always be ground back a little more after being expanded.

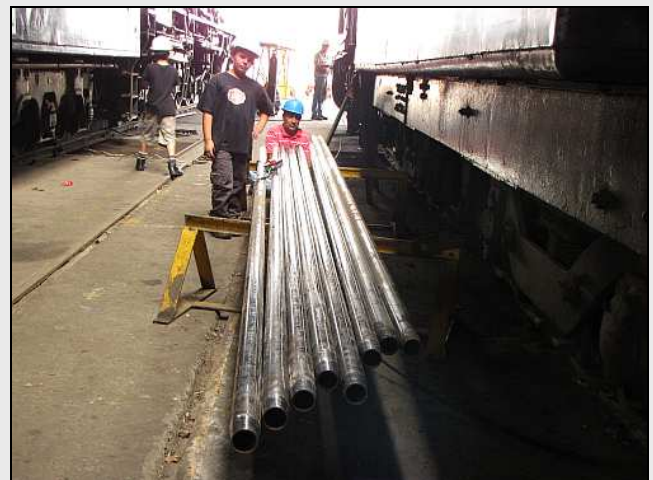
C12 – Jeremy grinds down the burrs on the insides of the newly cut tubes while Gabriel supervises. The tubes act as great sound pipes and I could hear the grinding clearly from the other end. It’s always weird to be able to clearly hear someone talking in a firebox when you’re in the smokebox.

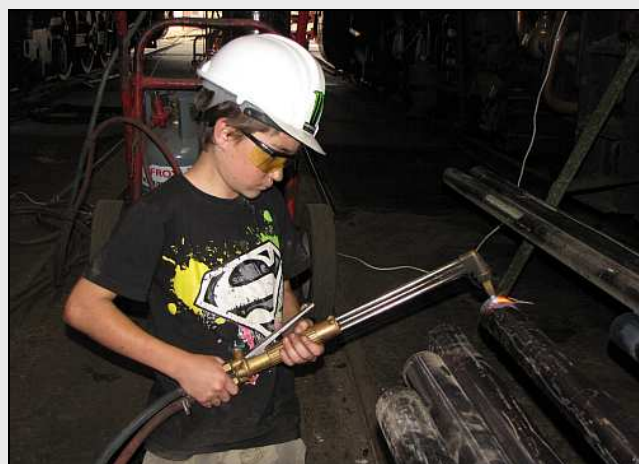
A04 – ‘Dad! You’re going too fast!’, he grumps. You can clearly see the streak of hot steel as the tube is being constantly turned. Josh was starting to hold the torch a bit too close at this point and the flames would soon star-out.

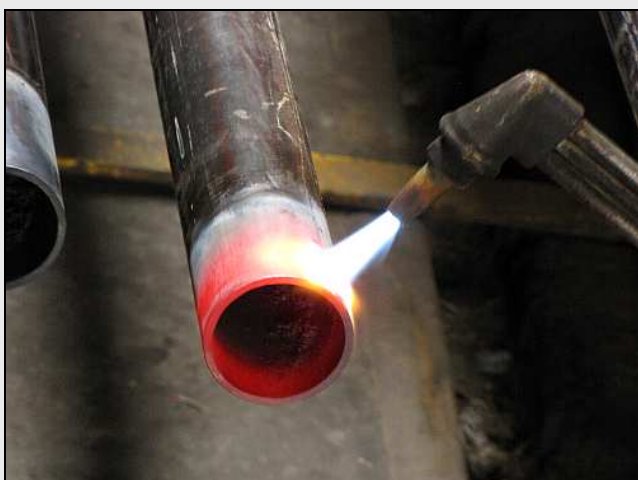
A05 – A close-up of the tube being annealed. The ends are softened by the slow cooling (Ductility), making them less liable to split when expanding them into the tube plate. It also homogenizes the metal – removing stress points. It also burns away any scale and the protective coating.

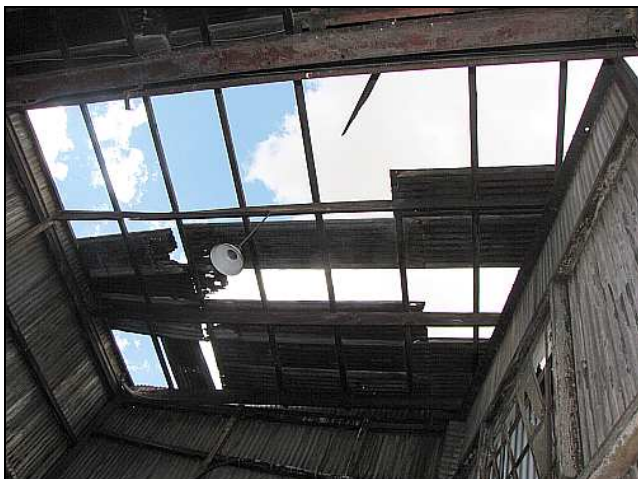
W01 – Here's a bit of insight into the original derelict state of the wheel lathe house's roof ... and this was BEFORE dismantling! When the remains of the sheeting was replaced, the rotted roof trusses were all replaced as well.

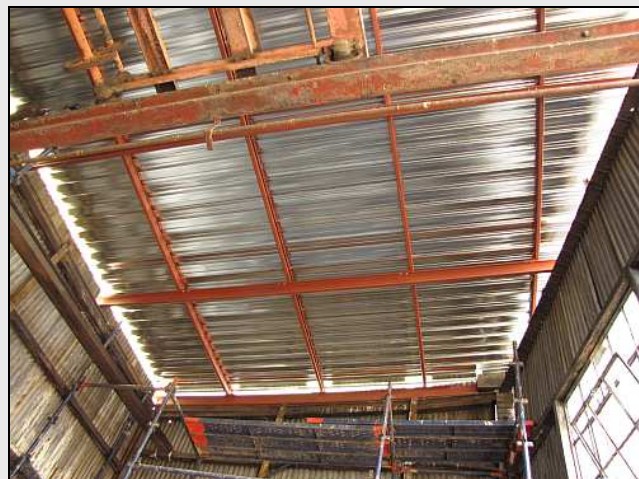
W02 – A similar view taken two weeks later! The old 15M workshop still has its original roof timbers in pretty good condition, but its roof is also starting to rust as the zinc has been consumed. We are getting quotes for repainting.

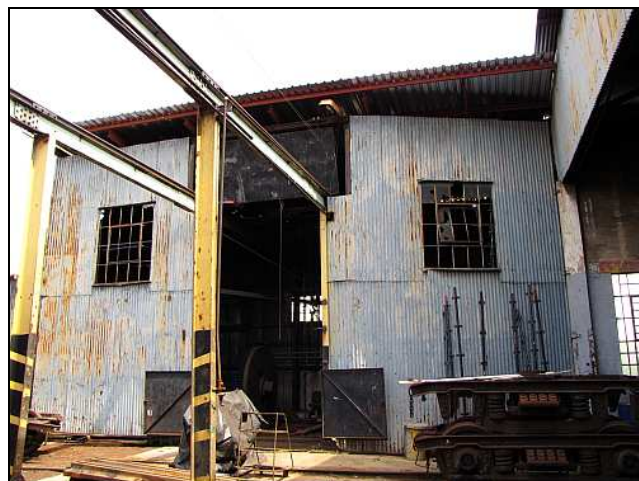
W04 – The new roof has a simpler, straight-sided structure than the old one – but the new overhangs will require effective fastening. Height-agonistic volunteers are needed to assist us with replacing windows and painting sheeting.

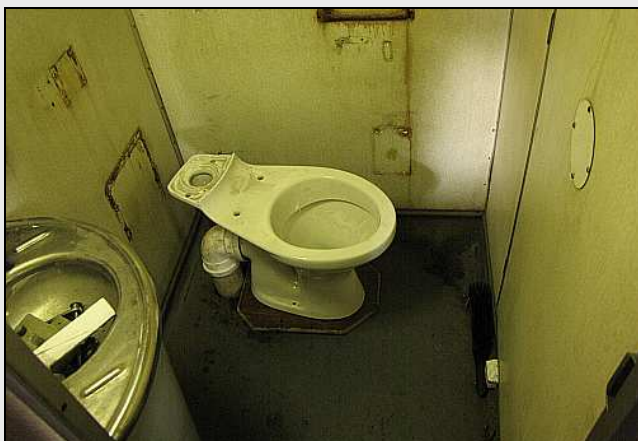
H03 – A domestic water-trapped porcelain toilet being fitted to Sandstone's Sleeper as a trial unit. This is one of two pans we had spare with a close-coupled cistern. (Future fittings will have remote tanks) It has been fitted loosely for future adjustment. Note the extra marine ply mounting pad.

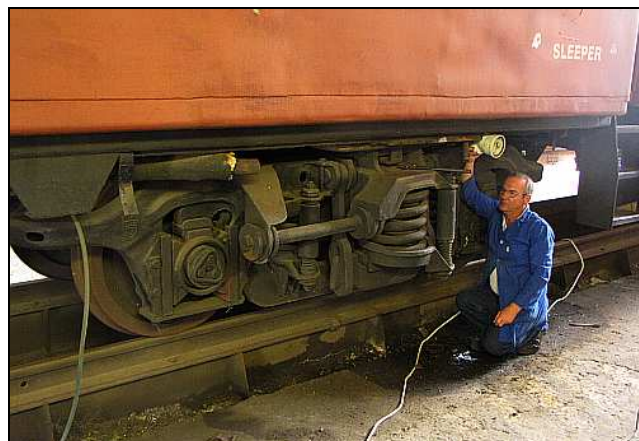
H45 – An amused Gordon holds the pipework while safely listening to Alan battling and grumping within the coach. Domestic piping isn't exactly compatible with the SAR and the toilet has to be mounted at an angle to allow space for less agile passengers who aren't keen on a twisted urethra.

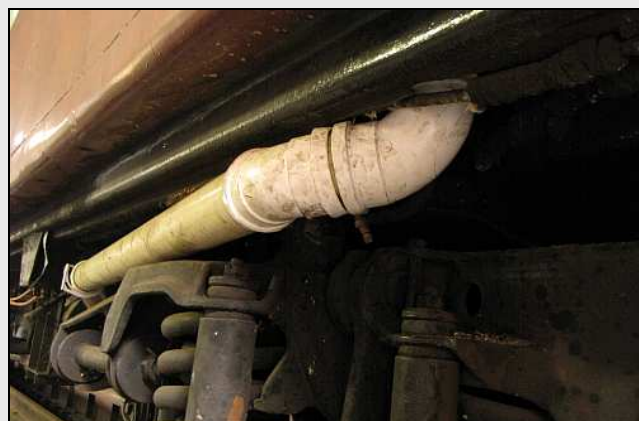
H06 – This is an experiment in using standard PVC pipework – note the awkward geometry to get past the frame and clear the bogie at the same time. The bracket at the far end is to be bolted to a welded extension bar – at a higher point to clear the bogie. If the experiment fails – the pipe can be removed again with no damage to the coach.

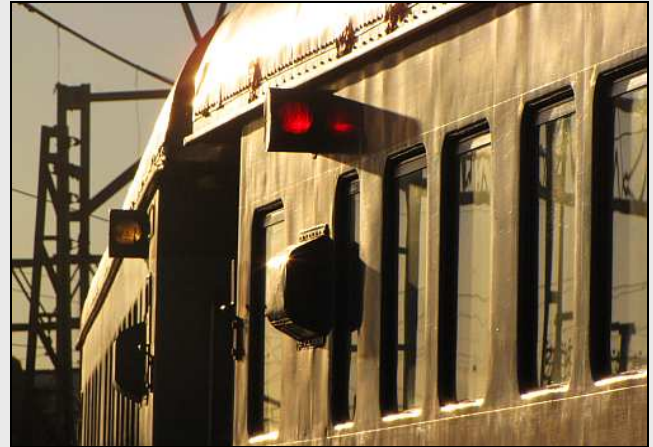
H02 – The wing-light lenses are beautifully backlit by the sun. They have sliding translucent-red plates behind their clear glass lenses. These two are functional but are usually unused as only the end-coach lights need to be illuminated.

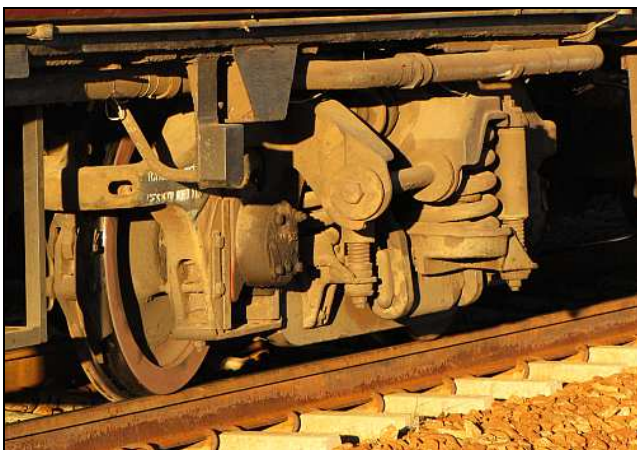
H05 – A sunlit commonwealth bogie, with a still intact land-power socket next to the jacking point. (Above the axle.) The drag link is angled for the track curvature too.

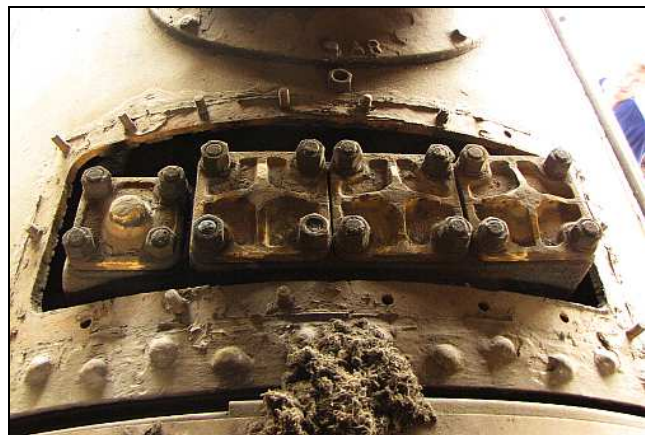
M02 – The exposed regulator chest on Susan the 12AR, waiting for the hydraulic boiler test. A quick test was done before the tubes were first removed, so the regulator's valves are already ground-in and sealed with silicone.

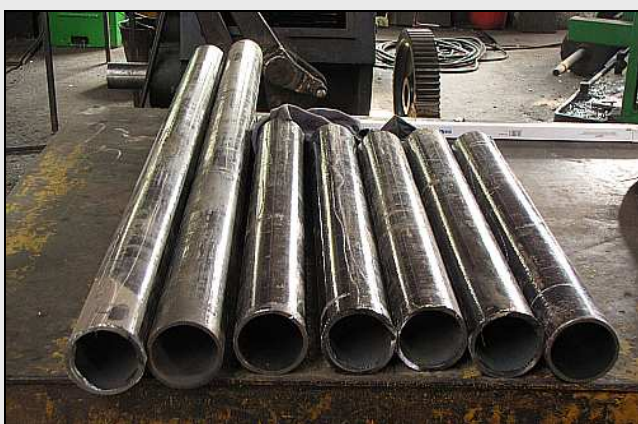
M04 – 15F No.3046 'Janine' rests cold with start-of-year smokebox cleaning in progress. (No trains booked this January.) She has exceeded her 4-month duty cycle and is well into overtime, but the old grinder has been running reliably while we await completion of the 12AR's repairs.

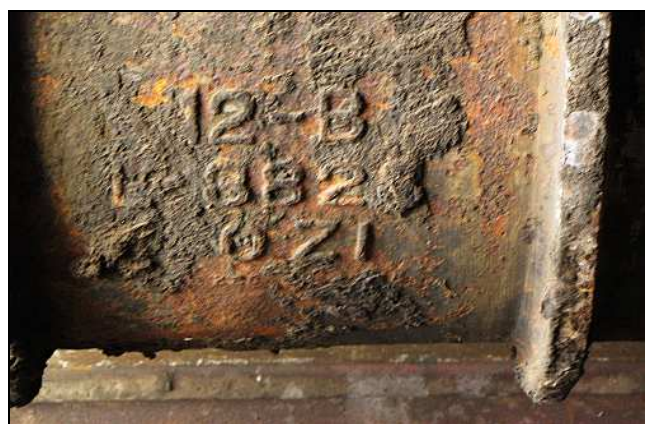
M06 – There has much been debate in the past to whether 12R No.1947 'Rosie' started life as a Class 12A or a 12B. The cylinder foundry marks show that she was a 'B.' (For 'Baldwin') When the loco is intact with cylinder cladding on, apart from the front bogie axle spacing being 2 inches longer, the original loco was visually identical to a 12A.

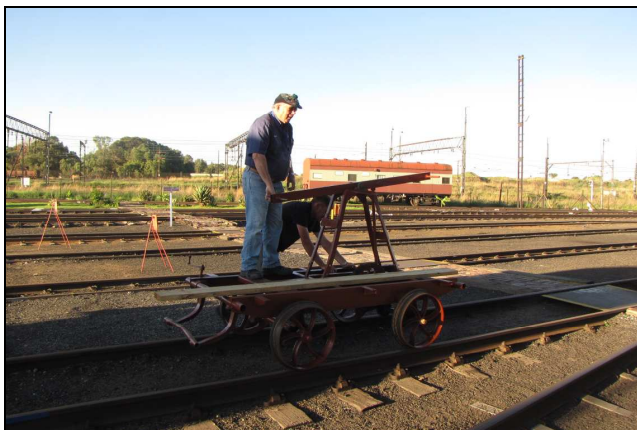
P01 – After a long but not very energetic day together, the devil got into these two to do something fun and different. Because the one-way ratchet was 'pointing' the wrong way, the trolley had to be wheeled out past the points first.

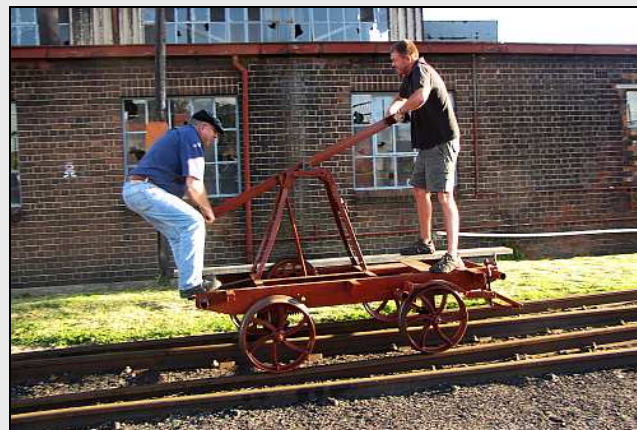
P02 – What was a bit surprising about the trolley was that in normal operation, the crank wheel only rotates through 180 degrees. So one fellow is always pulling up on his bars and one fellow is always pushing downwards.

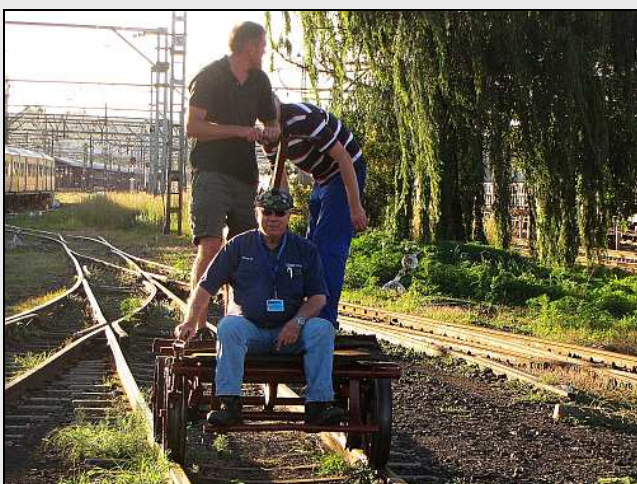
P03 – How NOT to run a volunteer preservation group. The chairman sits on his arse while the members do all the grunt work. Actually, these pump trolleys were built as inspection vehicles so the manner in which Dennis is sitting is realistic – notice that he has his hand on the rim brake.

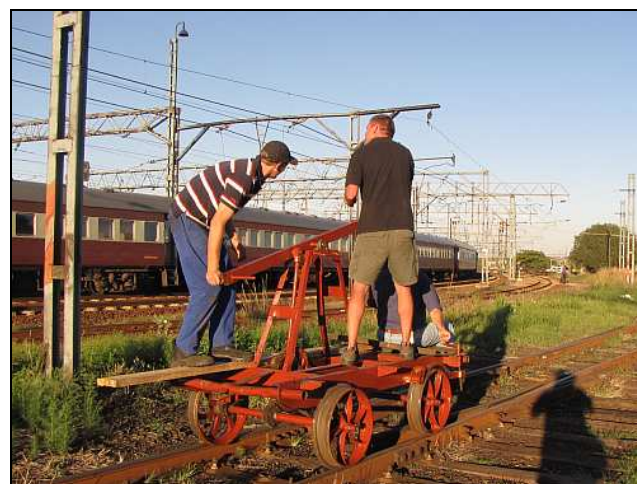
P04 – The chaps get into the rhythm and are pumping their way uphill to the depot after turning then newly painted pump trolley around. (The drive ratchet only works one way) This was the second last Magaliesburg Express train of the year and it was waiting for the home-road.

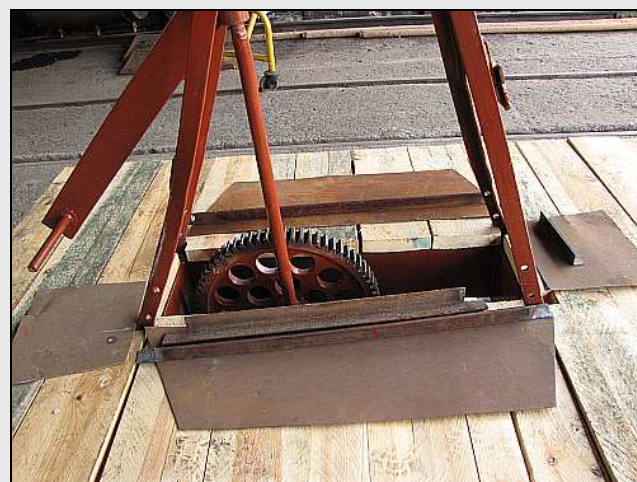
P06 – Here's a close-up of the custom-fabricated plate work and upper frames for the closure of the gear and rod aperture. We would hate for some curious kids to get their fingers between the gear teeth or nipped in the crank.
