1). PROJECT : 12AR STEAM DOWN PIPE REMOVAL:

2). PROJECT – WHEEL LATHE REBUILD:

3). PROJECT : 12AR BOILER TUBE INSERTION:

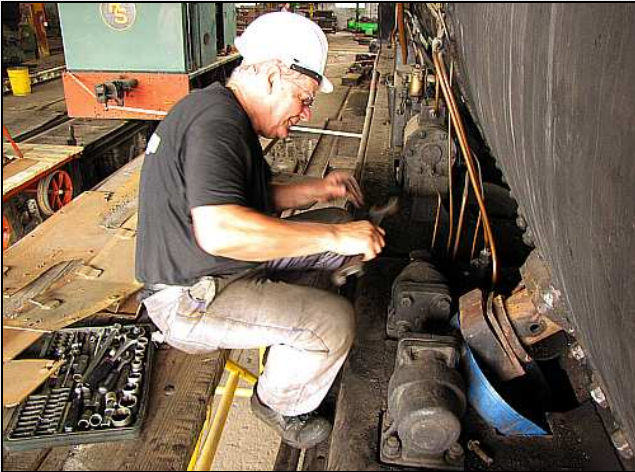
R01 – Trying to do the work without removing the vacuum breakers and the cowling was false time saving. Johann Breydenbach exchanges a coal shovel for a spanner and settles into ‘slogging’ the ‘nutz orf.’ Johann was fortunate enough to have the household’s single car available today so he got to come in for a workday – a rare treat for him.

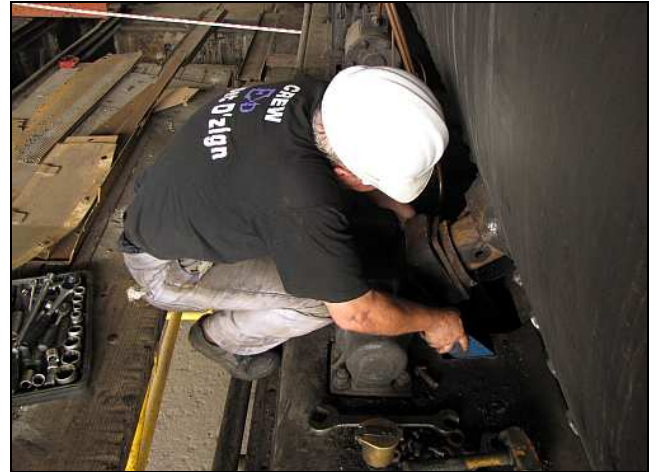
R02 – Johann B. wisely pulls the bucket over the flanges to keep debris out of the valve chest. To recap, the RHS steam down-pipe was obstructing a boiler tube’s removal. Upon rotating the pipe to clear the obstruction, it was found to have been holed. (The pipe is turned 180 degrees in the photo – the visible hole is the steam chest gauge’s port.)

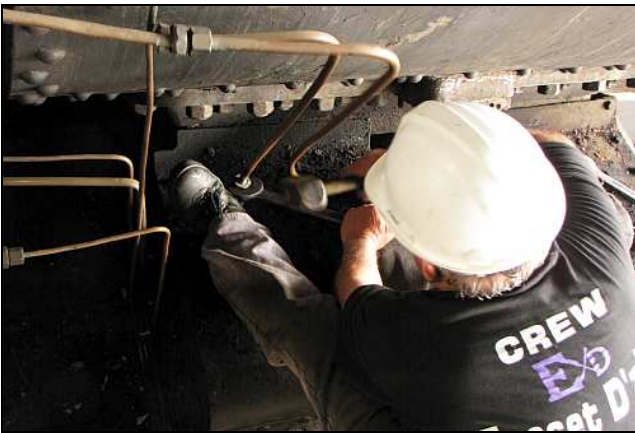
R03 – The chokes on the cylinder oil lines also needed to be uncoupled and removed from the cowling. They use differently proportioned counter-porting to ensure the steam in the cylinders doesn’t blow back up through the oil lines.

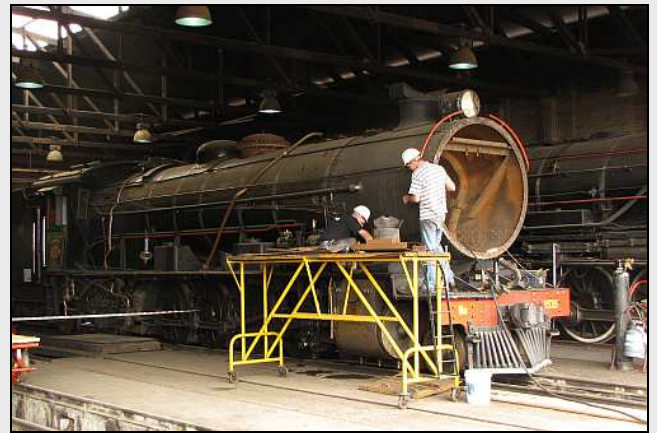
R04 – A view of Class 12AR No.1535 ‘Susan’ under repair. There were also three other fellows hidden away within the firebox. Here, you can see the slanted spark-arrestor chord plate, and the complex bends of the LHS steam down-pipe.

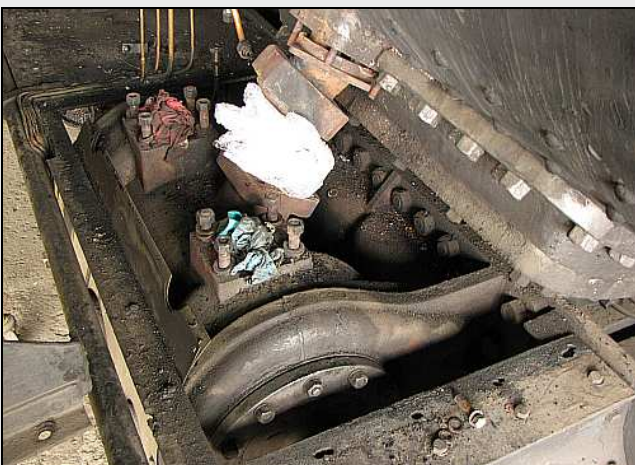
R05 – A bit later with the cowling and breakers removed, one gets to appreciate the gritty-looking craftsmanship of the long-ago pattern makers. Steam loco steam chests are amazingly cast pieces of engineering in their own right.

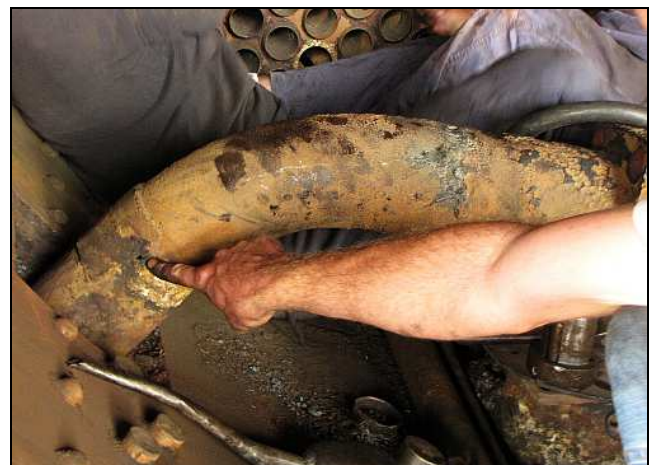
R06 – Dr. Smudge points to the discovered hole, which normally points rearwards. Notice that the pipe had been patched previously. The plan at this stage was remove the pipe for a thickness test to check for a min. of 4 from 6mm.

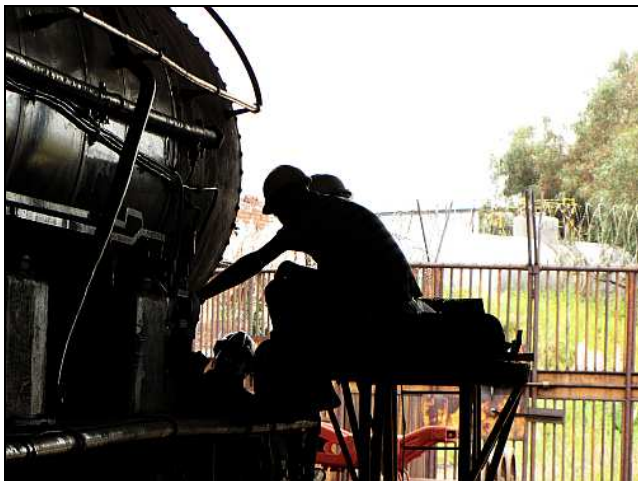
R07 – Dr. Smudge and Bullie-bach are discussing the strategy to complete the job. That is ‘Swak Hart’ Dawie looking in. He was either within the smokebox or firebox during the whacking and heard ... every ... single ... blow!

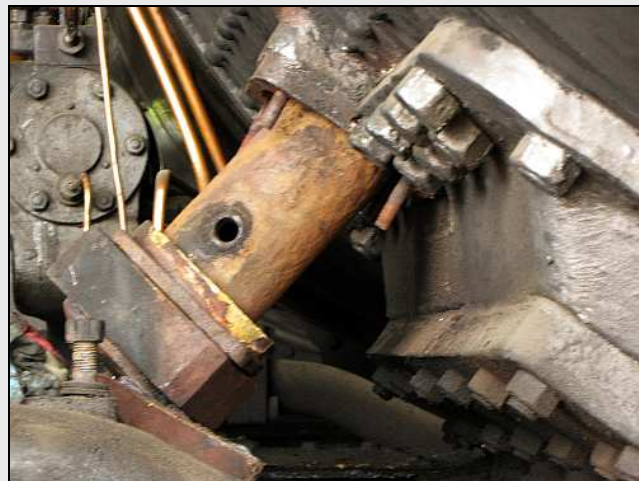
R08 – On a model steam engine, this is usually just a cute piece of threaded brass tube. The real pipe had been expanded within the flange and would need to be cut away. Note the detail of the 12AR’s composite smokebox saddle.

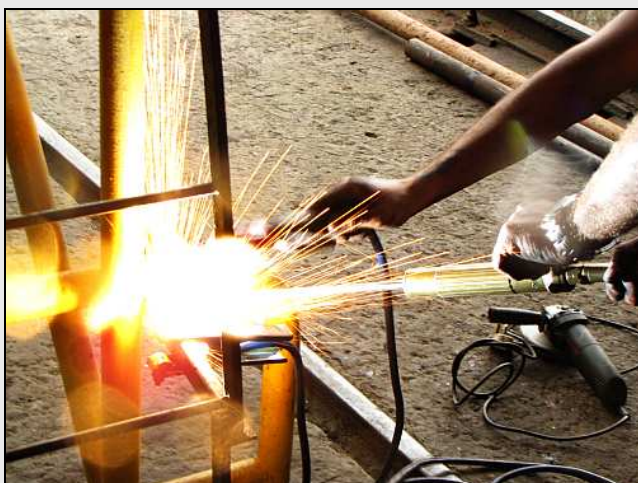
R09 – As I rarely ask the guys to pose, and I take photos under less-than-optimal conditions, I discard about half the photos I take. But occasionally I do get it right, like this moment that the cutting torch is ignited with an arc welder.

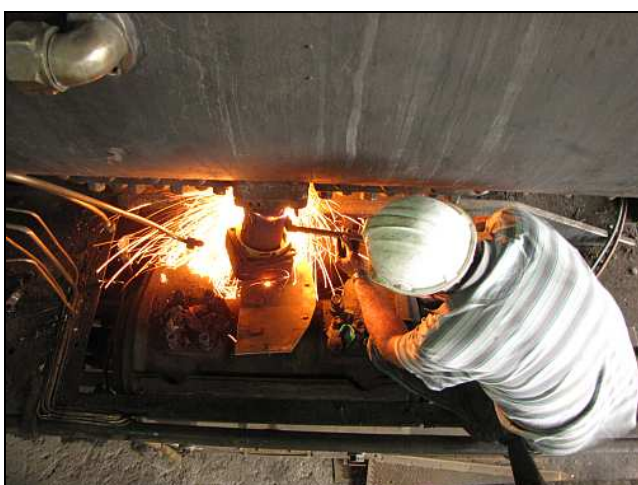
R11 – A top view of the pipe cutting in progress. Of interest is the bundle of small bore-pipes at the left. Two of them are condensate drains for the reverser’s power cylinder, one is a condensate drain for the vacuum ejector exhaust line and one is the discharge for the reverser’s valve chest.

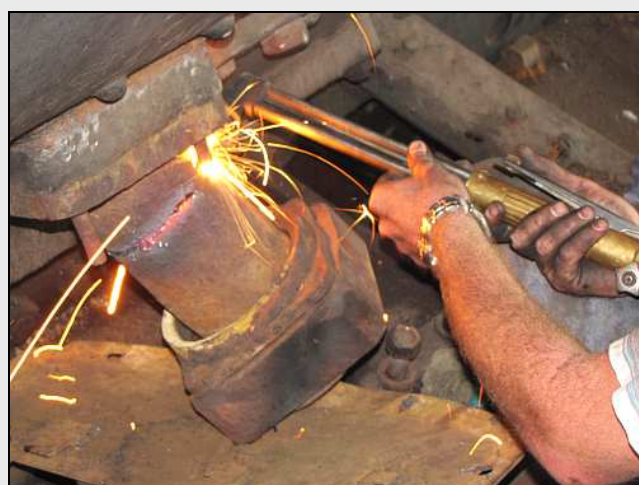
R12 – The cutting job was going well – a bit TOO well. It turns out the whole steam pipe has thin walls and it was sagging under its own weight during the cut. Note that the plastic tray protecting the valve chest inlet had been replaced with something with a MUCH higher melting point!

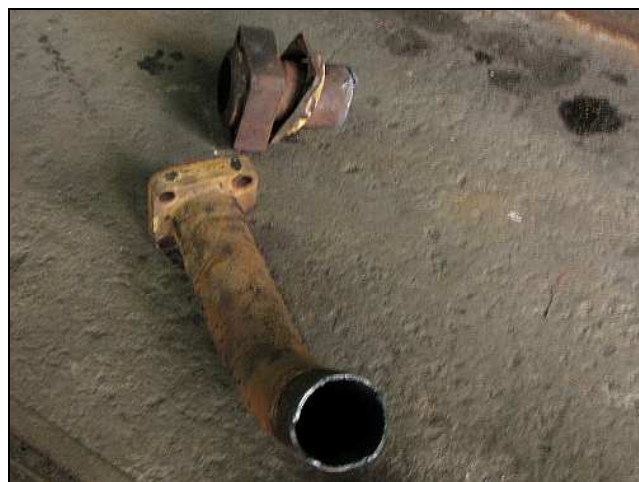
R13 – The heavy flange drops onto the baffle plate and is left to cool while the inner section of the pipe is withdrawn. The rotated square piece is the loose stuffing cover for the upper joint – sealed with graphited rope as packing. The cover is relatively lightweight, as it is 'only' a vacuum joint.

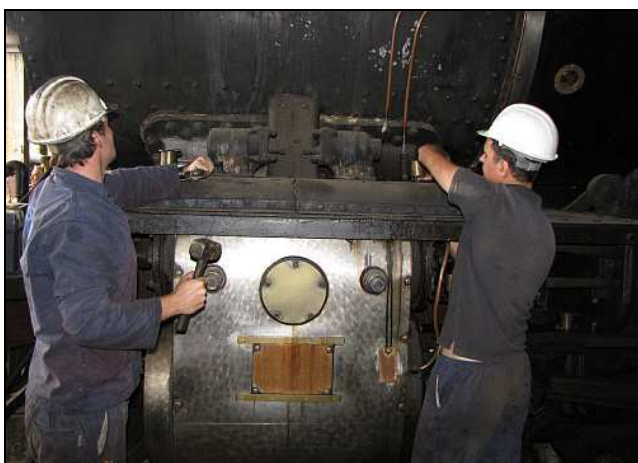
R14 – The RHS steam pipe is definitely thinner than the left side. So either some long-ago fitter took a short cut or the pipe has been replaced before. We aren't even going to bother to check the pipe – just getting sections made up and bent for decent quality replacements. (On both sides.)

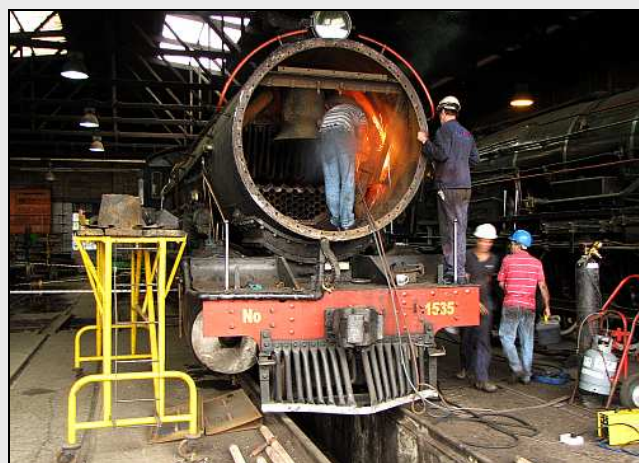
R16 – More pyrotechnics on the job as Dr. Smudge cuts away the rusted-on nuts from the waist flange. The new nuts will be 'copper-slipped.' (The 'oud Spoories' used graphite in a vain attempt to stop threads from rusting.) The table plate and baffles are to be rebuilt from abrasion resistant-steel sheeting and the bolts treated the same way.

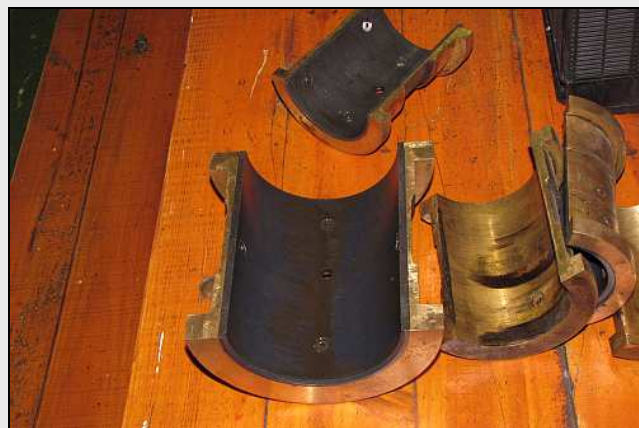
W04 - The loose bearing shells were locked away from theft and souvenir hunters. As these are gear shafts, the reaction loads are sidwise rather than downwards – so the single screws are correctly at the joints where they would cause the minimum disruption to the oil's boundary film.

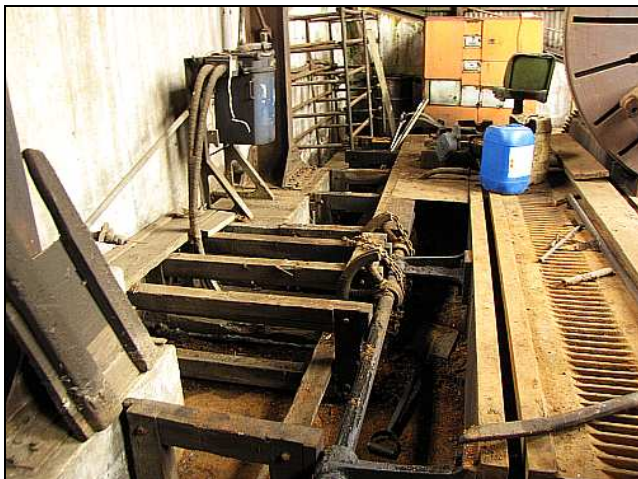
W07 – The old floorboards were lifted and decades of debris and lost tools were shovelled out once the ‘sump water’ drained away. (The spade is not exactly OEM!) In the center is the ratchet-operated tool feed shaft which connect via chains set into those quadranted sheaths.

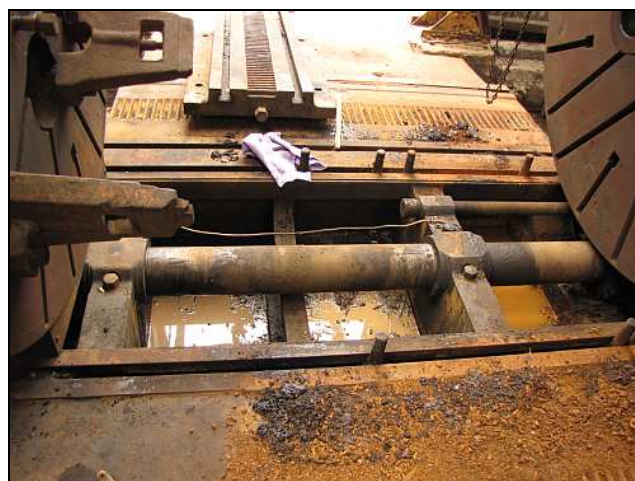
W10 – This was the state of the transfer shaft pit with the project just started. Although the lathe itself was covered in a tarp, water still got into the building through the decayed roof. Note the oil line running to the center bearing.

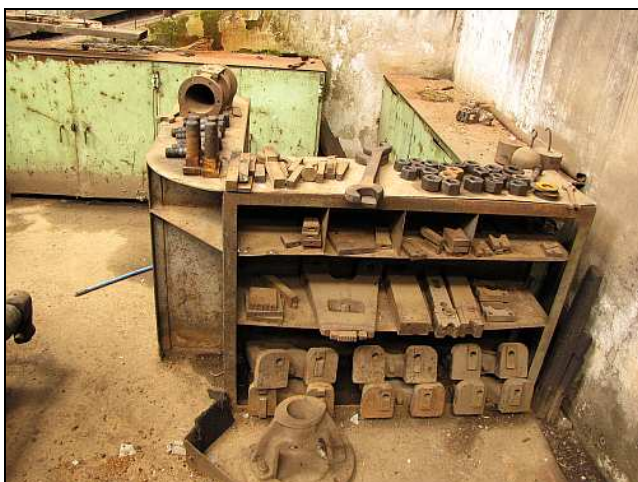
W11 – Unusually, we seem to still have a good collection of tools and hardware for the lathe. Of course, we still need to figure out precisely what everything is for! Andrew ‘Noddy’ King was the last person to operate this machine and we will POUNCE on him the next time he visits the depot!

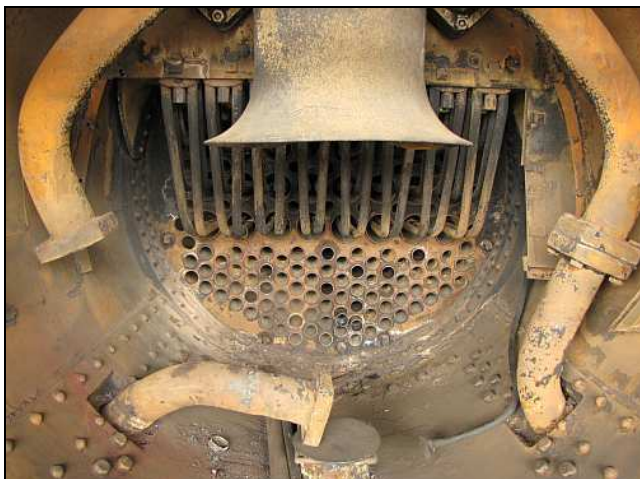
B01 – A view of Susie’s cute ‘little’ smokebox just before the boiler boys climbed in. Both of the steam down pipes would be removed by the end of the day and the blast pipe would remain safely capped. The thin grey-looking pipe to the right is the steam line for the blower. Can you spot the five visible washout plugs in the front tube plate?

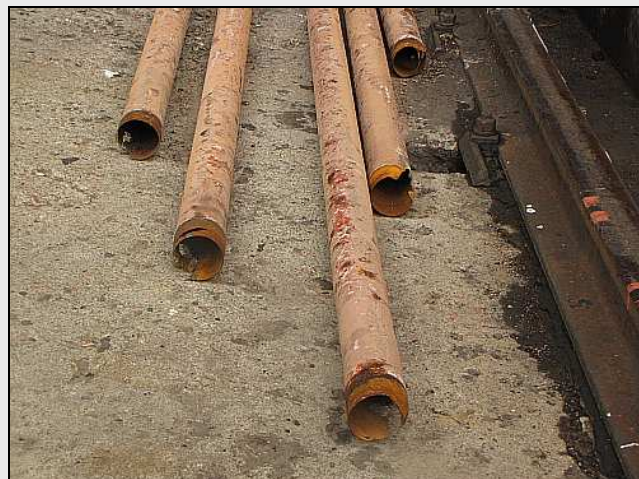
B02 – A view of some of the old tubes that were pulled out. You can see how the tube ends were chiselled to split and collapse them – they are ‘only’ restrained at the front end by friction via expansion. Once the rolled-over ends at the back-end (the beading) and its welds are ground away on the tube plate, the old tube is free to be withdrawn.

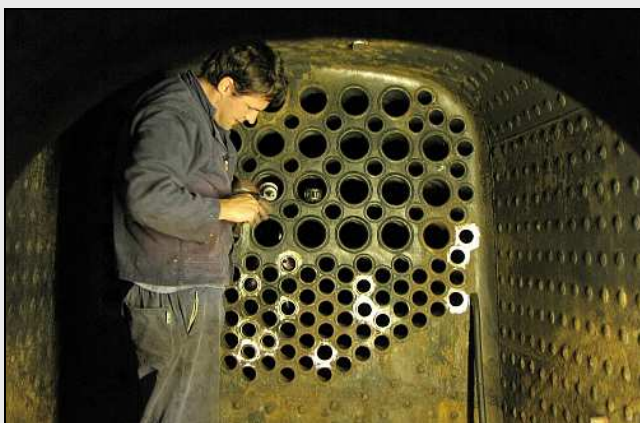
B03 – At the other end, Dawie is adjusting his vernier calliper. On the 12AR, the tube ends must protrude 8mm from the tube plate to get a proper rolled bead without interfering with adjacent tubes, or being too short to weld. As this tubeplate is slightly warped, each tube has to be individually measured and positioned to suit its location.

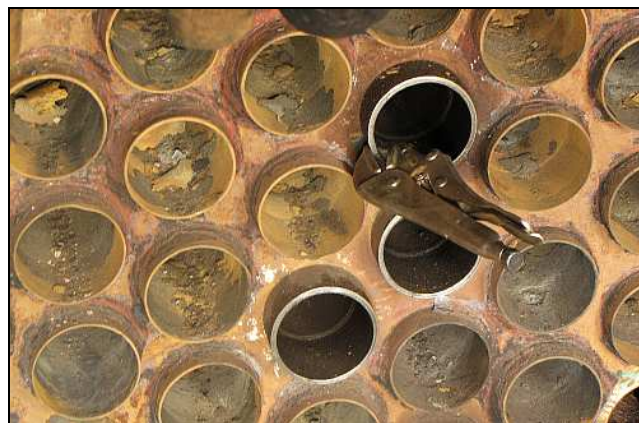
B04 – Boiler tubes are not only damaged by corrosion, leading to perforation, but are also worn by char cutting. You can clearly see how the old tube ends are worn down compared to the new tubes. The 3 new tubes had already been expanded into place and you can see the inner ridges which mark the inner face of the front tube plate.

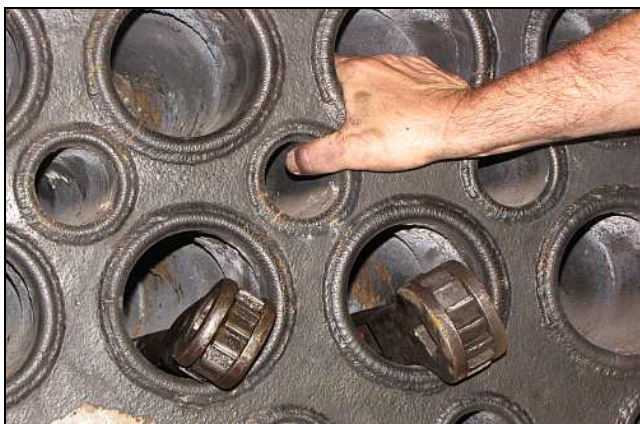
B05 – A nice clean rear tubeplate shows the end results, how the tubes and flues are beaded over and then welded. Superheater flues make handy built-in tool storage pockets.

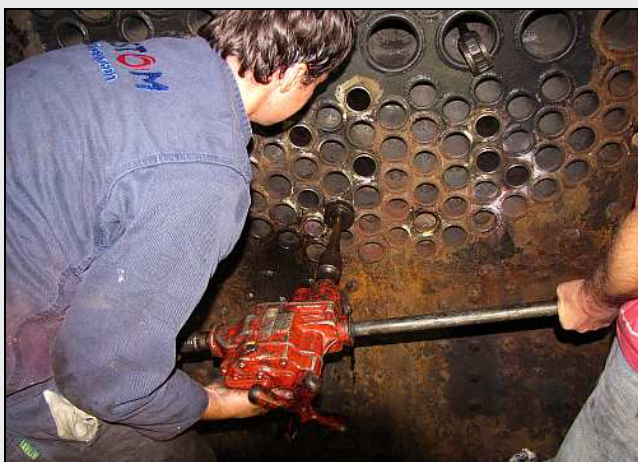
B07 – Once the mandrel and the expander are matched up, the air-motor can be attached. The job usually has to be done in several stages as the expanders are exchanged in stages for bigger ones as the tube-end expands into the aperture. Doing the job too fast will tend to split the tube.

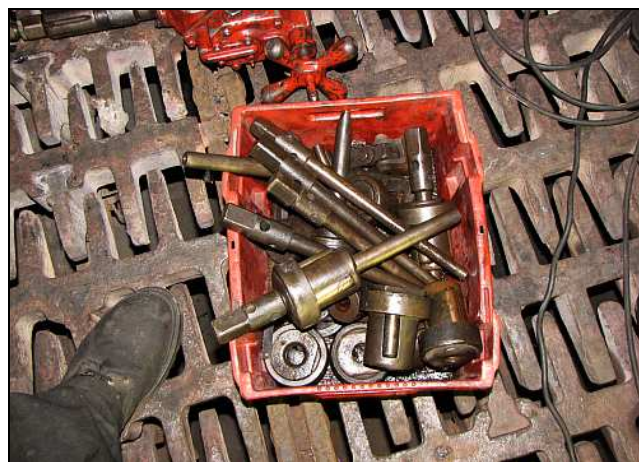
B08 – A box of assorted tube expanders and conical mandrels showing the different sizes. You can clearly see the inclined-axis rollers that tend to drive the expander inwards as well as imposing a tapering force onto the tube. It is the mandrel that sets the expansion plane of the rollers.

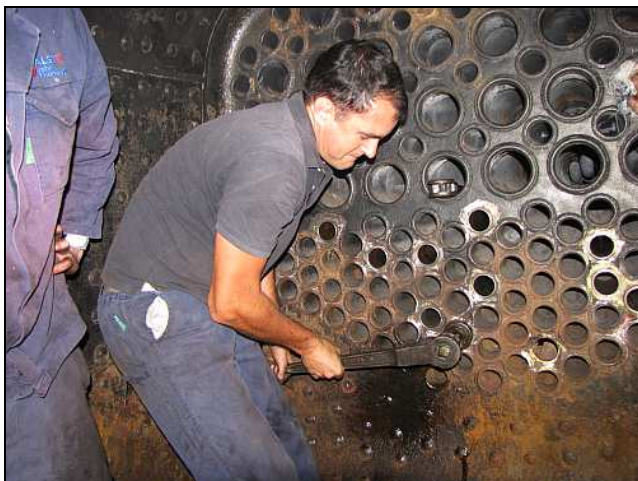
B09 – Michael does the final crunch-up using the ratchet driver on the square shank. In the final stages, hand tightening gives you more control. Also, using the air-motor can be dangerous at this stage, as it tends to kick back while running at full power driving the now-tightened tool.

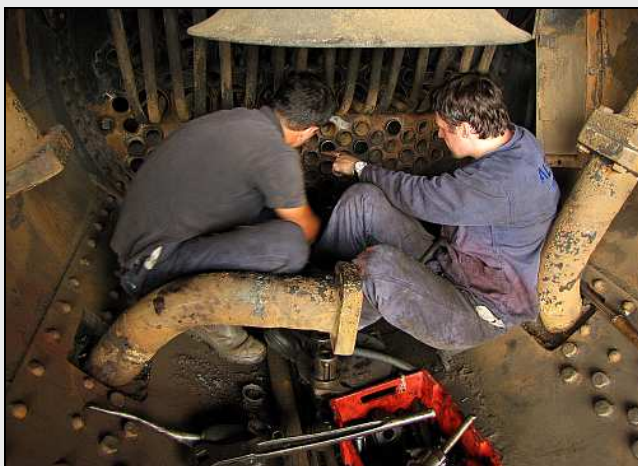
B11 – Sitting room only. Although there is more light and air available at this end, it is also a bit more cramped. Dawie and Michael discuss what to do next. All the boiler tubes need to be installed and expanded-up by the weekend 26/27th Jan. for a preliminary Boiler Hydraulic test.

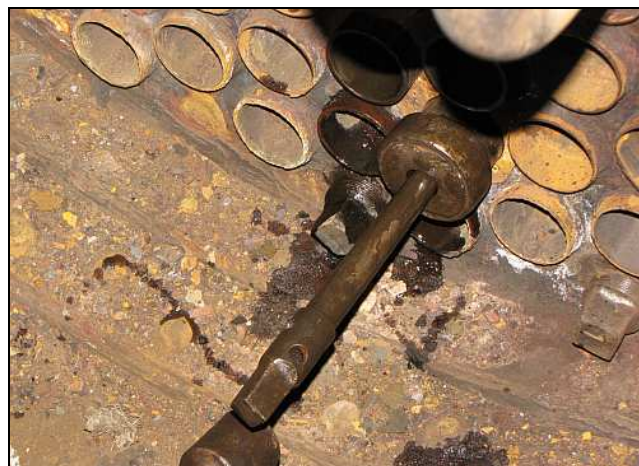
B12 – This tube would give hassles as the end is protruding a bit too far and is blocking full penetration of the expander. They could have cheated by putting in bigger mandrels but that would have belled the end out. Instead, the expanders were changed more frequently than usual.

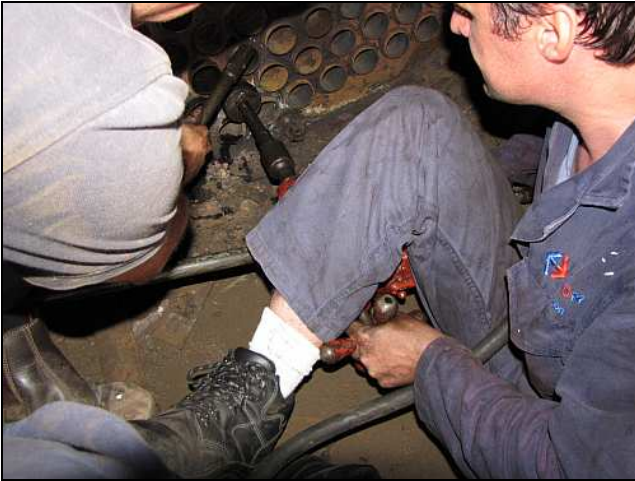
B13 – At the end of a good expansion job is the need to get the expander and mandrel out again – with the rollers squeezed in TIGHT between the tube and the mandrel. Michael gets a bit of rap action going. Note Dawie’s cute and still miraculously clean white soddies in those rugged work boots – this dude is STYLIN’ !

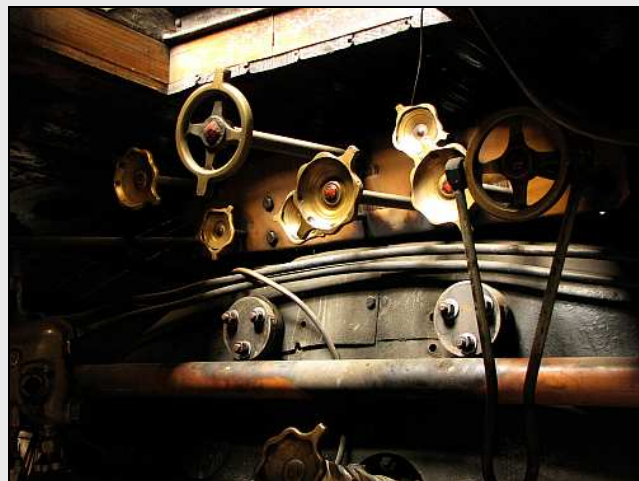
M04 – Second-hand light on the spindle board of the 12AR No.1535 parked under a translucent roof panel. The water columns have been removed and blanked for hydraulic testing, although the pressure gauge has since been fitted.

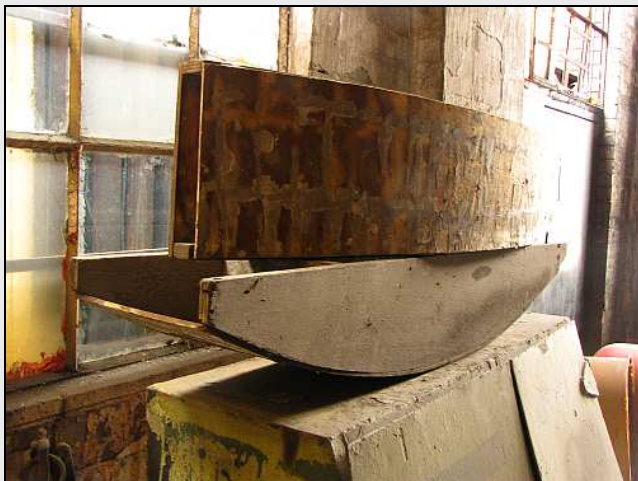
M07 – This pair of boat-shaped frames are the formers upon which the fire clay bricks of the 12AR's fire arch will be erected. As she doesn't have arch tubes, the fire arch will need to be supported while the mortar dries. (Even though it will use a wedging keystone, like a Roman arch.)

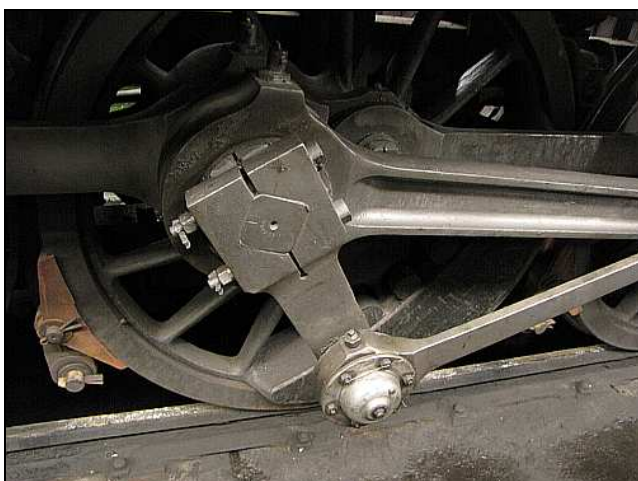
M09 – Monochrome Motion. A study of the RHS return crank on 15F No.3046, with a rusted cast iron brake shoe providing nearly the only colour. Note the cotter pins safely retaining the journal bolts, the bolts themselves routed through semi-circular slots in the square crank pin end.

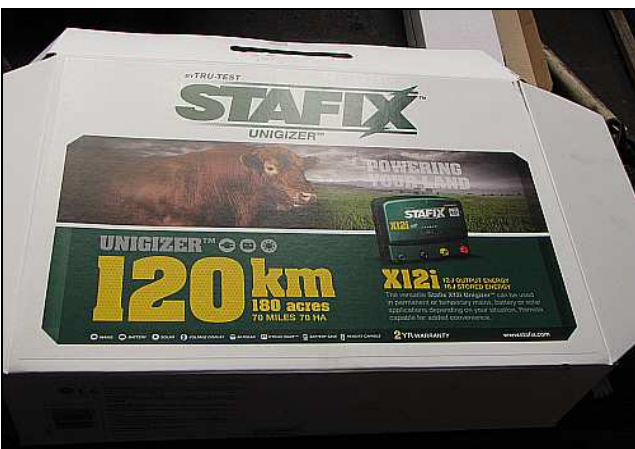
M17 – The new energizer for the balloon fence extension is genuinely an cattle-grade energizer at about 3 times the joule (energy) capacity of a domestic fence. It will run on 'only' about 0.8 to 1.2KV, making it less likely to arc to ground. However, the fence will be more vulnerable to volt drops within the joints. It is still gonna hurt like hell though!

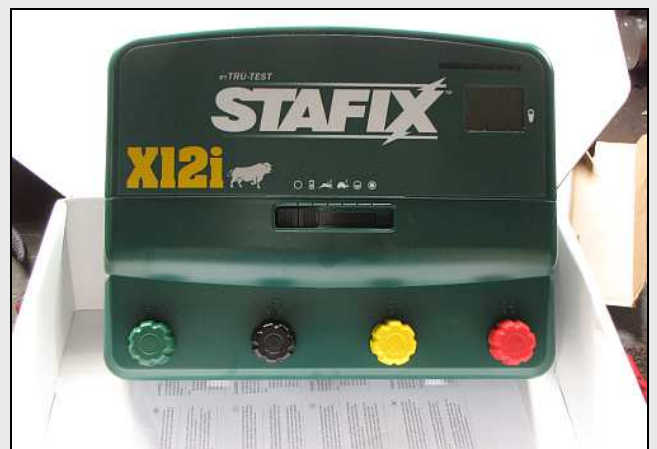
M18 – Here's the beast which was mounted and energized on 20th Jan, although the HT wasn't wired yet. An interesting feature is a photo sensor that allows the setting of a different voltage for night time use – usually higher as that's when the buggers roam. Being mounted above a workbench, it will be easy to increase the battery capacity.
