**1). A CATCH-UP (TO 14<sup>TH</sup> APRIL):**

**2). PROJECT – 12AR NO.1535 BLAST CONE MODIFICATION :**

**3). PROJECT : STRIPPING CRANE NO.578'S 'DONKEY PUMPS':**

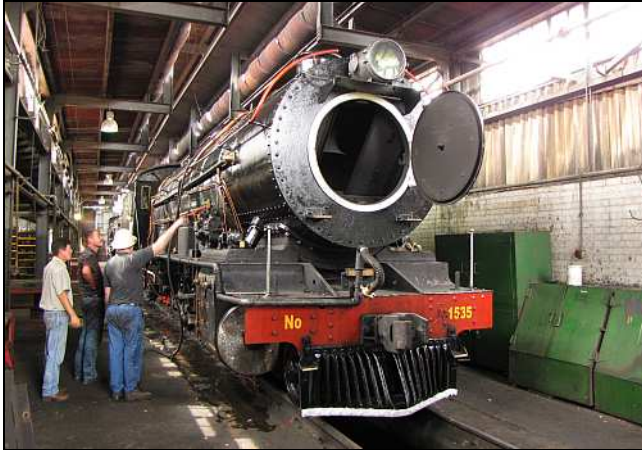
B01 – Class 12AR No.1535 ‘Susan’ waits for her modified blast cone. The smokebox had been finished in black gloss enamel rather than our now-standard etching primer, due to lack of time to prepare the base finish. We’ll do it up later.

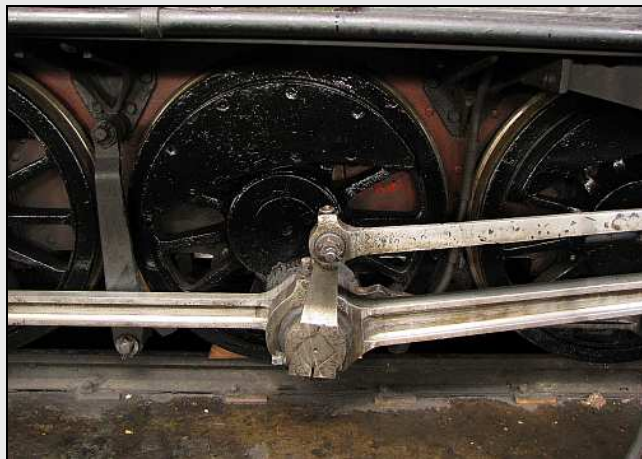
B03 – Susie’s driving wheels are now all black – the spokes were originally bare steel. The motion has already been wire-brushed but not yet scrubbed and wiped clean. It’s a surprising amount of work cleaning all that naked steel!

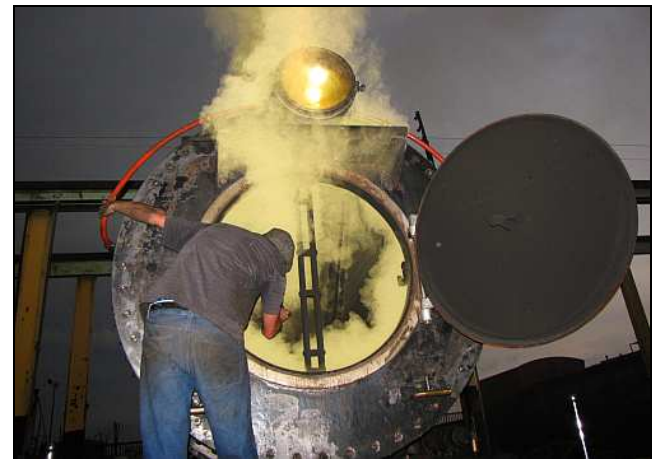
B04 – Where today’s work started – during the steam test, the induced draft blower was found to not be working. Shaun Ackerman is seen trying to ‘smoke-out’ the bug. We could hear the blower roaring inside, but there was no draft.

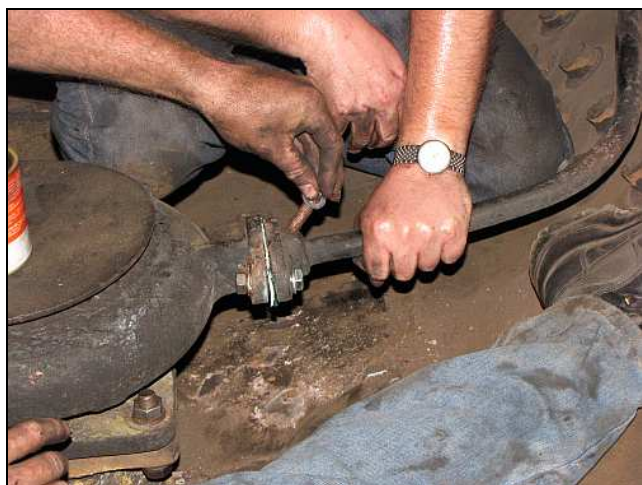
B05 – The blower fault turned out to be a loose flange and a matching blown gasket on the outer end of the blower’s steam pipe. In amongst the many assorted tight-schedule jobs and the late night on 9<sup>th</sup> March, the bolted flange on the other end wasn’t tightened properly. Oops!

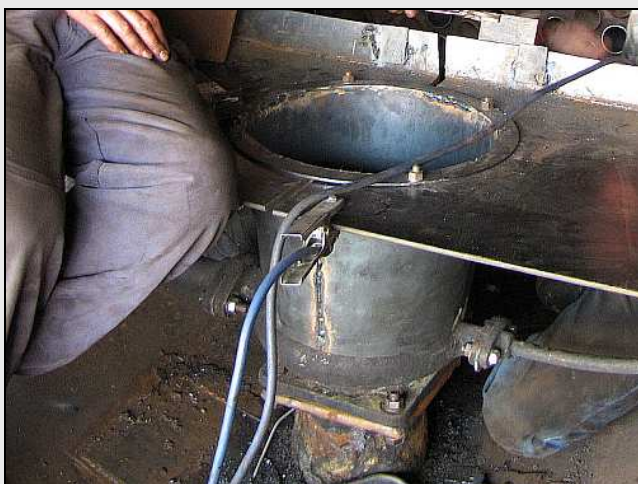
B07 – THIS was the problem – the solid-walled blast cone that we had Dawie Viljoen fabricate for us to try reducing the 12AR's tendency to throw sparks through the chimney when working hard. It turns out that the laminar turbulence, and the inability of the blower's steam jets to mix with the surrounding gasses at their source, render the blower ring totally ineffective – although the exhaust worked fine.

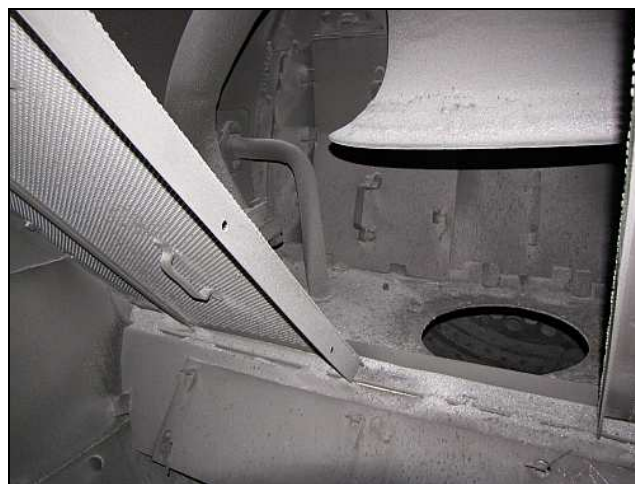
B08 – Showing the cone's aperture in the brand new table plate. The flue gasses are deflected downwards via those solid baffle plates, passing under the table plate and around the angled lip. The centrifugal force at the change-of-direction throws out the char against the smokebox front plate. The final exhaust gasses actually flow from front to rear through a bank of perforated spark arrestor grids.

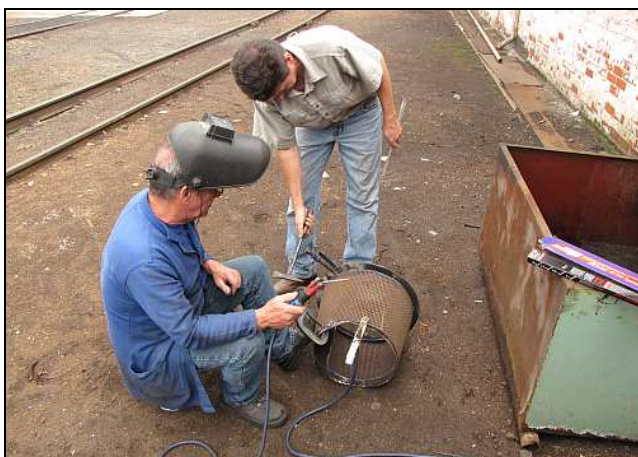
B09 – Alan taps the slag off the welds while Gordon (sitting on a paint tin nearly hidden by his overalls!) takes a breather. The chaps cut down a spare Class 15F cone to get a decent grid 'basket' and were cutting and shaping in a customized particle shield as well as fitting the new cone to the Dawie Cone's existing upper flange. (The wide end.)

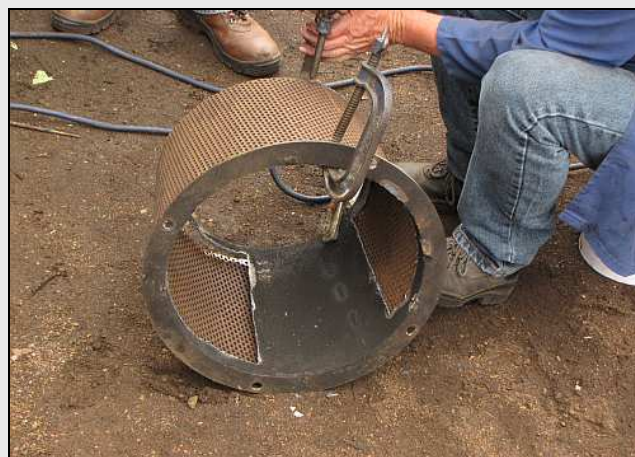
B10 – A view from the top down of the new cone clearly shows the new shield segment that will face the tube plate. Thus the 'sparks' that get through the lower, center boiler tubes will still not have a direct path right up the smoke stack - but the blower ring's annular jets are still contiguous with the smokebox's air-space via that conical grid.

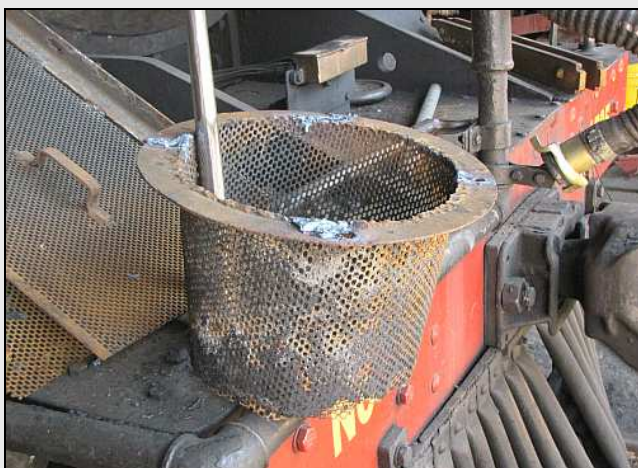
B11 – Here's what 'Susan's' exhaust 'basket' looked like in May 2012. The lower end was being eroded away.

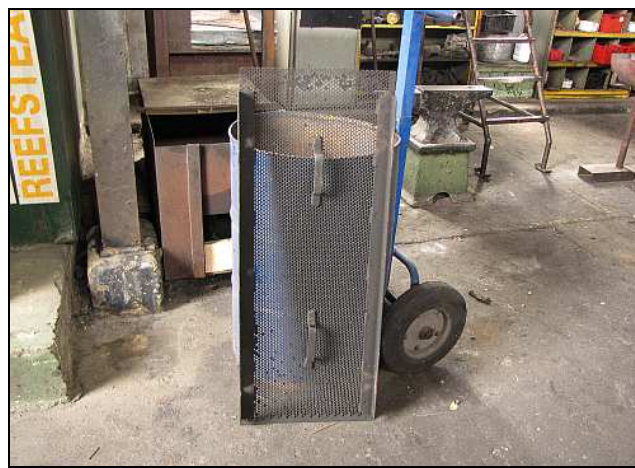
B12 – One of the three spark arrestor plates, which is still fairly clean! What a chore these are to unclog!

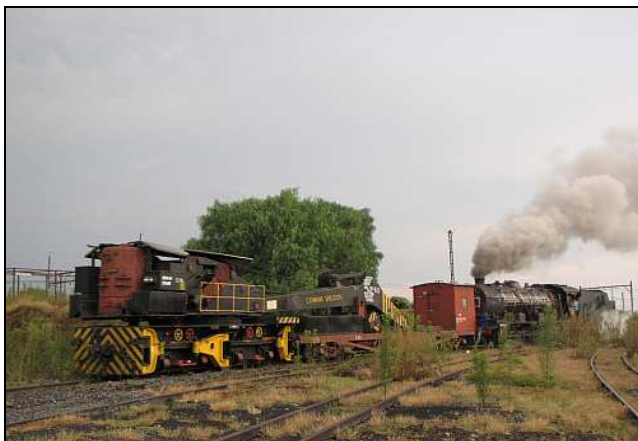
P01 – One of the first jobs for the 12AR, shunting Sandstone Heritage Trust's 60T Cowans Sheldon steam crane from the Carriage Shed into the 15M workshop. The two titular donkey pumps had been removed previously.

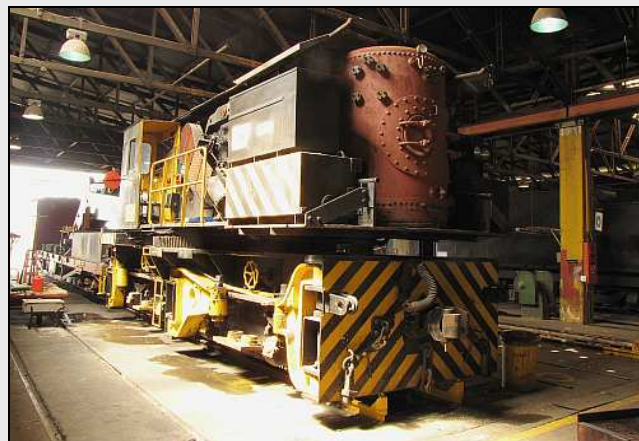
P02 – Crane No.578 is shopped-in for boiler testing. The foundation ring rivets all need to be replaced as they hadn't clenched properly when they were previously installed by parties unknown. The boiler base leaks under gravity fill.

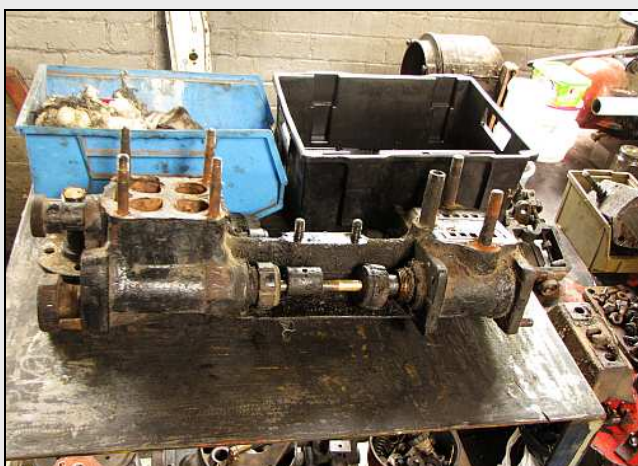
P03 – The crane has two of these pumps. The first one draws water from the main water tank on the match wagon, and pumps the water to the side-tank mounted on the boiler platform. The second pump draws water from that side tank to feed the crane's boiler. This pump was intact, but fouled with coal deposits spilled from the boiler's coal bin.

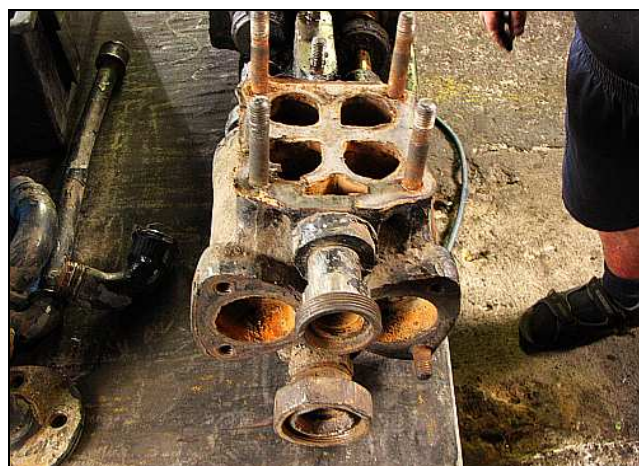
P04 – This complicated casting is the duplex water pump, with the lower pipe as the inlet and the upper pipe pressurized by valves – thus the inlet is 'swamped.' The bow-tie shaped flange is for the pump's cylinder heads. The casting had cracked into three pieces and had been re-welded. James plans to have a new one fabricated.

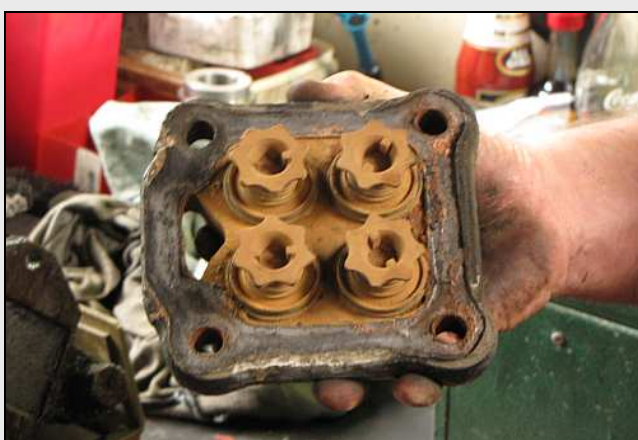
P05 – Here's the upper side of the valve plate. The spring-loaded poppet valves were all mercifully intact on both pumps. The disks will obviously all be lapped in. The water flows from the bottom up through the one-way valves and then down to the outlet via that triangular aperture.

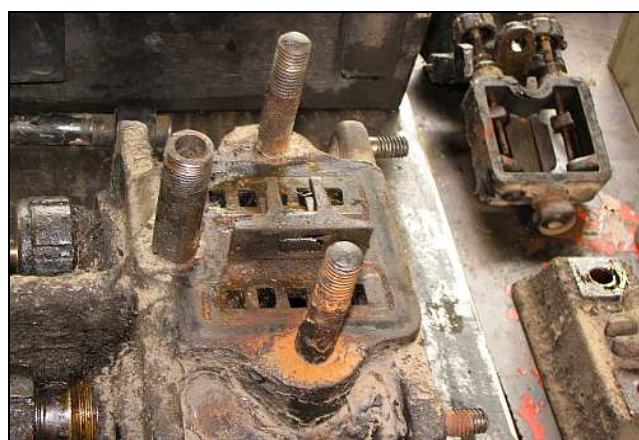
P06 – One of the D-valve elements and the port plates. The 2<sup>nd</sup> & 4<sup>th</sup> of the five ports are not admission ports as may be supposed. They expose more valve area to the differential pressure between the live steam and the cylinder – helping to press the valve down for a better seal.

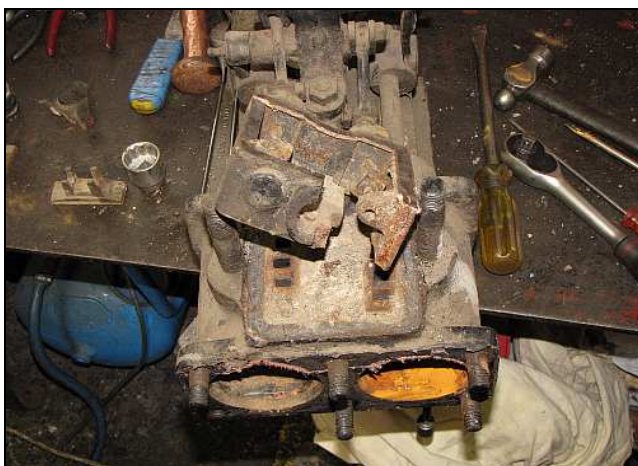
P07 – This pump’s duplex double-acting engine has a burst valve chest – probably from an initial fracture. It could probably be brazed with the still-available broken pieces patched in. However, Sandstone Estates have spares retrieved from other similar cranes that were scrapped at Danskraal. (Arrangements were made with REKLAM according to an agreement with Steam in Action, to allow for the stripping of spares from the cranes before they were scrapped – so Crane No.578 has plenty of spares available!)

The Booth Rodley Crane No.96 has the same type of pump, so we will borrow a valve chest casting from there in the meantime.

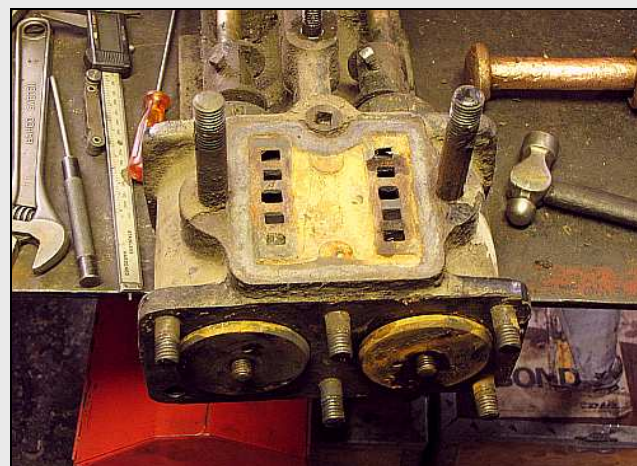
P08 – The first real challenge of the donkey pump strip-down – how to get the power pistons out. They are made from bronze and need to be treated with some care, especially with the piston rings scratching their way along. The cylinders have steel liners within the bronze casting and that’s where the obstructive rust came from.

On the valve chest plate between the protruding studs, you can still see the ghostly outlines of where the D-valves came to a stop when the pump last operated.

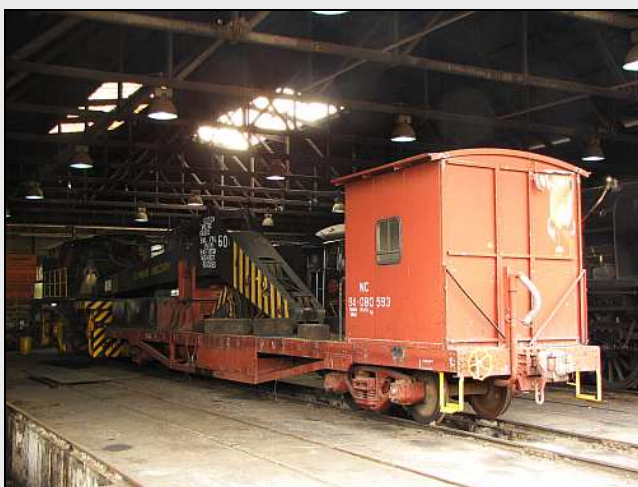
P09 – Here’s the steam crane from the other end – taking up almost a full bay. A problem here is that those clear roof panels in the background have been holed with hail damage so the ‘mechanical end’ of the crane is still likely to get wet. We are going to experiment with blocking those panels over with standard sheets and seeing how the lighting works. A new set of translucent roof panels are more than we can afford right now.

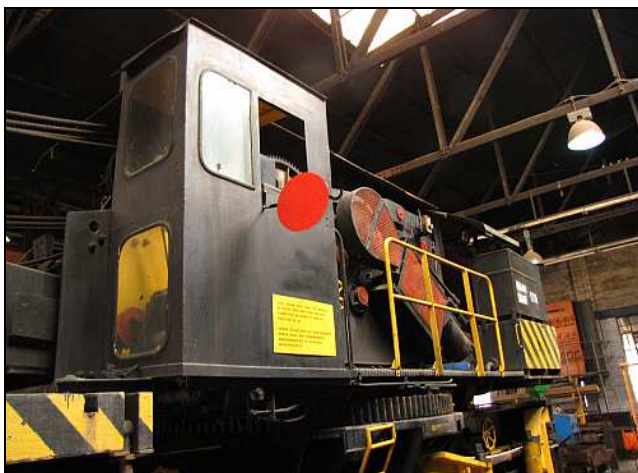
M05 – Sandstone's Steam Crane No.578 is now also correctly flagged-out for maintenance work. This old crane has even has its own built-in anti-intruder system – once again, a swarm of wasps have made their home within the cosy, secure confines of the geared slewing ring.

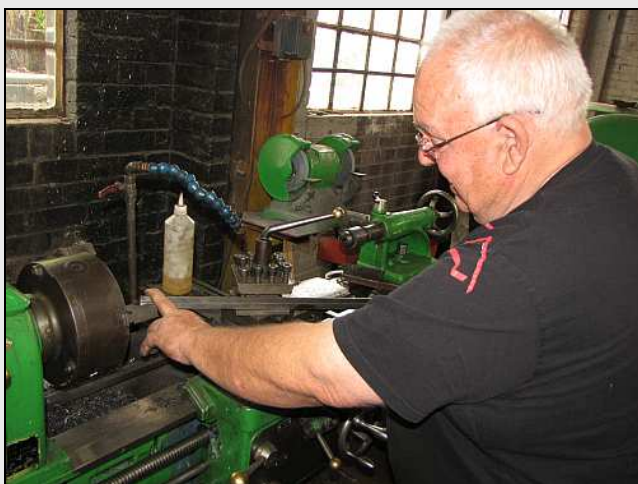
M07 – Our chaps have been battling with this lathe recently as the cutting tools are starting to chatter. James shows the cause – the lower clamping plate on the tool holder has become distorted. James is planning to make new plates, and a matching tool holder for the other end – one dedicated to machining and one for cutting threads.

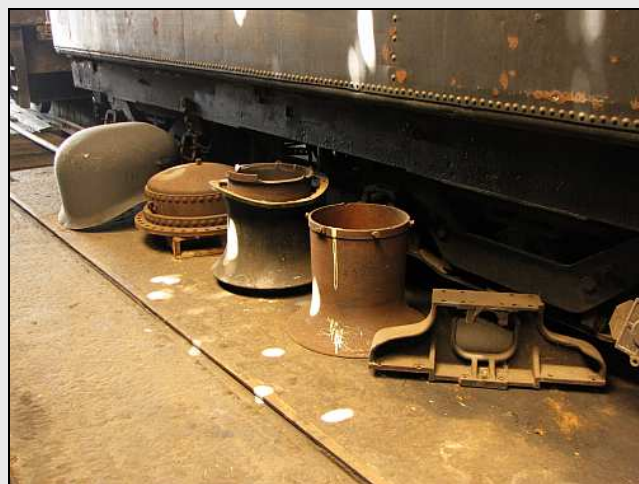
M14 – The bits belonging to 12R No.1947 ‘Rusty Rosie’ have been neatly lined up and out of the way. From rear to front, a dome cover, a steam dome, the original chimney, a spare blast petticoat and the steam reverser’s pedestal.

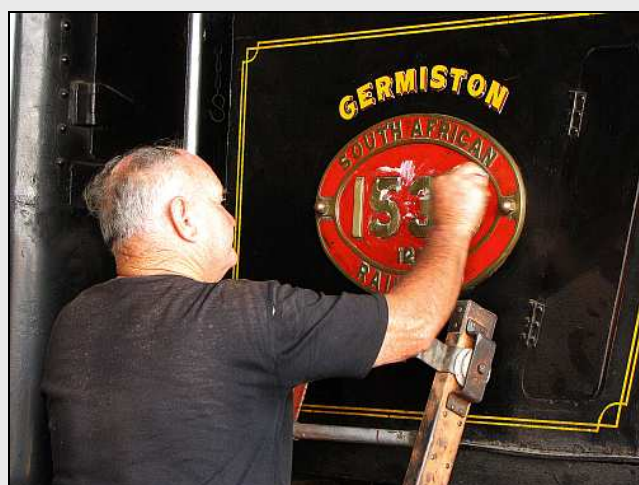
M18 – Oude Drywers never die, they just get demoted to cleaners! (Right back where they started, decades ago!) Attie is aware of the irony, but he is still happy to do this stuff. That ‘Shield’ brand polish worked well on the brass oval, but the buffing machine took some of the red paint off the inset surfaces. (As that paint was never primered.)

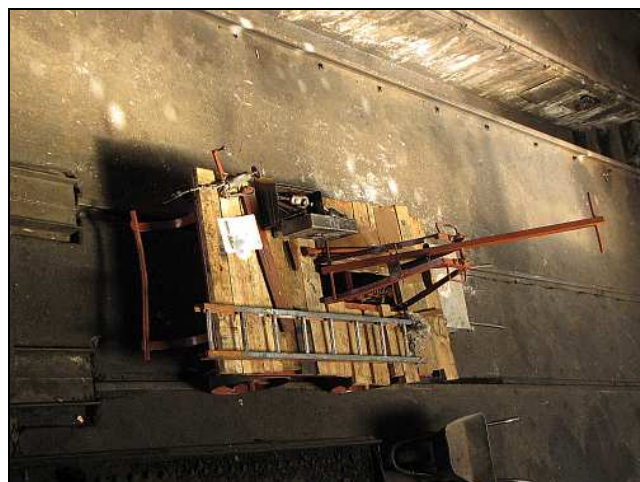
M20 – The deck planks have been put back onto the pump-trolley, all with more 'character' after being used to support components in the 12AR's smokebox. The trolley's crank rod had been removed to immobilize it, before someone hurt themselves playing on the unfinished little machine.

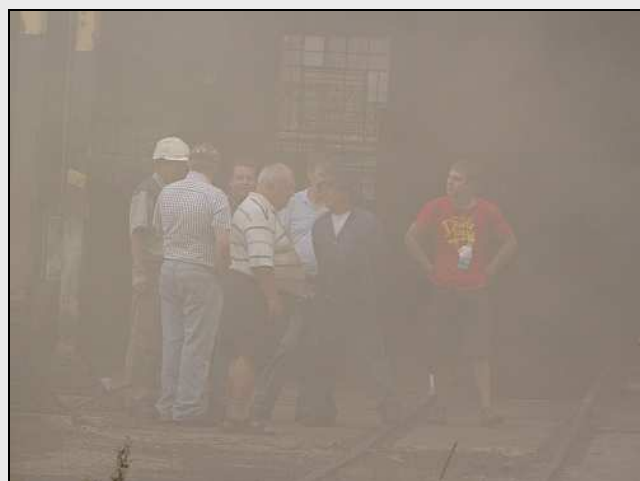
M22 – When the blower ain't goin', the smoke is showin' and it's really laying low'in as fast as the Mini Mienie can keep thow'in the carbon! These guys don't seem to mind though – they actually LIKE the scent of coal smoke! (Odd.)
