1). PROJECT – STEAM CRANE NO.578 – FEEDWATER PUMP STRIP DOWN:

2). PROJECT – 12AR NO.1535 RUNNING REPAIRS:

3). FETCHING A DONATED FLY PRESS – 13TH APRIL:

4). MOVING TWO HALVES OF A TUBE SWAGER – 23 MARCH + 13TH APRIL:

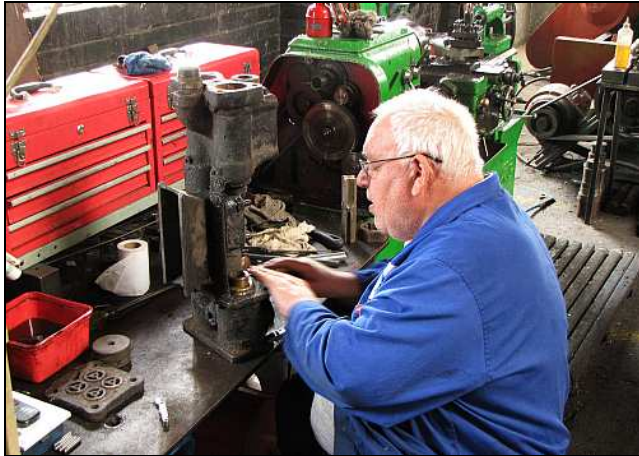
D01 – His name is James and he can make a lathe sit up and beg! But for now, he is happily absorbed, with a cup cake inside him, with further strip-down of one of the boiler feed-water pumps from Sandstone's Steam Crane No.578.

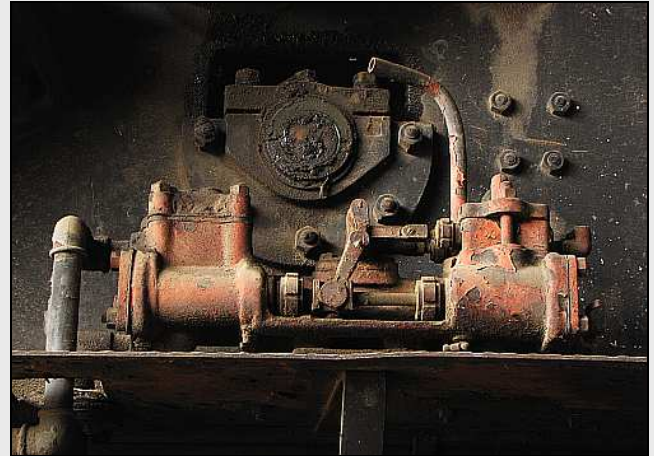
D02 – Here is a very similar duplex feedwater pump as fitted to the 36 ton Booth Rodley Crane No.96. The twin cylinder steam engine is to the right, with the water pump at the left, and you can see the valve hammers in between.

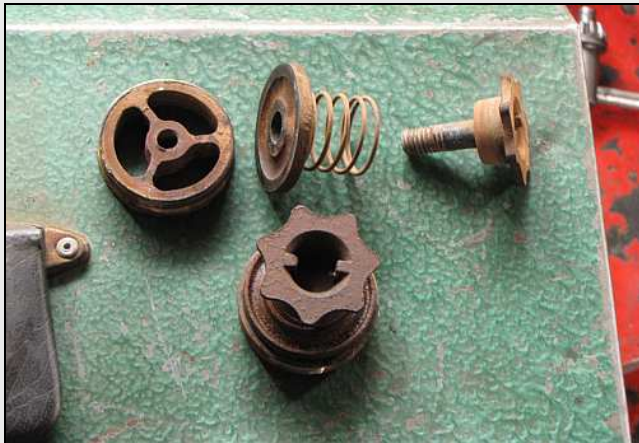
D03 – The outlet valves (four for each feed-water pump) all survived in reasonable condition, with springs and adjusting nuts intact. They just need to be cleaned, matched to their seats and then individually lapped in again.

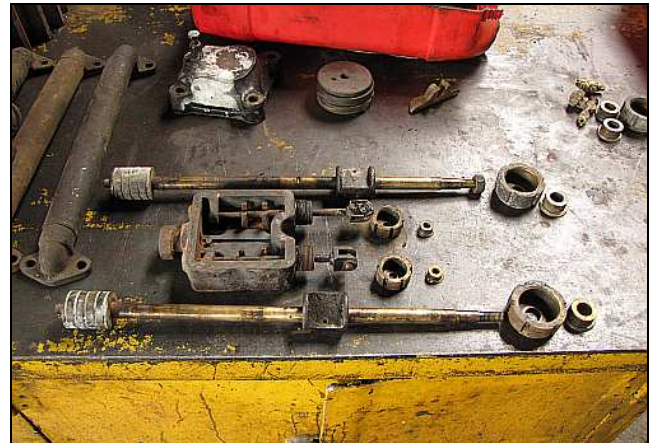
D04 – The valve gear all survived intact, but with serious wear at every joint and at every gland. Here you can see the valve chest between the piston rods and packing nuts. The water pump rings (L) had corroded into their grooves.

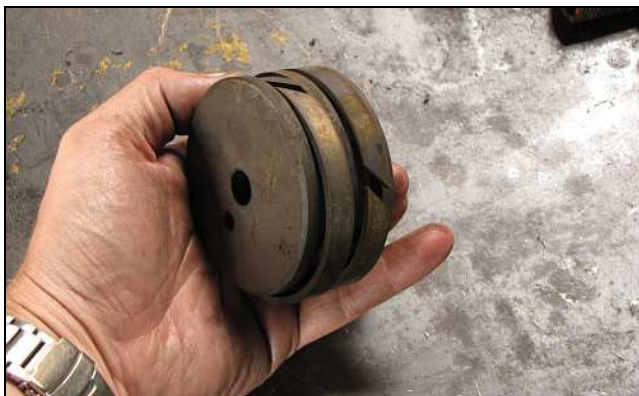
D05 – The two steam-driven pistons are worn as well and new ones will need to be made. They will need to be made to match the cylinder sleeves, which need to be bored out oversized and parallel. The piston and valve rods are also worn, but they will be machined to consistent sizes and re-used with seats and bearings remade for a custom fit. It will save time but has the disadvantage of rendering the pump parts no longer interchangeable with each other.

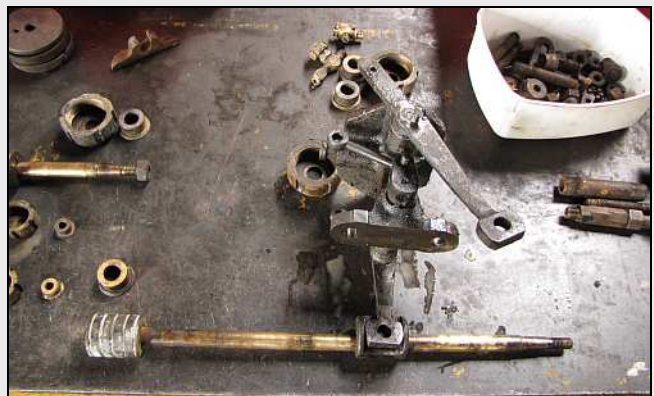
D06 – The valve relay tower and fingers shown in position on a piston rod, each piston operating the valve on the other side. There was so much wear within the valve motion that there was hardly any of the valve events left. We initially blamed the abrasive coal deposits, but the cleaner water tank's pump was also badly worn. So it was basically a consistent lack of lubrication – especially over a steam crane's typically short duty cycle style of operation.

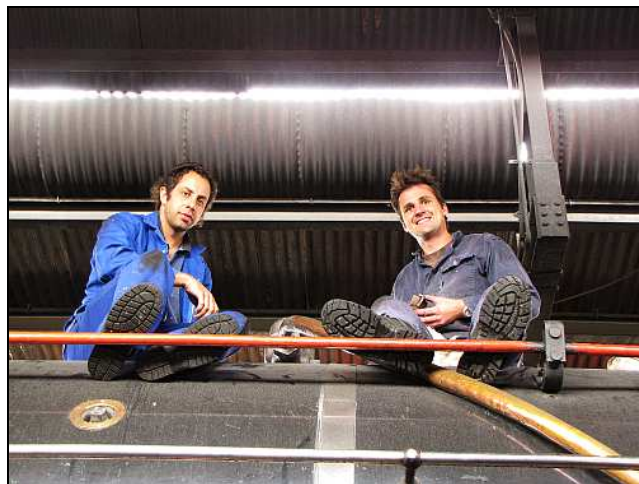
R02 – This pair of goofballs are Andreas 'Bob-Tail' Matthee (L) and Dawie 'Swakhart' Viljoen. They had just camped-out up top of the Class 12AR's boiler to start with re-lapping the clack valves that were leaking. Dawie had just taken his hard hat off, hence the rather wild 'kuifie' hairstyle.

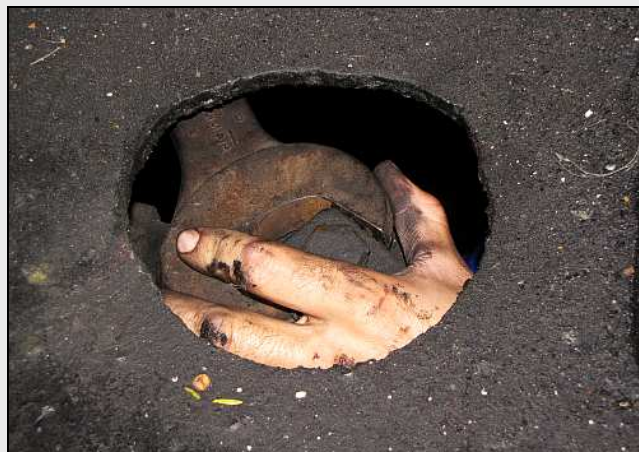
R04 – Ooh and there were some naughty Afrikaans words coming out from under the running board when the time came to open and service the non-return valves. The standardized valves are too tall for the piping center line.

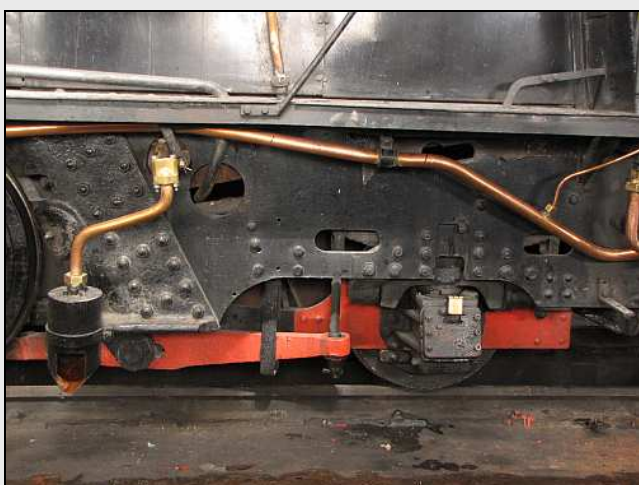
R05 – A side-on view of the equalizing beam (in red) and the rear suspension. Notice the small upper oval-shaped access holes which make that ash pan such a joy to clean.

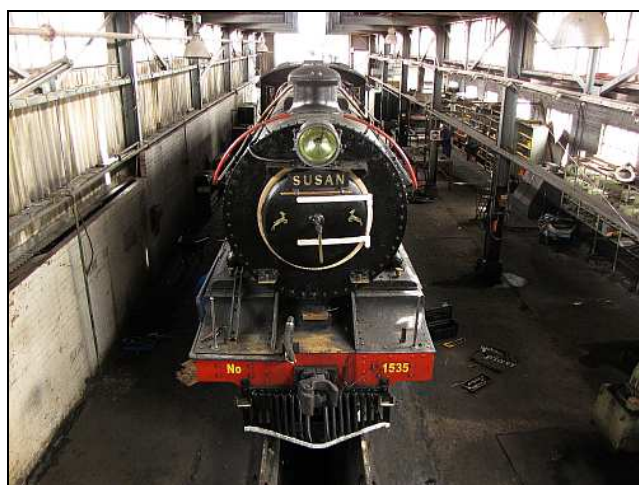
R06 – Susan, the last surviving Class 12AR – A forehead view. Note the clench bars resting on the front risers – the smokebox door wasn't latched closed.

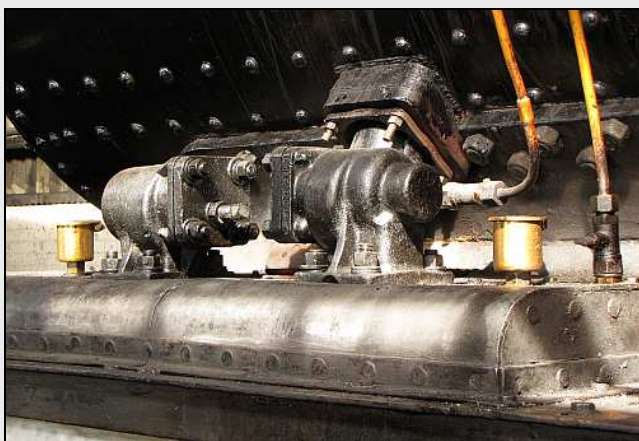
R07 – A view of Susan's recently-painted bypass valves. The steam down pipe is currently sans its cowling for quick rectification of any stuffing box or gasket issues. The horizontal sparkplug-like device is the steam oil atomizer.

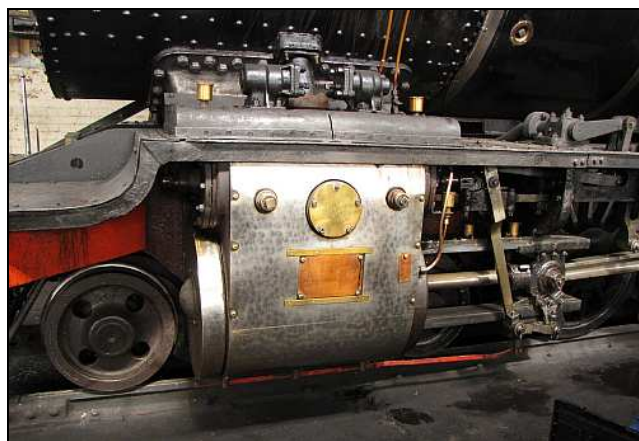
R08 – The business end of the motion on the left side. The piston is at rear-dead center at mid-gear. The crosshead on the other side had been set at mid-point to measure the clearances in the most-worn parts of the slide bars.

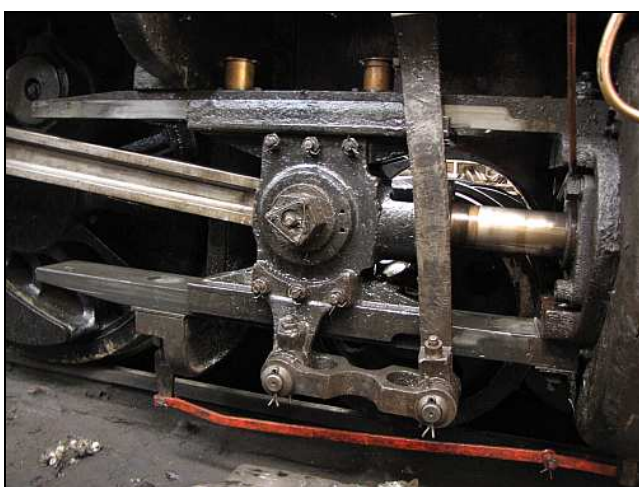
R09 – Here is other side's crosshead at mid-stroke. The clearance between the slippers and the two separate slide bars was about 5mm in the center. To complicate matters, the center parts wear more than the ends. Setting the center clearance correct would make the ends too tight.

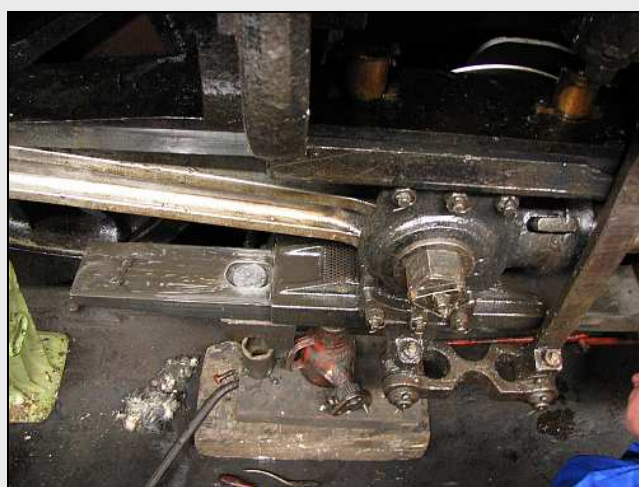
R10 – The ideal slipper gap on this locomotive would be 1mm. The slide bars are too unevenly worn to get this clearance set up, so a compromise had to be made. Eventually, the four slide bars will need to be removed, and the white-metal surfaces re-machined straight and parallel.

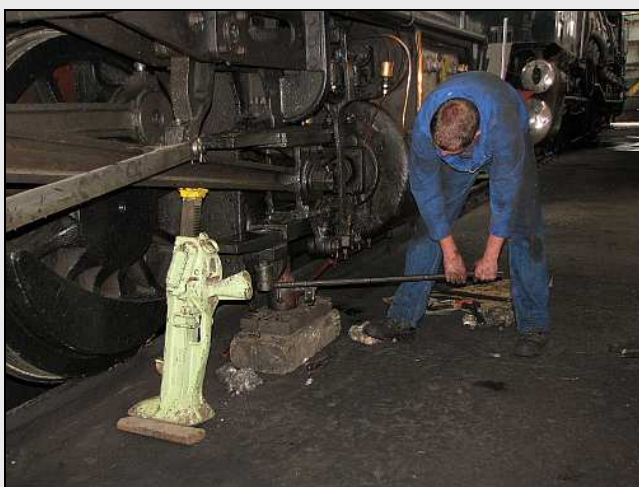
R11 – Doctor Smudge is tightening up the rear shim bolt to seat a newly inserted shim on top of the existing shim-stack. The front end is held on by two smaller bolts. Note the jack under the crank rod – it is taking the weight of the rod, bushing and crosshead away from the lower slide for measuring.

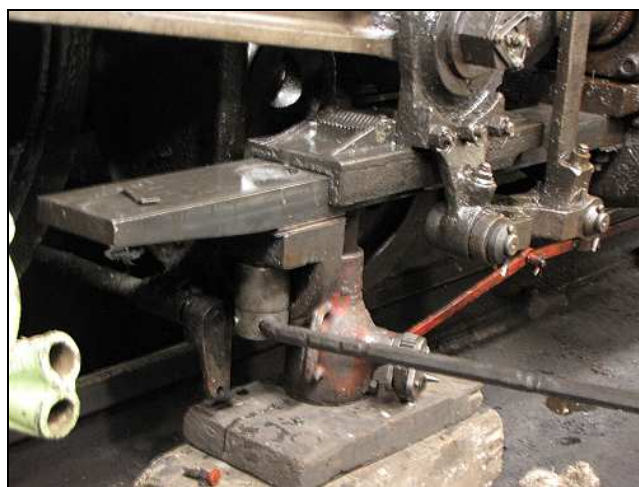
R12 – In this slightly blurred view, you can clearly see three rust-tinted shim plates above the tube spanner. Not only does a loose crosshead cause knocking and problems at the cylinder's garter ring & packing gear, the points of the pivoting cross head also stresses the oil film as the surface area is much lower. (Hence, exerting higher pressure.)

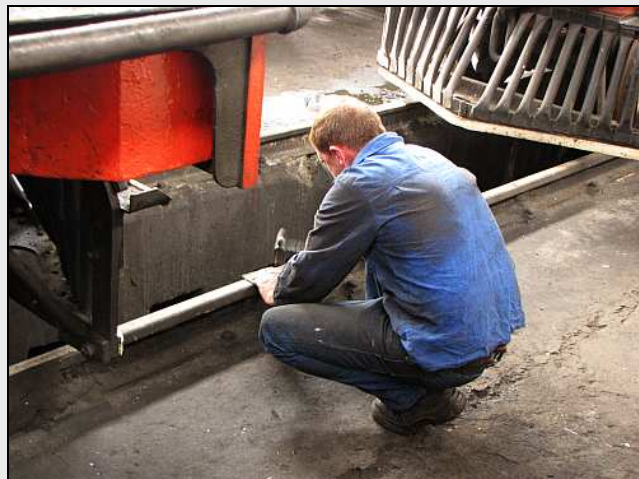
R14 – Rail heads are naturally plentiful around any loco depot and they are also useful as impromptu anvils. The incomparable Dr. Smudge is seen tapping a bend out of one of the rectangular two-holed front shims.

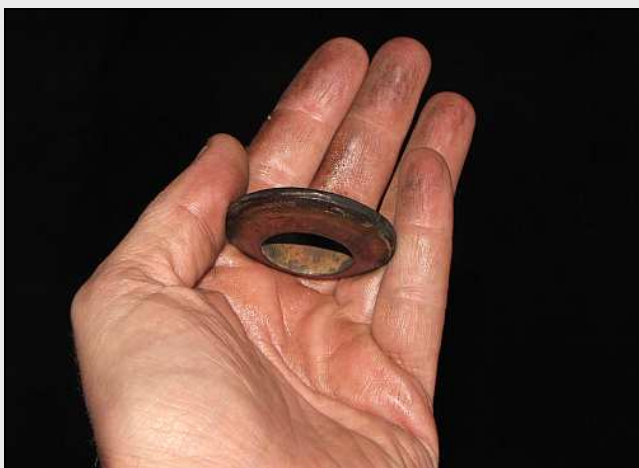
R15 – A close-up of one of the double-conical olives that seal the joint between the water column cocks and the backhead's flanges. Unlike compression olives, as in many solid-wall fuel or hydraulic lines, these don't crush into place. Unfortunately, they can shift during installation and a dry, cold fit can't be tested. Fitting water column cocks onto a steam locomotive is a lot trickier than it looks!

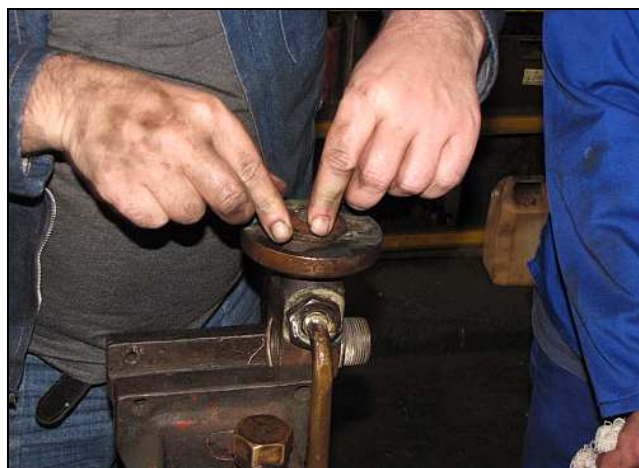
R16 – The olives are lapped in like a poppet valve against its seat. Grinding paste is applied to the conical surface and the olive rubbed vigorously against its matching recess. The same process is done with the other side for the backhead and the two sides must not be flipped. But even a ground-in olive will leak if the cock and its flange are not parallel or the flanges are distorted.

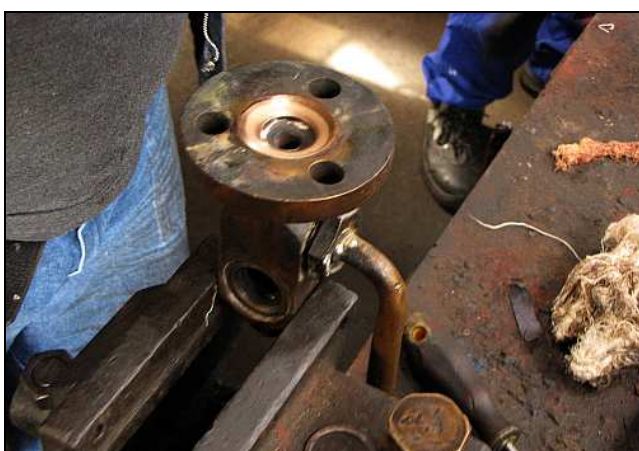
R17 – A sign of a good seal would be a matching contiguous, concentric ring of bright, clean metal on the seat and on the sealing olive itself. This one is only half way through the process.

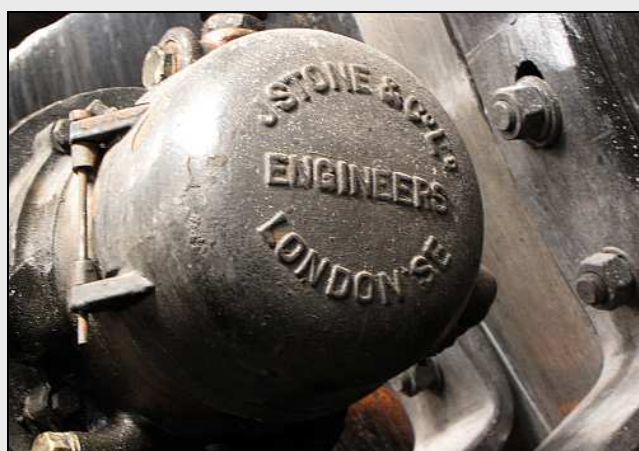
R18 – Not strictly a repair picture. Susie's replacement dynamo (Technically, a turbine-driven magneto) governor cover still has crisp-edged lettering for good ol' J. Stone and Company.

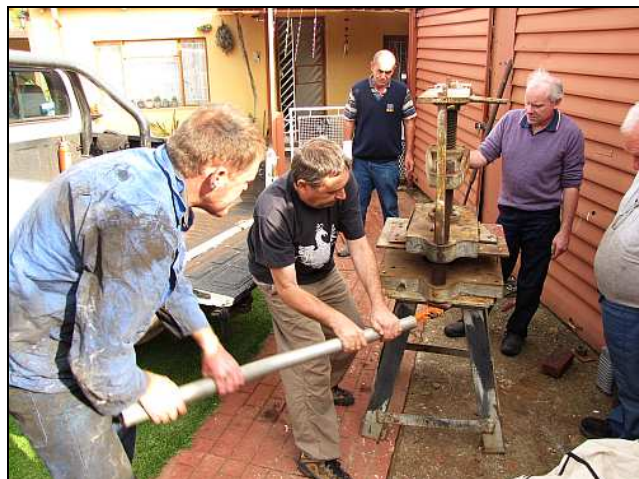
F02 – The fly press was smaller than any of us imagined it would be, but none of us were fooled by its ‘diminutive’ size in terms of weight. We took turns in removing the guide rod nuts to split the press into two easier-to-handle pieces.

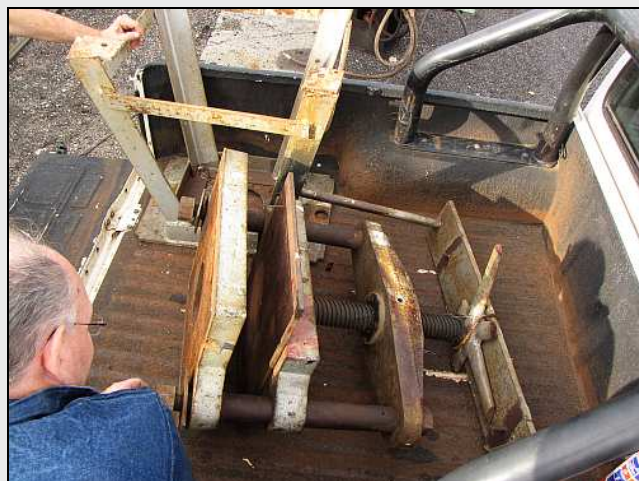
F04 – A view of the press itself. Fly presses use weights on long levers to add inertia to the turning motion. They can be used as die punches too. This press used to have a weighted fly wheel – of which some spokes can be seen.

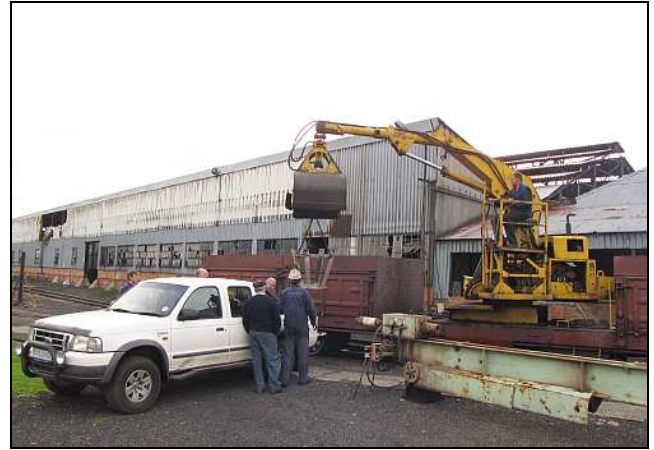
F08 – A nice easy load for the coal grab and the fly press's stand is lifted upside down. The 4-way octopus chains hanging from the coal grab's bucket are shackled to the central impulse plate and they are removed for coal loading service. Dawie (R) and Dennis had come out for a look.

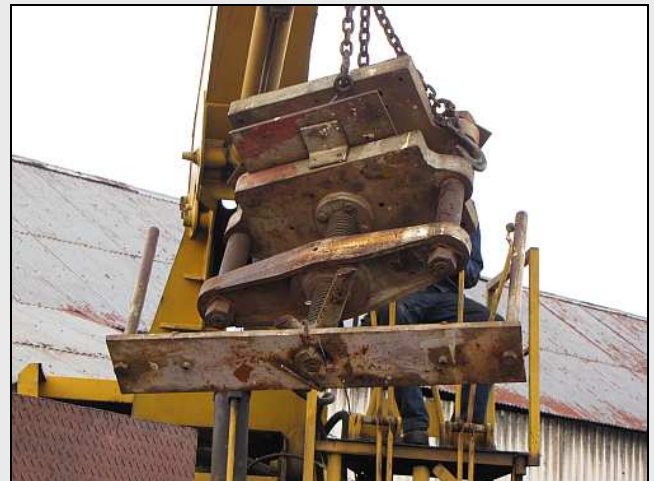
F10 – A top view of the press going up. By replacement of that handle with a properly weighted one, we expect this to be useful for small work. The two existing hydraulic presses are powerful, but they are also hard to modulate.

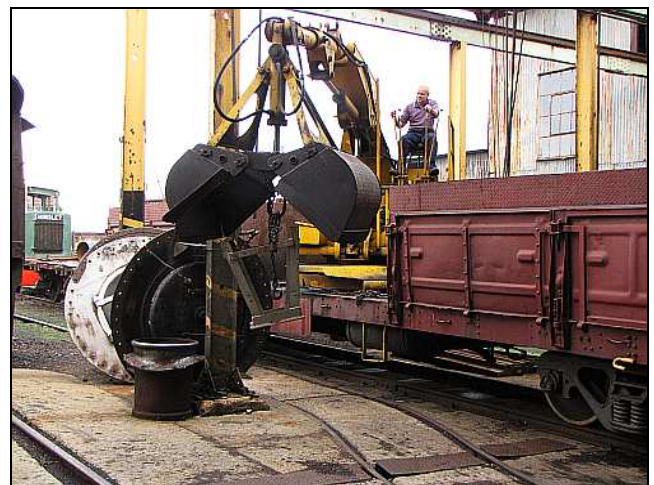
F12 – Andrew took over on the grab's controls in the 15M yard to warm up before tackling the next project – the Tube Swager. Notice the damage to the coal grab's bucket – done by a previous staff member by directly lifting coach bogies. Repair work started on the bucket last week. (21st)

M10 – Parking the Coal Handling Wagon’s Boom away after a long day. The clamshell buckets have since been dismantled and the bent sections cut out, pressed flat in the 50 ton hydraulic press and made ready for re-welding.

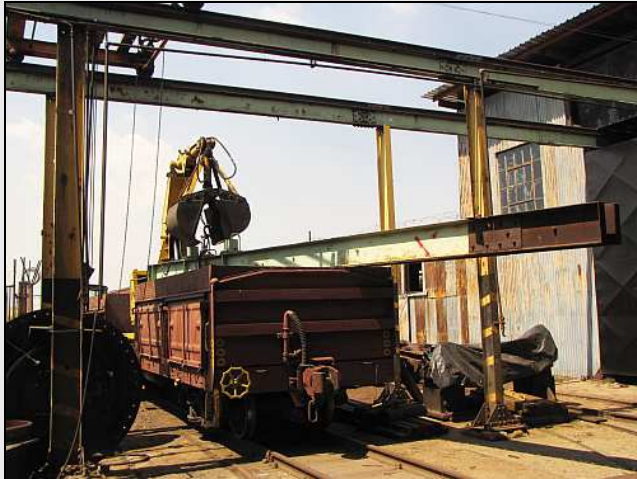
S01 – The ex-SANRASM Tube Swager was dismantled into 2 main pieces and the upper set of beams were moved on Sat, 23 March. Here, you can see the upper half waiting to be unloaded, using the Wheel Lathe's gantry crane.

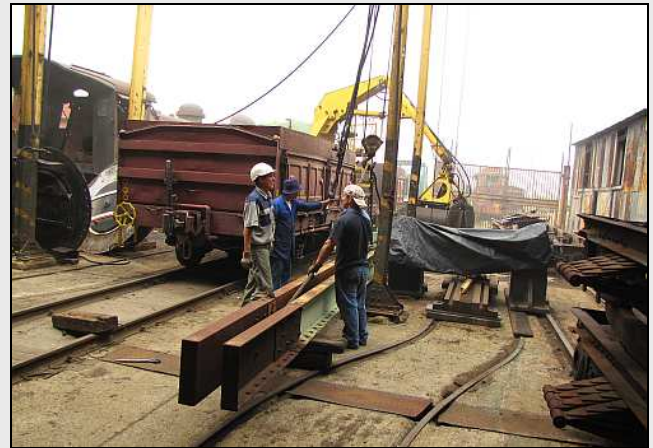
S04 – In this view, the double C-Beam construction of this large but simple machine is obvious. The use of wood blocks eases the slinging in future. The second half would have to be unloaded without the crane, as these guys had unavoidably taken that unloading spot under the gantry.

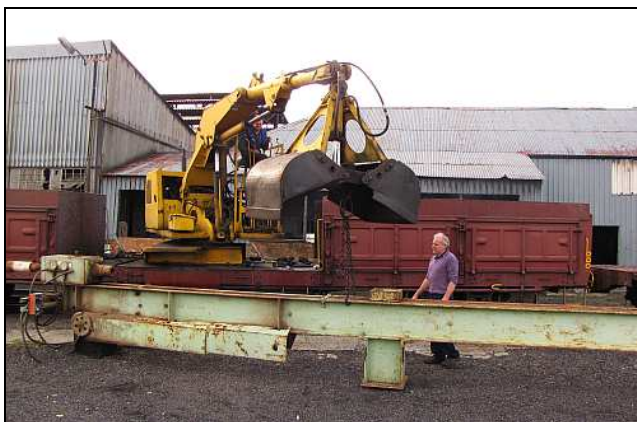
S05 – On 13th April, we had to 'swagger' the lower half of the swager in towards the rails. It was delivered by road truck, hence the awkward angle. Care had to be taken not to roll this lot over, as it is top-heavy on those pedestals and the foot flanges tended to dig into the soft ground.

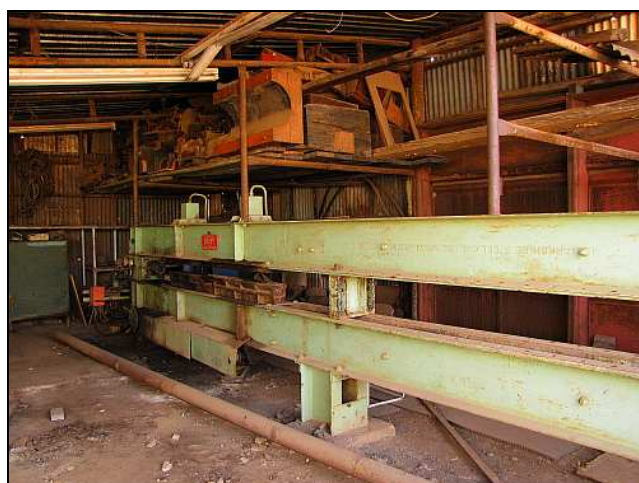
L12 – The Tube Swager at SANRASM North Site’ Machine Shed in Sept. 2010 – it also held up the shelving and the shed roof itself! Visible are the tube V clamps and vertical rams to hold the tubes in place. The center piece can be unbolted and relocated to suit the length of the boiler tubes.

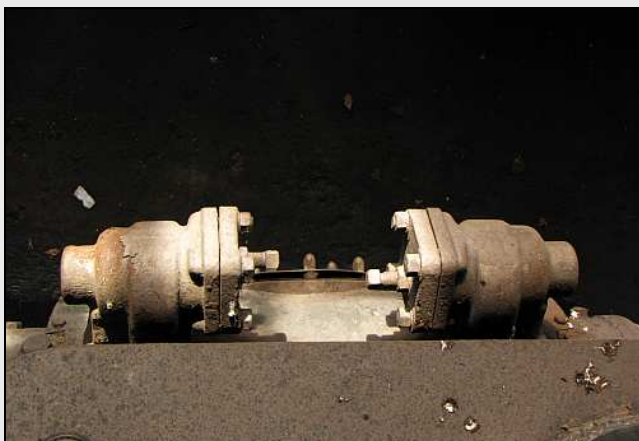
M03 – A different view of the RHS bypass valves (and a few birdie splats) on the GMAM Garratt No.4079 'Lyndie Lou.' You can't get this view on a standard locomotive, as the smokebox would be where I was then standing.

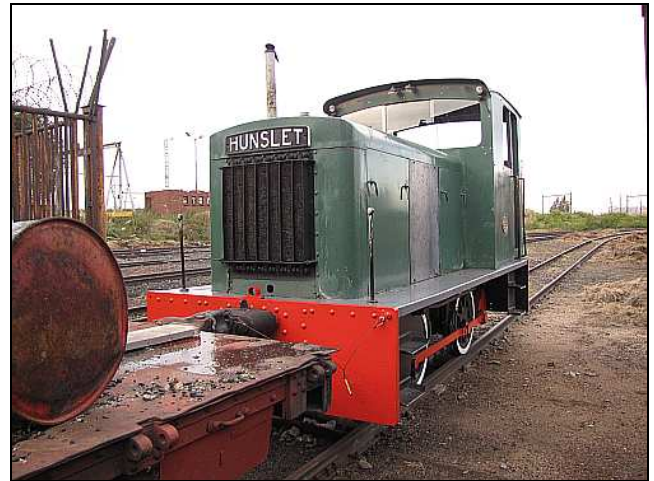
M08 – ‘Andrew’ the Hunslet Taylor shunter has recently been smartened with painted wheels, rods, walkways and buffer beams. Notice one of two new engine covers. It is of corrosion resistant steel, but will still need painting soon.

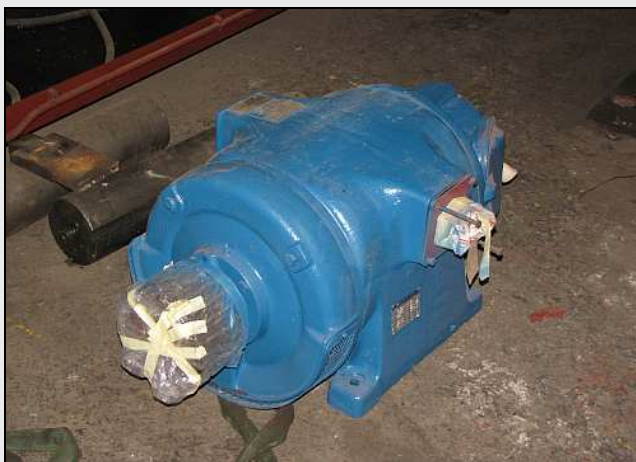
M11 – The newly rebuilt motor for the Wheel Lathe. We now have everything we need to start reassembling the gearboxes and the drive .. except for time. Once 15F 3046 is ready for boiler inspection, this will be Depot Manager’s Gordon’s next major project amongst his normal tasks.

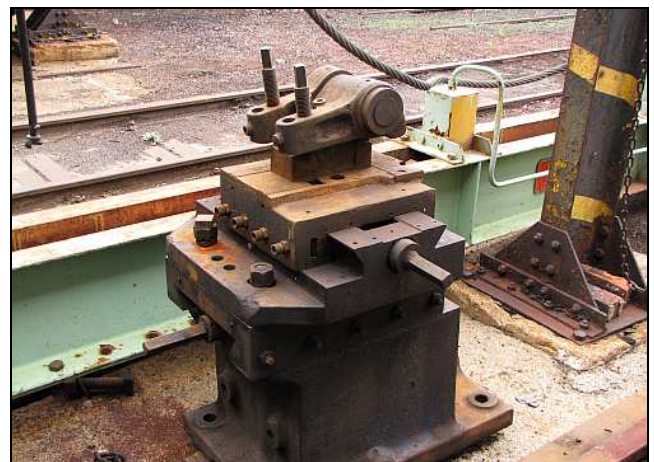
M12 – One of the two tool towers for the wheel lathe – intact and just needing a good cleaning and lube session. The shaft protruding to the left is the one which the chain-driven clutch is mounted as an automatic tool feed.
