This Reefsteamers Waybill Newsletter was compiled by Mr. Lee D. Gates on behalf of Reefsteamers Association NPC.
For observations, corrections and suggestions – email me at documenter@reefsteamers.com

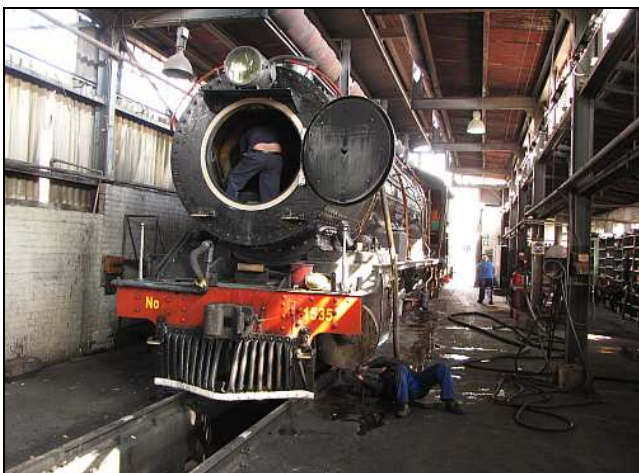
P01 – Taking a break before the busy June season, Class 12AR No.1535 ‘Susan’ is undergoing running repairs on the cylinder cocks and superheaters.

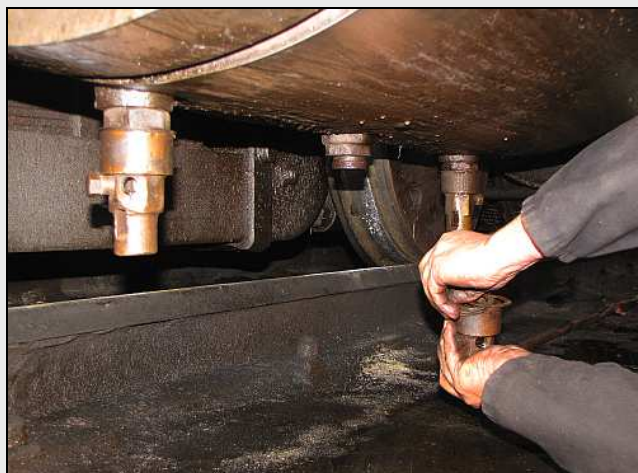
P02 – Fireman Johann Breydenbach discovers some stacked copper sealing rings, while realigning a cylinder cock. (The cocks were discharging inwards.)

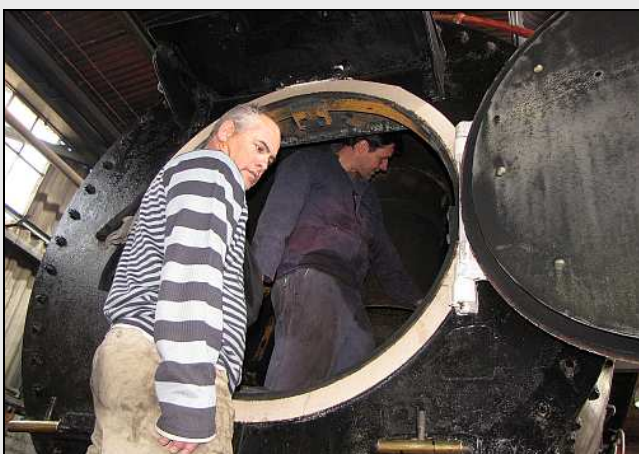
P03 – Michael (L) and Dawie (R) confirm that they are to start with opening-up the Steam Delivery Pipe Flanges for inspection of the front-end steam leaks.

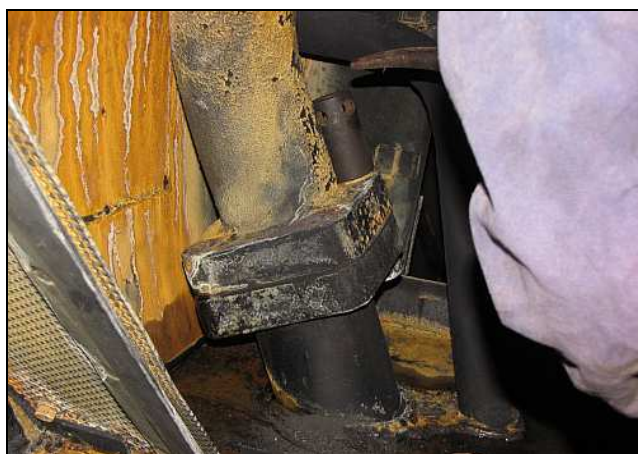
P04 – The RHS waist flange is being dismantled to inspect the blown gasket – note the thoroughly steam-cleaned smokebox barrel.

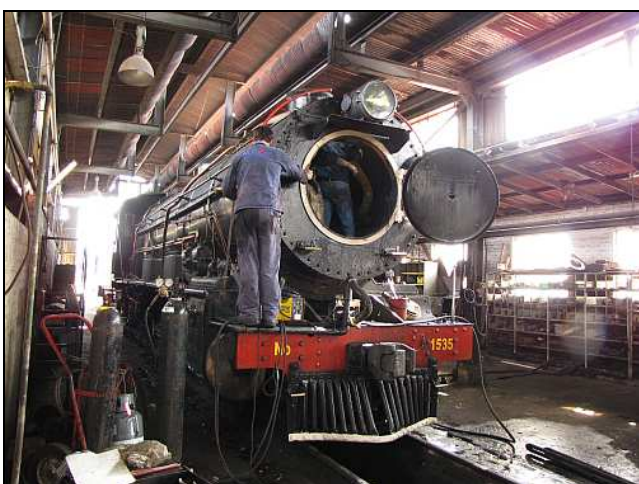
P05 – The 12AR gang are discussing removing the petticoat for better access to the holed superheater. Dawie is moving a shaker lever to hang a chain hoist within the chimney to support the loose petticoat.

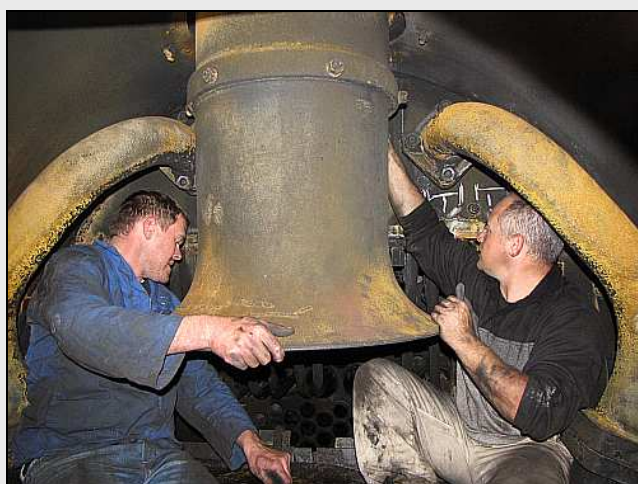
P06 – Smudge (L) and Rekots (R) start undoing the long-cooked bolts holding the petticoat into the chimney. Dawie had spanned the chimney with the shaker lever by now and was fetching a chain hoist.

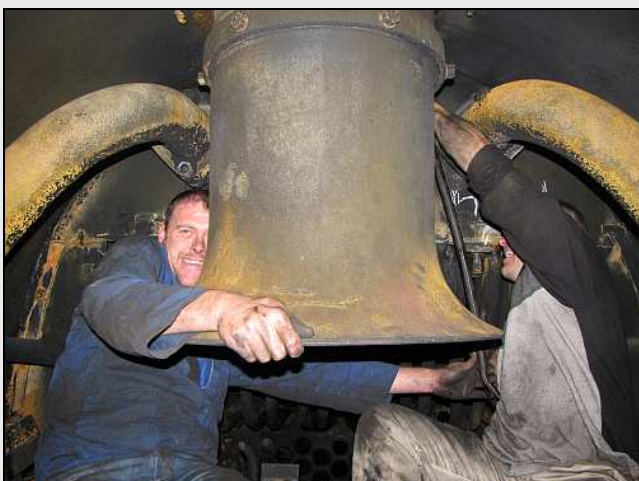
P07 – Michael holds the gwalan n' tube socket combination firmly onto the bolt, while a cheerful Shaun reaches for the lower end to give it a pull.

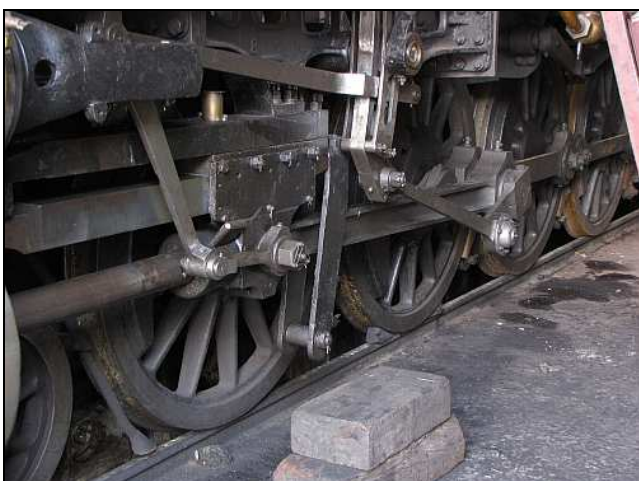
P09 – The LHS valve motion on Class 15F No.3046 'Janine' – just reassembled after replacement of three worn bushes with new ones that were custom-machined in Vesconite™.

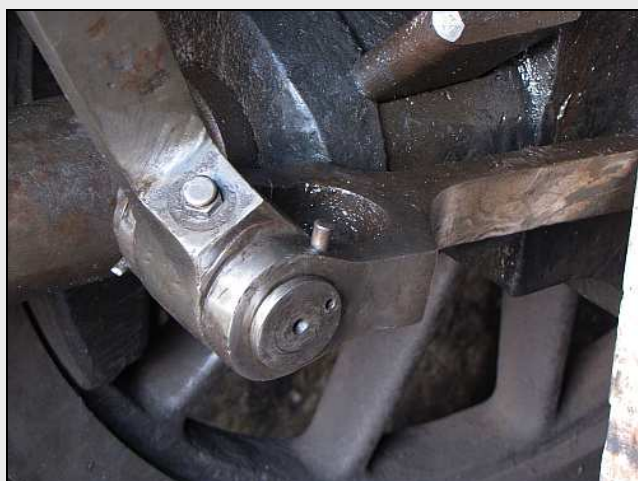
P10 – Class 15F 3046 – A clevis-type joint at the leading end of the Union Link, still clean with a new Vesconite bushing installed. (This provides the valve event cross-head lead for the Combination Lever.)

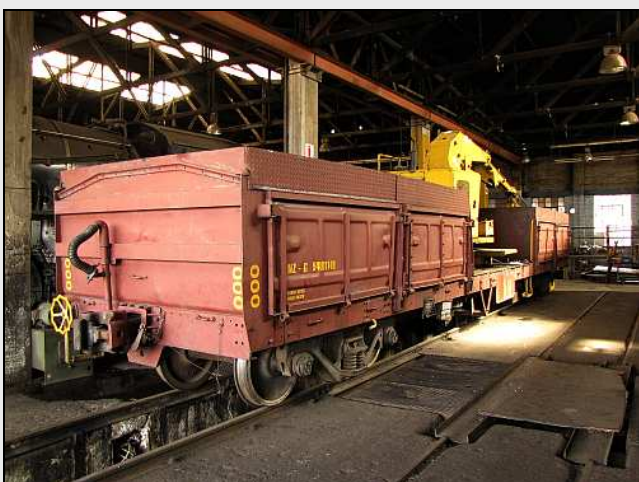
P11 – The Coal Handling Wagon in the 15M shop after the bent, cracked clam-shell grab was repaired and reassembled, and a bent scuttle plate straightened and welded back on again.

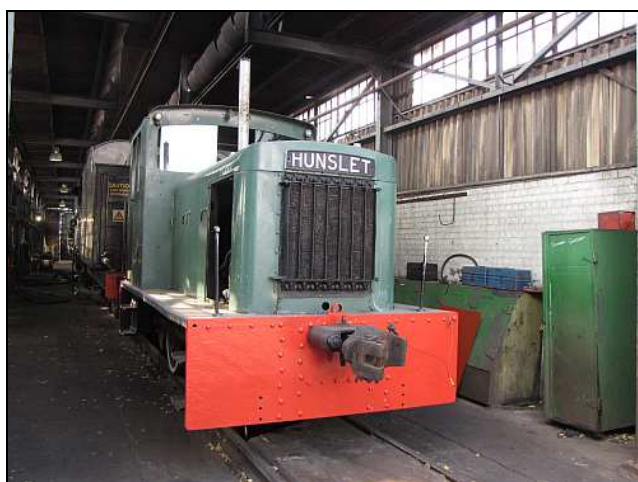
P12 – 'Andrew' the little Hunslet waits for his newly primed engine covers to dry, before they could be painted and fitted. (Since done.) You can see one cover against the cabinets behind the buffer beam.

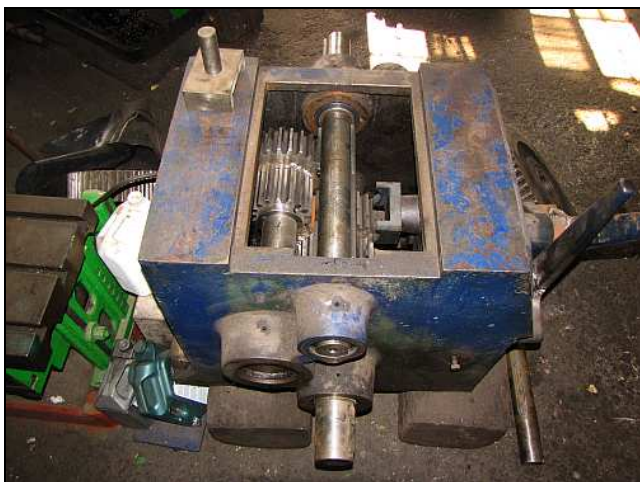
P13 – The incomplete Input Gearbox for the Wheel Lathe drive. It was being temporarily reassembled to check the meshing of the gears and the bearing fits.

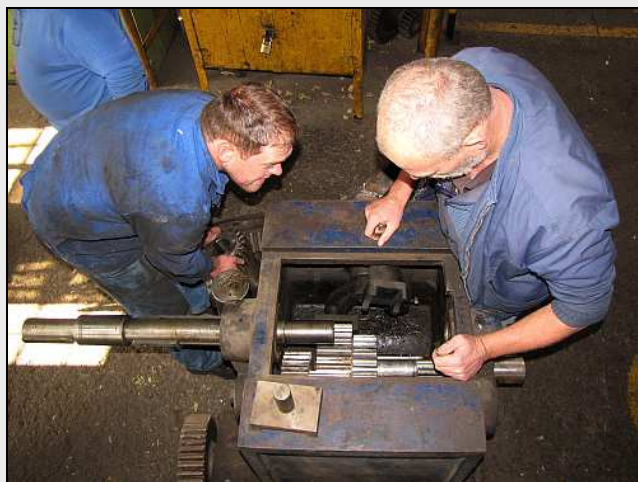
P14 – Shaun Ackerman (L) and John Gundry (R) had just withdrawn a keyed shaft before attempting to fit a sliding pinion gear.

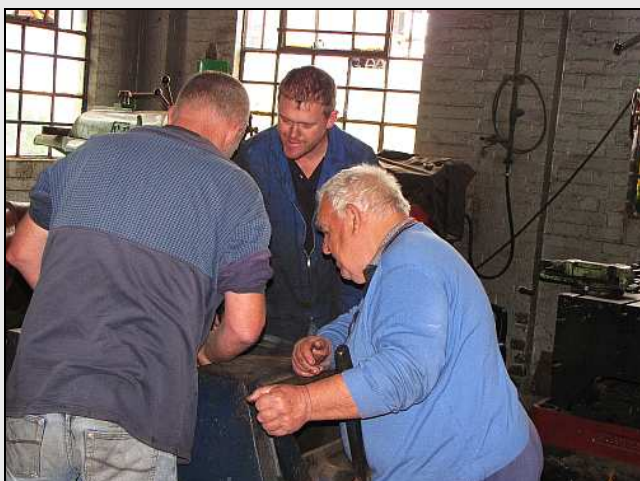
P15 – John (L), James (R) and Shaun (C) discuss the action of the crudely designed gear selector yoke. There ain't no synchromesh on these big puppies!

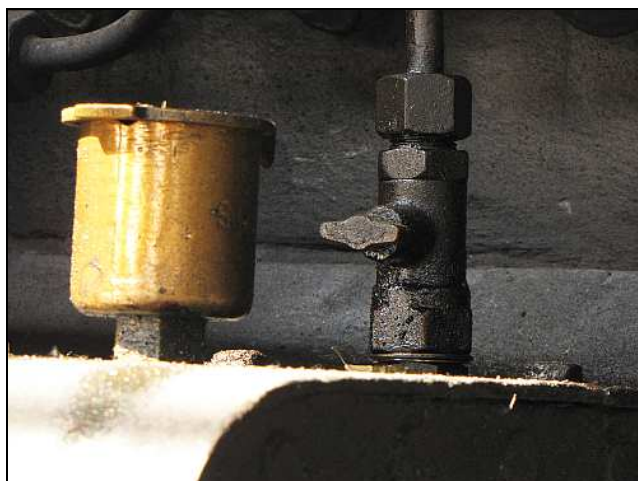
P16 – Close-up of an oil cellar and one of the steam cylinder oil line choke valves on the Class 12AR. The latter could have done with a good cleaning!

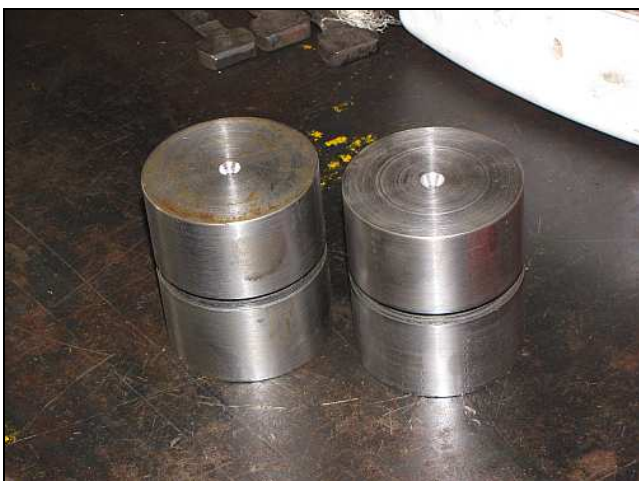
P21 – A pair of steel blanks (By James Thomson) that will become new steam-driven pistons for one of Steam Crane No.578 boiler feedwater pumps.

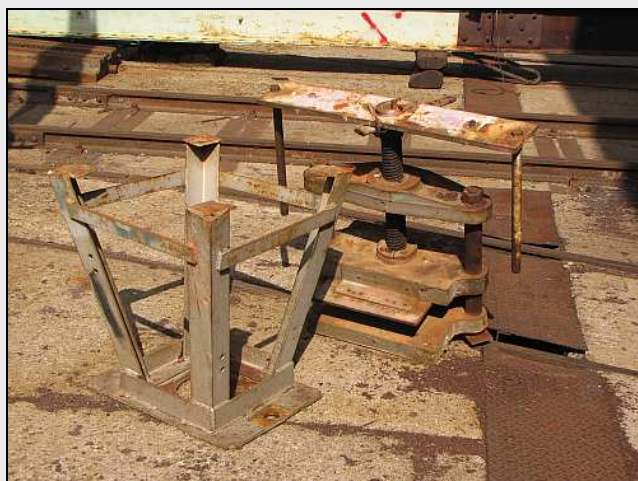
P22 – The recently donated fly press that is now waiting alongside the Gantry Crane's run. It was split into two pieces to facilitate transport.

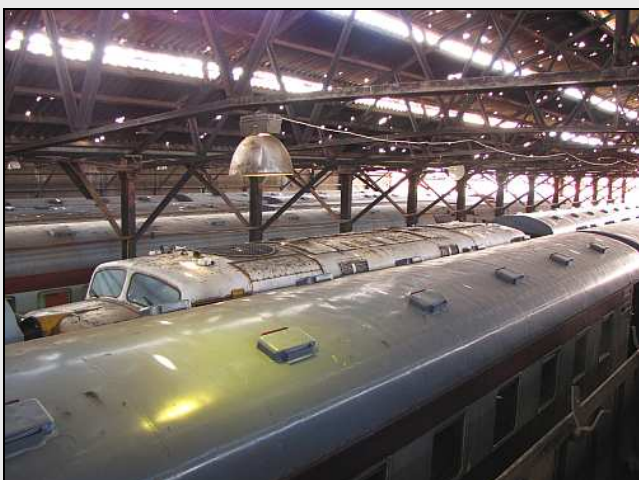
P23 – Sandstone's DE2 Diesel waits amongst the coaches. It isn't coping well with the hail-damaged roof letting in the rain. We will cover the diesel with the wheel lathe's tarp before the next rainy season.

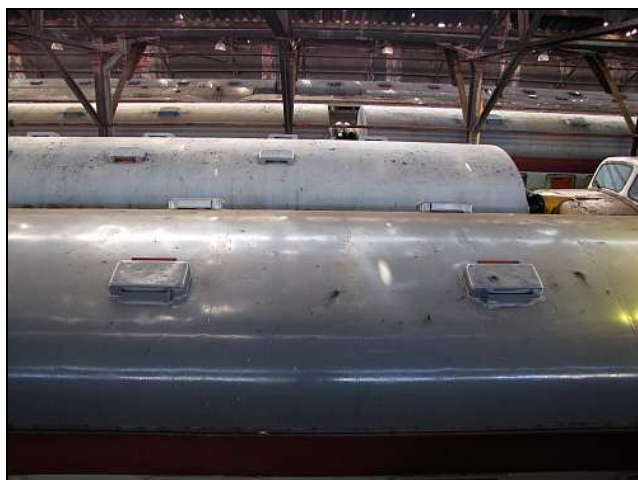
P24 – Where once the GMR locos underwent running repairs, the RS coaches now sleep. Note the details on the 'Monsoon' vents, with the side loops acting as rain shields for the actual vent apertures.

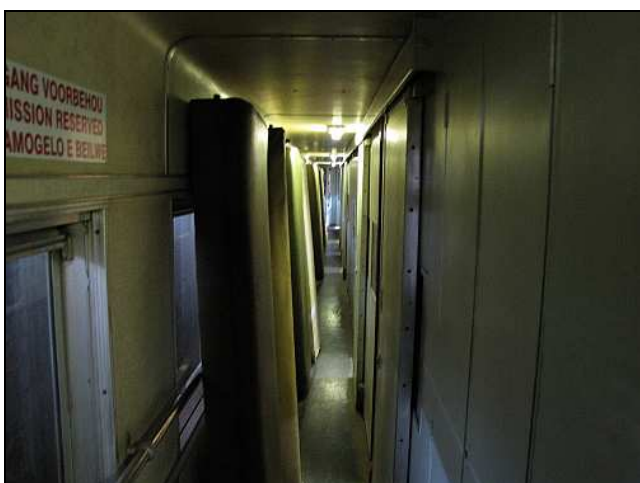
P29 – A silver class corridor full of bunks that had been removed. Silver class compartments will now run with two bunks along one wall, but more widely spaced and using the foam mattress as a chair back.

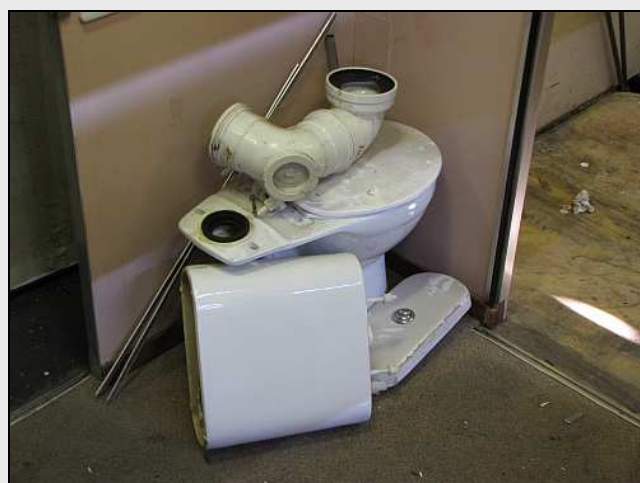
P30 – The close-coupled toilets will be cleaned and reinstated. These will still discharge to trackside, which won't be so bad on a tour that is mainly moving and not using the train as a 'rolling hotel.'

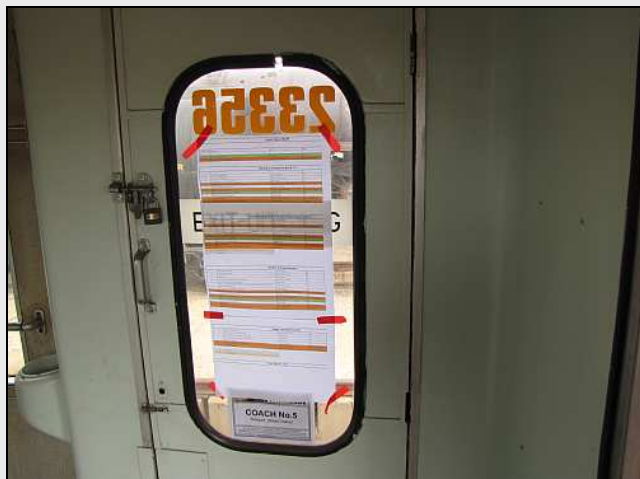
P31 – Tacked up in a door glass is a 'basic' work list for the coaches. We have 6 months to go on this project but it will still be a squeeze, especially to get the detail work in after the major stuff is done.

The plan is to do the coaches 2 at a time now that all the Gold and the Silver Classes have been stripped. They will be lifted off their bogies once the interiors are done and before they are shunted back into the main carriage shed again.
