This Reefsteamers Waybill Newsletter was compiled by Mr. Lee D. Gates on behalf of Reefsteamers Association NPC. For observations, corrections and suggestions – email me at documenter@reefsteamers.com

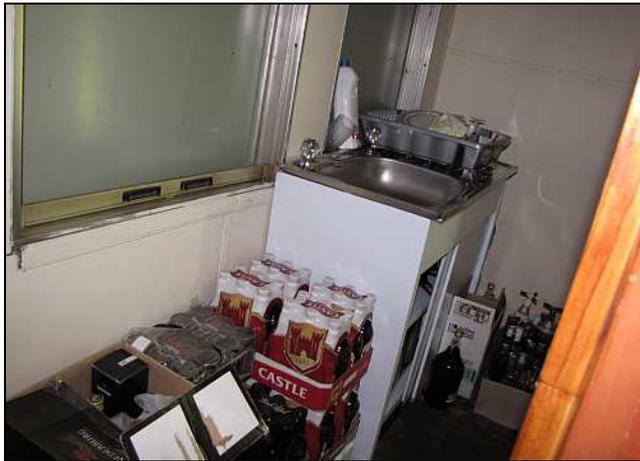
W01 – I recently sent out an email seeking volunteers for the 'Locomotion Coach' project. However, since then I was informed that we are planning to convert the Bar Coach's store (above) and possibly the toilet area into a kitchenette to heat up and serve warm foods.

The job will most likely involve carpentry work for shelves and cabinets, a hot water geyser, perhaps a larger sink and some plumbing work. We will let you know ASAP and ask for assistance. (Pic - 19 Nov 2009.)

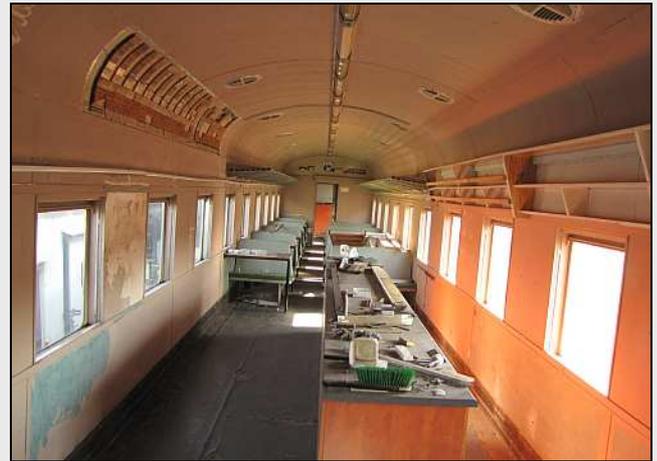
W02 – The new Bar Coach kitchenette project and the Sleeper Coach upgrade projects are higher priority now, but we would still like people to commit to helping us with stripping and repainting the 'Locomotion' coach's interior. Unfortunately, the current pink paint job is so bad and roughly textured that it actually has to be removed before repainting.

It is not a cosmetic issue – the rough paint actually grazes your skin and it will be nigh on impossible to keep clean.

This coach needs a team of people to strip out the dining furniture and then to carefully remove the aluminium strips after recording their locations. The entire coach interior needs to be stripped, which will require a mixture of machinery and hand sanding.

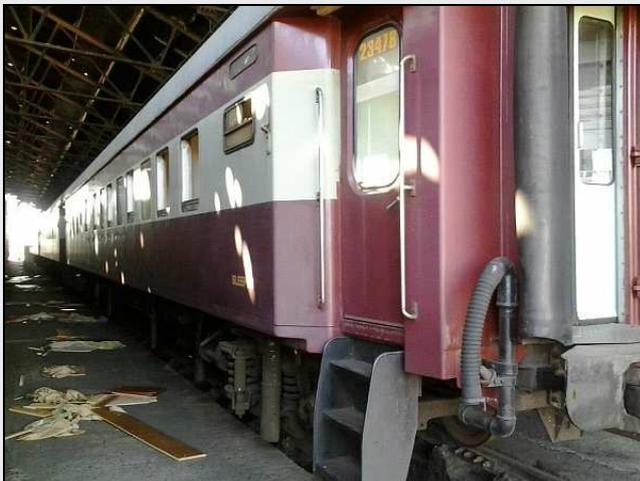
W03 – Most of the conversion work done on the Sleeper Coaches by Setimela was shoddy and much of it is being corrected. Philipp Maurer took a few weeks off work and flew over from Switzerland to get this project started. (He is also heavily involved in marketing the November Tour.)

Current work involves stripping out the poorly done, open sided showers in the Silver Class and also the garish vinyl flooring from the Gold Class coach. The Silver Class Coach bunks are also being worked on to revert them to the original one-sided double-decker SAR arrangement. People in the lower beds could not turn over and the bunks were obstructing the sliding doors into the ensuite bathrooms. There is lots more to do – a whole FILE full of jobs. **We are calling for sustained assistance to continue this project, as Philipp will be leaving for home soon.**

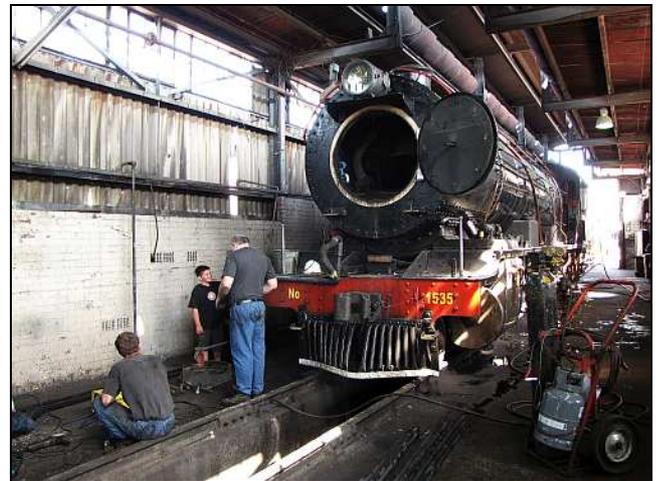
W04 – 12AR No.1535 'Susan' was reported to be blowing within the smoke box with the regulator open. The problem turned out to be a perforated superheater element. Unfortunately, it was in the top row so the three elements below had to be taken out as well. Conveniently, the smokebox front plate did not have to be removed.

While the 12AR 'Susie-heaters' are well aged in general, this one had been hammered into place, with the indents impinging into the hot gas flow and encouraging further erosion. It was ground-back and welded with relative ease.

Some of the superheater header T-bolts were found to be loose and were tightened, but we have missed a few. Luckily, she still ran OK on her last trip but another session in the smokebox is called for before Susie runs again.

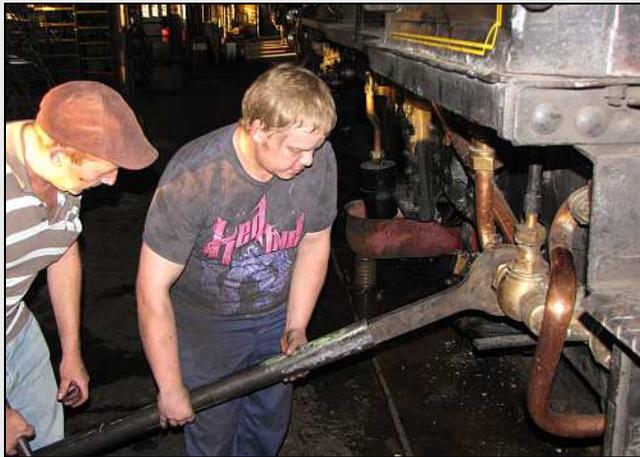
W05 – The 12AR's left injector was running poorly, picking up hesitantly and only in the rear quadrant. The crew were struggling to keep the water level up in the hardest parts of the route. The injector was partially dismantled on 29 April and we found that the steam cones hadn't been replaced as they should have been in 2012. Luckily, the new cones were found stashed away in the brass store and refitted.

It didn't solve the problem though, and more investigation was called for a week later. A clue was that the injector would only work OK with the ash pan coolers running. The problem turned out to be that this water valve had been rotated 180 degrees within its body. It wasn't sealing and was lifting away its seat in operation. All is well now!

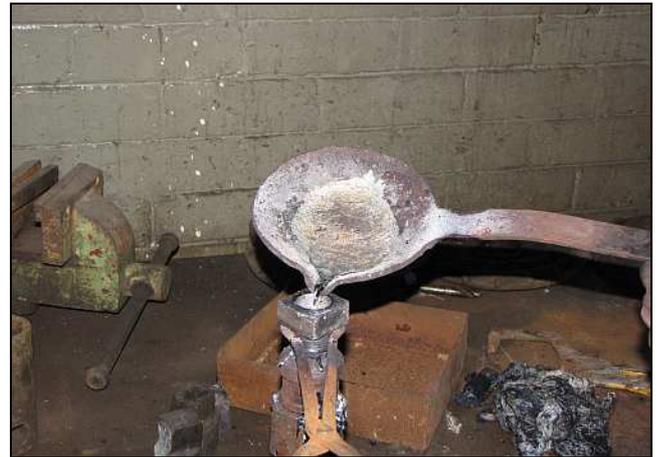
W06 – The 12AR was also treated to a freshly-cast set of fusible plugs as the fitted ones weren't standing up too well. The photo shows the hot, melted lead being poured into the core cavity, while the plug is being held into a mandrel with a semi-hemispherical cavity to mould out the domed head.

Susie's back plug still leaks from the threads and needs attention. It's a pain, as it drips into your cooking shovel!

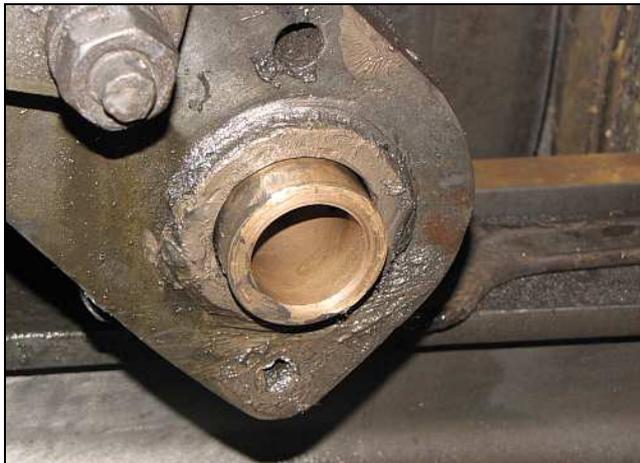
W07 – Class 15F No.3046 has had the front end of her left valve motion stripped due to excessive wear. Pictured is the eccentric bush that forms the bearing between the eccentric rod and the expansion link. When the locomotive was recommissioned 3 years ago, these bearings were incorrectly made from plain old brass instead of the proper phosphor bronze and they have worn badly in service. You can see the outer wear gap even in the reduced photo.

James Thomson has been tasked to machine new bushes from Vesconite™. We have been using this synthetic material for over 6 years in some of our engines, with no discernible wear in main line service.

To not delay things after boiler testing, only the worn bearings will be replaced, so 15F No.3046 will run with Vesconite bushes on the left and ol' 'brassies' on the right.

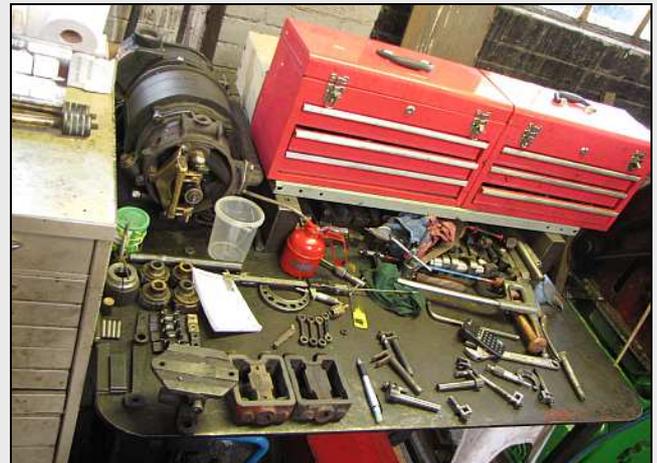
W08 – The Sandstone Crowan Sheldon Steam Crane No.578 project is continuing with further stripping and analysis of the two dismantled feedwater pumps, many components of which are seen on the work bench.

The red-painted casting is a valve chest chamber that has been borrowed from the identical feedwater pump on the Booth Rodley Steam Crane No.96. You will recall that the original casting had burst, probably due to a crack.

The steam-driven duplex pumps, by the way, are made by Worthington Simpson Co.

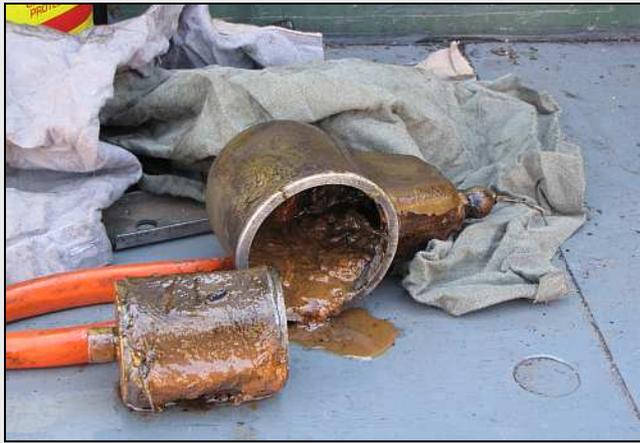
The picture is of the primary fuel filter showing some bad sludging due to water contamination of the diesel fuel. The condensate cock was also disabled and was found to be bunged up with hessian threads. It was probably leaking fuel at one time and somebody ‘fixed’ it.

Unfortunately, the diesel injector pump is already a bit worn and it leaks diesel fuel into the crankcase. (Via the gear drive chamber.) So, we have to keep a careful eye on the constantly rising engine oil levels, and also the resulting lower viscosity of the diluted lubricant.

The finely sieved copper filter element was taken home for brazing as it was coming loose from its end caps, and Dennis has medium-sized brazing equipment available from his model railway activities.

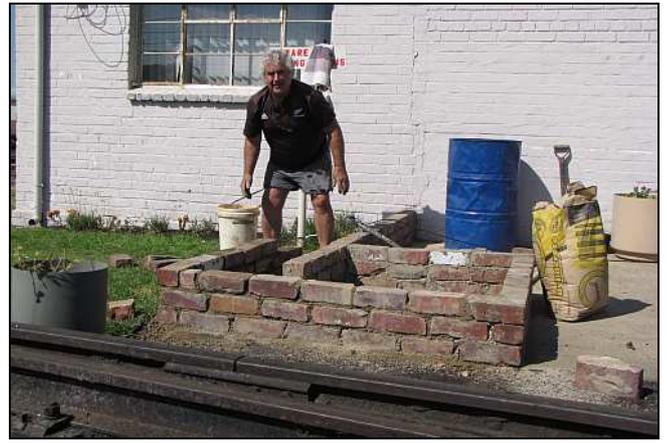
W10 – Now that he is retired and his bad leg has improved, Coen Pretorius has taken on the task of maintaining and expanding the Depot’s Gardens. He enjoys the work, and it gives him the freedom to work all day barefoot.

Pictured is the second of two plant boxes being built around the bare concrete apron in front of the formal club house.

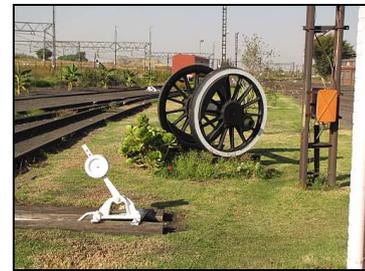
Freshly mowed and getting ready for a cold dry winter! Note the banana bushes growing along the fence. How did they ever survive in our depot? (Oom Attie planted that lot.)

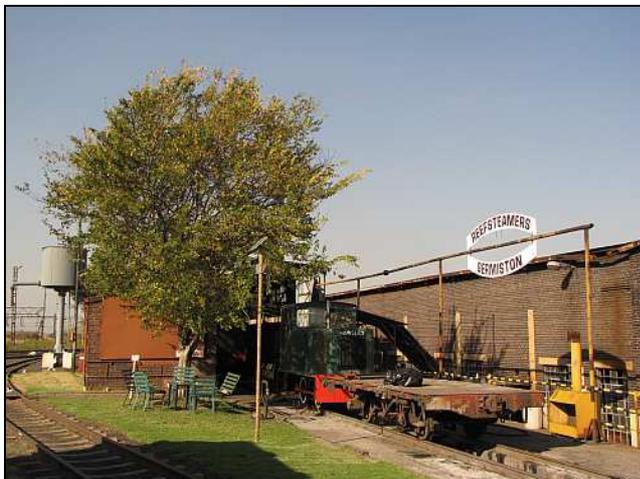
W11 - The foliage on the T&P tree says that the autumn season is clocking over to winter. We have a whole dry season then before we need to fix the hail-damaged roofs, broken windows and the 15M shop guttering.

Gordon is currently investigating blocked workshop drains. Transnet are also working on a blocked sewer line that crosses our premises from the Diesel Depot.

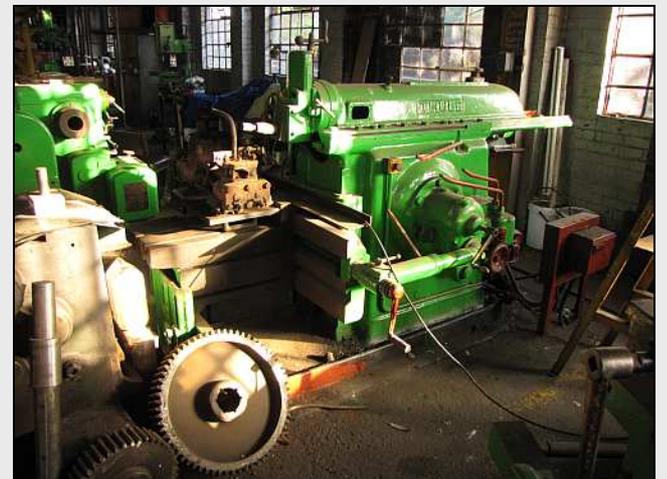
W12 – One of the old Wheel Lathe gears leans tirdly against one of the Thule shapers in the late afternoon. We are still very keen to get the Wheel Lathe project going but for now, the workshops focus is on getting the 15F 3046 back into steam, getting the sleeper coaches upgraded and getting some semblance of catering facilities back onto the day trip train.

The wheel lathe gearboxes need to be reassembled and tested (human-powered) before being dismantled again and the gears sent away for hardening. As we need them for patterns, we will not scrap the worn, old gears until the rebuilt lathe gearbox is proofed and reassembled.
