Here is the second of the new Reefsteamers Waybill series.

5). CLASS 15F 2914 FIREBOX REPAIR PROJECT:

9). WORKSHOP PROJECTS FROM SAT, 11 MAY:

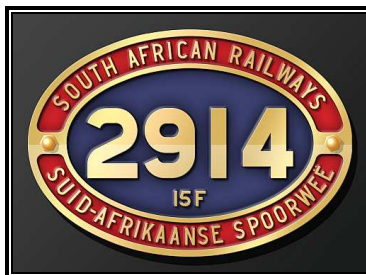
George Hoddinott has seemingly been very quiet on the Class 15F 2914 project, but it is still progressing even if the old rail basher is gathering dust on her fresh black primer coat. The last round of testing work on the locomotive's foundation ring revealed the ring to be a total write-off. In the SAR days, it was so poorly poured and then forged that there are embedded pockets of slag the size of golf balls. As a result, there are some major hidden cracks and not just in the usual corner sections either. The new welds to fill in the previously-discovered cracks in the RHS rear corner were simply causing cavities within the material and not bonding properly. The idea of transplanting a foundation ring from a donor 15F locomotive was considered and then abandoned. (What a nasty and labour-intensive job THAT would have been!)

However, we are following a new path, to convert Class 15F No.2914 to a welded firebox design, such as on the more modern 25NC and GMAM, and to eliminate the foundation ring altogether. The proposal has been discussed with Andrew King as well as OSG (Our Boiler Inspectors), and they have approved of the idea. As with any work involving cutting into or patching a locomotive's pressure vessel, a set of drawings have to be produced to illustrate the concept. So far, the rough concept drawings have been approved.

Basically, the inner and outer sheets of the firebox will be closed off at the bottom by welded sections of half-round pipes. This is a common modern boiler standard and is called 'Trough Construction.' The GMAM and the 25 Class families have 'troughed fireboxes' rather than separate riveted foundation rings.

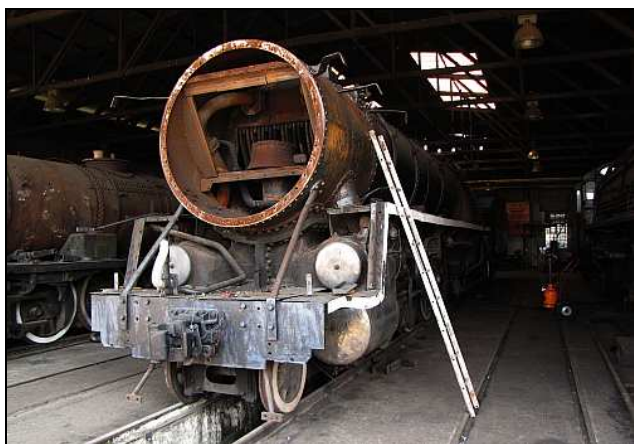
P02 - The raw-looking Class 15F No.2914 on Sat, 23 March 2013. She was then having even more rear-end hardware removed for better access to the ash pan and the condemned firebox foundation ring.

George is busy preparing eight hand-drawn design drawings to be submitted to OSG for official approval. The new welded firebox footer design requires four lap joints, so those joints need designing as well as determining the welder's certification.

An extra row of firebox flank stays will have to be installed. Six of the washout ports and the two blow down cocks will be moved. In addition, the sliding cleats that hold the rear of the boiler onto the frames will need to be relocated and modified. But there, we will emulate the 25 Class design, so it won't be a total redesign.

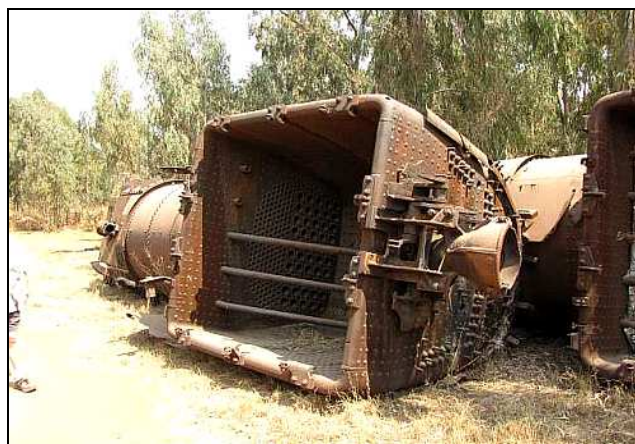
P03 - The original specification welded-trough style firebox base of a GMAM locomotive is visible on this very dead boiler. Notice the lack of the typical double row of closely-spaced diagonally-offset rivets at the bottom of the firebox (now the left) to hold a foundation ring in place.

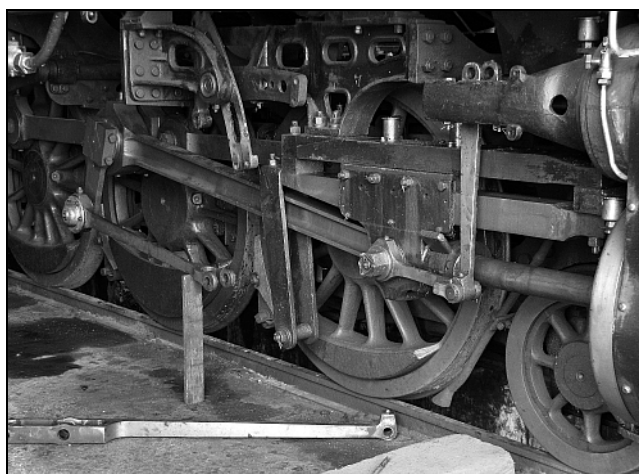
Partially dismantled valve gear on 15F 3046 'Janine.'

- Prepare for boiler hydraulic testing now that No.3046 has passed her visual inspections by OSG.
- General repairs and improvements as required on the locomotive.
- Complete machining new valve gear bushes from Vesconite, and fitting them. (RHS Motion.)
- Greasing work as required on the locomotive's Bissell truck as well as the tender bogies.

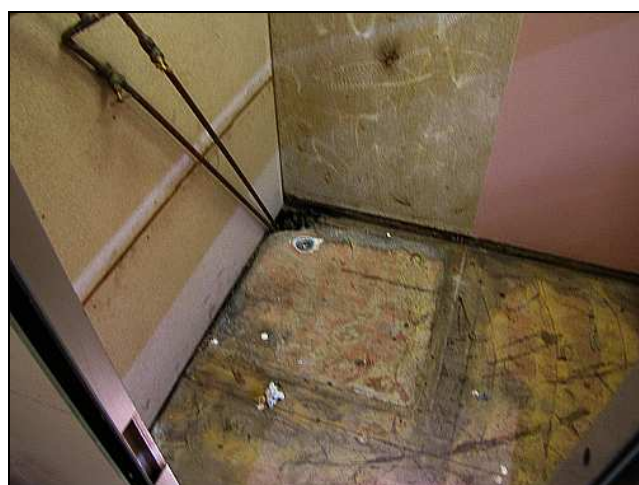
A stripped bathroom in a Silver Class Sleeper Coach.

- A long list of work is required on the Sleeper Coaches. Most of it is non-technical.
- VOLUNTEERS NEEDED TO COMPLETE THIS PROJECT. Philipp Maurer had done most of the stripping, as well as purchasing the hardware.
- R60 000 of material has been purchased and is waiting to be fitted. There should be no 'hanging around' waiting for material or supplies.
- Two coaches need to be lifted by jacks and their bogies and bolster gear checked, lubricated and serviced.
- The rubbish needs to be cleared away and the unused bunks properly stored.

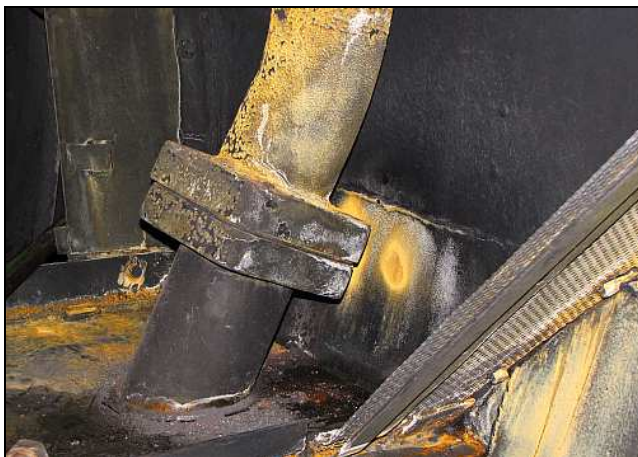
**W01 – Showing and Blowing.**

Some more steam-emitting faults found within the 12AR's smokebox on Saturday, 11th May, included steam leaks at the steam delivery pipes on BOTH sides. You can see the characteristic marks on the smokebox barrel where the steam jets literally blasted the soot away. However, the welded-together pipes are doing quite well!

It also explains the blowing sound that people were hearing from the outside. (The element leaks were just pinholes.)

This side was just a bit loose. The gasket had actually failed on the other side. We'll put those bolts down for more regular checks as the 12AR is on a strict smoke-box cleaning schedule anyway, to extend the life of the known-worn front tube plate. Once they settle into service, those bolts rarely work loose – it's just that we have new gaskets still compressing and the threads were 'copper-slipped.'

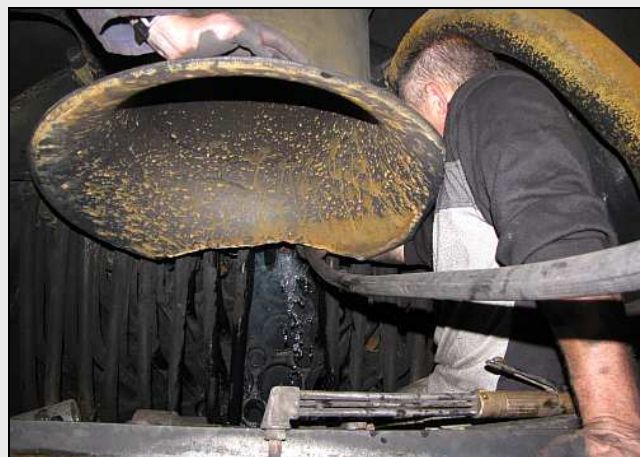
**W02 – Drenching before Wrenching.**

The Susie-heaters are known to be tired in general, especially those in the top row. (Which usually corrode first anyway, because of the inevitable water retention in their sink trap-like riser shape.) And the 'toppers' are the ones for which we lack spares. ☹ The second pinhole leak that was found was right behind the petticoat and in the top row.

The fellows managed to get the lower three elements out but the Superheater Header's tee-bolt on the top unit would not budge. It necessitated some gas torch and cold soak treatment. You can see the steam behind the water trail.

Dawie and Michael were going to try and weld the element up in the limited space behind the flared petticoat. But Engineering Director Shaun Ackerman imposed his 'anti-sukkelaar' policy and the fellows unbolted and removed the petticoat too.

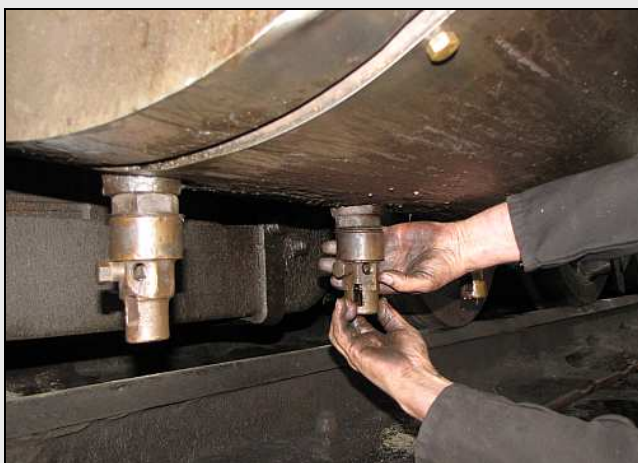
**W03 – Inward Focus.**

A silly mistake that had been made when recommissioning 12AR No.1535 'Susan' was that all three cylinder drain cocks on the left side were all mounted 180 degrees out of alignment.. The circular outlet ports for the condensate were jetting INWARDS against the front bogie's frames!

Oh, the humanity! The right side cocks were installed OK.

You can clearly see the circular outlet port in the front cylinder cock that had just been re-installed by Johann Breydenbach. The cock-bodies can only be fitted in one of two orientations because of the rectangular slot of the cam rod, but it is easy to forget where the outlet port is pointing.

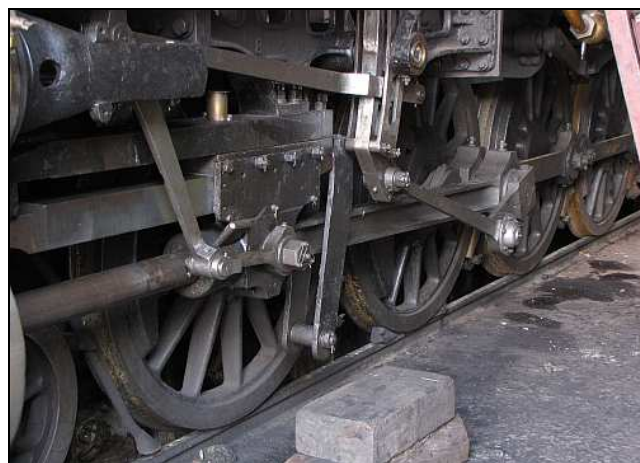
**W04 – Busy with Bushings.**

Class 15F No.3046 'Janine' has been fitted with some new Vesconite bushes on the left side. The new bushes are at the leading ends of the union link and of the radius rod. (Lower and upper left of pic respectively.) The third bush is between the slotted expansion link and the eccentric rod.

Although we grease the Vesconite bushes as per usual, they are self-lubricating and tolerant of running dry.

The new bushes were machined to suit by James Thomson during the week and refitted by Jeandre and Gordon. As the job was fairly quick, they have decided to replace some of the more marginal bushes on the right hand side as well.

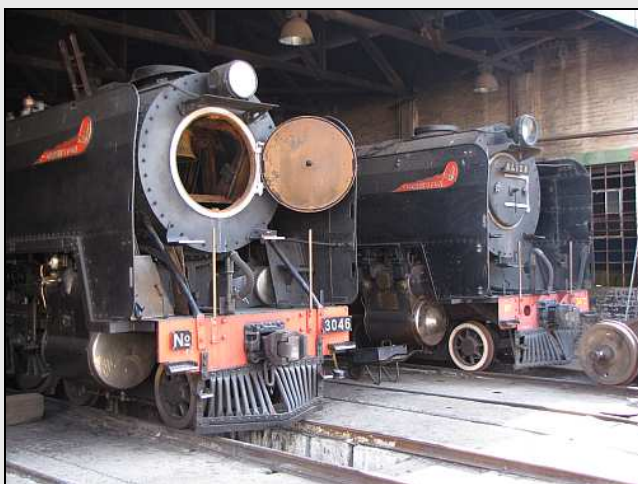
**W05 – Ready for the Doc.**

15F No.3046 all stripped and ready for a visual inspection of the boiler by OSG. (Since passed.) This was Gordon and Jeandre's first strip-down and washout all on their own, although advice was never more than a phone call away. We don't expect issues with this horse-boiler.

This boiler washout included special attention with high pressure sprays onto the crown sheet and down into the water spaces on the sides of the firebox.

The flare probe was put into use too – basically a long, rod version of a paraffin flare lamp. It is slim enough to be inserted through the washout plugs in its lit state. It also provides a back light to be checked against when looking for the silhouette of remaining sludge and scale though the opposite wash-out port. It is also used in this way along the entire lower length of the boiler shell.

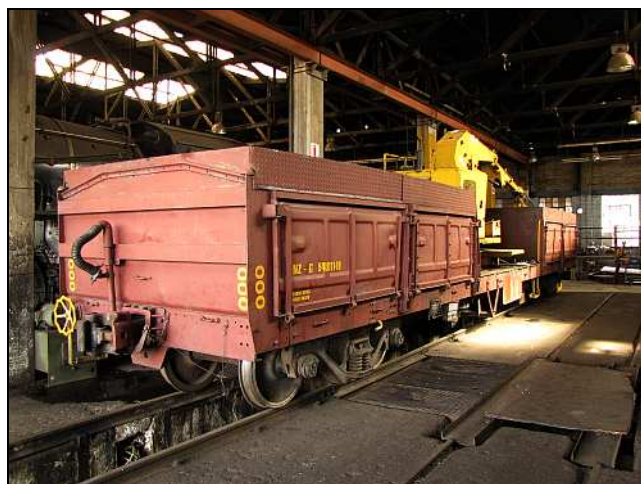
**W06 – Scuttled, but in a good way!**

The coal handling wagon has had the bent scuttle plate straightened and welded back into place. The welds need to be painted for weatherproofing and then the machine is ready to go. The scuttle plate recently got bent when we used the coal grab to relocate the heavy ex-SANRASM tube swager. The repair job is at the corner diagonally opposite to this one!

The previously damaged grab's clamshell was also stripped and patched, and it received a service at the same time.

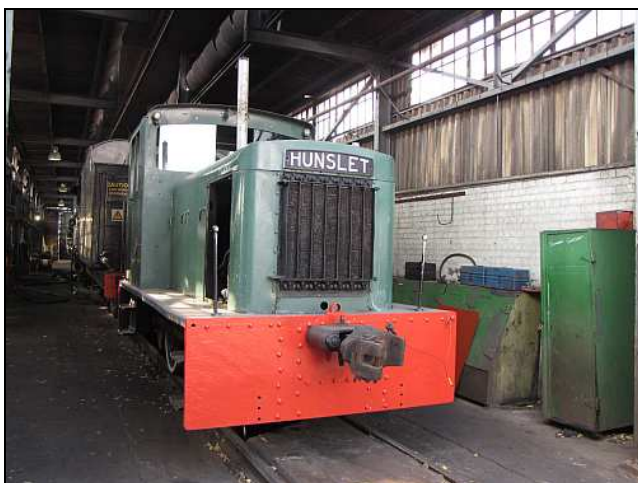
**W07 – Hunslet.**

'Andrew' the Hunslet has had his fuel filter service and is back in operation. He still needs to have the alternator replaced. But it isn't as simple as it is on a car as the alternator is actually halfway along the engine block and is driven via a shaft and a flexible coupling rather than a Vee-belt. The alternator itself is sort of an antique, being a higher current version of the classic Lucas ACR type.

This 1951-built shunter isn't looking too shabby these days! Oom Attie has been doing the painting work.

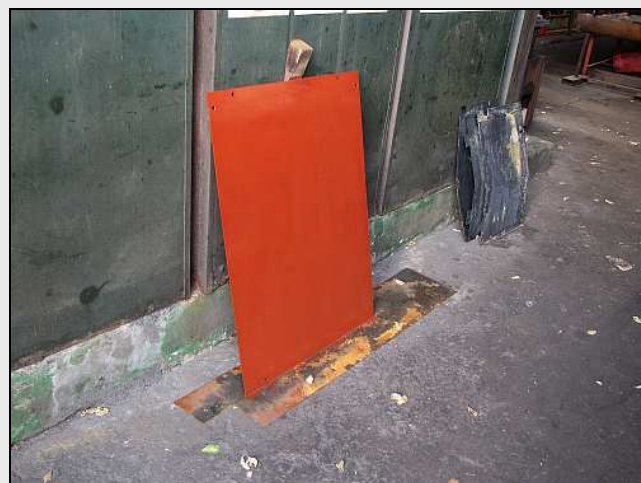
**W08 – Red Flag Engine Cover.**

Somewhere on the premises are two original engine covers for the Hunslet Taylor Diesel. They were 'put away for safety' and the location forgotten, although it is most likely they are stashed in the 'Millsite' store somewhere. The covers were initially removed to provide access to the starting battery and the fuel shut off valve. Later they were left off the front end to assist with cooling.

The locomotive has been running since the gearbox rebuild with two new covers in bare-metal finish in corrosion resistant steel plate. They have since been primed ready for painting.

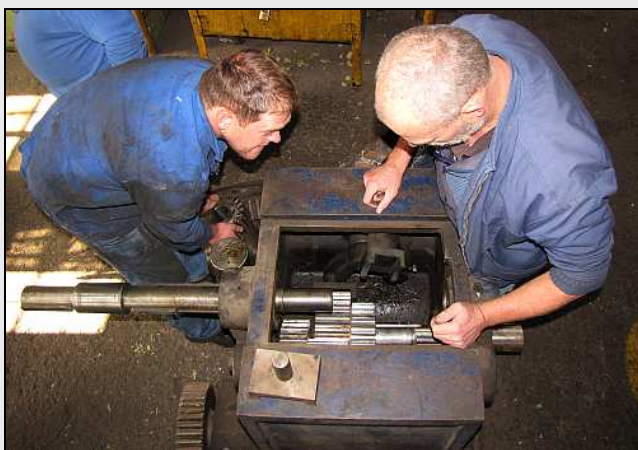
**W09 – Wheel Lathe Monkey Puzzle.**

Some exploratory work has started in terms of reassembling the wheel lathe's two gearboxes to test them, for clearance, free running and easy gear changing – turning them over by hand. This is the input gearbox. Pictured to the right is sweet, innocent John Gundry who initially came to enquire about model-related exhibits for the coming Depot Open Day, and ended up getting roped in. He enjoyed himself!

The person who dismantled the gearboxes is no longer with us, and naturally, he did not take any notes ... so this all has to be figured out from scratch! Classic!

Once the gearboxes are tested, they will be dismantled again and the new gears sent for hardening.

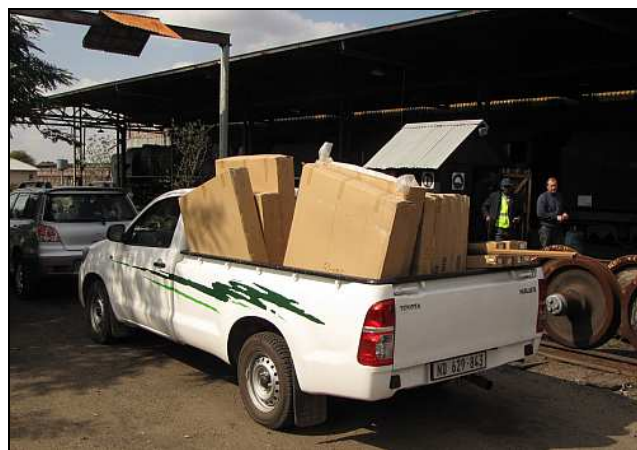
**W10 – Presents for good little coaches.**

Santa Maurer has been in town. This bakkie is full of hardware and supplies for the sleeper coach refurbishment project. The big boxes visible are moulded plastic bases for corner showers. Hidden behind those bulky but light boxes are boxes of wooden laminate 'planks', bundles of extruded aluminium trim, three glass shower door/enclose kits, a roll of foam insulation and some plumbing hardware.

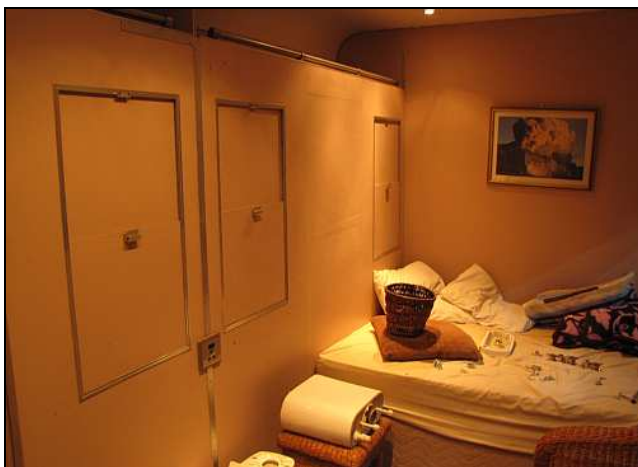
**W11 - A Gold Class Mess.**

All three of the gold class compartments have had their intrusive L-shaped cupboards removed – restoring a flat wall and allowing access to the useful overhead storage. The beds will rotate 90 degrees. With the flatter walls, we can fit more furniture in. We'll put some wall hooks up too.

The silver class compartments have all had their horrible L-shaped bunk beds removed and are being restored to a single sided one-up-one down arrangement traversing the coach. The top bunks have all been removed. The middle bunks will be located higher and will be bolted into place – relying on the mattress as a seat back during the day. (Our coach mattresses were custom-made with a tapered profile anyway.) The released floor space will allow for a small bench or chairs alongside the windows for easy viewing of the trackside scenery – something that was spoiled by the now-removed lower bunks.

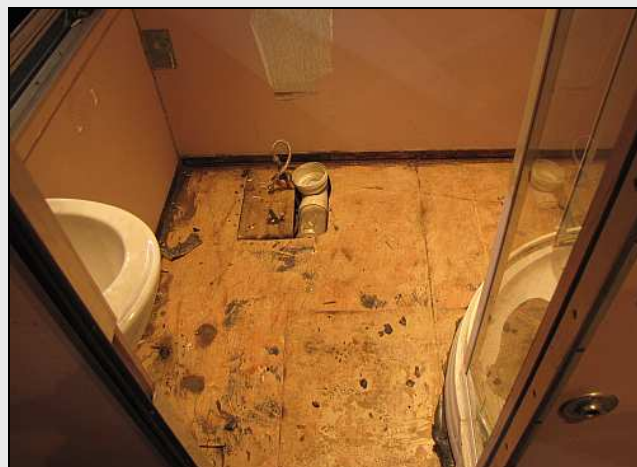
**W12 – Bath mats are optional.**

Most of the bathrooms have had their vinyl sheet floors stripped and the toilets removed. The floors are to be re-laid with warmer adhesive wood laminate planks. This particular sink is to be lowered to fit a porcelain pedestal.

This is a center compartment so the curved corner shower will remain. New corner showers are to be fitted to the Silver Class coaches, with the walls backed up with tiles and using decent quality taps and heads.

The Gold Class showers were crammed into the old linen and service cupboard spaces. The cupboards and the electrical chambers in the corners are to be removed and opened up so those compartments (Gold A and C) can have proper showers installed. The doors are also being worked on ensure that they open fully – but many will be modified as their handles block the door's movement.

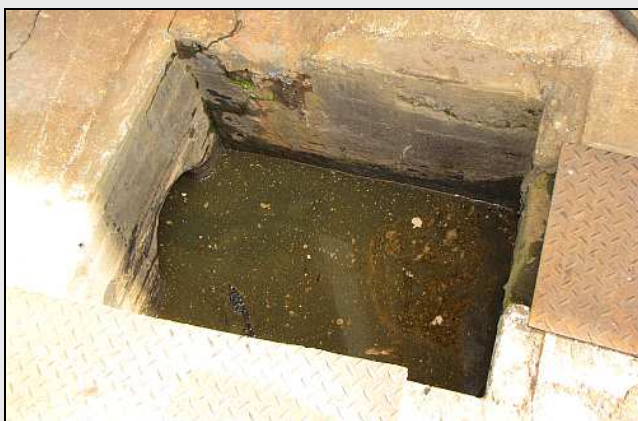
**W13 – Sump'in is in the Sump.**

A long standing blocked sewer line problem has been cleared up with some heavy-duty rodding, and some digging to clear out long-overgrown manholes. 'Black Water' was starting to back-up within the Transnet Diesel Depot, whose drain lines cross our land.

The contractor kindly rodded out the branch drain lines from our Depot, even though it wasn't in his main scope of work. His equipment didn't reach all the way. We still need to get a plumber out to clear out manholes and branch lines back into the main sewer line. But at least the job should now be feasible without digging up all the drains!

We currently siphon the 15M shop drains into the wheel drop pits and pump it to the main drain via the sump pump.

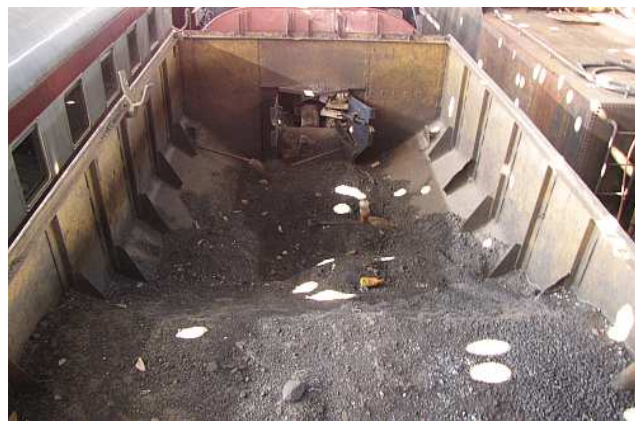
**W14 – Sunspots and Coal Dust.**

Locomotive Tenders that are out of use should have their left-over coal removed, particularly if the coal gets wet. The coal contains sulphur, the water-leached compounds of which form an acid and corrode the steel work.

This is the almost empty tender of 15F 3016 'Gerda'. The white spots are the sunspots from the hail holes in the roof. And where the sun can come in, so does the rain. The final cleaning will be done by one of our casuals and we have a lady willing to do weeding for the small chunks and kibble.

We had a number of unused tenders with coal several years old. We have been exchanging the lumps of old coal to some local ladies in return for weed-pulling work on our tracks. They have been breaking their coal down and reselling it for a profit in the local squatter camps.
