5). GOLD CLASS COACH WORK FROM SAT, 1 JUNE 2013:

6). **SOME 12AR 1535 RUNNING REPAIRS!**

7). **MIENIE-POWERED COACH LIFTING:**

8). **SEALING UP 15F 3046 FOR BOILER TESTING:**

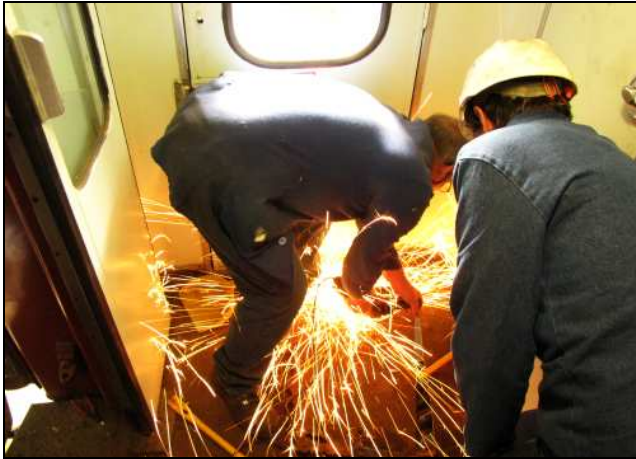
C01 – Inspection of the vestibule floor under-plating through the cut-outs in the timbers made by Simon revealed that the plating had corroded under the ply-wood sheets. Today, all of the timber and plating was removed.

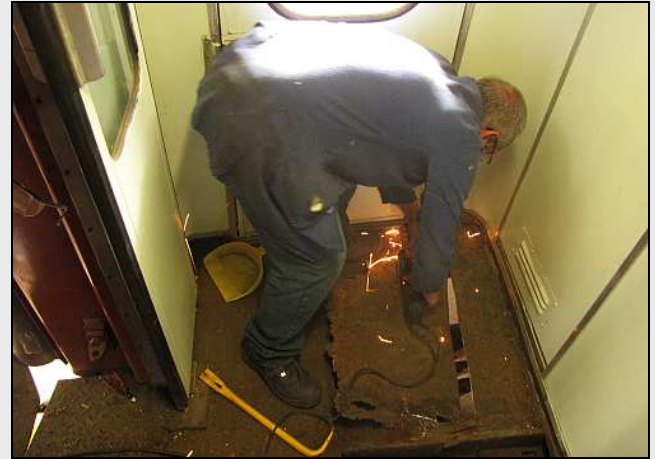
C02 – As Gordon worries away at a nearly-cut plate, you can clearly see the corroded edges. The water was getting into the floor timbers from underneath, as well as through the bathroom, open doors and the gangway drips.

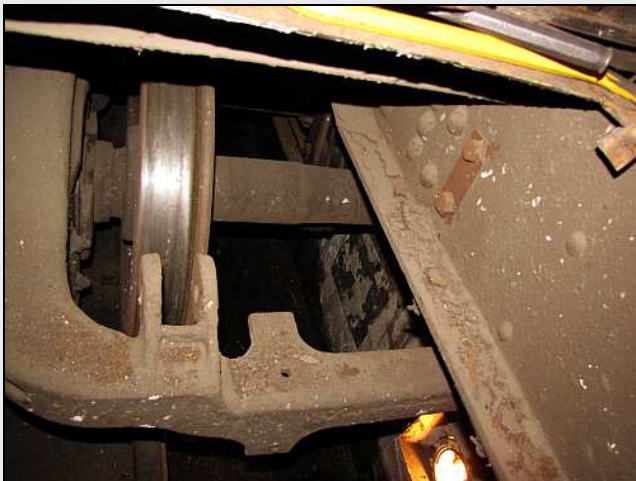
C03 – Seen through the new hole, you can see how the wheel would spray water into this area. As the vestibules are designed to be crumple zones, there is no corrugated under-frame plating here, as per the habitable spaces.

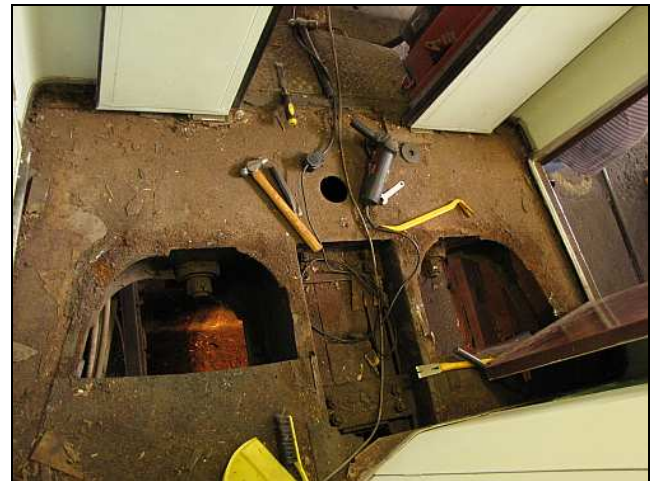
C04 – Here is the vestibule floor with the under-plating removed. The steel visible here is a part of the coach frame. It needs to be de-rusted, cleaned and primed for a new floor. The big nuts are for the buffer-plate rams.

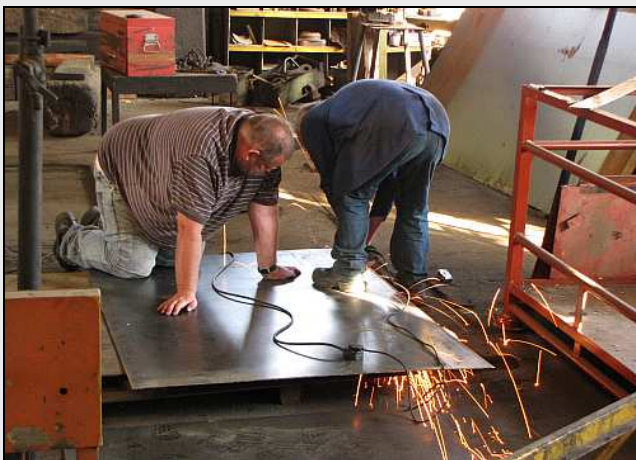
C05 – Gordon and Robbie start working on cutting out steel plates to repair the floors. They were concerned about the length of time it would take to cut the plates and weld them in – especially as there are 4 more coaches still to do! But this job was cancelled after a single cut.

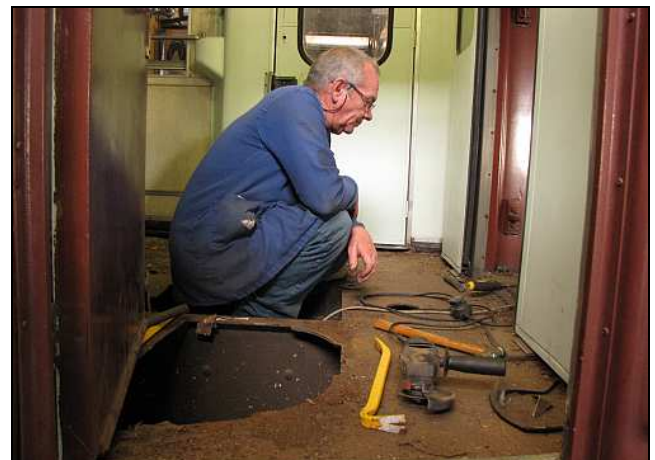
C06 – Sitting on the draft cushion stack, Gordon is thinking things through. If we plate this floor with our stock of thicker plate, and then put new plywood on top, the higher floor will foul the inward opening doors. It is also one of the reason why cheap vinyl was originally laid – it is THIN!

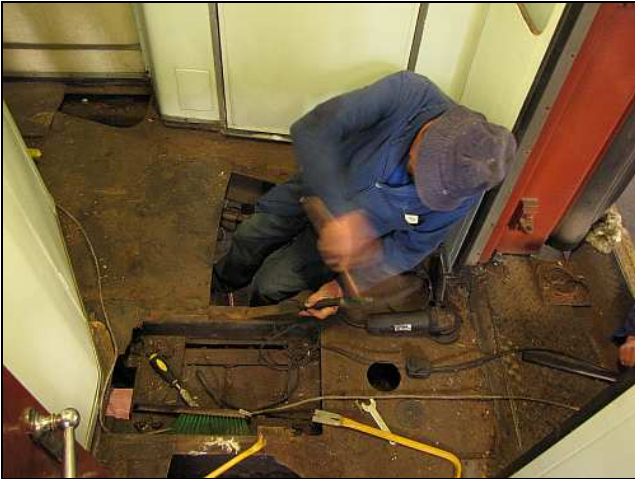
C07 – The consensus is that we will lay the new plywood sheeting directly over the access holes, but with a coating of bitumen on the undersides and along the edges. To minimize unsettling floor flexion under heavy people, we'll span the holes with a piece of scrap angle iron welded in.

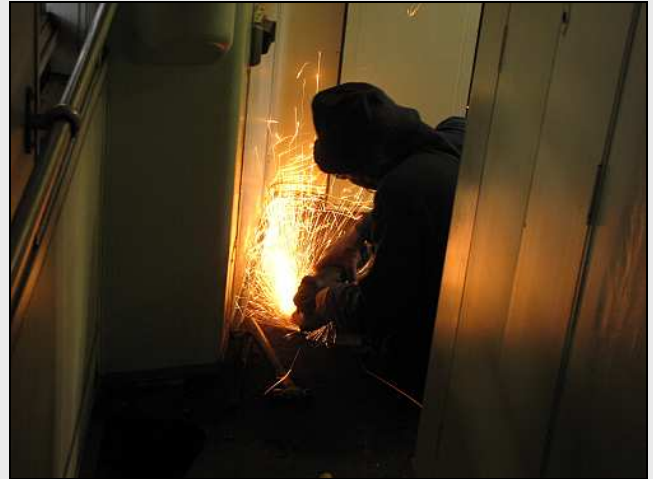
C08 – With that decision made, work continued on chiselling away the leftovers from the hole covers and grinding down the welds. In spite of the planned bitumen, the floor boards will also be mechanically held down with cadmium-plated countersunk screws.

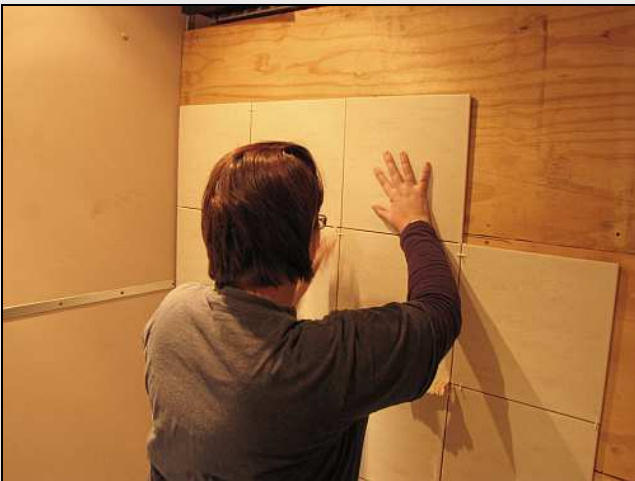
C09 – Lauren 'Smidge' Ackerman is placing the splash-back tiles in the center bathroom. They are being fastened with generous blobs of clear silicone and will be grouted with white silicone. The silicone will impart some flexibility to the hard ceramic tiles on a moving, vibrating coach.

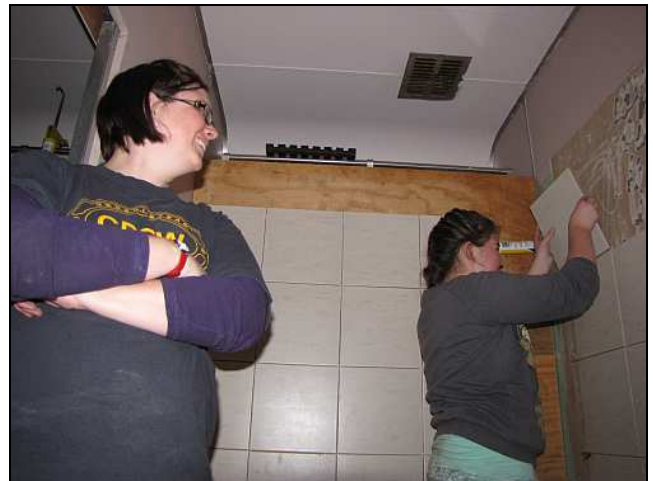
C10 – This awkward shot, taken from ground level through the window, serves to show a better rendering of the neutral tile colours chosen. At work is Cheylin Blore, Lauren's eldest of three. The bare space in the corner is reserved for the pipe risers and mixer valve panel.

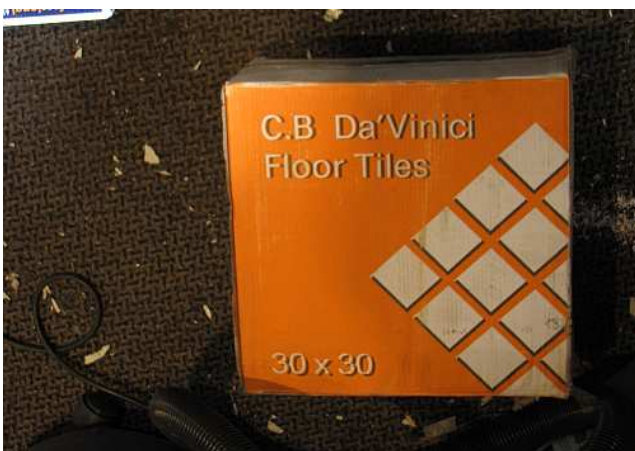
C11 – The decision was made to go for oversized floor tiles rather than normal bathroom tiles. It would reduce the number of grouting joints to be made, and the silicone would help prevent cracking. We would have still had the same number of tiles to trim, regardless of their size.

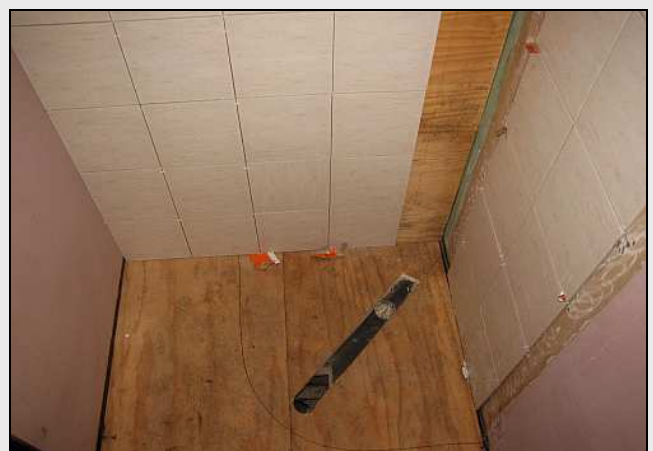
C12 – A view looking down into the shower-to-be. The tile cutter purchased for the job wasn't able to handle the floor tiles. That dead space in the left corner will allow continued stand-up and 'bunk steps' access to the standard overhead storage which extends over the corridor ceiling.

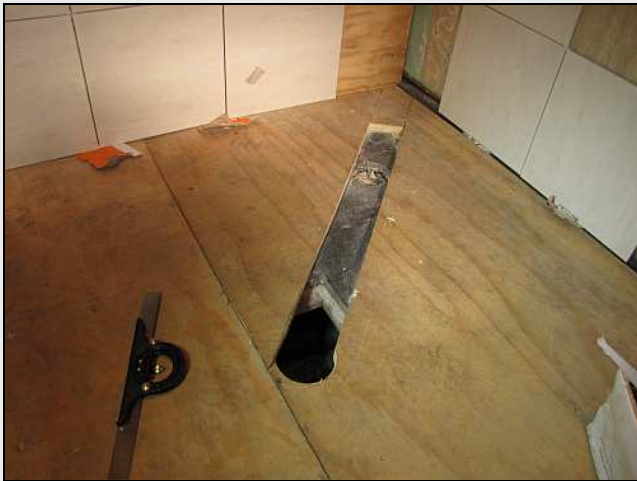
C13 – The shower drains are to be rigid PVC pipes rather than flexible stuff – this trench will also house the water pipes. Each coach's shower drains will need to be reconnoitred in advance, due to framing and bogies getting in the way. They also need to fit beneath the shower pan.

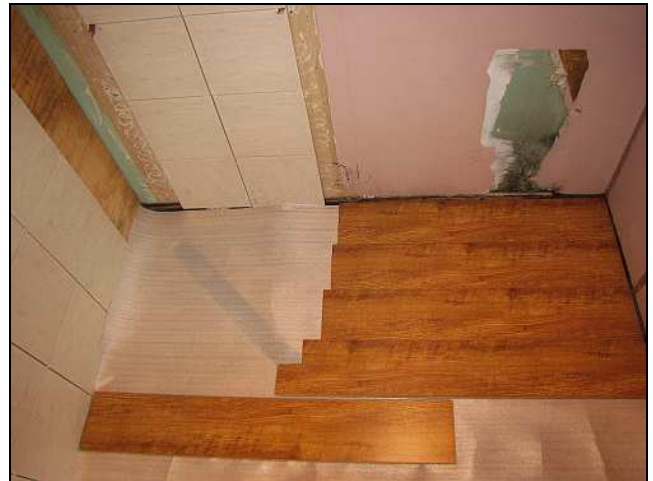
C14 – While the silicone cures behind the tiles, the foam under-floor sheet (with integral water proofing membrane) has been laid and Alan Lawton had started putting the new laminated T&G flooring in. The toilet's waste pipe will be re-routed through the wall to eliminate an extra S-bend.

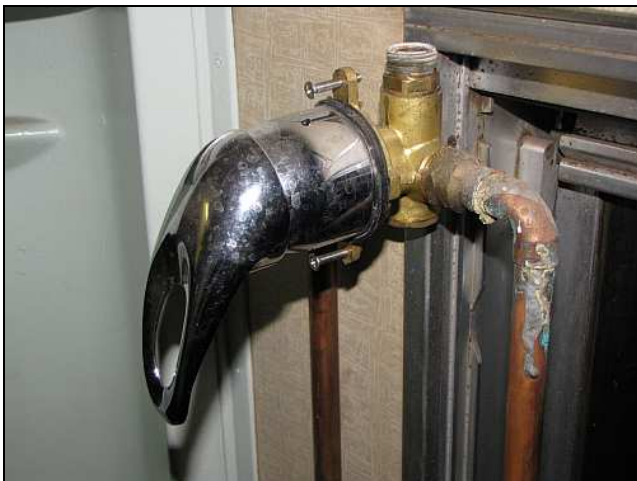
C15 – Leaning loose in the corridor, this is one of the modern shower mixer units that had been purchased and installed by Setimela. They aren't bad quality and have seen little use, so we are going to reuse them. We already know they fit in the corner panels.

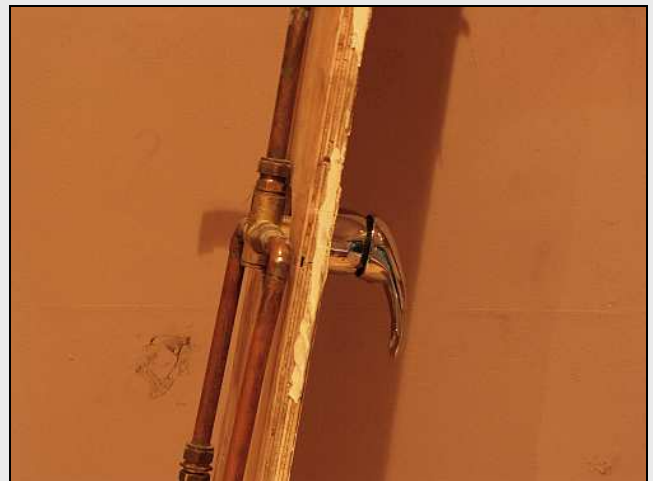
C16 – Classic plumbing by the now-failed Setimela Tours Company. Neither the pipes or the mixer valve were physically attached to the timber. They had relied on two screws through the plastic escutcheon plate for the mixer, and on the shower rose's pipe to hold everything together.

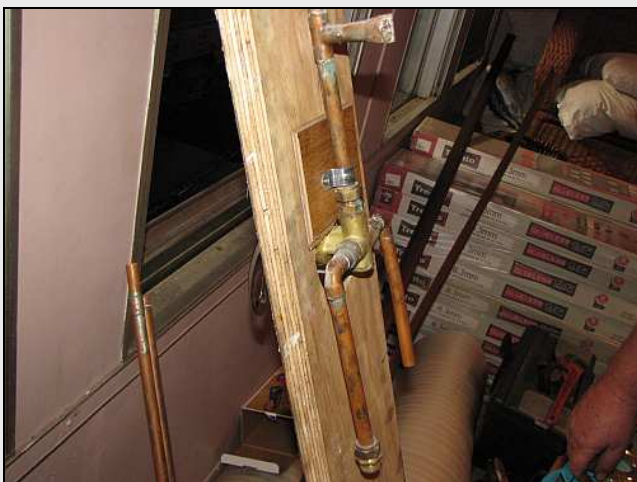
C17 – A little extra work involving saddle clamps and some scrap flooring as spacers makes for a more rigid mounting. At least one of these showers had already started to leak due to fractured pipes. Note the stray tee-piece .. not ours!

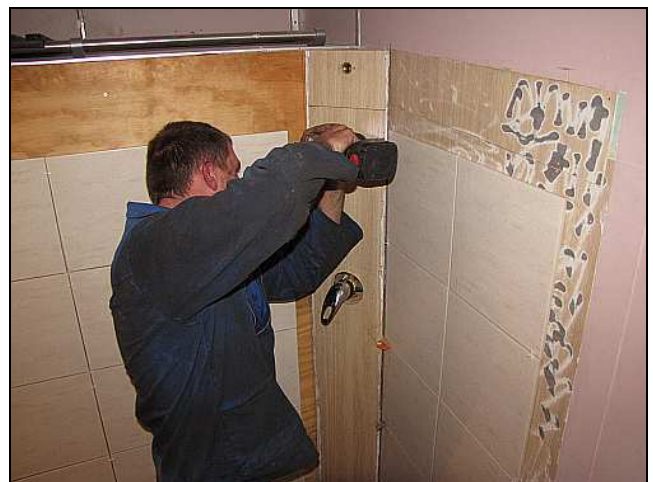
C18 – Smudge Ackerman fastens the corner panel with the same self-drilling screws used for the skirting boards. The RHS bolts had to be angled perpendicular as that firewall has two sets of laminated ply astride a sheet steel plate.

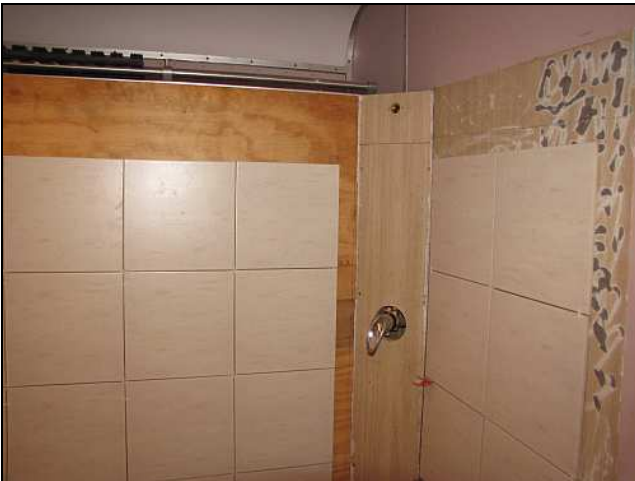
C19 – The outlet pipe for the shower rose is threaded, not soldered, so the shower heads can be removed later on. We are going to try out a low pressure high flow 'sunflower' type shower rose on the pumps before purchasing more.

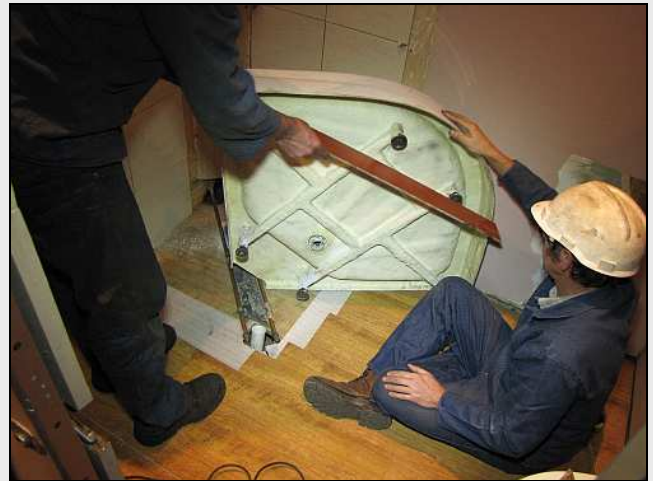
C20 – Fitting the shower pans proved to be tricky with SIX adjustable feet to set up level, and with the pan tilted by the planking too. Note that shower water pipes had already been brazed in – joints above rather than below floor level.

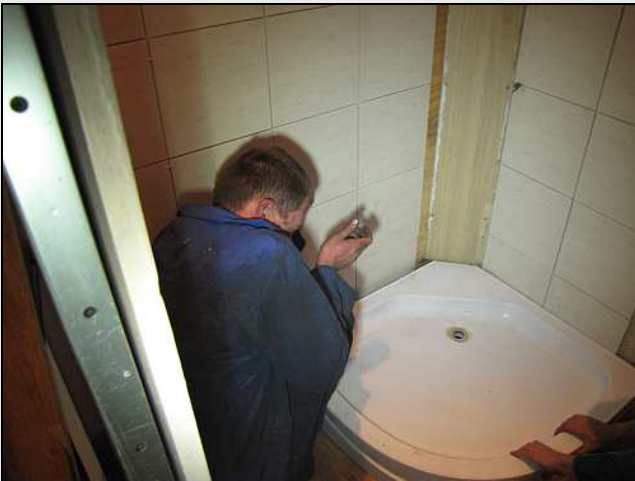
C21 – Because this bathroom floor was now physically higher because of the extra layer of 7-ply plywood sheeting that had been fitted, and then the laminated planks, that corner panel had to be trimmed to fit the pan. It was still a bit long, so it was trimmed twice more.

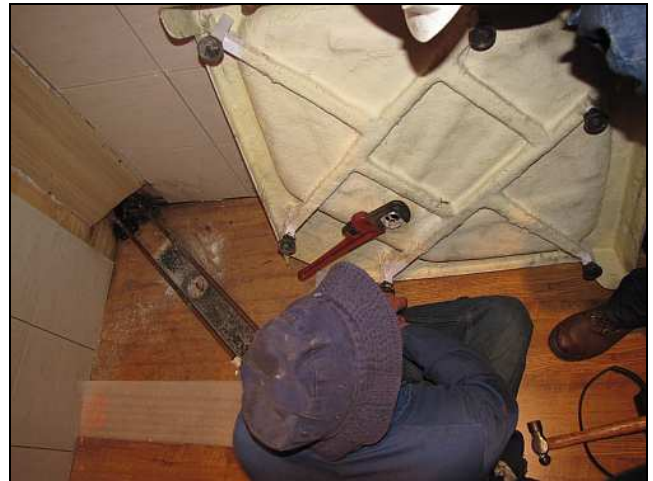
C22 - The grotty and badly siliconed Setimela-era drain fitting was replaced after the levelling operation. The fellows had to turn the body against the drain's grid to get it loose, but they managed without fracturing the shower's fibreglass pan. (Sighs of relief all round.)

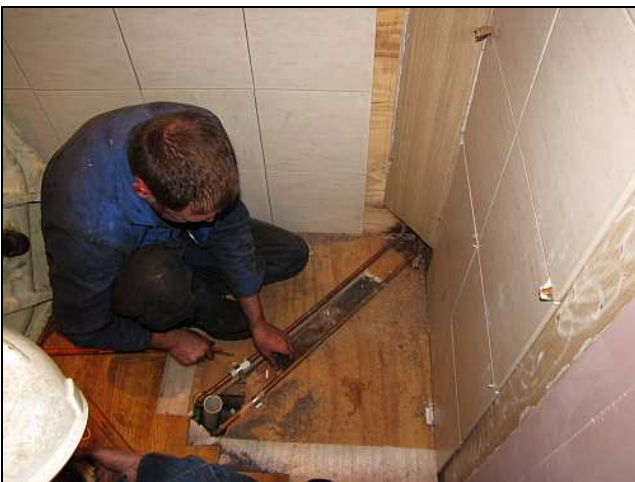
C23 – A part of the customization that will need to be done for each shower. Dr. Smudge uses a crow bar to peel off the floor vinyl remaining in the drain trench to provide clearance for the PVC drain pipe. Note the lack of a drum trap or U-bend – not necessary for external discharge.

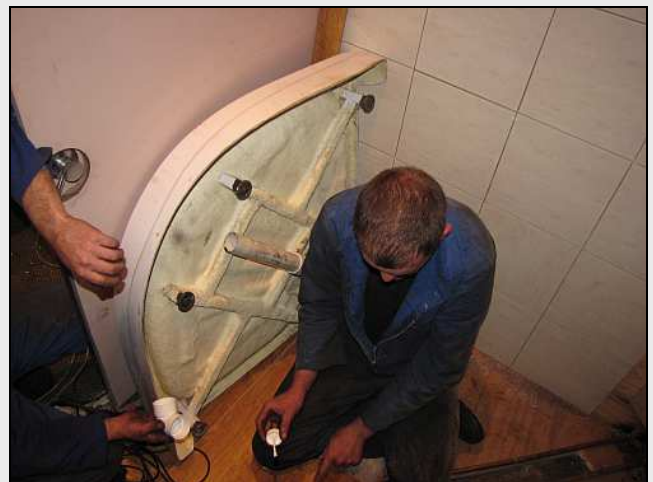
C24 – The drain pipes were put together with proper liquid adhesive for PVC for a true chemical bond, rather than just any old glue ... or even silicone! It made for some mad dashing though, to try and fit the vertical pipe up from underneath before the fusing PVC had time to set.

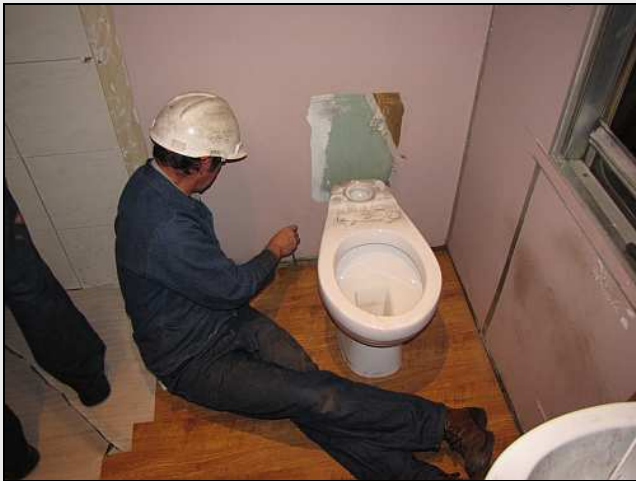
C25 – We will be re-using the close coupled toilet pans that were originally installed by Setimela, but with better quality seats. The fellows were debating putting the toilet in the center line for more leg room on the user's left side, but the route for the waste pipe dictated the offset position.

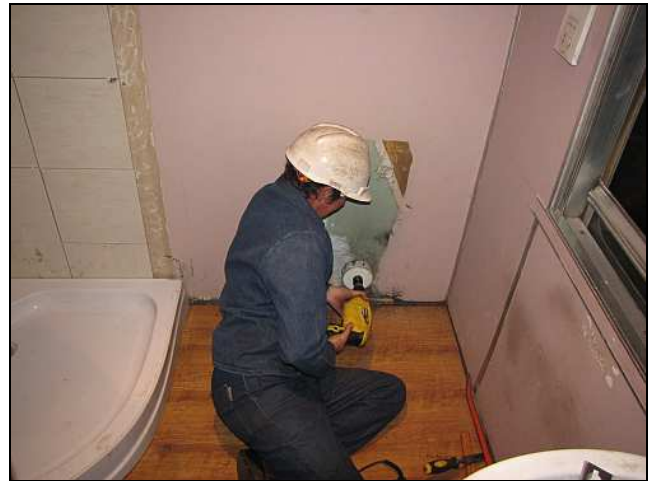
C26 – Alan has a go through that wall with his 110mm diameter hole saw. Unfortunately the teeth no longer have any set and all the saw was achieving was scorching a groove into the plywood. And that stuff REEKS when it gets all hot and smoky!

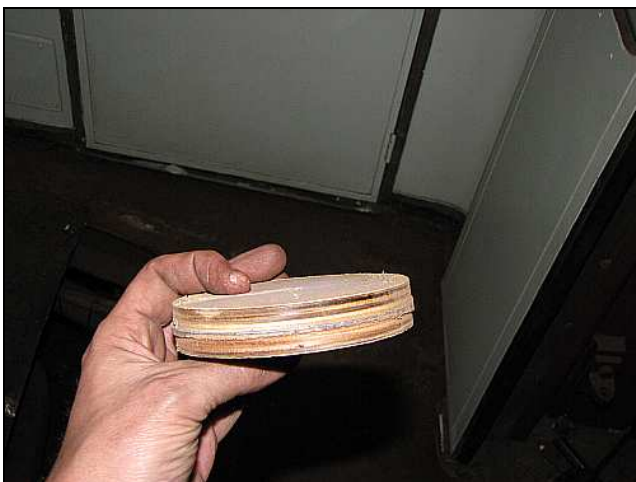
C27 – The chaps eventually cut the hole with a tungsten jigsaw blade and some swearing. In the resulting 'biscuit,' you can see the double five-ply of an UCW Coach firewall – with the fire-retarding steel plate right in the middle.

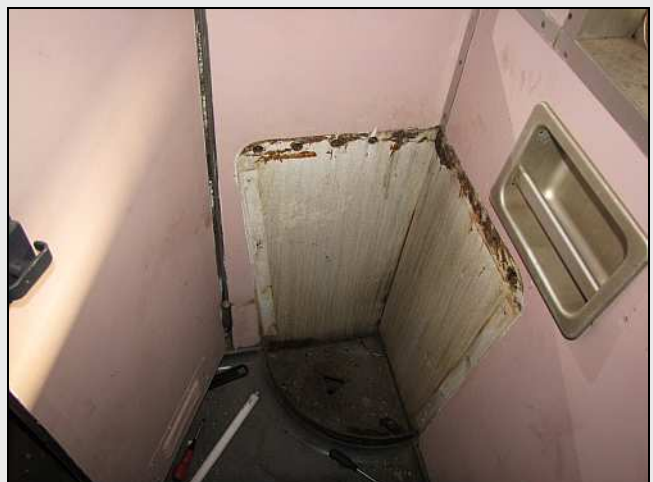
C28 – Generously-built Robbie Davis-Hannibal had to fold himself into this small space and strip the original bathroom. Once cleaned up, this room will become the lockable linen store for when the sleeper train is out of use.

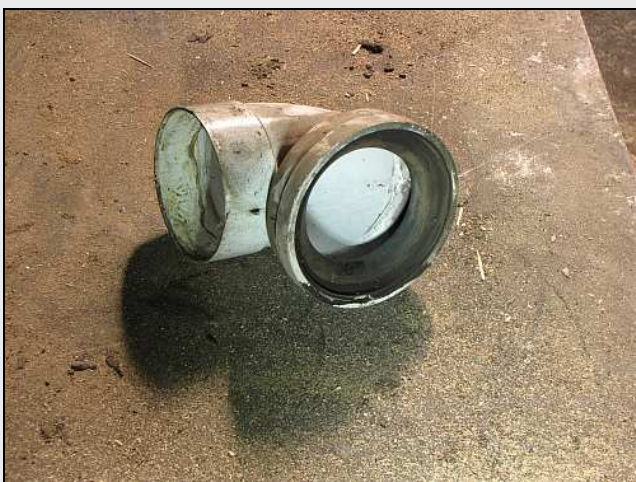
C29 – Another fine Setimela stuff up. To ease the fitting of their PBC waste pipes, they had used the rubber-ringed pan couplers as standard bends between pipes underneath the coaches – so some of the pipes were not rigidly joined.

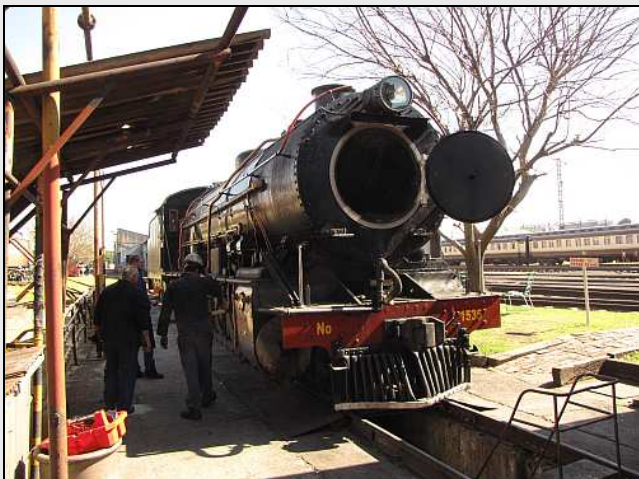
W01 – Our Susie Girl had been pulled out over the ash tracks for some undercarriage work. The smokebox had been cleaned out and washed the previous week. Jeandre had left the door open on purpose to help it all to dry out.

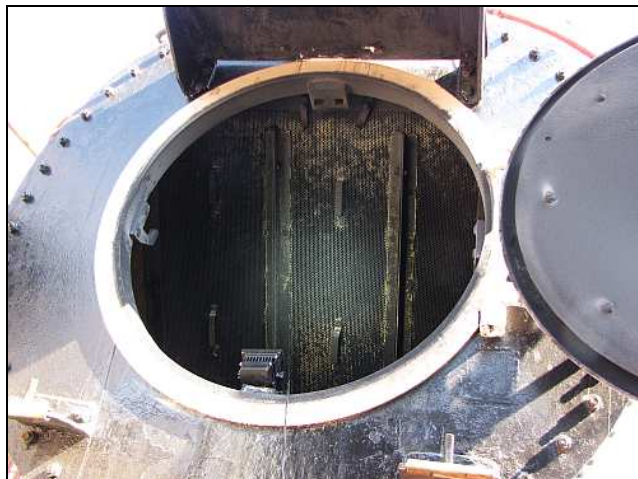
W02 – As the front tube plate is known to be wasted, the 12AR Loco is on a strict cleaning schedule to forestall any further sulphur-leached corrosion from wet char and ash. The smokebox gets cleaned after Every ... Single ... Trip.

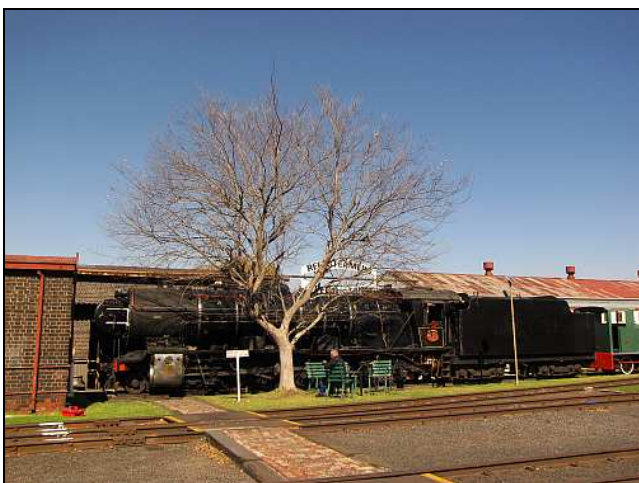
W03 – The 12AR 1535 was pulled out for improved lighting as there are no lights in the pits in the Top Shed. The diesel shunter's driver was enjoying the sunshine, taking a break between the rigorous work of jockeying the levers.

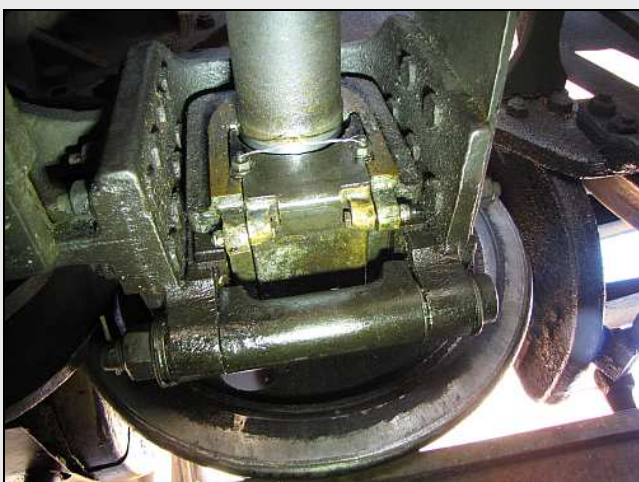
W05 – While working under all the iron, the fellows checked other bolts and safety wires as well. A good habit to have! Seen is the detail of one of the bronze front bogie bearings, with an oil box packed with oil impregnated 'socks.'

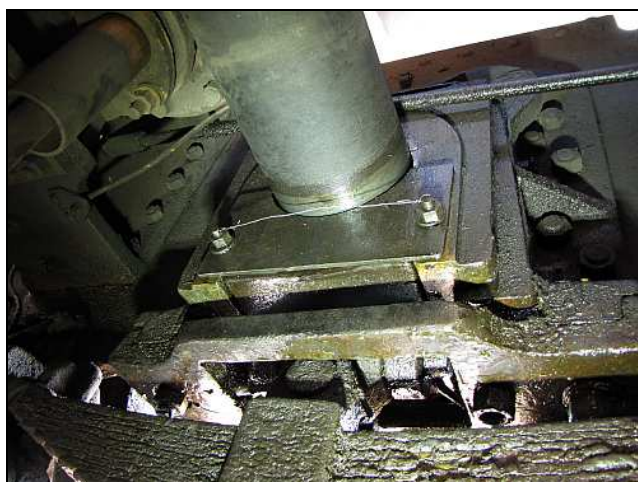
W06 – Here is the main project underneath – some of the driver axle boxes had loose wedges. You can see the tapered wedge to the right of the picture (Front). It adjusts the side clearances between the box and the axle horns.

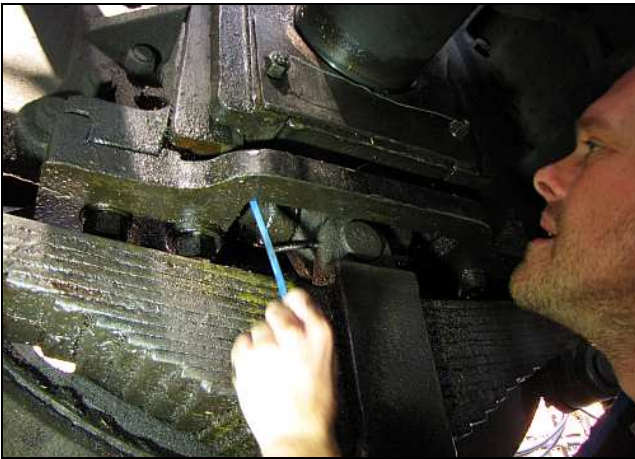
W07 – The correct axle box clearance on this loco is about 1mm. The thickness of a worn hacksaw blade makes for a rough feeler gauge. If the clearances are too wide, the axle boxes bang backwards and forwards with the motion of the rods. (It knocks the rod bushes oval.)

Too tight, and the axles cannot move up and down within the horns of the frame and the locomotive's suspension goes stiff. Sustained running with the axles tilted could cause an axle bearing to run-out.

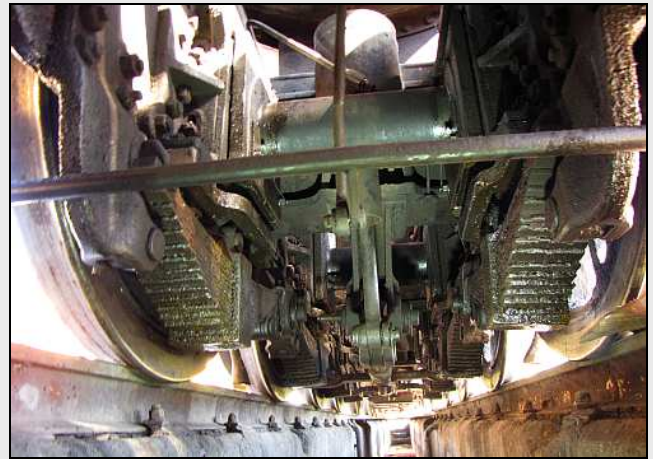
W08 – Here you see why the loco was pulled into daylight! It's bright-ish under there – albeit with a flood lamp as well. Some of the axle keeps had worked a bit loose too, so the undercarriage was checked and tightened from end to end.

In the foreground is the pull rod for the locomotive's independent brake. It is steam operated and works with the same set of linkages as per the vacuum brake, with the vertical steam cylinder visible.

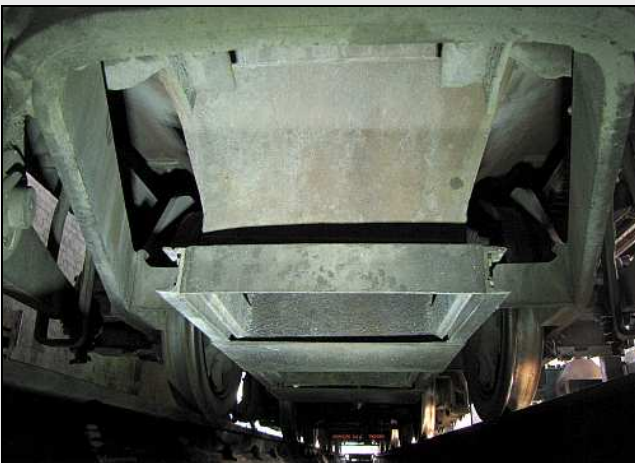
W09 – Back in the top shed and looking at the 12AR's ash pan hopper. Jeandre Gordon had been tasked with repairing the stopper on the linkages. They were going over-center and jamming, making the ash pan difficult to open without repeatedly bouncing the stirrup handle.

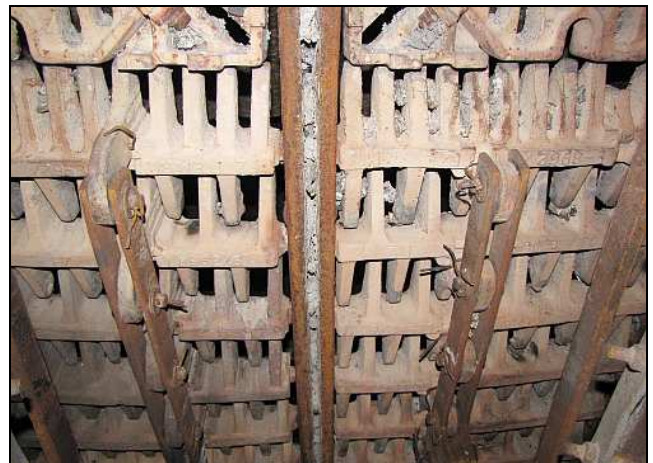
W10 – The relay rod for the steam-powered rocking grates had been removed. It is to have its journals machined and then fitted with Vesconite bearings. I wasn't able to get a pic, so as a consolation prize, here is a view of the rocking grates themselves as seen from underneath.

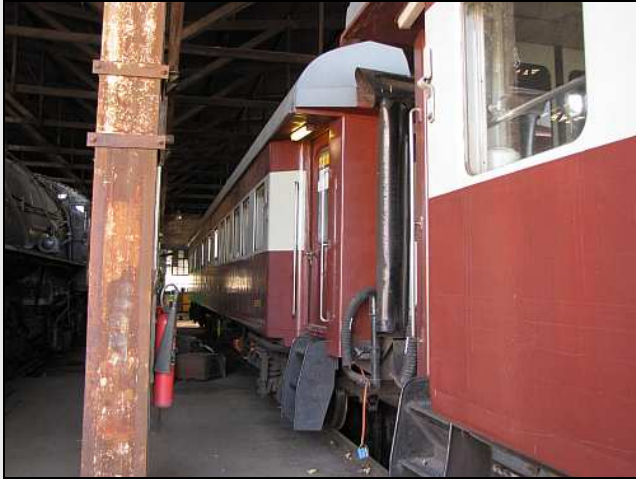
L01 – The Sleeper Coaches all have to be lifted off from their bogies at alternate ends to inspect the pivots, bolsters and their bearing rings. We'll lube-up the brake rods with the coaches up topside, as the light will then be better.

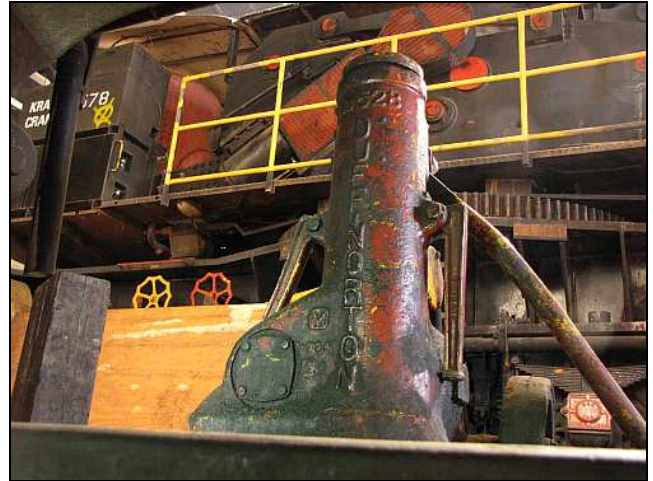
L02 – One of the pneumatically powered 'Duffy' jacks waiting for service. (The manufacturer's name is Duff-Norton – still trading today.) The hand ratcheted jacks are known as 'Bhudda' as they are of the BUDA brand

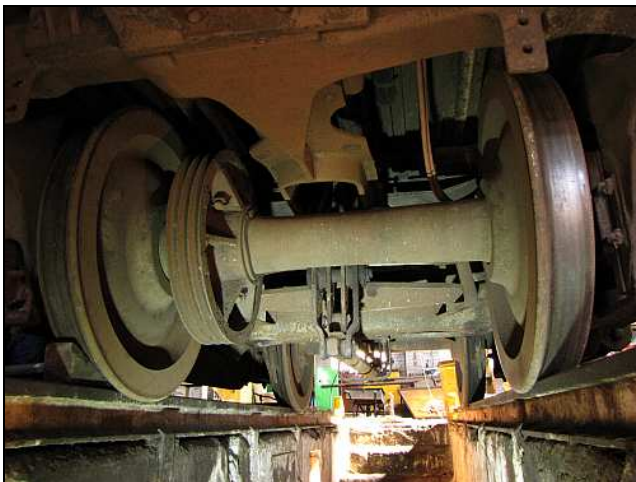
L03 – That unused split-pulley for the axle-dynamo drive will be the next scrap item to go. Hennie would need to get up into the gaps and uncouple the bolster ring and then disconnect the brake rodding. Short guys can stand under the flooring, but then their arms are too short. Sheesh!

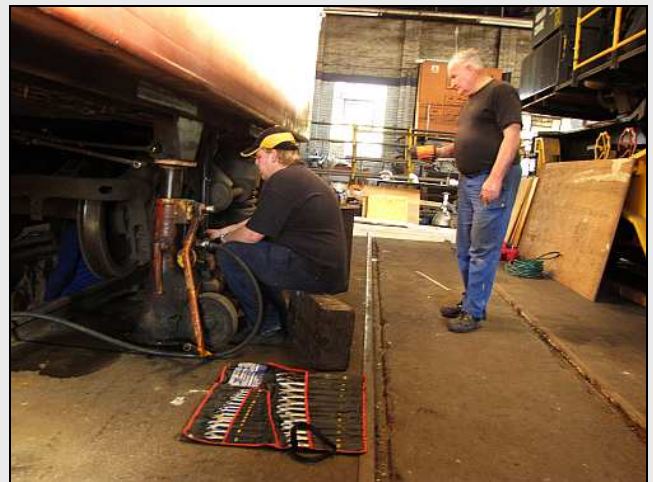
L04 – Victor operates the 'Duffy' Jack on this side while Alan operates on the other side. Attie is aiming his torch at the pivots and brake rods to check for any entanglement or trouble. Gordon was assisting at the end to check that the coach didn't tilt with the two independent jacks at work.

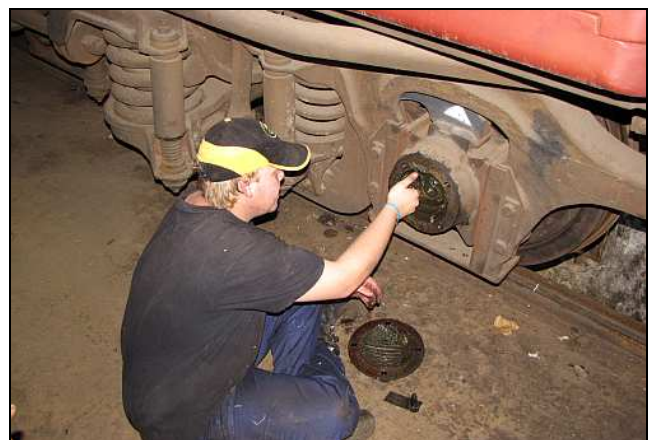
L06 – Victor checks and spreads the tired grease on this axle. When the coaches don't move, the grease settles down to the bottom of the journal box, especially in the heat of the sun. All of the boxes will need to be inspected.

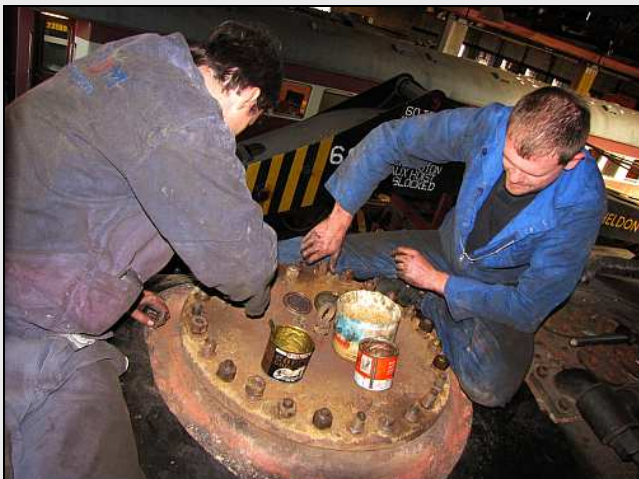
F01 – With the copper sealing ring freshly annealed and replaced under the cover, Swakhart and The Smudge are happily chatting while spinning cleaned hex nuts onto the freshly greased studs.

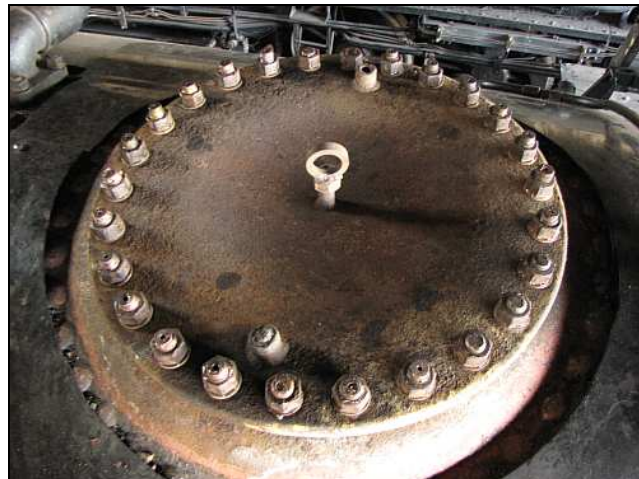
F02 – The 'dome cover' on the 15F's is actually a manhole manhole cover. Noticed the concave dishing to withstand the pressure. Those nuts all need to be tightened with an air gun before the boiler can be fully pressure tested.

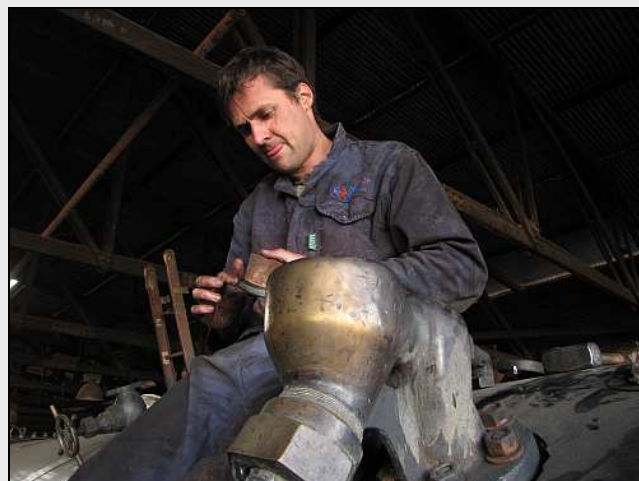
F04 – Dawie is applying grinding paste to the vane element of the clack valve in the foreground. We normally grind 'em in lightly and then apply silicone to the valve seats to prevent false boiler leak readings. But Dawie had spotted a flaw in the valve seat and trying to cut it down.

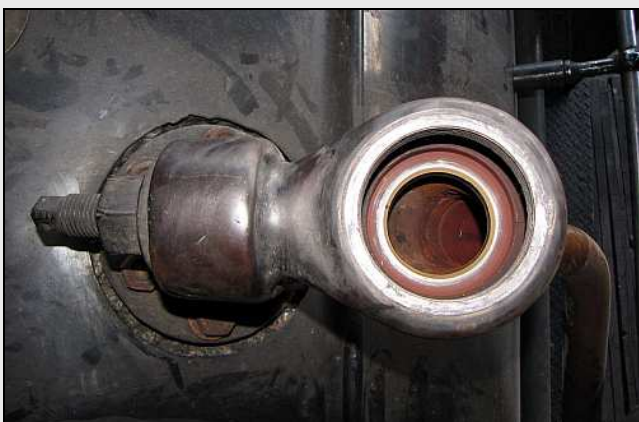
F05 – Looking down into the clack housing, you can see the flaw at 10 o' Clock on the valve seat. (The dark spot.) The clacks are self-cleaning, as they spin when they lift. But that's to deal with water-bourne scale and impurities and isn't capable of resolving damage to the valve's seat.

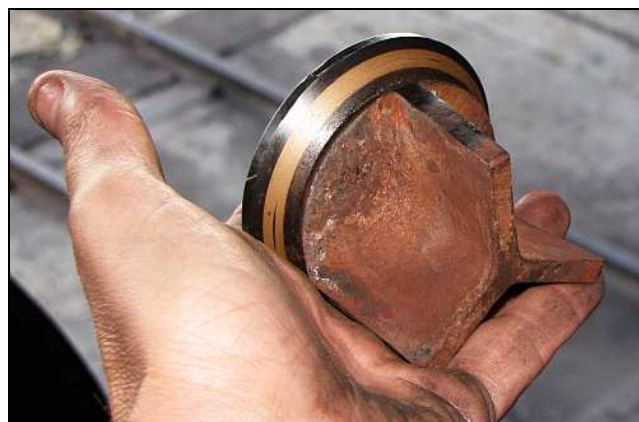
F06 – The problem is that the spinner vanes are a bit worn, which allow the valve to tilt in the housing. A small steam leak can quickly cut a groove into the valve components. It also accounts for the inconsistency that we were experiencing with the steam leak.

F08 – Dawie was later lucky enough to find a brand new valve cutter head, still in its original protective wax coating. So he was able to cut that seat down smooth and re-lap the valve. But the job will need doing again soon, unless new valve elements can be sourced or fabricated.

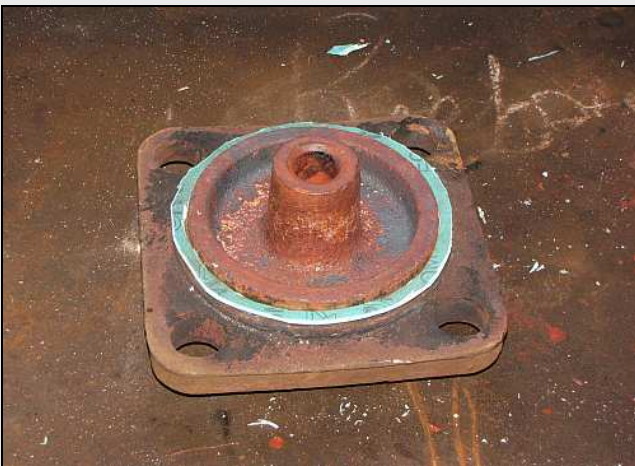
F09 – All alone and neglected in his dimly-lit, oil-scented cave, Aidan McCarthy made up five new Klingerite™ gasket rings for the regulator spool covers – 4 mains and a smaller one for the pilot.

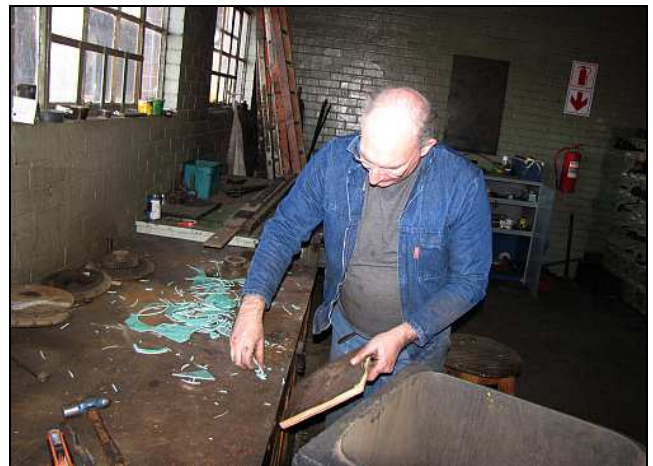
F10 – Aidan clears the cuttings away. This stuff is sheet Klingerite. It's good stuff for hot applications but this universal grade sheeting doesn't handle joints with different materials too well and can be troublesome on brass/bronze joints due to the high thermal expansion. It's fine for this application but laboursome to use, as you can see..

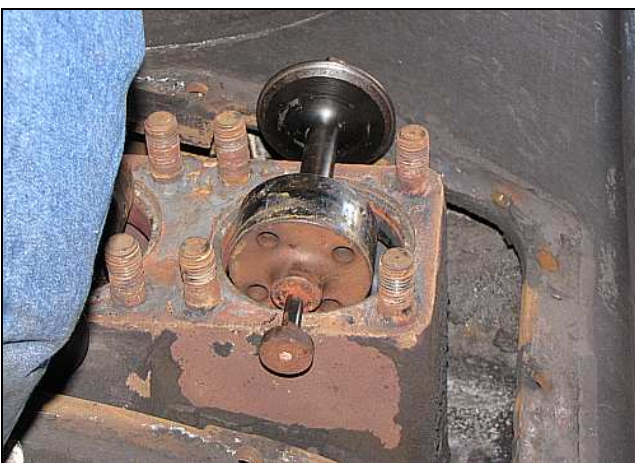
F11 – One of the double-beat valve spools of the regulator waits between its studs. As per Dawie with the clack valves, Aidan was lightly grinding the valves in and then sealing them with silicone for the hydro-tests. The silicone will blow out when the regulator is first used on a live boiler.

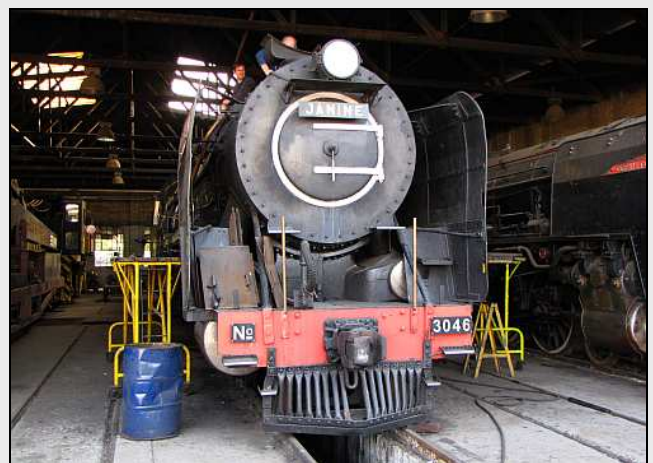
F12 – 15F No.3046 is happily being worked on with two gangers sharing the same pot of grinding paste! Two of the washout plugs incorrectly installed and the blow downs need to be blanked, but otherwise she's ready. Gordon would test-fill the boiler to mains water pressure this week.

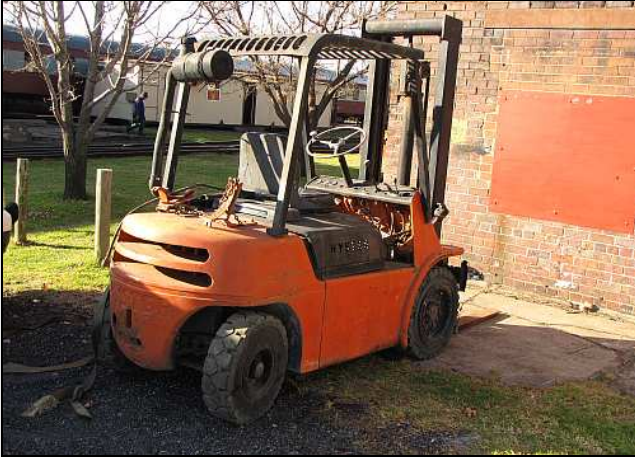
M01 – Shield Chemicals also donated an LPG-burning forklift to the depot. This Hyster is intact and just needs a bit of wiring work and the HT ignition system put together before going back into service, and likely a new battery. We even got four gas cylinders in the deal. Thanks!

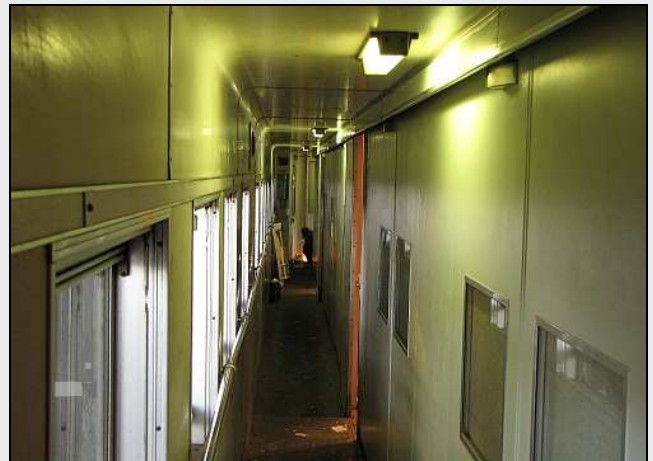
M04 – A view down the Gold Class corridor at Gordon grinding off endless welds. The entire floor has been stripped and now it acts like a big fly-trap. If you don't keep moving, your boots literally stick to the glue left on the floor!

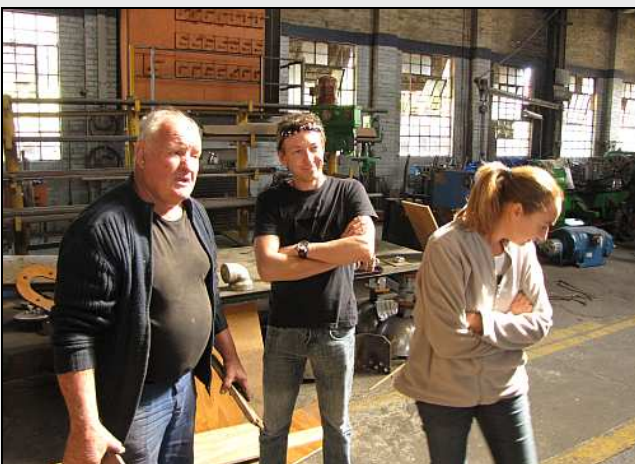
M05 – Mr. Gibson™ (Center) had come to measure up the flooring and seating of the Bar Coach. He's going to call in a long list of favours owing and see if he can't get some new flooring sponsored for us (Unique to that coach) as well as materials to repair the fraying bench seat cushions.

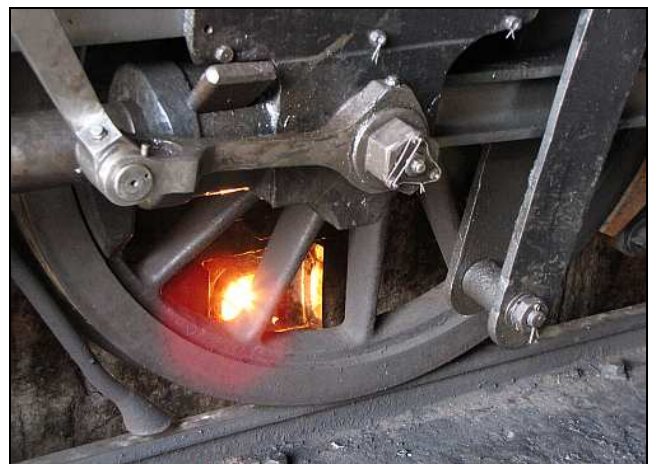
M06 – Class 15F 3046 driver wheel over an illuminated inspection pit. The worn valve gear bushes have been remade in Vesconite and reinstalled, so she's basically ready to run again once the boiler tests are done and the fire arch rebuilt.
