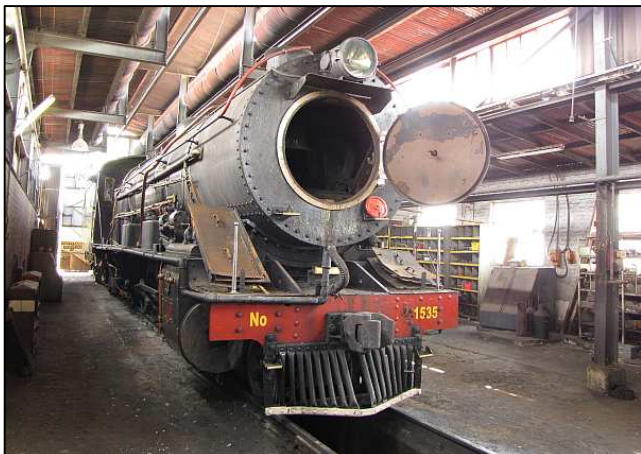
P01 - Suzie-girl has just had her first boiler washout out for the year and the door was left open to draw the air through for drying. Jeandre was tasked to check the baffles, table plate, blast basket, petticoat and washout plugs as well.

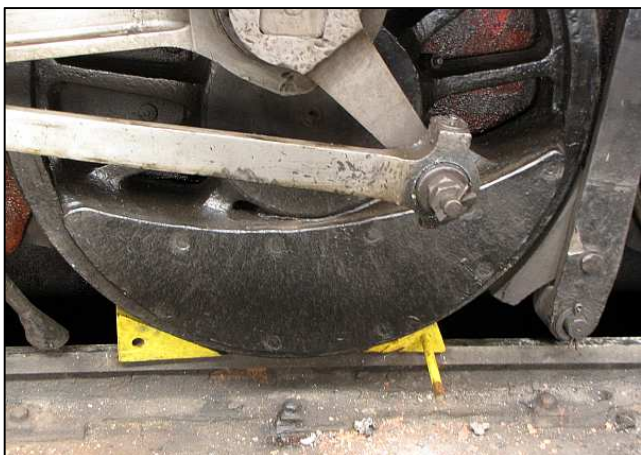
P03 - Properly scotched on both sides of the main driver axle as per our current standard. This is now a mandatory requirement for all standing locomotives at Reefsteamers, even if the tracks on which they stand is supposedly 'flat' and including all stock parked in the Top Shed and 15M shop.

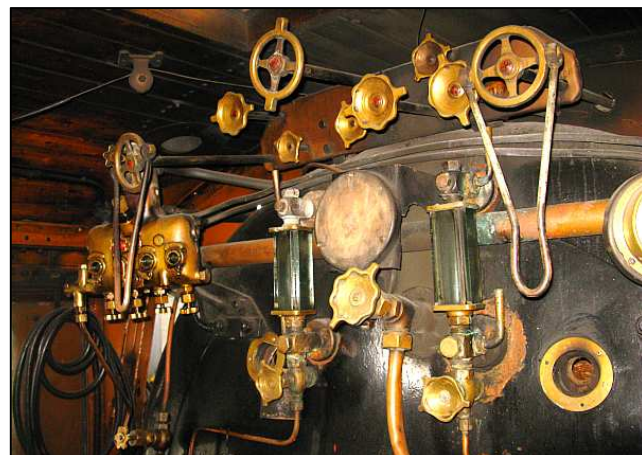
P04 - On the boiler backhead within the dark cab, there is just a blank circular wooden patress where the boiler pressure gauge would be. Although not necessarily a task within a standard boiler washout, the gauge was removed for repairs and recalibration. You can see the rear corner of the crown sheet through the washout plug aperture.

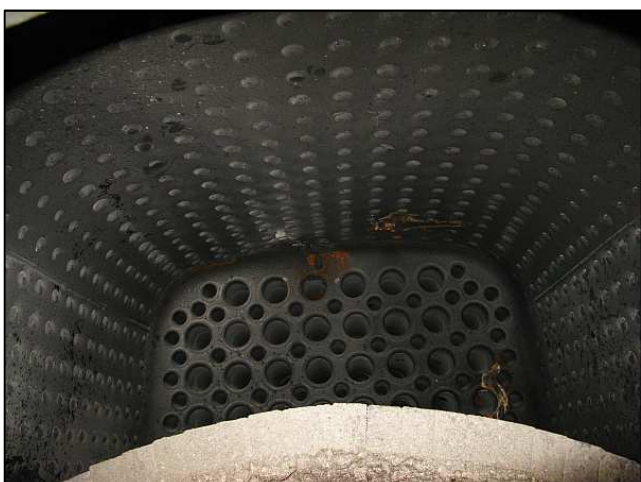
P05 - A quick peek into the firebox shows that the relatively new fire arch isn't in bad shape. But there is a weep from the right front fusible plug and from one of the boiler flues as well.

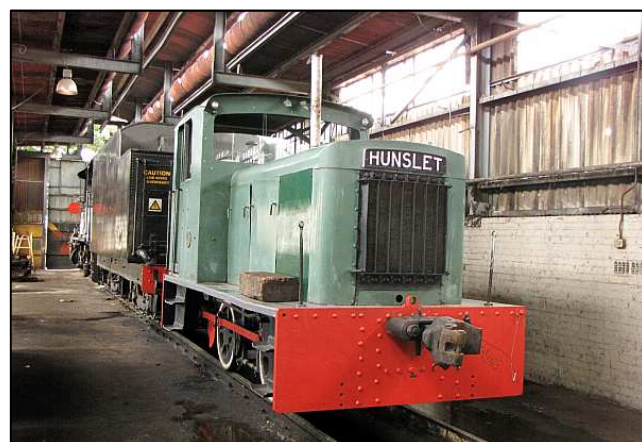
P06 - By the following week after the boiler had been air-dried to perfection, the 12AR was shunted right to the back of the Top Shed. 'Andrew' the Hunslet would have to skedaddle before 15F 3046 got back that evening. This is where 12AR 1535 stands at the time of writing for the work on the crosshead slide bars.
