**1). PROJECT – INSPECTION WORK 12AR 1535**

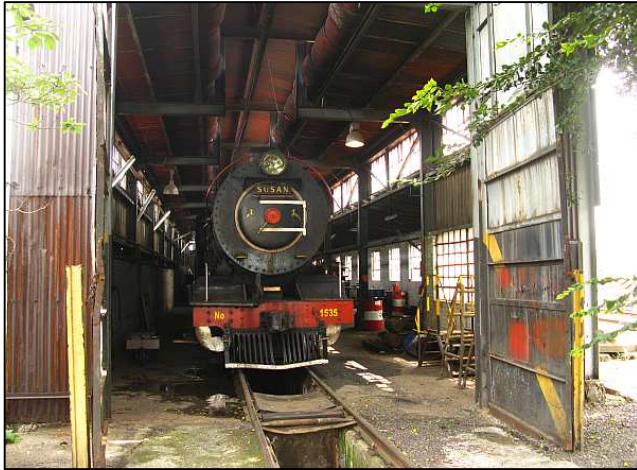
P01 - This 1919-built machine with a 1955 boiler is reasonably reliable for what she is – but that reliability doesn't come without regular inspection and maintenance.

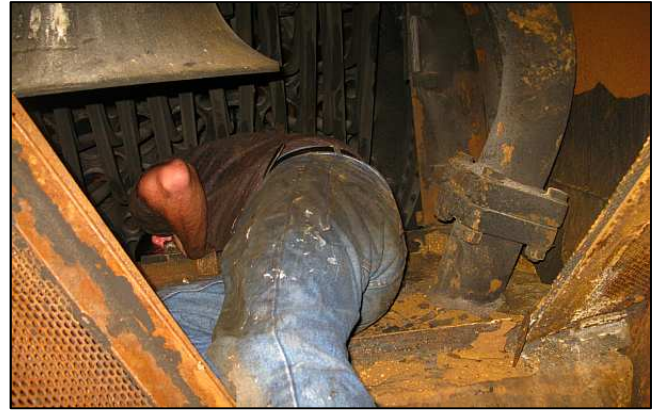
P02 - Smudge in da box. Shaun checks apprentice steam fitter Jeandre Gordon's boiler washout work before authorizing the baffle plates and spark arrestor grids to be refitted. (Which would obstruct access to the tube plate.) He is checking the front tube plate washout plugs here.

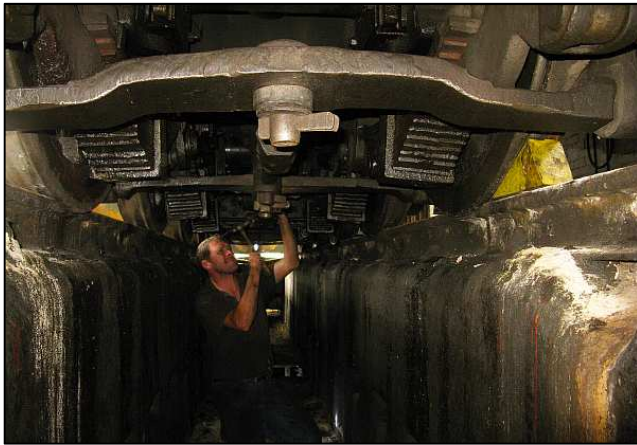
P03 - After the compensating beam was attended to, Susan the 12AR got an extra early underside inspection, including checking the clearance on the brakes (routine) and tapping for loose fittings. You can see a cotter pin (US terminology) in the foreground – which functions like a wedging split pin.

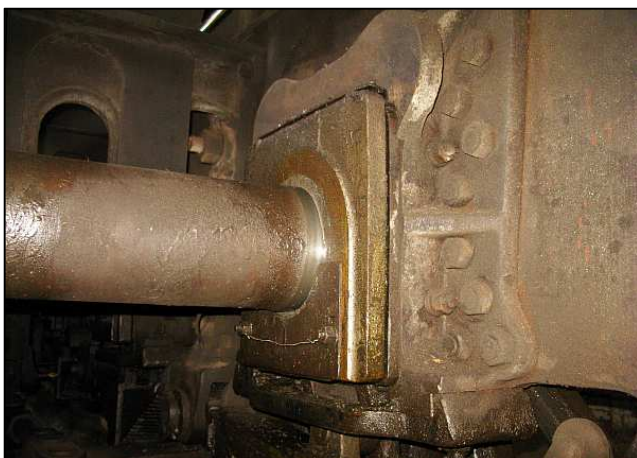
P05 - Here is an axle box, with the correct safing wire. The 12AR's axle wedges need regular checking as this small-wheeled locomotive is prone to knocking her axle boxes loose (fore and aft movement) if the locomotive driver isn't handling the cut-off properly or is a bit too speedy.

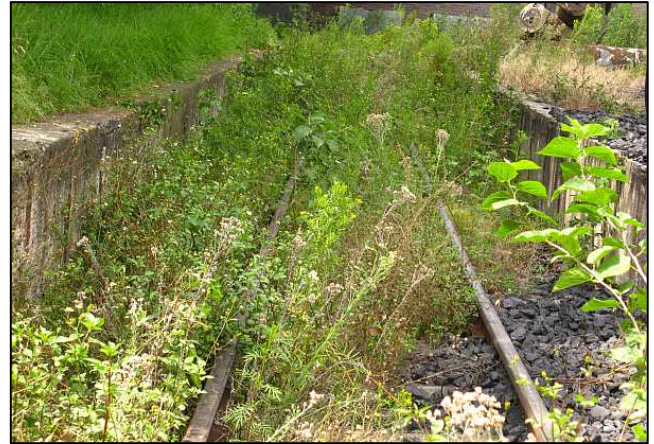
P08 - With the depot being closed for two months over a hot, wet summer because of permit issues, the weeds have taken over the entire site and we are still battling against their head start. This is the overgrown coaling dock.

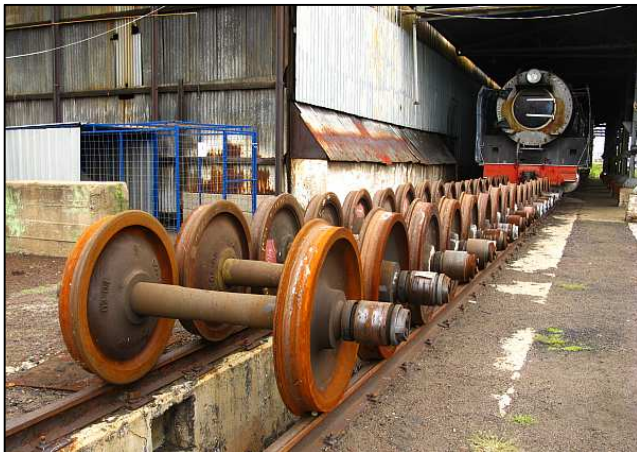
P09 - The axle stock for Shongololo Express's long distance coaches were moved over to the inner track of the old washout shed – lined up neatly in front of FotR's Class 25NC 3404 'Elsabe.' The recent blue structure in the background is the Security Forces' dog cage.

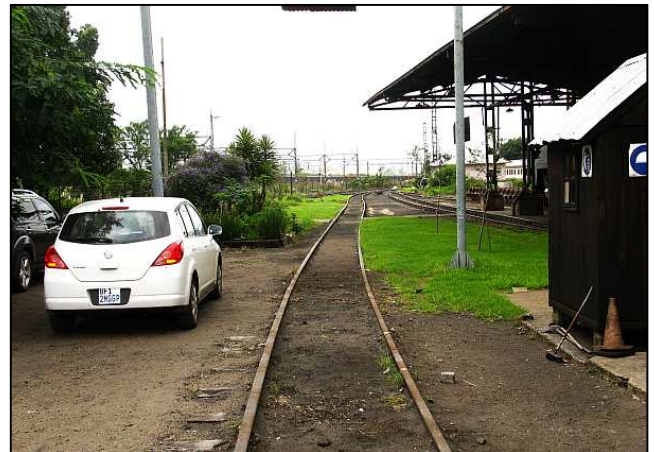
P10 - This is where the axles came from. This track is to be lifted back to the garden and buffer wedges welded on the ends. This means that a bakkie or a truck can now drive along over one rail of that track and stop opposite the clubhouse from unloading for special functions.

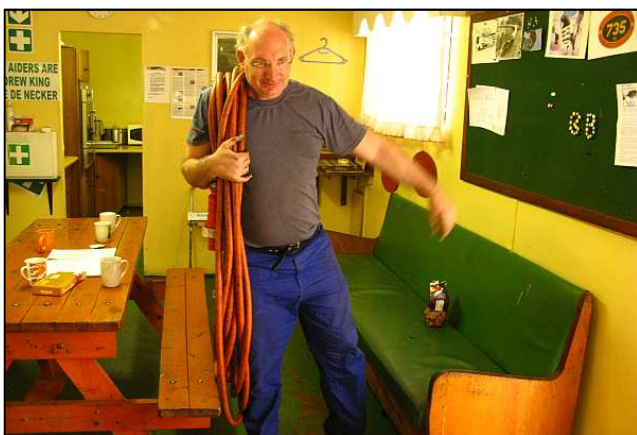
P11 - A j(Y)umbo-sized extension lead. Aidan is pulled a bit off balance taking the heavy lead out to the electric-powered Yumbo grab. The lead is now detachable, as the previous fixed lead was stolen several times for the copper.
