**1). STRIPPING COACH INTERIOR AND TOILETS – SAT, 22 MARCH 2013:**

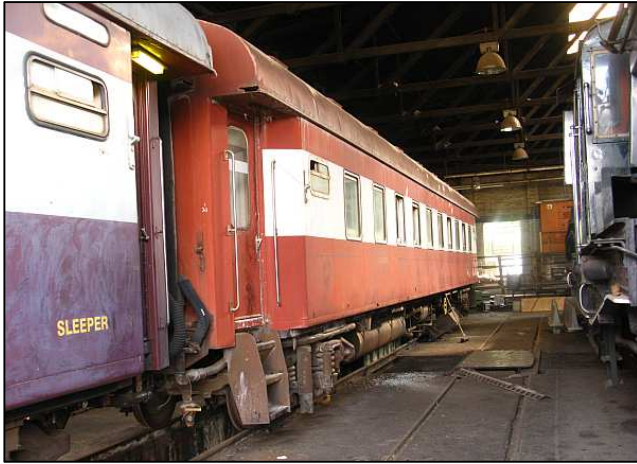
P13 - Work continued on 'Dusty' the Semuma Coach. The contrast in the paint colours is interesting to see, and Dusty still wears the old style oxide red roof. There are so many holes to patch, the coach will likely need to be resprayed.

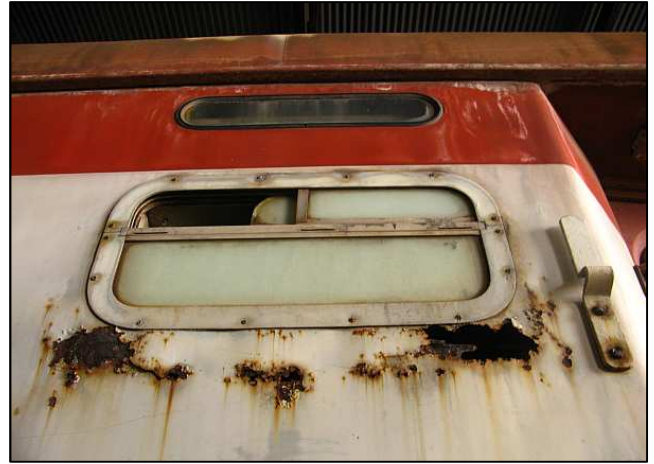
P14 - Here is some bad rust that broke out around a toilet window. This is an unusual location for the rust especially as the toilets don't have steam heaters and it is likely there is a roof or window frame leak letting water into the framing.

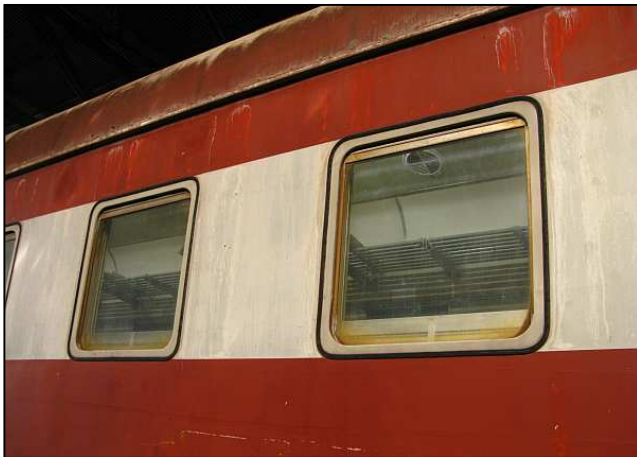
P15 - Here's a problem the coach boys found! Dusty's windows have a fibreglass cowling as an insert (see the extra rubbers?) and they do not match those of our other coaches. The window glasses are a lot harder to remove.

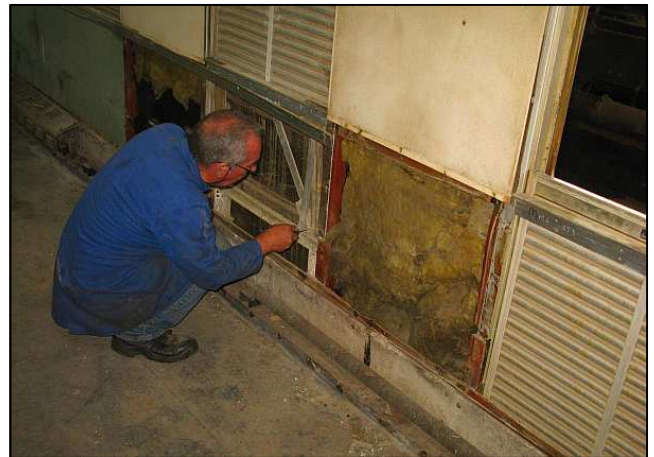
P16 - Gordon wrestles with the jammed counterpoise linkage of a seized window. One of the other windows was smashed. As the louvered shutters are incompatible with the sleeper coaches, they will now remain where they are!

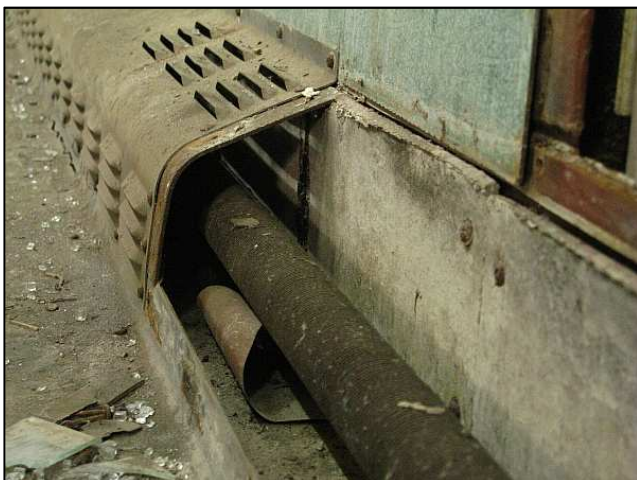
P17 - To get the wall panels off, the steam heater covers had to be removed, leaving this 'cross-sectional' view of the densely-finned heating pipes. These have caused rust in many coaches through rising steam from leaks and we are removing this obsolete equipment on any coach we rebuild.

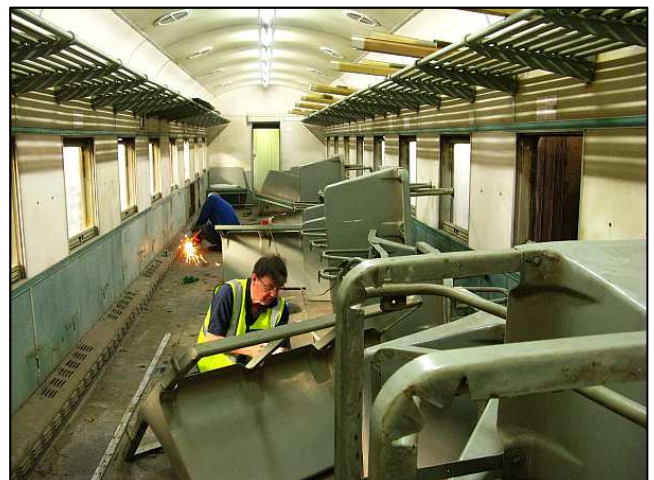
P18 - This was the second coach interior stripping session. Nicholas is seen gamely working away at the BIG jumbled pile of 3<sup>rd</sup> class seats – all of which were cleared by day's end. In the background, Gordon is grinding away the corroded bolts that retain the steam heater skirting covers.

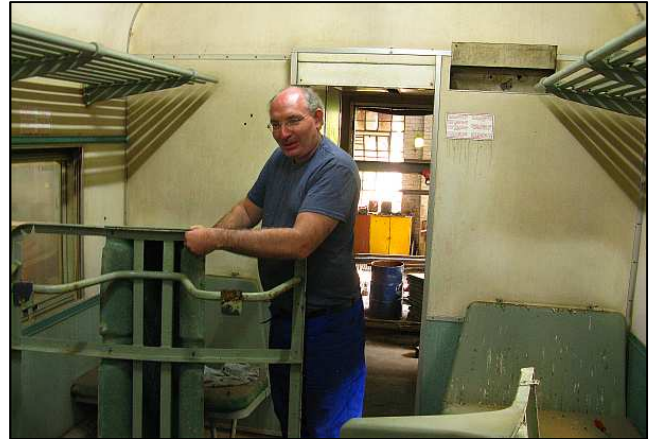
P20 - Aidan brokers a divorce between another seat back and frame. These were each held on with eight bolts and none of them were captive fittings. As the coach was stored with the windows closed, the bolts weren't too bad.

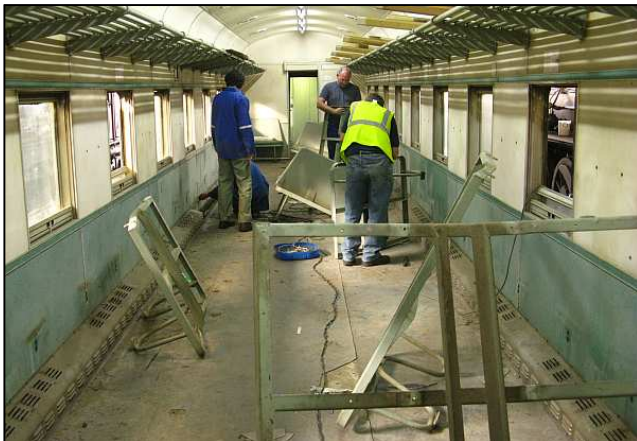
P21 - The passenger cabin is almost clear by 4pm. We have approx. 100 retired aircraft seats stored on our behalf at Rand Central and are discussing the fitting of this coach with those seats for better comfort than the existing. If it doesn't work out, we will work out a padded solution – but we don't want to turn out another 'hard back' coach.

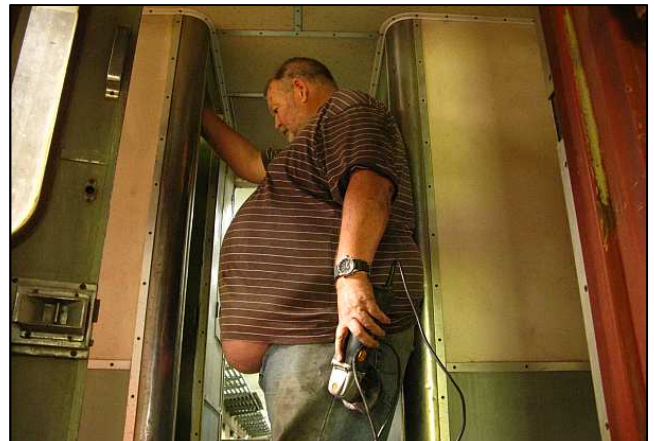
P22 - 'Big Robbie' figures out how he is going to get into that little cubicle to wrinkle the SAR-style 'thunder pot' out. We are going to demolish the left toilet compartment to use that area as a corridor, and extend the right compartment to the middle. Otherwise, fitting a domestic type toilet results in very cramped seating and the door getting in the way.

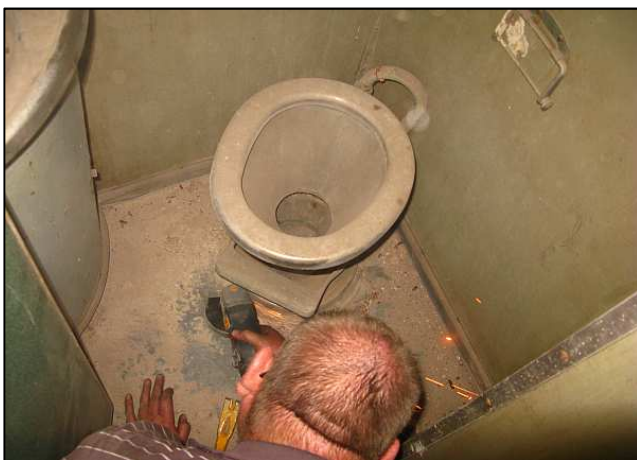
P23 - Robbie patiently grinds away the rusty, urine-corroded bolts holding the flap-bottomed toilet pan down. These little compartments look dingy even when those old laminates are cleaned, and fresh paint doesn't help much. The walls need removal before the new flooring is laid.

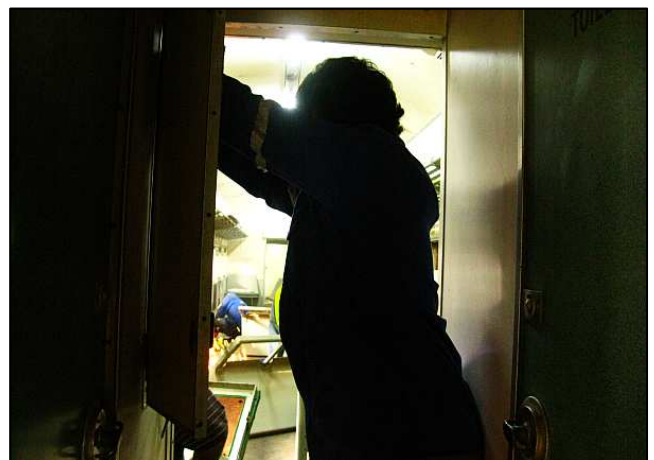
P24 - Alan's FAVOURITE position – elbow-deep inside a live distribution board. The vestibule lights will need to use converted existing-style fittings as the high-efficiency integrated fitting used in the interior are now only available in 2ft lengths, too long to fit into the existing recesses.
