1). YUMBO GRAB – ASSEMBLING THE VALVE BLOCKS – 22 MARCH 2014:

2). YUMBO GRAB ACTUATOR REPAIR – 22 MARCH 2014:

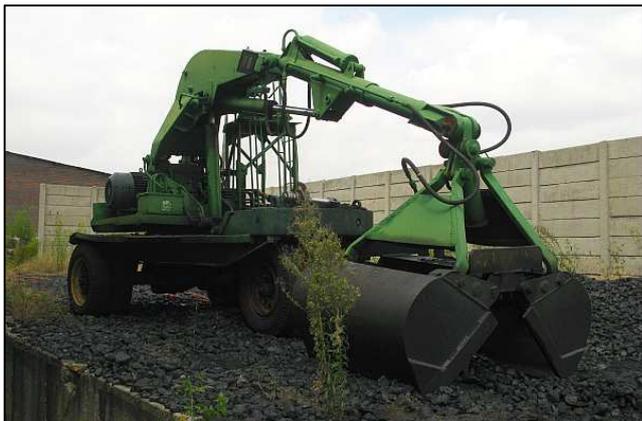
P01 - Our useful self-propelled Yumbo grab has been leaking hydraulic oil lately, especially from the clamshell's actuator cylinder. It has also long been annoying the coal-dock operators with some dangerous sudden movements when lowering a boom (Flow restrictor issues), and not holding steady in certain positions. (Spool valve leaks)

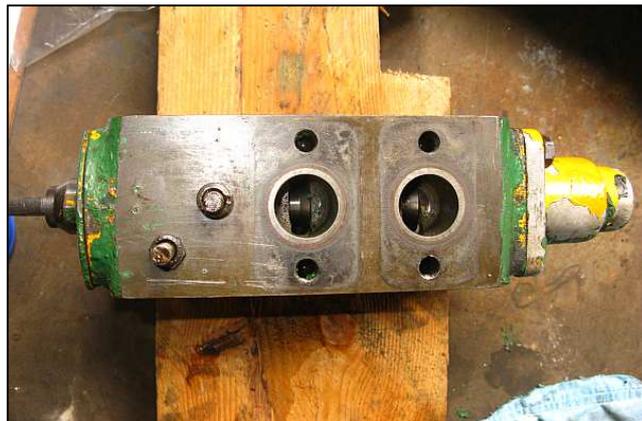
P02 - One of the modular common-rail hydraulic valve blocks is complete and is having indexing studs fitted. Apart from coal grit ingress, detective work showed previous incorrect assembly such as misplaced springs and inverted seals. Looking down the actuator flow ports, you can see the valve spool located in the central control bore.

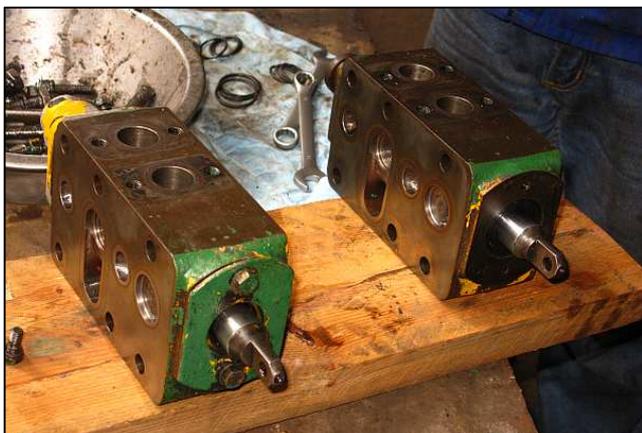
P03 - The individual valve blocks bolt together in a stack and are mechanically interchangeable, but the valves and porting may be different. Several bags of generic seals were purchased to repair the worn or mis-fitted hardware within the valve blocks. The oval shaped indents are the oil supply ports from the common rail oil gallery. (Bottom).

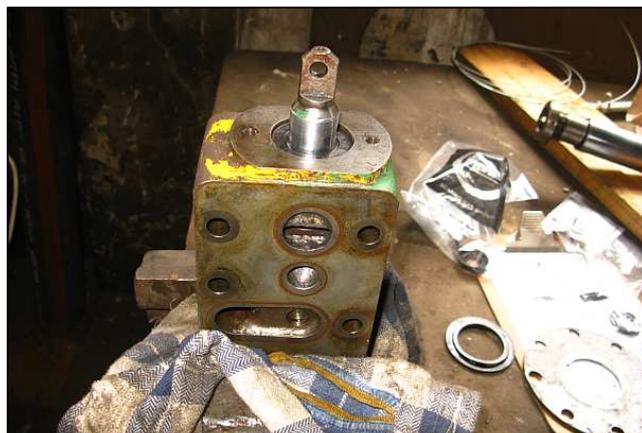
P04 - The boys found that the block controlling the main boom had been swapped for one without a restrictor – allowing overly-rapid oil drainage. This is why the coal grab's heavy boom drops suddenly and has to be modulated by rapidly pumping the valve's lever. You can see a slotted aperture restrictor insert within the upper port.

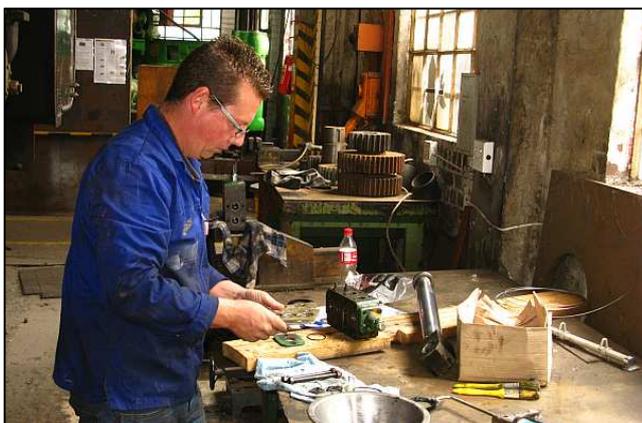
P05 - Simon Bennett did the reassembly and refitting work on the valves. Here, he is shuffling a deck of sealing plates which go inbetween the individual valve blocks and the terminator cover. The seals were made up with silicone. (The blocks did not have conventional gaskets fitted.)

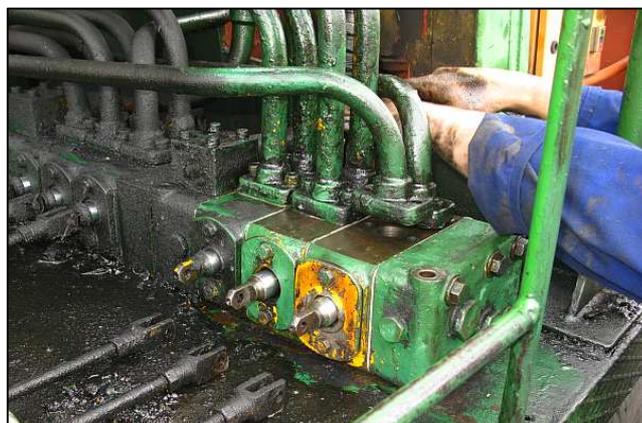
P06 - The three repaired valve blocks are being fitted, with special attention to the proper location to the main boom's block. It is hoped the saving in hydraulic oil leaks will pay for the various supplies in short time – and we won't be denting the top rims of locomotive tenders quite so much!

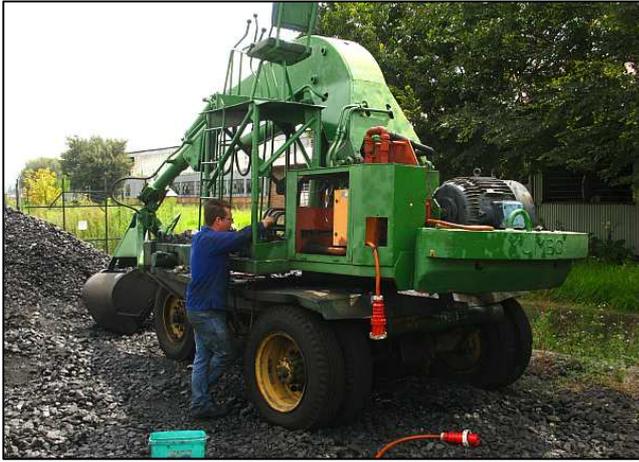
P07 - Simon is seen remounting the hydraulic valves. You will notice that the Yumbo grab is electrically powered via an extension cord. It was originally built as a diesel powered machine and used the Perkins engine that now drives the light-service generator in the S&B Van.

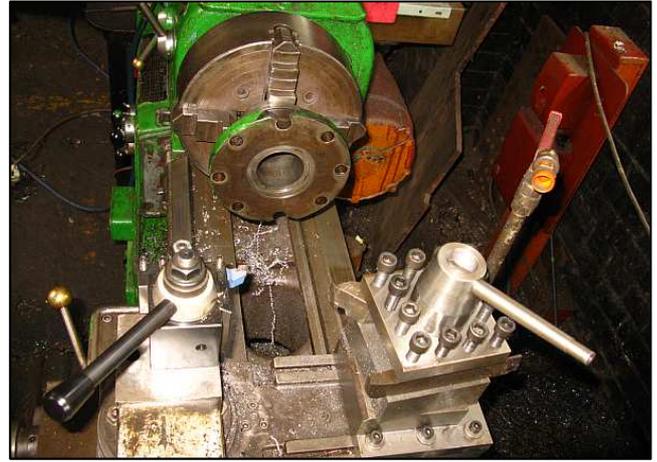
P08 - The top-hat profile cover for the clam shell's hydraulic actuator has been placed into James's TPS lathe for truing up. It had been quite brutally fitted by past employees and that thick casting was slightly distorted as well as broken in two places.

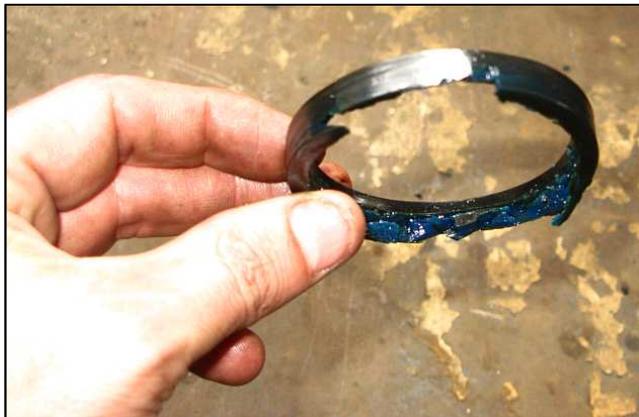
P09 - The hard steel disk scraper plate had been loosely fitted over the end cap and it was too bent to be of much use. This worn wiper seal shows the results of the constant ingress of abrasive coal grit at the dirty end of the machine!

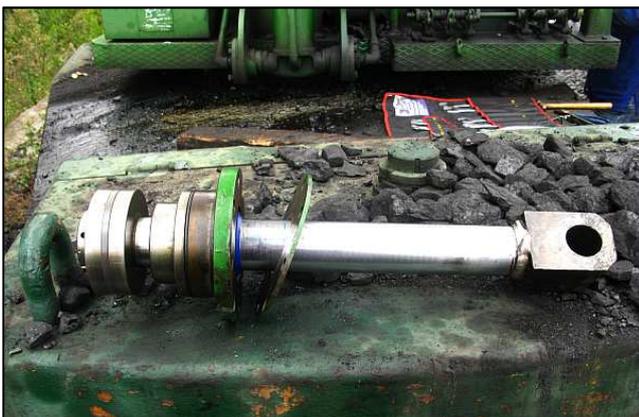
P11 - Here is the serviced and reassembled clam-shell actuator rod, piston and cover gear. The new bright blue seal is the wiper seal over the actual hydraulic pressure seal, while the disk plate is the scraper for bigger stuff.

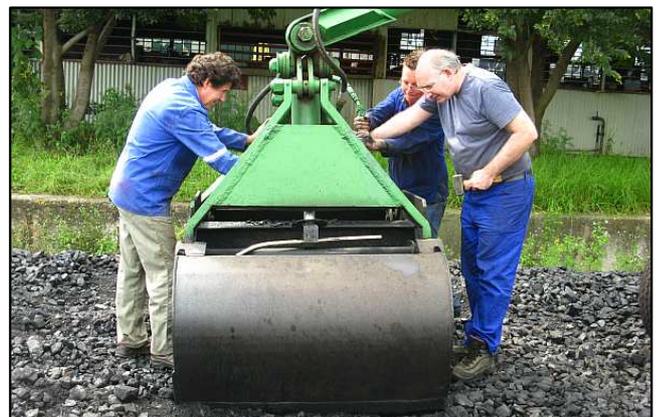
P12 - After uncoupling, the actuator's innards were removed without removing the cylinder, by using the hydraulic pump to force it out. It was quite awkward getting everything back in again through the canted cylinder and then trying to get the worn cover bolts to line up through the scraper, the tightly fitting end cap and the actuator body – and working upside down as well. They managed it!
