1). LIGHTING UP 12AR 1535:

After several weeks of being awkwardly perched up on wooden blocks for a bogie axle repair, Class 12AR No.1535 'Susan' was finally steamed up for some action. We would be taking a rare Sunday run on the following day, to join in with the fun at Friends of the Rail's Open Day at Hermanstad. (We normally run on a Saturday) We were hoping to take both 15F No.3046 'Janine' and 12AR No.1535 'Susan' with us for a double-header. Unfortunately, lil' Susie developed an bad leak overnight at the front fusible plug, which was dripping copiously onto the fire arch. Thus, she had to be withdrawn for reliability reasons.

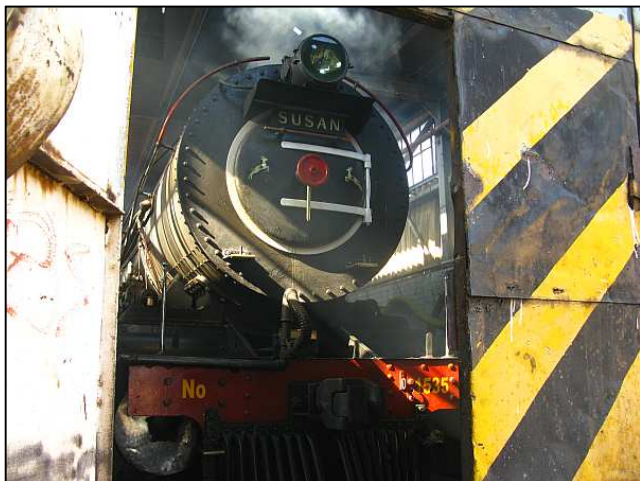
P01 - A bit closer to the ground now that the bogie has been re-installed, the 12AR No.1535 steams up behind the still-closed gates. As we had two blowers on the compressor, the draft was a bit diluted and the steam-up took a while.

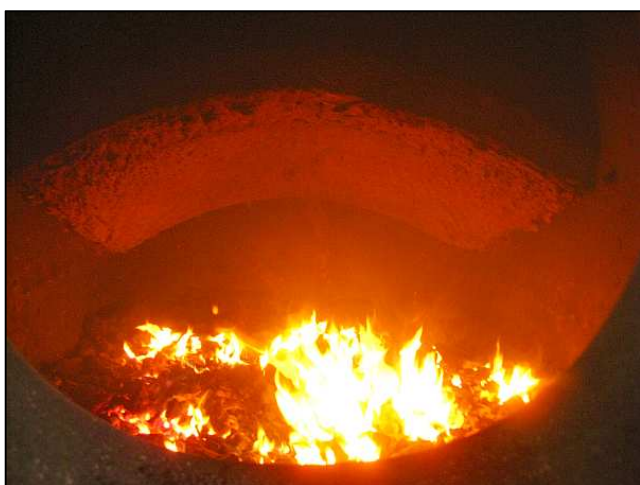
P03 - Today's coal wasn't great – sullenly burning down to a dull clinkery powdery mass. This fire had burned down, but I don't generally don't interfere with another man's fire.

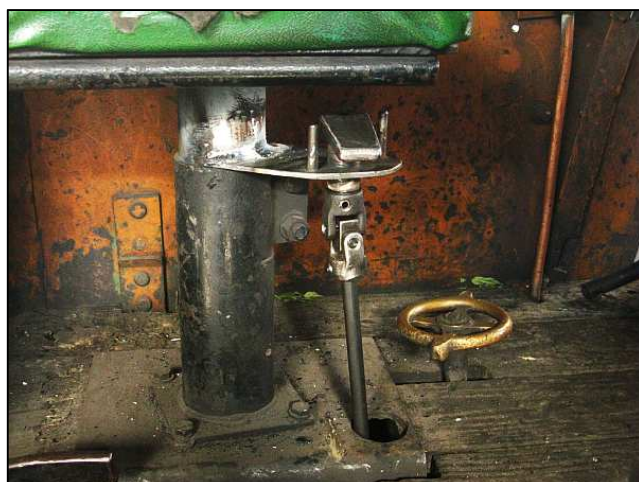
P08 - This is a side view of the new extended injector water kick-lever, (Fireman's Side) which is now hand-operated. The pedestal plate will be painted black in a week or two. The lever originally protruded from the hole in the floor.

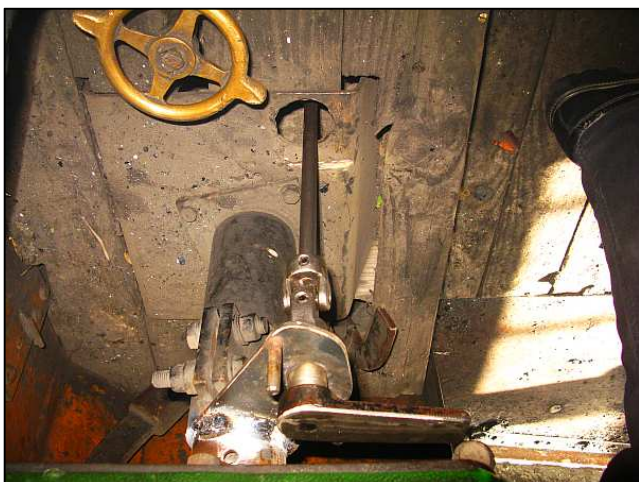
P09 - This is what the fireman would see if he looks down between his knees. ('Off' position.) The lever can now be operated with the stronger, more coordinated right hand. This new arrangement is gonna be great for the guys with big feet that battle with the original floor-mounted levers.

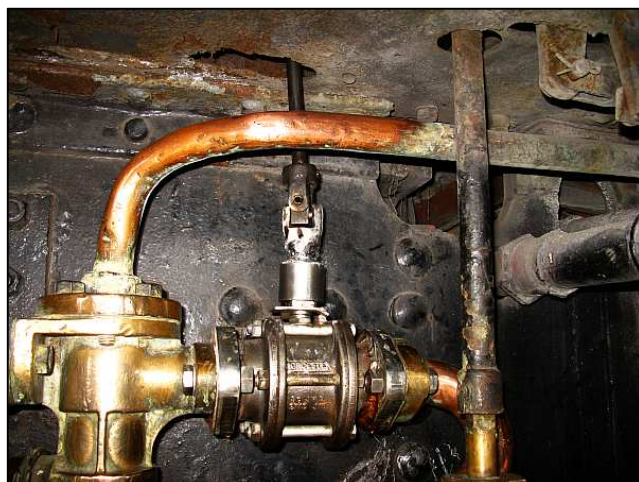
P10 - This is the new valve at the other end of the shaft. It operates with a smooth positive action but does need some strength to operate. Apart from reducing distraction for the Fireman, we estimate a saving of eliminating about 4500 litres of 'dribble water' from the overflows in a typical day.

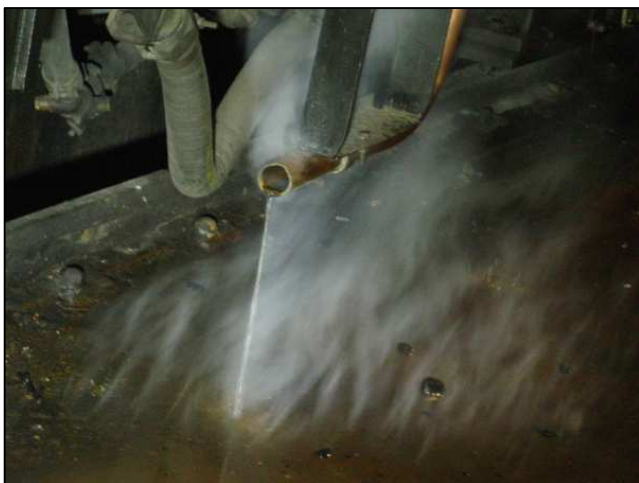
P11 - As seen on the 15F locomotive later that night, this is the constant dribble that we are trying to eliminate. This looks artistic and is a part of the 'living ambiviance' that a steam locomotive has – but it is wasteful of resources.

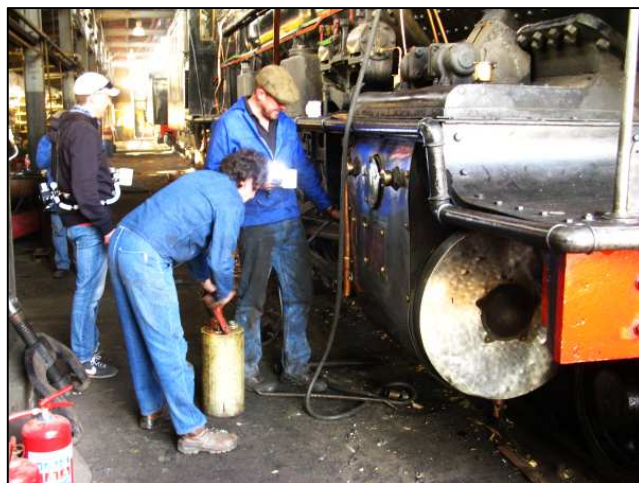
P12 - Susie the 12AR was treated to extra oil. The slide bars are being 'sauced' after the bogie boxes had been topped up. The bogie crown boxes, like any wick system, deliver oil continuously and this one would run overnight.

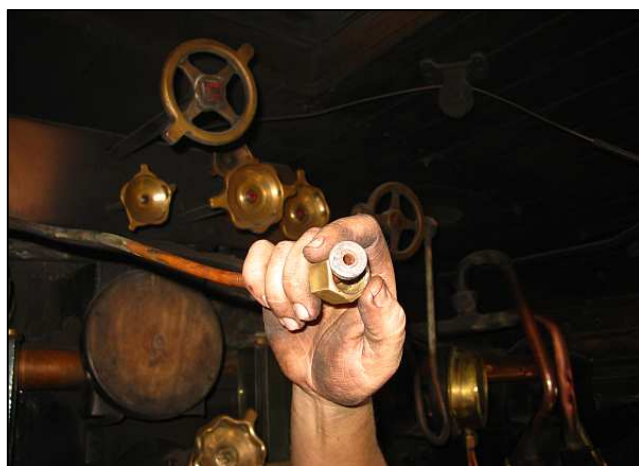
P14 - Seen after the pipe had been threaded through the cab's spectacle plate, this is the new ferrule that was machined out and then brazed onto the copper piping. Ten points for remembering to put the nut on before brazing!

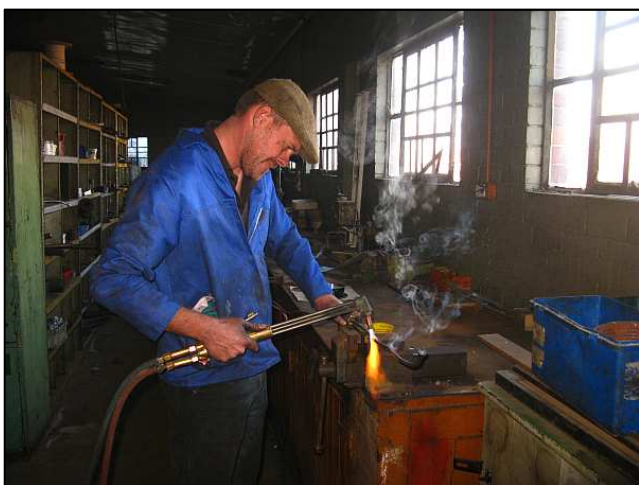
P15 - The copper piping needed to be annealed once it had been removed, to avoid it fracturing when being manually bent into place again. Simply put, annealing is the process of heating to glow and then cooling. Copper can either be slow-cooled in air or salt or fast-cooled by water, brine or oil. Water is naturally the cleanest method for fast quenching.

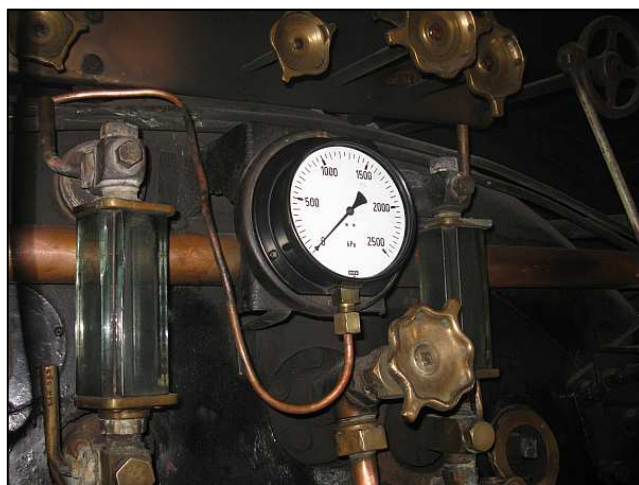
P16 - A new pressure gauge installation on a slowly warming boiler. We were battling to get new brass-cased gauges and imported gauges are expensive. The black gauge will do the job just fine. The Safety Valve blow-off line would be drawn in a little later, according to the 12AR boiler logs. (This boiler is slightly de-rated from standard.)

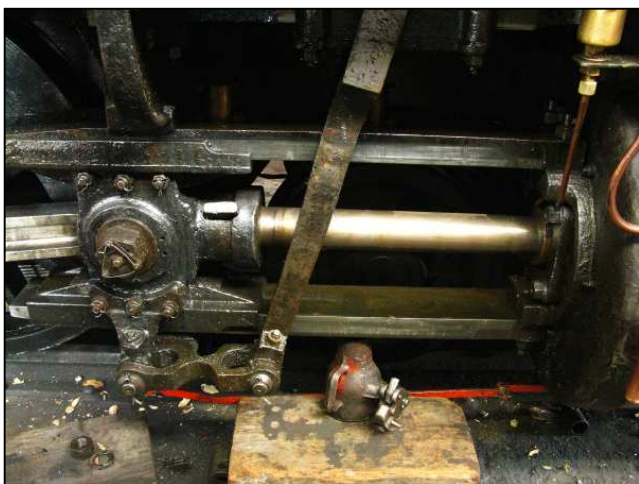
P27 - The recently repaired crosshead slide bars on the right side had settled into service on their shims and needed to be adjusted slightly to remove about 0.6mm of clearance. Note the supporting jack under the bottom bar.

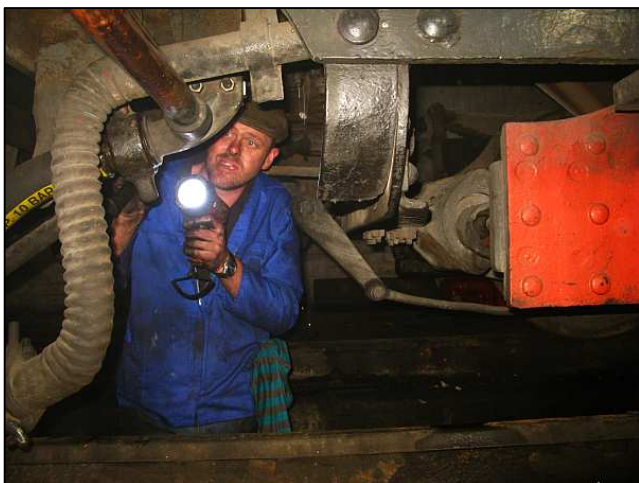
P29 - Smudge wisely did an early road-worthy on the 12AR. Here he is under the cab and using a flashlight to re-check the tightness of the bi-eared collars for the recently fitted water transfer hoses, and then the ballpeen on the elbow bolts.

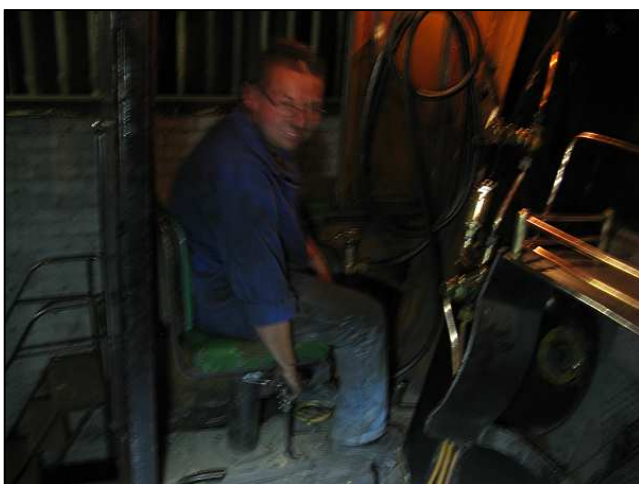
P31 - Although this photo is a bit dark n' blurred, it shows the new extended injector kick lever being operated for the very first time under steam. And it was done by a Bennett!

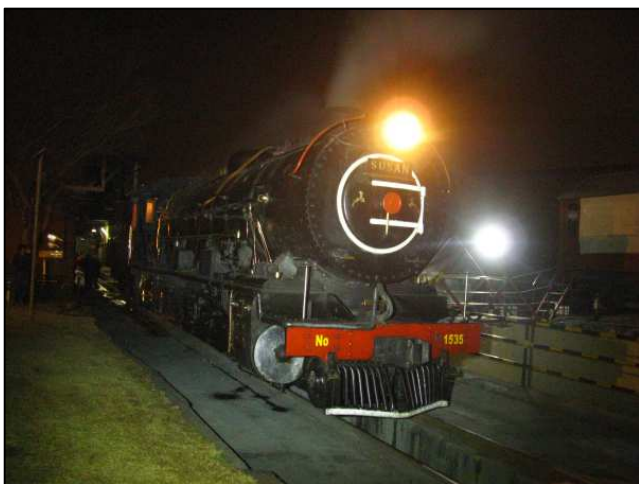
P32 - The 12-bucket finally moved out at about 6:30 after an extended time of standing and blowing through the open cocks to warm up the winter-chilled cylinders.

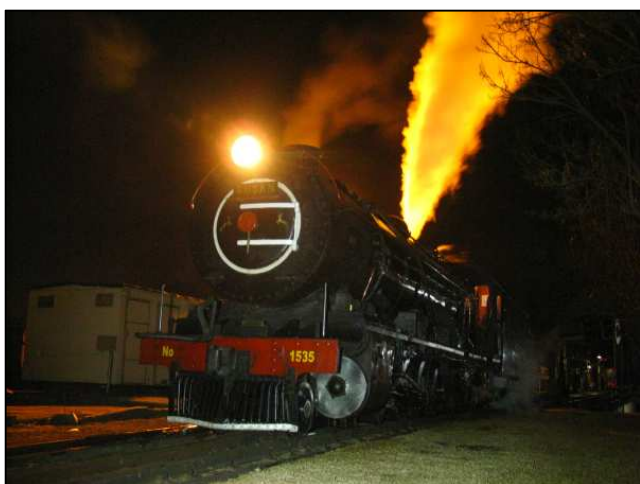
P36 - In spite of Simon deliberately 'capping' the hot boiler by running the left injector to spray down the cab and backhead BEFORE cleaning the fire, she still popped-off. Obviously excited to be in steam once more.

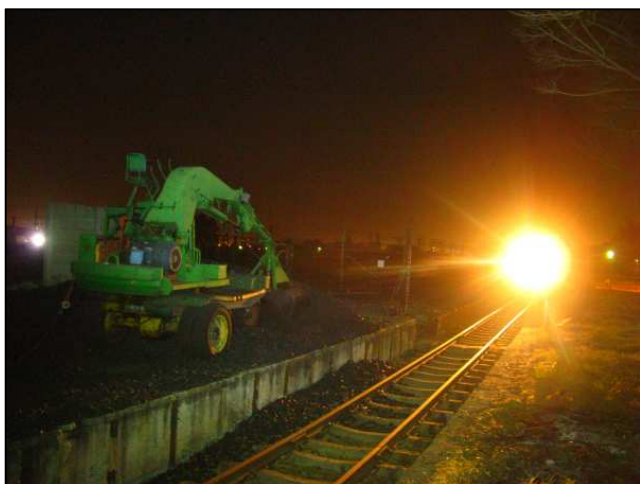
P38 - Aidan battles to connect the 3-phase 'extension cord' as the rubber weather seals go stiff in the cold weather. The grab's heavy electrical cord is now a plug-in, as it has been stolen several times. We lock it away between uses.

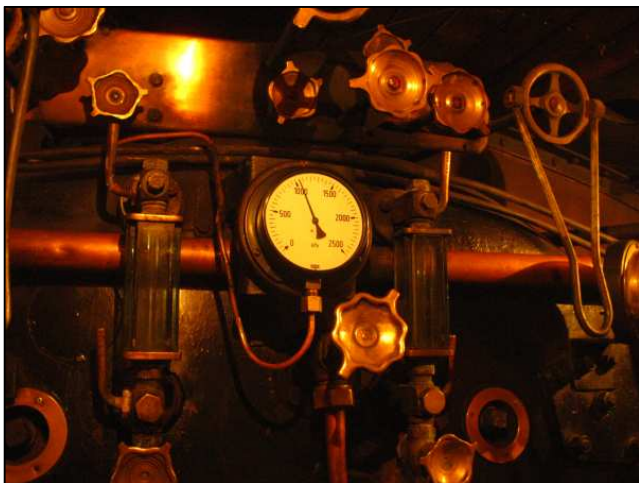
P43 - The new boiler pressure gauge in service. This one is only metric, and has a higher scale (2500 kPa) than the originals, which makes the readings less granular. The needle will never go past vertical before the safeties lift.

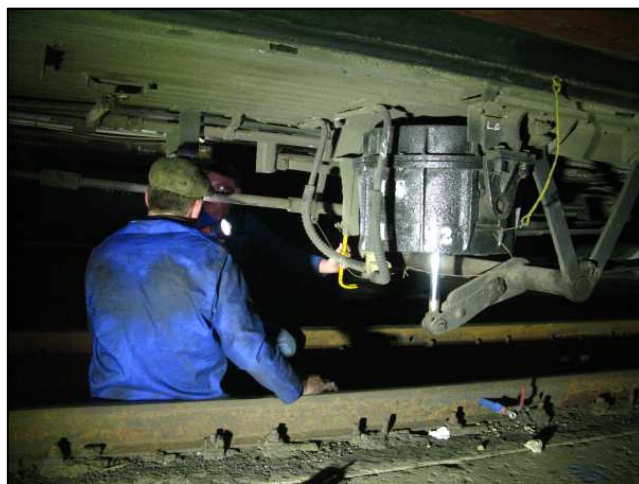
P46 - While we had a vacuum-braked steam loco hooked on the train, we took the opportunity to do a quick (and cold) check of the brakes, although the official vacuum test would still be done in the morning. Gordon is using a mini-crow bar to tighten up the adjustable main pull rod under a coach.
