7). A LOOK AROUND THE 15M SHOP:

8). WORKING ON STEAM ENGINES:

9). STEAM LOGISTICS:

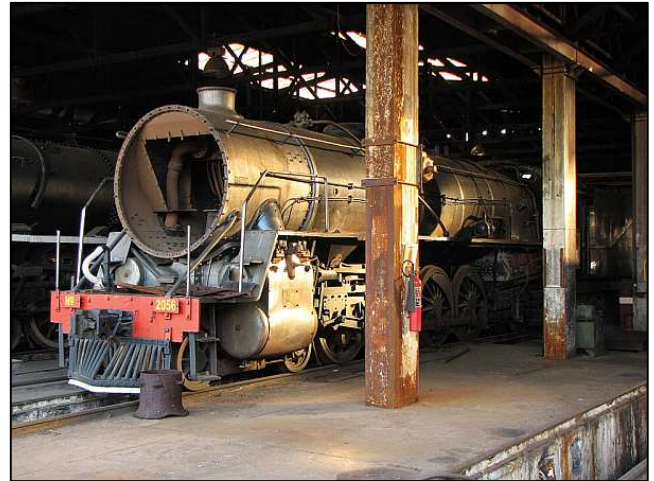
P086 - Some otherwise intact locomotives are sleeping in the 15M Workshop due to the expense of the repairs needed. This is our Class 15CA No.2056, which needs a full set of new boiler flues at approaching R450 000.

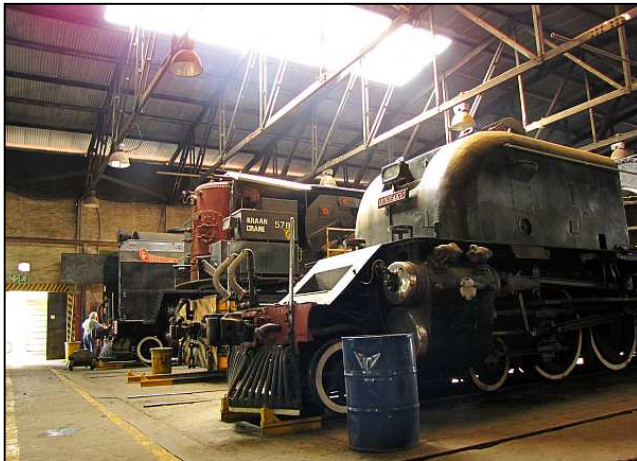
P087 - A variety of steam machines at rest, as they are waiting for other projects upon which they are dependent. The GMAM Garratt in the foreground and the Class 25NC at the rear are 100% intact but are waiting for the wheel lathe's completion to enable wheel profile correction.

P118 - Challenge – Wheel Lathe. Both of these large locomotives, a Class 25NC and a GMA/M Garratt, are in operable condition. But they are not allowed on the main line due to wheel profile/flange wear. Between them, they have 44 wheels – with 12 driving axle sets that need to be removed to machine the wheels.

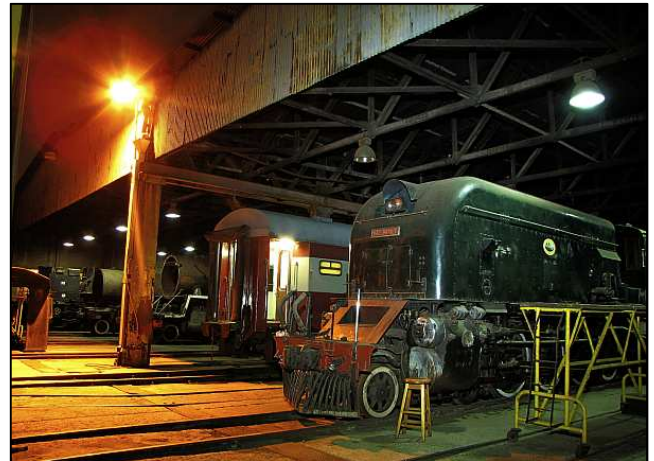
P088 - Coaches sometimes make their way into the workshop as well. Hiding behind the Garratt is a silver Class coach that was undergoing an interior refurbishment for an international Steam Tour that ran in Nov. 2013. The pressure was on and volunteers were working evenings.

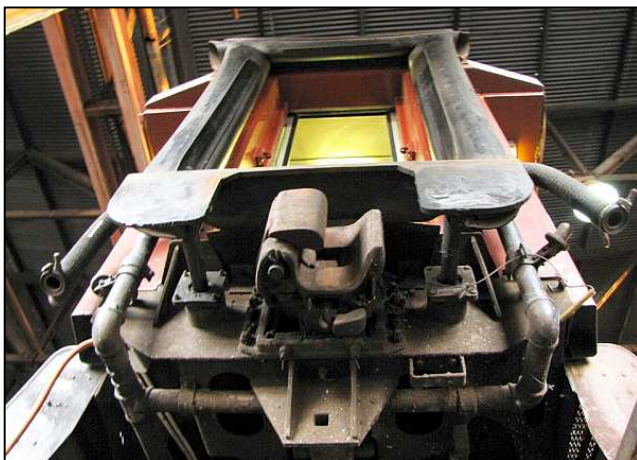
P089 - The 15M workshop's inspection pits come in useful for the servicing of the draft gear and buffer plates of the coaches, all of which need lubrication and checking at regular intervals.

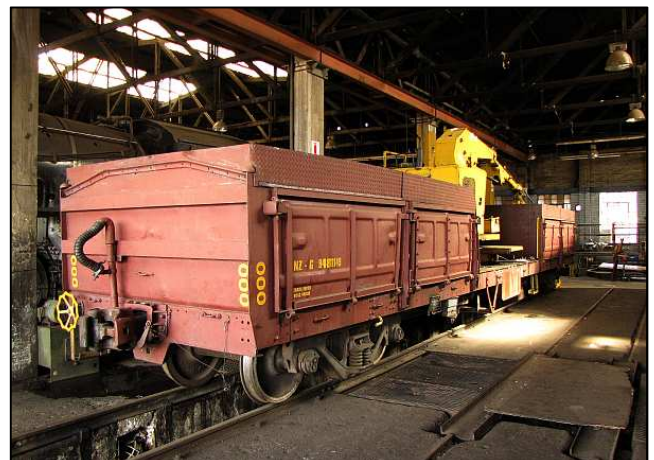
P090 - You might find some of our support vehicles in for repairs in the 15M shop too, such as the coal handling wagon (Pictured), a caboose, or perhaps one of the water tankers.

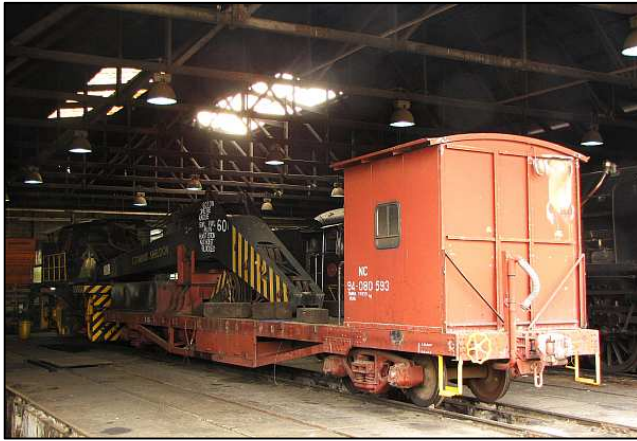
P091 - One of the long term guests of the 15M shop is this magnificent 100% intact privately owned 60 Ton Steam Crane which was rescued from scrapping at Danskraal. This is one of two steam cranes stored in the 15M shop.

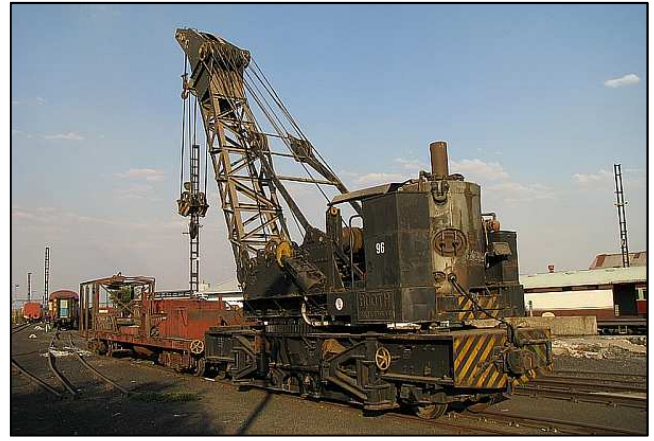
P092 - We have an intact Booth Rodley Steam Crane waiting for a replacement boiler to be fitted. No.96 'Shosholoza' was last used in 2008 to clear some scrap and move wagons from the boiler washout area– the uncertified boiler was then charging on compressed air.

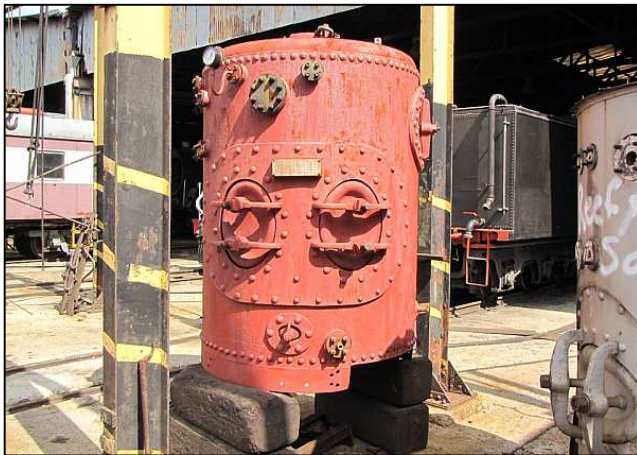
P093 - This is the Cowan Sheldon steam crane's vertical boiler which is in the process of having the leaking rivets of the foundation ring replaced before it can be pressurized with water to test for leaks.

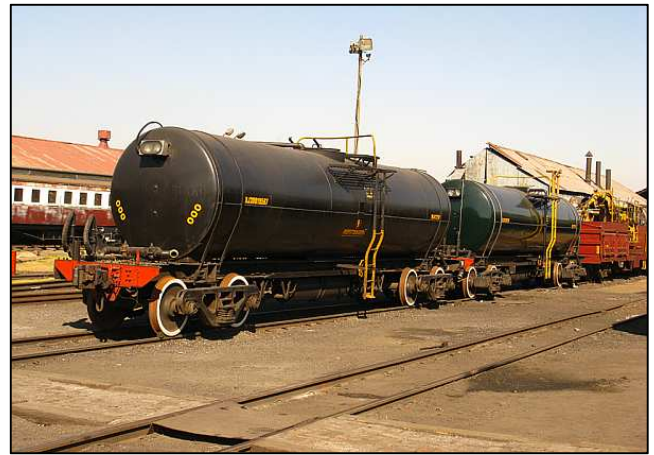
P094 - We have a small fleet of water tankers are our disposal, all of which need servicing. One of them has been especially lined as a drinking water tanker and one of them has a fitted fire-fighting pump. These tanks are required to extend the range of our thirsty steam locomotives on a railway that no longer has water supplies.

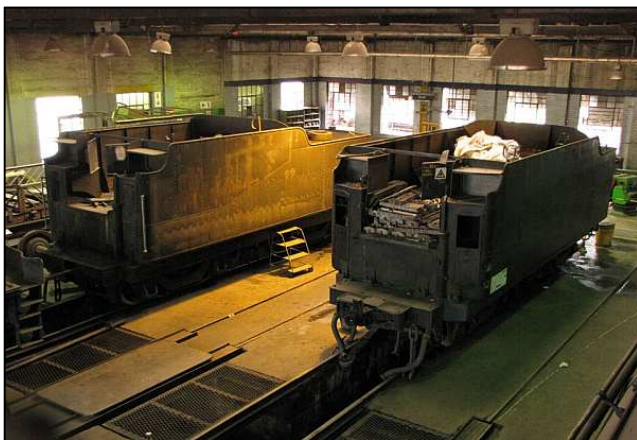
P095 - Tenders also need to be repaired. These two examples are waiting for their locomotives to be repaired first though! The tender in the foreground is for Class 15F No.2914 and it has a stack of removed fire grates sitting in the coal space. The tender is waiting for plate work and conversion of the axles to roller bearings.

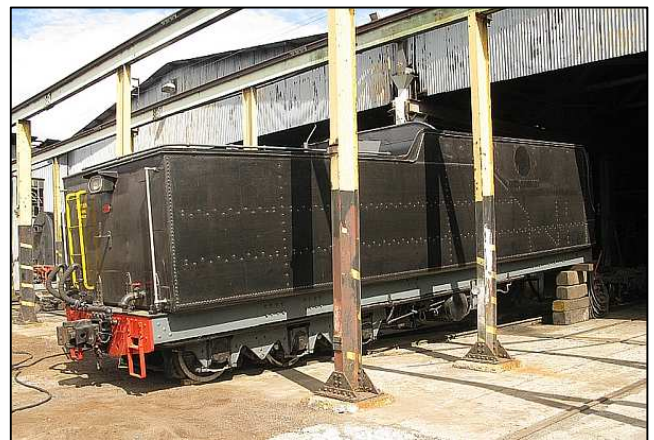
P096 - Occasionally the jacks and blocks come out – this is the rebuilt type EW tender of Dave Shepherd's Class 15F No.3052, which was treated to new decking, rebuilt bogies, rebuilt brakes and a rebuilt mechanical stoker, as well as new bracing within the coal bunker.

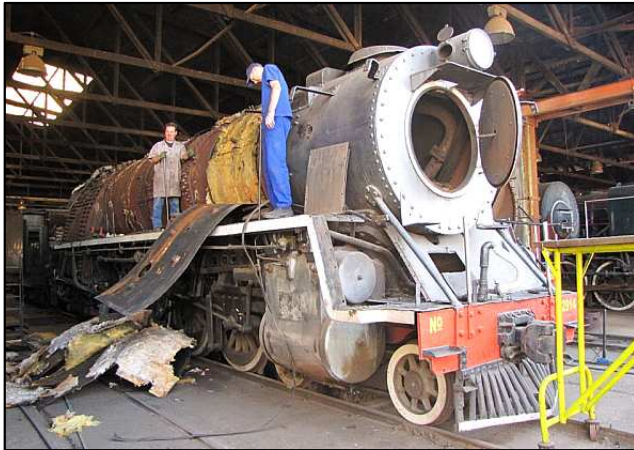
P097 - An example of scruffy and labour-intensive stripping work. Here, the boiler cladding sheets and the underlying thermal insulative lagging are being removed from the boiler shell of Class 15F No.2914 and what a messy, itchy job that turned out to be!

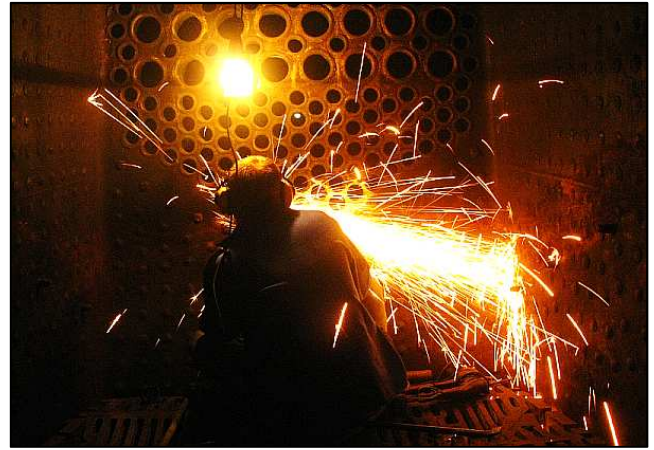
P098 - We often have to work within the dark ferrous sarcophagus of a locomotive's firebox too. This old-fashioned narrow firebox is having the tube plate ground clean and old copper ferrules being removed prior to installing new boiler tubes.

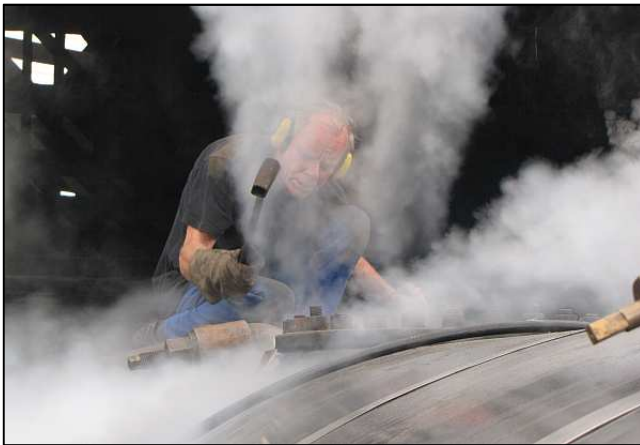
P099 - Some of the work has to be done with the locomotive hot! Here, the safety valves are being calibrated on a newly commissioned boiler. A locomotive's safety valves have to have their settings certified by a Boiler Inspector and then sealed to prevent tampering.

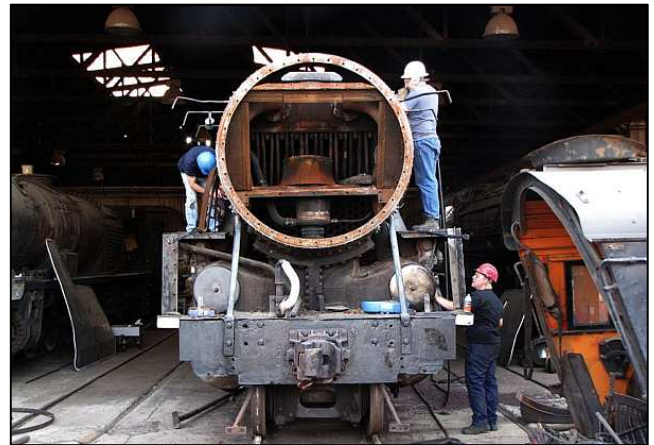
P100 - Because of their size, SAR steam locomotives allow for double-deck work on multiple levels. This locomotive is simultaneously getting etching primer paint applied, old paint removed and baked-on heat resistant graphite paint being removed from the smokebox.

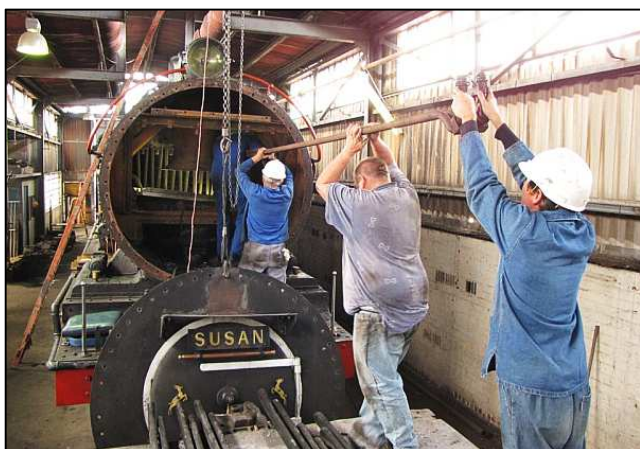
P101 - Teamwork – today it takes four fellows to slide replacement superheaters element into the 12AR's boiler flues, as there was nothing available for them to brace themselves against. The two steam-heads in the foreground are standing on the works flat wagon.

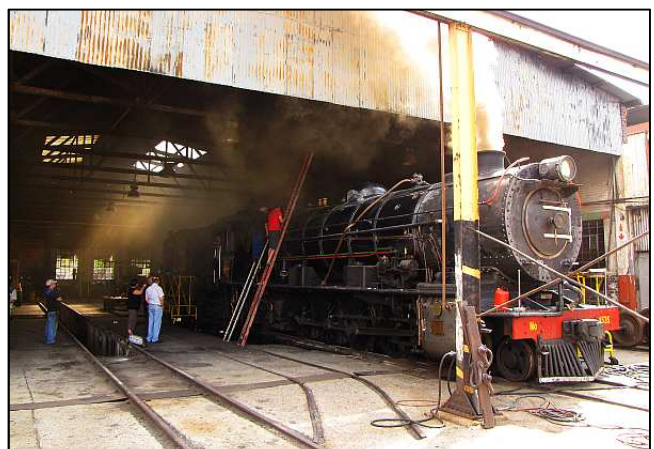
P102 - Although the Top Shed is usually used for locos in steam, the live steam boiler tests are usually performed in the 15M shed area. This is the 12AR undergoing boiler testing in March 2013 – she was still building up pressure at this point prior to setting the safety valves.

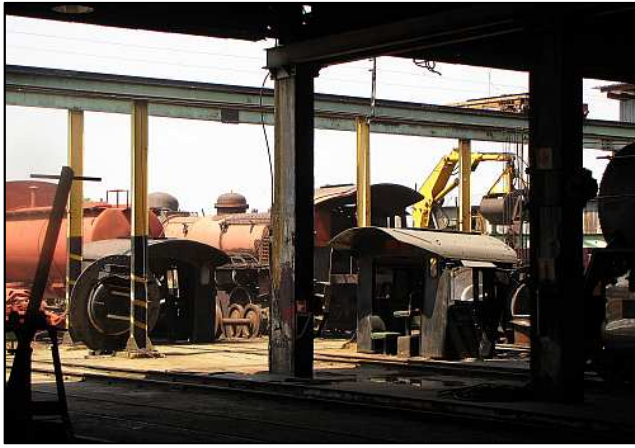
P103 - A weak point in the 15M shed operation is the lack of storage space as it was never intended to have several long term projects in storage at once and with big components all within necessary reach of the gantry crane. The 15M yard can get a bit cluttered sometimes.

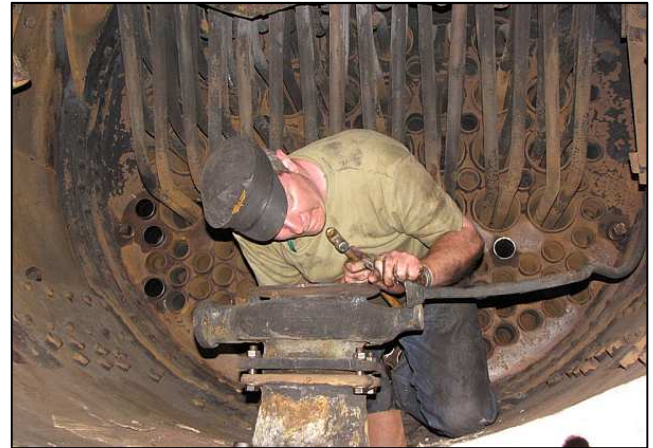
P104 - Not all the work is heavy duty. This fellow is gently cleaning gasket residue off the blower pipe flange and is taking care not to damage the mating surfaces.

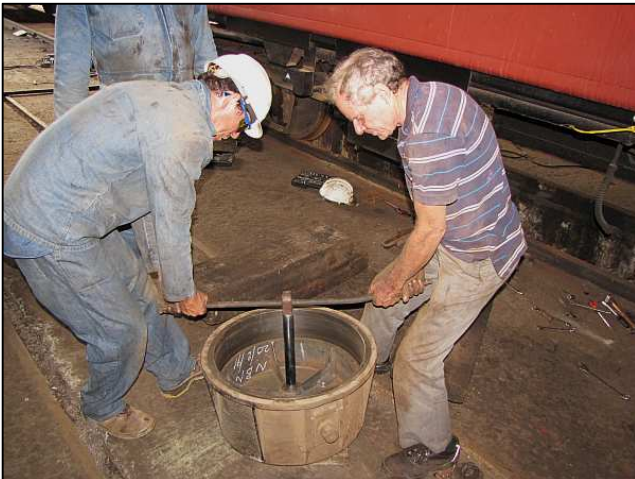
P105 - Although we do have a dedicated coach repair track, it tends to be used for lighter-duty interior fittings, electrical and cosmetics work. Mechanical coach work, such as the repair of the vacuum brake cylinders shown here, are performed in the 15M shop for access to tools and equipment.

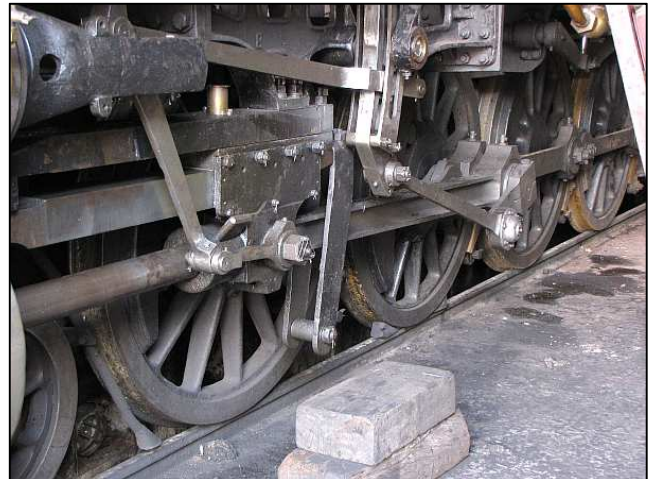
P106 - Reefsteamers is a pioneer in using Vesconite bushes in steam locomotive rodding, even when the railways said it would not work. Vesconite is a synthetic self-lubricating material that is tolerant of dry running. It has been so successful that it is now the Reefsteamers standard to replace all valve gear bushes with Vesconite when the original bronze bushes become worn.

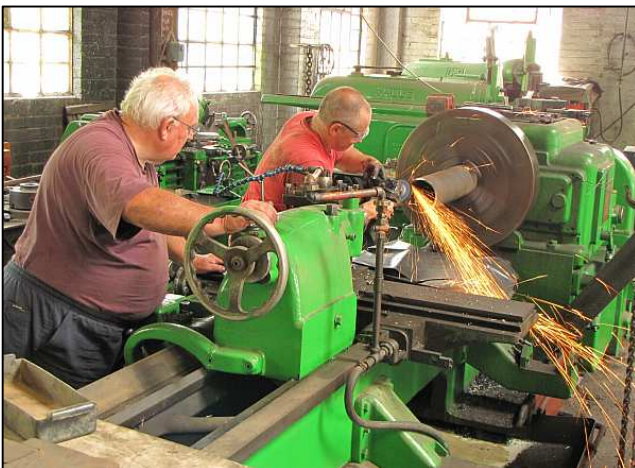
P107 - Making a plan. A genuine ex-Millsite Fitter is using a handheld angle grinder to dress the chamfers on a new steam downpipe being spun in the big Dean Smith lathe.

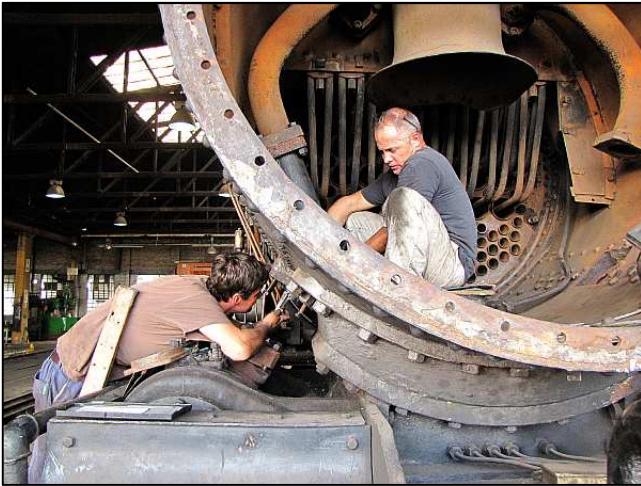
P109 - Locomotive work requires team work, even when the role players cannot actually see each other. They are lining up a tacked-together steam pipe for final measurements before welding – a job made challenging as the pipe bends in two planes.

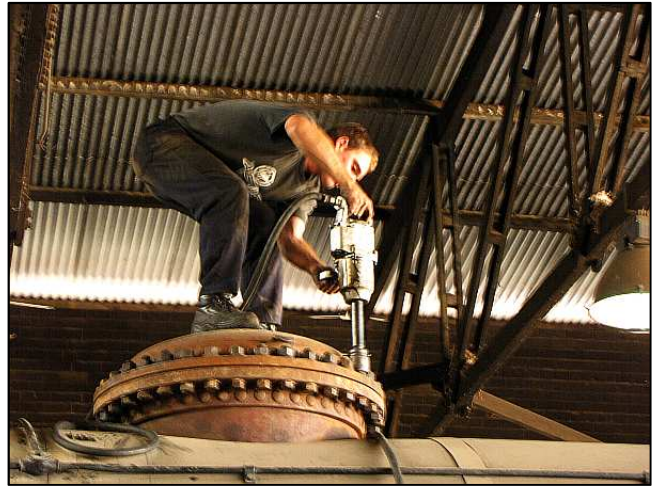
P110 - It helps to not have a fear of heights when in the 15M shops! Perched up on high, Jeandre is going around the 12AR's exposed steam dome with a pneumatic socket driver after the dome's copper sealing ring was found to be weeping during a hydrostatic boiler test.

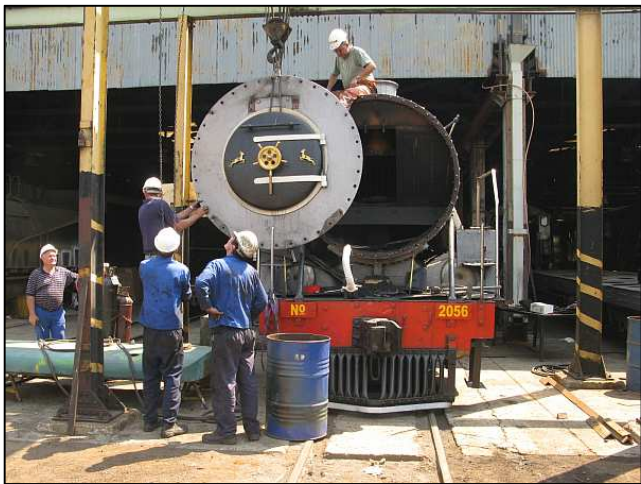
P111 - Here is the traversing crane in use to take the front plate off the 15CA locomotive to start the process of investigating a failed flue. Although the hoist is operated by a pneumatic motor, it is traversed by manual chain drive.

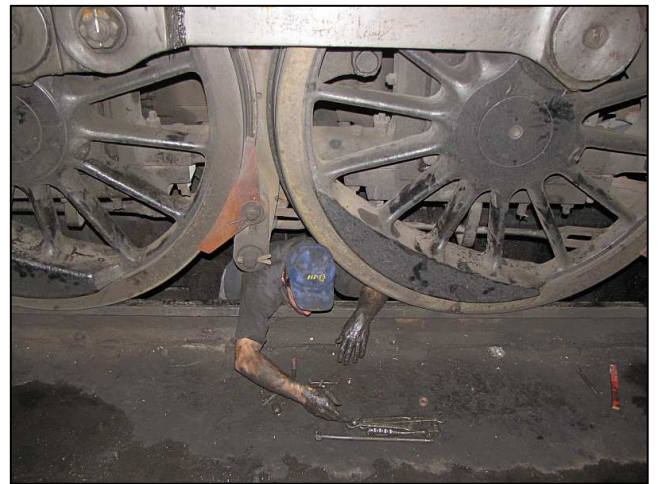
P112 - Work sometimes has to be performed between the frames and the wheels, which is usually a greasy job for the stout of heart and slim of build. Every bay on the 15M workshop has a work pit.

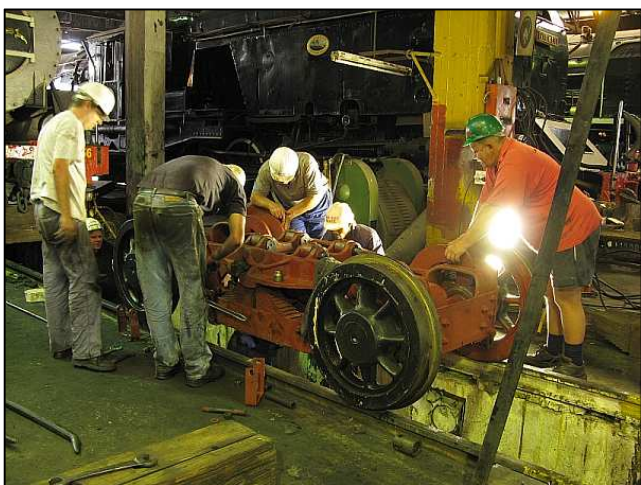
P113 - The depot gang can be seen overhauling the surprisingly complicated front bogie of a locomotive.

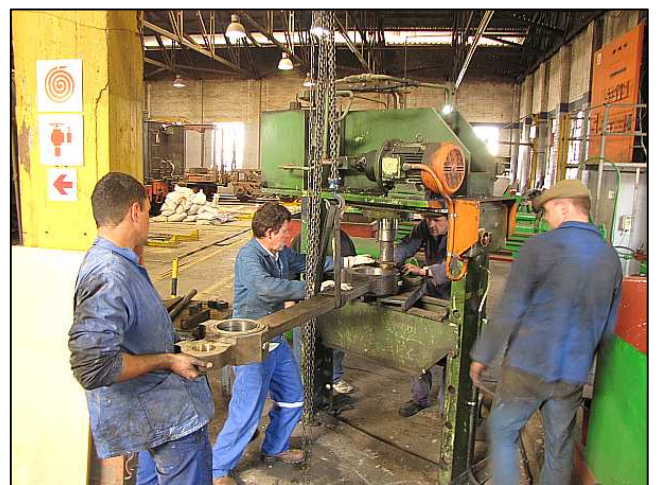
P114 - Locomotive parts are heavy! This team is busy pressing in bronze bushings into a replacement coupling rod, using the hydraulic press. It is taking two fellows to guide the rod even though it is suspended from a hoist.

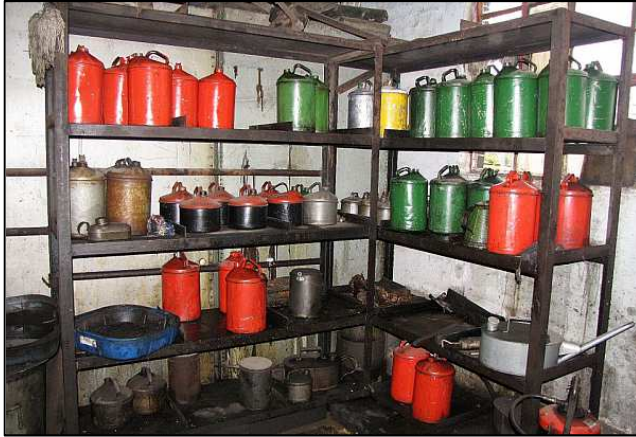
P115 - Challenge – Lubrication. Steam locomotive require quite a variety of expensive greases and oils to operate. This is a view of the oil racks with MH Oil (Red), Steam Oil (Green) and the shorter paraffin cans. The steam cylinder oil is actually tallow-based and has to be pre-ordered.

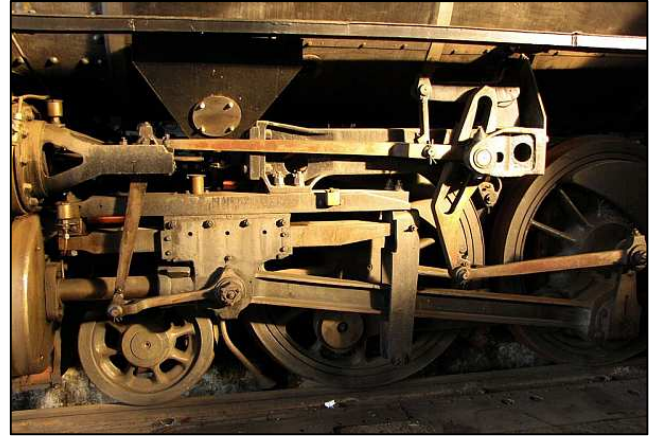
P116 - Challenge – Lubrication. This is where a lot of those greases and oils end up – the exposed bearings and crossheads slides of a steam locomotive’s valve gear are a ‘total loss’ system. Pictured here is the Walshaerts valve gear of the staged Class 15CA locomotive.

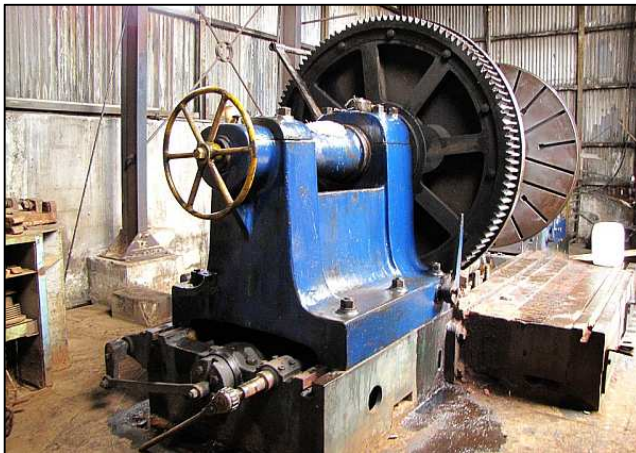
P117 - Challenge – Wheel Lathe. We are in the process of restoring this mighty machine which is able to clamp multiple ton locomotive axles and re-machine the wheel profiles. Not only would we be able to machine our own equipment, but can also take on paying work from other railway and industry-related bodies to earn revenue.

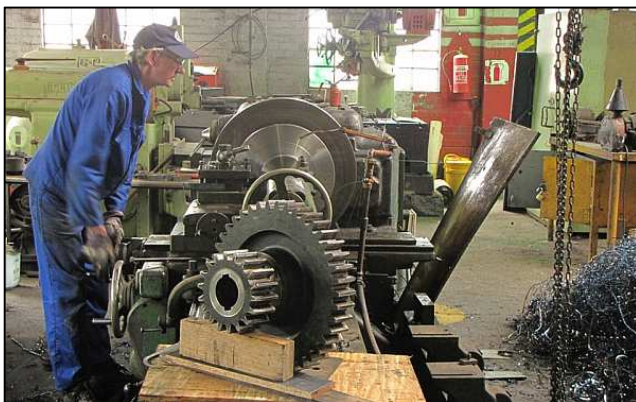
P119 - Challenge – Wheel Lathe. New gear blanks are seen in the process of being machined for the restoration of our wheel lathe, and by a genuine ex-railways machinist too! They were sent away for the cutting of the actual gear teeth. As of Feb 2014, the new gears have all been cut.

P120 - Challenge - Looking like a giant clockwork toy, the components of the wheel lathe’s tertiary gearbox are in place in their inverted housing. The gears had been newly made and the bearings relined, so the whole lot was test-assembled to check for free running. It would need to be stripped again to send the gears for case hardening.

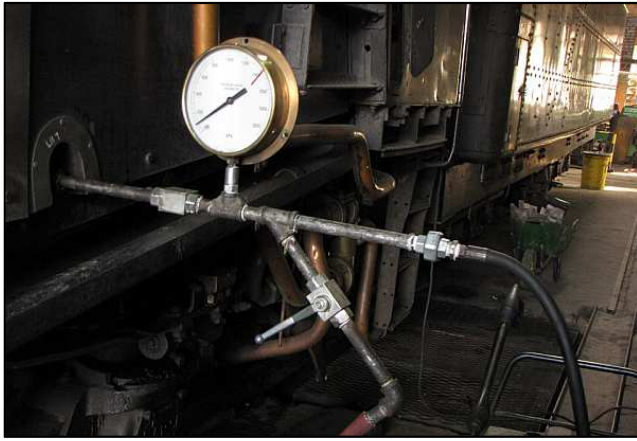
P121 - One of the heart breakers of South African Steam preservation is the mandatory three year boiler ticket, without which a locomotive cannot be fired up. Here you can see a test injection gauge connected to a class 15F's boiler. The cold boiler is pumped up with water and pressurized to 125% working pressure to check for leaks.

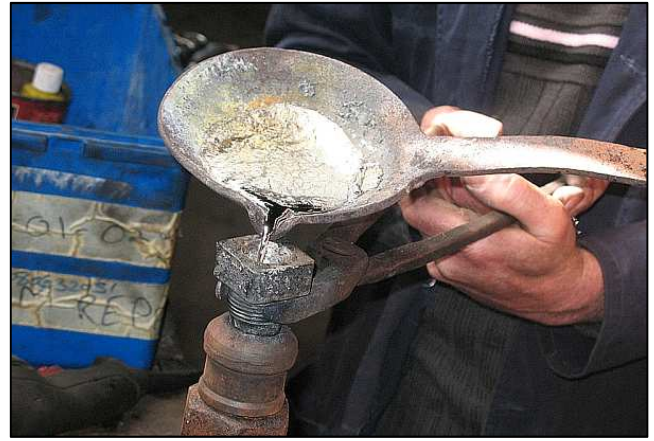
P122 - Before a locomotive is steam tested, the various fusible plugs in the firebox all need to be removed, stripped, cleaned and then their heads re-cast into a hemispherical mould with the correct grade of molten lead. This has to be done by a certified person and the individual plugs need to be date stamped and recorded in the locomotive's log book.

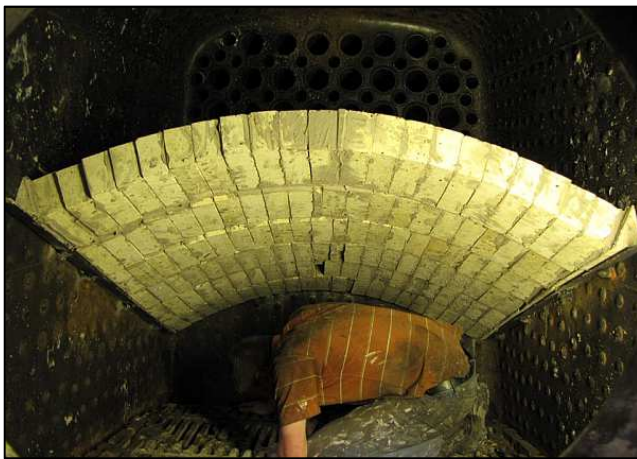
P123 - There is masonry work on a steam locomotive too! This is a brand new fire arch within the firebox of the Class 12AR locomotive. The arch is built from specially angled refractory bricks and cemented together with a special heat resistant mortar. Baked by the locomotive's fire, the bricks and mortar eventually fuse into one solid mass.

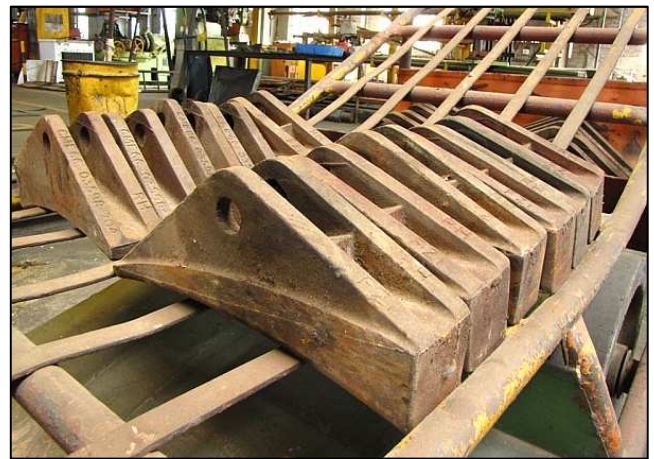
P124 - There is no such thing as popping down to your local Midas franchise to buy spare parts for your locomotive! Parts have to be scrounged, repaired, modified or re-made to fit. This is a trolley load of spare cast iron brake shoes intended for a Class 24 locomotive – some of which would be modified to fit the GMA/M Garratt.

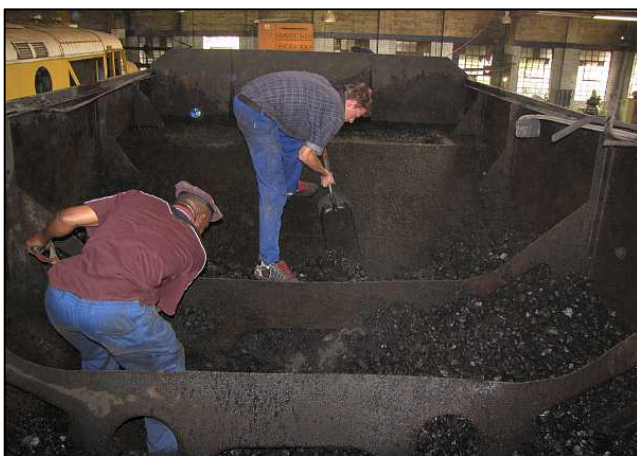
P125 - Unlike diesel which can be pumped with ease, coal has to be mechanically handled – one of the subtle reasons why steam traction is no longer used. Two members are 'trimming' unused coal forward in the Class 25NC's tender, so it can be reached from the cab to light up the fire.

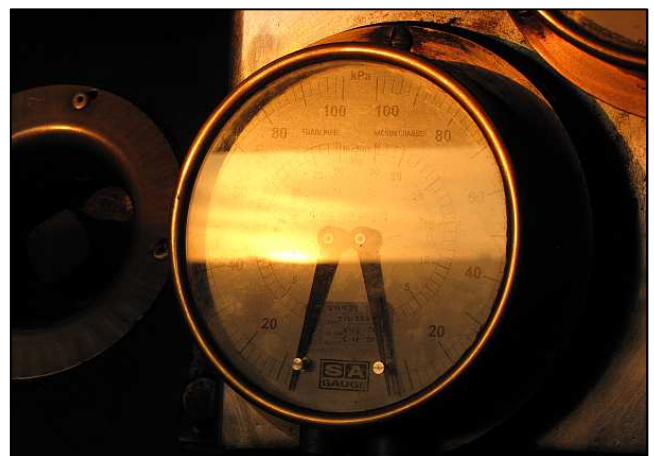
P126 - Not all locomotive work is brutal or dirty. The various relatively delicate pressure gauges, and the vacuum gauges for the brake system, have to be recalibrated and certified at regular intervals. Seen at sunrise on a tour is a classic duplex vacuum brake gauge.

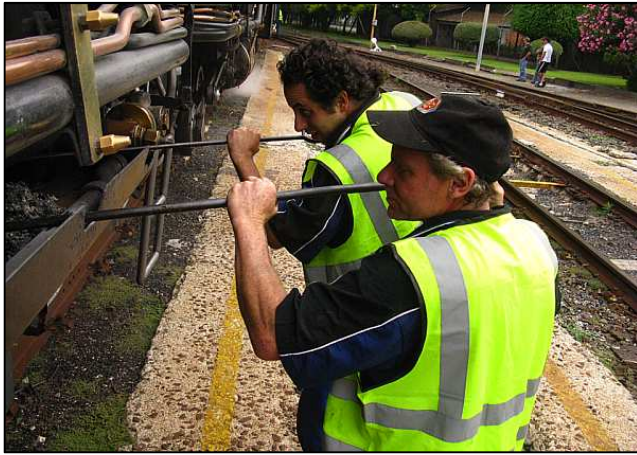
P133 - It takes teamwork to keep these often cantankerous machines going. Two of our Reefsteamers are incidentally moving in perfect synchronization as they strive to break up a HUGE chunk of clinker blocking the 25NC's ash pan.

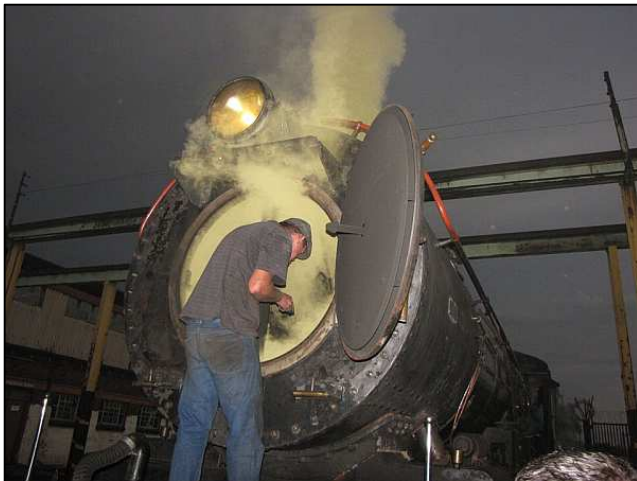
P135 - Things don't always go right! This 12AR locomotive had just undergone a steam test but the blower was not working, and thus the fire couldn't be drawn-up bright. We are treated to an unusual view of a smokebox door being opened on a live boiler while the fault is being looked for. (It was simply a flange that hadn't been bolted properly.)

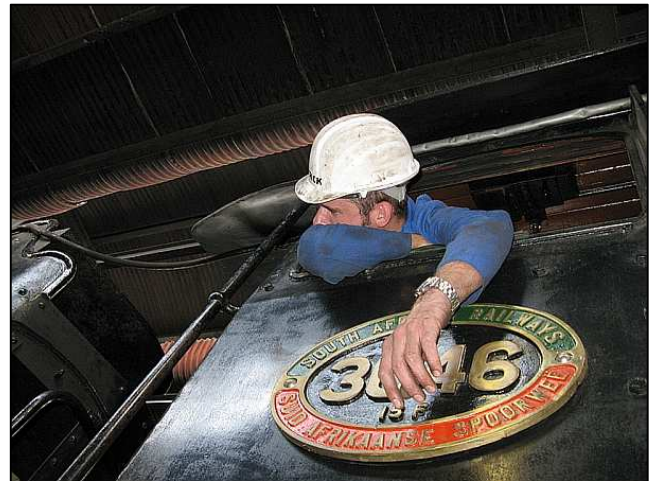
P136 - It can be hard work working on these beasts and they can even wear out the fit athletic youngsters, like this fellow. He has just plain had enough after battling with a vacuum brake ejector that had been changed out after a day's struggle and the replacement had another fault which they could not diagnose at that time.

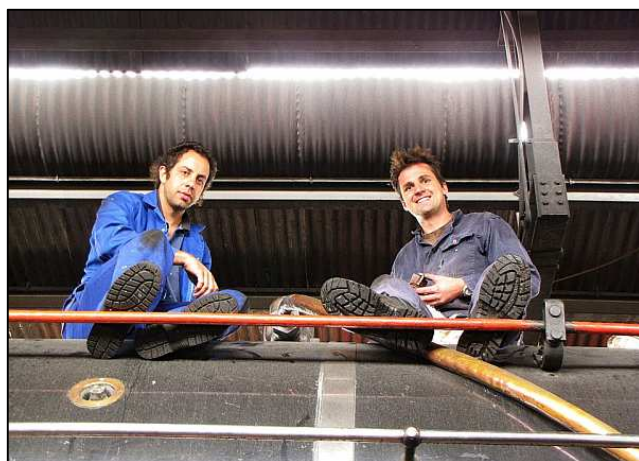
P142 - And you also get them way up on top as well! Andreas (Left) and Dawie are busy inspecting and lapping in one of the boiler's clack valves which has been leaking. They are actually resting their big feet on the regulator rods.

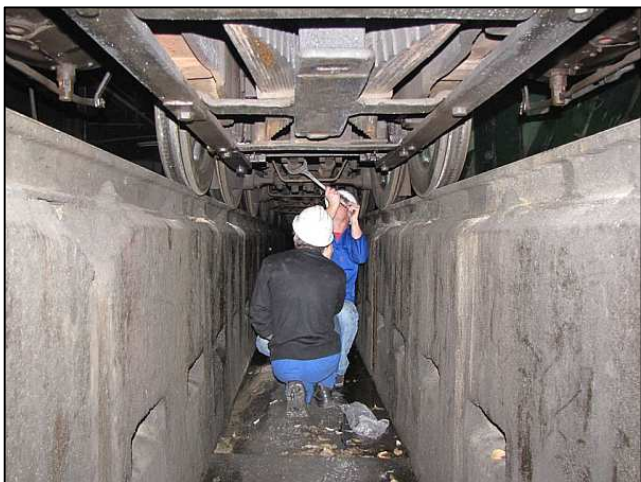
P143 - You get them underneath! Here, a locomotive's brake pull rods are being tightened up to eliminate excess clearance between the brake shoes and the wheels. This is a frequent task in preparing and road-worthying a locomotive for a day's run.

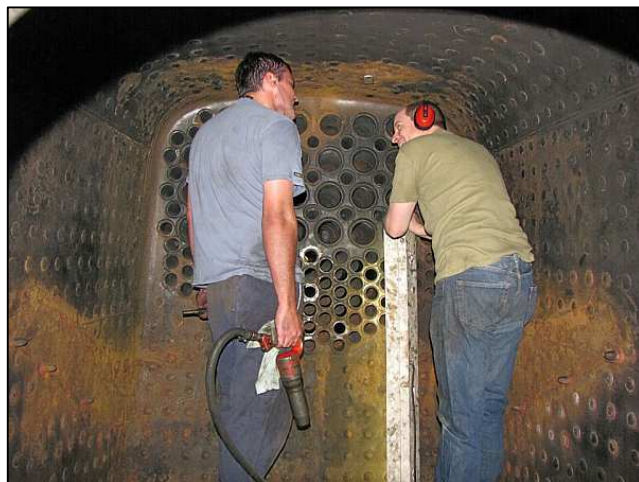
P144 - ...And you get them inside. Two fellows chat in the narrow firebox of the 12AR. Philipp Maurer, on the right, had literally just flown in from Switzerland and gotten off the aeroplane two hours earlier. Only a true steam freak would understand...

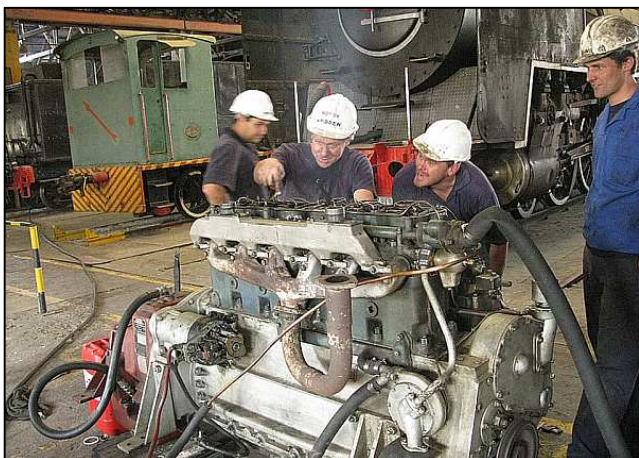
P147 - A certain grumpy Yorkshireman (Center) looks pleased for a change as the diesel shunter's engine is running as a bench-test on the second try. (The starter motor failed the first time round.) He is happily explaining the need to tighten up the valve clearances to the STEAM boys who aren't familiar with internal combustion engines.

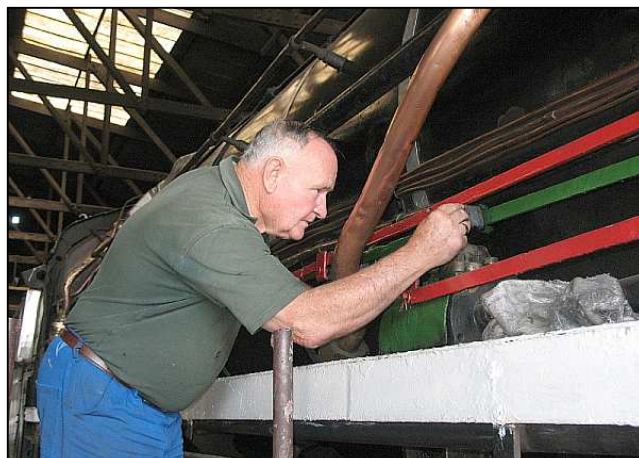
P148 - We usually have gentle work available for the old lads who are getting a bit creaky at their hinges. Oom Attie, currently South Africa's oldest certified steam driver at age 74, is seen quietly painting the green indicator rod for the powered-reversing gear and is staying out of mischief!

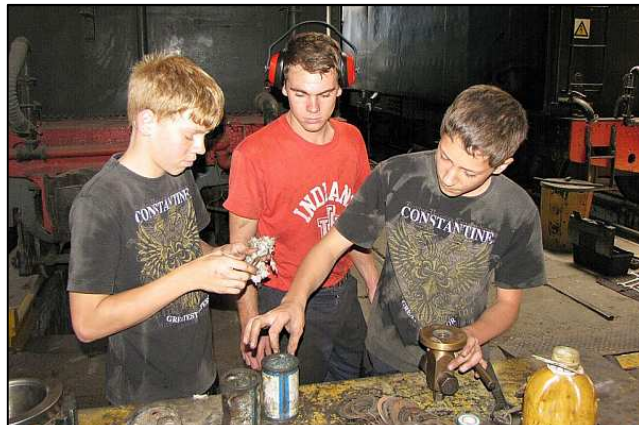
P152 - The younger people are allowed to do the less critical work on the locomotives too, obviously under supervision. The youngsters to the left and right of Jeandre are using grinding paste to lap in the brass sealing olives for water gauge cocks. Jeandre (center) is a full time staff member and is a 21st Century Apprentice Steam Fitter.

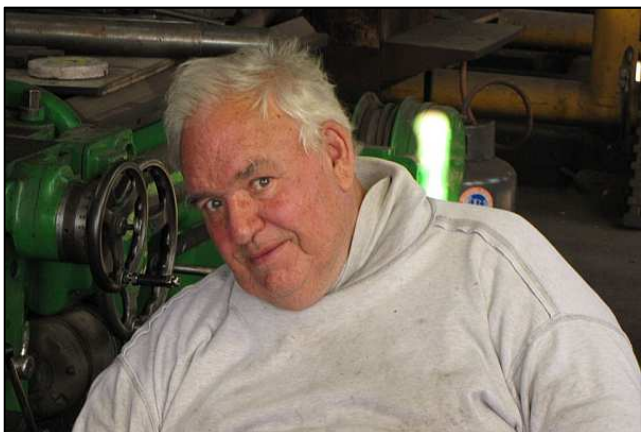
P153 - We keep the older boys busy too! James is fast approaching 70 and his days of clambering around locomotives are long over. We keep James busy in the machine shop as our senior machinist. In this winsome pose, you can see a glimpse of the naughty young rascal that he once was.

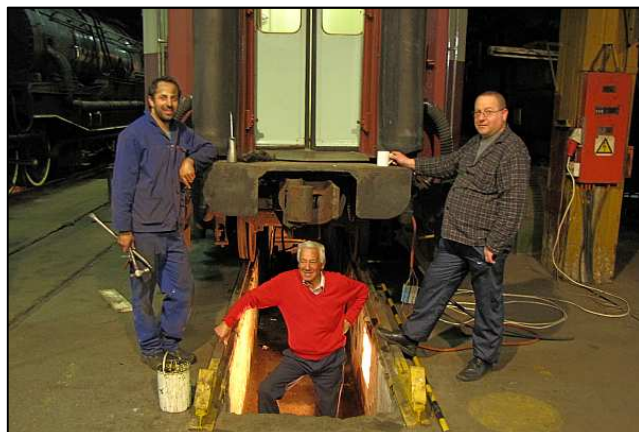
P154 - A railway family within our family. Andreas (L) and Michael (R) stand on either side of their father. Clifford, after 'lifting' a coach to check the undercarriage and brakes. Cliffie is our resident Carriage and Wagon expert. Andreas is a signal & comms technician, while Michael drives electric locomotives for TFR. And they all love steam!

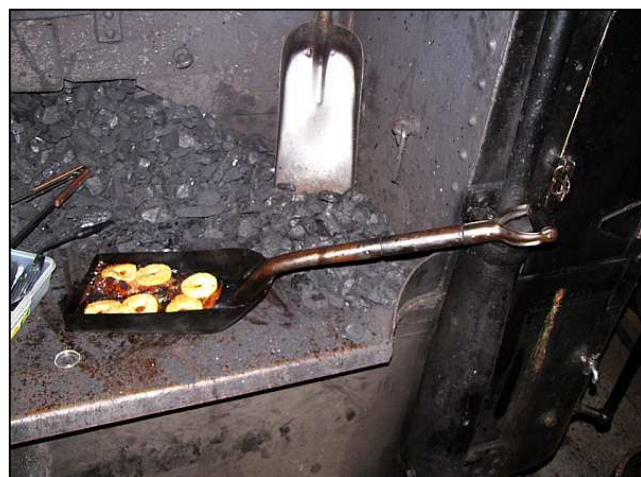
P160 - Most of the fellows cook on a plain coal shovel which has been thoroughly cleaned – but there is always a danger that the food might just slide off the open end. This coal shovel has been converted into a frying pan and it is being used to cook peppered pork steaks and pineapple rings on a loco minding shift.
