P01 - Justifiably proud of his work, our Senior Machinist James Thomson has been making some great progress on cleaning and restoring the two tool stands for the wheel lathe project. The tool stand on the right is very near completion in this picture.

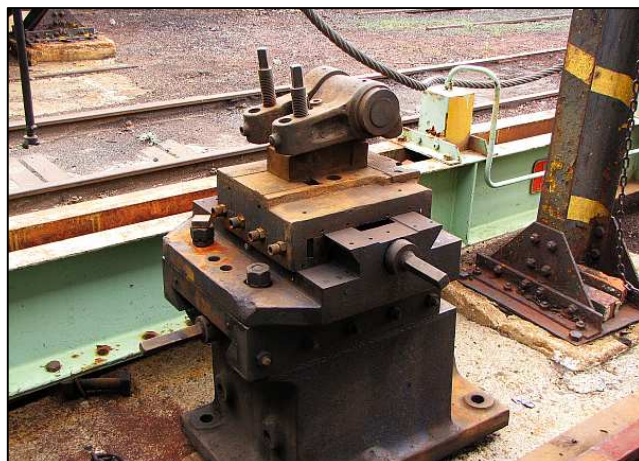
P02 - This is what the tool stands looked like when they were first removed from the wheel lathe house. They were rusty and worn, and their slides grooved with shavings. But thanks to their loose clearances, they hadn't seized up. They had suffered the same neglect and abuse that the lathe's gearboxes had been and they were exposed to rain.

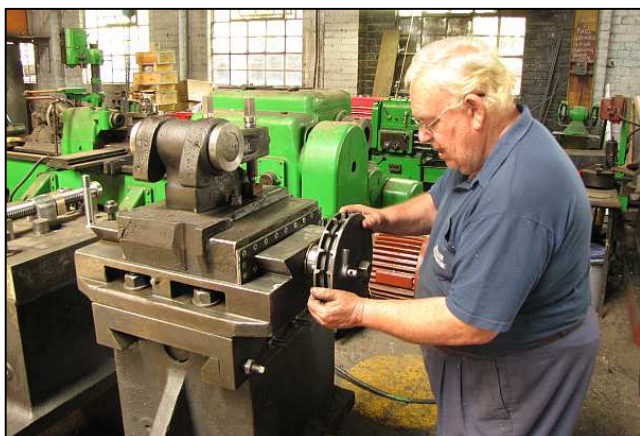
P03 - James demonstrates the one-way action of the restored chain-driven ratchet that performs the incremental traversing of the tool head while the lathe is in operation. We discovered that the pawls are engaged via weights.

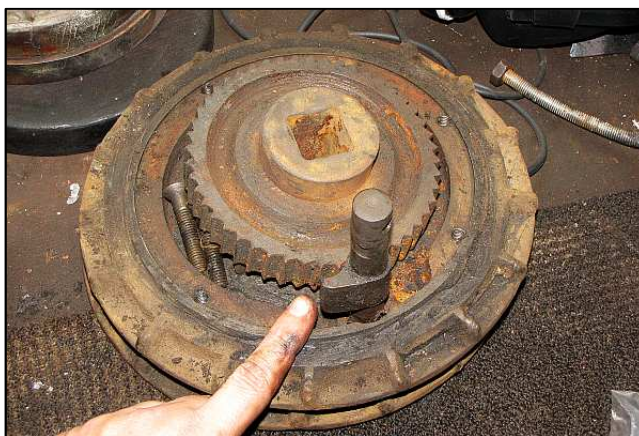
P04 - Here is the interior of one of the ratchet drives after a rough initial cleaning and you can clearly see the pawl. We could only find one of these at first, but fortunately the second one was found when cleaning out the lathe house.

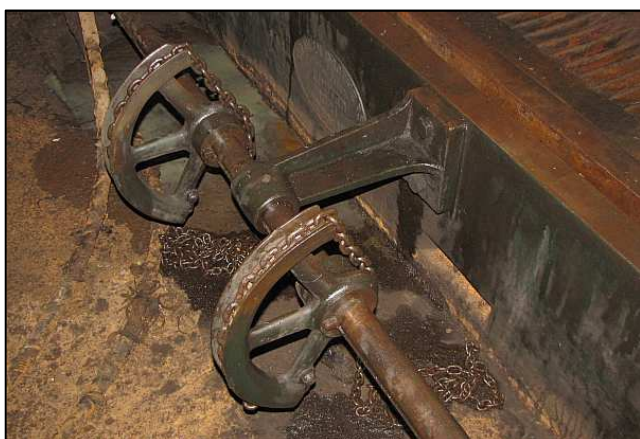
P05 - These are the cleaned rocking quadrants that drive the two oscillating chains which provide an intermittent feed to the two ratchet clutches. This means the tool tower feed screws can be driven no matter how much they are moved towards the center line of the lathe. (e.g. : To turn wagon axles instead of locomotive axles.)

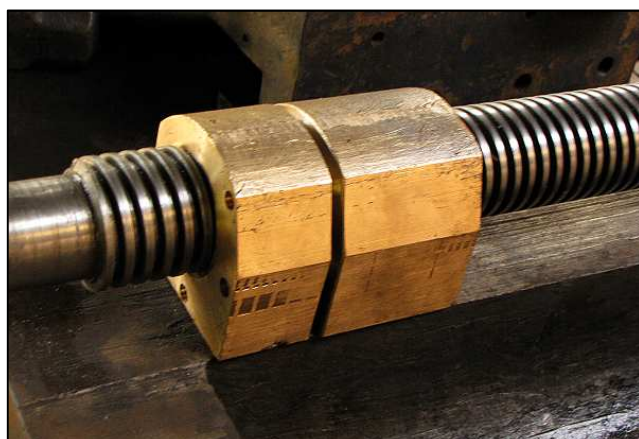
P06 - The worn die blocks for the traversing tables on both of the tool stands have had matching threaded extensions added to eliminate the free play. The existing blocks were kept as they have indents that engage with drive noggins for the tables.

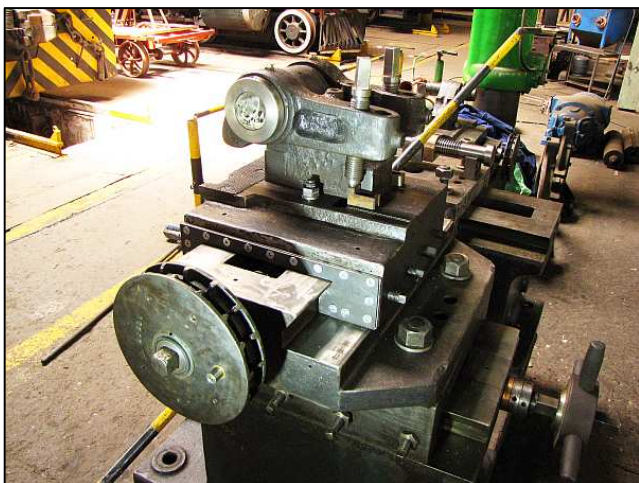
P07 - This floodlit view shows a James modification. He has fitted close-fitting hard steel scraper plates to the tool table to help remove the shavings. On both stands, the existing slides were badly scored from unclean operation.

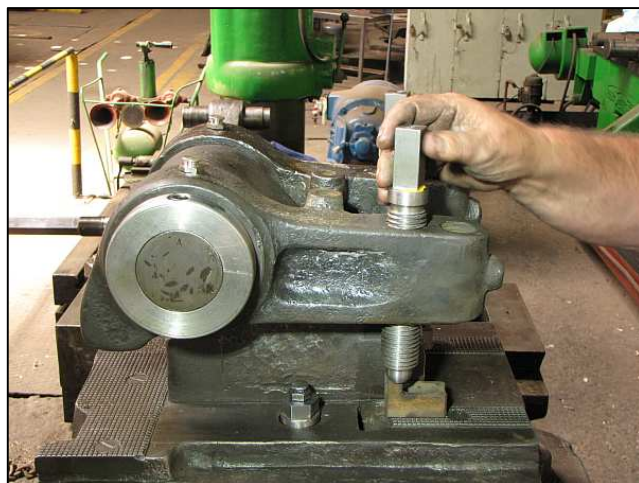
P08 - The pivoting tool heads have been refitted with brand new tangent bolts, which are used to tilt the actual cutting tools.

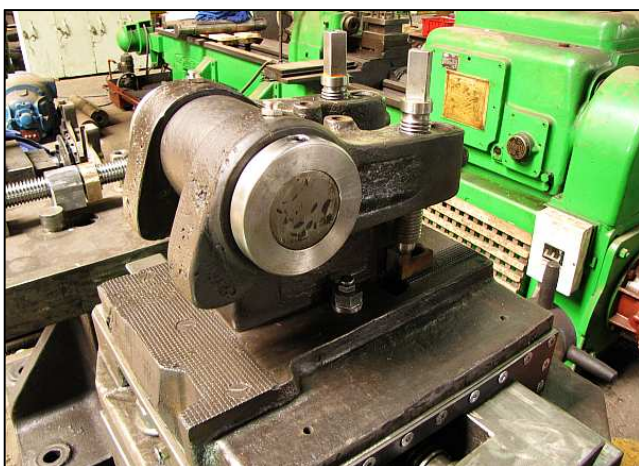
P09 - James has also been drilling, tapping and fitting new grease nipples in strategic locations. Although the tool stands were blatantly neglected, they weren't designed with easy lubrication in mind in the first place.

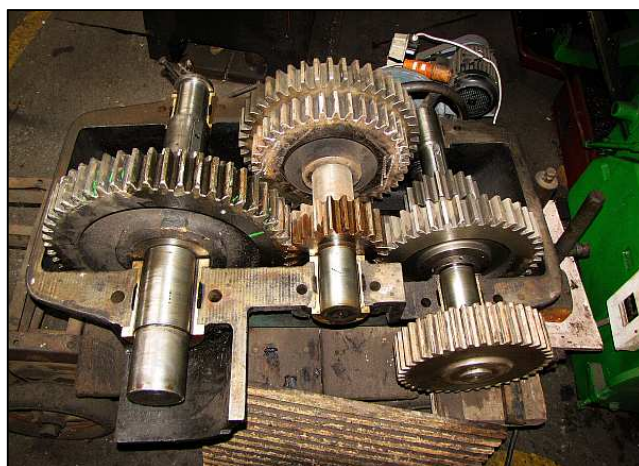
P10 - Both of the lathe's overhauled gearboxes have been test assembled and proven to be free-running in their new bearings. This, the tertiary gearbox, has had the existing worn bronze half-shell bearings all relined with Vesconite.

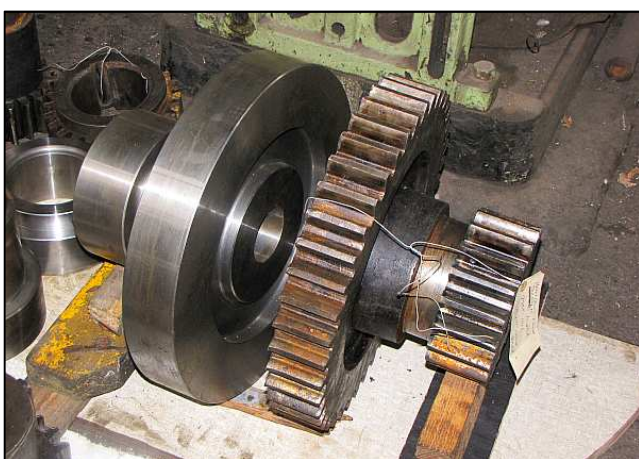
P11 - Each gear has been recreated from blanks (left) that were cut to the original pattern by Peter Labuscagne. Now the teeth have been cut and the gears test fitted, the individual gears need to be case hardened to 60 Rockwell to a depth of 1.5 – 2mm deep. It is estimated the job will cost about R8 000.

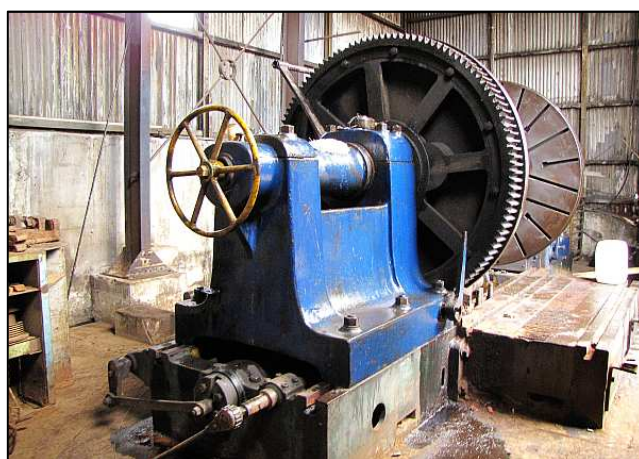
P12 - Lest we forget... here is a view of the wheel lathe itself. It is presently covered with a tarp and the door locked, so it is currently inaccessible. The remaining infrastructure work here will be the cleaning and safig of the motor's switch board – everything else is close on ready for installation.

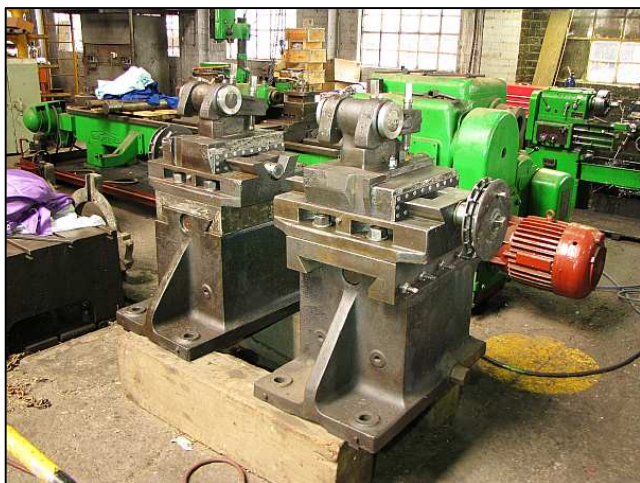
P13 - By the 2nd of March the second tool tower (left) had been reassembled and the new grease nipples finished. The last fabrication work will be a pair of spoked wheels to be slipped over the square shanks of the traverser shafts.

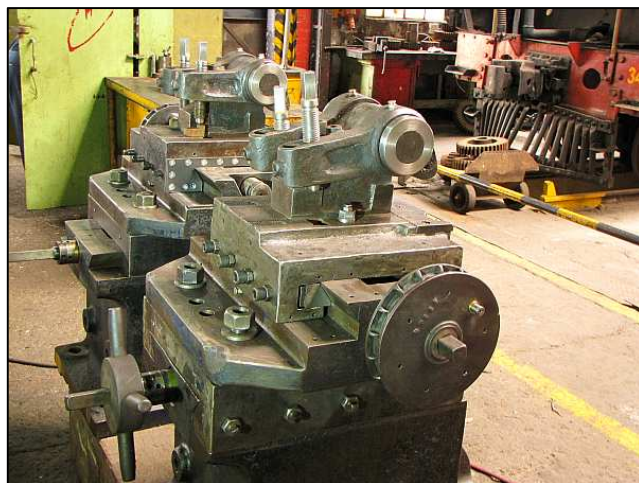
P14 - This view shows the adjustable tapered key that is used to adjust the clearances. The slides had to be machined. You will notice an extra spacer added behind the wedge. The spoked wheel is the last one surviving.

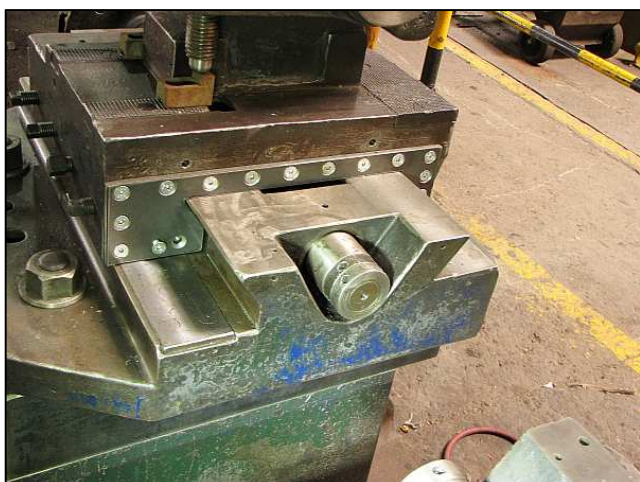
P15 - One of the new hard steel scraper plates in the process by being fitted – using countersunk allen key machine screws. Incidentally, you can also see that the tool carriers were once painted blue over a green base.

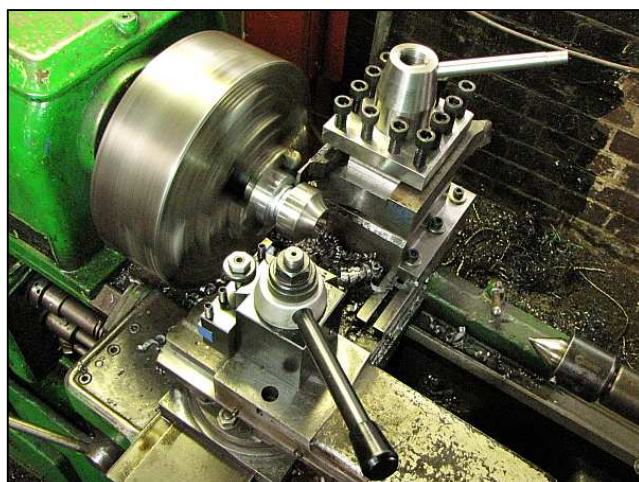
P16 - The jacking pads for the tangent bolts were originally machined double headed on circular stock. Here the two ends are being parted with a deep cut. The cut was too deep for the tool and had to be finished with a hack saw.

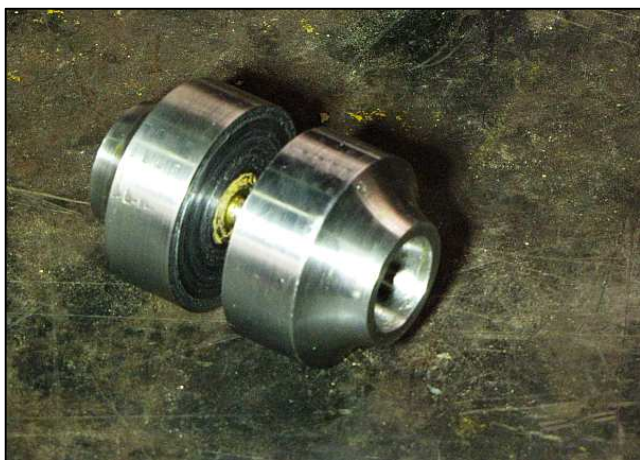
P17 - Looking like a weight lifting dumbbell, the assembly awaits final sawing to separate the two heads and then the bases to be re-machined flat again. You can see the hemispherical socket into which the tangent bolt will engage – almost like a pushrod into a tappet on an old car engine.

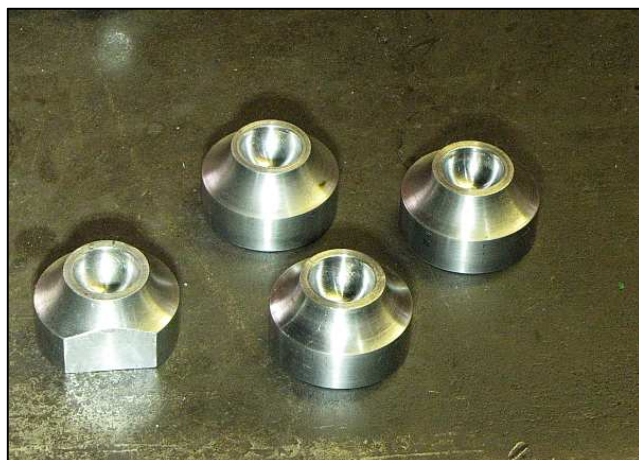
P18 - The leftmost pad has already had a 'flat' machined out as the diameter is too wide for installation. It was quite a sight to see that asymmetric shape whirling sideways in the lathe's chuck – but our James knows EXACTLY what he is doing!

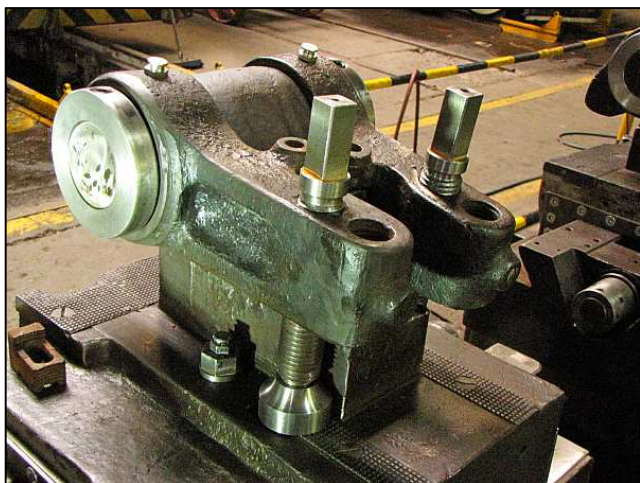
P19 - The jacking pad is fitted into a typical position, but it is free to move along the checker bar as the slant of the tangent bolts tilts when it is adjusted. (As that forces the whole radial mounting to rotate.) The whole assembly is held together under thrust while the wheel profiles are being cut, but is still accessible for adjustment. Although it looks primitive, it is actually quite a clever design.

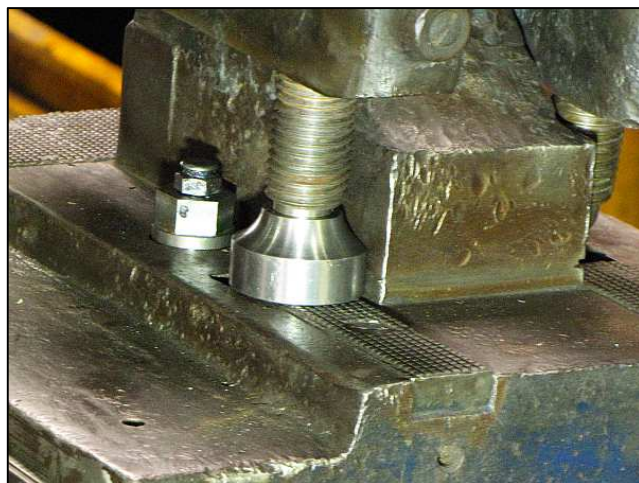
P20 - Here you see the improved design by James as the original bolts used to bear directly on pads laid on against the checker-bars. (We don't just fix locomotives, coaches and our machinery – we make them BETTER than new!) The cup will protect the hemispherical ends of those bolts, which provide a hinging action. The wider base will also spread the load as this assembly have to handle the thrust-reaction from the cutting operation.

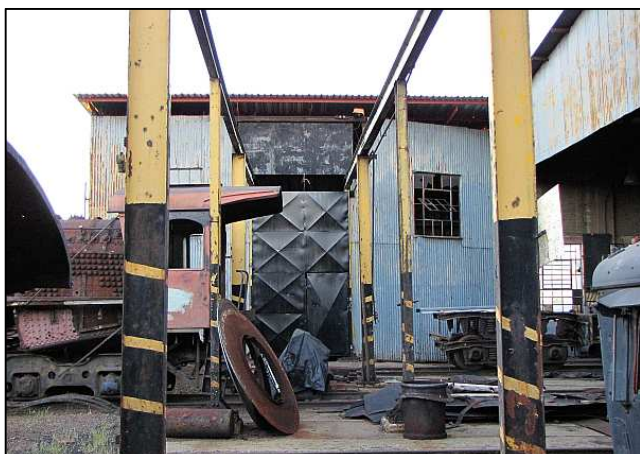
P21 - This view of the closed doors emphasises the original intended purpose of the gantry crane – to transfer locomotive axles to the wheel lathe for profile correction.

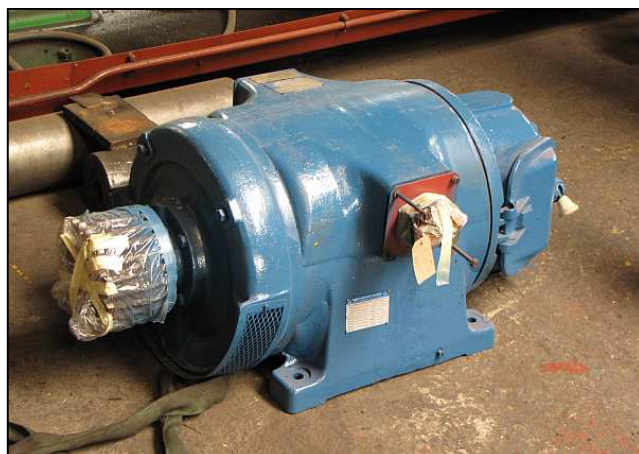
P22 - The rebuilt electric motor has since been relocated and is ready for installation.

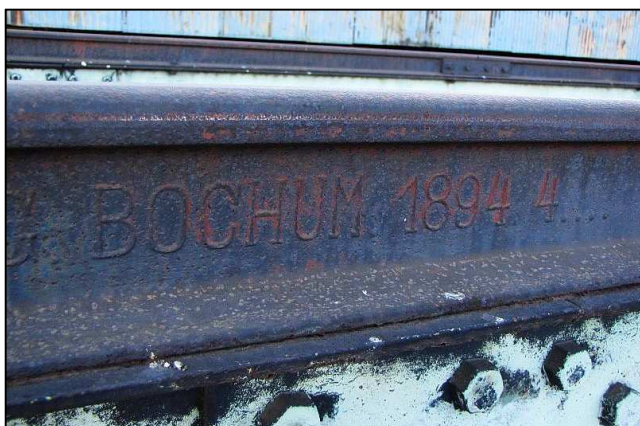
P23 - Possibly one of the oldest items we have on shed. The gantry crane's rails were rolled out in April 1894. I wonder in which main line they were originally used before they were removed and repurposed? Were they in a siding or secondary line before being used on the gantry crane?
