1). INTRODUCTION :

2). PROJECT - GMAM NO.4079 – BACKHEAD WASHOUT PLUG REMOVAL :

3). PROJECT - GMAM NO.4079 – BOILER WASHOUT PLUG REMOVAL :

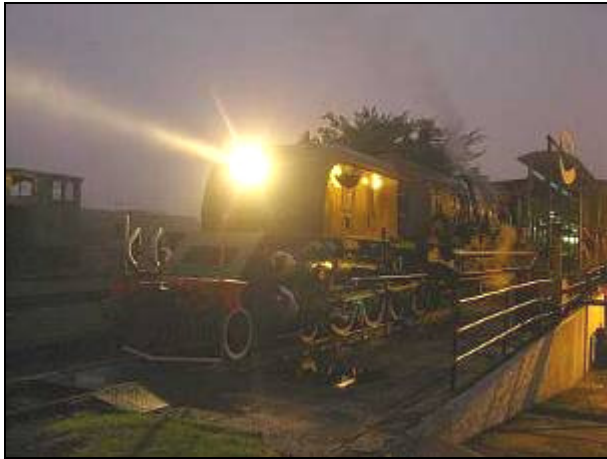
BH00 – It shouldn't be too long before the Big Green Hefelump is back in steamy action again. As expected, she gave us very little trouble during the boiler certification phase. There was just a little trouble with a leak at one of the clack valve seats.

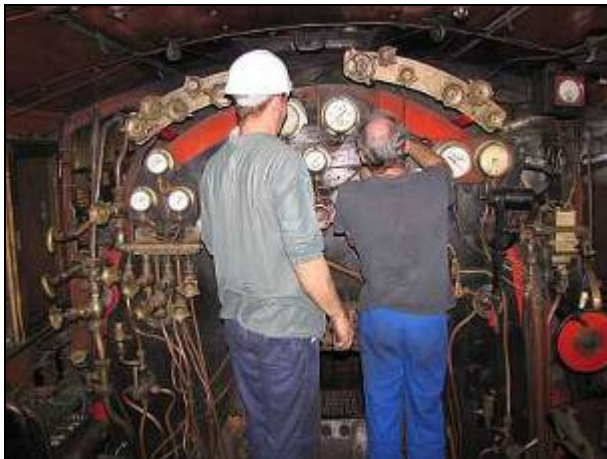
Although the boiler has passed the Hydraulic Test – standing for 30 minutes pumped creakingly full of water at 150% operating pressure without leaks, the test will not be signed off until some cracked tube beads are repaired. So we will be seeing some repair work done in the firebox anyway, not to mention the rebuilding of the fire arch.

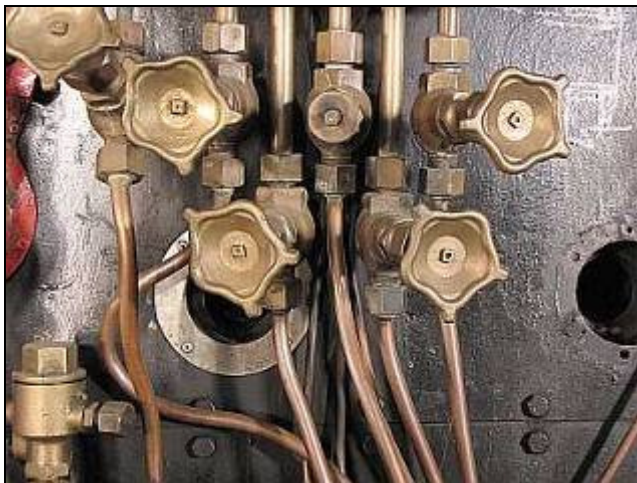
BH07 – Brilliant coordination in engineering and design. As happens on most mechanically stoked engines, the stoker jet valves or their pipes get in the way of the left-most arch-tube plug. Actually, this looks worse than it is because I centered the camera on the 'fine coal' valve. (Center).

The long plug sockets have narrow shafts so that obscured washout plug was actually removed without too much difficulty.

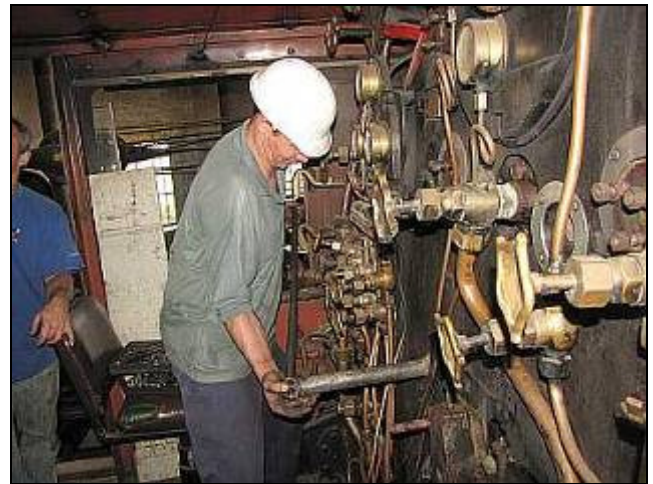
Here, Lucas tackles one of the washout plugs that open up into the water space between the firebox's inner rear wall and the boiler backhead. This particular washout plug also covers the upper end of one of the five arch tubes.

The long socket is necessary to gain clearance between the rod and the backhead fittings. Unfortunately, the long sockets tend to tip on the square heads as they aren't a perfect fit, and you easily go out of line holding the extra length – so it's easy to slip off, and skin your knuckles.

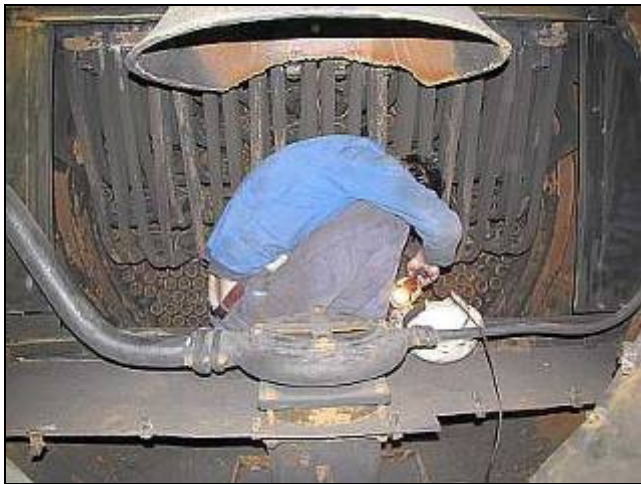
As you can see, the petticoat peeking in from overhead is suffering from a bit of char cutting. A typical petticoat is 7-11mm thick and so you see the remarkably abrasive effect of constant rubbing with high speed grits and char entrained and pulled through by the blast of the exhaust steam. T

he spark arrestors only stop the bigger and presumably hotter chunks, letting the little grits and glowing cinders through to die of fright as they get blasted up out of the chimney. But the little grits are still abrasive enough to do damage over time, even if they don't start line side fires.

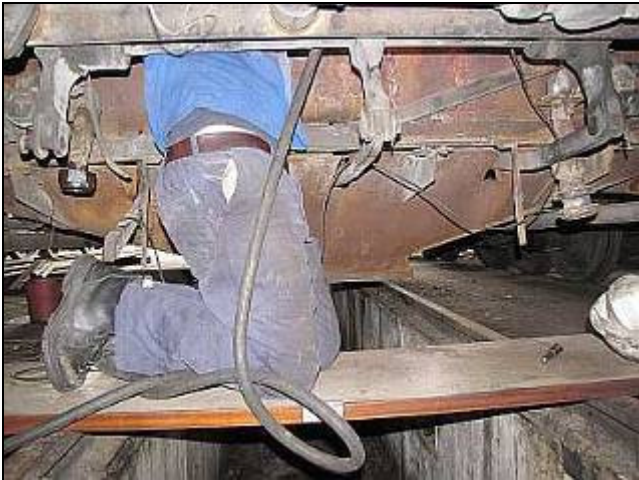
You can see by the rust and lime scale marks that this wrapper plate has been seeping for a while. As awkward as this position looks on the GMAM, a conventional locomotive has frames at that point which makes access very difficult indeed.

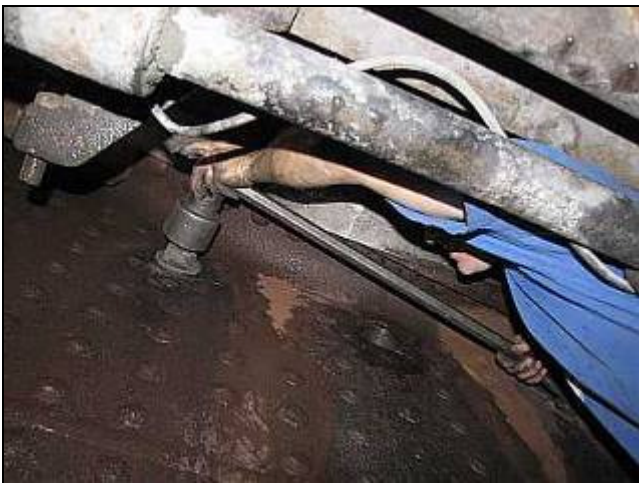
TW03 – It is a tedious job but the process is working – you can see the center plug is out already. Although Dawie Viljoen is no weakening himself, Michael Thiel is quite powerfully, but compactly built. This made him the perfect choice to apply torque in such a limited space.

The fact that the heads of all these plugs are square instead of hexagonal really does limit the number of positions that the tommy bar can be placed at. It leads to some interestingly awkward postures in tight spaces!

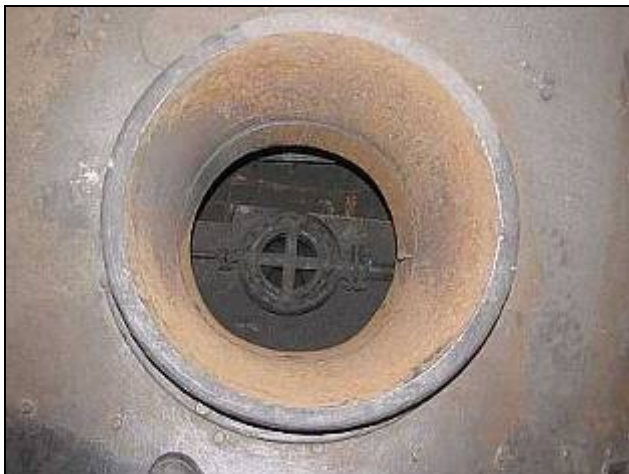
RG07 – A view right down the GMAM's chimney right onto the blower ring. The chimney is actually still wearing its petticoat, but because I have rocked backwards to centralize the camera flash, the shadow of the petticoat does not show.

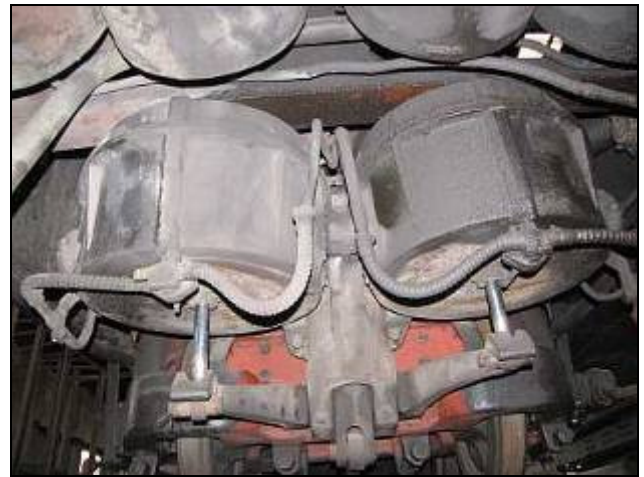
RG06 – The GMAM's 'nads'.

The space under the wheel-less boiler is used to good affect to house the brake system, including the unusual twin vacuum cylinder layout for the brakes. Because of the twin engine unit layout, there are 16 wheels that have to have brakes applied, as well as the need to overcome the frictional drag of the extra linkage between the central, suspended boiler and the two pivoting engine units.

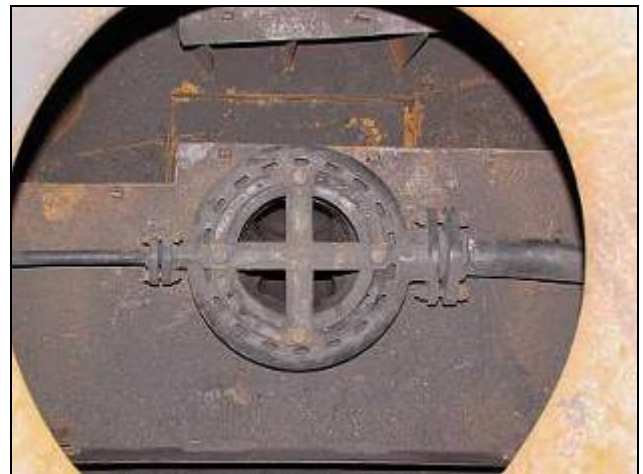
RG08 – This device that looks like a gas burner ring is the blower ring. It is basically a hollow doughnut with a ring of rectangular holes discharging steam upwards to create a fire-drawing vacuum in the smokebox. The thin pipe from the left is the high pressure line from the fireman's blower. The wider gauge pipe from the right is the lower pressure steam exhaust from the brake vacuum ejector.

Under the cross-like blast restrictor, the exhaust ports can be seen. Their fore-and aft arrangement is typical of Garratt locomotives, whereas a conventional locomotive has the holes oriented from side to side. The difference is because the cylinders of the GMAM (or any Garratt) are not directly under the smokebox – so their exhaust is piped from the front and the rear engine units.

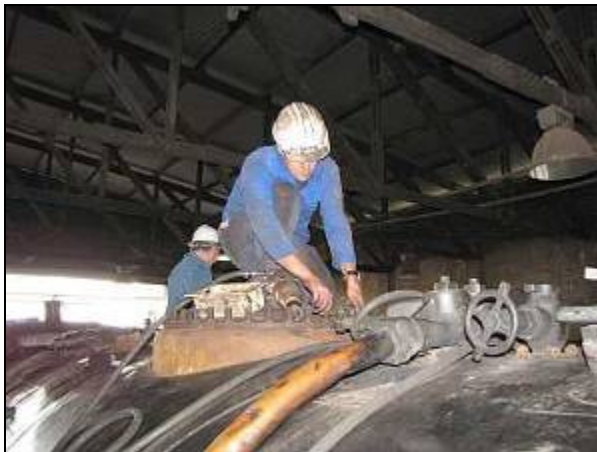
RG09 – Dawie Viljoen undoes the 36 dome cover nuts by hand after he's gone around with the air-wrench. In the foreground, the very low profile clack box and then the auxiliary, or vent valve, with the spoked wheel. This valve is used for venting air out the boiler when it is filled up in the shops. In the railways days, it was also used to pre-fill the boiler, usually with hot water cooked up in stationary boilers. This was done to save time in raising steam for service after the locomotive has been cold and under repairs or maintenance.

Like most of the later and larger SAR locomotives, the GMAM's 'dome' is actually more of a manhole cover. However, the GMAM's dry-pipe does pick up steam from the dome in the old fashioned way. (See pic RG12) The cover was removed to facilitate visual inspection of the boiler interior.

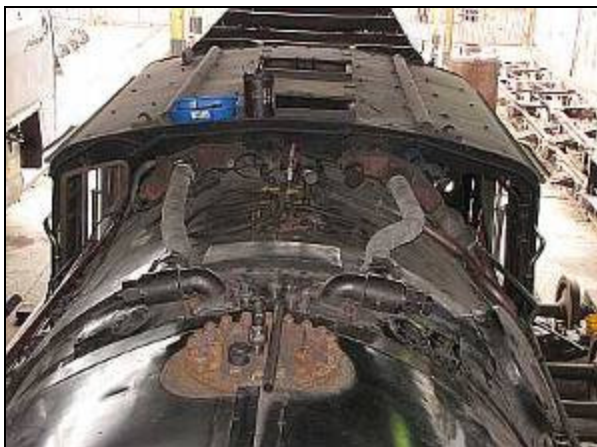
RG11 – The GMAM has an extra access cover just in front of the firebox – for access to the turret pickups and for viewing of the crown stays above the firebox.

The safety valves are still missing here, normally sitting where the three rear blanking plates are. The rear blanking plate also has a test venting and drain valve, the hose for which can be seen lying loose on the boiler. This small bore valve allows for a very gentle, controlled draining on a boiler that has been hydraulically pumped to above its rated operating pressure and as the boiler slowly relaxes – it initially displaces the drain water UPWARDS through that vent valve.

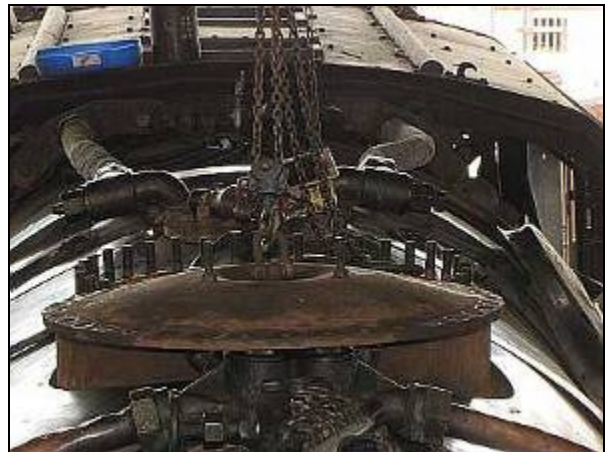
RG10 – Looking like a low-profile flying saucer, the dome cover has been removed and is hanging via the angled chain of the hoist, which is hanging from a roof beam and not a crawler.

In the foreground is the clack box.

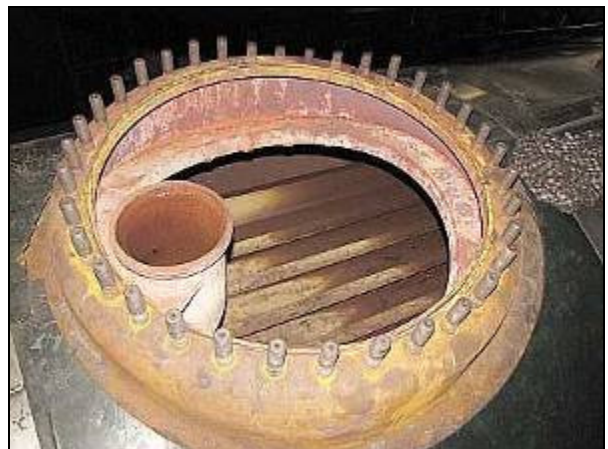
RG12 – Here's a view down the hatch – the front of the locomotive is to the left. The raised end of the 'dry pipe' is obvious. Ironically, the so called 'dry pipe' is full of standing water in this photo. This is the pipe that feeds steam to the regulator chest.

In normal operation, this dome and the 'dry pipe' is filled with steam, or merely air if the locomotive is cold. Water can get into the dry pipe via over filling or foaming. Mild water carry - over weakens the lubrication film in the steam chests, but also shocks the super heaters. A major water carry-over (a prime) locks up the pistons and motion as the water ingested in the cylinders is incompressible.

The copper sealing ring is still in place and this will need to be removed and re-annealed (softened) before it can be put back into service again.

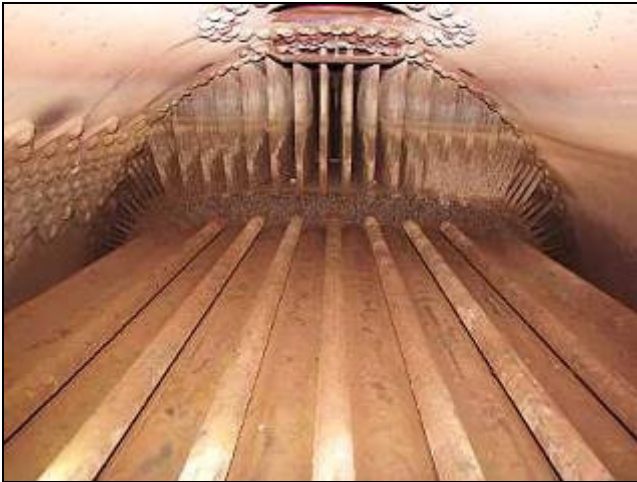
RG13 – A view inside the GMAM's boiler, looking back towards the firebox, the upper front corner of which appears in speckled grey. The splice plates are prominent to the left, where the edges of the rolled boiler plate were riveted together to form this 'course' of the boiler's barrel.

The rivets above are the flange rivets for the inspection hatch, beyond which is seen the fall-plate for the two independent turret inlets and the safety valves.

If you look carefully down the center two rows of stays, you can see daylight. That light is coming in through the cab, from the holes left by the three removed backhead washout plugs and the five removed arch-tube plugs.

The two shiny objects towards the front center of the firebox, spaced four vertical stays apart, are the still new and reflective cast lead domes of the fusible plugs.

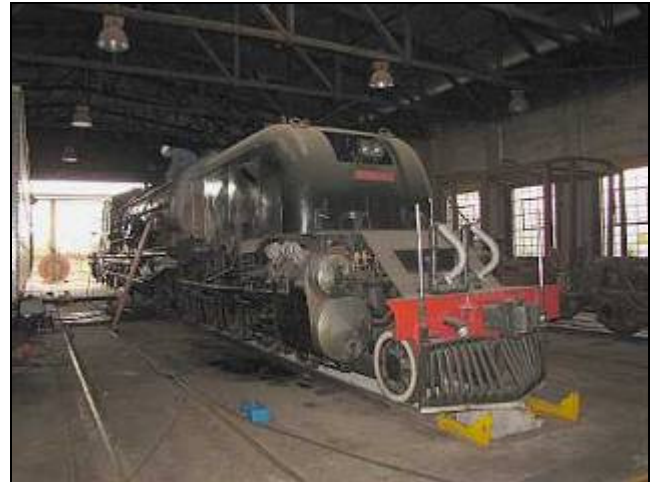
RG14 – Here is the beast in her 28 wheeled self and looking a bit embarrassed with a later of dust on her forehead. That is Aidan McCarthy working in the background.

That lubricator has been dripping oil. But the mechanically lubricated engines usually do mess their beds if stored after being operated.

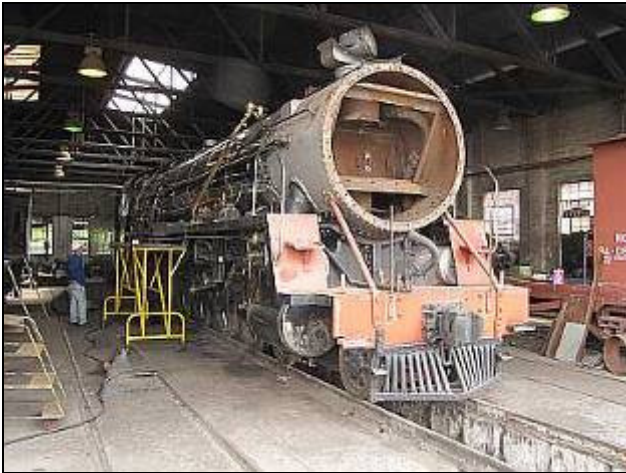
FW00 – Class 15F No.3046 in repose. Some simple finishing work was done today, but the locomotive is primarily waiting for a visual boiler inspection. Peter Labuscagne has claimed this track as his workshop, with all the scaffold trolleys and steps in this area. He has put the old grease store into use too.

Notice that the baffle plates have been reinserted into the smokebox and one of the handles has been re-fabricated and freshly welded on, hence the shiny ends. 'Lappies' is checking them for ease of fitting, as he did later the spark arrestors, although they will need to be removed again for access by the Boiler Inspector for the visual boiler inspection.

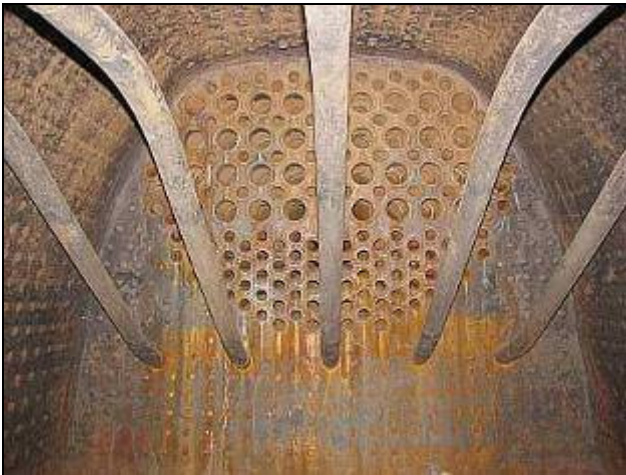
FW02 – Here's the wide Class 15F firebox, with the five arch tubes completely innocent of any fire arch. The fire grates are all in, although you can't see them here.

On this assembly, the fire arch is modular and goes on OVER the tubes so there is quite a lot of space underneath and the characteristically deep firebox of the Class 15F is obvious here.

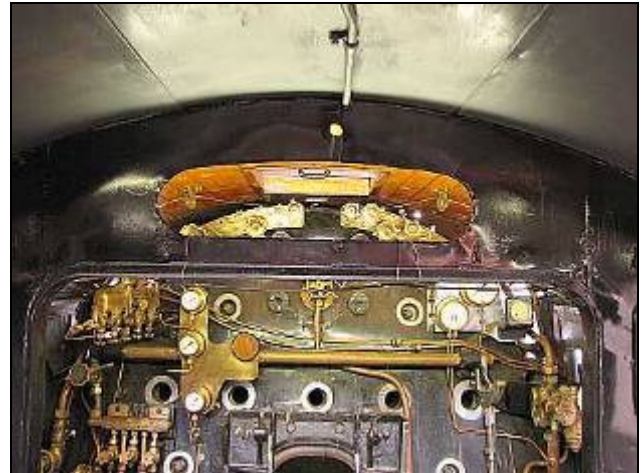
FW01 – The almost complete backhead for the 15F's boiler. The light from within is coming from a fluorescent work lamp unit wired to the cab's backplate cross member.

With the exception of the firebox door, the weighted latch and the flame plate and shelf assembly, the backhead is complete.

The five blank holes are where the washout plugs for the arch tubes have been removed to facilitate their cleaning and the visual inspection, which is the next step in the certification process. The blanking plates have been removed from the water column flanges too, but the rubber gaskets are still in place.

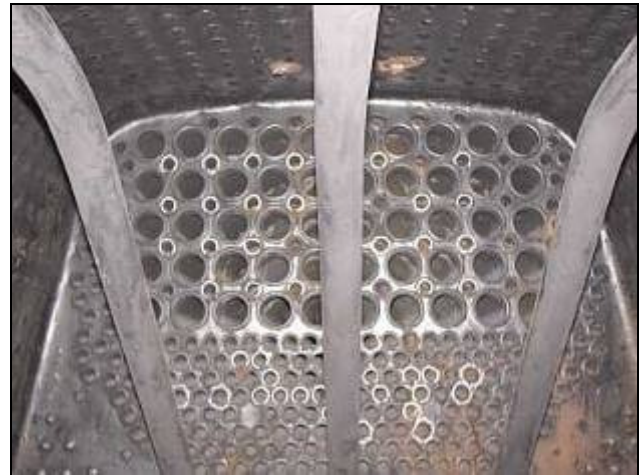
FW03 – By comparison, this is the firebox of Sandstone's GMAM Garratt No.4079. Notice the increased number of boiler tubes as well as the five rows of superheater flues opposed to the 15F's four. There are also boiler tubes staggered at the end of their rows and alongside the flues, to fit the maximum number of tubes within the boiler's circumference.

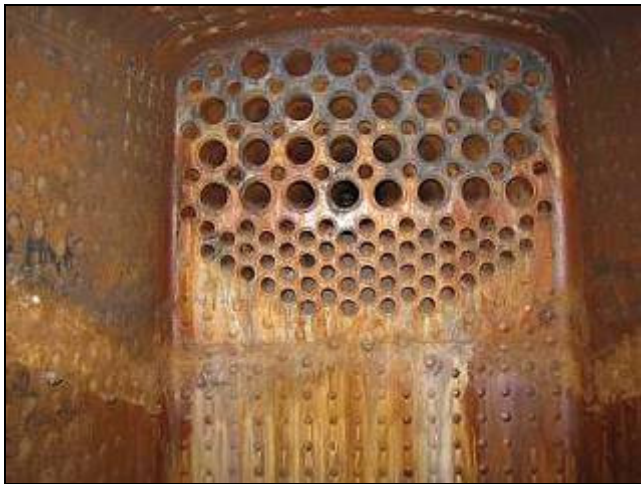
FW03 – And here, by comparison, is the much older firebox of the Class 12R No.1947 'Rosie.' This firebox is 37sq. ft – just over half the size of the 25NC. The old fashioned straight inner walls are obvious. In spite of the long period of disuse, the lighter band marks left by the sides of the long-ago fire arch are still visible. The mounting studs for the arch side rails are still there as well.

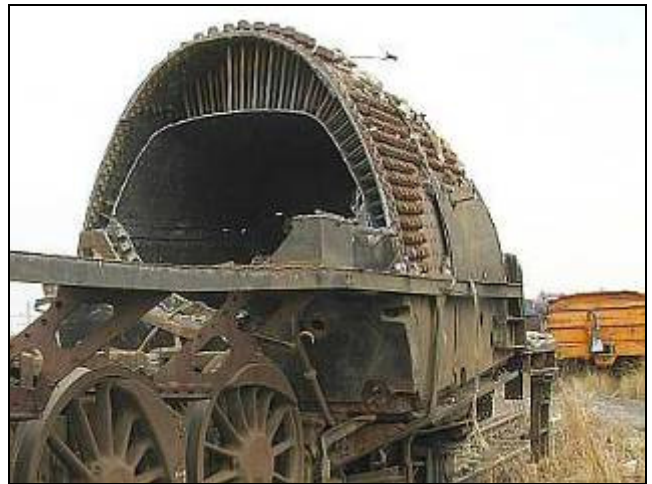
FW04 – A 15F locomotive as dead as ol' Granddad's hat band.

Here we see how the extra curved top corners of a 15F's firebox actually contribute to easier convection current flow to the arched steam raising space right above the crown sheet.

These are the remains of Class 15F No.3033 which was cut up by REKLAM next to the 15M workshop yard in August 2008.

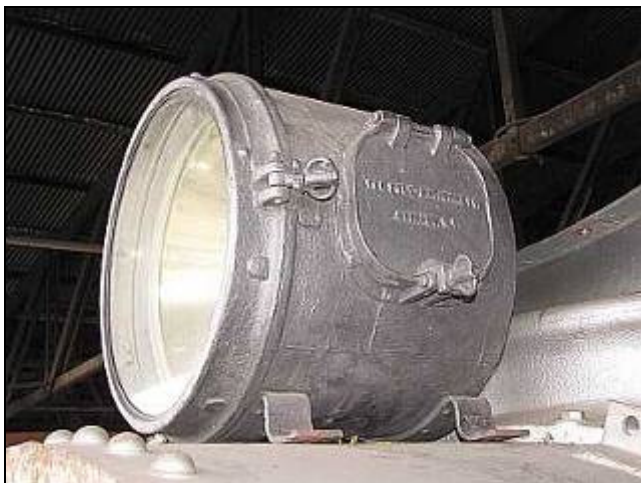
FW05 – Reefsteamers' practice is to backdate our locomotives to as-delivered state with single barrel headlamps. This rugged looking lamp was made by 'The Pyle National Company' of Chicago! So that's why this headlamp looks like it belongs on a piny backwoods Shay somewhere!

These are heavy fixtures but the locomotive forehead brackets on the 15F's were originally designed to take heavy lamp fixtures anyway. The disadvantage of these antique lamps is the potential exposure of the separate parabolic reflector to oxidation and rust, or mechanical damage through misguided attempt to clean them. The reflectors of the prosaic standardized double-bulb box lamps are protected from dirt and interference as the lamps themselves are sealed beams.

The silvery coloured smokebox and chimney is to be painted semi gloss black. There is to be no graphite paint to be used on this locomotive. The graphite paint doesn't last very long. It is slippery when dry and positively lethal when it is wet or has the slightest trace of oil on it. In fact, traces of oil on your boots are enough to put you at risk.

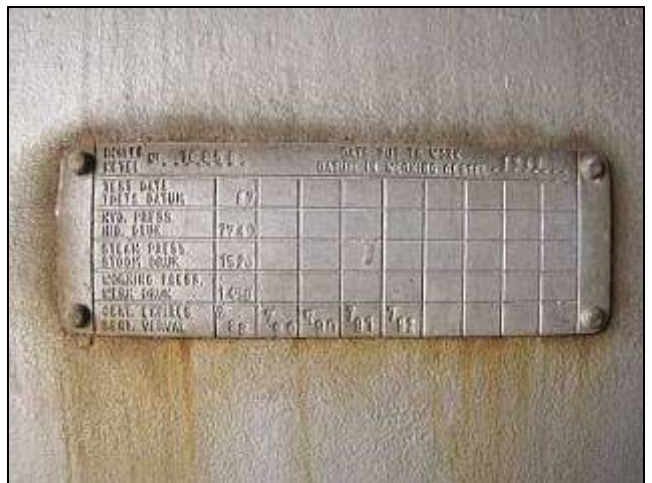
FW06 – Here is the boiler information plate for Class 15F No.3046. The boiler entered into service in 1948 and this is boiler 10056. Hydraulic test pressure is 1740kPA. Steam test pressure is 1520kPA and the working pressure is 1450kPA.

The numbers are interesting – notice how much higher the test pressures are than the rated operating pressure – there is much margin for safety originally designed into these boilers.

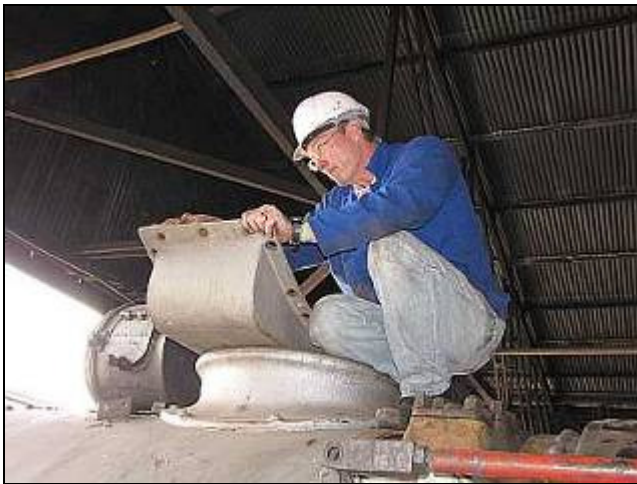
FW07 – Geneticist Colin Hall works on a very different horse from the twitchy four legged beasts with which he is used to. He is sanding down the curved flanges of the regulator cover before remounting it and bolting it down.

The clevis link in the foreground is the front end of the pull rod for the regulator. It has been deliberately disconnected by Peter so if anyone fiddles with the regulator handle back in the cab – the tightly sealed regulator valves are not disturbed or left dry and open. In fact, if anyone opens the regulator fully, the clevis link will move back and drop – jamming the linkages against the crank.

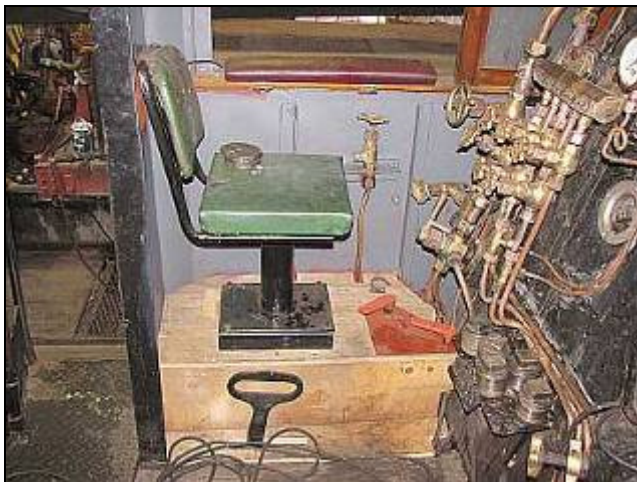
FW09 – The newly assembled fireman's seat and the platform. If the background looks a bit empty it's because the spray pipe hose hasn't been fitted yet, although the valve is there right in front of the seat. On the dusty, but neat looking seat cushion, is a stack of just-removed steel blanking disks that were used to seal off the water gauge column flanges for the testing.

Note there are two 'putting tee' handles protruding through the red painted reinforcing plate. The one at the rear is usually a spoked wheel and operates the ash pan coolers – but the kick levers are easier to use. The front lever is the fireman's injector water valve. Normally these are left unpainted but it looks as though Peter 'Lappies' Labuscagne has other plans...

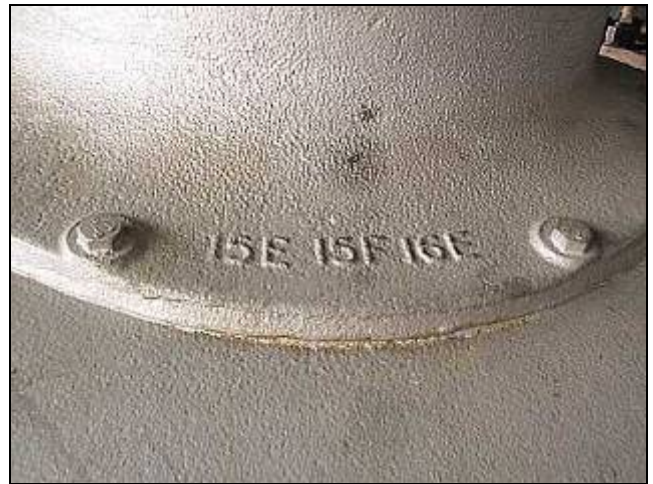
FW08 – Most post WWII locomotive chimneys have the compatible model numbers stamped into their flared fittings and here we see some of the compatible models for this chimney casting. The shape of the chimney has more to do with the pitch of the boiler (center line height), combined with the diameter, and then the fitting of the blast petticoat to the underside of the chimney.

Note there aren't many layers of paint on the chimney as you can still see the grade stampings on the bolt heads. Many of the other locomotives just have vaguely hexagon-ish looking blobs where the bolts were, from years of paint and graphite being added over existing layers.

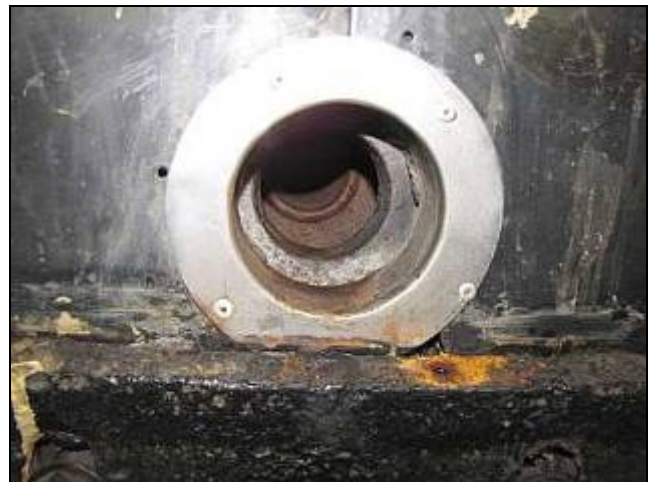
FW10 – A closer look at the upper end of an arch-tube through the washout plug pocket. There are three layers of the firebox visible here. The outer layer is the sheet metal cladding to improve the aesthetics of the boiler, but also to retain and protect the thermal insulation. The thickness of the insulating layer on the backhead can be seen by the depth of the stainless steel 'top hat' section trim.

The powdery dark grey plate with the thread in it is the outer rear wall of the firebox. The rust coloured plate is the firebox's inner wall. The space between the two walls is full of water. The arch-tube end is visible and is very neatly beaded.

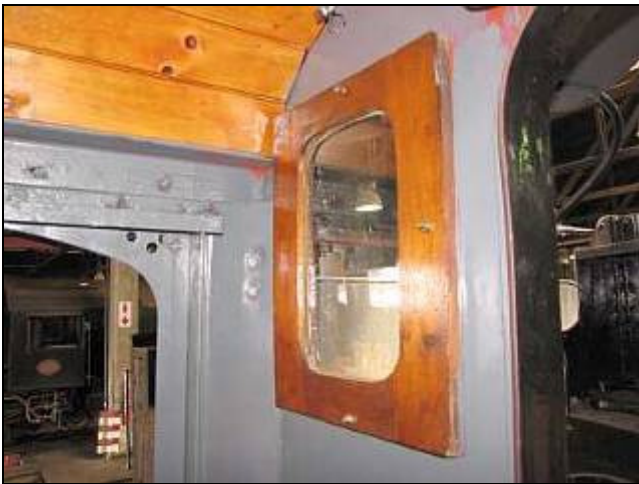
FW11 – A rather old fashioned way of mounting the curtain plate's windows. This makes for easy unit replacement of the glass if it breaks. But the loco crews aren't going to appreciate those protruding bolts if they settle down with their heads back during a break! SAR locomotives use square shanked carriage bolts which only have round heads protruding from the inside.

I rather like this practical battleship grey colour. Whoever did the painting either ran out of time, paint or patience as you can see there are still some touch ups required.

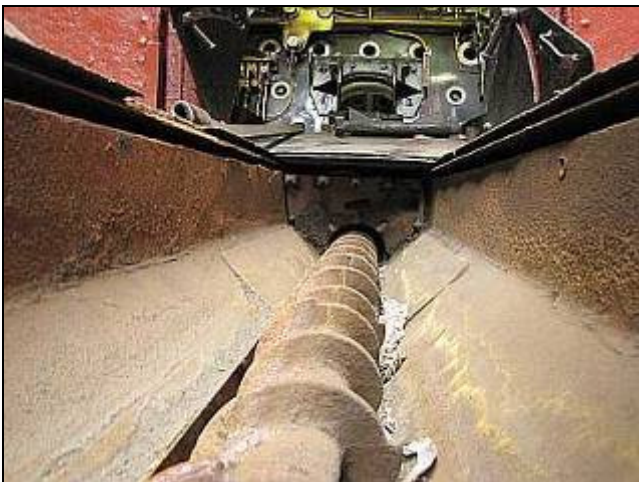
FW13 – Here is a totally different interpretation to the common photographic phrase, 'a worm's eye view.' The camera is right at the back of the trough. Although this is usually called the stoker 'worm' it is more correctly called an 'Archimedean Screw.' The grooves for the sliding cover plates are prominent above the trough and you can see the notch where the plates can be removed towards the top left corner.

There is an extra gap between the vertical side plates for the stoker trough and the grooved rail for the stoker slides. It is to be filled up with steel bar stock welded in place.

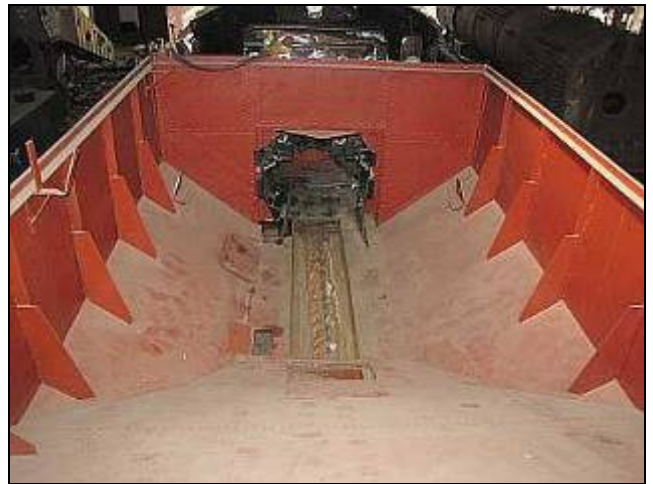
FW12 – A view into the rather dusty but perfectly empty tender of the Class 15F No.3046. This tender is in as new condition. I had just removed the three 'stoker slides' to be able to view the full length of the stoker worm.

All three of the service hatches are open. The one nearest to the viewer is for access to the stoker worm's gearbox. There are two service hatches to the left – each of which provides access to a universal joint.

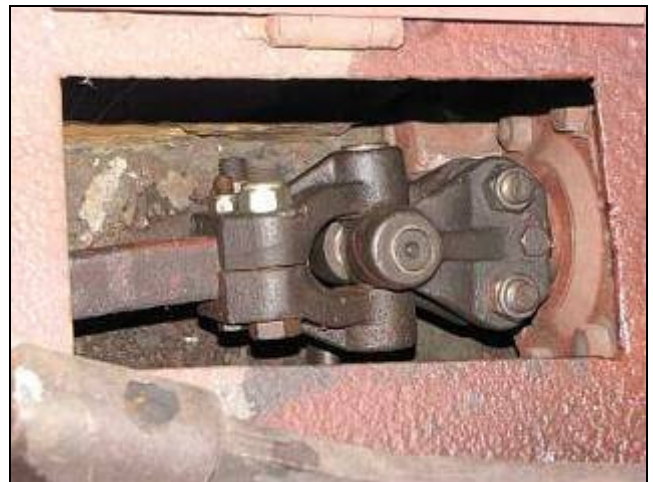
FW04 – Here is the front universal joint in practically new condition. The yokes are of split design and have been bolted with new cadmium plated nylock nuts. The split design means that a universal joint can be repaired in-situ and no presses are needed to disengage the spider.

Notice that the drive shaft is of square cross section. This means it is keyed by its shape and thus no drive flanges are needed. Unfortunately, these joints usually receive very little lubrication in service. But as they use plain spiders without the needle bearings as used in automotive Hardy Spicer type UJ's, they are robust enough for this gritty service!

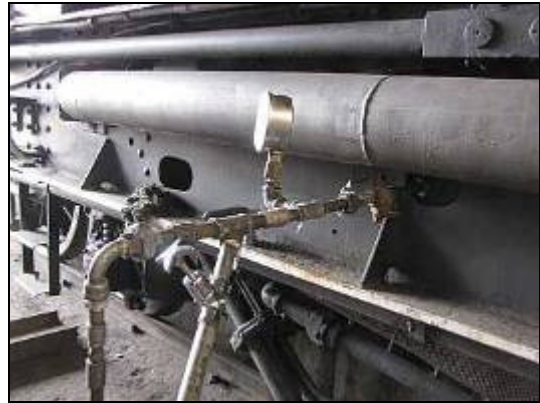
M02 – The pressure testing coupling screwed into the GMAM's firebox box corner plug. The two plug valves are currently open. The drain valve (An in-line domestic globe valve in this case) is used to drain the boiler slowly from its high stressed state during hydraulic testing. During pumping, the valve can also be left open to create a flow to drain and thus a control enabling pressure drop across the pump-side valve. (Left)

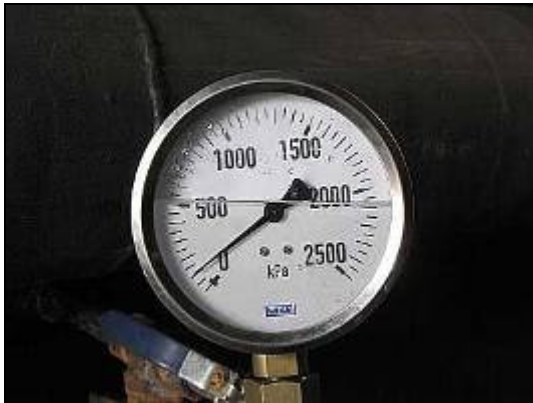
M03 – The almost new WIKA™-made damped pressure gauge which was used for boiler testing. Quite often, any old brass gauge is plumbed-in for initial tests but accuracy can be a problem on the older units. Generally the high pressure required for official testing is out of range of most of the locomotive backhead originated gauges anyway.

The pump isn't running here. The pressure seen here is the residual pressure from the weight of the water still in the boiler.

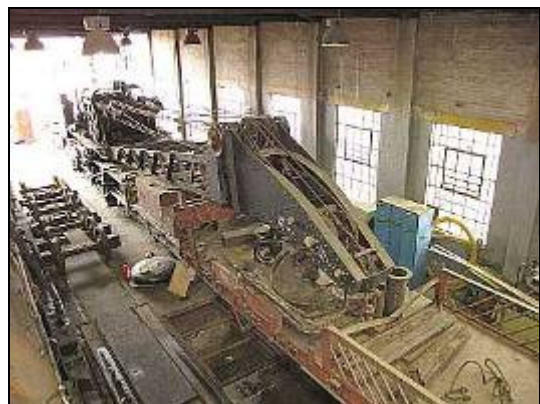
M06 – A pic from up on high, the 36 ton Booth Crane waits patiently for attention. We are extremely short staffed in terms of skilled machinists n' fitters at the moment and it is taking all of our efforts to keep the locomotives running. This crane is likely to stand and wait (in safety) for quite a while longer yet.
