2). 15F 2914 'SPIKKELS' FIREBOX REPAIR WORK :

This Depot Report was compiled by Mr. Lee D. Gates on behalf of Reefsteamers Association NPC.
For observations, corrections and suggestions – email me at documenter@reefsteamers.com

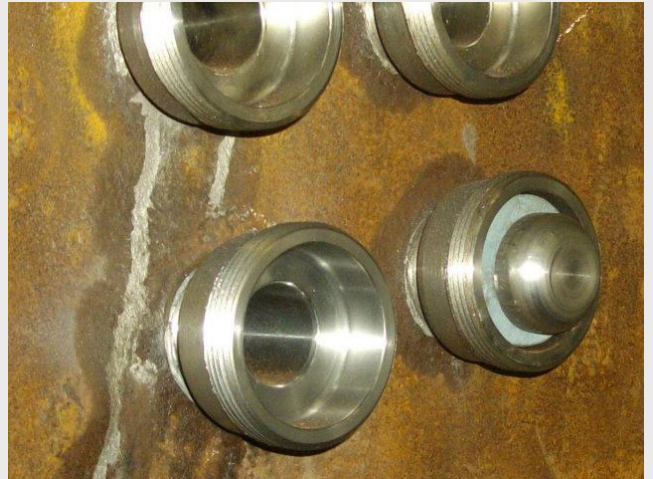
F08 – For comparison, here are some new flexible stay seats recently made and fitted to Umgeni Steam Railway's Class 19D. Note that one has already had the stay rod inserted and tightened. (Pic. by Edwin Andy Anderson.)

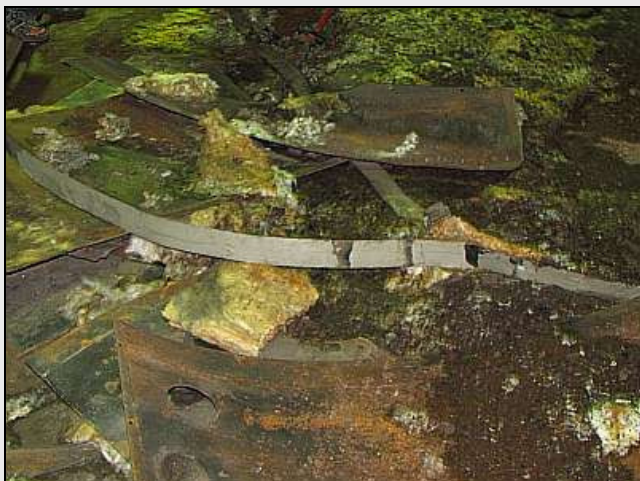
F11 – Like most machines, steam locomotives follow McCarthy’s Law of Dismantling. The area taken up by the removed parts will expand to take up all available floor space – irrespective of the original size of the machine. This grotty-looking photo is a junk pile of 2914’s rusted cladding, old insulation and some straps, lying on wet concrete where they were tossed down from above. This area has, of course, since been cleaned up.

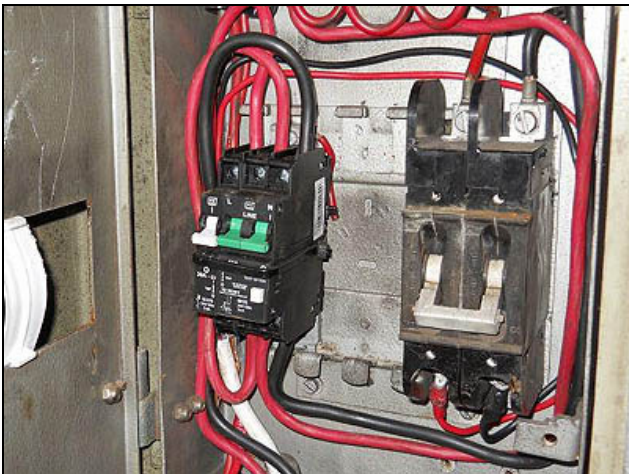
C03 – The ‘Semuma Coach’ is being upgraded to use 220V power, like all the other coaches. The size difference of new distribution board hardware is remarkable – showing several decades of development of MCB switchgear.

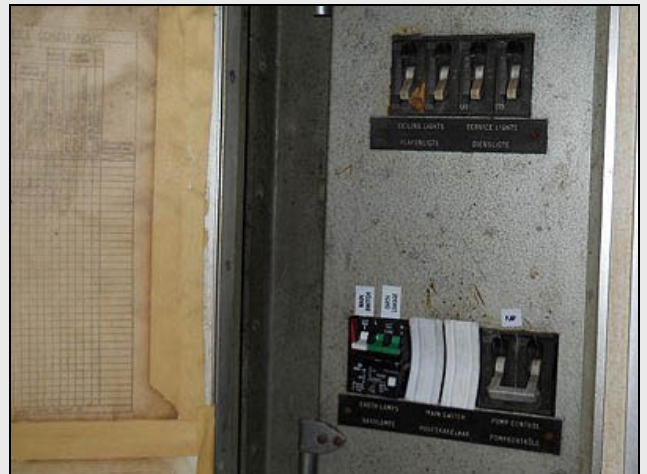
C04 – An external view. As the coach only has a single cabin instead of multiple compartments, the board is relatively simple. Notice that the Earth Leakage is an isolator (green) – the mains is protected on the live side.

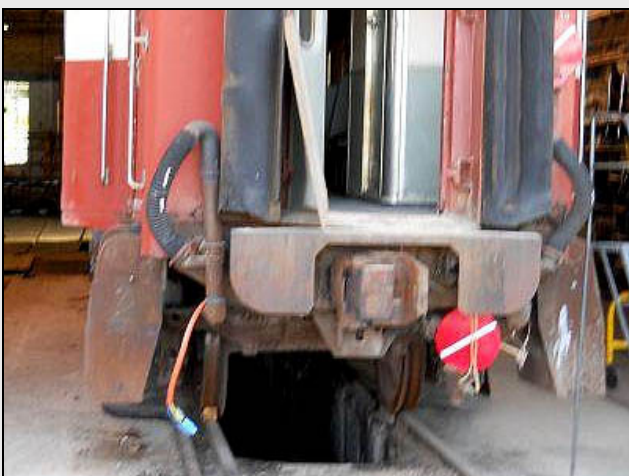
C05 – Inter-coach mains wiring is now in place. (The orange wire strapped to the train brake line.) The coach wiring is being done during the week by John Dunn.

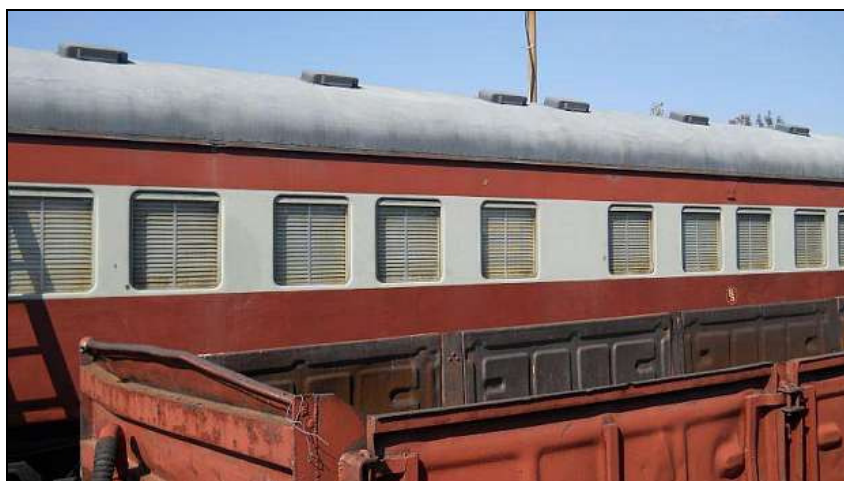
C18 – The ‘Sandstone Sleeper’ No 28332, being the ex-Locomotion Restaurant Dormitory coach, now has a full set of working ventilated shutters for the sleeper compartments. Our guests can now have the windows down and still get some ventilated privacy.

We plan to continue this shutter-relocation project with the rest of the sleeper coaches as several coaches, such as the bar/lounge coach, have working shutters that are not really used. We are only ‘shuttering’ the sleeper compartment windows – the corridor windows being left as they were.

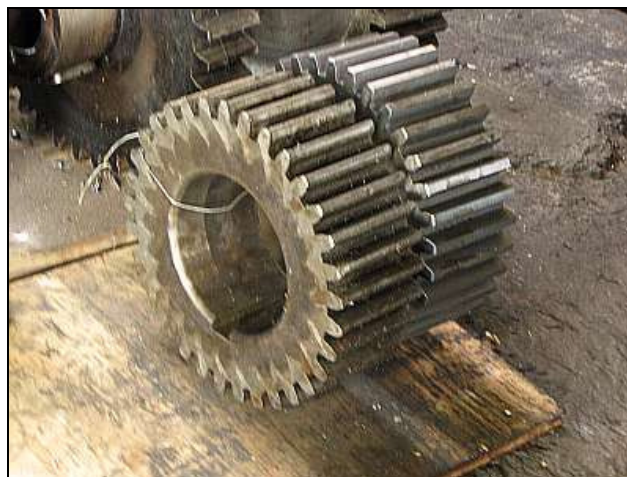
M04 – Although a certain clapped-out old 15F is hogging most of the limelight with her dramatic repairs, the depot wheel lathe rebuilding project is still going on quietly in the background. New gears are still being cut one-by-one and new keys are being manufactured for the freshly skimmed shafts.

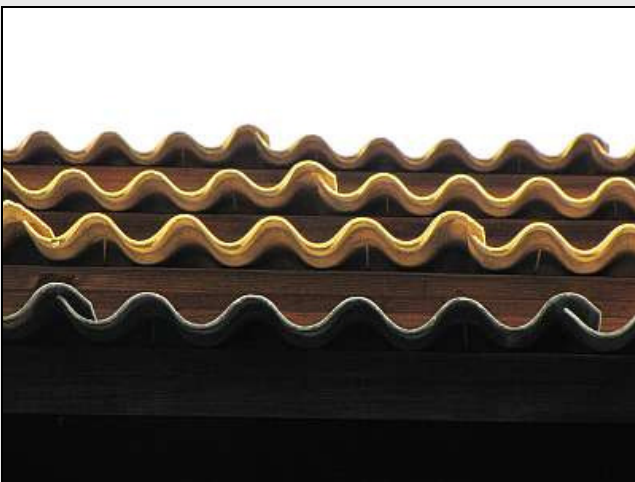
M11 – A Dianderson-type study of the old running shed's roof. Noticed they only overlapped half a corrugation...

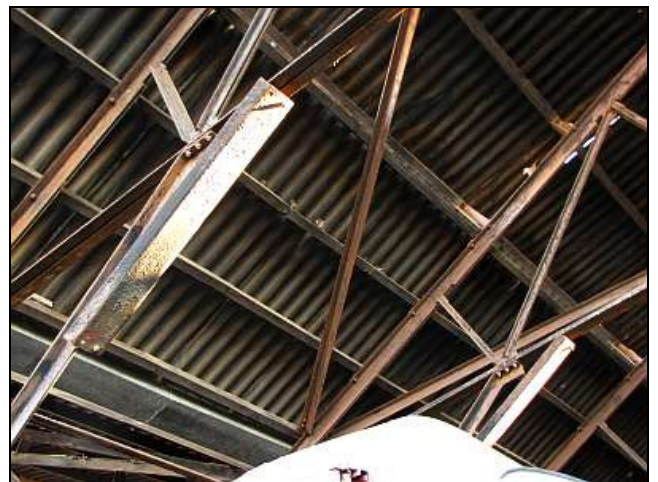
M12 – Unnoticed detail. Loco-blast deflector shields are still protecting the steel beams in the old running shed.
