## RAISING FUNDS FOR REPAIRS

PLEASE HELP US GET OUR IRON LADY BACK ON THE RAILS

**2). PROJECT SUMMARY, CLASS 15F NO.2914 RESTORATION :**

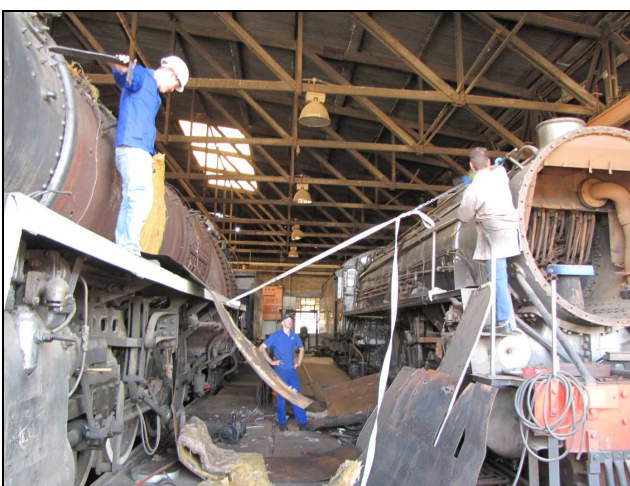
P15 - Adjoining locomotives form great anchor points for winching and the Class 15CA No.2056 'Dorothy' serves in that role here.

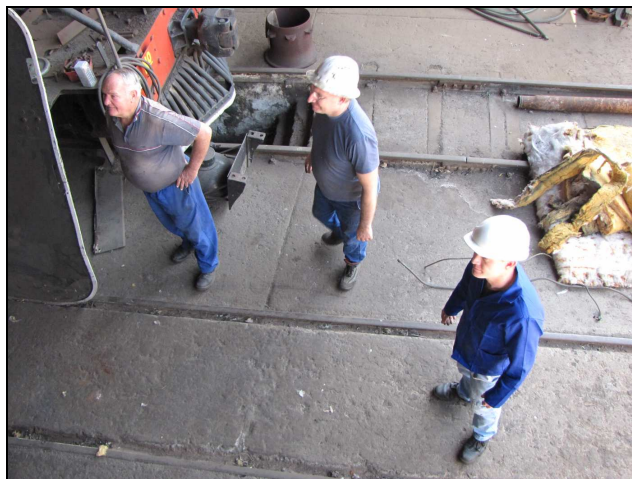
P16 - Standing safely out of the way of straining webbing and watching the fun!

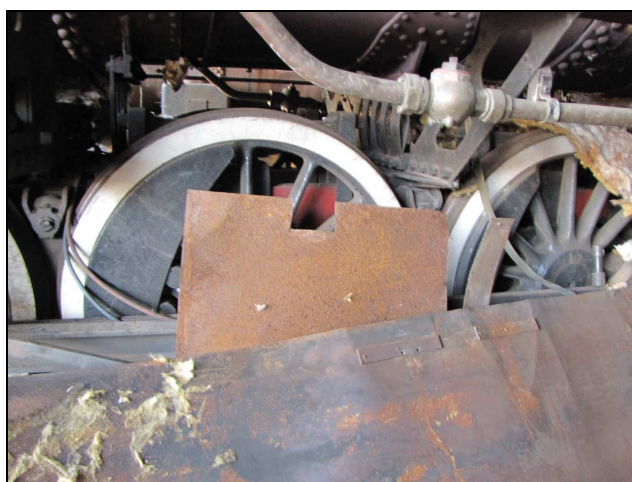
P17 - McCarthy's law of locomotive repair came firmly into play and the loose bits were filling up both aisles and washing up against the wheels. (McCarthy's law says that removed pieces of locomotive, and the tools used to remove them, will automatically spread out evenly to fill all the available working area until a solid obstacle is reached.)
