1). INTRODUCTION :

Here is the latest Reefsteamers Depot Report, issued on 24 February 2013, which covers events up to the previous weekend. This week's photographs have already been uploaded and processing has begun.

2). PROJECT – 12AR 1535 BOILER WORK:

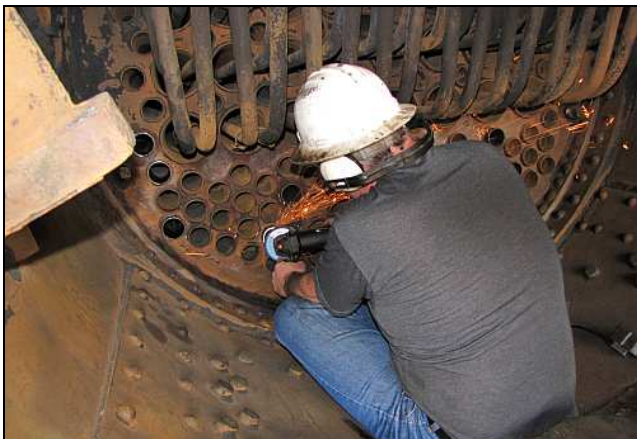
B01 – Aidan noisily works at grinding down the protruding ends of a dozen new tubes. Except for two of them, they ended up fairly close to the originals. Overly-long tubes are more vulnerable to knife-edging from char cutting.

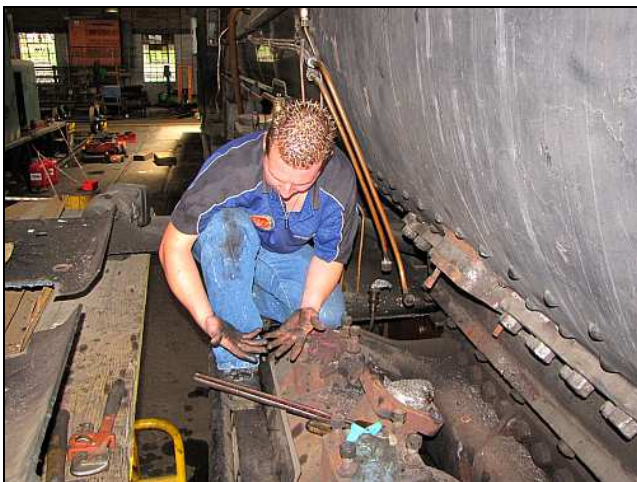
B05 – Stud : Three – Bennett Jr.: Nill. And it was a dirty and blistered defeat too. I love these guys – they are often quite funny just by having a pulse and being their own funny steam-lovin' selves. (This picture was unposed.)

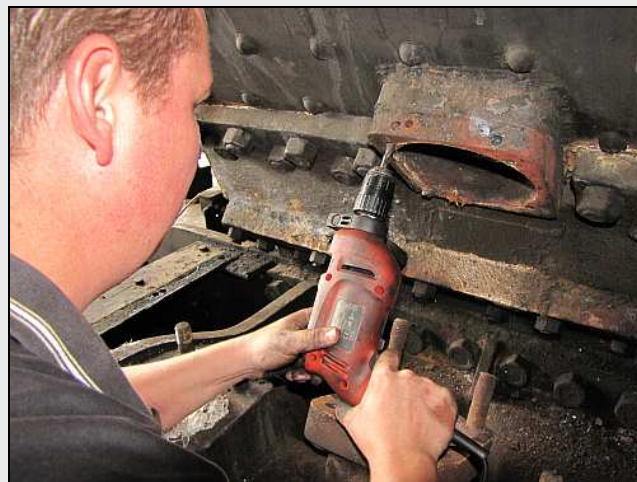
B06 – The cut-down studs had to be flatted and then drilled out. And ooh, you should have heard the bad language when that key-less chuck kept slipping! Fair enough to scorch my delicate electronically enhanced ears.

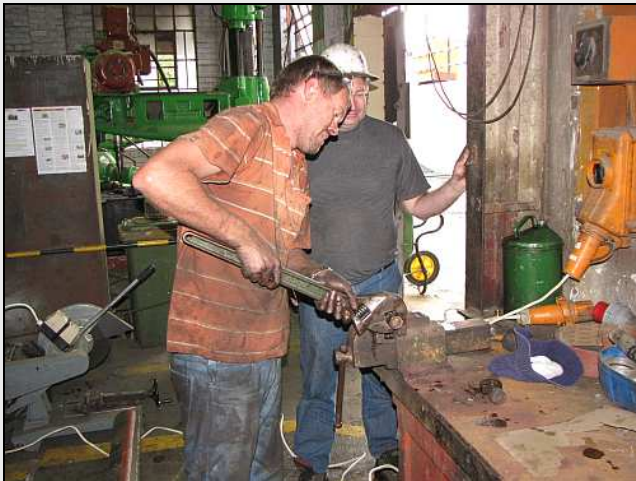
B07 – Of the studs pointing up from the steam chests, 3 out of 8 survived. Here, Dr. Smudge is running a clean hex nut along the threads, with lots of oil, for a rough cleaning and straightening before re-cutting the thread with a proper die.

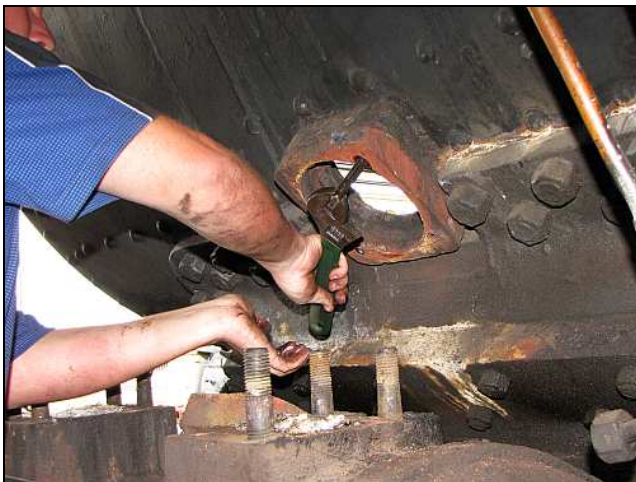
B09 – Simon is busy re-tapping the stuffing box cover for the vacuum seal. 'Big Robbie had just finished removing the upward pointing studs with the largest stilson wrench he could find. Simon was about to discover that not all of the old stud's remains were out and that hole was too shallow.

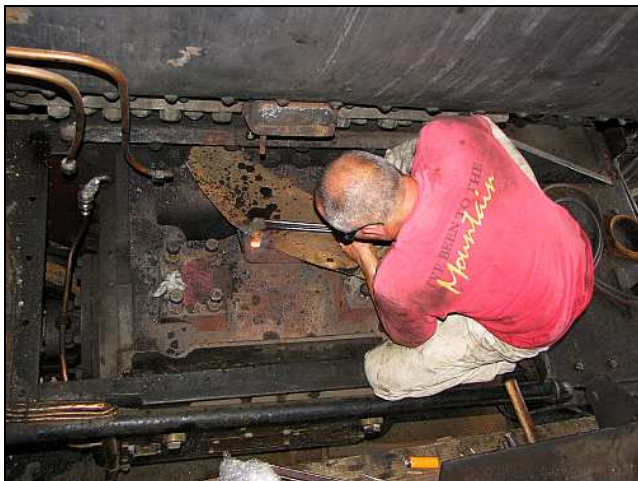
B13 – Another top view at the right steam chest (cf B04) – a stubborn Michael gets stuck into those stubborn studs. The new steam pipes need to be fitted and measured in-place for cutting, so all the old studs need to be removed beforehand, to be able to use temporary drifts and bolts.

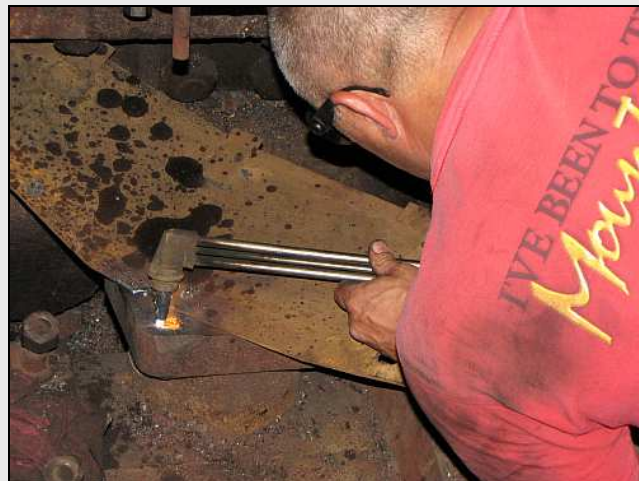
B14 – This picture shows the exacting nature of this work – Michael had to burn away the remains of the cut-down studs without damaging the flange. If you look closely, you can see some of the old threads are still intact. Naturally, the holes will be re-tapped, even drilling out, if necessary.

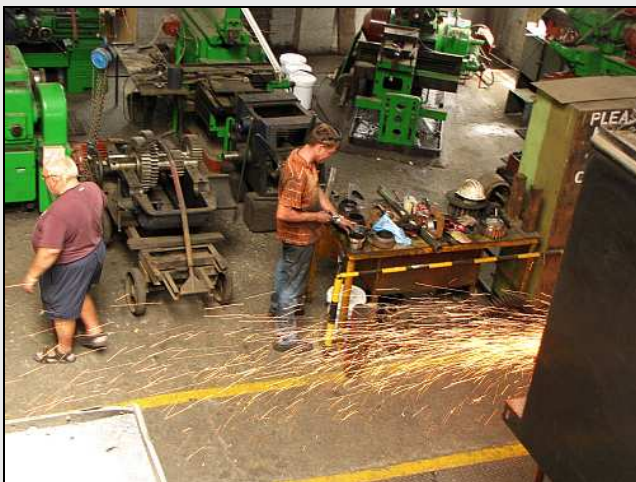
B21 – Illustrating the previous point, those sparks are showering down the walkway. The cut-off machine is clear off from the other side of the class 25NC's tender. The two gearboxes for the wheel lathe are going to be moved during the week in a machine shop clearing project by the staffers.

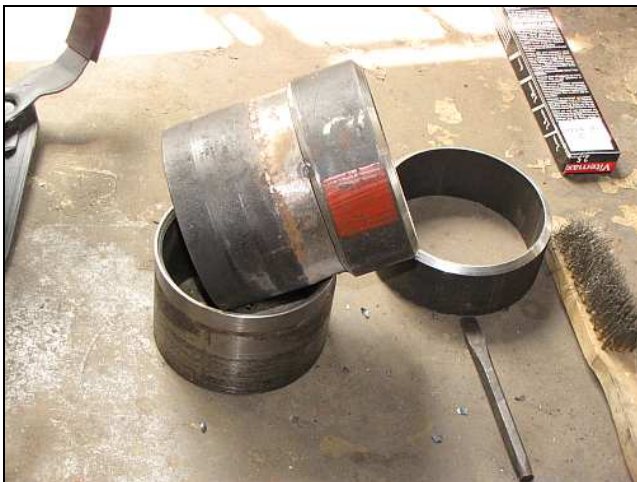
B27 – Dawie was busy making the lower end adapters as the steam pipes are wider than the sections that go into the steam chest flanges. The cut off piece was necessary to allow access for welding to the inside of the lapped join for a smooth path for the steam and for a stress-free transition.

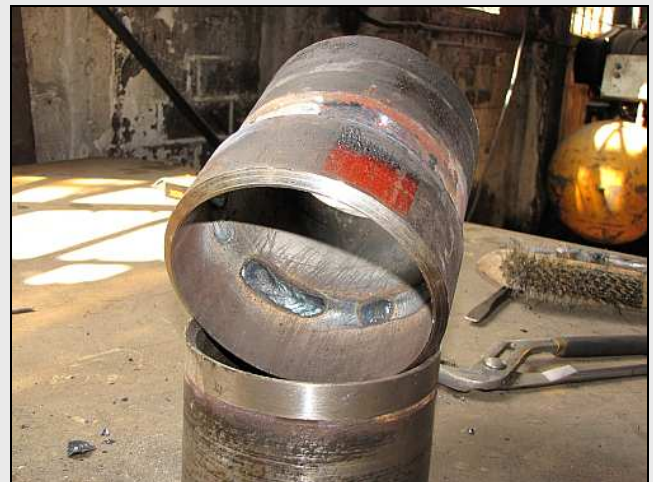
B28 – Here's a view of the start of the second pass of the interior weld – as seen through the full width ring that would be welded to the rest of the straight down-pipe section. Note the cleaned and chamfered edge at the near end for deep-penetrative welding to the straight section.

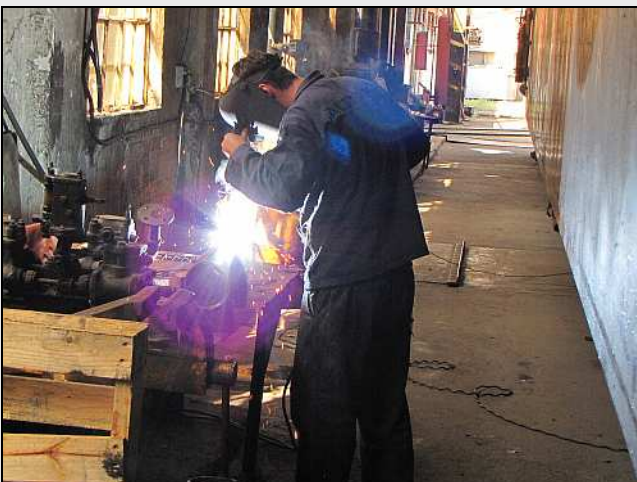
B29 – The magnificent Viljoen was happily occupied welding these pipe ends for most of the day and it kept him out of our way. Both steam pipes will now have matching 6.6mm diameter thick walls and should last many years.

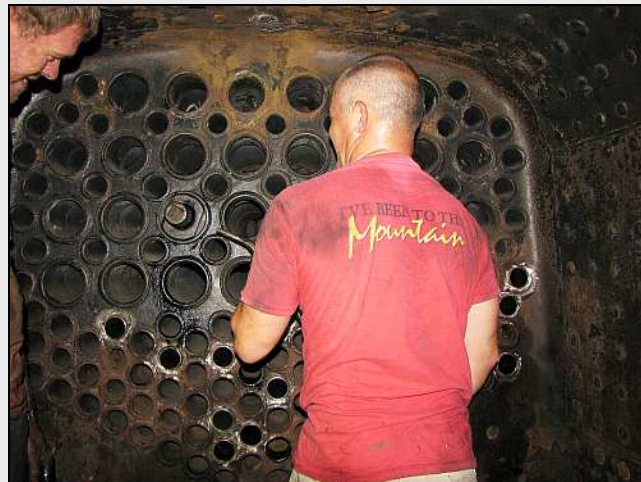
L02 – Michael has been to The Mountain, and he is the only one of the boiler boys who can stand up straight in the 12AR's firebox! We had one flue and two tubes reported with cracked beading. You can clearly see the weeping water from the flue tube currently being re-expanded.

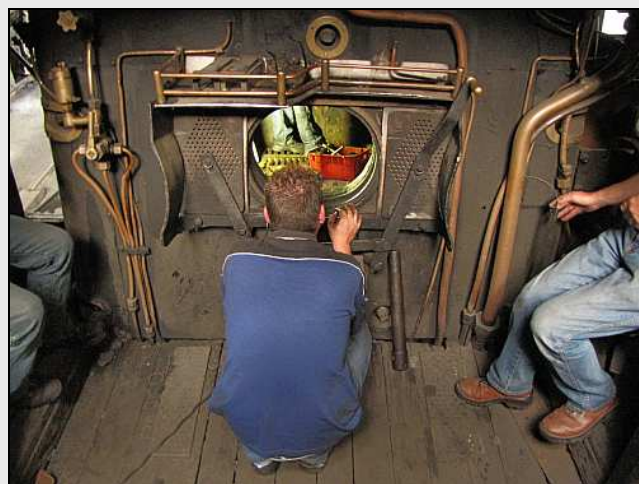
L08 – It is fascinating watching guys working in the firebox and Simon gets caught in the single-channel 'Tube-Tube.' The wrapper sheets and boiler got wetted with that extra leak, so the fellows would concentrate on those tubes instead and check for external leaks again during the week.

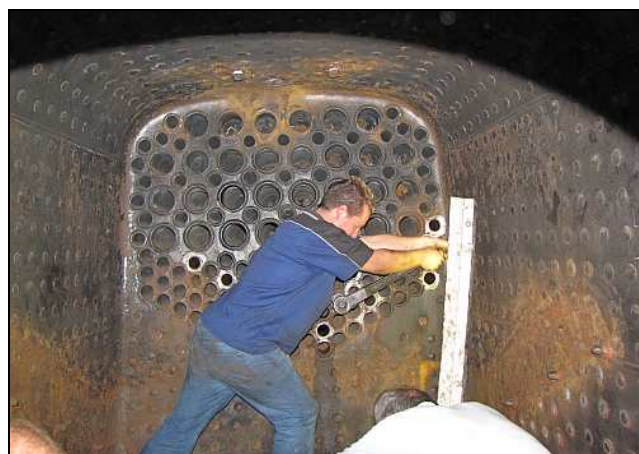
L10 – Simon gets a-going with the ratchet and driving the tube expander, with the boiler at about 1400kPa. As you can see, we slipped up a bit and had neither the firebox or tube plate cleaned properly, which was another reason why the Boiler Inspector was a tad grumpy on Wednesday.

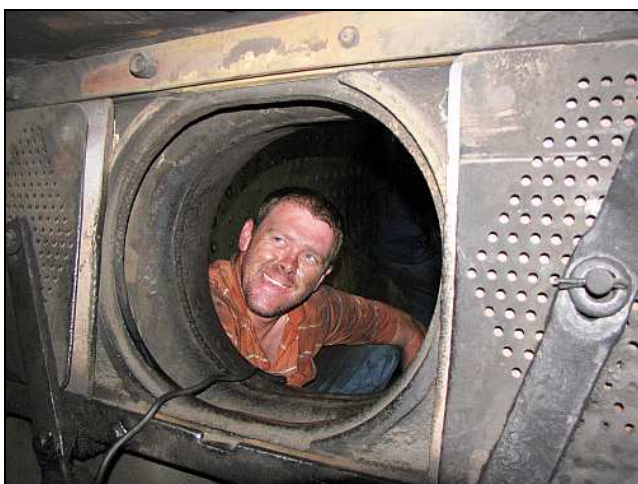
L11 – Dr. Smudge looks cheerful enough, but there was a little rat of worry scurrying within his mind. We had run out of taper on the mandrel for the flue tube's big expander, and two of the smaller tubes just would not stop weeping.

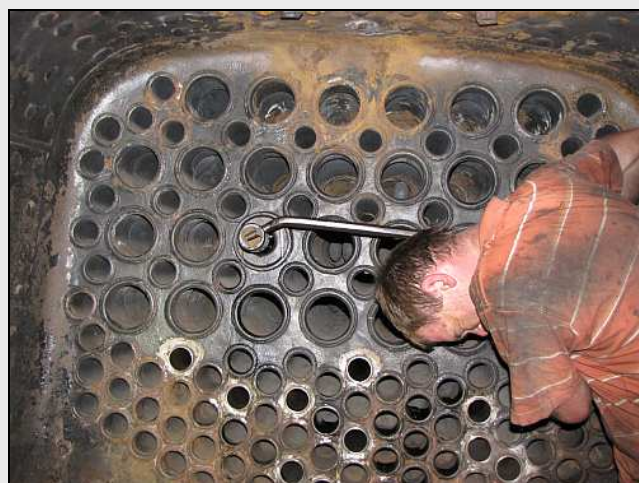
L16 – He is really putting some grunt onto this one! (Boiler is at 1600kPa.) What makes this tricky is that water gets into the doughnut-shaped cavity between the bead and the copper ferrule. When the tube is expanded, the trapped water is squeezed out under pressure. The trick is to work out if it is a squirt or a leak before over-expanding the tube.

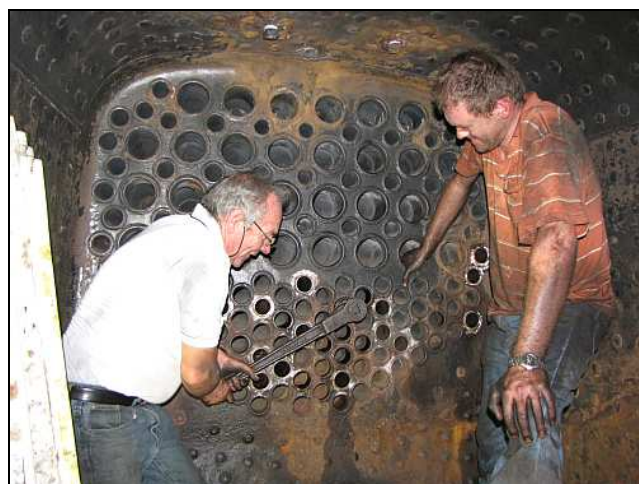
L18 – The flue tube seemed to seal up OK. Gordon Bennett has a go at a tube. Due to a general abdominal hernia risk, he wasn't able to take the ratchet up to the full-squeeze, but he did manage to get a few good licks in.

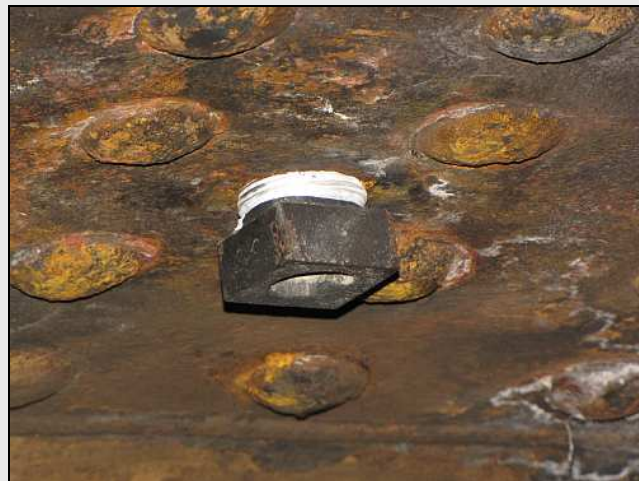
L20 – A cleaned and serviced fusible plug. (The other two will be removed before the first light up and they will be cleaned and the lead section re-cast n' date-stamped.

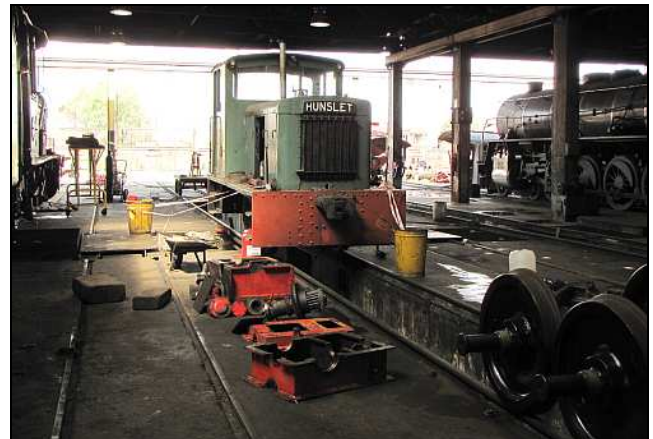
G04 – ‘Andrew’, the partially disembowelled Hunslet looks on towards his own spread-out viscera. There are four main sections to this ancient gearbox – the basement-level sump is out of sight behind Greg McLennan’s Class 24 tender axles. (Pic by Lee)

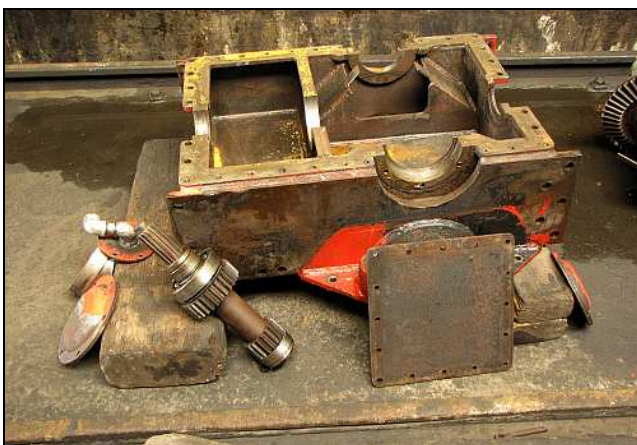
G05 – The main frame waits with a cover plate and the input shaft, both chambers forming an upper level sump. Interestingly enough, this complicated frame was not cast but machined. It fits in exactly between the Shunter’s plate frames, hence the lack of paint on the flanks. (Pic by Lee)

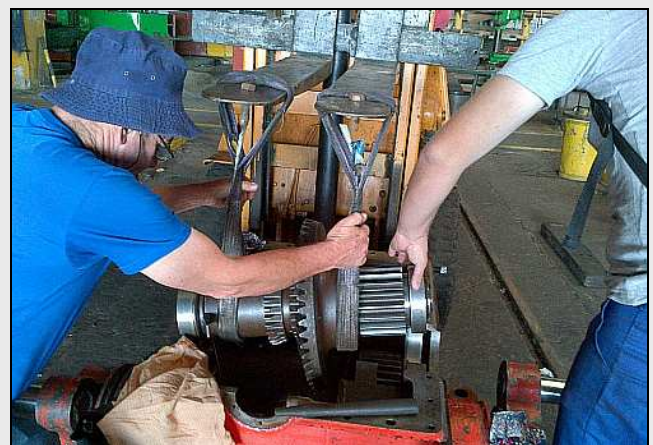
G06 – The jackshaft and counterweights went in easily, using the forklift as a hoist. And they had gotten two of the four frame sections bolted together. But the reversing shaft caused some heart palpitations as the new roller bearings were too small for the bearing seats. (Pic by VLM)

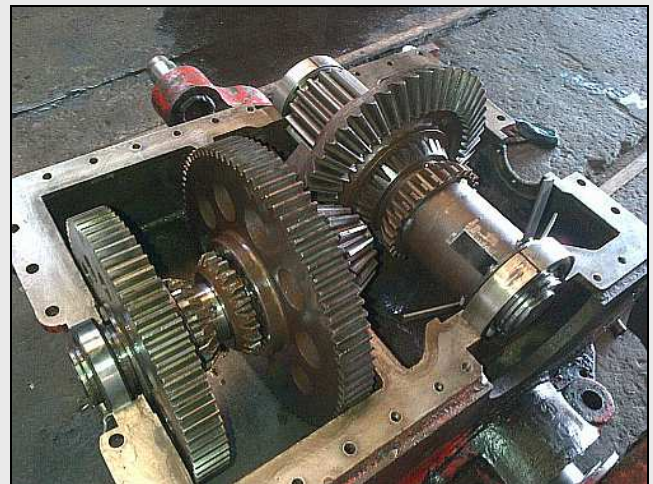
G10 – The shafts are in with the two speed cluster shaft in the foreground. The cross-shaft was once a reversing shaft and had a second crown gear working with that dog clutch. Reversing is now done with the hydraulic clutch. Note the oil dippers that take the place of the missing bevel gear in terms of drip-fed lubrication for the bearing. (Pic by VLM.)

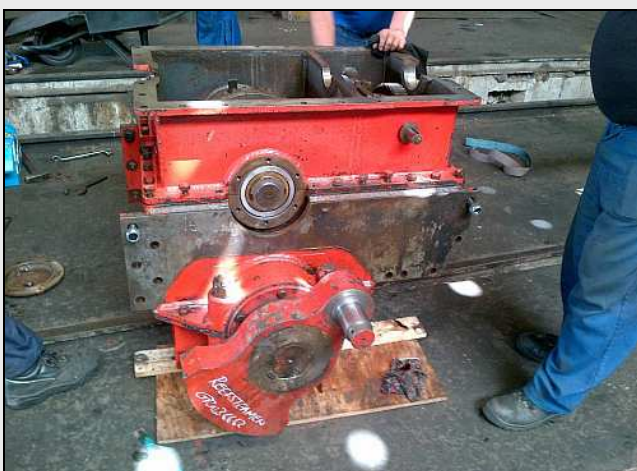
G11 – The upper frame is being bolted in. This gearbox goes together like a big ferrous sponge layer cake, with silicone sealer applied as an oil seal on the joints. Notice the new square key on the counterweight. (Pic by VLM)

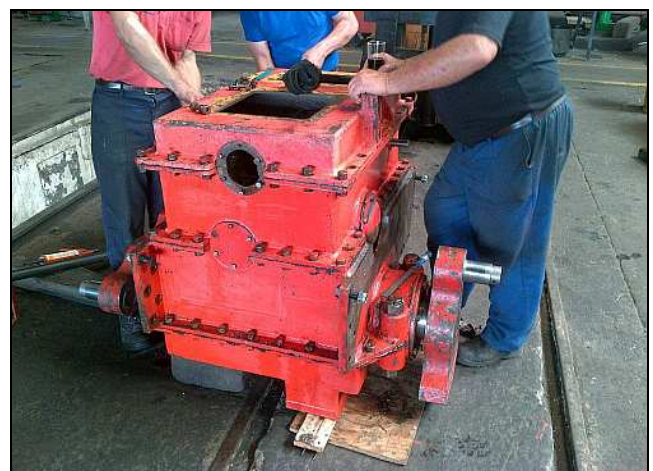
G12 – This rear view shows the gearbox is almost done and Attie (with the coke and boep) has ambled out to check progress. While it is clean, you can see the literally dozens of bolts that hold this 3D jigsaw together. (Pic by VLM)

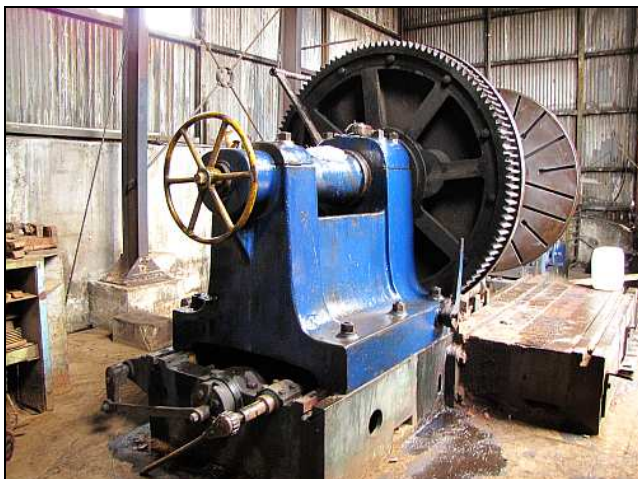
W01 – Work has been continuing in the wheel lathe house with pressure washing, cleaning and lubrication of the existing equipment. You can still see the oils and diesel runoffs – the floor needed to still be cleaned.

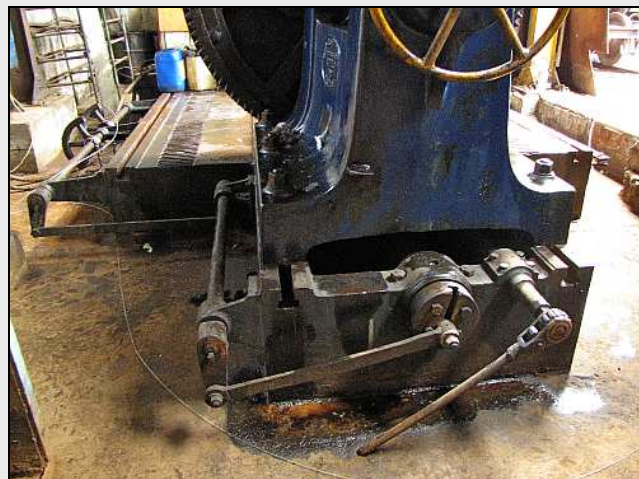
W02 – With the floorboards gone, you can see the crazy-looking linkage and the crank that drives the tool feed quadrants. Notice the ingenious slot arrangement in the crank for resetting the linkages and the quadrants.

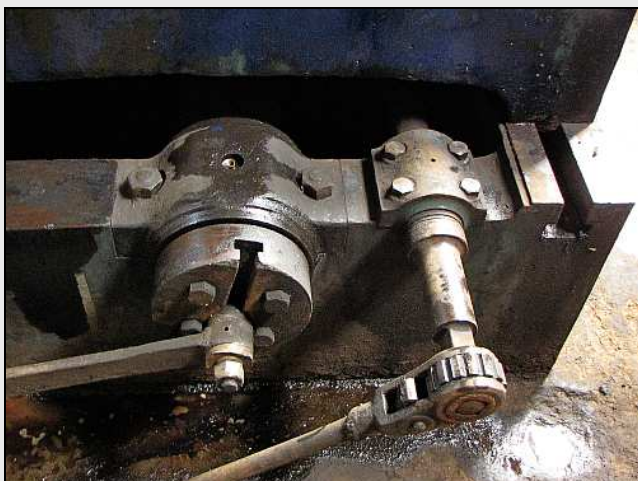
W03 – Here's a close up of the tool-feed crank. The shaft to the right advances or retracts the entire tender-side chuck pedestal. The mechanism is complete, including the stock-lock, but it still needs more cleaning and lubrication.

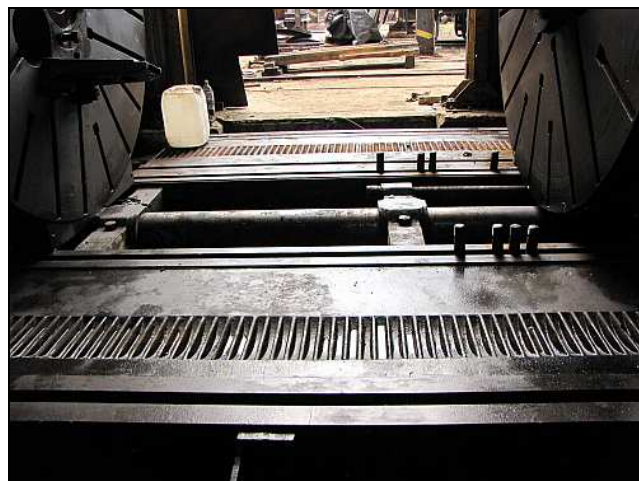
W04 – Both of the tool beds have been cleaned and the tool tower studs freed up. The outer bed still needs to have the rack indents wire-brushed and lubed, but the casual doing the work had since been put onto weed bustin'.

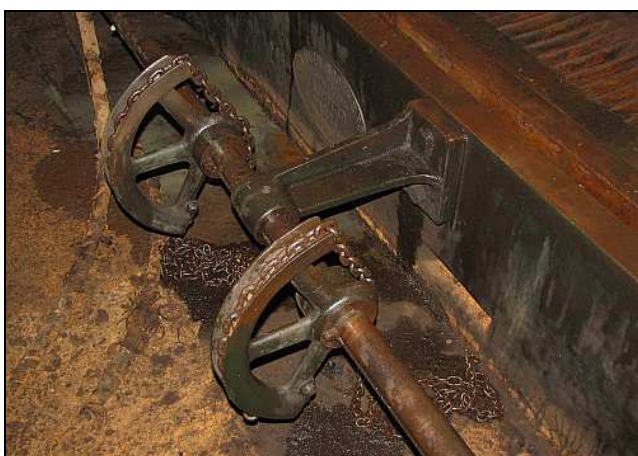
W05 – Clean and green – the tool feed quadrants and their chains were pressure washed.

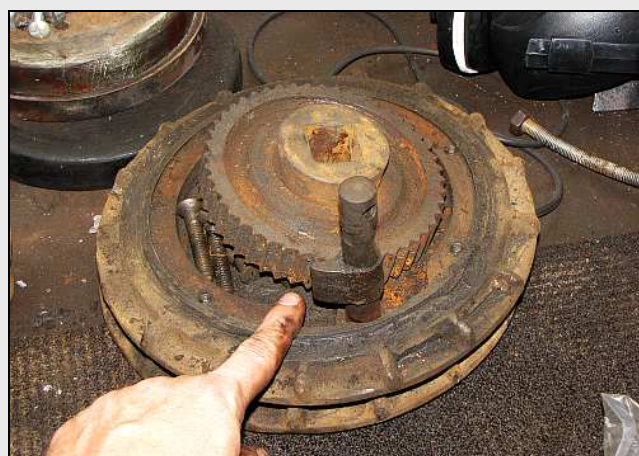
W06 – Another look at the chain-driven ratchet clutches still waiting for cleaning. This view shows the pawl that is manually rotated to be able to turn the center drive boss backwards and retract the cutting tool.

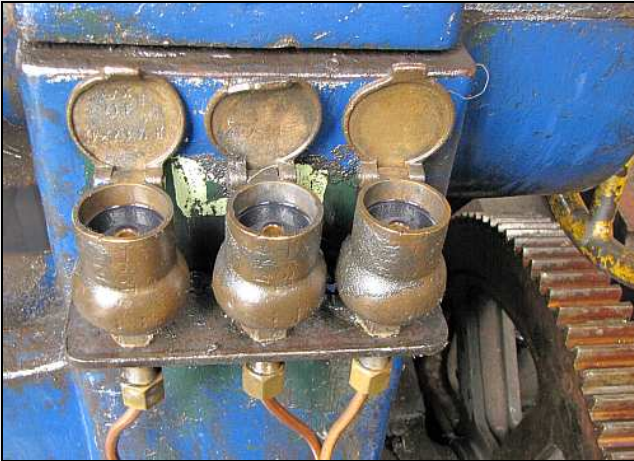
W07 – The oil cellars had their old wicks removed and were cleaned out. They were deliberately flooded with oil to get the overflow down into the copper pipes. The fact that the oil levels are all down to the wick-stems in a good sign.

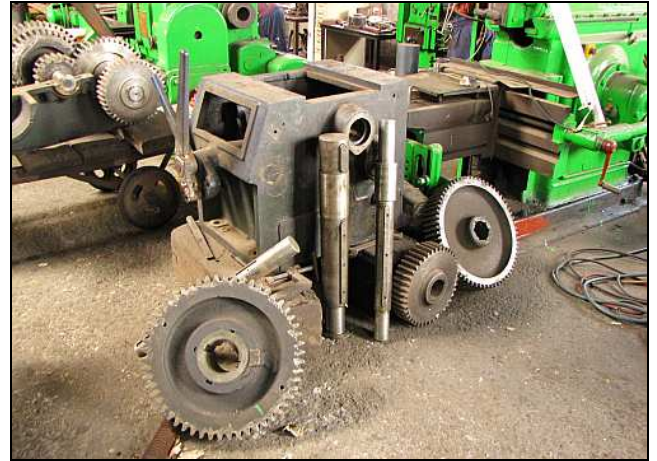
W08 – The two gearboxes have all their shafts, keyways, gears and selectors ready, and new Vesconite bearings or liners. (You can see one between the vertical shafts.) Once the lathe has been rotated and its bearings assessed, the gearboxes can move on over for reassembly.

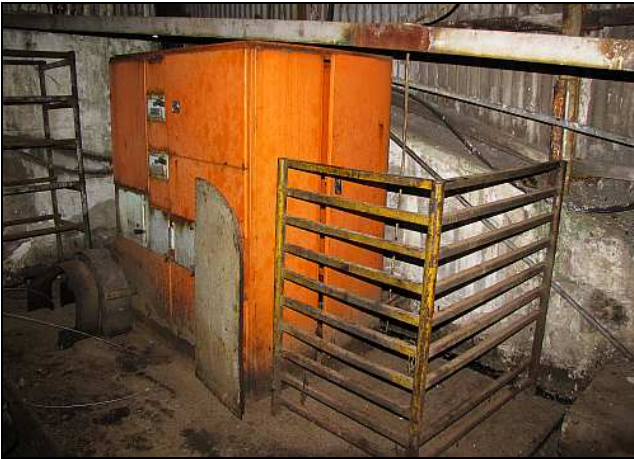
W09 – The switch board, surprisingly, is still functional but the scary switchgear within needs servicing after years of rain water – the motor starter may need to be re-rated to suit the refurbished motor. The drive gear's safety cage looks like we can use it after all, with just one rung needing to be replaced, which saves a bit of extra work.

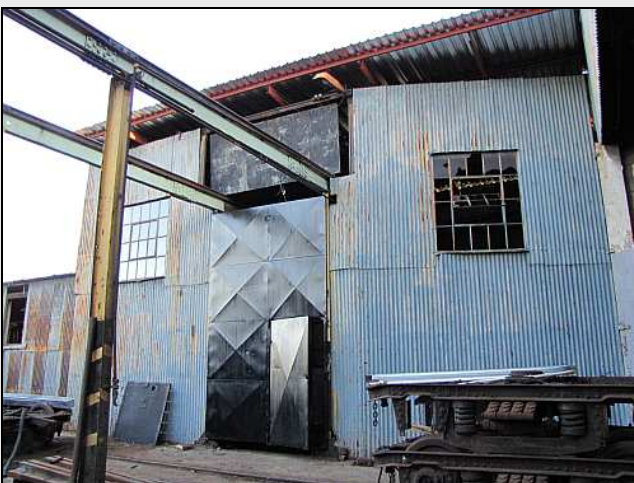
W11 – The wheel lathe house now has a new full height access door, with a separate personnel-door inset within. It originally only had a 5 foot high gate. Note too that one of the windows has had the broken glass repaired

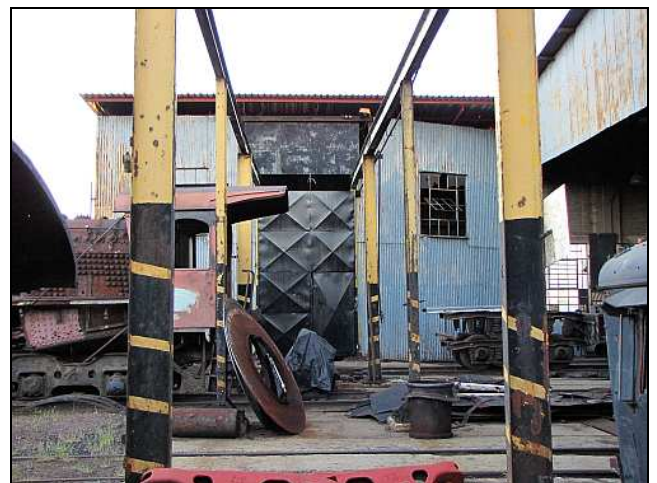
W12 – This scrofulous scene shows the main reason for the traversing crane's existence. Work on the wheel lathe project will be slowing down temporarily until the Class 12AR and the Hunslet Taylor locomotives are running.
