Welcome to the first Reefsteamers newsletter of the year. January is a quiet month with no trains scheduled. It gives the members the opportunity of fixing up all those little and big jobs that have been 'in the job jar' for the last few months.

Motive Power Report

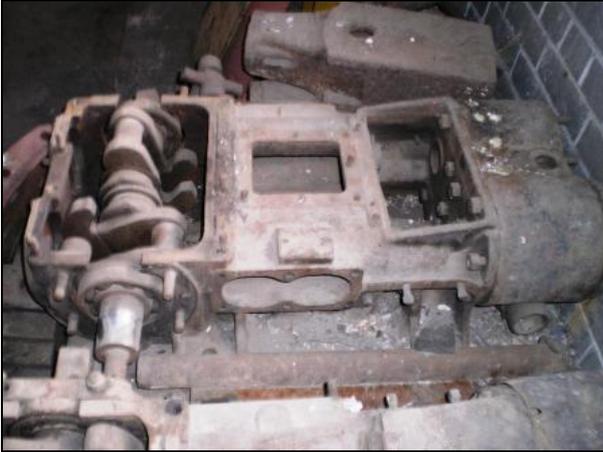
Partly Dismantled Stoker Motor

James, our specialist turner, has completed the second spare steam turbo generator and has now turned his attention to mechanical stoker donkey engines. The plan is the make one or two good spare units from a number of old units that are in stock. The pictures show the numerous parts that have been stripped out of one unit.

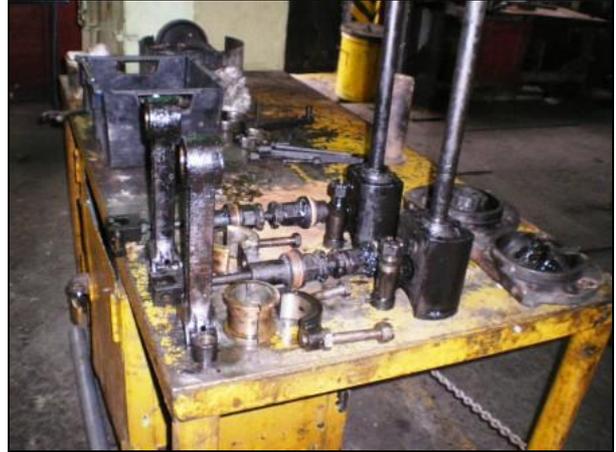
The inside bits

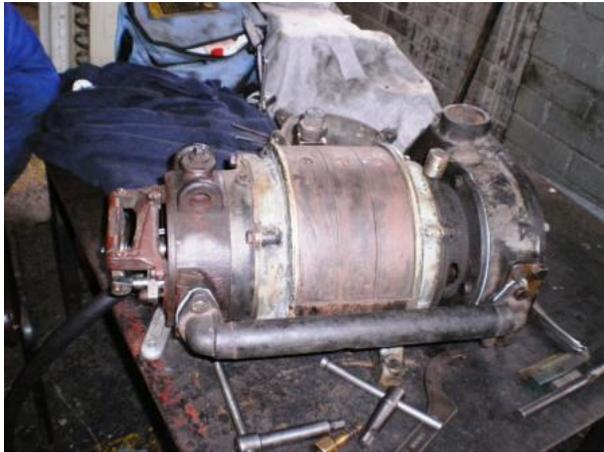
A 99% Complete Turbo Generator

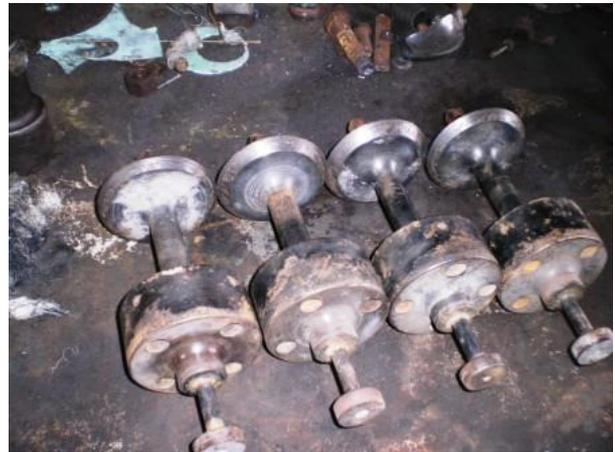
Internal bits from a regulator

Sandstone Estates' GMAM No.4079 'Lyndie Lou' is being still worked on for overhaul of the steam regulator as reported in last month's Waybill. Boiler inspection (For recertification) is pending.

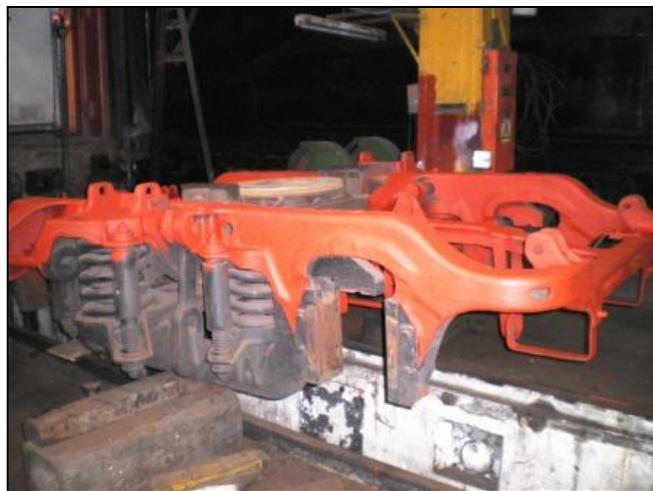
Painting in progress on the Coach Bogie

The Sandstone Sleeper Coach No.28332 is having its bogies overhauled and the one that is out from the coach has been red oxide painted and is just waiting on a set of new wheels. To be donated from a scrap coach

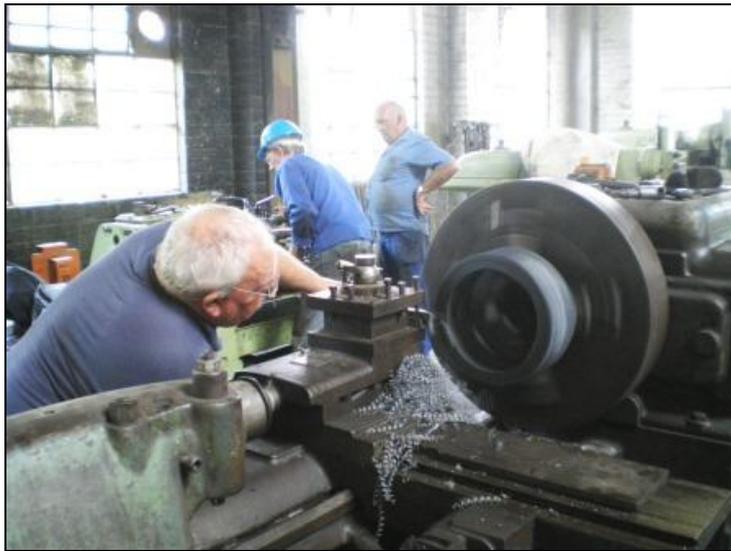
James on our Big Lathe turning a new Bush for the Coach Bogie

The centre pivot of the bogies were found to require new self lubricating bushes and James is busy turning them on our big lathe.
