# **INTRODUCTION : WAKE UP – LIL' SUZIE!:**

File Name : 12AR FIRST RUN - 2009-M03-29-FP1.Doc Doc. Author : Lee D. Gates Date of Print : Thu, 18 Feb 2010 Page 1 of 21

# PROJECT : Susan gets her name :

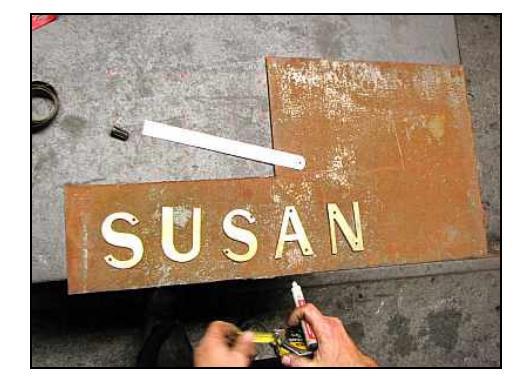
NP02 – This was the starting point, a plate of rusty 3mm thick scrap mild steel which would be an attractive nameplate by sparrow-rise the very next morning.

If you look at the letters, which are commercially made brass letters, you will see that most of the brass worm-holes are off center. This is because these letters were originally made in a serif font but Michael had already trimmed off the pointed serifs and filed the ends down flush to replicate a simple standardized font.

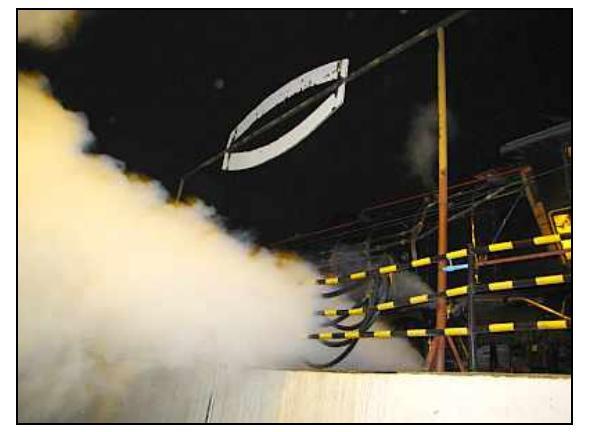
LM01 – How to waste steam and influence people. (Negatively) This is the second of two blow downs I had to do before the pressure gauge eventually settled down to 1200KPa and stayed reasonably put until easing off to 1000KPa by tickle-time at 4:15am.

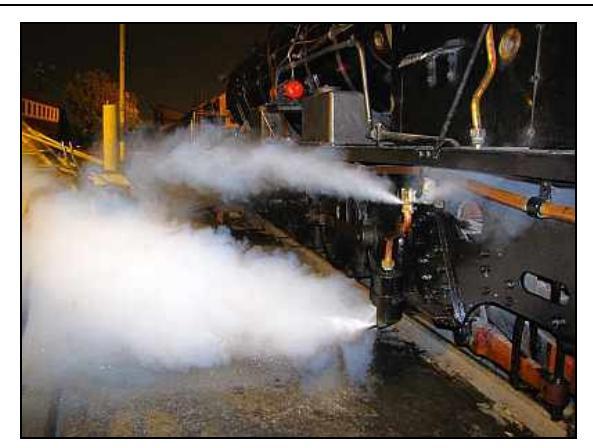
LM02 - You can see the discharge pipe's collar is leaking. I had attempted to tighten those two through bolts earlier in the evening, but they're tight enough – the seating or the pipe end must have gotten damaged during the hydraulic testing prep.

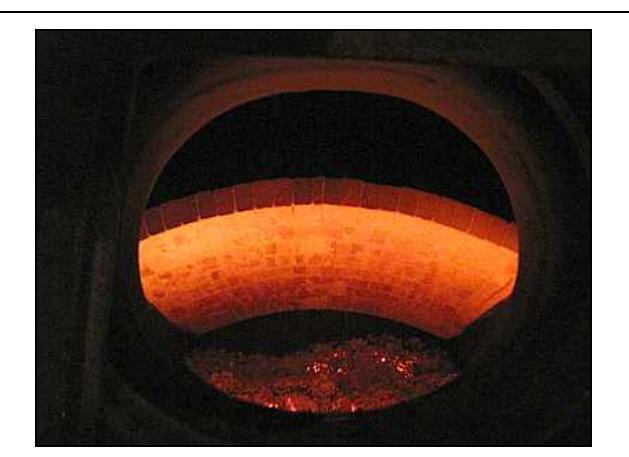
LM03 – The brand new fire arch ably reflects the heat of the drowsing fire with the individual fire-clay bricks still discernable. The separate bricks of the arch have already fused via heat and mortar and the visible joints will fuse over time. Eventually, after some hot runs, stalactites will start to form on the concave under surface.

That's all the shunter's junk at the front – only the banked coal right at the back was still burning – you can see the tapered glow on the fire arch

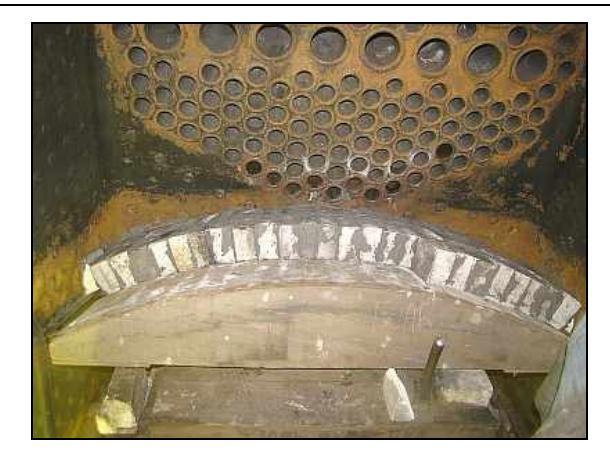
The angle iron braces (one visible on the left) actually burn away in the fierce heat – but the fire clay bricks fuse to the steel walls making the arch fully self supporting – it is an interesting piece of architecture right within the fiery heart of a steam locomotive.

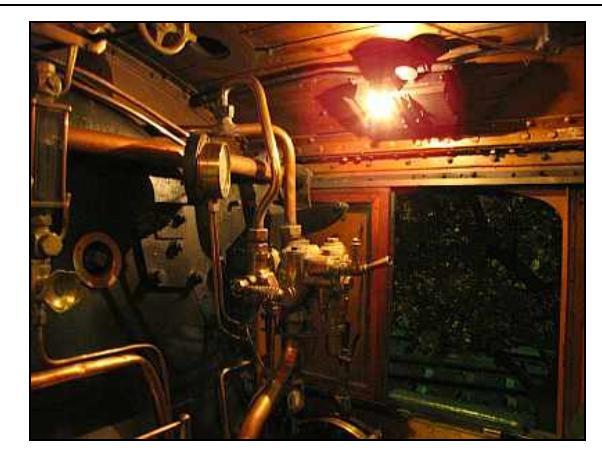
LM06 – The relatively simple driver's side controls of the 12AR – there isn't even a steam chest pressure gauge - the one visible gauge being the dual vacuum gauge for the brakes.

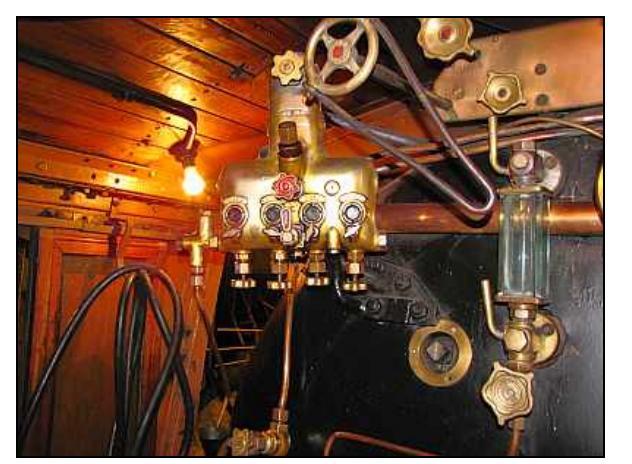
LM7 – Of interest is that big protruding valve wheel with the extension handle on. This is the turret steam valve for the left injector. As this locomotive does not have Sellers valves, there are no intermediate controls for the injector steam supply – the corresponding turret valve on such locomotives is opened at prep and left open. The Seller's valves operate with pull levers alongside the firebox and from a seated position. (Roughly under where that black funnel is.)

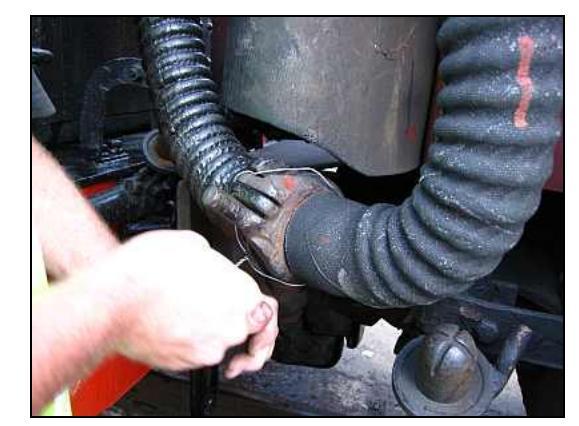
AB06 – Wiring up the brake hose coupling between the loco tender and the first coach. This isn't such a dodge as it first appears as the vacuum within the hose (train brakes off) sucks the two coupling halves together and makes an air-tight seal. It is when the brakes are released and the train brake pipe vacuum drops, the couplers have to rely on their own clips. A stiff (especially in cold weather) or misaligned hose, or one with a worn rubber washer, may not seal under vacuum again – which means the brakes won't release

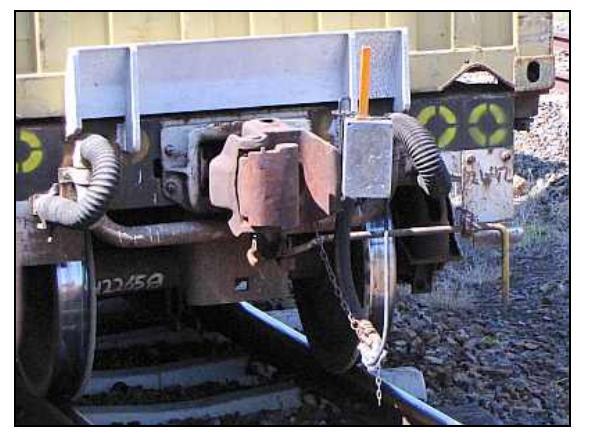
AB19 – A brake transponder in service on the trailing end of a passing AIR-braked container train – a rather bland replacement for those characterful V8-designated guard's vans. It measures the true brake pressure at the end of the train and sends the signal via radio to an instrument up front in the cab.

The brakes on a train, whether air or vacuum, operate in a wave that travels from the front towards the back – as the change in the train pipe pressure activates the brake cylinders one by one. Thus the wagons or coaches at the front of the train begin to brake before those at the rear do, and they release their brakes quicker too. This causes differential movement between the couplers and they may run in (buff) or pull out harshly (slack) on a poorly driven train, uncomfortable jolting for passengers, damaging to the cargo, and possibly even damaging the couplers or draft gear.

Apart from the obvious function of monitoring his brakes for failure, the train driver uses the transponder signal to judge when his brake application really has reached the end of his train. More advanced transponders used in America and other countries with very long trains can remotely release air from the rear of the train and thus start the rear end of the train braking at the same time as at the front.

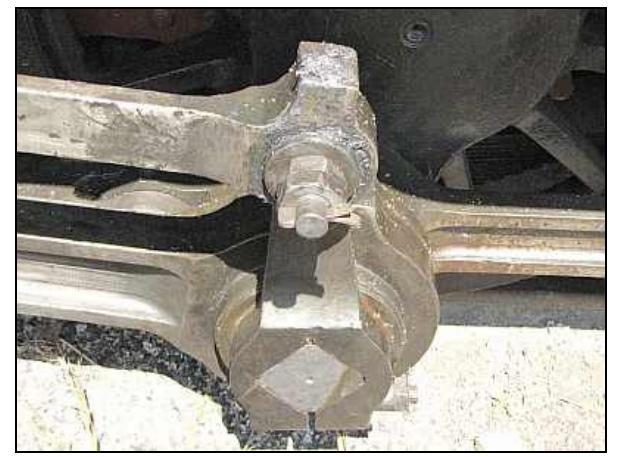
SM05 – Reefsteamers has had great success in using Vesconite on steam locomotive bearings and currently have four locomotives with Vesconite equipped valve gear – Class 25NC, 15CA, a 15F and now the 12AR. The GMAM Garratt has custom moulded vesconite plates in the Bissel trucks although the valve gear is still brass bourne As brilliant as Vesconite is, one thing it is not tolerant of is tight working clearances – needing to be cut slightly more than traditional brass or bronze.

The left return crank's eccentric bearing (top joint in the picture) had been machined a bit tight and had been damaged by the run. With extra grease it would get us home but at a reduced speed – all the other bearings in the rebuilt valve motion were operating as normal.

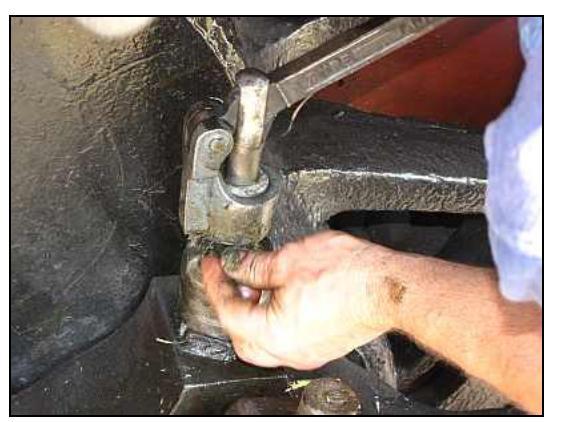
SM09 – Knuckle chopper in action. Michael Thiel is discovering the delights of using sticky grease sticks (Called 'Skaap Worsies – Trans = 'Little Mutton Sausages') in a grease pump. These pumps couple to the grease nipples with an action similar to a bayonet light bulb – slip on and twist the collar to lock.

The plunging piston chops the end off from the grease stick and pumps it in the cavities when the handle (at 2 o'clock) is pumped down. Inevitably grease oozes back past the pistons of worn tools and out back through the hole – Michael is gathering up the last smeared bits of grease for the final stroke.

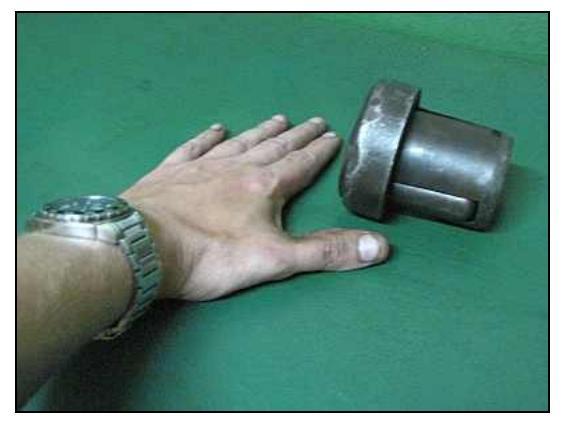
JH01 – Locomotive Hairball. As our Susan started her train and passed over the level crossing at Magaliesburg, line-sider Patrick Ackerman saw something come rocketing out the chimney, and then plummet back to earth and bouncing off the sidewalk plate. The driver heard it too and throttled back – but Patrick waved him on once he realised what the hairball was. He also had the presence of mind not to try and pick it up as it would be too hot to handle. Fortunately it didn't hit anyone or damage somebody's car.

The 'hairball' was a tube expander, one that was known to have gone missing from a set. It was suspected as having dropped down the blast pipe and into the steam chest passages and was fished for with wire and draw tape but to no avail. So we assumed it just 'took a walk' or maybe got accidentally discarded amongst scrap It turns out it was lurking down there after all and came loose with the fierce upgrade draft.

Without the modulation of the Goodfellow tips, and running on raw unthrottled blast from the cylinder exhausts, the locomotive burnt the coal very fiercely – overheating the fire and forming clinker. The draft was so fierce that the fireman was having some trouble positioning his coal properly in the back corners. It also made the door-open time for the firebox more problematic in terms of deeper, faster drafts of cold air being drawn in above the fire bed.

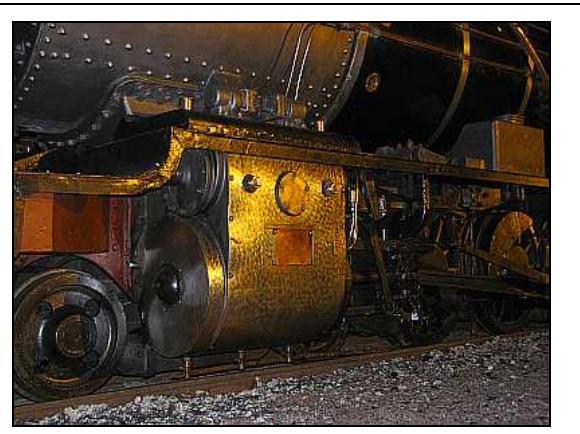
HB07 – The business end, tinted deep gold by the yard lights, these are the stainless steel sheathed cylinders that have worked so hard today, still warm but quiescent with no steam leaks from the glands, nor any issue from the cylinder cocks, due to the newly served regulator still sealing nice and tight.
