## 2). PROJECT : FINISHING UP THE GARRATT :

# - REEFSTEAMERS DEPOT REPORT – PAINT AND PAIN - 15 AUGUST 2010

# 4). PROJECT – PREFABRICATION OF 12AR VALVE SPOOL :

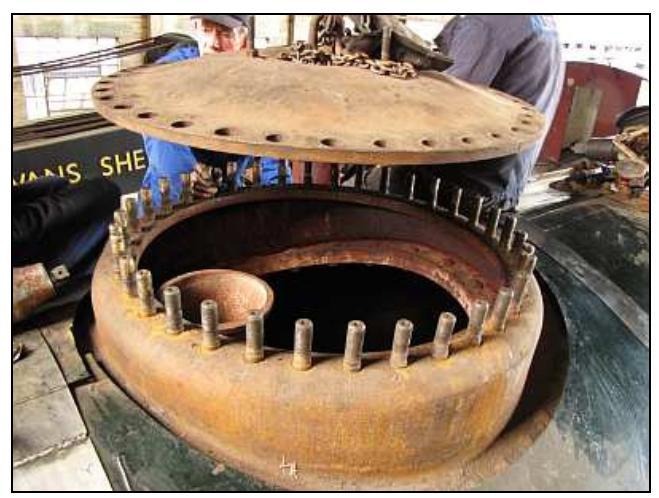
### D01 – Hangin' around.

The GMAM Garratt No.4079 has been driving us nertz for a few months as it has been so close to completing a steam test but seemingly just not making progress. The dry pipe's corroded hangars have been repaired so that should be one less clank from within the articulated pork barrel. The drive is on now to get the mighty GMAM back into steam. The only known work is the final machining and fitting of the new Bissel truck pivot pins and rebuilding the fire arch.

Here is the dome cover hanging while Dawie's first of two attempts at a copper sealing crush-ring was tested for fit. We tested that chain-suspended dome for soundness (pun intended) and it rings like a lifeless bell ... as flat as the damp-proof course at the footings of the bell tower. Dr. Smudge struck six on the clock and made our ears ring!

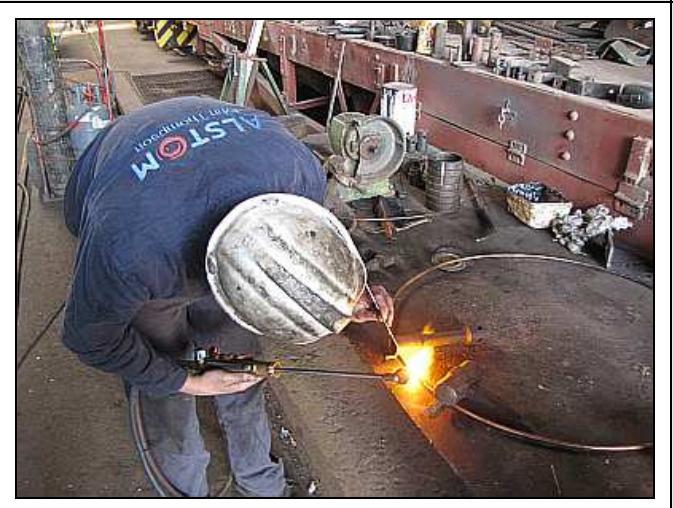
D05 - Cookin' copper :

Dawie gets to work with the acetylene torch on the second attempt. The lapped joint means that there is always almost a full diameter of copper to back up the brazing material when the ring is crushed to make the steam-tight seal.

I was waiting for someone to pick up that hot ring after brazing but was disappointed. The steel table and the items used to wedge-up and hold down the ring 'sunk' most of the heat. Regardless, the freshly brazed joint was reannealed.

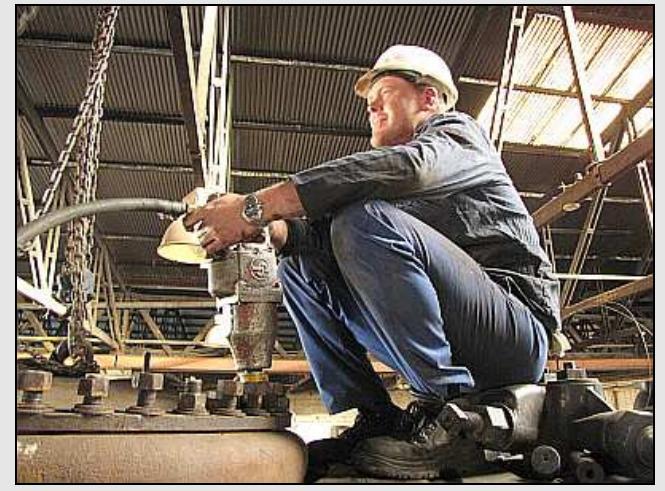
D06 - Stand by for tangle.

The second copper ring fitted and it was time to get the steam dome cover knuckled down before afternoon tea...

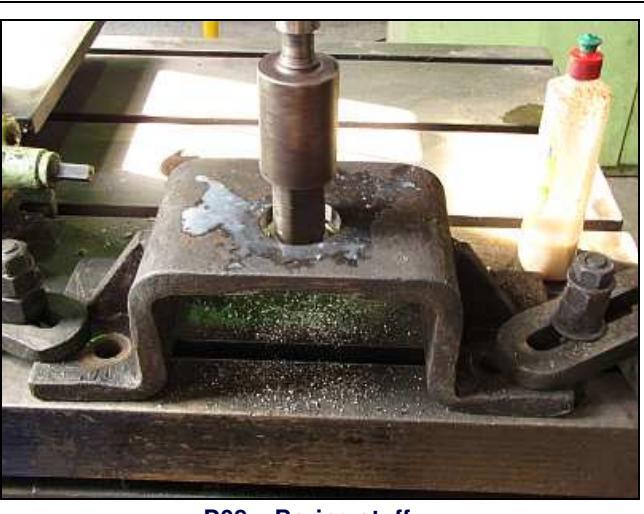
#### D08 – Boring stuff.

Other work in progress on the GMAM Garratt No.4079 'Lyndie Lou' is the fabrication of a new pair of pivot pins for the Bissell trucks as both of the existing pins were a little worn. They could perhaps have been re-used at a pinch but the corresponding holes in the bracket (foreground) had been beaten oval.

'Lappies' has been busy machining new slightly oversized pins from hardened steel and re-machining the holes in the corresponding bracket to match. Because the pins have to pass through the still circular eye at the apex of the wishbone-shaped Bissel truck frame, the new pins now have machined steps to fit the various diameters required. This means that the pins and the brackets (and their Bissel truck) are now matched sets and are not interchangeable.

The diameter of the final hole needed to match the long axis of the original worn-oval hole. But to add to the challenge was the centralization.

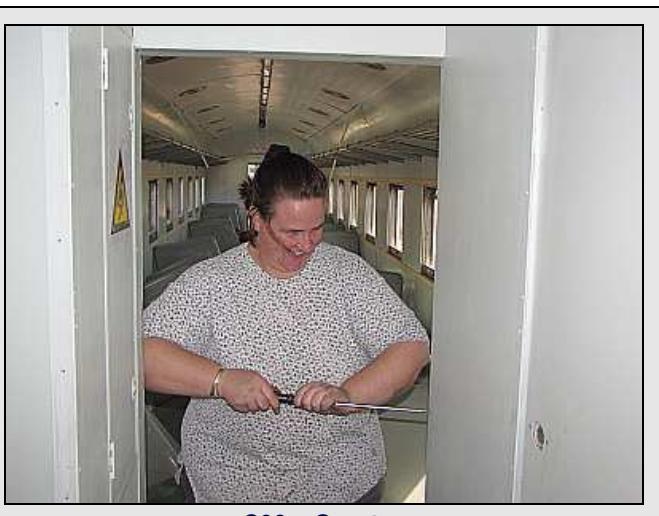
C06 - Grunt.

The original screws were countersunk semi-dome headed Philips screws. But over the years screws get changed out and missing screws replaced with different types, so these people needed a wide variety of screwdrivers. The previous, somewhat rough paint job also filled in the slots on the screw heads as well, making extraction even harder.

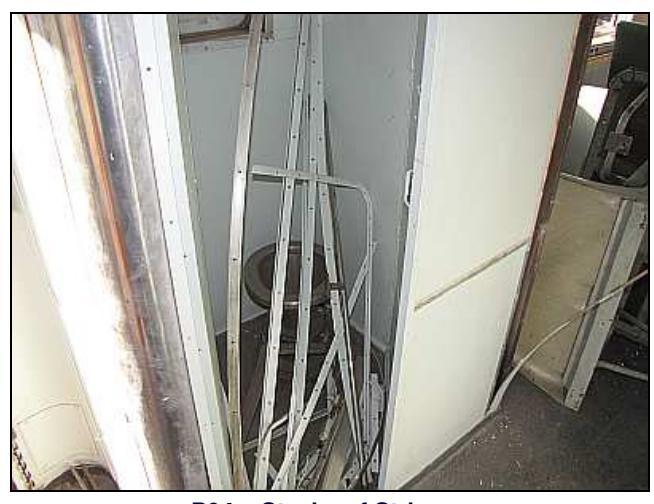
P04 – Stacks of Strips.

There is a truly scary amount of aluminium strip in a steel coach's interior. Some of it is simply trim strip but some of it actually holds the coach's interior panels in place. And it's hard to tell when removing the screws. Some of the strips had to remain because of seized screws but some could not be removed for risk of loosening certain panels.

A few sections did get bent but they'll be replaced from stock left over from the first Sandstone coach refit. This is only half the removed trim, the other half is in the other toilet cubicle at the opposite end of course!

All the screws, assorted, or bent, or rusted, or stripped heads or otherwise intact, are going to be universally replaced with coarse threaded self-tappers with counter sunk heads.

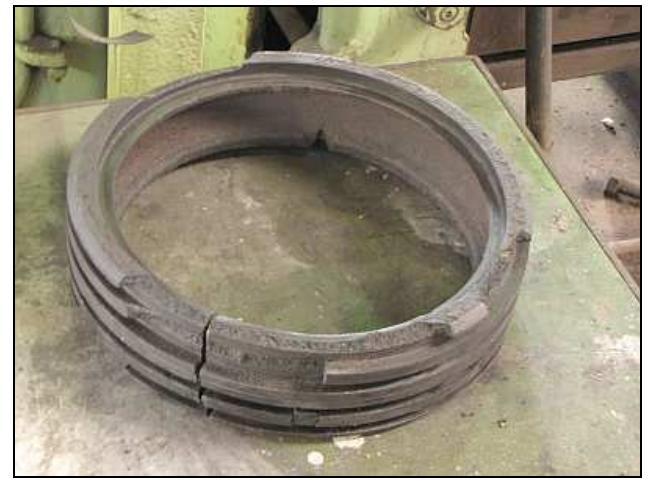
V01 – Chunked and Clunked.

The class 12AR No.1535 'Susan' suffered a valve failure above her right cylinders during her last trip. The fastening for a spool valve failed and caused it to fracture an outer land when it tilted. This, in turn, allowed the valve rings to twist and break, which compounded the mechanical failure. The two broken rings snagged in the valve chest porting, twisting between their lands and thus forcing the brittle lands to break off. Poor Susie was still running with this although making guite a noise and was a 3 beat machine.

One of the ring end stops is totally broken off although you can see that the lower one, at six o' clock, is still intact. The split was made to expand the spool casing and to loosen the two concavely conical end disks.

The fact that the circumference of the broken spool casing is not very shiny is normal – the ring-lands of a steam locomotive's valves and pistons do not actually contact the bore if the mechanicals are lined up and are properly tightened. The steam oil used colourizes the surfaces too.

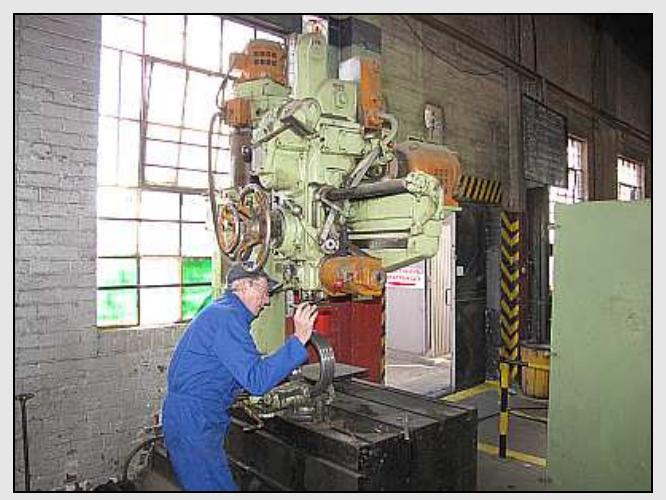
### V03 – Drill Press.

Pieter Labuscagne spent this Saturday finishing off and test fitting the spool casing that he had machined to fit during the week. The old SAR&H-era Asqwith-manufactured radial arm drill still functions perfectly, although Peter was not using the auto-feed at the moment.

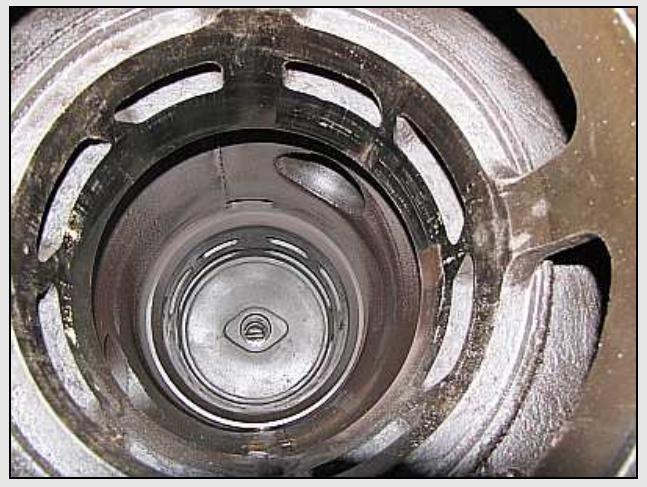
Unlike the piston rings in a 4-stroke engine, the piston rings don't get to work against contigious cylinder walls. A steam loco's valve rings (spool-valve set-up) pass back and forth over these complicated annular ports. Any misalignment of break in the rings can cause the ring to snag in one of the ports and breakage is bound to follow. You can see previous scoring and damage closest to the camera.

The square hole at 12 o'clock leads to the rear of the two bypass valves mounted on top of the steam chest. The canted hole at 8 o' clock is the vacuum relief port which leads to the snifter valves in the side of the steam chest.

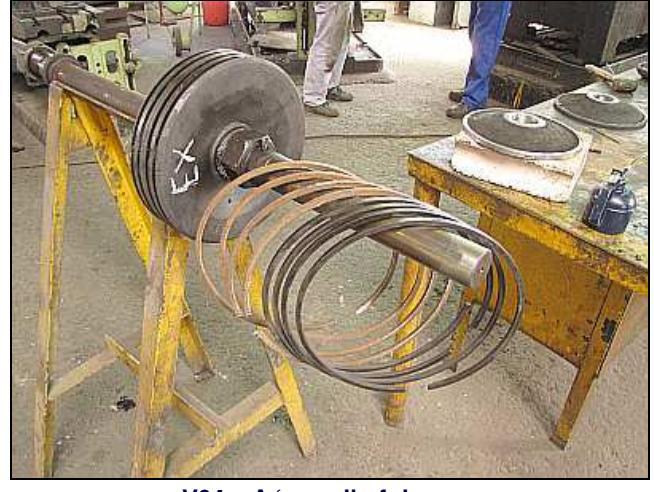
V04 – A 'round' of rings.

A full set of valve rings, one used (Polished with work) and one new set with very light surface rust, wait on the leading portion of the valve spindle. Loco valve rings are originally made slightly oversized and their slots are filed down to fit the actual spool \ bore combination in which they will work.

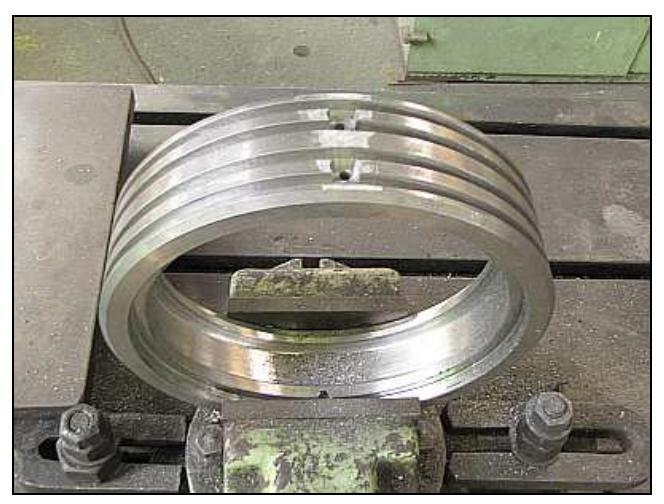
#### V05 – Spool Case.

Peter has been drilling the holes for the valve ring stops. Peter copied the original, which seems a bit unusual as all four valve ring gaps line up. The stops are special bolts whose diameters protrude into the ring slot. Thus they prevent the rings from turning in relation to the valve spool – and thus the vulnerable ends can be restrained to running on a contiguous surface between the ports within the steam chest. On the 12AR, this is the 12 o' clock position.

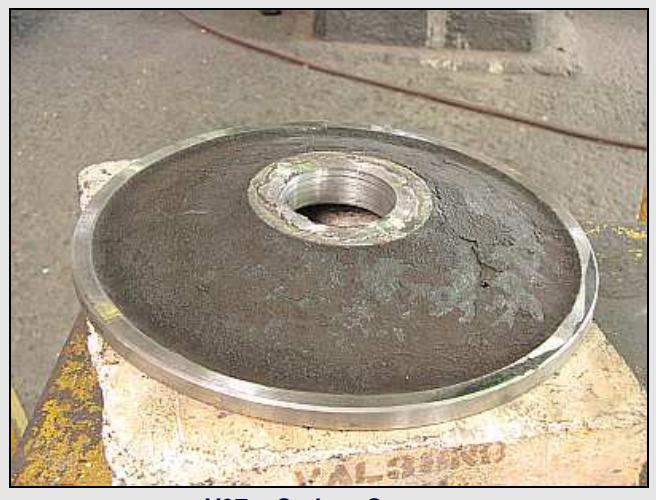
### V07 – Carbon Cone.

This scabrous, flying saucer-shaped object is one of the two conical end disks that fit into the end of the spool case to form the faces of the valve piston. The damaged bore had to be built up and then re-machined. It isn't quite finished, hence the rough looking surfaces. The multi-part valve piston concept reduces the engineering and fabricational complexity of trying to make a one-piece casing. This also means that in cases of serious damage, just like this, only the spool casing needs to be replaced.

The conical shape is actually stronger under the reciprocating forces, allows for a protected pocket of space on the spindle for the spool fasteners at top dead center as well as incidentally providing a void for condensate and oil.

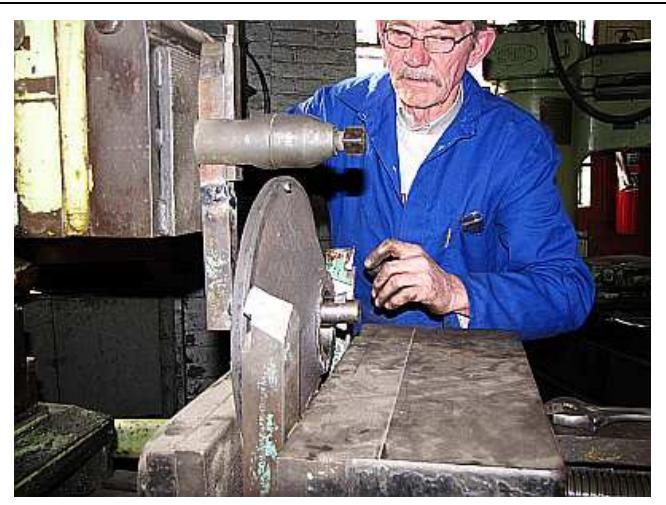
### V09 – First Stroke.

The repaired spool cap ended up with a plain bore and now has to have a new key way slot cut in. Our vintage genuine Germiston fitter, 'Lappies' is still setting up the Thule-made reciprocating shaping machine. He is having to adjust the height as well as the depth of the stroke and the angle to tool – this is a true thee-dimensional job.

Notice the locating peg at the top of the conical end cap.

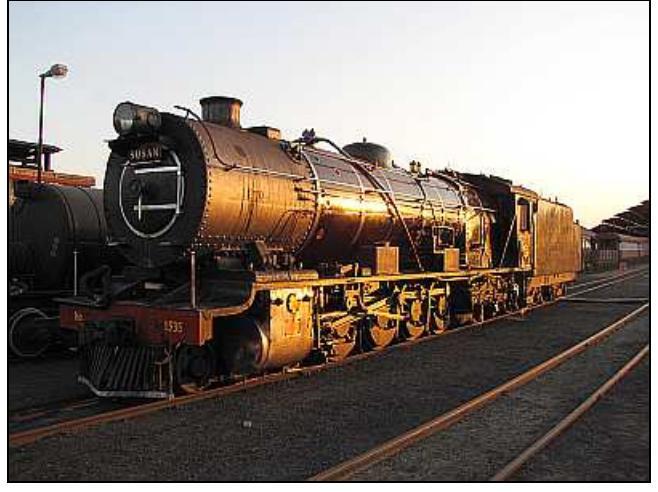
### V11 - Kindly posed by my driver.

At the time of issue of this particular report, the valve spool repair job has been completed. Class 12AR No.1535 'Susan' was tested on Friday, 20<sup>th</sup> August and did a very short revenue earning run on Saturday, 21st August, to pick up our coaches for their last leg of their journey home from the Rotary Great Train Race in Middleburg. The valves operated well and we had four beats again.

She suffered a reverser failure just as we finished up the pick-up job – the reverser going over to hard-reverse, lifting up the radius rods and staying put-O no matter were the reverser lever was put. It is suspected that the D-valve slide has come off the spindle in the actuating cylinder. We managed to get the old lady to bed under her own steam though, by putting the reverser lever linkages forward to open the cataract valve (unlock) and then manually lowering the radius rod downwards (Forward Gear) with engineer-weighted crow bars. The grand old lady at least had the decency to fail in the yards.
